NASA/TP-97-206257

The Characteristics of Fatigue Damage in the Fuselage Riveted Lap Splice Joint

Robert S. Piascik
Langley Research Center, Hampton, Virginia

November 1997

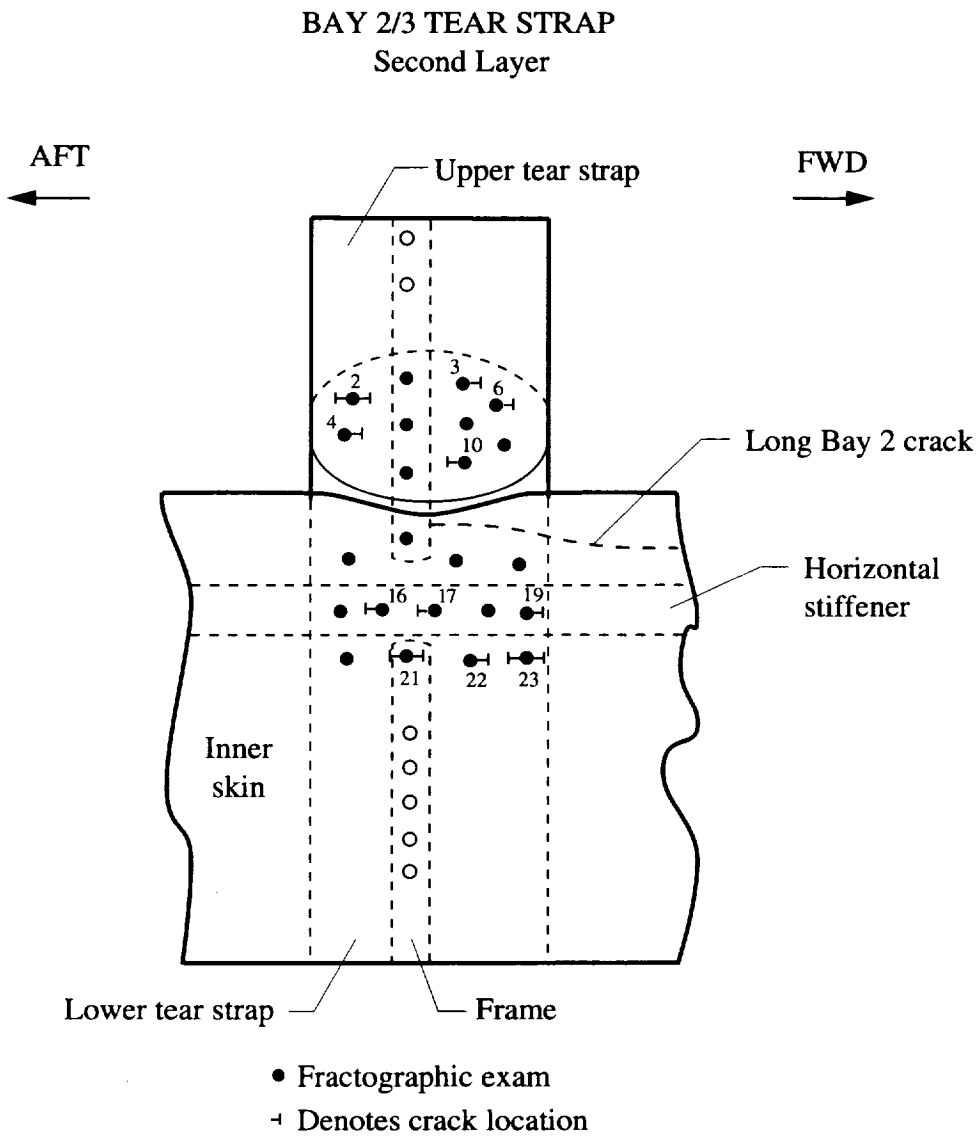
Figure 8.3 The schematic shows the location of fatigue cracks found in the second layer (upper tear strap and inner skin) of the bay 2/3 tear strap by destructive examination. The dashed dark line depicts one end of the long bay 2 crack extending into the tear strap.

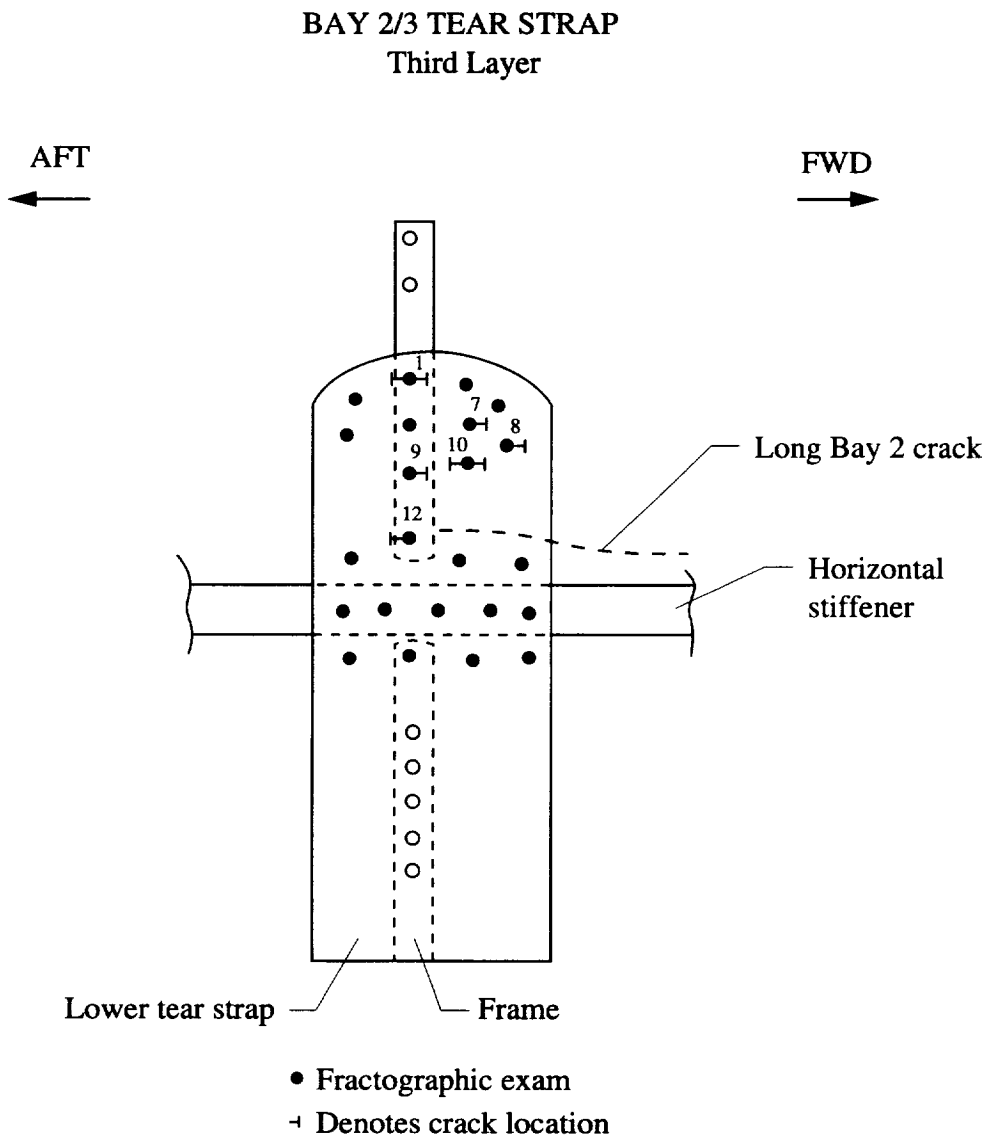
Figure 8.4 The schematic shows the location of fatigue cracks found in the third layer (lower tear strap) of the bay 2/3 tear strap by destructive examination. The dashed dark line depicts one end of the long bay 2 crack extending into the tear strap.

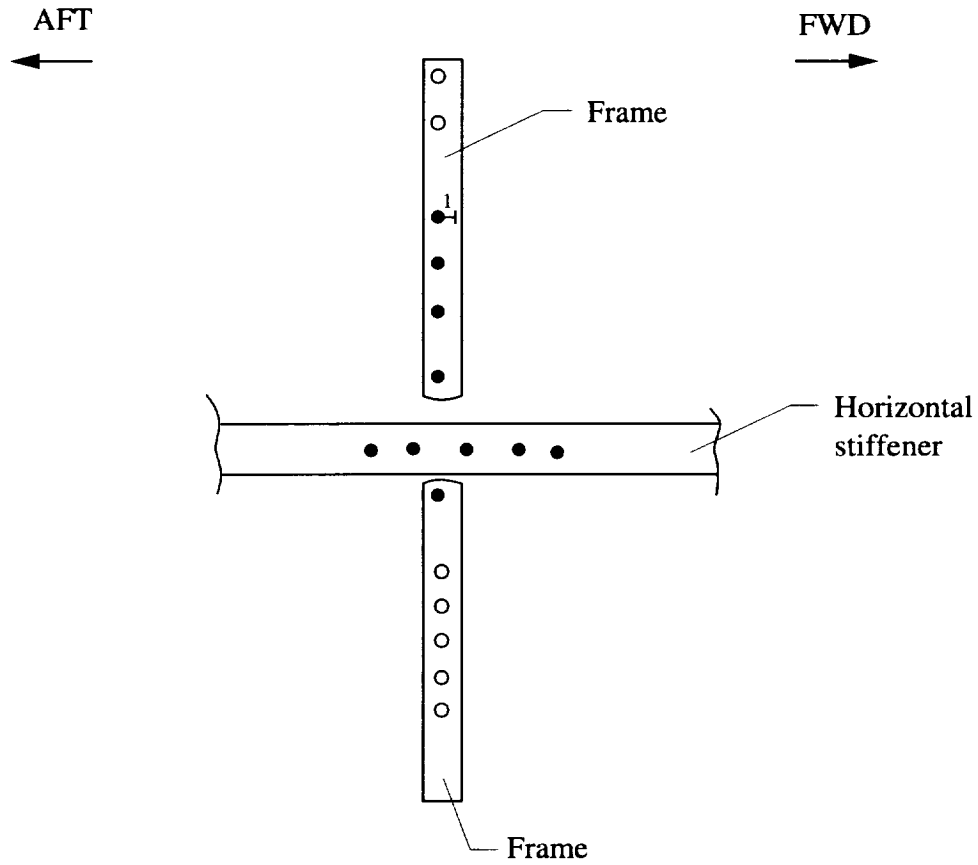
BAY 2/3 TEAR STRAP
Fourth Layer

Figure 8.5 The schematic shows the location of the single fatigue crack found in the fourth layer (frame and horizontal stiffener) of the bay 2/3 tear strap.

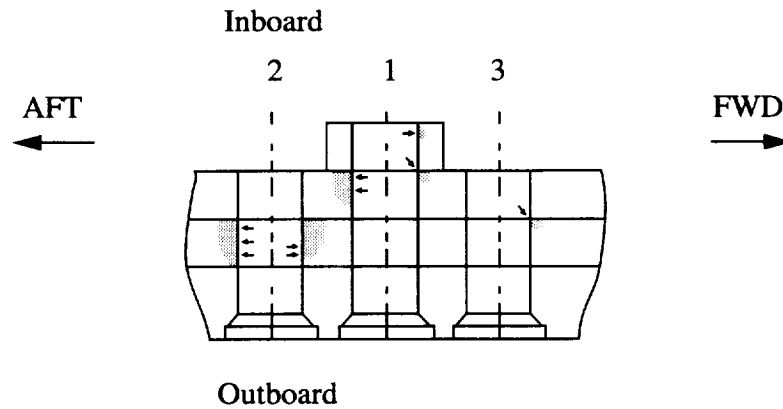
Bay 2/3 Tear Strap

Hole #	Location	Length mm (in)	Type	Initiation site
2 (Aft)	Upper tear strap	1.540 (0.061)	Through	Multiple surface
2 (Fwd)	Upper tear strap	1.470 (0.058)	Corner	Multiple surface
1 (Aft)	Lower tear strap	0.350 (0.014)	Corner	Multiple surface
1 (1Fwd)	Lower tear strap	0.209 (0.008)	Corner	Inboard Corner
1 (2Fwd)	Frame	0.052 (0.002)	Surface	Surface
3 (Fwd)	Upper tear strap	0.124 (0.005)	Corner	Inboard Corner

Figure 8.6 The through thickness schematic shows the location and initiation site of fatigue cracks found in holes number 1, 2 and 3 in the bay 2/3 tear strap. The table summarizes crack location, crack length, crack type, and initiation site for each fatigue crack shown.

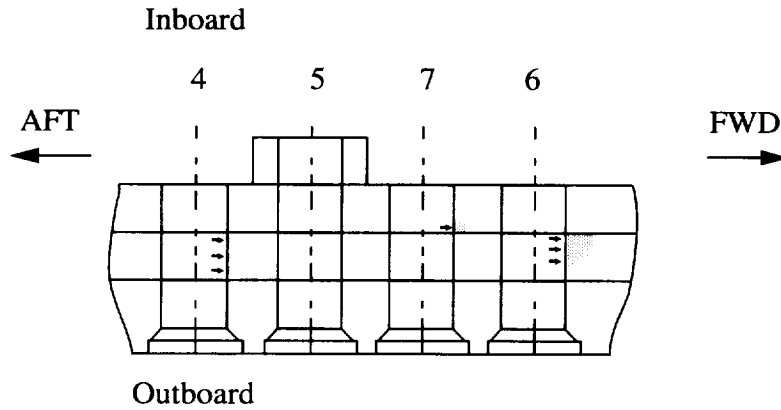
Hole #	Location	Length mm (in)	Type	Initiation site
4 (Fwd)	Upper tear strap	0.214 (0.008)	Surface	Multiple surface
6 (Fwd)	Lower tear strap	0.815 (0.032)	Corner	Surface
7 (Fwd)	Lower tear strap	0.419 (0.016)	Corner	Outboard corner

Figure 8.7 The through thickness schematic shows the location and initiation site of fatigue cracks found in holes number 4, 5, 6, and 7 in the bay 2/3 tear strap. The table summarizes crack location, crack length, crack type, and initiation site for each fatigue crack shown.

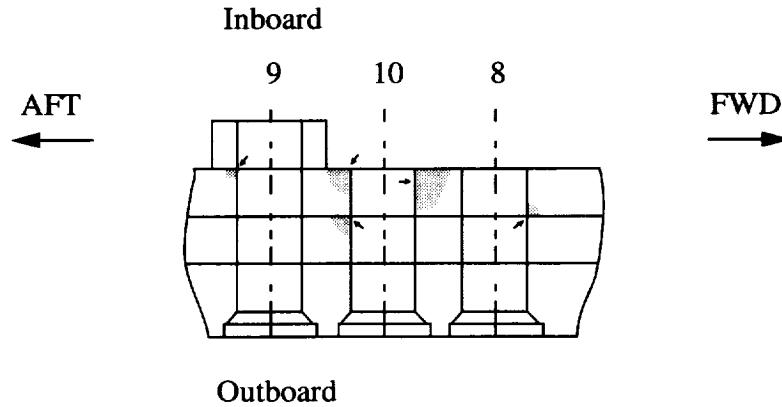
Hole #	Location	Length mm (in)	Type	Initiation site
8 (Fwd)	Lower tear strap	0.926 (0.036)	Corner	Not determined
9 (Aft)	Lower tear strap	0.143 (0.006)	Corner	Inboard Corner (IC)
10 (Aft)	Upper tear strap	0.324 (0.013)	Corner	IC
10 (Aft)	Lower tear strap	1.277 (0.057)	Corner	IC
10 (Fwd)	Lower tear strap	1.818 (0.072)	Corner	Surface

Figure 8.8 The through thickness schematic shows the location and initiation site of fatigue cracks found in holes number 8, 9 and 10 in the bay 2/3 tear strap. The table summarizes crack location, crack length, crack type, and initiation site for each fatigue crack shown.

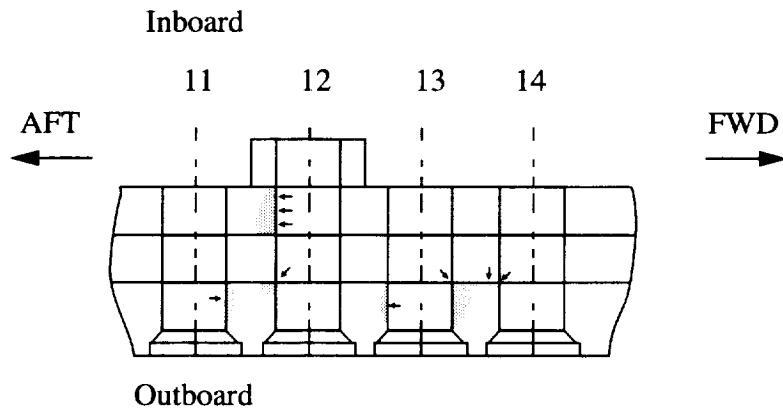
Hole #	Location	Length mm (in)	Type	Initiation site
11 (Fwd)	Outer Skin	<0.052 (<0.002)	Countersink	Center of shank
12 (Aft)	Tear strap	0.109 (0.004)	Countersink	Inboard side of shank
12 (Aft)	Inner Skin	1.190 (0.047)	Through	Multiple Surface
13 (Aft)	Outer Skin	0.214 (0.008)	Countersink	Center of shank
13 (Fwd)	Outer Skin	1.270 (0.050)	Countersink	Inboard side of shank
14 (1 Aft)	Outer Skin	0.166 (0.007)	Fretting	Inner skin / outer skin
14 (2 Aft)	Outer Skin	0.157 (0.006)	Fretting	Inner skin / outer skin

Figure 8.9 The through thickness schematic shows the location and initiation site of fatigue cracks found in holes number 11, 12, 13, and 14 in the bay 2/3 tear strap. The table summarizes crack location, crack length, crack type, and initiation site for each fatigue crack shown.

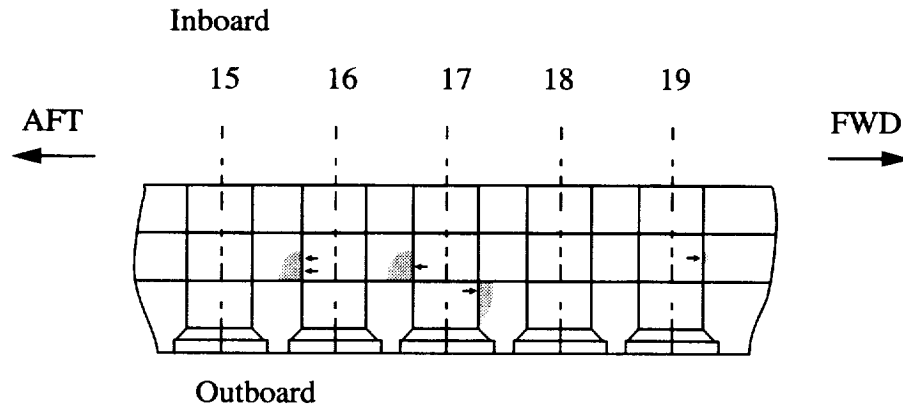
Hole #	Location	Length mm (in)	Type	Initiation site
16 (Aft)	Inner Skin	0.539 (0.021)	Corner	Multiple surface
17 (Aft)	Inner Skin	0.776 (0.031)	Corner	Surface
17 (Fwd)	Outer Skin	0.186 (0.007)	Counter sink	Inboard side of shank
19 (Fwd)	Inner Skin	0.110 (0.004)	Surface	Surface

Figure 8.10 The through thickness schematic shows the location and initiation site of fatigue cracks found in holes number 15, 16, 17, 18, and 19 in the bay 2/3 tear strap. The table summarizes crack location, crack length, crack type, and initiation site for each fatigue crack shown.

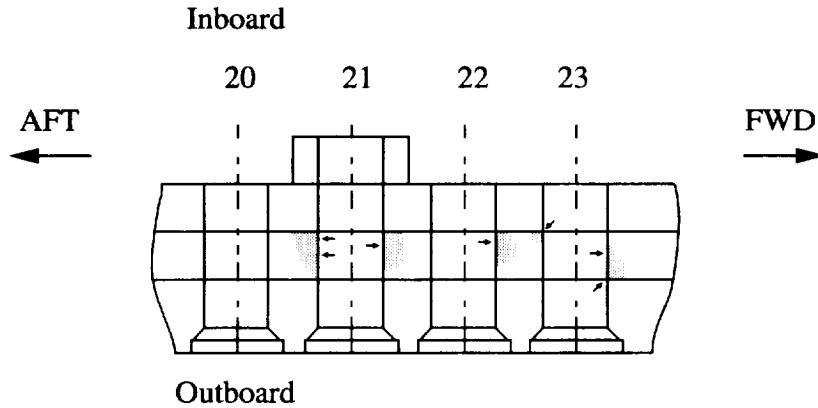
Hole #	Location	Length mm (in)	Type	Initiation site
21 (Aft)	Inner Skin	2.600 (0.102)	Through	Multiple Surface
21 (Fwd)	Inner Skin	0.532 (0.021)	Corner	Surface
22 (Fwd)	Inner Skin	0.597 (0.023)	Surface	Surface
23 (Aft)	Inner Skin	0.168 (0.007)	Corner	Inboard corner
23 (Fwd)	Inner Skin	0.686 (0.027)	Corner	Surface and corner

Figure 8.11 The through thickness schematic shows the location and initiation site of fatigue cracks found in holes number 20, 21, 22, and 23 in the bay 2/3 tear strap. The table summarizes crack location, crack length, crack type, and initiation site for each fatigue crack shown.

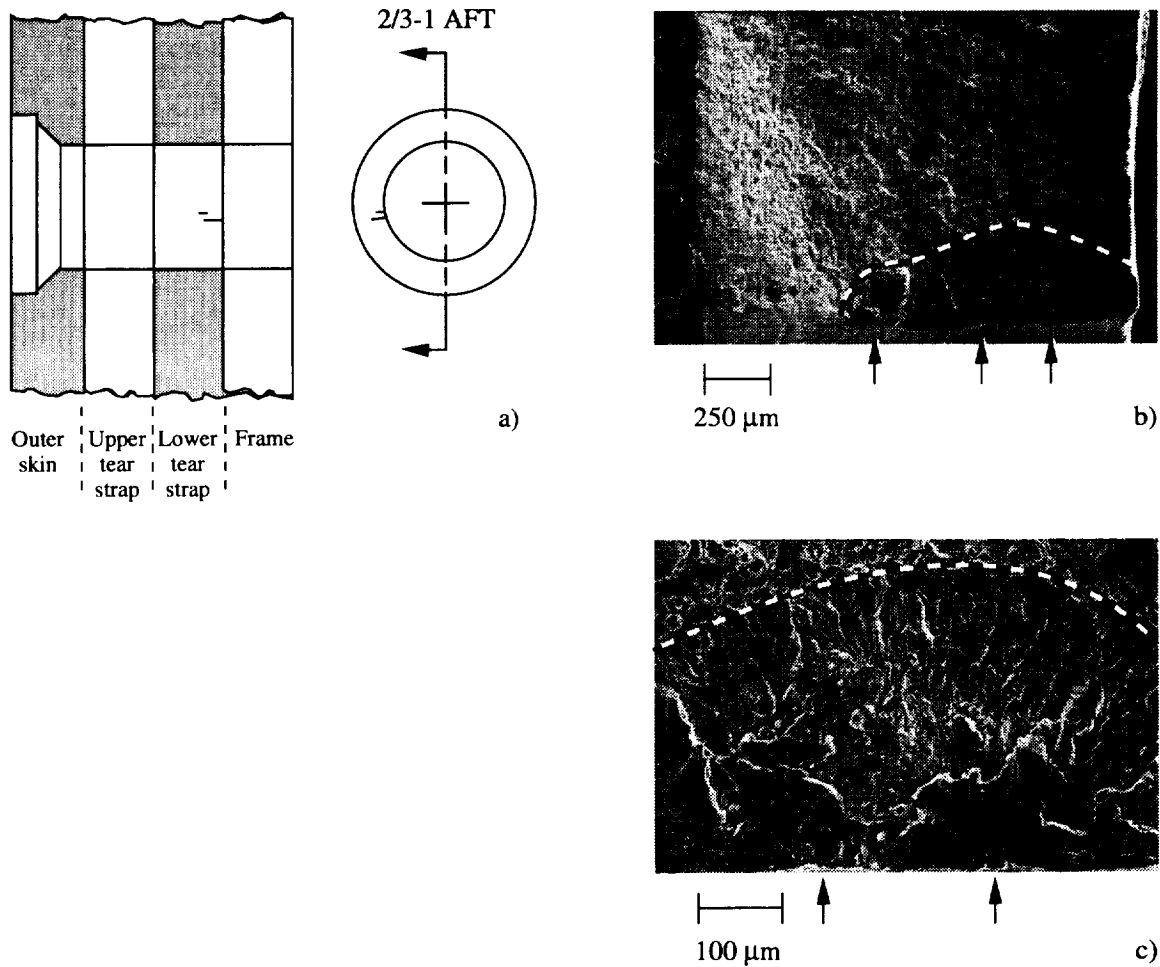
Figure 8.12 a) The schematic shows the rivet hole 2/3-1 configuration and the location of lower T.S. and frame fatigue cracks oriented in the forward direction and about the 2 o'clock position. b) The SEM micrograph shows the location of a small fatigue crack located (arrow) at the inside surface of the rivet hole. The rivet hole is located at the top of the micrograph. c) The SEM micrograph shows the fatigue crack located on the inboard corner of the lower T.S. rivet hole. The rivet hole is located at the top of the micrograph. d) The SEM micrograph shows the fatigue fracture surface of region "d" in Figure 8.12.b at high magnification.

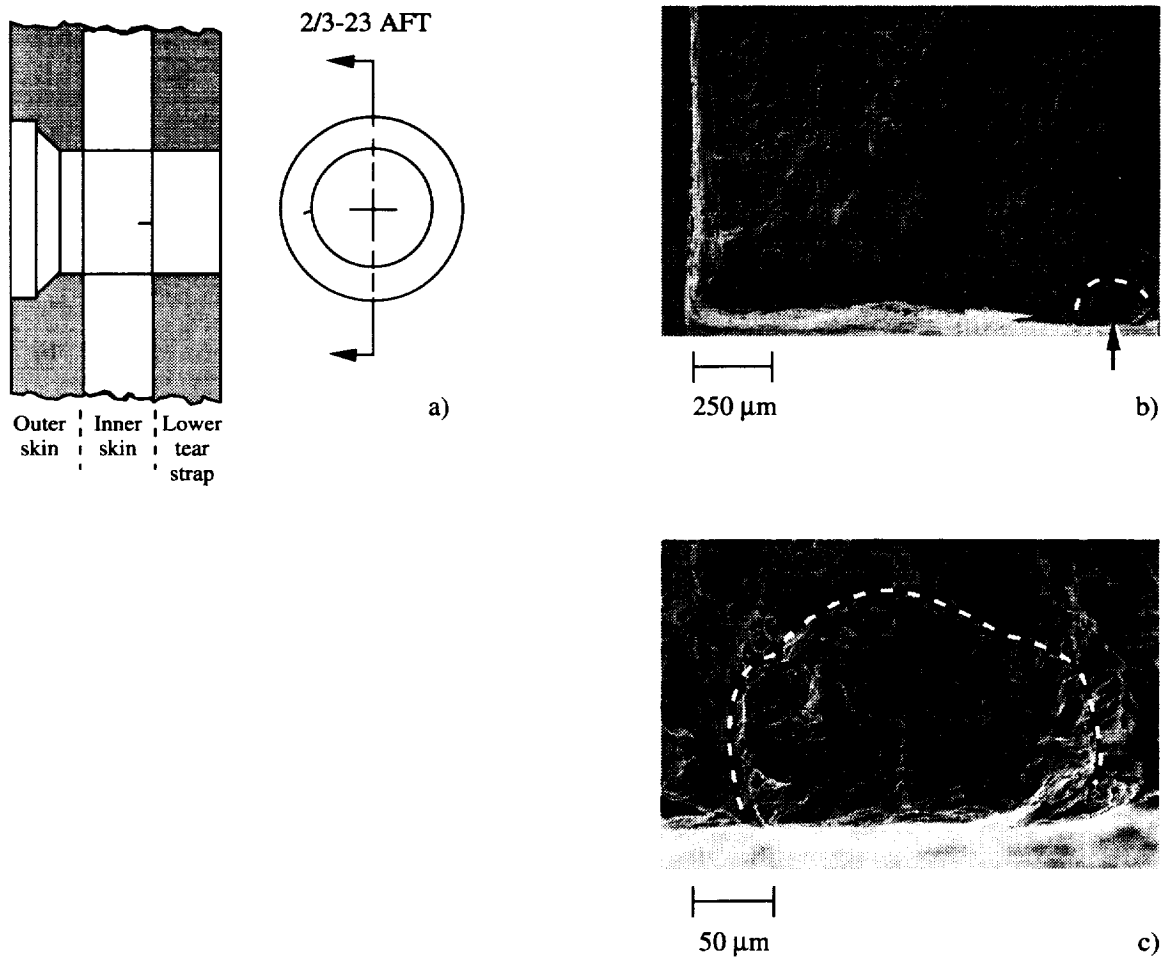
Figure 8.36 a) The schematic shows the rivet hole 2/3-23 configuration and the location of the inner skin fatigue crack oriented in the aft direction and below the 9 o'clock position. b) The SEM micrograph shows the fatigue crack fracture surface located at the inboard corner of the inner skin. The arrow marks the crack initiation site and the dashed line marks the fatigue crack front. c) The SEM micrograph shows the corner fatigue crack at higher magnification. The dashed line marks the fatigue crack front.

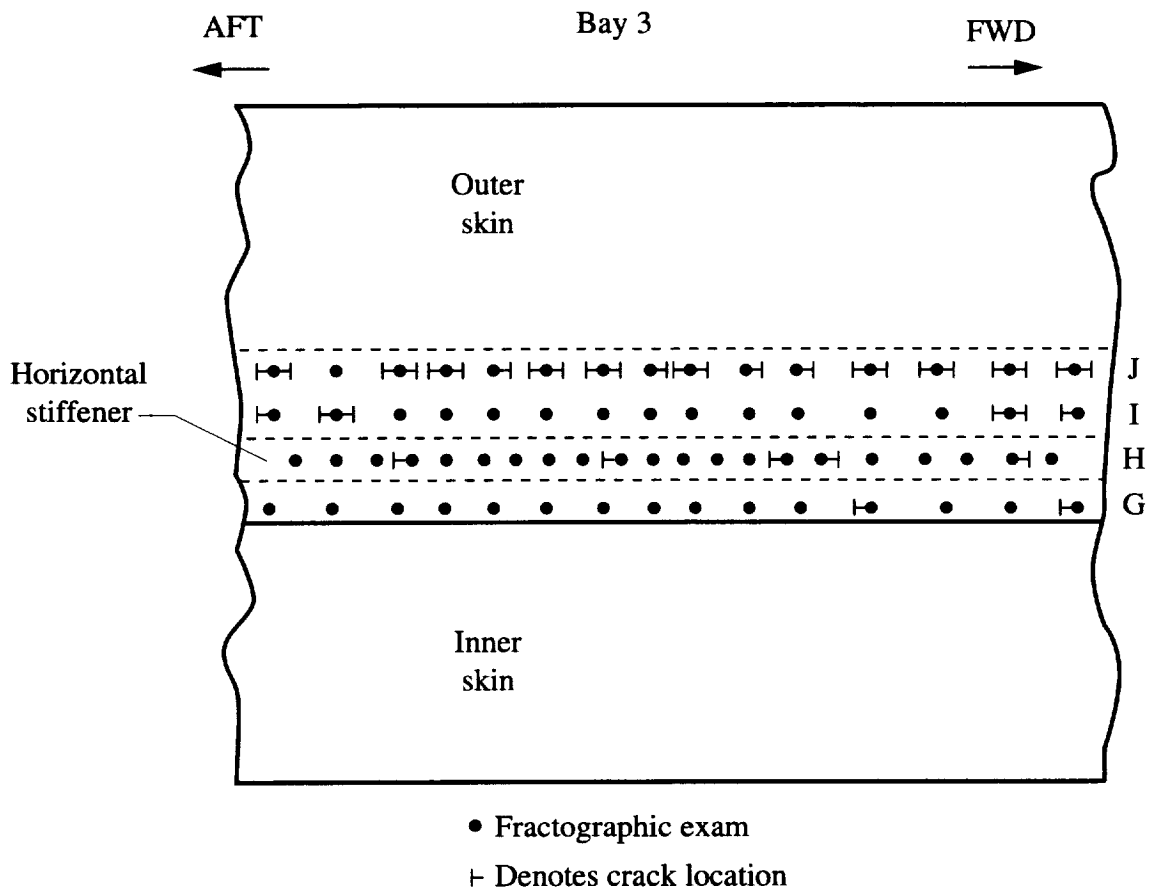
All rivet holes shown in Figure 9.1, a total of sixty-six rivet hole locations, were destructively examined. Fourteen of the fifteen upper rivet row locations exhibited fatigue cracking (a total of 24 fatigue cracks). The remaining rivet rows contained fourteen fatigue cracks in 9 rivet hole locations: six cracks in row I, six cracks in row H, and two cracks in the bottom row G. Figures 9.2 and 9.3 show the location of all fatigue cracks found in the first layer (outer skin) and the second layer (inner skin), respectively. Rivet rows J and I contained outer skin cracks and rows H and G contained both inner and outer skin cracks. The through-thickness schematics shown in Figures 9.4, 9.5, 9.6, 9.7, and 9.8 summarize crack location, crack length crack type and initiation site for rivet rows J, I, H, and G, respectively. The following is a detailed description of the fatigue damage in bay 3.

Figure 9.1 The schematic shows the location of all fatigue cracks found in the bay 3 lap splice joint by destructive examination. All bay 3 rivet holes were destructively examined.

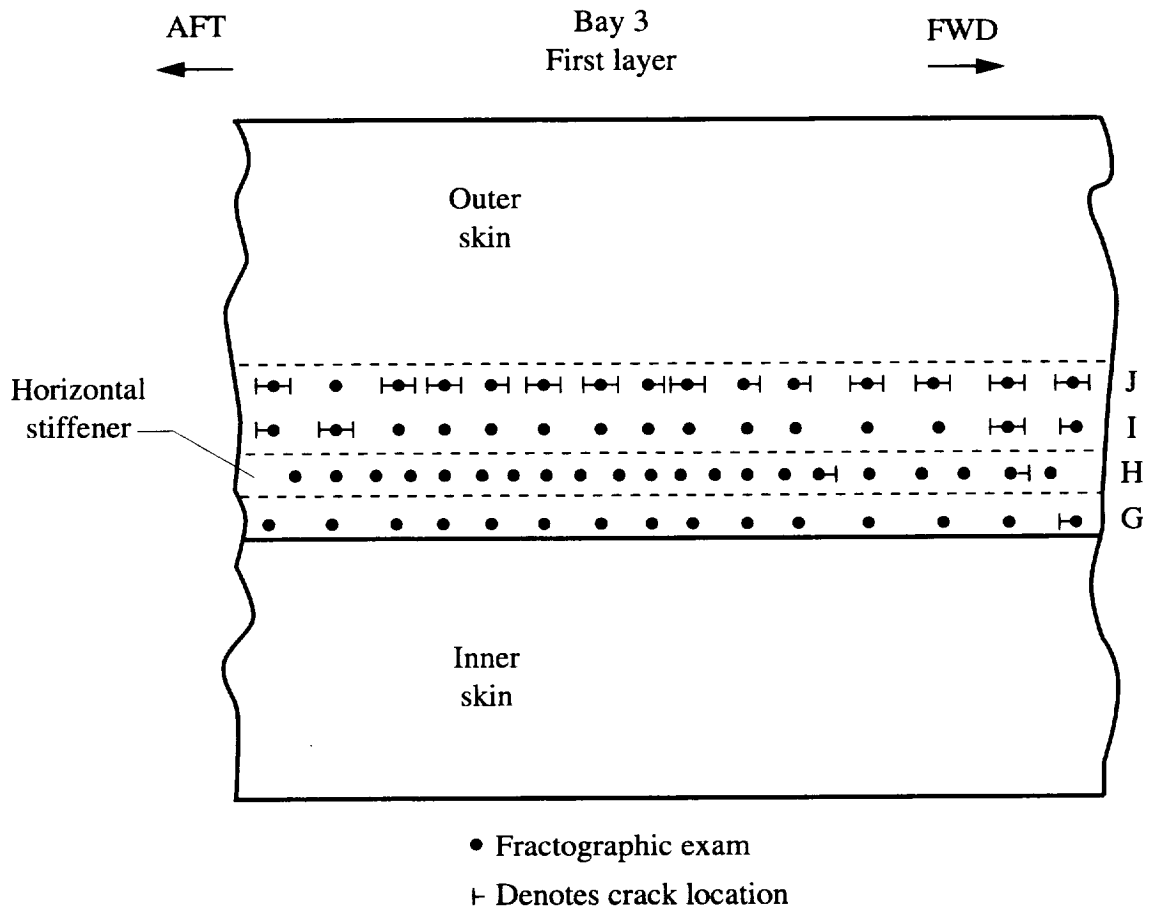
Figure 9.2 The schematic shows the location of fatigue cracks found in the first layer (outer skin) of the bay 3 lap splice joint by destructive examination.

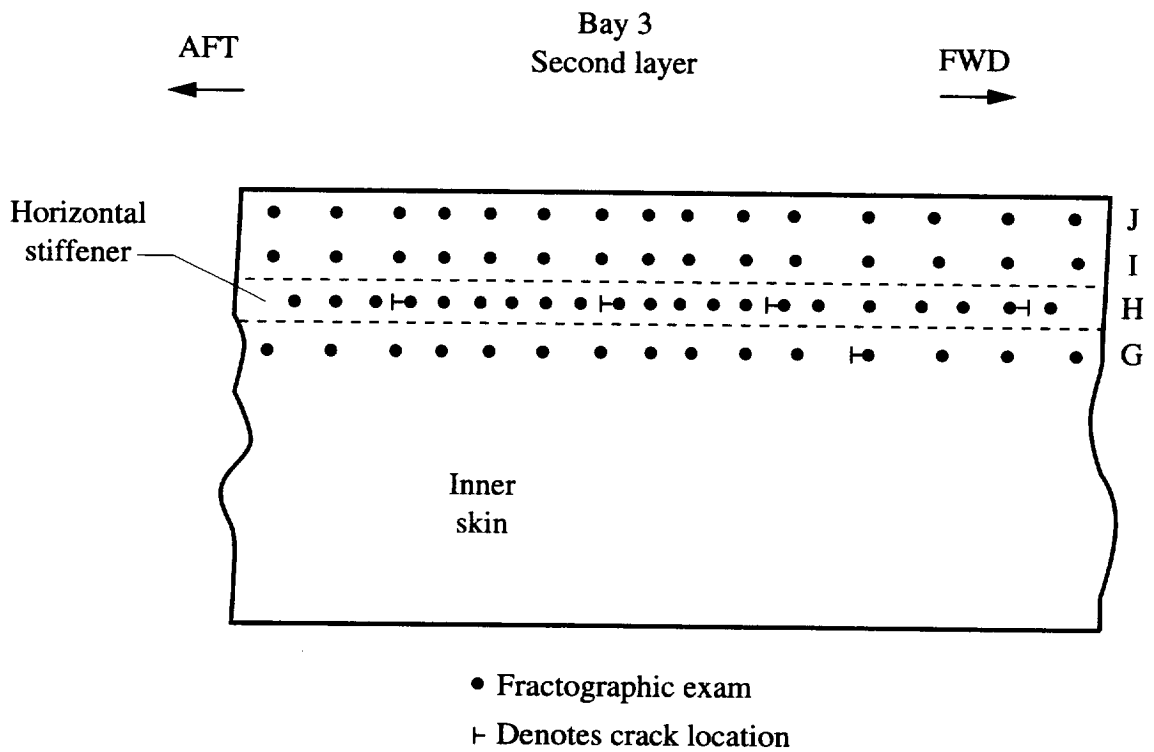
Figure 9.3 The schematic shows the location of fatigue cracks found in the second layer (inner skin) of the bay 3 lap splice joint by destructive examination.

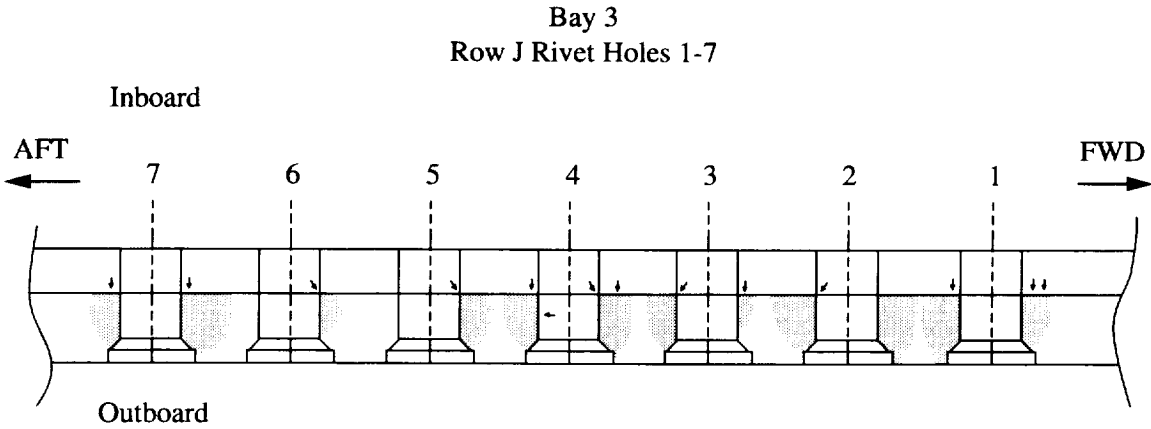
Hole #	Location	Length mm (in)	Type	Initiation site
1 (Aft)	Outer Skin	4.733 (0.186)	Through	Inner skin / outer skin
1 (Fwd)	Outer Skin	2.550 (0.100)	Through	Inner skin / outer skin
2 (Aft)	Outer Skin	2.300 (0.091)	Countersink	Inboard corner of shank
2 (Fwd)	Outer Skin	4.222 (0.166)	Through	Not determined
3 (Aft)	Outer Skin	1.625 (0.064)	Countersink	Inboard side of shank
3 (Fwd)	Outer Skin	1.071 (0.042)	Fretting	Inner skin / outer skin
4 (Aft)	Outer Skin	1.833 (0.072)	Countersink	Multiple sites
4 (Fwd)	Outer Skin	2.439 (0.096)	Countersink	Multiple sites
5 (Fwd)	Outer Skin	1.737 (0.068)	Countersink	Inner skin / outer skin
6 (Fwd)	Outer Skin	0.662 (0.026)	Countersink	Inboard side of shank
7 (Aft)	Outer Skin	1.419 (0.056)	Countersink	Inner skin / outer skin
7 (Fwd)	Outer Skin	2.500 (0.098)	Fretting	Inner skin / outer skin

Figure 9.4 The through thickness schematic shows the location and initiation site of fatigue cracks found in rivet row J (holes 1-7) of bay 3. The table summarizes crack location, crack length, crack type, and initiation site for each fatigue crack shown.

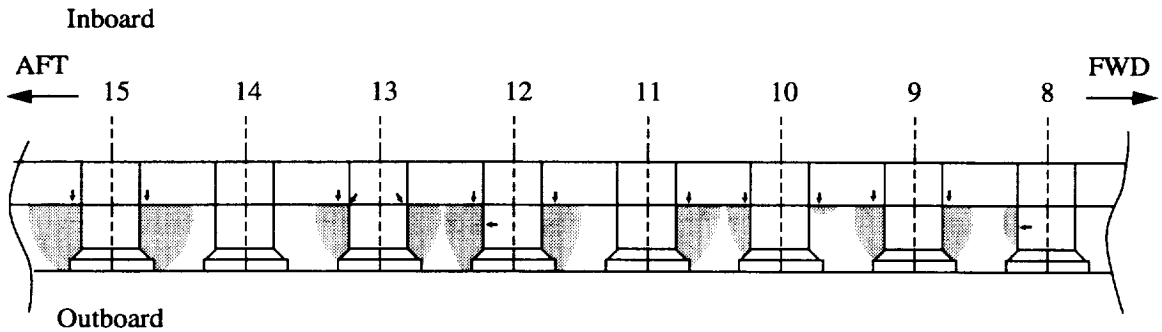
Bay 3
Row J Rivet Holes 8-15

Hole #	Location	Length mm (in)	Type	Initiation site
8 (Aft)	Outer Skin	0.742 (0.029)	Countersink	Center of shank
9 (Aft)	Outer Skin	1.737 (0.068)	Countersink	Inner skin / outer skin
9 (Fwd)	Outer Skin	1.130 (0.044)	Countersink	Inner skin / outer skin
10 (Aft)	Outer Skin	0.905 (0.036)	Countersink	Inner skin / outer skin
10 (Fwd)	Outer Skin	0.307 (0.012)	Fretting	Inner skin / outer skin
11 (Fwd)	Outer Skin	4.160 (0.164)	Countersink	Inner skin / outer skin
12 (Aft)	Outer Skin	3.220 (0.127)	Through	Multiple sites
12 (Fwd)	Outer Skin	4.890 (0.192)	Through	Inner skin / outer skin
13 (Aft)	Outer Skin	2.030 (0.080)	Countersink	Multiple sites
13 (Fwd)	Outer Skin	2.500 (0.098)	Countersink	Inner skin / outer skin
15 (Aft)	Outer Skin	3.040 (0.120)	Through	Inner skin / outer skin
15 (Fwd)	Outer Skin	2.980 (0.115)	Through	Inner skin / outer skin

Figure 9.5 The through thickness schematic shows the location and initiation site of fatigue cracks found in rivet row J (holes 8-15) of bay 3. The table summarizes crack location, crack length, crack type, and initiation site for each fatigue crack shown.

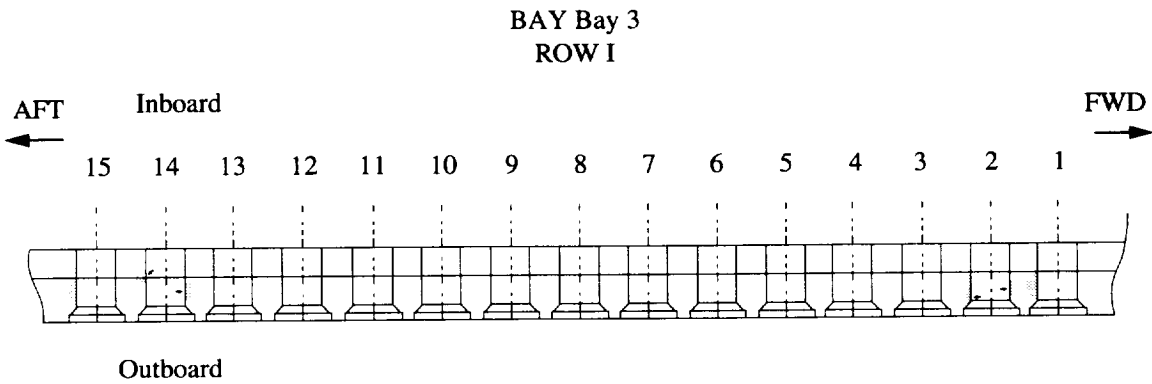
Hole #	Location	Length mm (in)	Type	Initiation site
1 (Aft)	Outer Skin	Not determined	Countersink	Not determined
2 (Aft)	Outer Skin	0.336 (0.013)	Countersink	Outboard side of shank
2 (Fwd)	Outer Skin	0.088 (0.003)	Countersink	Center of shank
14 (Aft)	Outer Skin	0.084 (0.003)	Countersink	Inboard side of shank
14 (Fwd)	Outer Skin	0.174 (0.007)	Countersink	Center of shank
15 (Aft)	Outer Skin	0.148 (0.006)	Countersink	Center of shank

Figure 9.6 The through thickness schematic shows the location and initiation site of fatigue cracks found in rivet row I of bay 3. The table summarizes crack location, crack length, crack type, and initiation site for each fatigue crack shown.

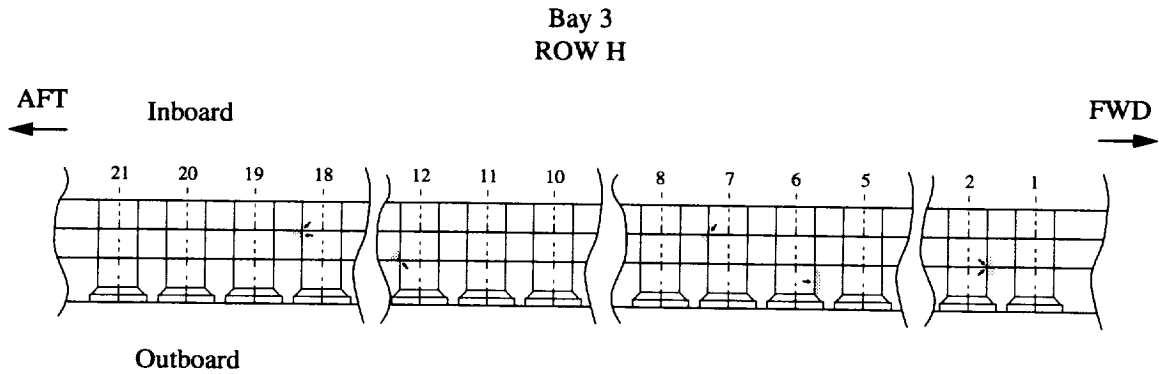
Hole #	Location	Length mm(in)	Type	Initiation site
2(1 Fwd)	Inner skin	0.246 (0.010)	Corner	Outboard corner
2(2 Fwd)	Outer skin	0.055 (0.002)	Countersink	Inboard corner of shank
6(Fwd)	Outer skin	0.125 (0.005)	Countersink	Center of shank
7(Aft)	Inner skin	0.183 (0.007)	Corner	Inboard corner
12(Aft)	Inner skin	0.170 (0.007)	Corner	Outboard corner
18(Aft)	Inner skin	0.184 (0.007)	Corner/surface	Corner and surface

Figure 9.7 The through thickness schematic shows the location and initiation site of fatigue cracks found in rivet row H of bay 3. The table summarizes crack location, crack length, crack type, and initiation site for each fatigue crack shown.

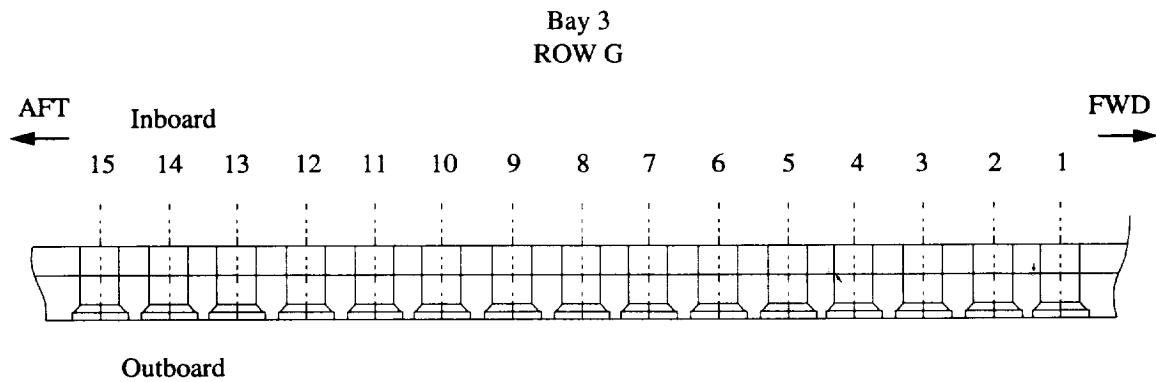
Hole #	Location	Length mm(in)	Type	Initiation site
1(Aft)	Countersink	0.091 (0.004)	Fretting	Inner skin/outer skin
4(Aft)	Inner skin	0.120 (0.005)	Corner	Outboard corner

Figure 9.8 The through thickness schematic shows the location and initiation site of fatigue cracks found in rivet row G of bay 3. The table summarizes crack location, crack length, crack type, and initiation site for each fatigue crack shown.

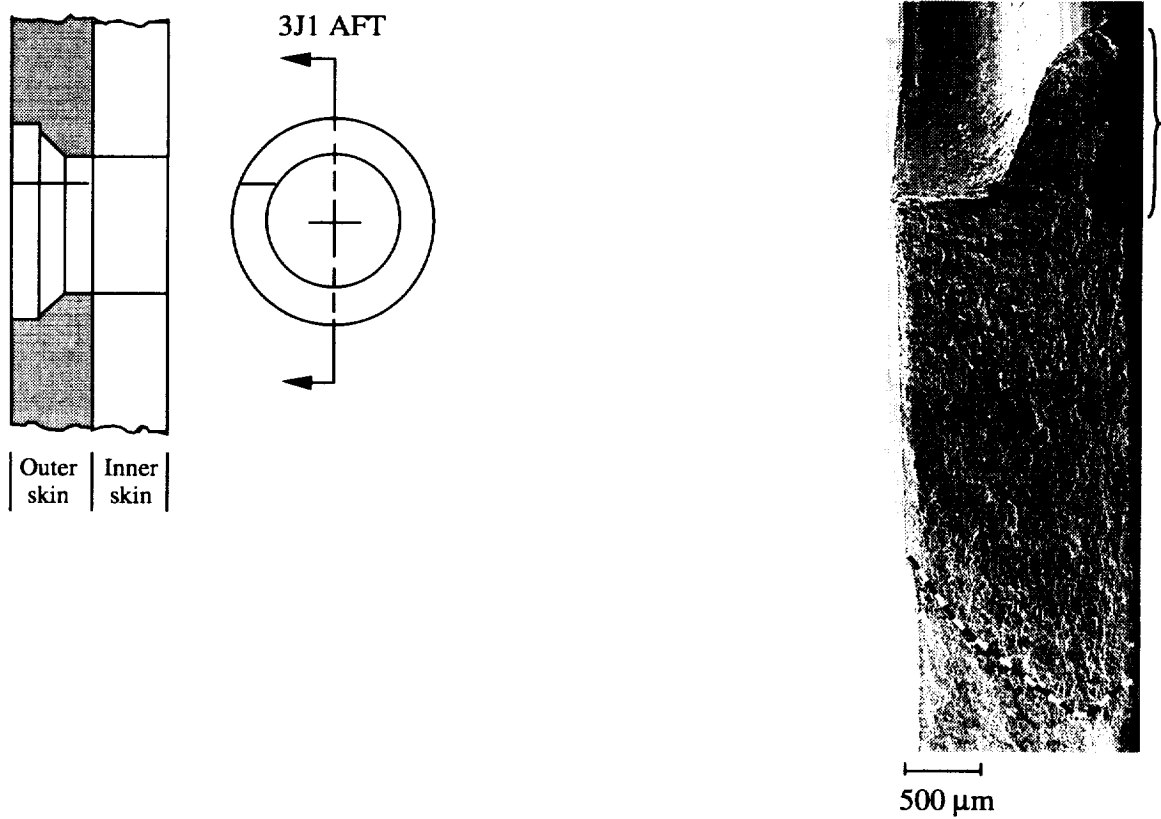
Figure 9.9 a) The schematic shows the rivet hole 3J1 configuration and the location of the outer skin fatigue crack oriented in the aft direction and about the 10 o'clock position. b) The SEM micrograph shows the through-thickness fatigue crack and the rivet hole (top). The bracket shows the likely crack initiation region along the faying surface and the dashed line marks the fatigue crack front. Considerable oxide was noted in the region of crack initiation.

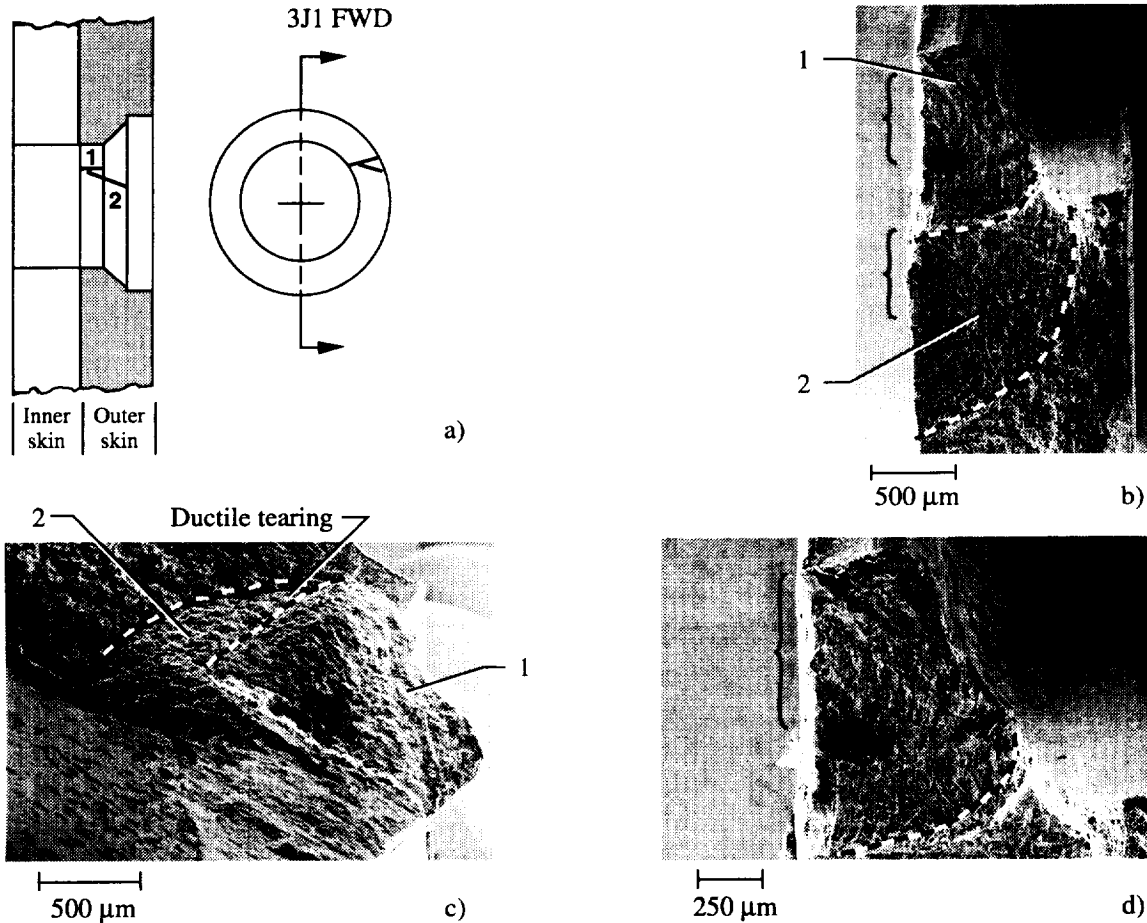
Figure 9.10 a) The schematic shows the rivet hole 3J1 configuration and the location of two outer skin fatigue cracks oriented in the forward direction and about the 2 o'clock position. b) The SEM micrograph shows the fracture surface of two (1 & 2) fatigue cracks and the rivet hole (top). The dashed lines mark both fatigue crack fronts. Brackets identify the crack initiation regions of both cracks along the faying surface. c) The SEM micrograph shows the fatigue fracture surface at an oblique angle. The dashed line marks a region of ductile tearing, suggesting that a portion of the crack fronts had not joined until this region was destructively examined. d) The SEM micrograph shows the fracture surface of crack #1 and the region of crack initiation (bracket) at higher magnification.

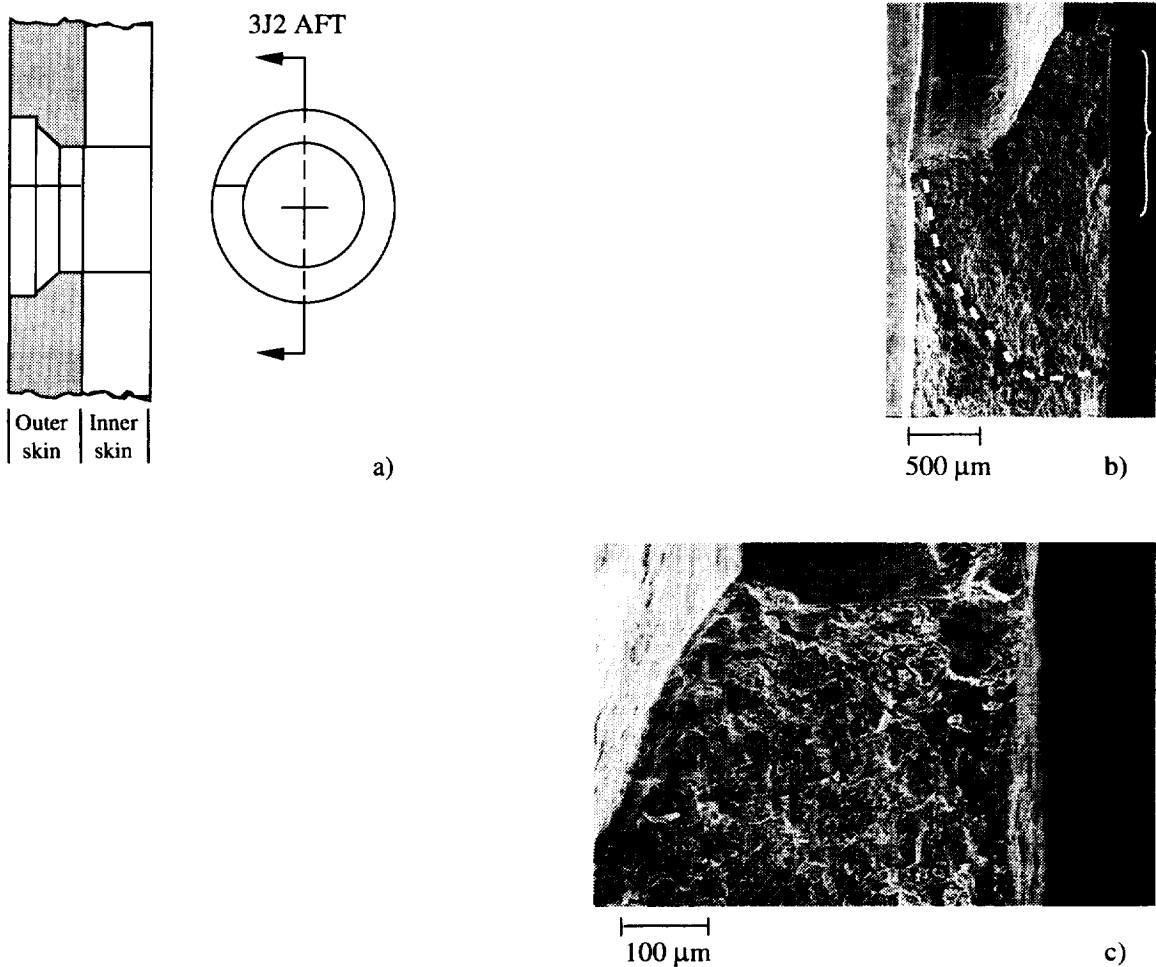
Figure 9.12 a) The schematic shows the rivet hole 3J2 configuration and the location of the outer skin fatigue crack oriented in the aft direction and about the 10 o'clock position. b) The SEM micrograph shows the through-thickness fatigue crack and the rivet hole (top). The bracket shows the likely crack initiation region along the faying surface and the dashed line marks the fatigue crack front. c) The SEM micrograph shows the rivet hole shank region at higher magnification.

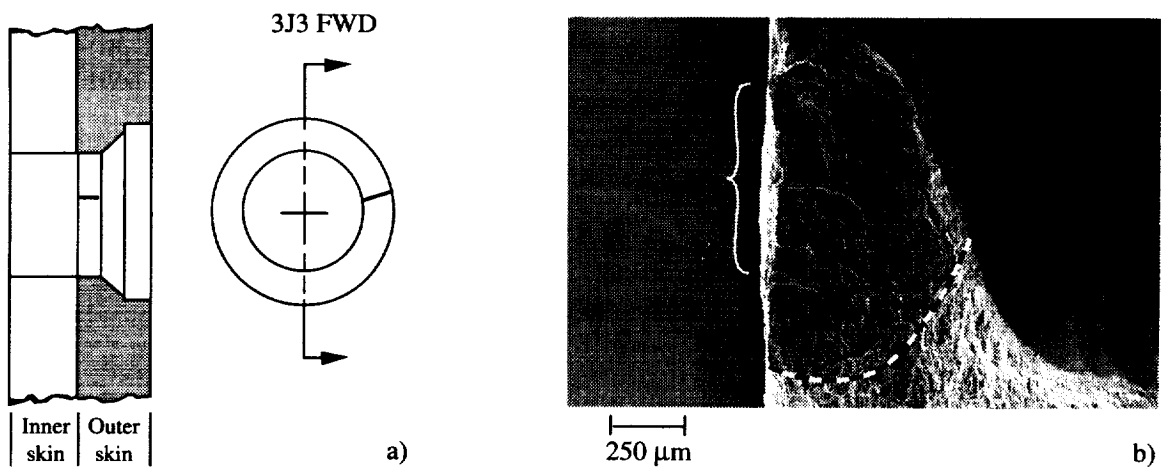
Figure 9.13 a) The schematic shows the rivet hole 3J3 configuration and the location of the outer skin fatigue crack oriented in the forward direction above the 3 o'clock position. b) The SEM micrograph shows the fatigue crack located at the rivet hole. The bracket shows the likely crack initiation region along the faying surface and the dashed line marks the fatigue crack front.

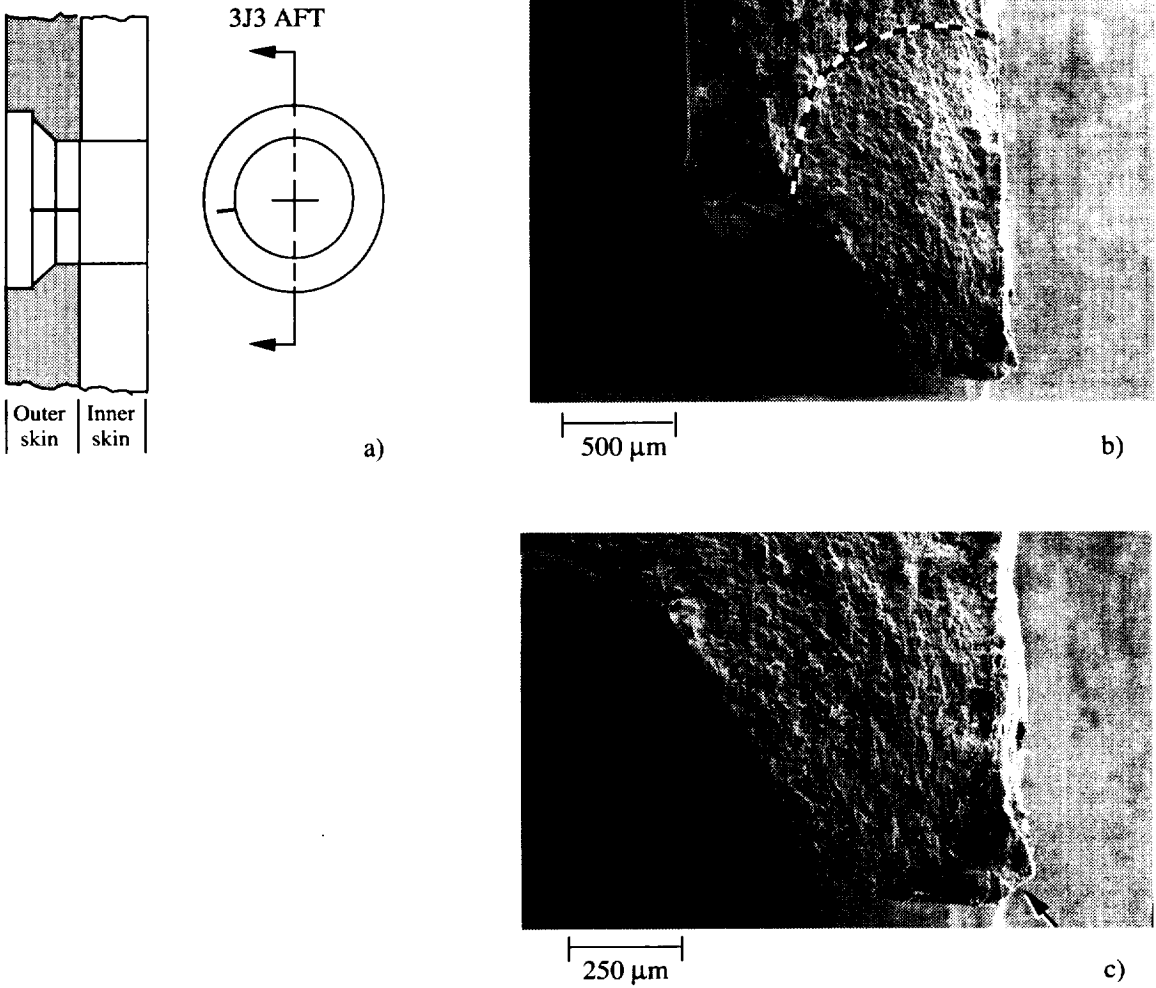
Figure 9.14 a) The schematic shows the rivet hole 3J3 configuration and the location of the outer skin fatigue crack oriented in the aft direction below the 9 o'clock position. b) The SEM micrograph shows the fatigue crack located at the rivet hole. The dashed line marks the fatigue crack front. c) The SEM micrograph shows the fatigue crack fracture surface at the rivet hole shank region. The arrow marks the likely region of crack initiation at the inboard corner of the rivet hole.

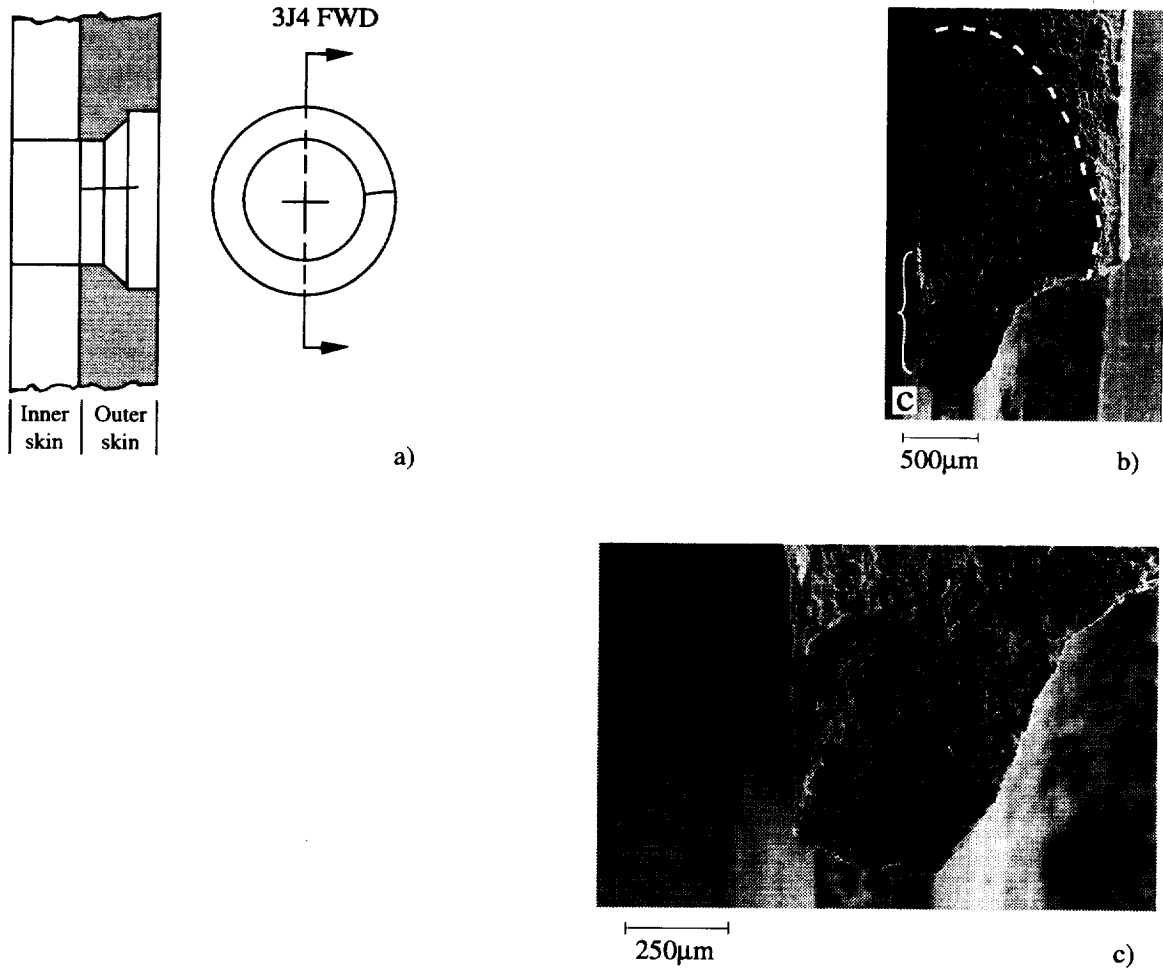
Figure 9.15 a) The schematic shows the rivet hole 3J4 configuration and the location of the outer skin fatigue crack oriented in the forward direction above the 3 o'clock position. b) The SEM micrograph shows the fatigue crack at the rivet hole (bottom). The bracket shows the likely crack initiation region along the faying surface and the dashed line marks the fatigue crack front. c) The SEM micrograph shows the fatigue crack fracture surface at the rivet hole shank region.
