NASA/TP-97-206257

The Characteristics of Fatigue Damage in the Fuselage Riveted Lap Splice Joint

Robert S. Piascik
Langley Research Center, Hampton, Virginia

November 1997

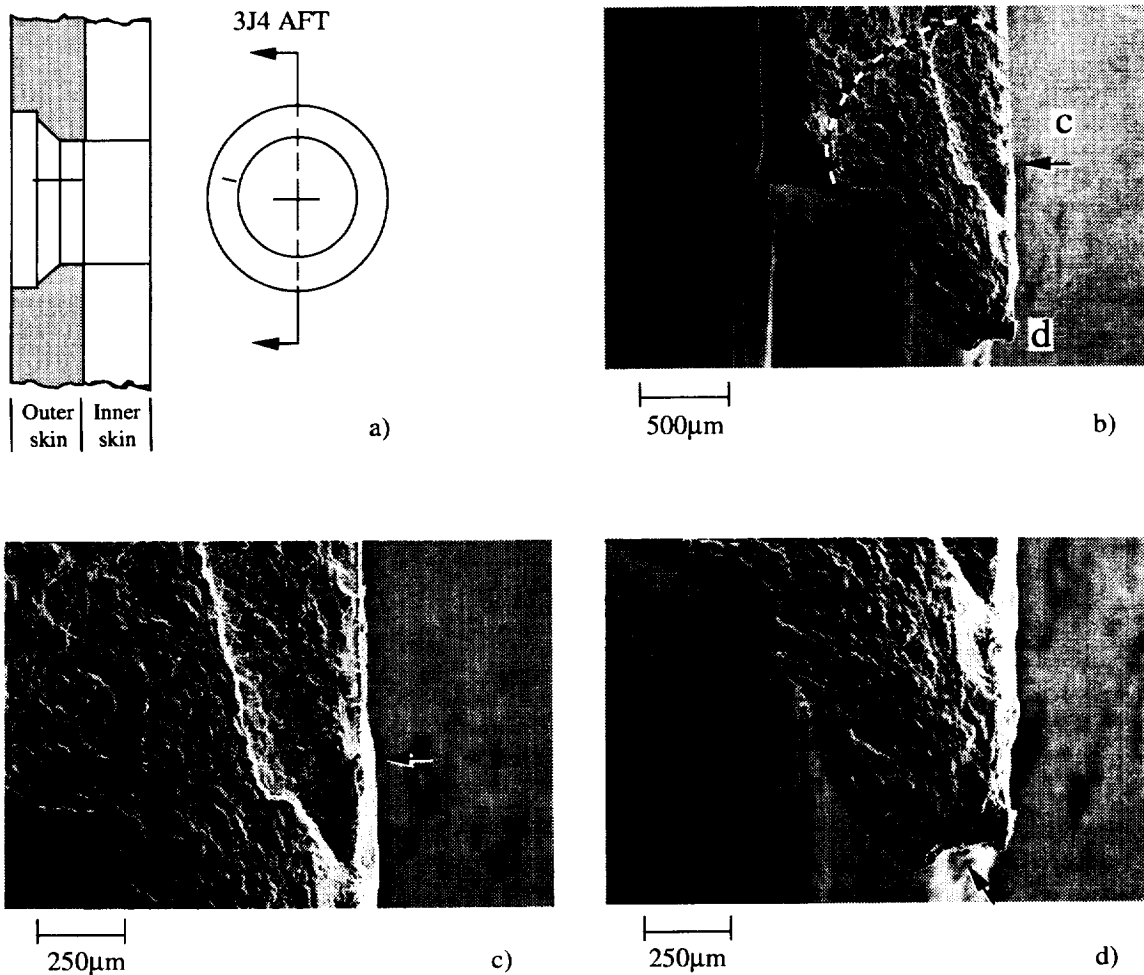
Figure 9.16 a) The schematic shows the rivet hole 3J4 configuration and the location of the outer skin fatigue crack oriented in the aft direction and about the 10 o'clock position. b) The SEM micrograph shows the fatigue crack at the rivet hole (bottom). The micrograph reveals that cracking occurred along two fracture planes ("c" and "d"). An arrow marks the likely crack initiation region for crack "c" along the faying surface. The dashed line marks the fatigue crack front. c) The SEM micrograph shows the fatigue crack surface at region "c". The arrow marks the likely crack initiation site along the faying surface. d) The SEM micrograph shows the fatigue crack surface at the rivet hole shank region "d" in Figure 9.16.b. The arrow marks the likely region of crack initiation.

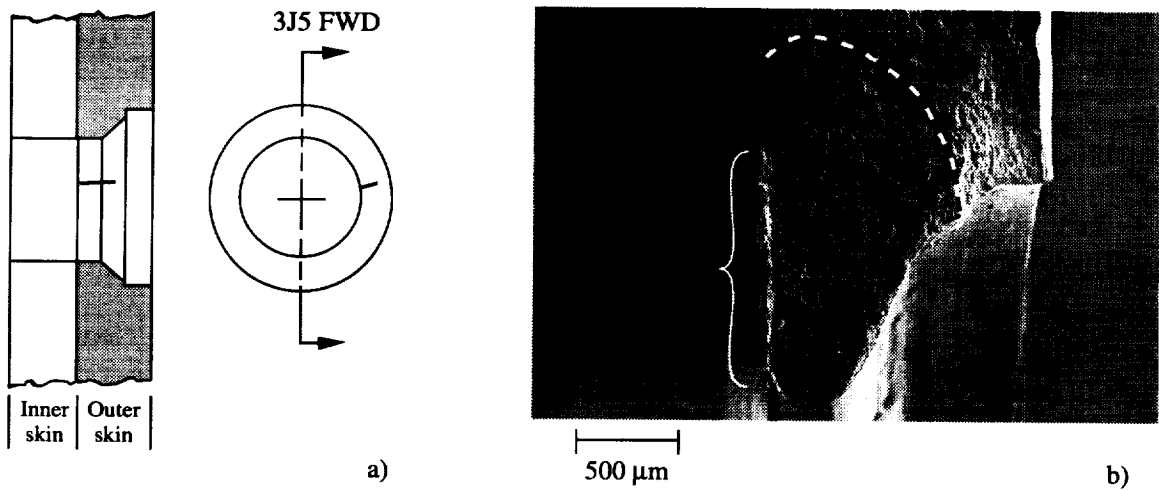
Figure 9.17 a) The schematic shows the rivet hole 3J5 configuration and the location of the outer skin fatigue crack oriented in the forward direction above the 3 o'clock position. b) The SEM micrograph shows the fatigue crack at the rivet hole (bottom). The bracket shows the likely crack initiation region along the faying surface and the dashed line marks the fatigue crack front.

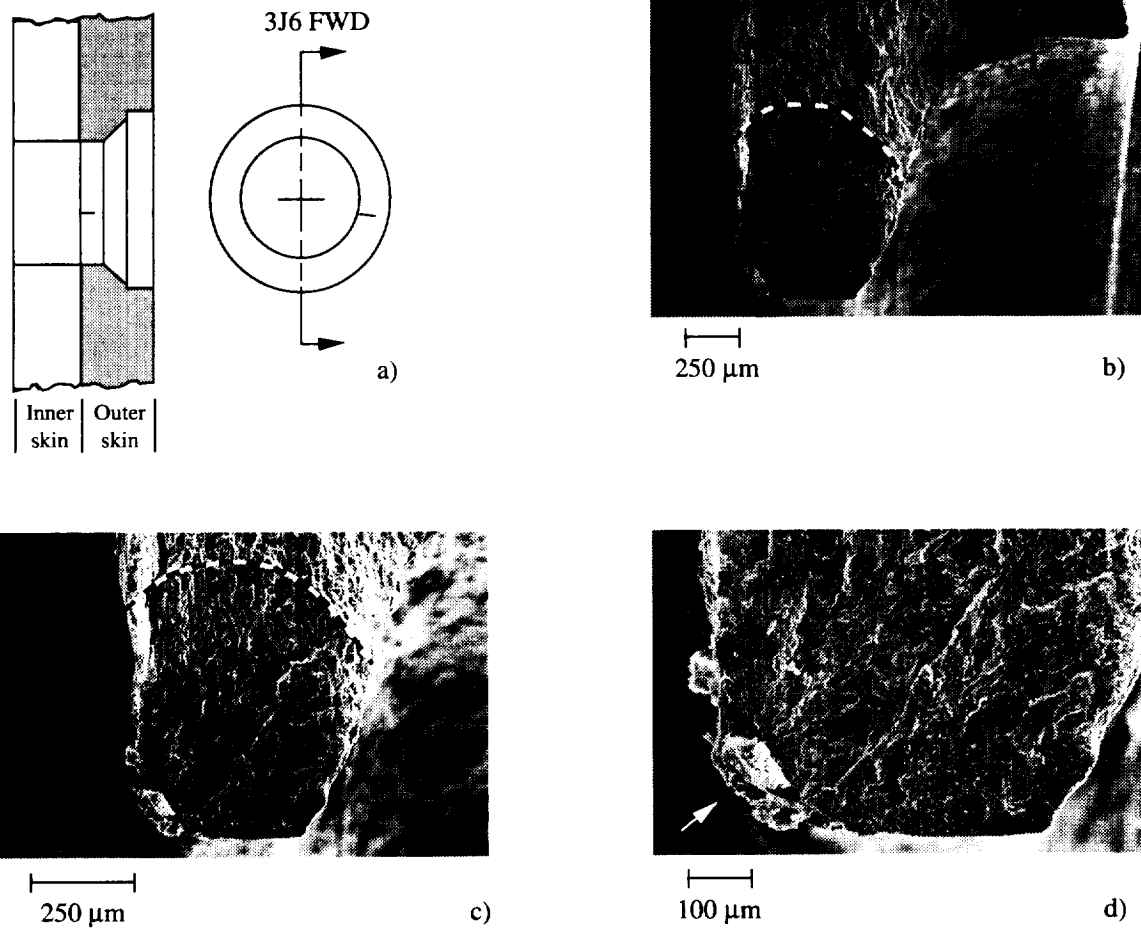
Figure 9.18 a) The schematic shows the rivet hole 3J6 configuration and the location of the outer skin fatigue crack oriented in the forward direction below the 3 o'clock position. b) The SEM micrograph shows the fatigue crack at the rivet hole. The dashed line marks the fatigue crack front. c) The SEM micrograph shows the fatigue crack fracture surface at the rivet hole shank region. The dashed line marks the fatigue crack front. d) The SEM micrograph shows the crack initiation site at the inboard corner of the rivet hole (arrow) at high magnification.

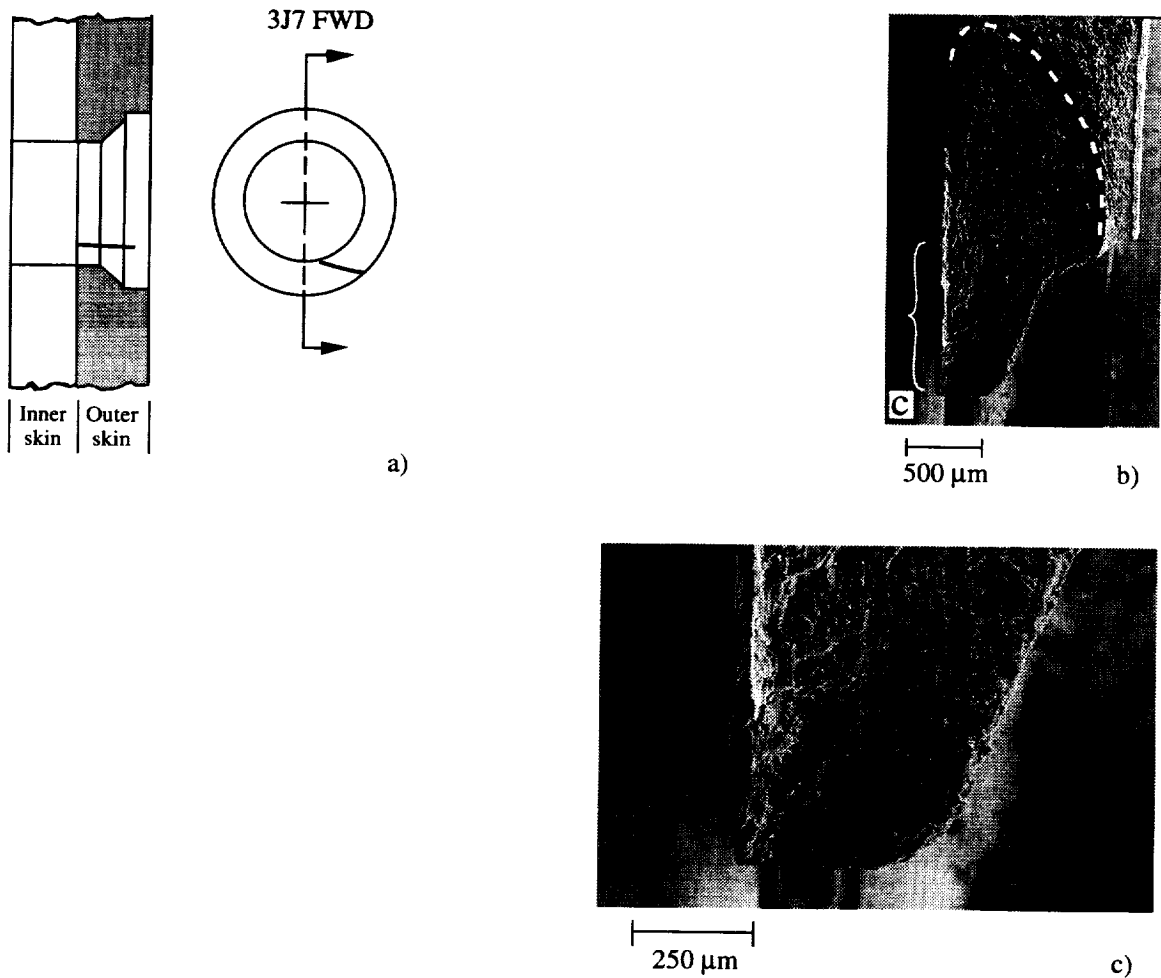
Figure 9.19 a) The schematic shows the rivet hole 3J7 configuration and the location of the outer skin fatigue crack oriented in the forward direction and about the 5 o'clock position. b) The SEM micrograph shows the fatigue crack at the rivet hole (bottom). The bracket shows the likely crack initiation region along the faying surface and the dashed line marks the fatigue crack front. c) The SEM micrograph shows the fatigue crack fracture surface at the rivet hole shank region.

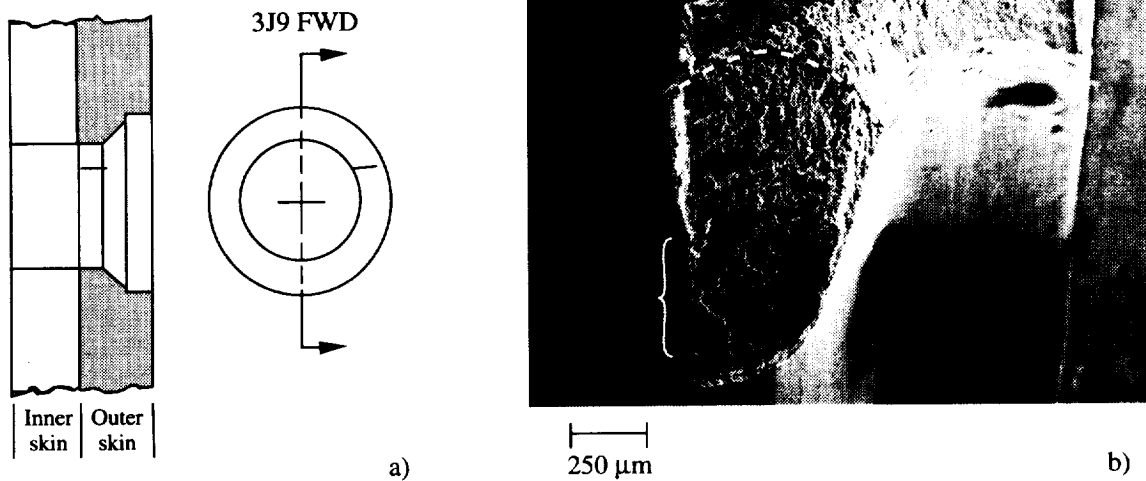
Figure 9.22 a) The schematic shows the rivet hole 3J9 configuration and the location of the outer skin fatigue crack oriented in the forward direction and about the 2 o'clock position. b) The SEM micrograph shows the fatigue crack at the rivet hole (bottom). The bracket shows the likely crack initiation region along the faying surface and the dashed line marks the fatigue crack front.

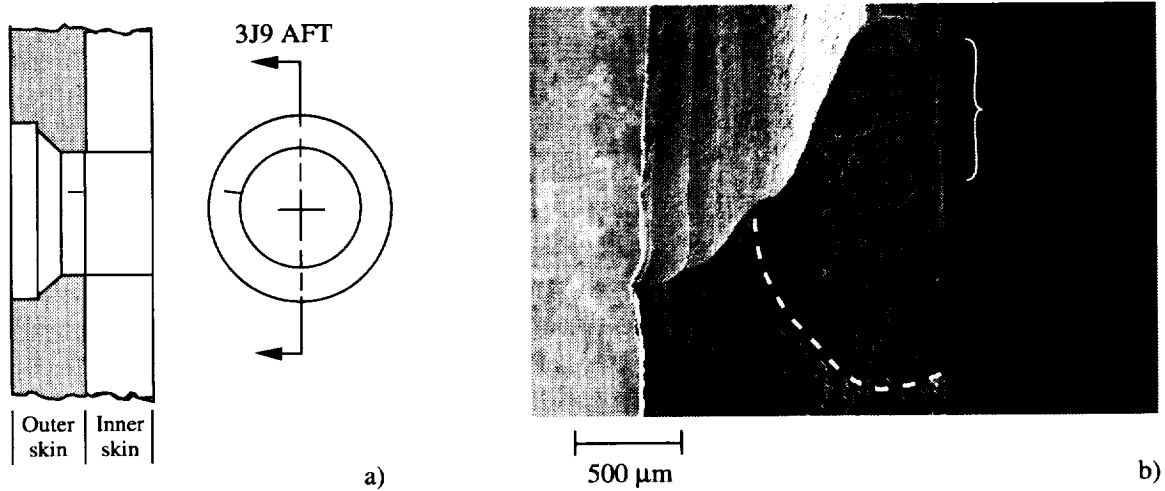
Figure 9.23 a) The schematic shows the rivet hole 3J9 configuration and the location of the outer skin fatigue crack oriented in the aft direction above the 9 o'clock position. b) The SEM micrograph shows the fatigue crack at the rivet hole (top). The bracket shows the likely crack initiation region along the faying surface and the dashed line marks the fatigue crack front.

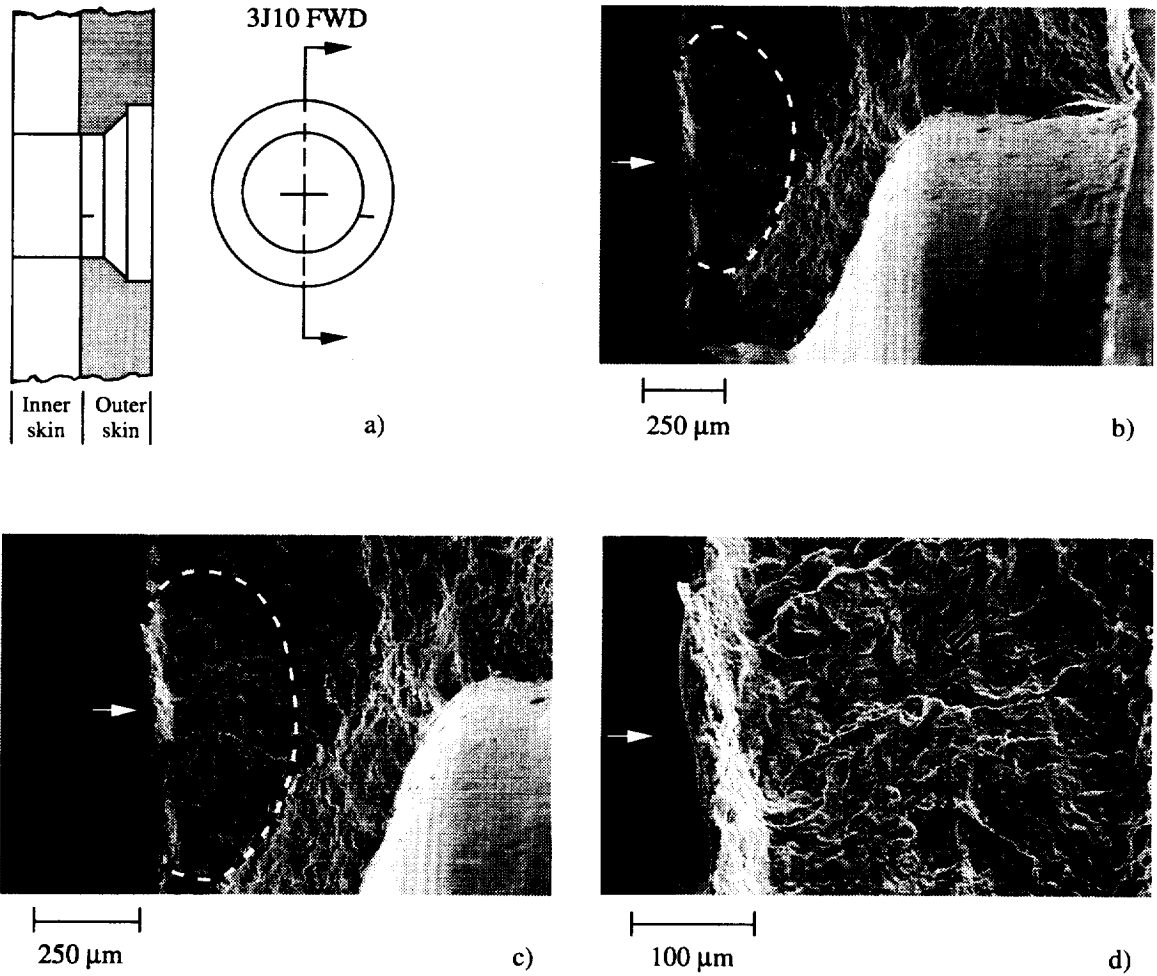
Figure 9.24 a) The schematic shows the rivet hole 3J10 configuration and the location of the outer skin fatigue crack oriented in the forward direction and about the 4 o'clock position. b) The SEM micrograph shows the faying surface fatigue crack at the rivet hole (bottom). The arrow identifies the likely crack initiation region along the faying surface and the dashed line marks the fatigue crack front. c) The SEM micrograph shows the faying surface fatigue crack fracture surface and the region of crack initiation (arrow). d) The SEM micrograph shows the rough faying surface at the site of crack initiation (arrow).

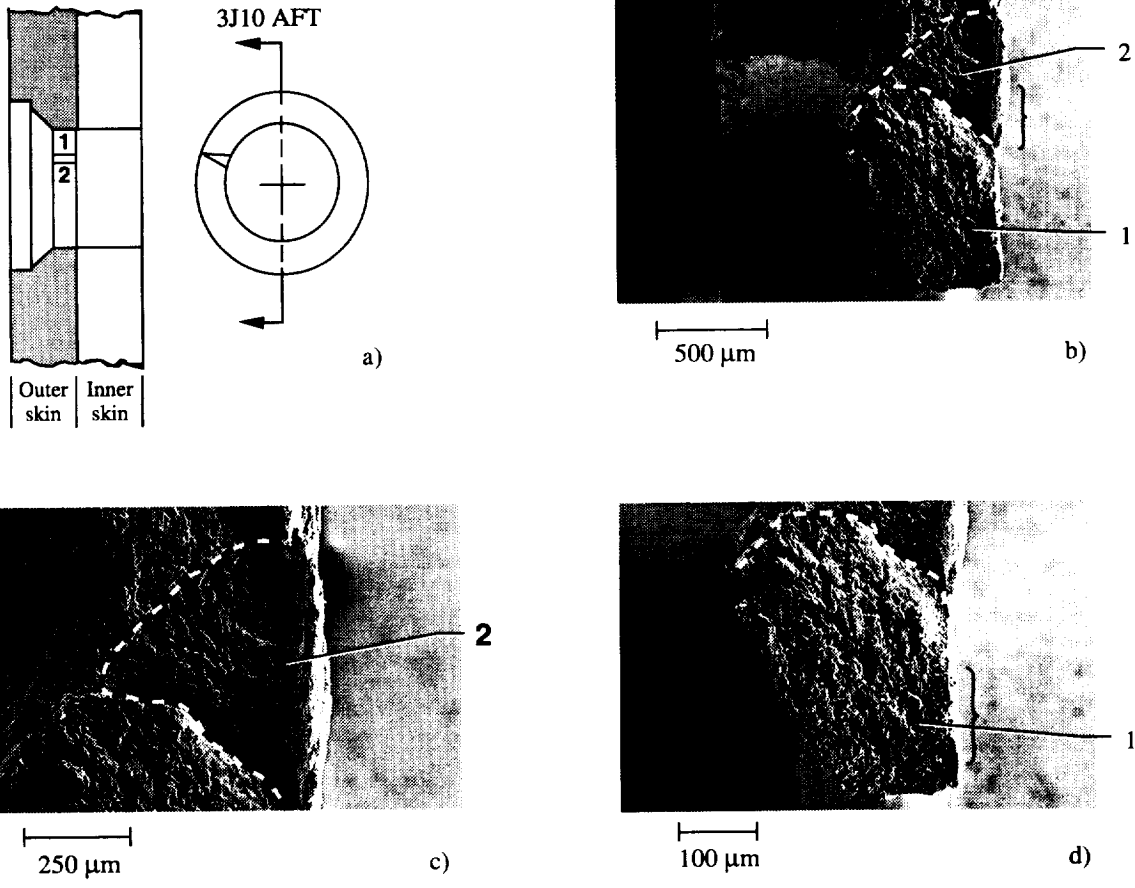
Figure 9.25 a) The schematic shows the rivet hole 3J10 configuration and the location of two outer skin fatigue cracks (1 and 2) oriented in the aft direction and about the 10 o'clock position. b) The SEM micrograph shows the fatigue crack at the rivet hole (bottom). The micrograph reveals that cracking occurred along two fracture planes (1 and 2). A bracket marks the likely crack initiation region for crack "2" along the faying surface and the region where the two cracks coalesced. The dashed line marks the fatigue crack front. c) The SEM micrograph shows the fatigue crack surface at the region of crack "2" shown in Figure 9.25.b. The dashed lines mark the fatigue crack front and the region where the two crack planes linked. d) The SEM micrograph shows the fatigue crack surface at the rivet hole shank and crack "1" in Figure 9.25.b. The bracket marks the likely region of crack initiation for crack "1".

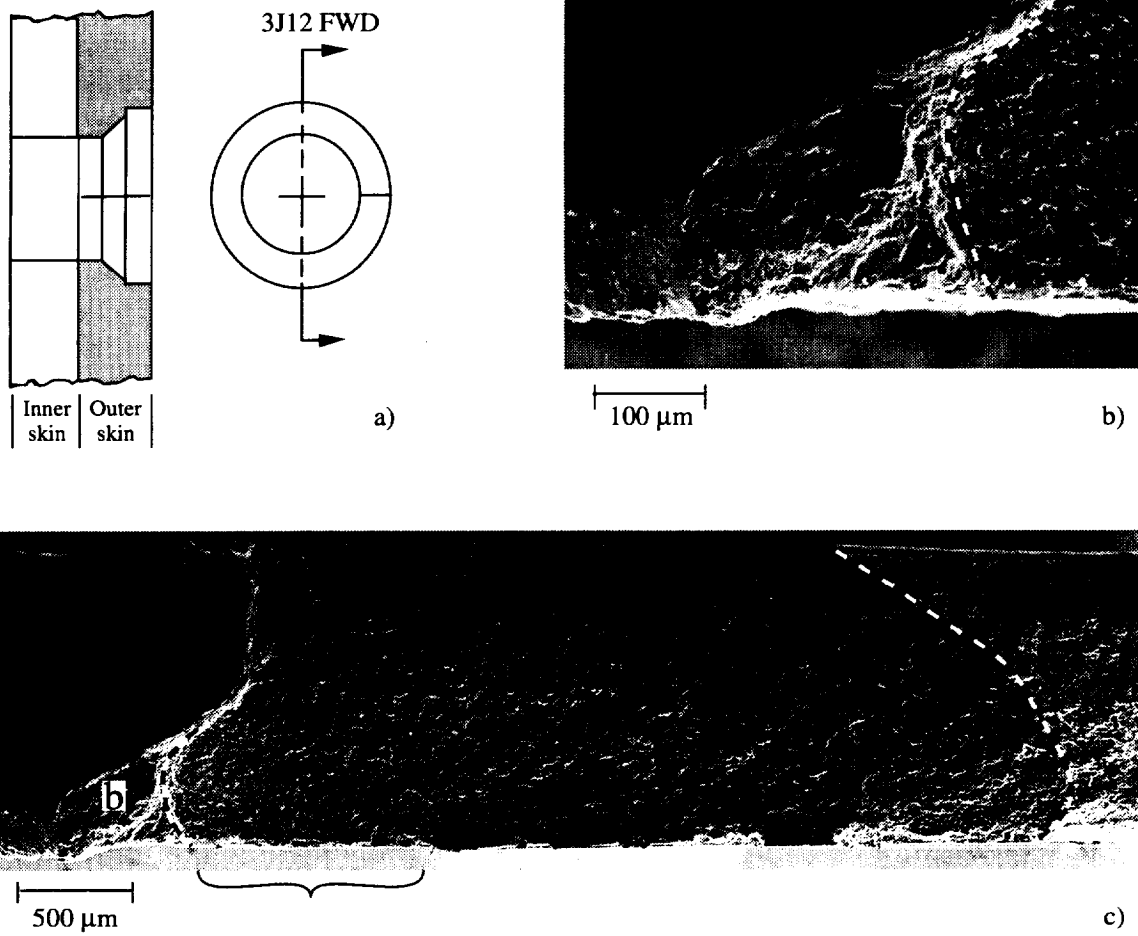
Figure 9.27 a) The schematic shows the rivet hole 3J12 configuration and the location of the outer skin fatigue crack oriented in the forward direction and about the 3 o'clock position. b) The SEM micrograph shows the fatigue crack surface at the rivet hole shank region "b" in Figure 9.27.c. The dashed line marks the fatigue crack front; to the right of the dashed line is the transgranular fatigue crack fracture surface and to the left is a region (ligament) that exhibits a ductile tearing morphology. c) The SEM micrograph shows the fatigue crack fracture surface extending from the rivet hole (left). The bracket marks the likely region of crack initiation along the faying surface and the dashed lines mark the fatigue crack fronts. Presumably, the crack initiated at a site located a considerable distance from the rivet hole, forming a ligament that failed by ductile tearing.

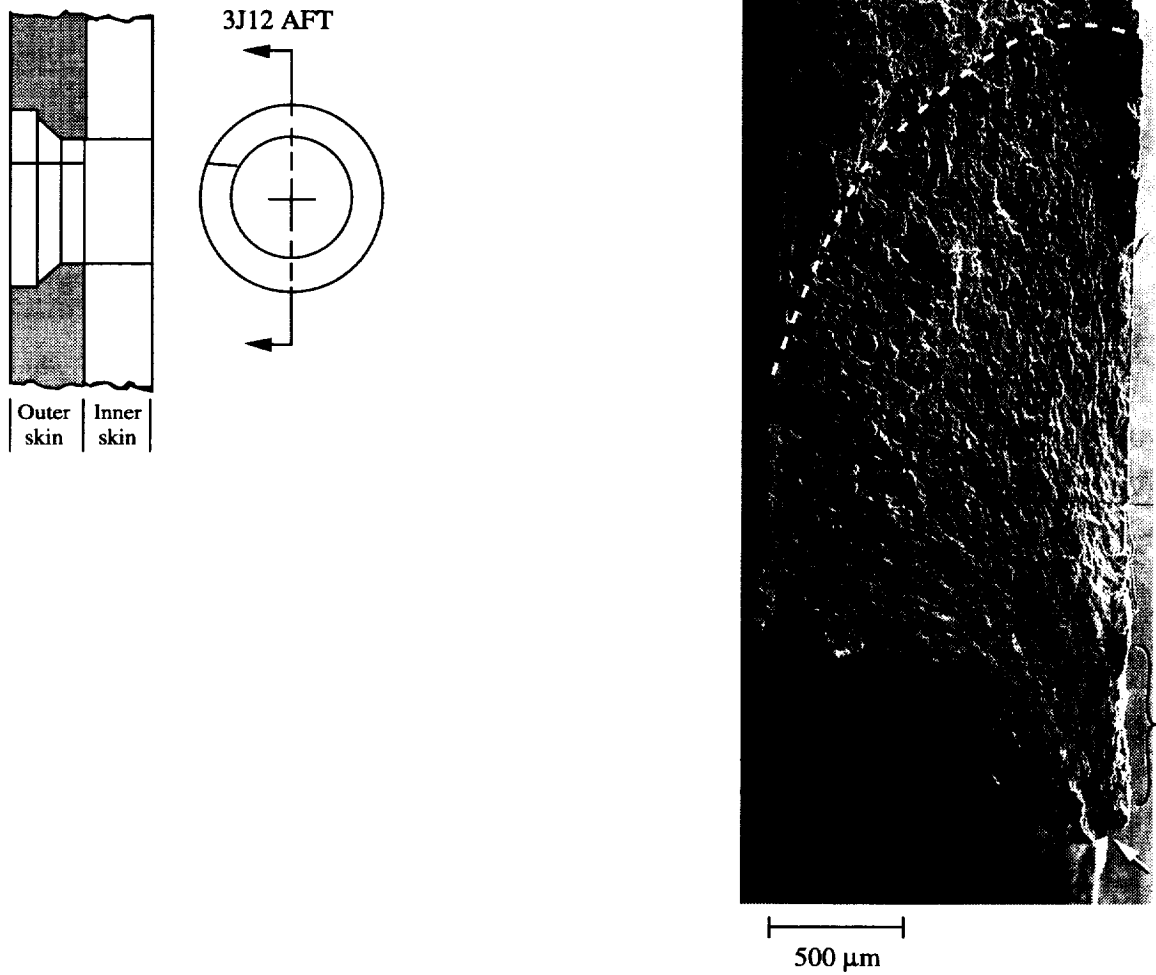
Figure 9.28 a) The schematic shows the rivet hole 3J12 configuration and the location of the outer skin fatigue crack oriented in the aft direction and about the 10 o'clock position. b) The SEM micrograph shows the fatigue crack fracture surface extending from the rivet hole (bottom). The arrow and bracket mark the likely regions of crack initiation at the inboard corner and faying surface of the rivet hole and the dashed line marks the fatigue crack front.

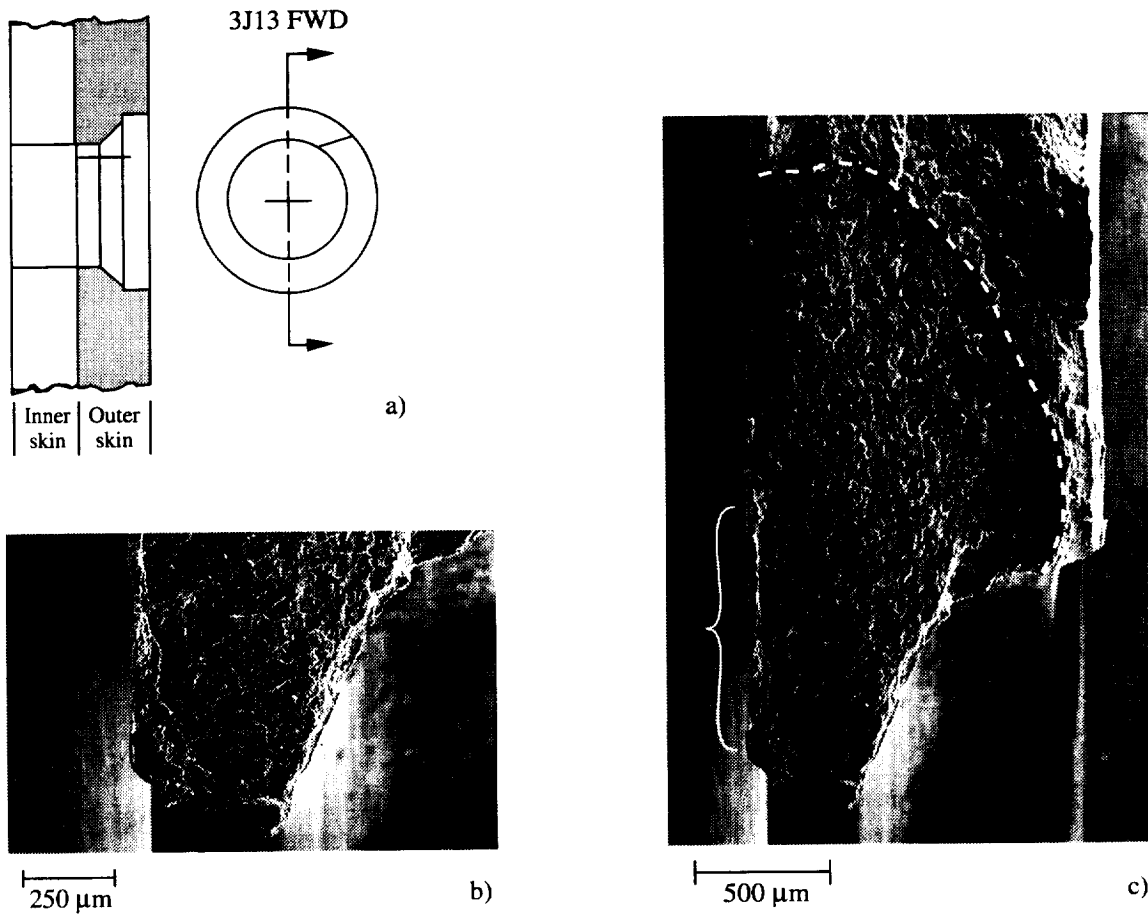
Figure 9.29 a) The schematic shows the rivet hole 3J13 configuration and the location of the outer skin fatigue crack oriented in the forward direction and about the 1 o'clock position. b) The SEM micrograph shows the fatigue crack surface at the rivet hole shank region c) The SEM micrograph shows the fatigue crack fracture surface extending from the rivet hole (bottom). The bracket marks the likely region of crack initiation along the faying surface and the dashed line marks the fatigue crack front.

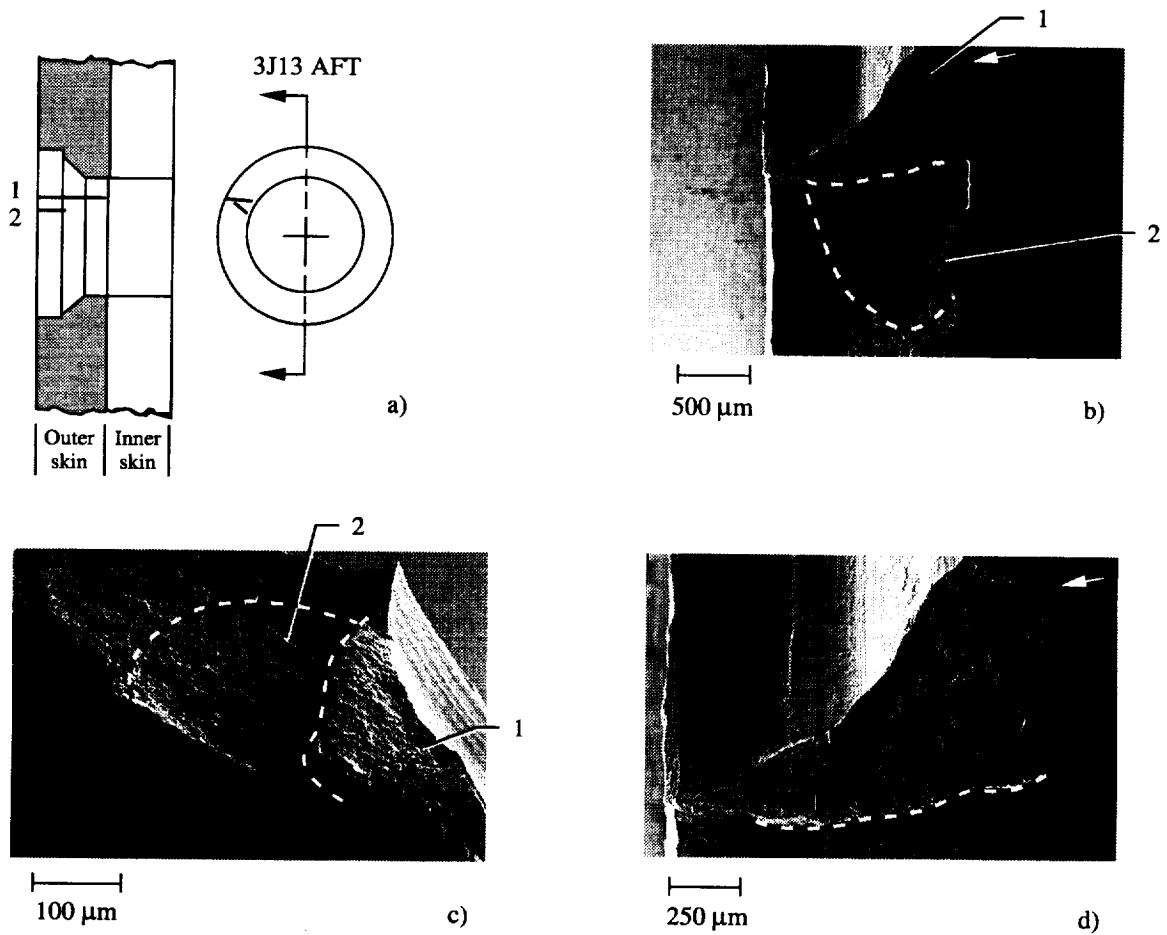
Figure 9.30 a) The schematic shows the rivet hole 3J13 configuration and the location of two outer skin fatigue cracks (1 and 2) oriented in the aft direction and about the 10 o'clock position. b) The SEM micrograph shows the fatigue crack at the rivet hole (top). The micrograph reveals that cracking occurred along two fracture planes (1 and 2). The brackets and arrow mark the likely crack initiation region for cracks "2" and "1", respectively, along the faying surface. The nearly horizontal dashed line near the middle of the fracture surface marks the region where both cracks coalesced. The dashed line extending to the bottom of the micrograph marks the final fatigue crack front. c) The SEM micrograph shows the fatigue crack surfaces of cracks "1" and "2" at an oblique angle. The dashed line on the left marks the final fatigue crack front. The near vertical dashed line marks the region where the cracks coalesced. d) The SEM micrograph shows the fatigue crack surface at the rivet hole shank and crack "1" in Figure 9.25.b. The arrow marks the site of crack initiation.

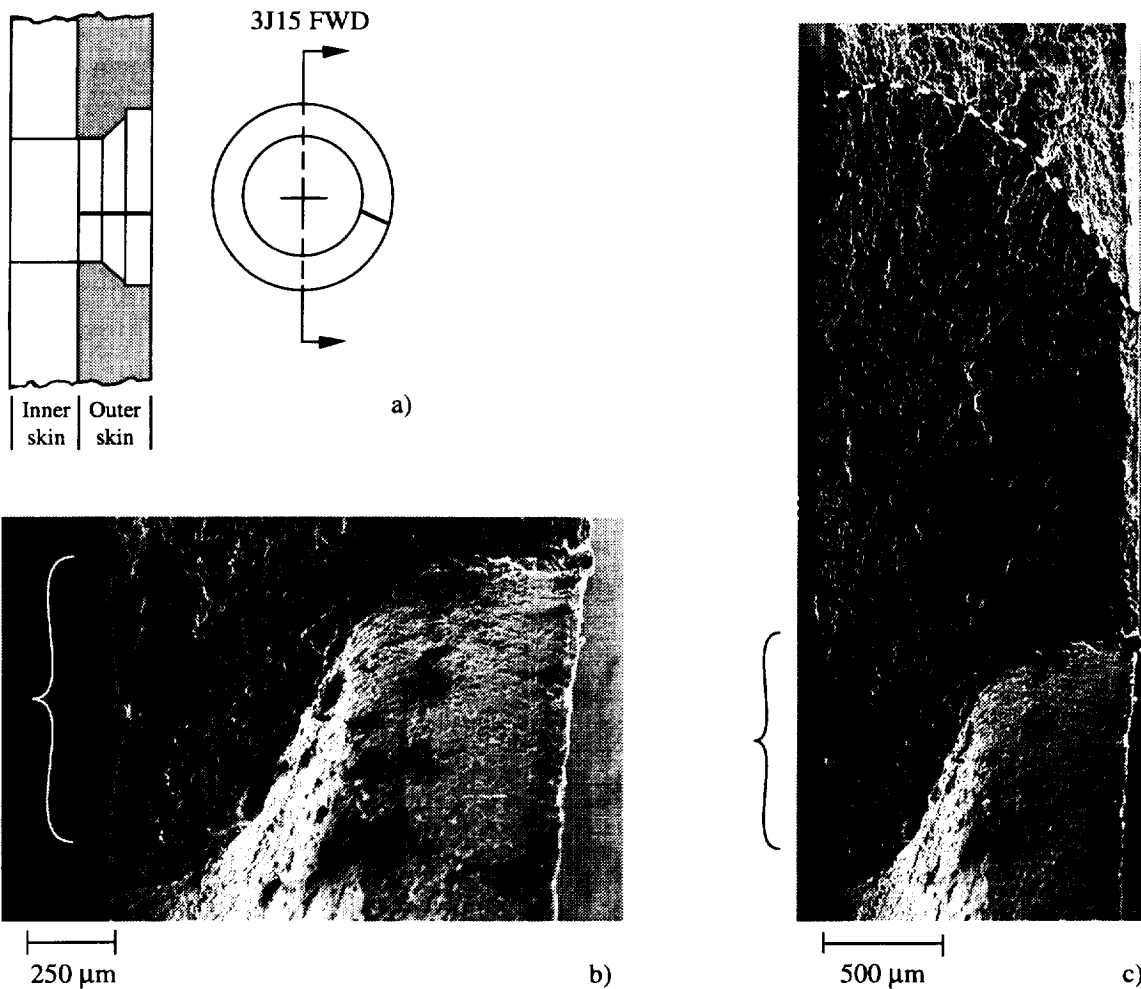
Figure 9.31 a) The schematic shows the rivet hole 3J15 configuration and the location of the outer skin fatigue crack oriented in the forward direction below the 9 o'clock position. b) The SEM micrograph shows the fatigue crack at the rivet hole. The bracket marks the likely region of crack initiation along the faying surface. c) The SEM micrograph shows the fatigue crack at the rivet hole (bottom). The bracket locates the region of crack initiation along the faying surface and the dashed line marks the fatigue crack front.

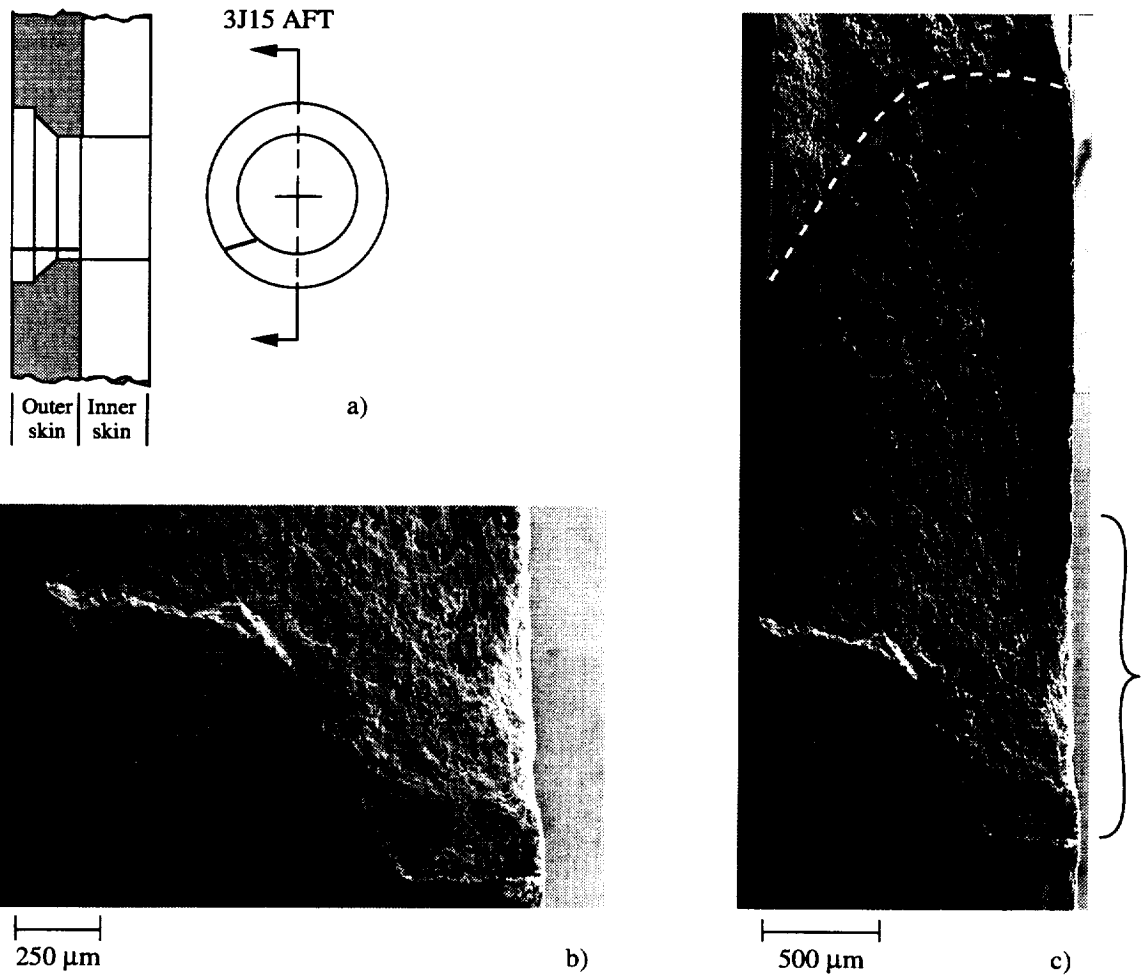
Figure 9.32 a) The schematic shows the rivet hole 3J15 configuration and the location of the outer skin fatigue crack oriented in the aft direction and about the 8 o'clock position. b) The SEM micrograph shows the fatigue crack region, marked by the bracket in Figure 9.32.c, at high magnification. c) The SEM micrograph shows the fatigue crack at the rivet hole (bottom). The bracket locates the region of crack initiation along the faying surface and the dashed line marks the fatigue crack front.

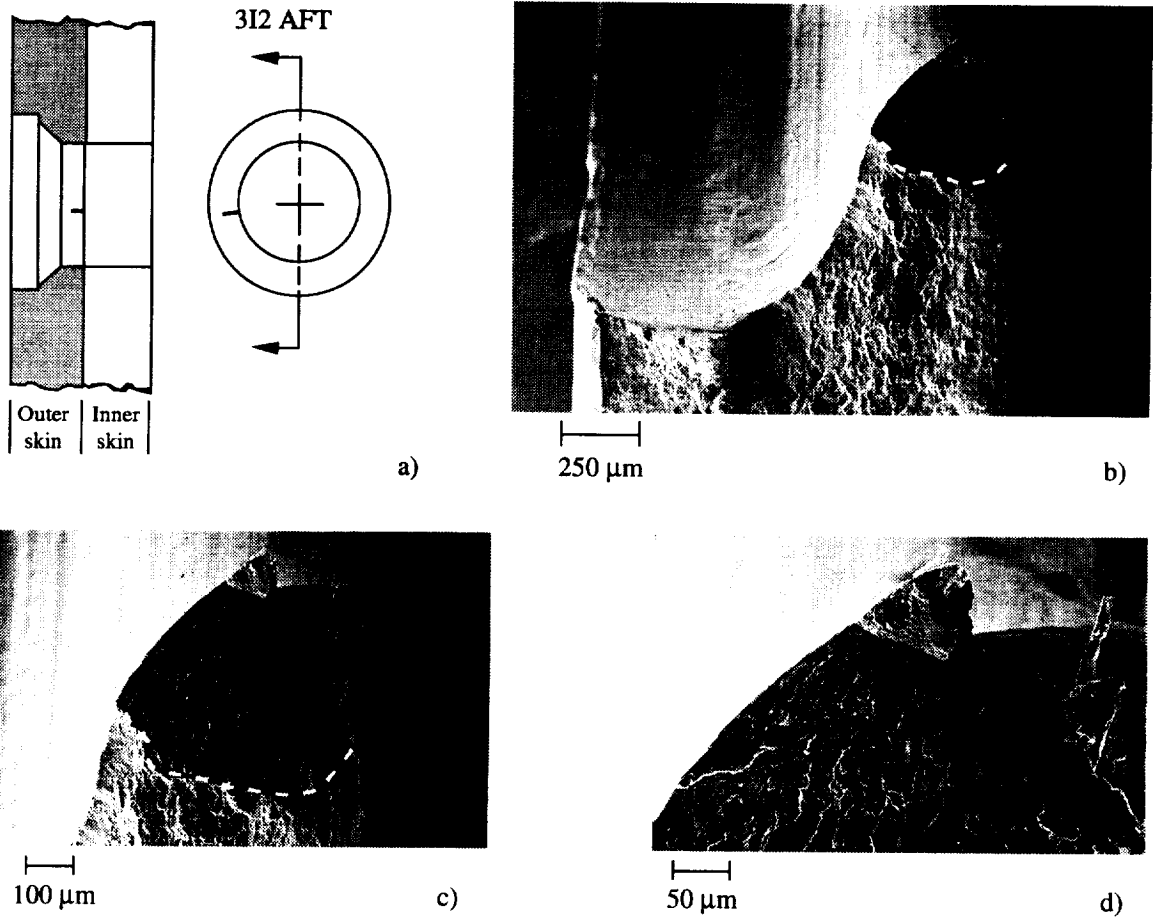
Figure 9.34 a) The schematic shows the rivet hole 3I2 configuration and the location of the outer skin fatigue crack oriented in the aft direction below the 9 o'clock position. b) The SEM micrograph shows the fatigue crack and the rivet hole. The dashed line marks the fatigue crack front. c) The SEM micrograph shows the fatigue crack region. The dashed line marks the fatigue crack front. d) The SEM micrograph shows the region of crack initiation at the deformed rivet hole shank.

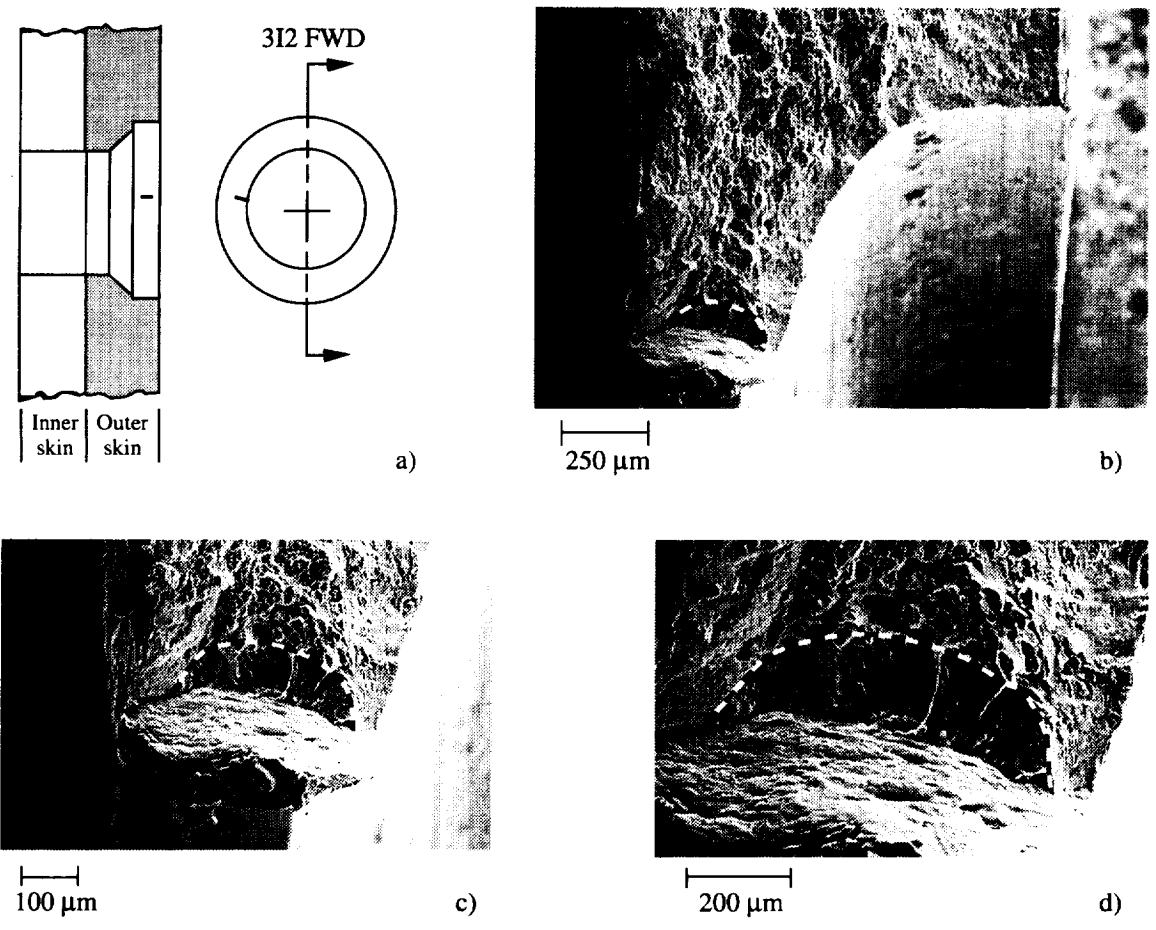
Figure 9.35 a) The schematic shows the rivet hole 3I2 configuration and the location of the outer skin fatigue crack oriented in the forward direction above the 9 o'clock position. b) The SEM micrograph shows the fatigue crack and the rivet hole. The dashed line marks the fatigue crack front. c) The SEM micrograph shows the rivet hole shank region. The dashed line marks the fatigue crack front. d) The SEM micrograph shows the region of crack initiation at the rough surface of the rivet hole shank.

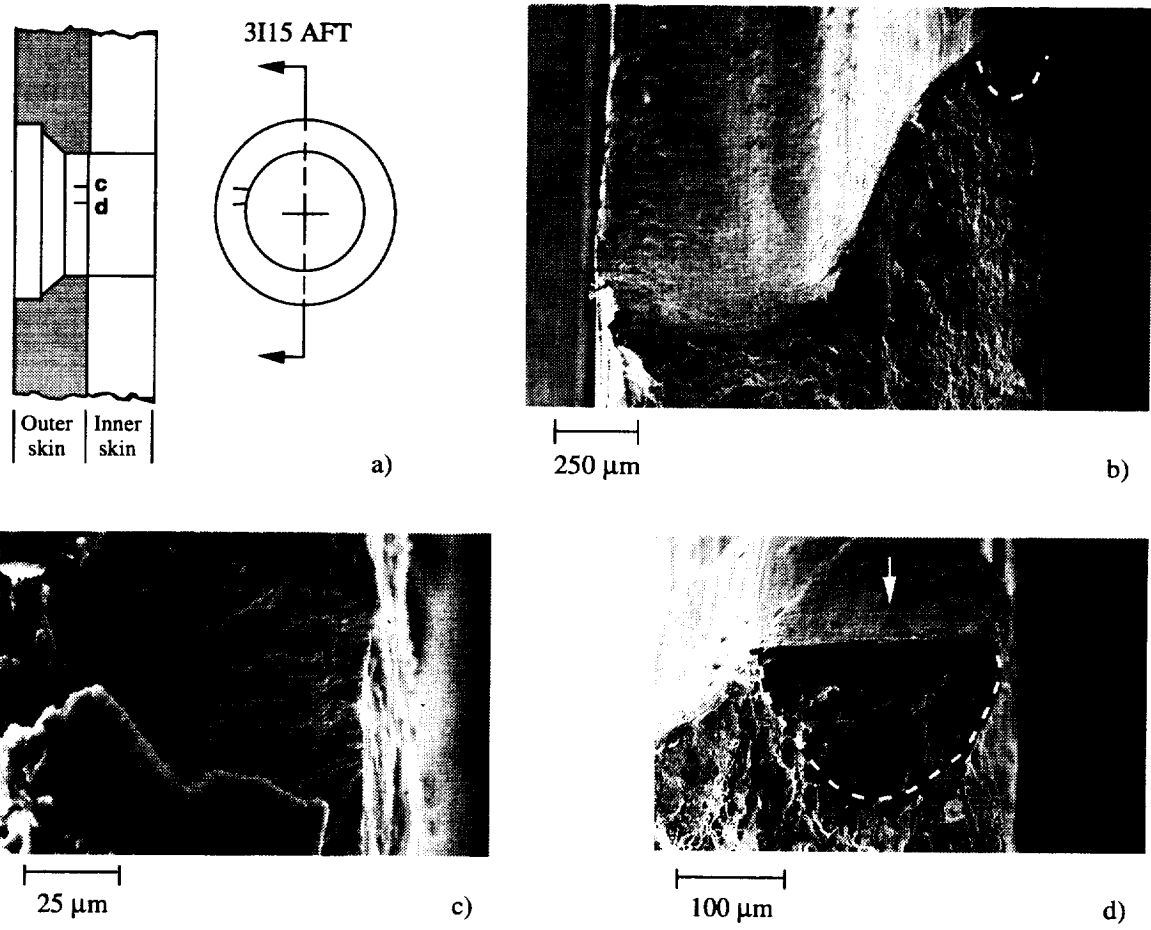
Figure 9.38 a) The schematic shows the rivet hole 3I15 configuration and the location of two outer skin fatigue cracks (“c” and “d”) oriented in the aft direction and about the 9 and 10 o'clock positions. b) The SEM micrograph shows fatigue crack “d” at the rivet hole. The dashed line marks the fatigue crack front. c) The SEM micrograph shows the partially opened fatigue crack “c” in Figure 9.38.a located at the inboard corner of the rivet hole. d) The SEM micrograph shows the fatigue crack “d” located at the rivet hole shank.

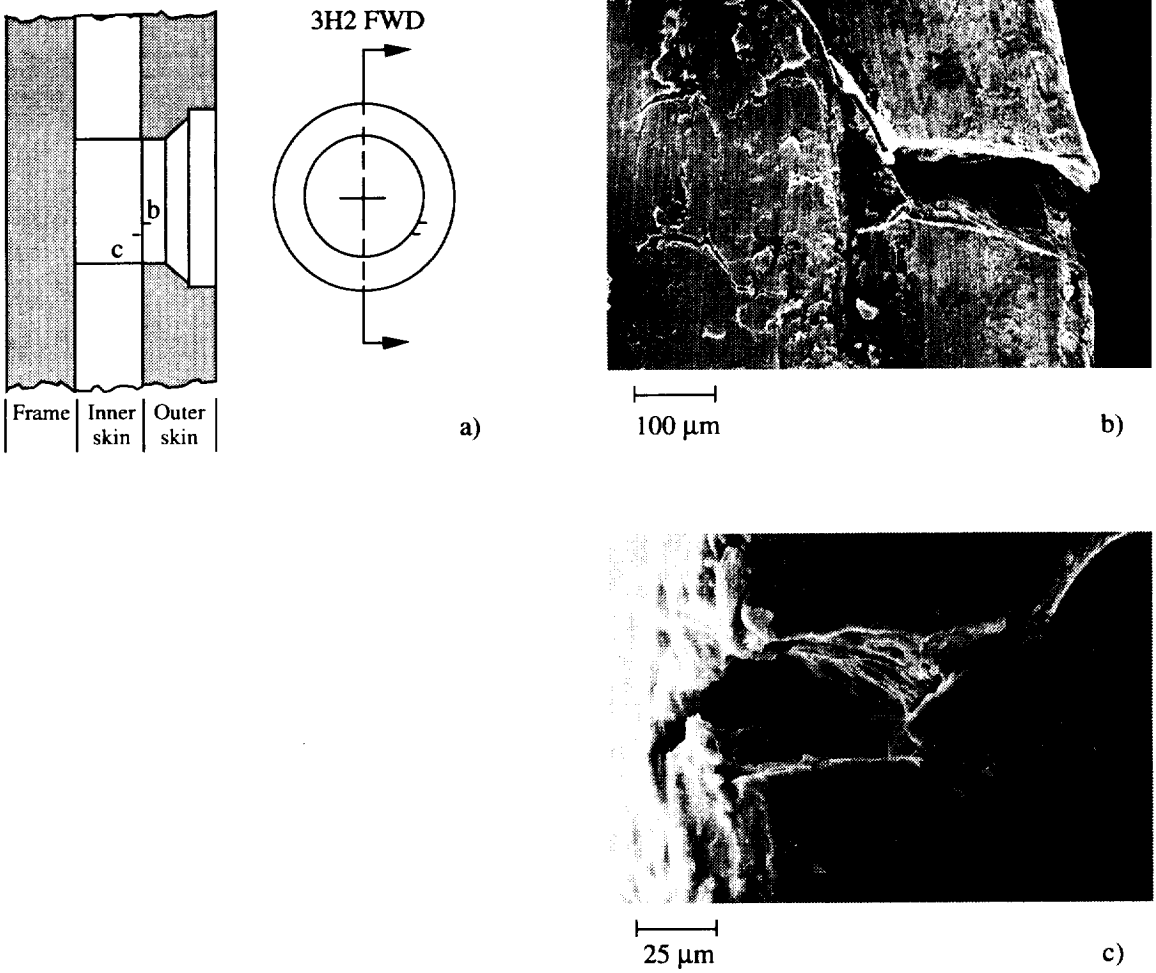
Figure 9.39 a) The schematic shows the rivet hole 3H2 configuration and the location of two fatigue cracks, (“b” and “c”) oriented in the forward direction and about the 4 o'clock position. Crack “b” is located at the outboard corner of the inner skin and crack “c” is located at the inboard corner of the outer skin rivet hole. b) The SEM micrograph shows the partially opened inner skin fatigue crack “b” shown in Figure 9.40.a. c) The SEM micrograph shows the partially opened outer skin fatigue crack “c” shown in Figure 9.40.a.

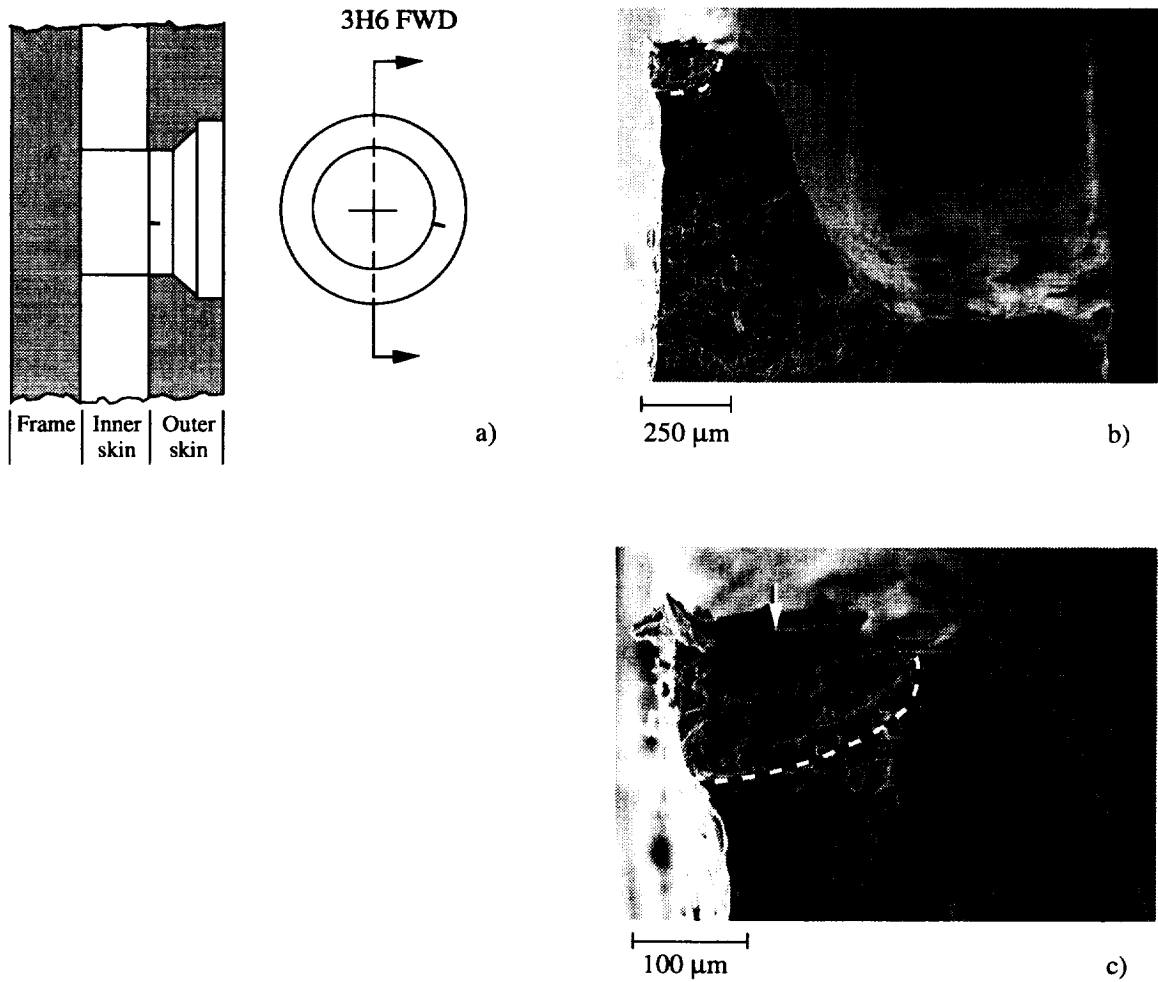
Figure 9.40 a) The schematic shows the rivet hole 3H6 configuration and the location of the outer skin fatigue crack oriented in the forward direction below the 3 o'clock position. b) The SEM micrograph shows the fatigue crack at the rivet hole shank region. The dashed line marks the fatigue crack front. c) The SEM micrograph shows the region of crack initiation (arrow) at the rivet hole shank. The dashed line marks the fatigue crack front.
