NASA/TP-97-206257

The Characteristics of Fatigue Damage in the Fuselage Riveted Lap Splice Joint

Robert S. Piascik
Langley Research Center, Hampton, Virginia

November 1997

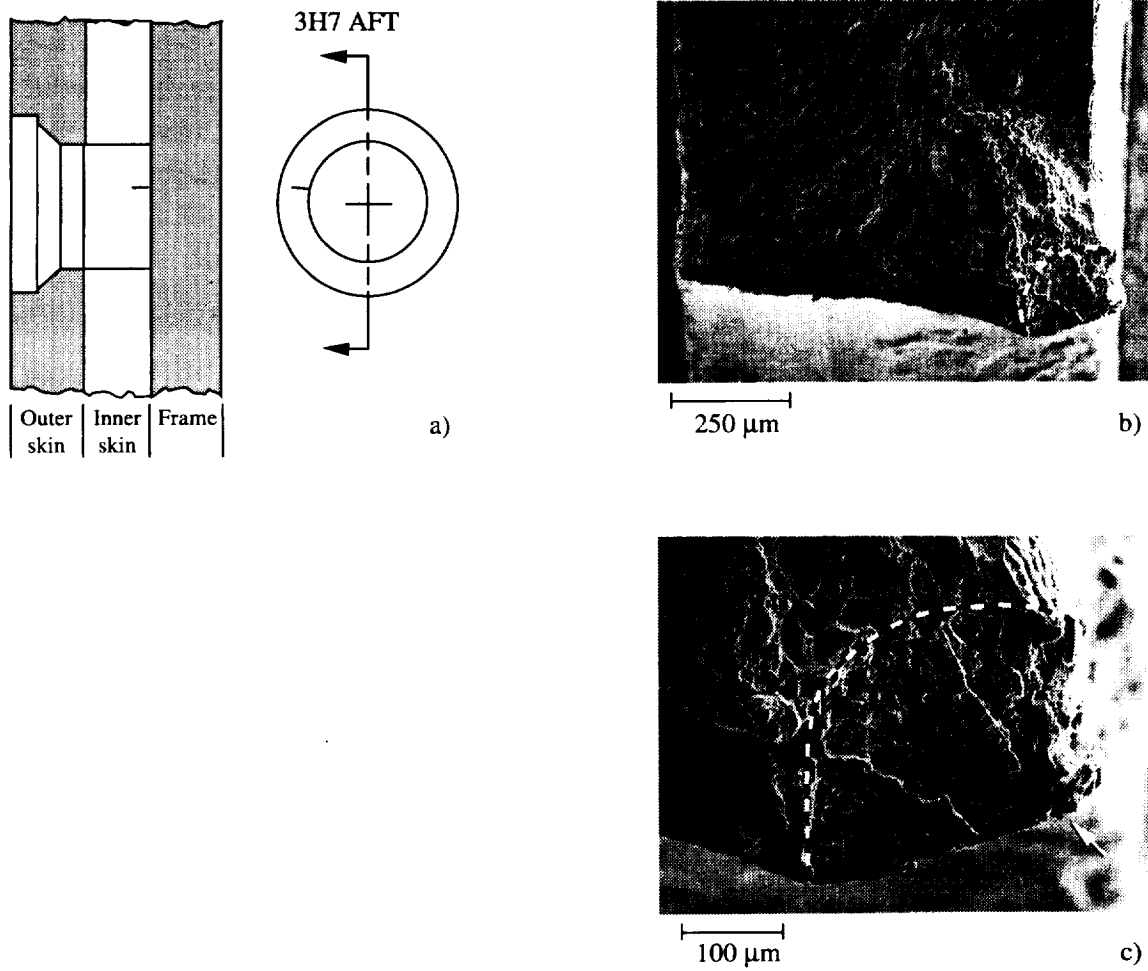
Figure 9.41 a) The schematic shows the rivet hole 3H7 configuration and the location of the inner skin fatigue crack oriented in the aft direction above the 9 o'clock position. b) The SEM micrograph shows the fatigue crack at the inboard corner of the rivet hole. The dashed line marks the fatigue crack front. c) The SEM micrograph shows the region of crack initiation (arrow) at the inboard corner of the rivet hole. The dashed line marks the fatigue crack front.

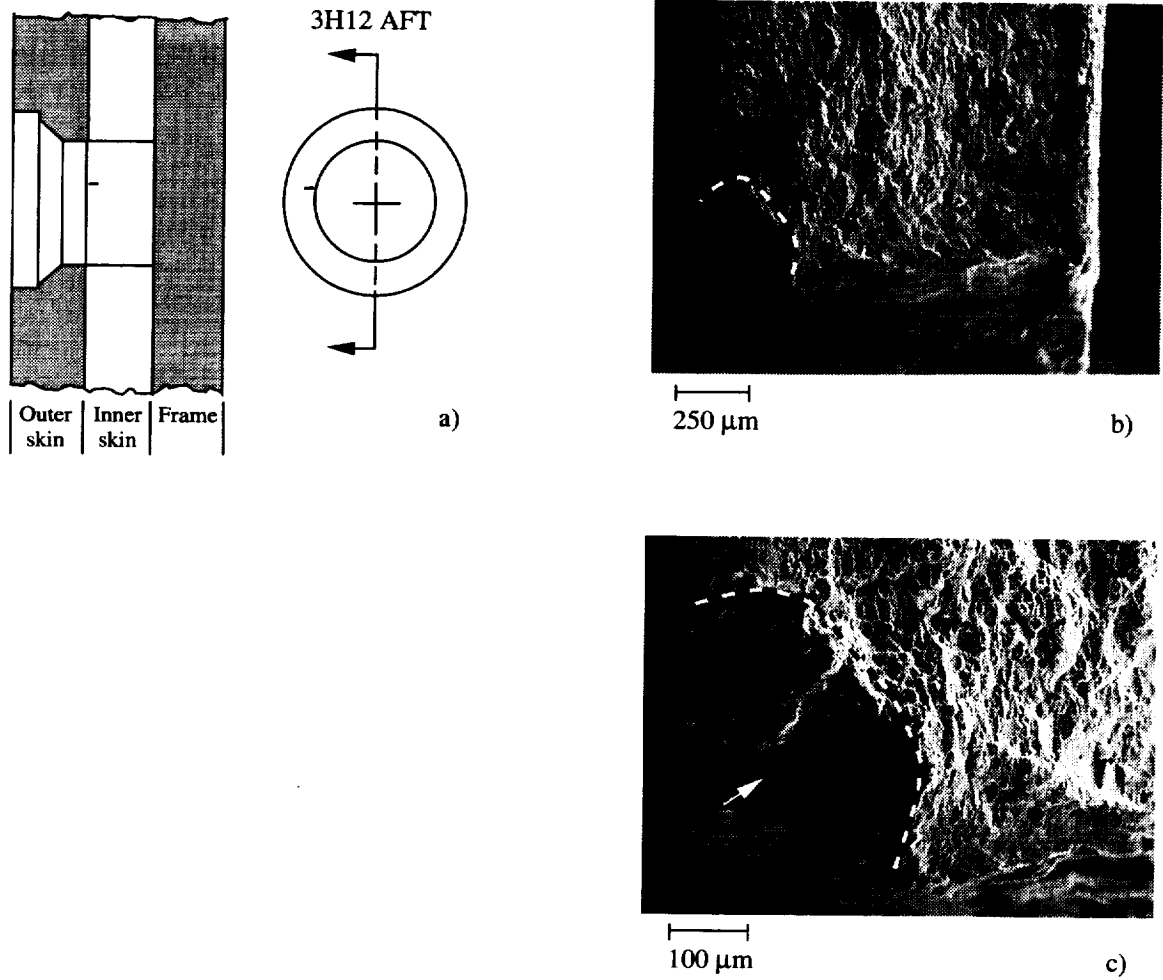
Figure 9.42 a) The schematic shows the rivet hole 3H12 configuration and the location of the inner skin fatigue crack oriented in the aft direction above the 9 o'clock position. b) The SEM micrograph shows the fatigue crack at the outboard corner of the rivet hole. The dashed line marks the fatigue crack front. c) The SEM micrograph shows the region of crack initiation (arrow) at the outboard corner of the rivet hole. The dashed line marks the fatigue crack front.

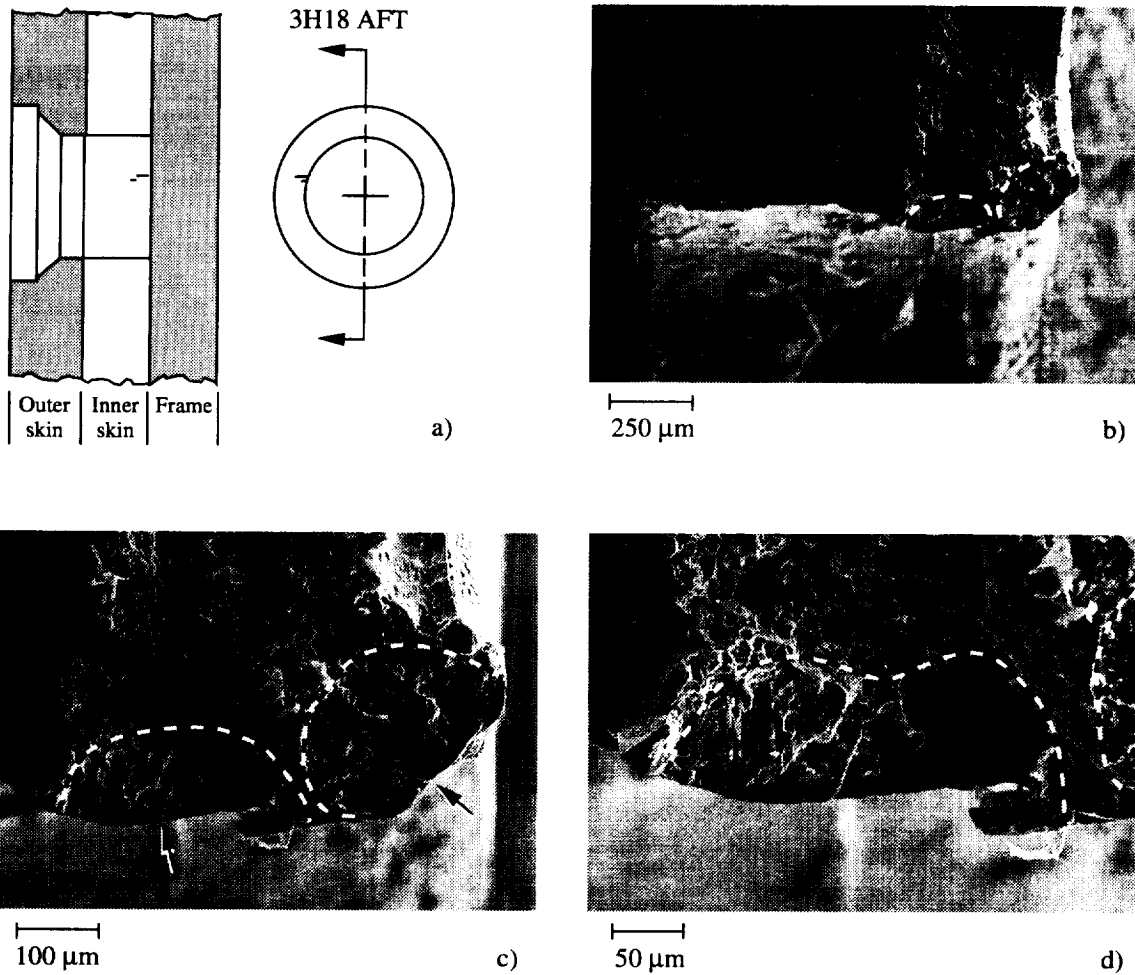
Figure 9.43 a) The schematic shows the rivet hole 3H18 configuration and the location of two inner skin fatigue cracks oriented in the aft direction above the 9 o'clock position. b) The SEM micrograph shows the fatigue cracks at the inboard corner of the rivet hole and at the rivet hole surface. The dashed lines mark the fatigue crack front. c) The SEM micrograph shows the region of crack initiation (arrows) of the inboard corner and surface fatigue cracks. The dashed lines mark the fatigue crack fronts. d) The SEM micrograph shows the rivet hole surface crack at high magnification.

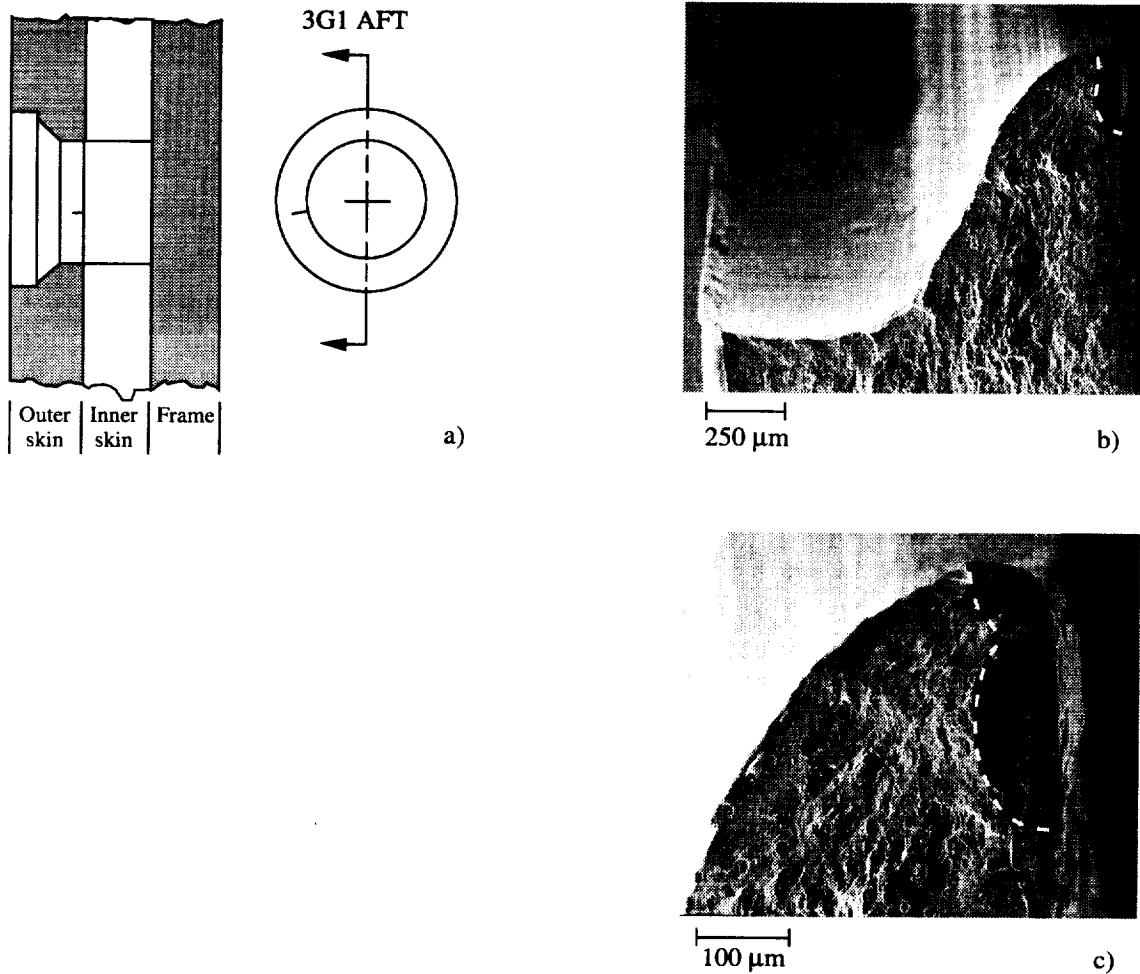
Figure 9.44 a) The schematic shows the rivet hole 3G1 configuration and the location of the outer skin fatigue crack oriented in the aft direction below the 9 o'clock position. b) The SEM micrograph shows the fatigue crack at the rivet hole faying surface. The dashed line marks the fatigue crack front. c) The SEM micrograph shows the fatigue crack region at high magnification. The dashed line marks the fatigue crack front.

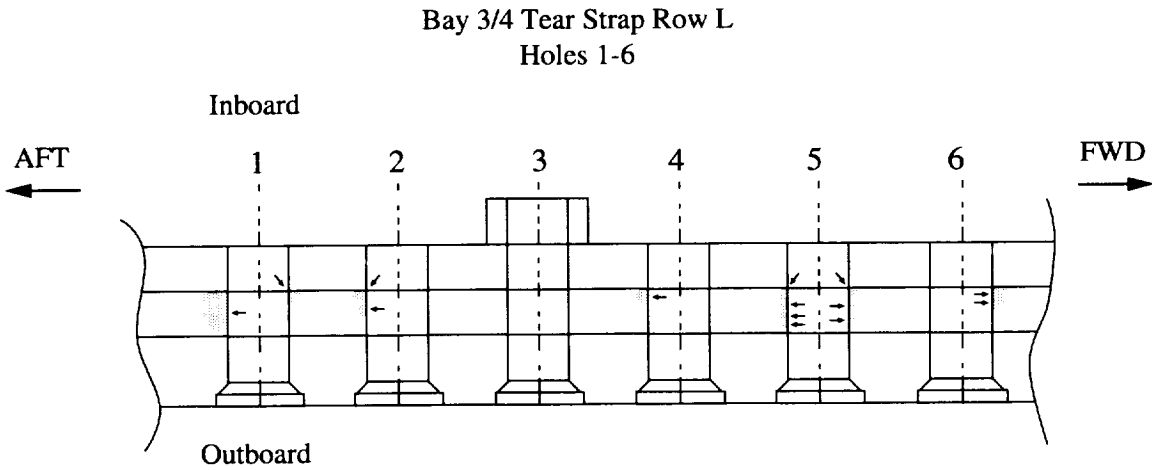
Hole #	Location	Length mm(in)	Type	Initiation site
1 (Aft)	Upper tear strap	2.388 (0.094)	Through	Surface
1 (Fwd)	Upper tear strap	0.143 (0.006)	Corner	Inboard corner
2 (Aft)	Upper tear strap	0.176 (0.007)	Corner	Multiple inboard corner
2 (Aft)	Upper tear strap	0.336 (0.013)	Surface	Surface
4 (Aft)	Upper tear strap	0.353 (0.014)	Corner	Surface
5 (Aft)	Upper tear strap	0.180 (0.007)	Surface	Multiple surface
5 (Aft)	Upper tear strap	0.171 (0.007)	Corner	Inboard corner
5 (Fwd)	Upper tear strap	0.619 (0.024)	Corner	Inboard corner
5 (Fwd)	Upper tear strap	0.143 (0.006)	Surface	Multiple surface
6 (Fwd)	Upper tear strap	0.603 (0.024)	Corner	Multiple surface

Figure 10.5 The through the thickness row schematic shows the location and initiation site of fatigue cracks found in holes number 1, 2, 3, 4, 5, and 6 (row L) in the bay 3/4 tear strap. The table summarizes crack location, crack length, crack type, and initiation site for each fatigue crack shown.

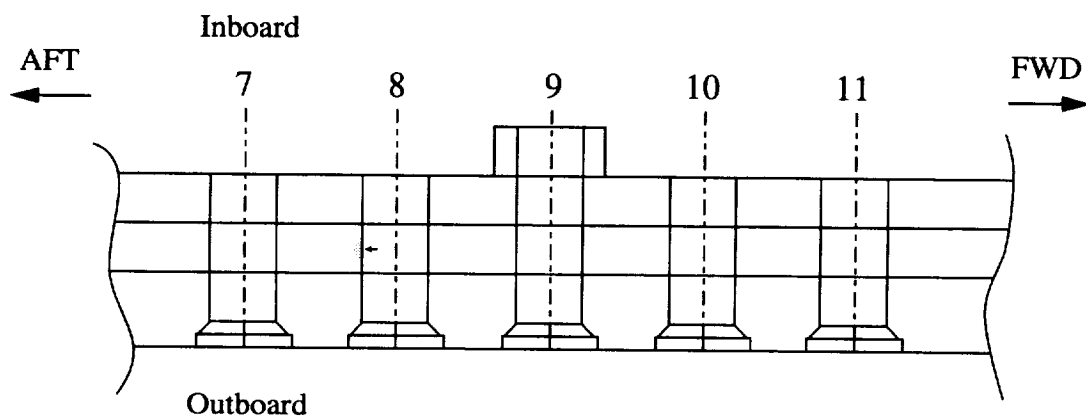
**Bay 3/4 Tear Strap Row K
Holes 7-11**

Hole #	Location	Length mm(in)	Type	Initiation site
8 (Aft)	Upper tear strap	0.069 (0.003)	Surface	Surface

Figure 10.6 The through the thickness row schematic shows the location and initiation site of fatigue cracks found in holes number 7, 8, 9, 10, and 11 (row K) in the bay 3/4 tear strap. The table summarizes crack location, crack length, crack type, and initiation site for each fatigue crack shown.

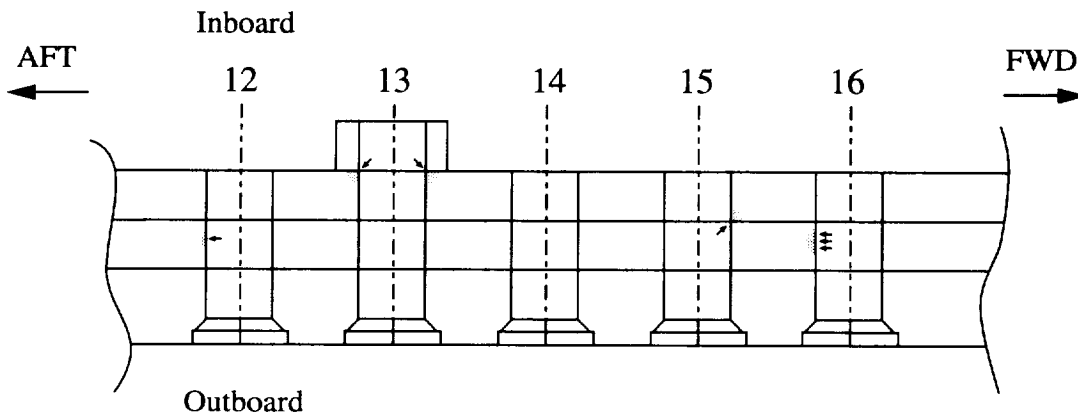
Bay 3/4 Tear Strap Row J
Holes 12-16

Hole #	Location	Length mm(in)	Type	Initiation site
12 (Aft)	Upper tear strap	0.284 (0.011)	Surface	Surface
13 (Aft)	Lower tear strap	0.377 (0.015)	Corner	Outboard corner
13 (Fwd)	Lower tear strap	0.177 (0.007)	Corner	Multiple corner
15 (Fwd)	Lower tear strap	0.196 (0.008)	Corner	Outboard corner
16 (Aft)	Upper tear strap	0.076 (0.003)	Surface	Multiple surface

Figure 10.7 The through the thickness row schematic shows the location and initiation site of fatigue cracks found in holes number 12, 13, 14, 15, and 16 (row J) in the bay 3/4 tear strap. The table summarizes crack location, crack length, crack type, and initiation site for each fatigue crack shown.

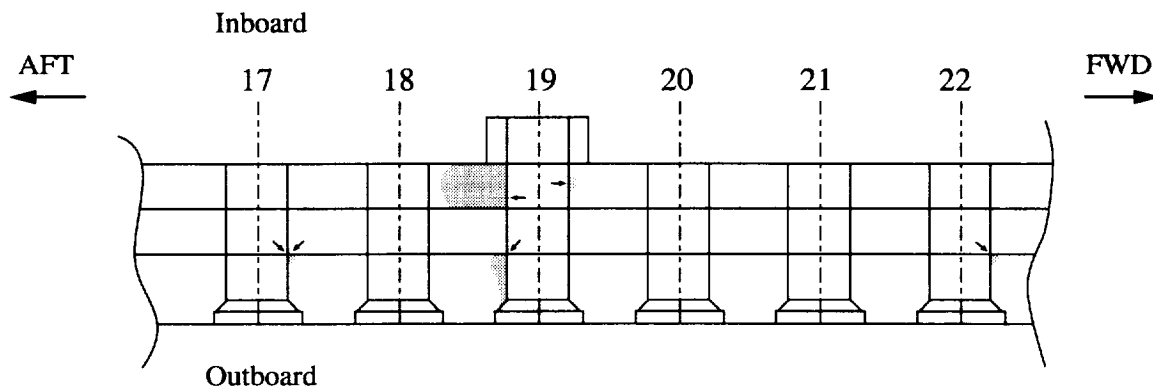
Bay 3/4 Tear Strap Row I
Holes 17-22

Hole #	Location	Length mm(in)	Type	Initiation site
17 (1 Fwd)	Outer skin	0.216 (0.008)	Countersink	Inboard side of shank
17 (2 Fwd)	Outer skin	0.470 (0.019)	Countersink	Inboard side of shank
19 (1 Aft)	Lower tear strap	5.224 (0.206)	Through	Surface
19 (2 Aft)	Outer skin	0.325 (0.013)	Countersink	Inboard side of shank
19 (Fwd)	Lower tear strap	0.213 (0.008)	Surface	Surface
22 (Fwd)	Outer skin	0.154 (0.006)	Countersink	Inboard side of shank

Figure 10.8 The through the thickness row schematic shows the location and initiation site of fatigue cracks in holes number 17, 18, 19, 20, 21, and 22 (row I) in the bay 3/4 tear strap. The table summarizes crack location, crack length, crack type, and initiation site for each fatigue crack shown.

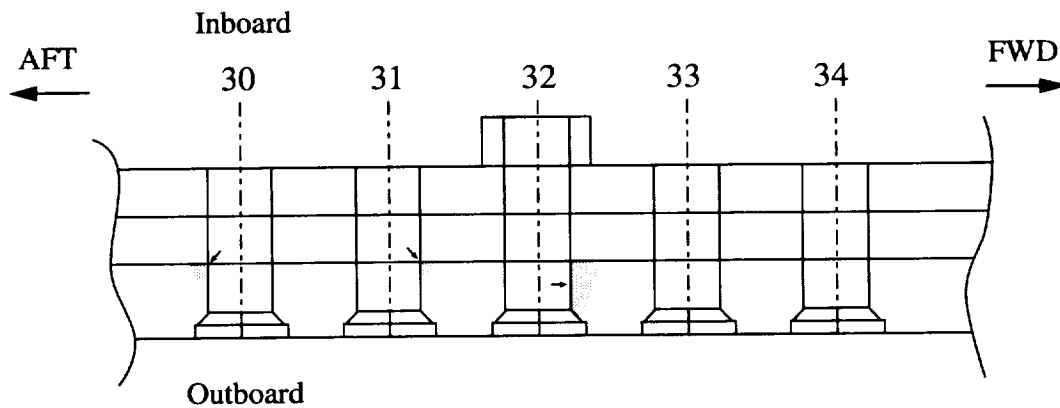
Bay 3/4 Tear Strap Row G
Holes 30-34

Hole #	Location	Length mm(in)	Type	Initiation site
30 (Aft)	Outer skin	0.208 (0.008)	Countersink	Inboard side of shank
31 (Fwd)	Outer skin	0.123 (0.005)	Countersink	Inboard side of shank
32 (Fwd)	Outer skin	0.529 (0.021)	Countersink	Outboard of shank

Figure 10.9 The through the thickness row schematic shows the location and initiation site of fatigue cracks in holes number 30, 31, 32, 33, and 34 (row G) in the bay 3/4 tear strap. The table summarizes crack location, crack length, crack type, and initiation site for each fatigue crack shown.

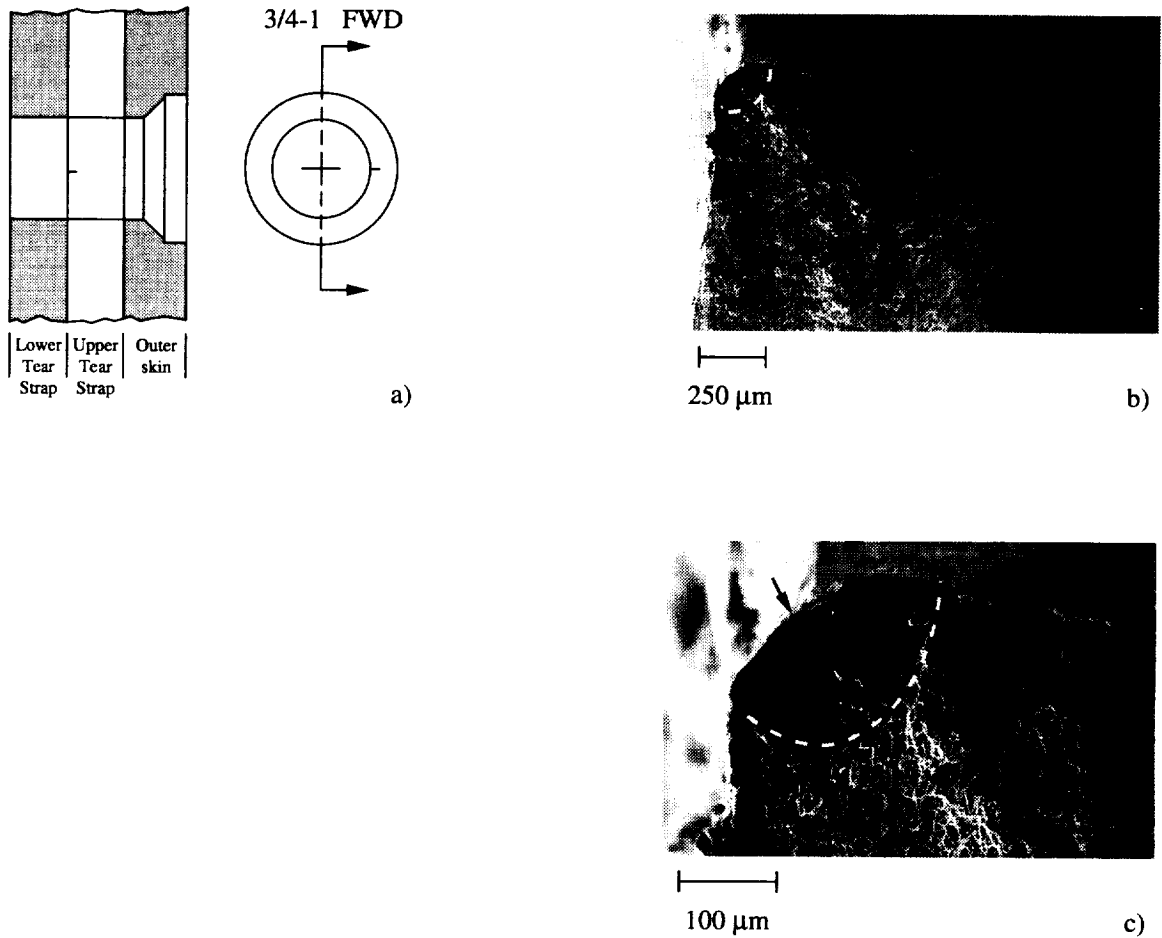
Figure 10.10 a) The schematic shows the rivet hole 3/4-1 configuration and the location of an upper T.S. fatigue crack oriented in the forward direction and about the 3 o'clock position. b) The SEM micrograph shows the location of a small fatigue crack at the inside corner of the upper T.S. rivet hole. The dashed line marks the fatigue crack front. c) The SEM micrograph shows the corner crack at high magnification. The arrow marks the likely crack initiation site and the dashed line marks the fatigue crack front.

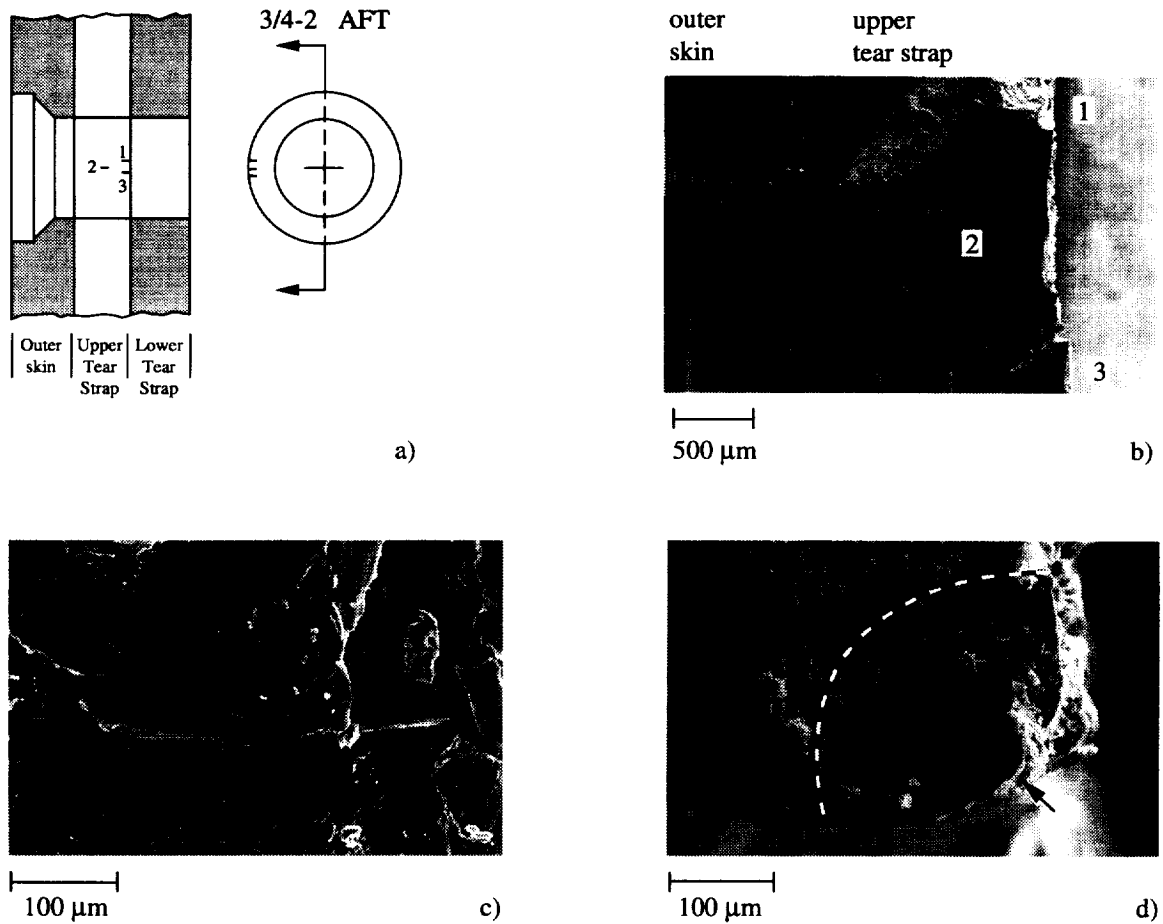
Figure 10.12 a) The schematic shows the rivet hole 3/4-2 configuration and the location of three upper T.S. fatigue cracks oriented in the aft direction and about the 9 o'clock position. b) The SEM micrograph shows the location of two partially opened upper T.S. cracks, crack #2 on the rivet hole surface and crack #3 at the inboard corner. Crack #1 is located at the inboard corner on the main fracture surface. c) The SEM micrograph shows the partially opened fatigue crack #2 in Figure 10.12.b on the disturbed metal surface of the upper skin rivet hole. d) The SEM micrograph shows corner crack #1 in Figure 10.12.b. The arrow marks the site of crack initiation and the dashed line marks the fatigue crack front.

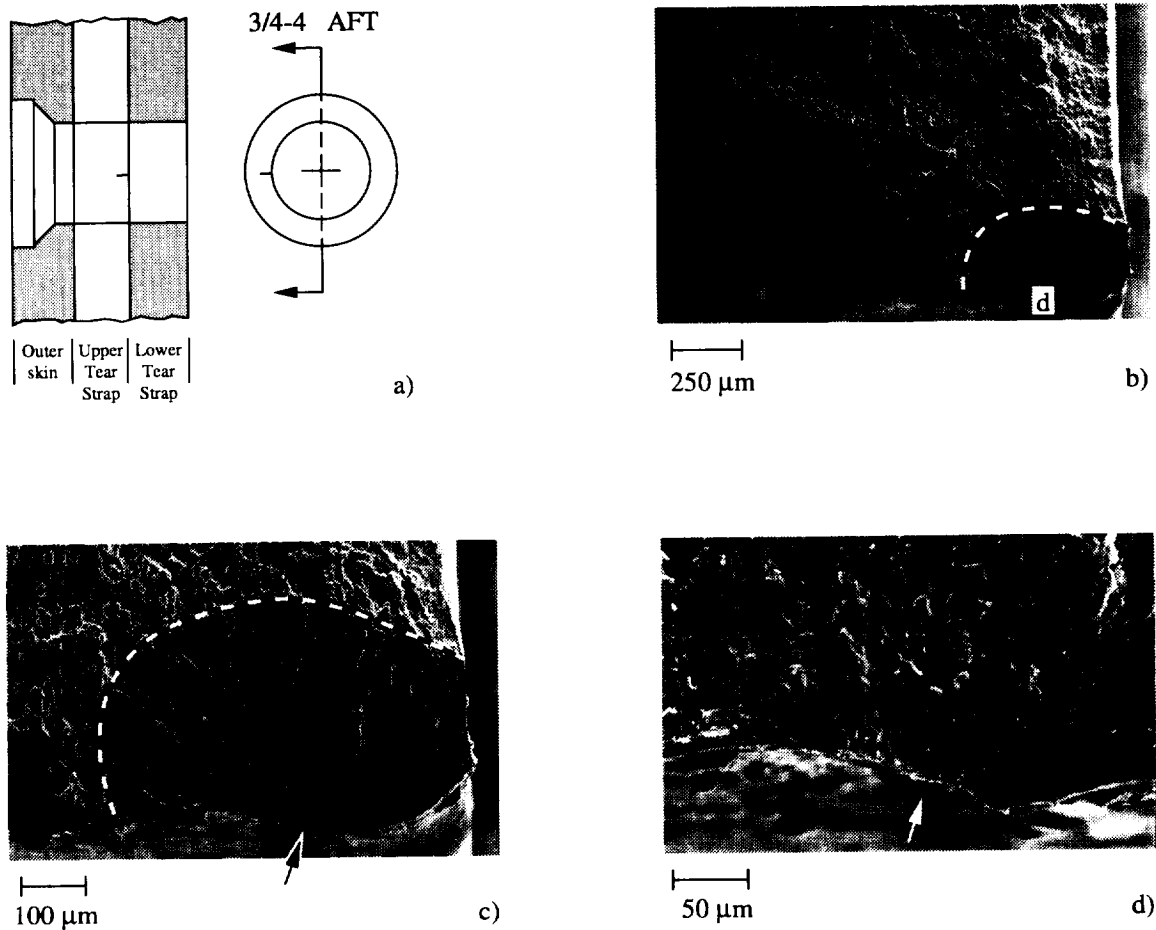
Figure 10.13 a) The schematic shows the rivet hole 3/4-4 configuration and the location of an upper T.S. fatigue crack oriented in the aft direction and about the 9 o'clock position. b) The SEM micrograph shows the upper T.S. fatigue crack located at the inboard corner of the rivet hole. The dashed line marks the fatigue crack front. c) The SEM micrograph shows the upper T.S. corner crack. The arrow marks the likely site of crack initiation and the dashed line marks the fatigue crack front. d) The SEM micrograph shows the region of crack initiation at high magnification, region "d" in Figure 10.13.b. The arrow marks the likely crack initiation site.

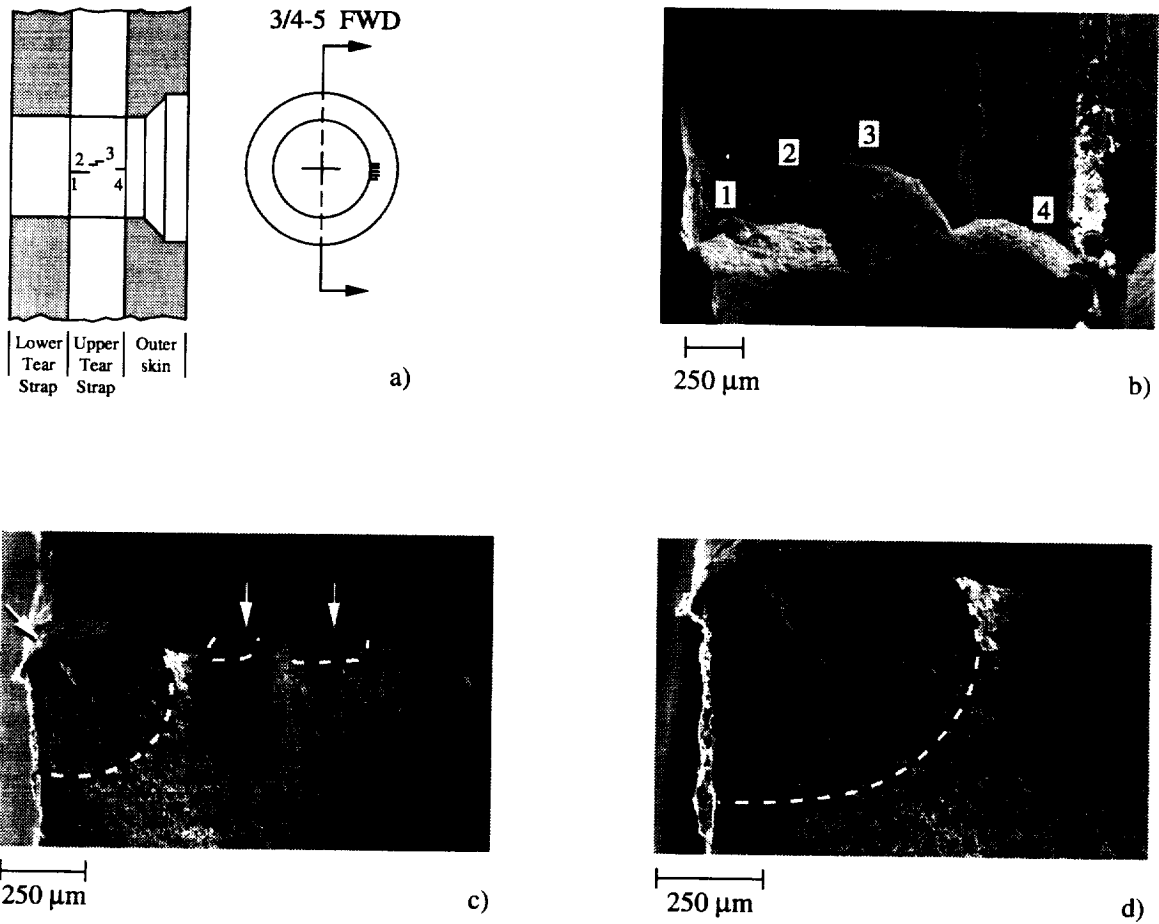
Figure 10.14 a) The schematic shows the rivet hole 3/4-5 configuration and the location of four upper T.S. fatigue cracks oriented in the forward direction and about the 3 o'clock position. b) The SEM micrograph shows the inside surface of the upper T.S. rivet hole. The main fracture surface is located at the bottom of the micrograph. c) The SEM micrograph shows three upper T.S. fatigue cracks located on the main fracture surface (arrows). Starting at the left, a fatigue crack initiated at the inboard rivet hole corner (crack #1), the middle arrow marks a surface crack (crack #3) partially hidden by a partially fractured ligament seen in Figure 10.14.b. The third arrow, located slightly to the right of center, marks the location of the third rivet hole surface crack (crack #4). Dashed lines mark the crack fronts. d) The SEM micrograph shows the inboard corner crack at higher magnification. The dashed line marks the fatigue crack front.

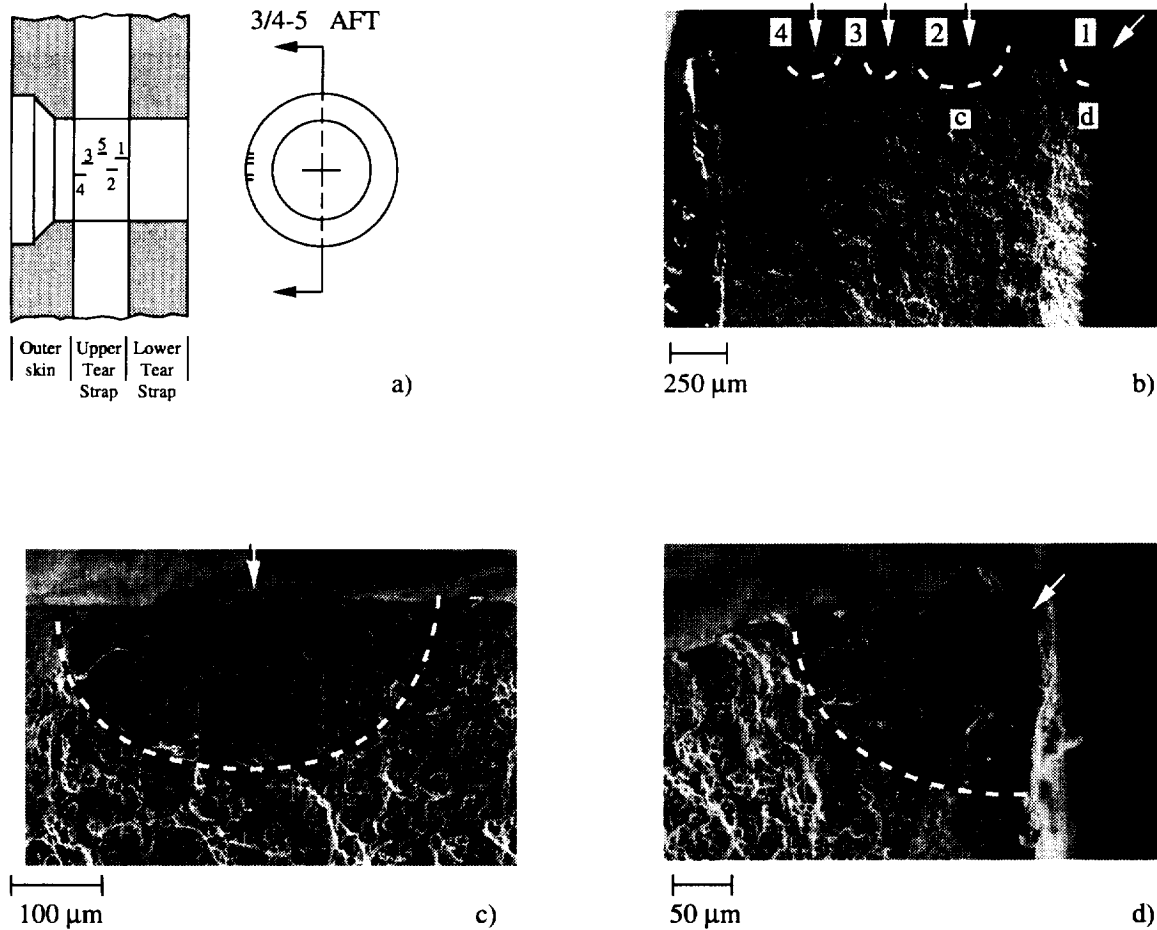
Figure 10.15 a) The schematic shows the rivet hole 3/4-5 configuration and the location of five upper T.S. fatigue cracks oriented in the aft direction and about the 9 o'clock position. b) The SEM micrograph shows the location of four fatigue cracks at the upper tear strap rivet hole (top). Cracks #2, #3, and #4 are rivet hole surface cracks and crack #1 is located on the inboard corner. The dashed line marks the fatigue crack fronts. The arrows mark the likely sites of crack initiation. c) The SEM micrograph shows the fatigue fracture surface of fatigue crack #2 at region "c" in Figure 10.15.b. The arrow marks the area of crack initiation and the dashed line marks the fatigue crack front. d) The SEM micrograph shows the inboard corner crack, region "d" in Figure 10.15.b, at higher magnification. The arrow marks the crack initiation site and the dashed line marks the fatigue crack front.

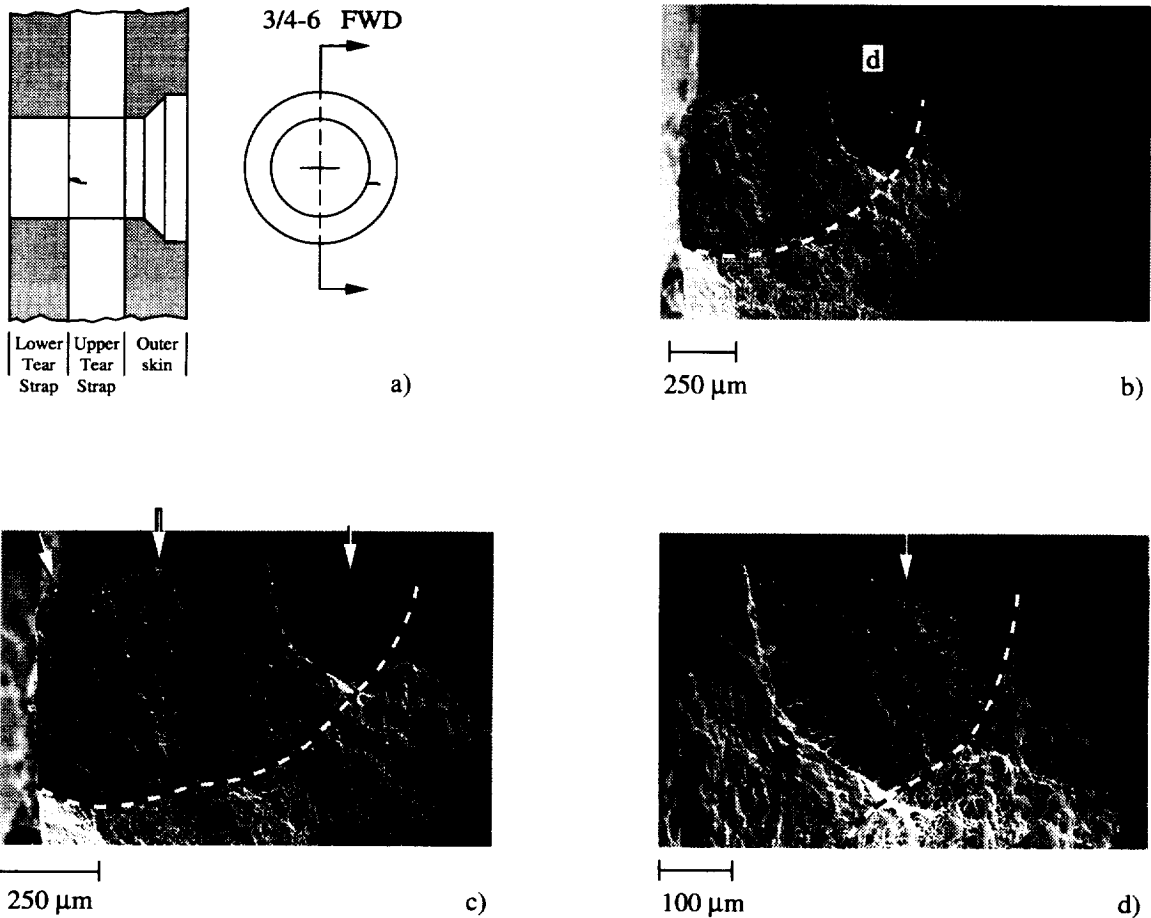
Figure 10.16 a) The schematic shows the rivet hole 3/4-6 configuration and the location of an upper T.S. fatigue crack oriented in the forward direction and about the 4 o'clock position. b) The SEM micrograph shows the fatigue crack located on the inboard corner of the upper T.S. rivet hole. The dashed line marks the fatigue crack front. c) The SEM micrograph shows three possible sites (arrows) where fatigue cracks initiated and subsequently coalesced into a corner crack marked by the dashed line. Two fracture surface ridges mark the location where the small fatigue cracks joined to form a single corner crack. d) The SEM micrograph shows region "d" in Figure 10.16.b at high magnification. The arrow marks the approximate site of crack initiation and the dashed line marks a portion of the fatigue crack front. A ridge created by cracks that coalesced runs from the upper left to the lower middle of the micrograph.

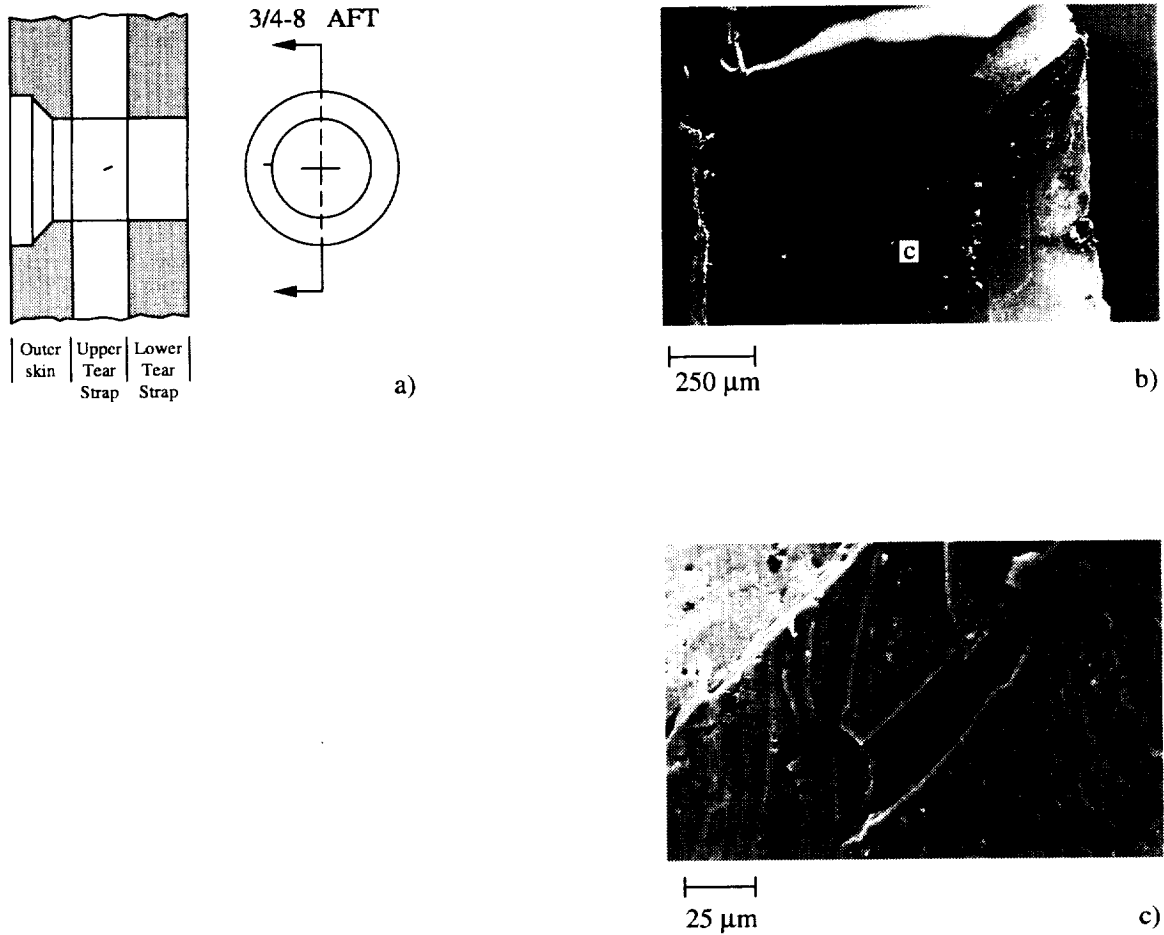
Figure 10.17 a) The schematic shows the rivet hole 3/4-8 configuration and the location of an upper T.S. fatigue crack oriented in the aft direction and about the 9 o'clock position. b) The SEM micrograph shows the inside surface of the upper T.S. rivet hole and the location of a small fatigue crack barely visible at the region marked "c". The main fracture surface produced during the destructive examination is located just above region "c". c) The SEM micrograph shows the partially opened surface fatigue crack located at region "c" in Figure 10.17.b. The crack mouth was opened during the destructive examination. SEM examination into the crack mouth confirmed transgranular fatigue crack growth.

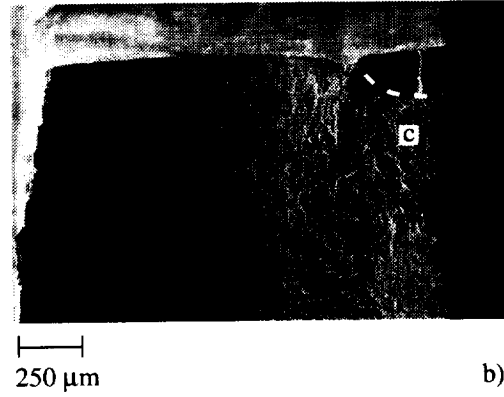
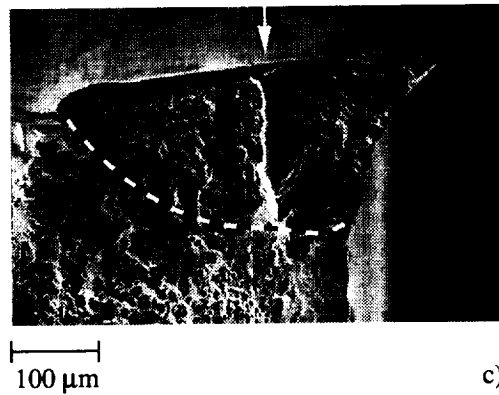
Figure 10.20 a) The schematic shows the rivet hole 3/4-13 configuration and the location of a lower T.S. fatigue crack oriented in the aft direction and below the 9 o'clock position. b) The SEM micrograph shows the fatigue fracture surface of the corner crack located on the inboard corner of the rivet hole. The dashed line marks the fatigue crack front. c) The SEM micrograph shows the fatigue fracture surface of the corner crack. The arrow marks the likely site of crack initiation and the dashed line marks the fatigue crack front.

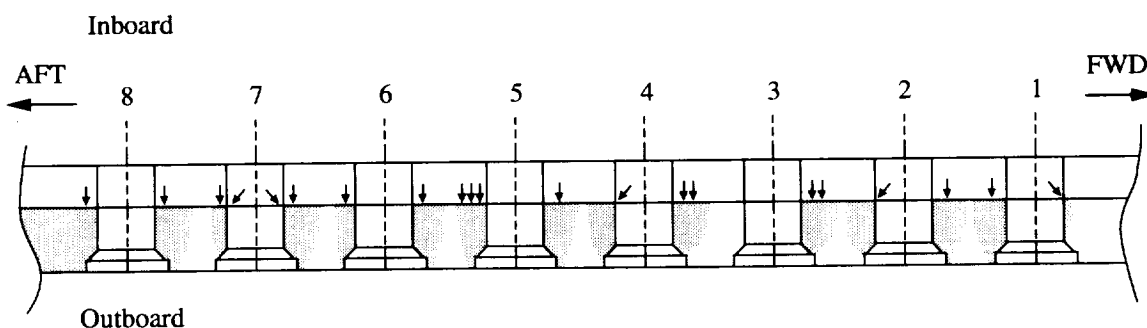
Bay 4 Row J
Holes 1-8

Hole #	Location	Length mm(in)	Type	Initiation site
1 (Aft)	Outer skin	2.893 (0.114)	Fretting	Inner skin/Outer skin
1 (Fwd)	Outer skin	0.769 (0.030)	Fretting	IS/OS
2 (Aft)	Outer skin	0.905 (0.036)	Fretting	IS/OS
2 (Fwd)	Outer skin	2.814 (0.111)	Fretting	IS/OS
3 (Fwd)	Outer skin	2.427 (0.096)	Fretting	IS/OS multiple
4 (Aft)	Outer skin	2.497 (0.098)	Fretting	IS/OS
4 (Fwd)	Outer skin	2.700 (0.106)	Fretting	IS/OS
5 (Aft)	Outer skin	5.334 (0.210)	Fretting	IS/OS multiple
5 (Fwd)	Outer skin	5.279 (0.207)	Fretting	IS/OS
6 (Aft)	Outer skin	2.714 (0.107)	Fretting	IS/OS
6 (Fwd)	Outer skin	3.848 (0.152)	Fretting	IS/OS
7 (Aft)	Outer skin	1.113 (0.044)	Fretting	IS/OS, inboard corner
7 (Fwd)	Outer skin	3.310 (0.130)	Fretting	IS/OS, inboard corner
8 (Aft)	Outer skin	Linkup with 4J9 (Fwd)	Fretting	IS/OS
8 (Fwd)	Outer skin	12.954 (0.510)	Fretting	IS/OS

Figure 11.4 The through thickness schematic shows the location and initiation site of fatigue cracks found in rivet row J (holes 1-8) from bay 4. The table summarizes crack location, crack length, crack type, and initiation site for each fatigue crack shown.

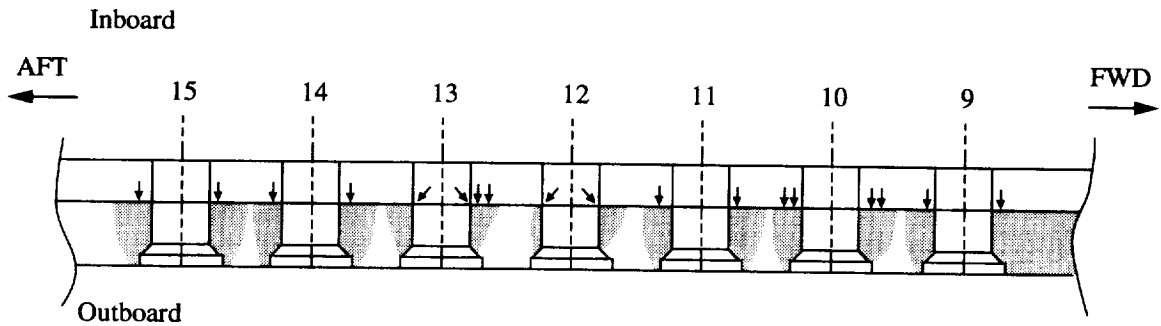
Bay 4 Row J
Holes 9-15

Hole #	Location	Length mm(in)	Type	Initiation site
9 (Aft)	Outer skin	8.265 (0.325)	Fretting	Inner skin/Outer skin
9 (Fwd)	Outer skin	Linkup with 4J8(Aft)	Fretting	IS/OS
10 (Aft)	Outer skin	4.194 (0.165)	Fretting	IS/OS multiple
10 (Fwd)	Outer skin	3.042 (0.120)	Fretting	IS/OS multiple
11 (Aft)	Outer skin	5.397 (0.212)	Fretting	IS/OS
11 (Fwd)	Outer skin	5.675 (0.223)	Fretting	IS/OS
12 (Aft)	Outer skin	1.874 (0.074)	Countersink	Inboard corner of shank
12 (Fwd)	Outer skin	2.460 (0.097)	Countersink	Inboard corner of shank
13 (Aft)	Outer skin	1.835 (0.072)	Countersink	Inboard corner of shank
13 (Fwd)	Outer skin	1.102 (0.043)	Fretting	IC,IS/OS multiple
14 (Aft)	Outer skin	2.995 (0.118)	Fretting	IS/OS multiple
14 (Fwd)	Outer skin	2.810 (0.111)	Fretting	IS/OS
15 (Aft)	Outer skin	8.559 (0.337)	Fretting	IS/OS
15 (Fwd)	Outer skin	6.959 (0.274)	Fretting	IS/OS

Figure 11.5 The through thickness schematic shows the location and initiation site of fatigue cracks found in rivet row J (holes 9-15) from bay 4. The table summarizes crack location, crack length, crack type, and initiation site for each fatigue crack shown.

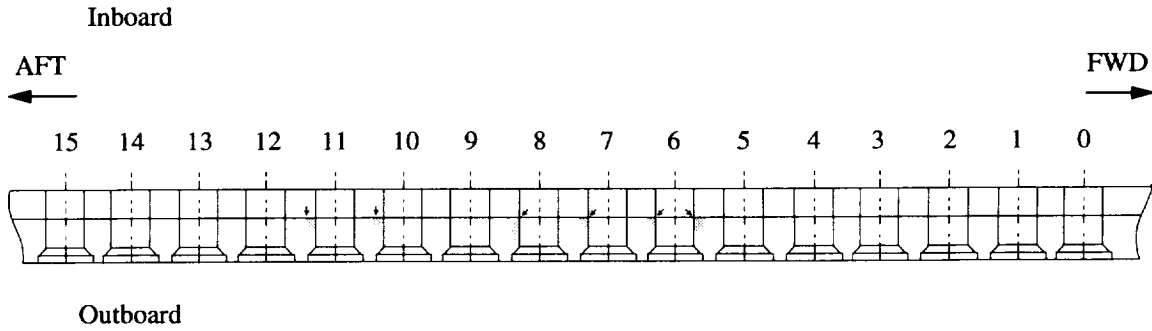
Bay 4 Row I

Hole #	Location	Length mm(in)	Type	Initiation site
6(Aft)	Outer skin	0.116 (0.005)	Countersink	Inboard corner of shank
6(Fwd)	Outer skin	0.285 (0.011)	Countersink	Inboard corner of shank
7(Aft)	Outer skin	0.105 (0.004)	Countersink	Inboard corner of shank
8(Aft)	Outer skin	0.199 (0.008)	Countersink	Inboard corner of shank
10(Aft)	Outer skin	0.089 (0.003)	Fretting	IS/OS
11(Aft)	Outer skin	0.039 (0.002)	Fretting	IS/OS

Figure 11.6 The through thickness schematic shows the location and initiation site of fatigue cracks found in rivet row I from bay 4. The table summarizes crack location, crack length, crack type, and initiation site for each fatigue crack shown.

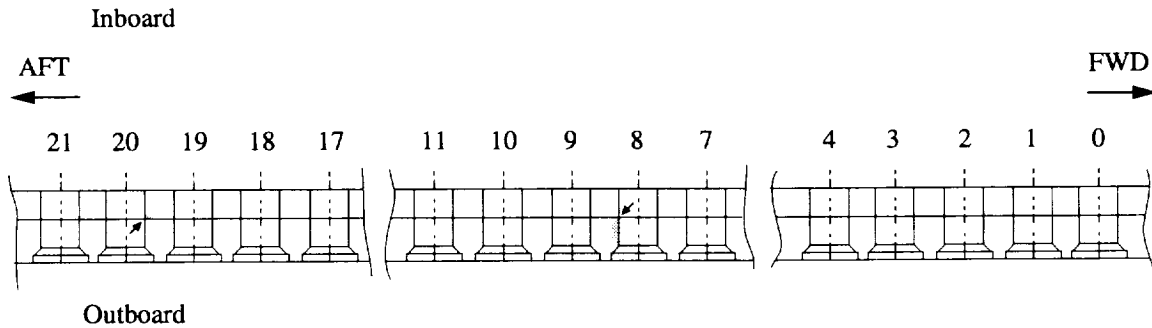
Bay 4 Row H

Hole #	Location	Length mm(in)	Type	Initiation site
8(Aft)	Outer skin	0.102 (0.004)	Countersink	Inboard corner of shank
20(Fwd)	Inner skin	0.237 (0.009)	Corner	Outboard corner

Figure 11.7 The through thickness schematic shows the location and initiation site of fatigue cracks found in rivet row H from bay 4. The table summarizes crack location, crack length, crack type, and initiation site for each fatigue crack shown.

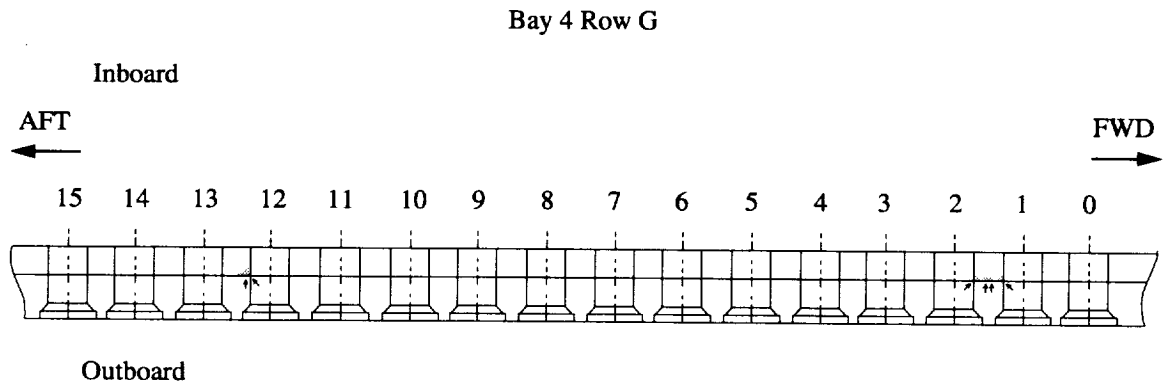
Hole #	Location	Length mm(in)	Type	Initiation site
1(Aft)	Inner skin	0.121 (0.005)	Corner	Outboard corner
2(Fwd)	Inner skin	0.131 (0.005)	Fretting and Corner	IS/OS, Outboard corner
2(Fwd)	Inner skin	0.180 (0.007)	Fretting	Innerskin/outerskin
12(Aft)	Inner skin	0.313 (0.012)	Fretting and Corner	IS/OS, Outboard corner

Figure 11.8 The through thickness schematic shows the location and initiation site of fatigue cracks found in rivet row G from bay 4. The table summarizes crack location, crack length, crack type, and initiation site for each fatigue crack shown.

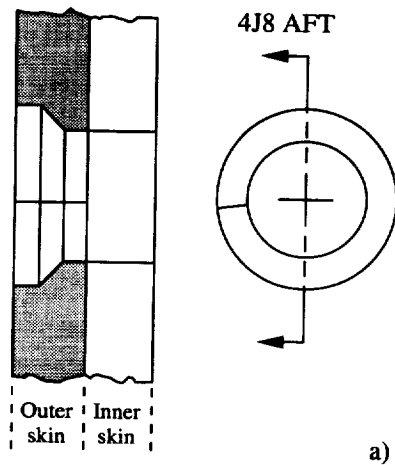
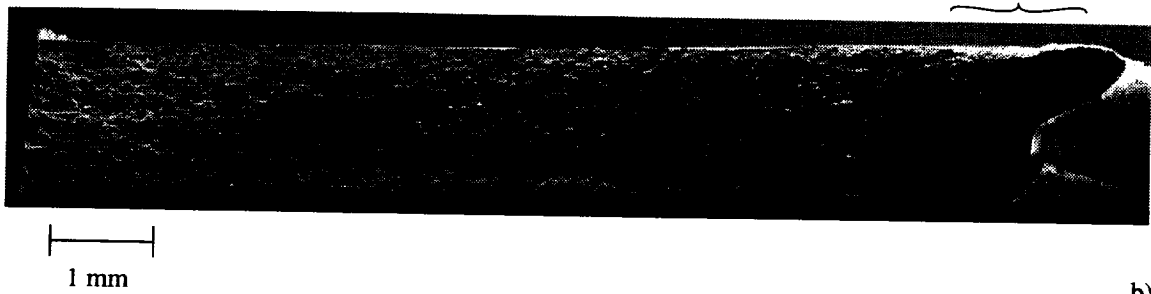
Figure 11.22 a) The schematic shows the rivet hole 4J8 configuration and the location of the outer skin fatigue crack oriented in the aft direction and about the 9 o'clock position. b) The SEM micrograph shows the fatigue crack fracture surface located at the outer skin rivet hole (right). The bracket marks the likely region of crack initiation. The crack front is not visible. This crack linked-up with rivet hole 4J9.

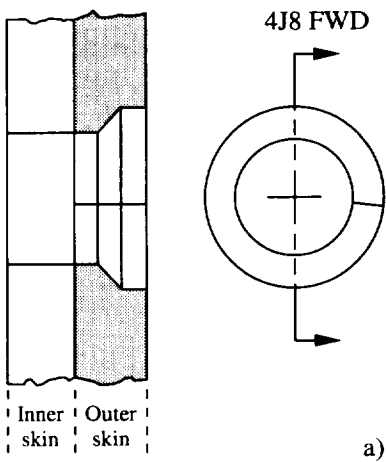
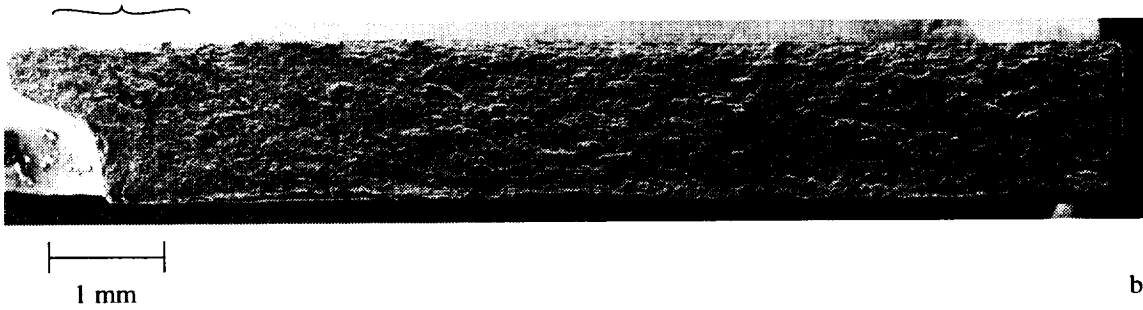
Figure 11.23 a) The schematic shows the rivet hole 4J8 configuration and the location of the outer skin fatigue crack oriented in the forward direction and about the 3 o'clock position. b) The SEM micrograph shows the fatigue crack fracture surface located at the outer skin rivet hole (left). The bracket marks the likely region of crack initiation. The crack front is not visible.
