NASA/TP-97-206257

The Characteristics of Fatigue Damage in the Fuselage Riveted Lap Splice Joint

Robert S. Piascik
Langley Research Center, Hampton, Virginia

November 1997

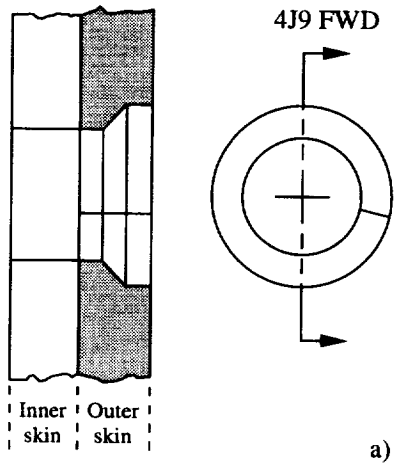
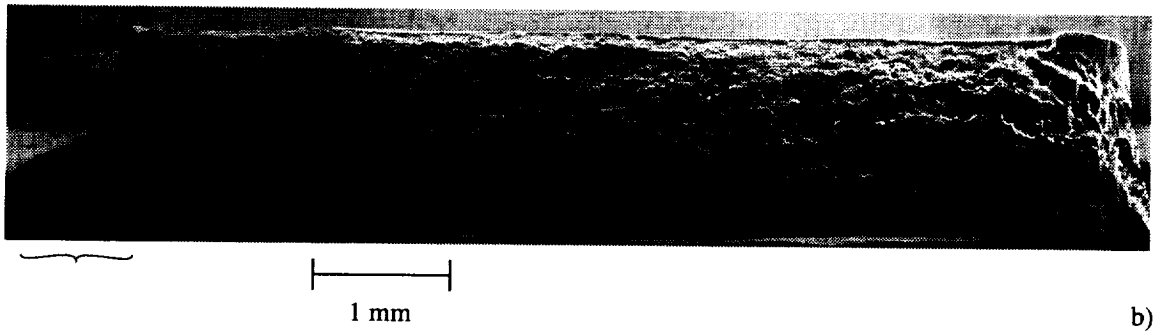
Figure 11.24 a) The schematic shows the rivet hole 4J9 configuration and the location of the outer skin fatigue crack oriented in the forward direction and just below the 3 o'clock position. b) The SEM micrograph shows the fatigue crack fracture surface located at the outer skin rivet hole (left). The bracket marks the likely region of crack initiation. The crack front is not visible.

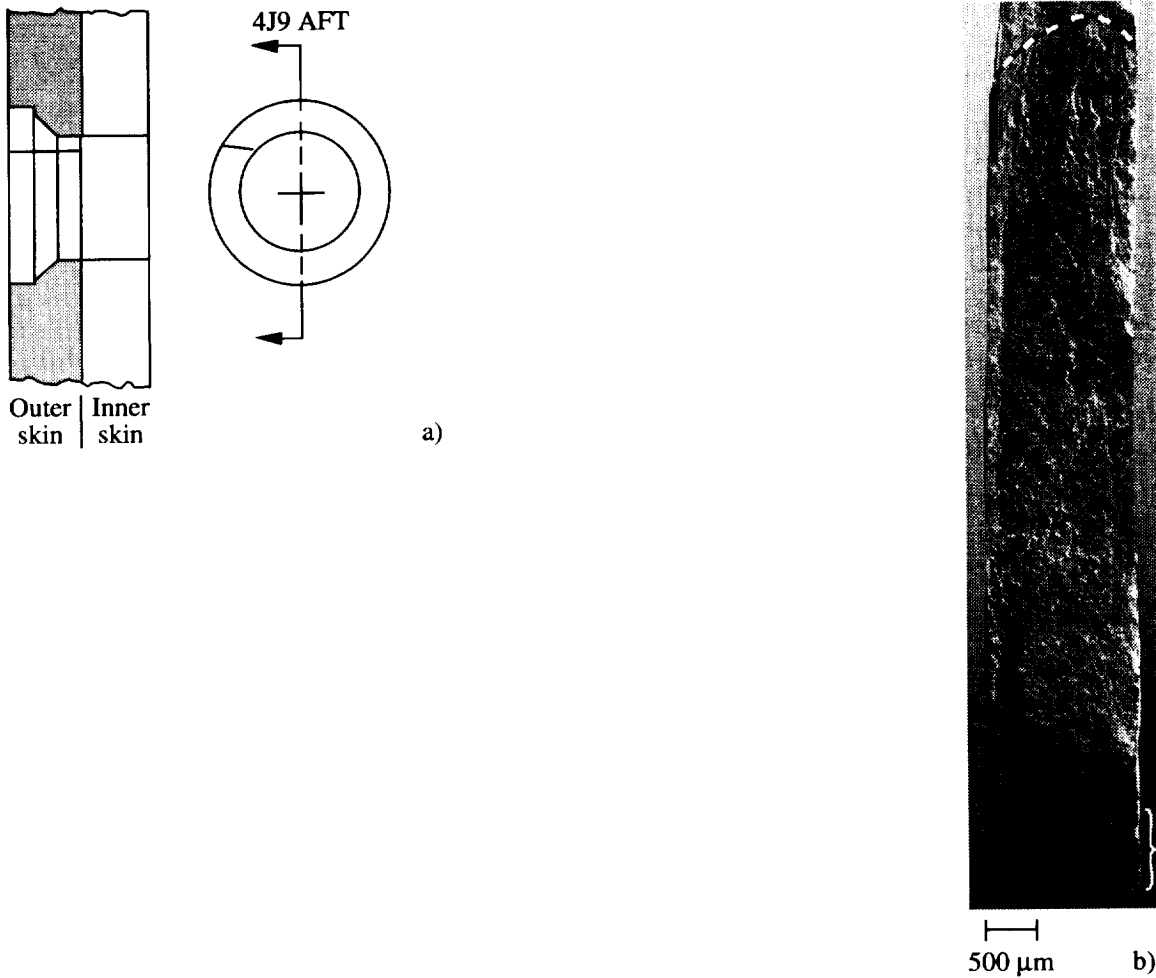
Figure 11.25 a) The schematic shows the rivet hole 4J9 configuration and the location of the outer skin fatigue crack oriented in the aft direction and about the 10 o'clock position. b) The SEM micrograph shows the fatigue crack fracture surface located at the outer skin rivet hole (bottom). The bracket marks the likely region of crack initiation and the dashed line marks the fatigue crack front.

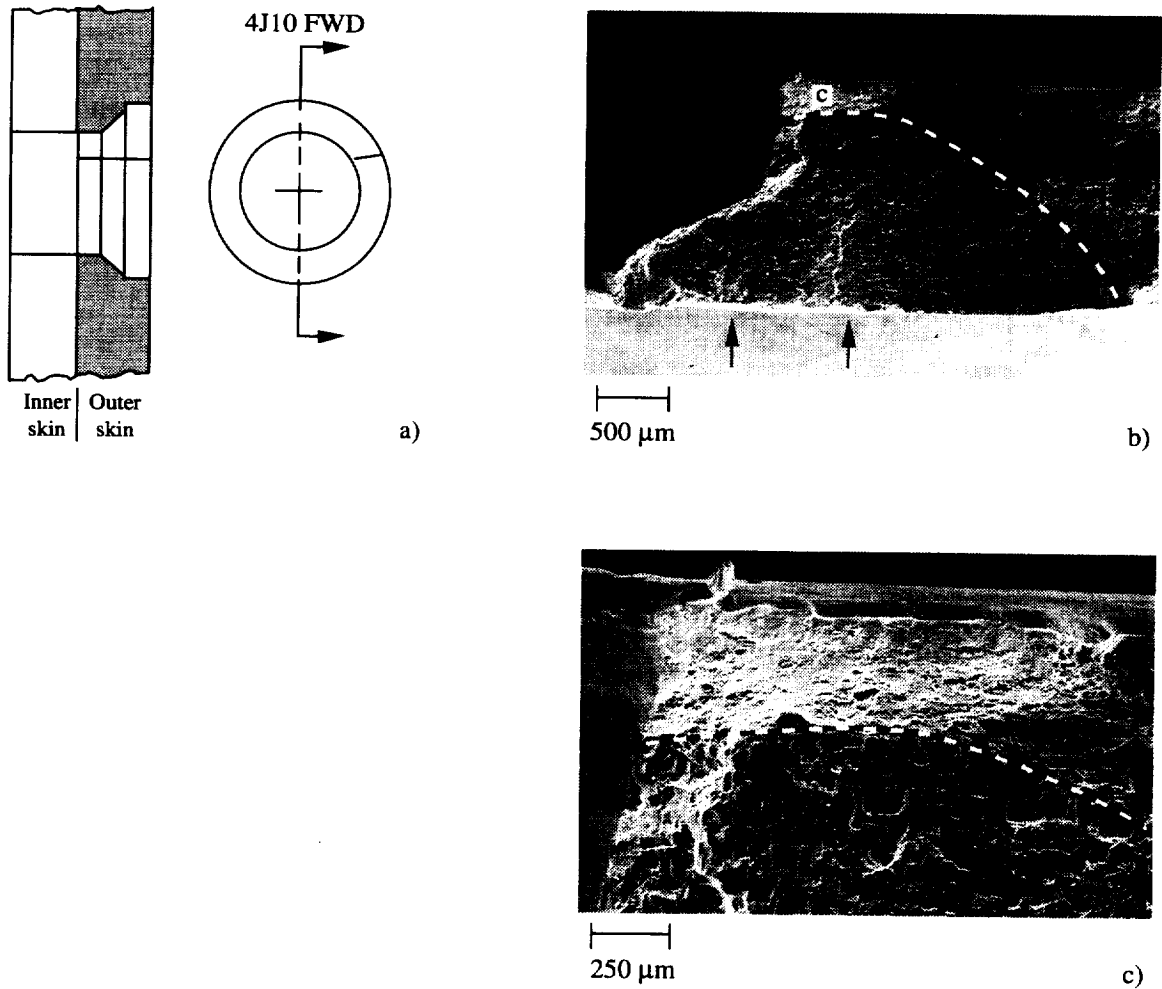
Figure 11.26 a) The schematic shows the rivet hole 4J10 configuration and the location of the outer skin fatigue crack oriented in the forward direction and about the 2 o'clock position. b) The SEM micrograph shows the fatigue crack fracture surface located at the outer skin rivet hole (left). The arrows mark the likely regions of crack initiation and the dashed line marks the fatigue crack front. c) The SEM micrograph shows the fatigue crack front ligament at region "c" in Figure 11.23.b. The dashed line marks the fatigue crack front where it intersects the rivet hole (left). The outboard surface of the outer skin is located at the top of the micrograph.

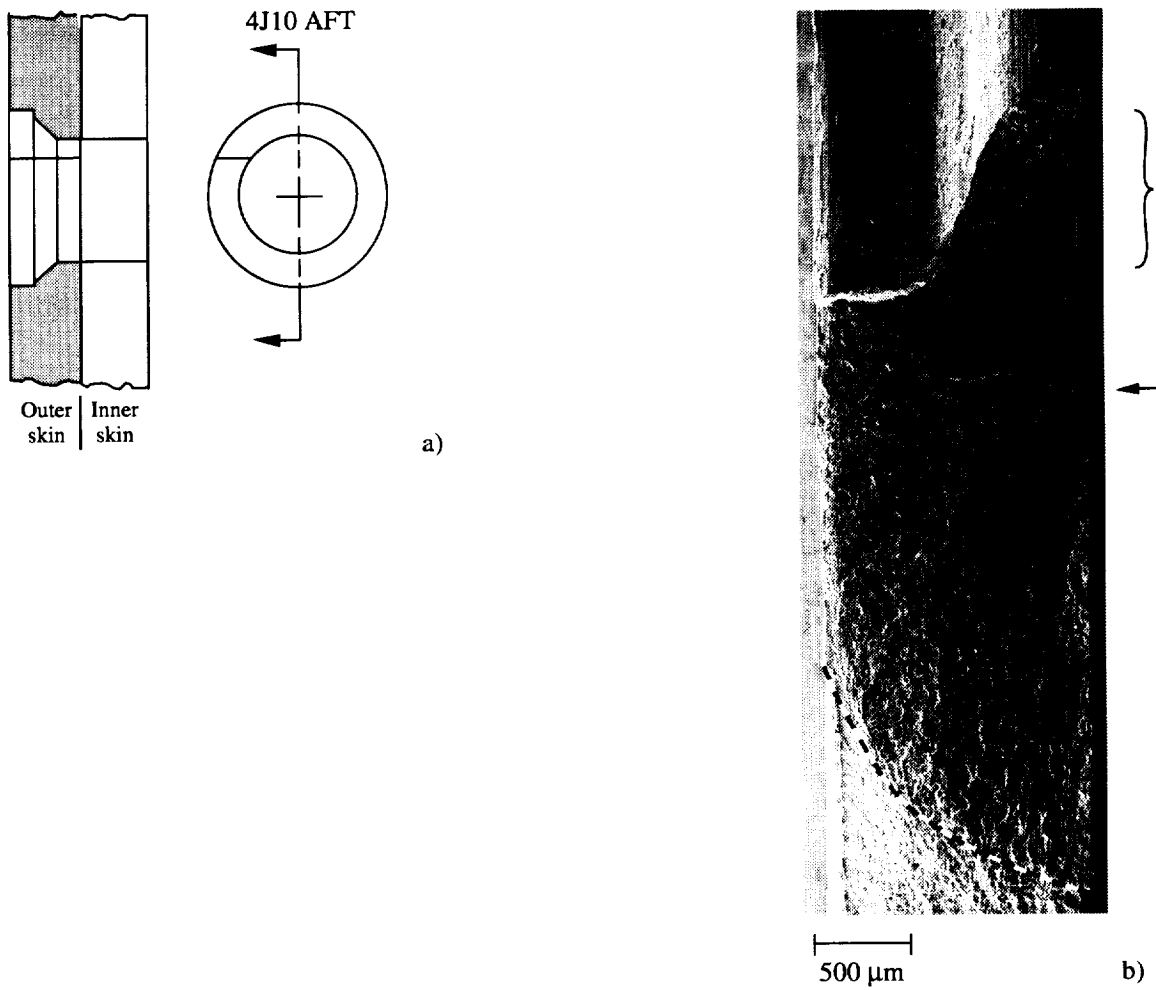
Figure 11.27 a) The schematic shows the rivet hole 4J10 configuration and the location of the outer skin fatigue crack oriented in the aft direction and about the 10 o'clock position. b) The SEM micrograph shows the fatigue crack fracture surface located at the outer skin rivet hole (top). Crack initiation occurred at multiple sites (bracket and arrow) along the faying surface. The dashed line marks the fatigue crack front.

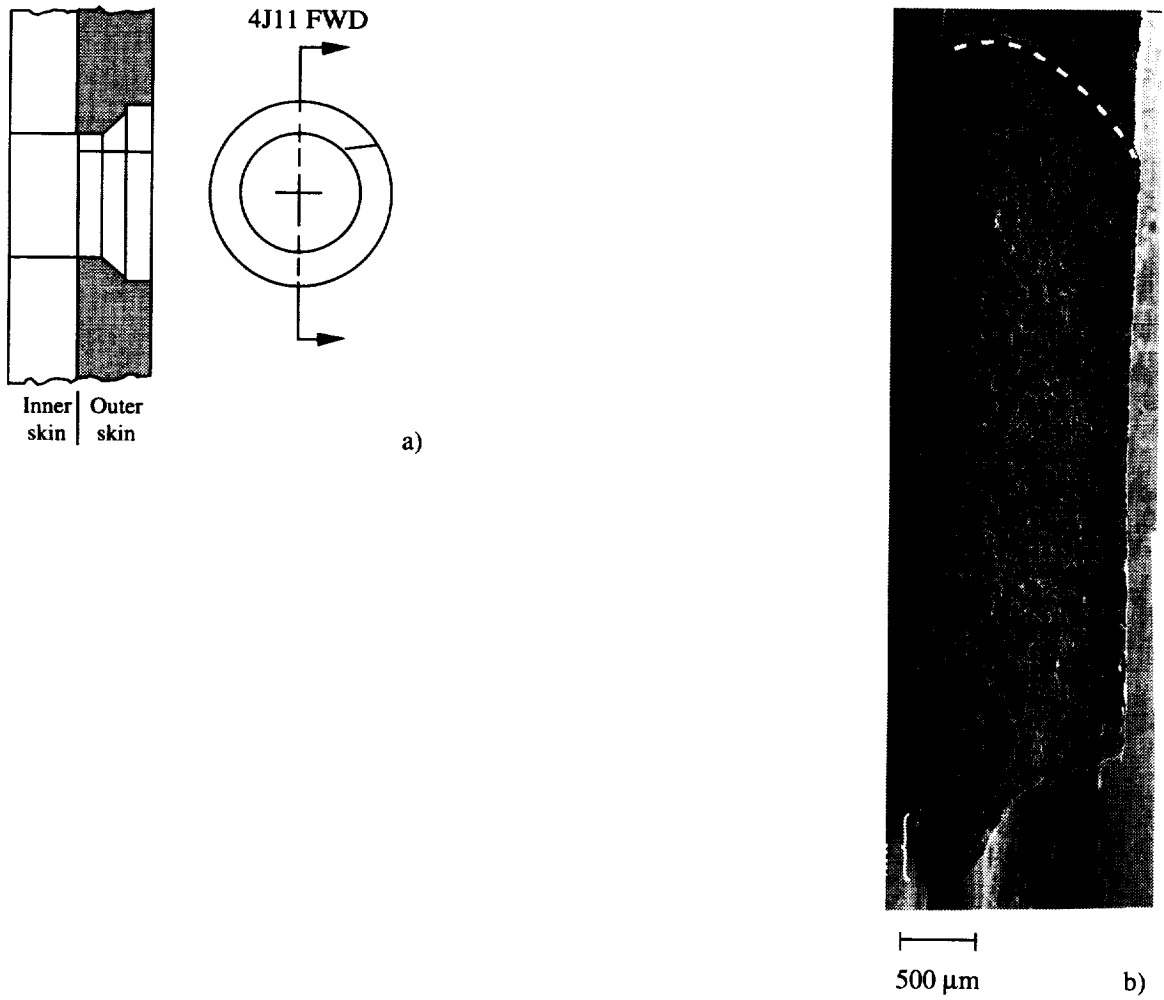
Figure 11.28 a) The schematic shows the rivet hole 4J11 configuration and the location of the outer skin fatigue crack oriented in the forward direction and about the 2 o'clock position. b) The SEM micrograph shows the fatigue crack fracture surface located at the outer skin rivet hole (bottom). The bracket shows the likely region of crack initiation and the dashed line marks the fatigue crack front.

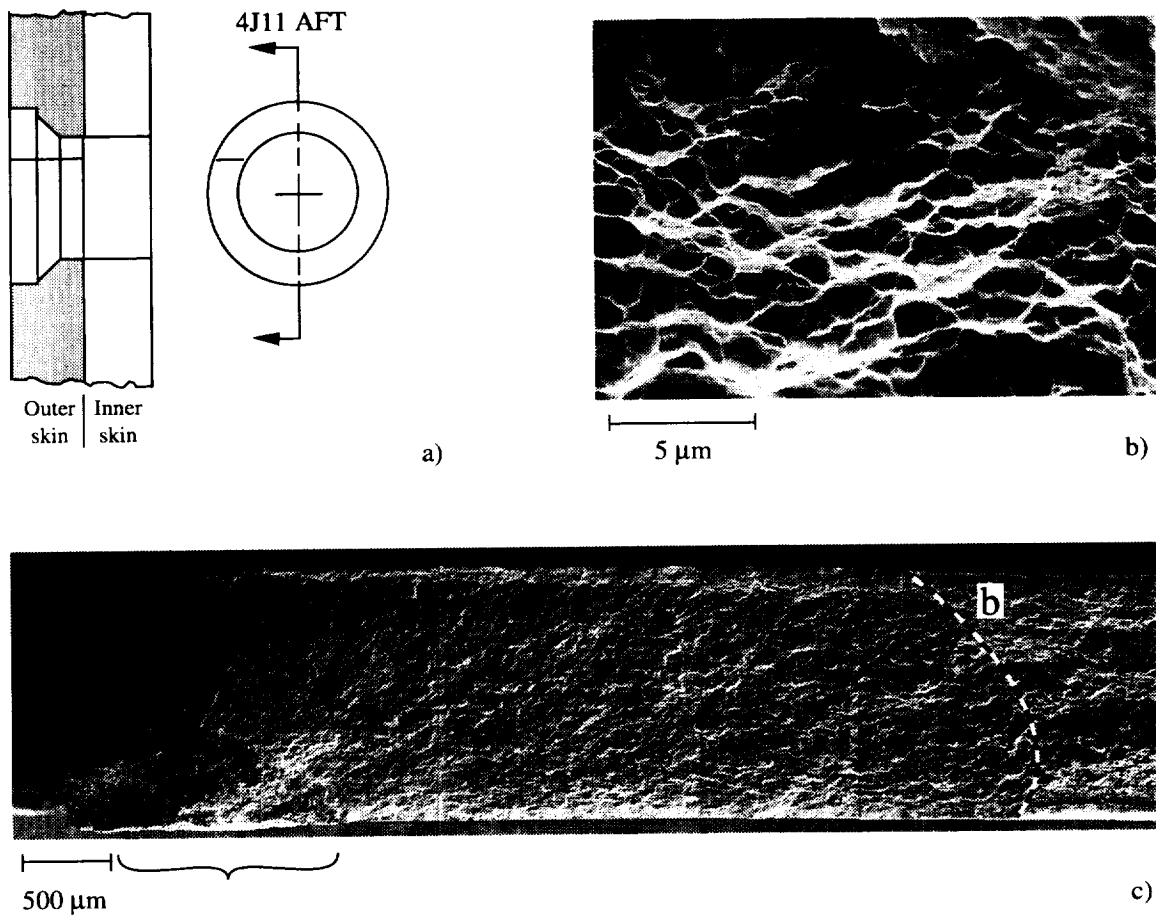
Figure 11.29 a) The schematic shows the rivet hole 4J11 configuration and the location of the outer skin fatigue crack oriented in the aft direction and about the 10 o'clock position. b) The SEM micrograph shows the ductile tearing morphology of the overload fracture surface at region "b" in Figure 11.26.c. c) The SEM micrograph shows the fatigue crack fracture surface located at the outer skin rivet hole (left). The bracket shows the region of crack initiation along the faying surface and the dashed line marks the fatigue crack front.

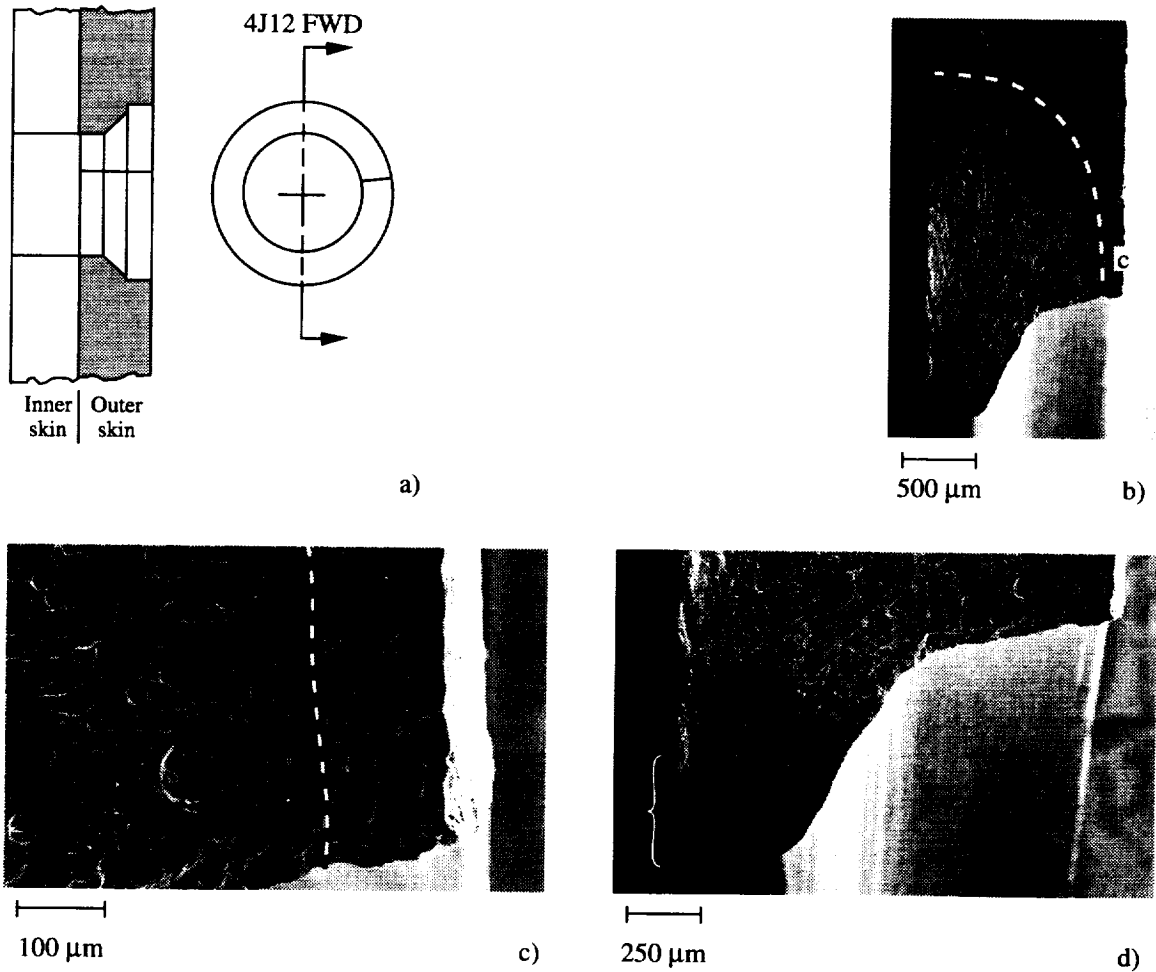
Figure 11.30 a) The schematic shows the rivet hole 4J12 configuration and the location of the outer skin fatigue crack oriented in the forward direction and above the 3 o'clock position. b) The SEM micrograph shows the fatigue crack fracture surface located at the outer skin rivet hole (bottom). The dashed line marks the fatigue crack front. c) The SEM micrograph shows the fatigue crack front at region "c" in Figure 11.27.b. The dashed line marks the fatigue crack front where it intersects the rivet hole (bottom). The outboard surface of the outer skin is located at the right of the micrograph. d) The SEM micrograph shows the fatigue crack initiation region located at the faying surface (bracket).

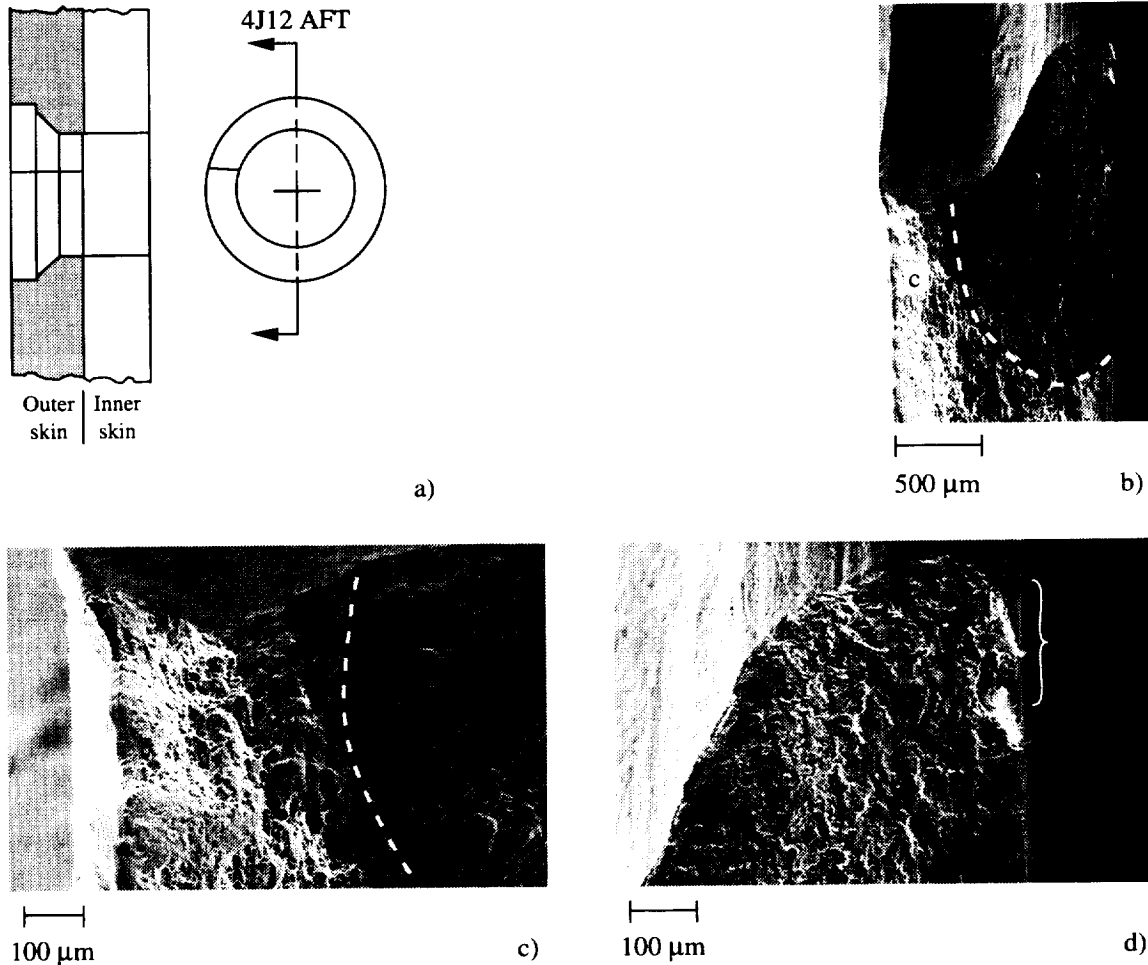
Figure 11.31 a) The schematic shows the rivet hole 4J12 configuration and the location of the outer skin fatigue crack oriented in the aft direction and above the 9 o'clock position. b) The SEM micrograph shows the fatigue crack fracture surface located at the outer skin rivet hole (top). The dashed line marks the fatigue crack front. c) The SEM micrograph shows the fatigue crack front at region "c" in Figure 11.28.b. The dashed line marks the fatigue crack front where it intersects the rivet hole (bottom). The outboard side of the outer skin is located at the left of the micrograph. d) The SEM micrograph shows the fatigue crack initiation region located along the faying surface (bracket).

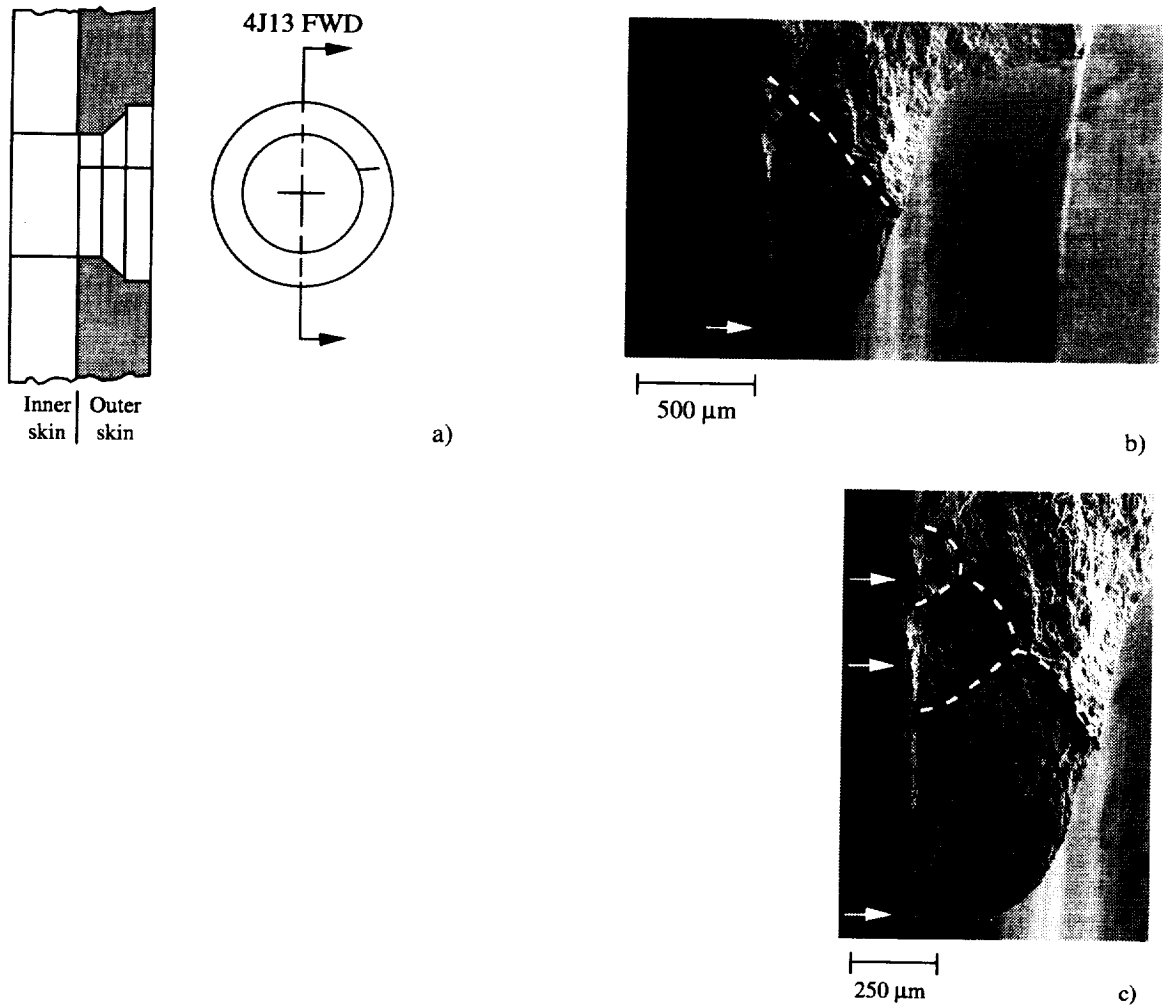
Figure 11.32 a) The schematic shows the rivet hole 4J13 configuration and the location of the outer skin fatigue crack oriented in the forward direction and below the 2 o'clock position. b) The SEM micrograph shows the fatigue crack fracture surface located at the outer skin rivet hole (bottom). The dashed line marks the fatigue crack front. c) The SEM micrograph shows the fatigue crack initiation region located along the faying surface (arrows). The dashed lines mark the crack front.

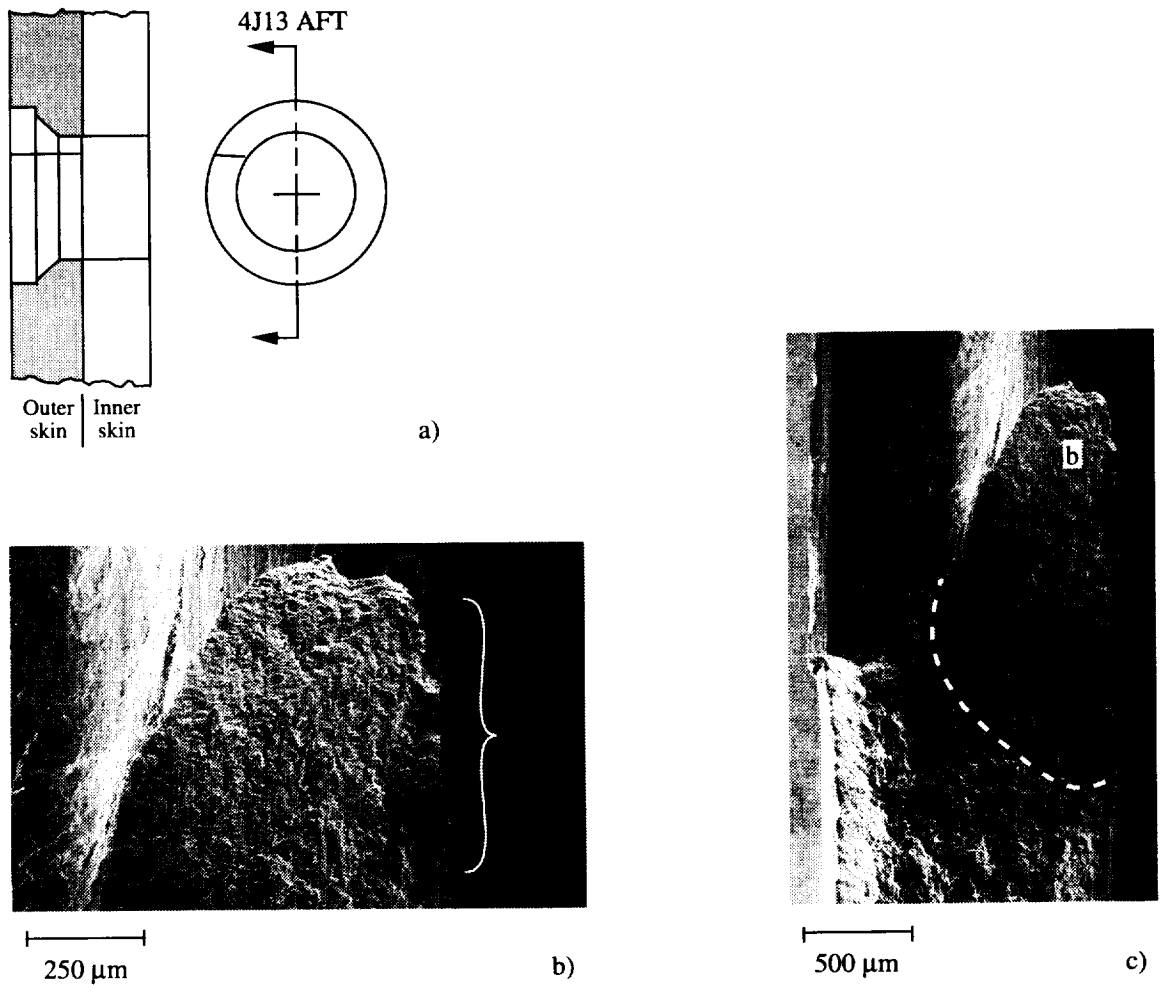
Figure 11.33 a) The schematic shows the rivet hole 4J13 configuration and the location of the outer skin fatigue crack oriented in the aft direction and about the 10 o'clock position. b) The SEM micrograph shows the rivet hole shank region and the likely fatigue crack initiation region located at the inboard corner of the rivet hole (bracket). c) The SEM micrograph shows the fatigue crack fracture surface located at the outer skin rivet hole (top). The dashed line marks the fatigue crack front.

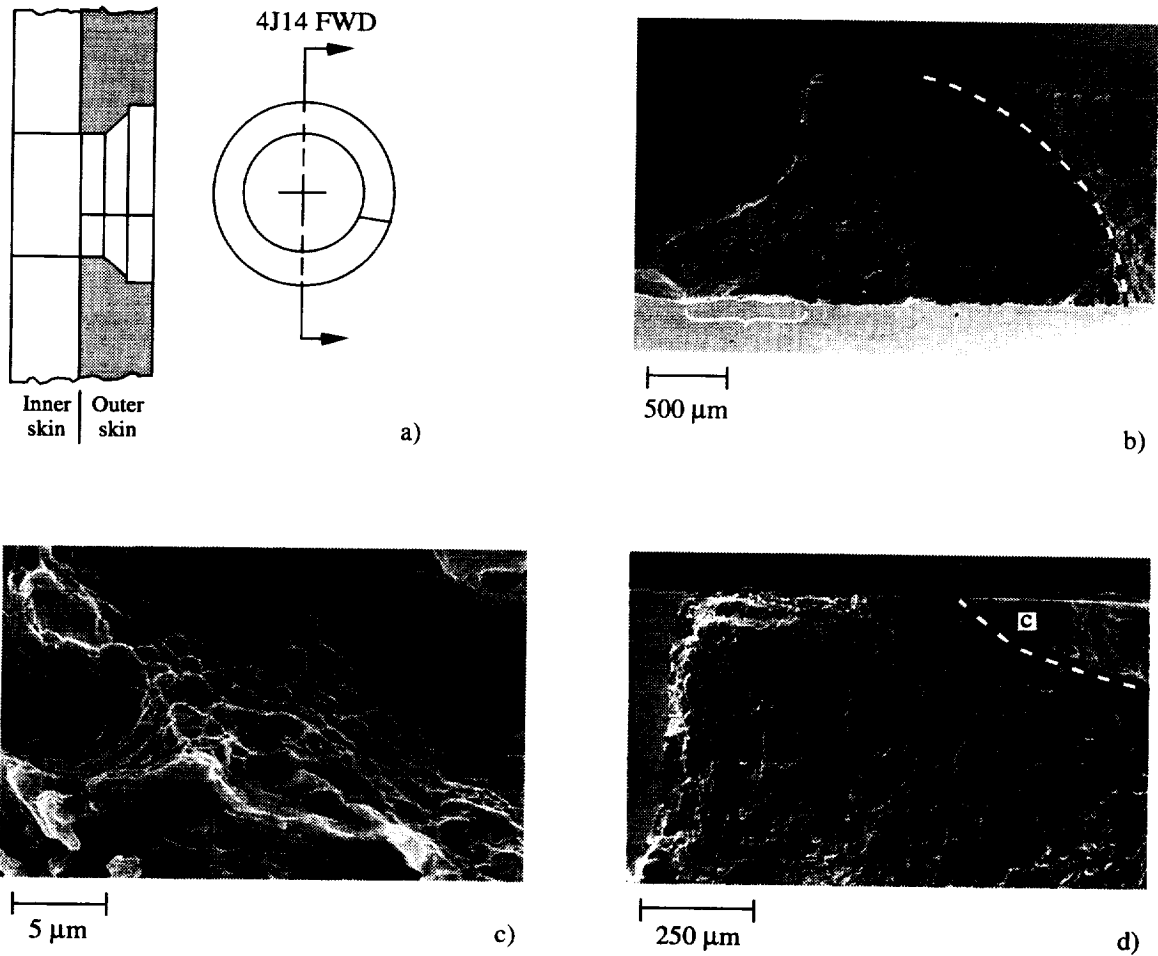
Figure 11.34 a) The schematic shows the rivet hole 4J14 configuration and the location of the outer skin fatigue crack oriented in the forward direction and about the 4 o'clock position. b) The SEM micrograph shows the fatigue crack fracture surface located at the outer skin rivet hole (left). The bracket marks the likely crack initiation site and the dashed line marks the fatigue crack front. c) The SEM micrograph shows the ductile tearing morphology of the overload fracture surface at region "c" in Figure 11.11.d at high magnification. d) The SEM micrograph shows the fatigue crack front region (dashed line) as it intersects the outboard surface of the outer skin. The rivet hole is located to the left.

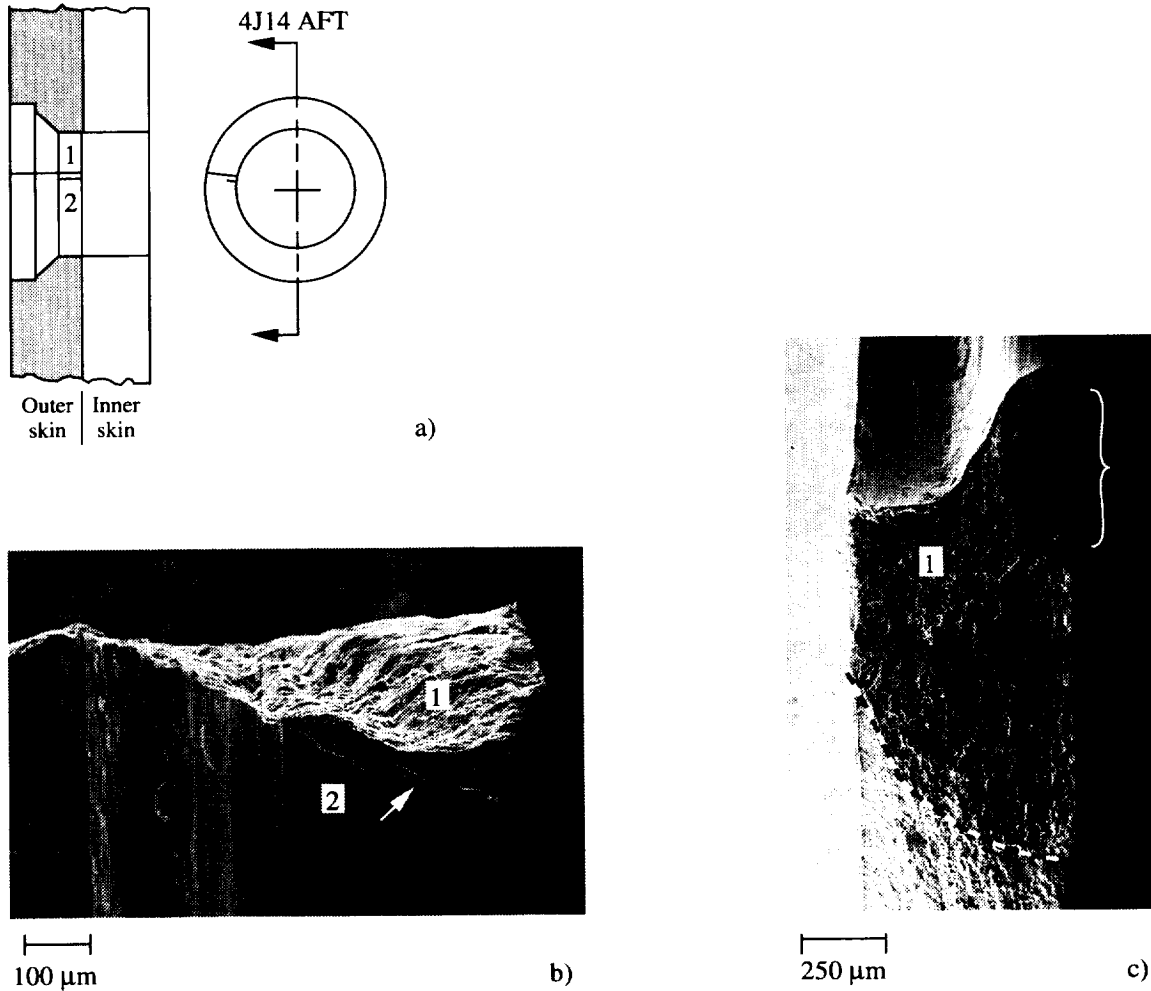
Figure 11.35 a) The schematic shows the rivet hole 4J14 configuration and the location of two outer skin fatigue cracks oriented in the aft direction and above the 9 o'clock position. b) The SEM micrograph shows the rivet hole surface and the fatigue crack fracture surface at an oblique angle. Fatigue crack #2 is located below the main fracture surface that contains fatigue crack #1. c) The SEM micrograph shows the fatigue crack fracture surface located at the outer skin rivet hole (top). The bracket marks the likely region of crack initiation along the faying surface and the dashed line marks the fatigue crack front.

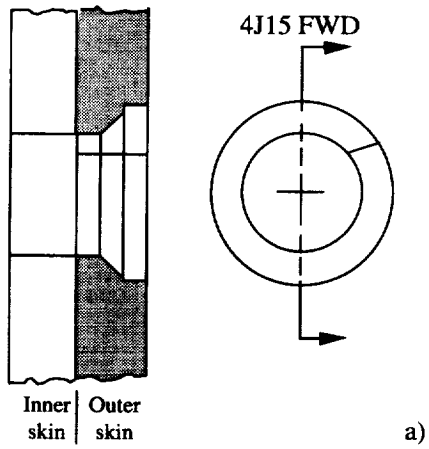
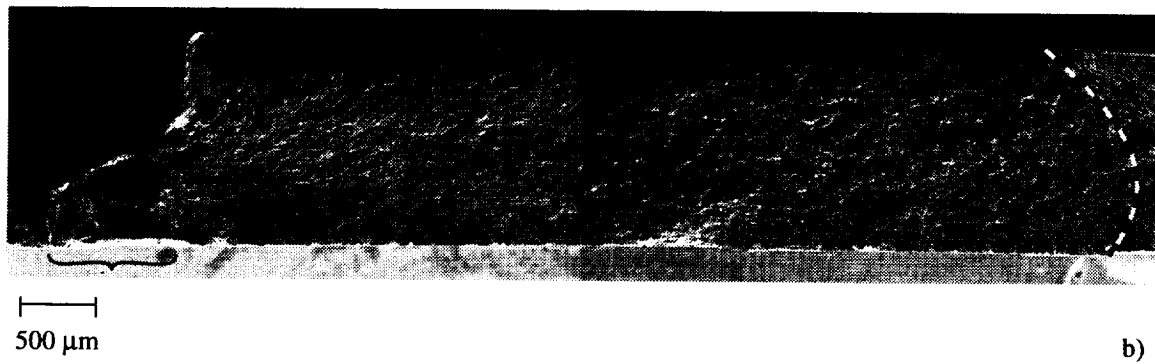
Figure 11.36 a) The schematic shows the rivet hole 4J15 configuration and the location of the outer skin fatigue crack oriented in the forward direction and about the 2 o'clock position. b) The SEM micrograph shows the fatigue crack fracture surface located at the outer skin rivet hole (left). The bracket marks the region of crack initiation along the faying surface and the dashed line marks the fatigue crack front.

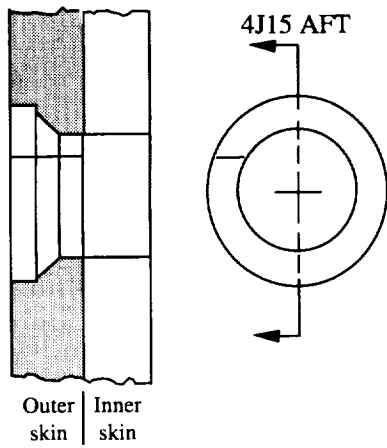
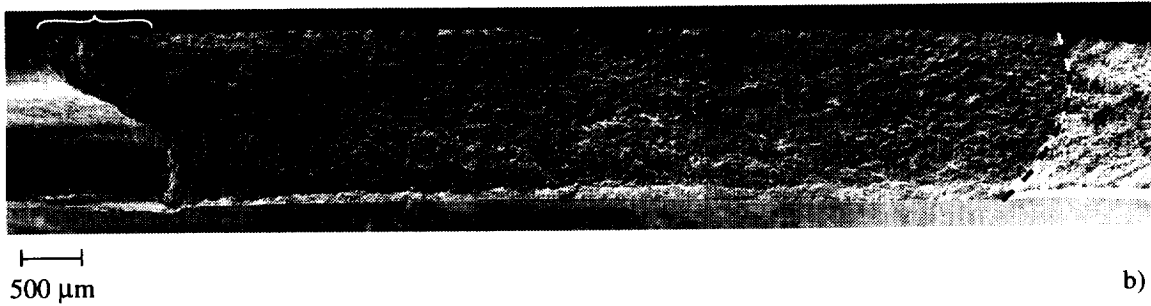
Figure 11.37 a) The schematic shows the rivet hole 4J15 configuration and the location of the outer skin fatigue crack oriented in the aft direction and about the 10 o'clock position. b) The SEM micrograph shows the fatigue crack fracture surface located at the outer skin rivet hole (left). The bracket marks the region of crack initiation along the faying surface and the dashed line marks the fatigue crack front.

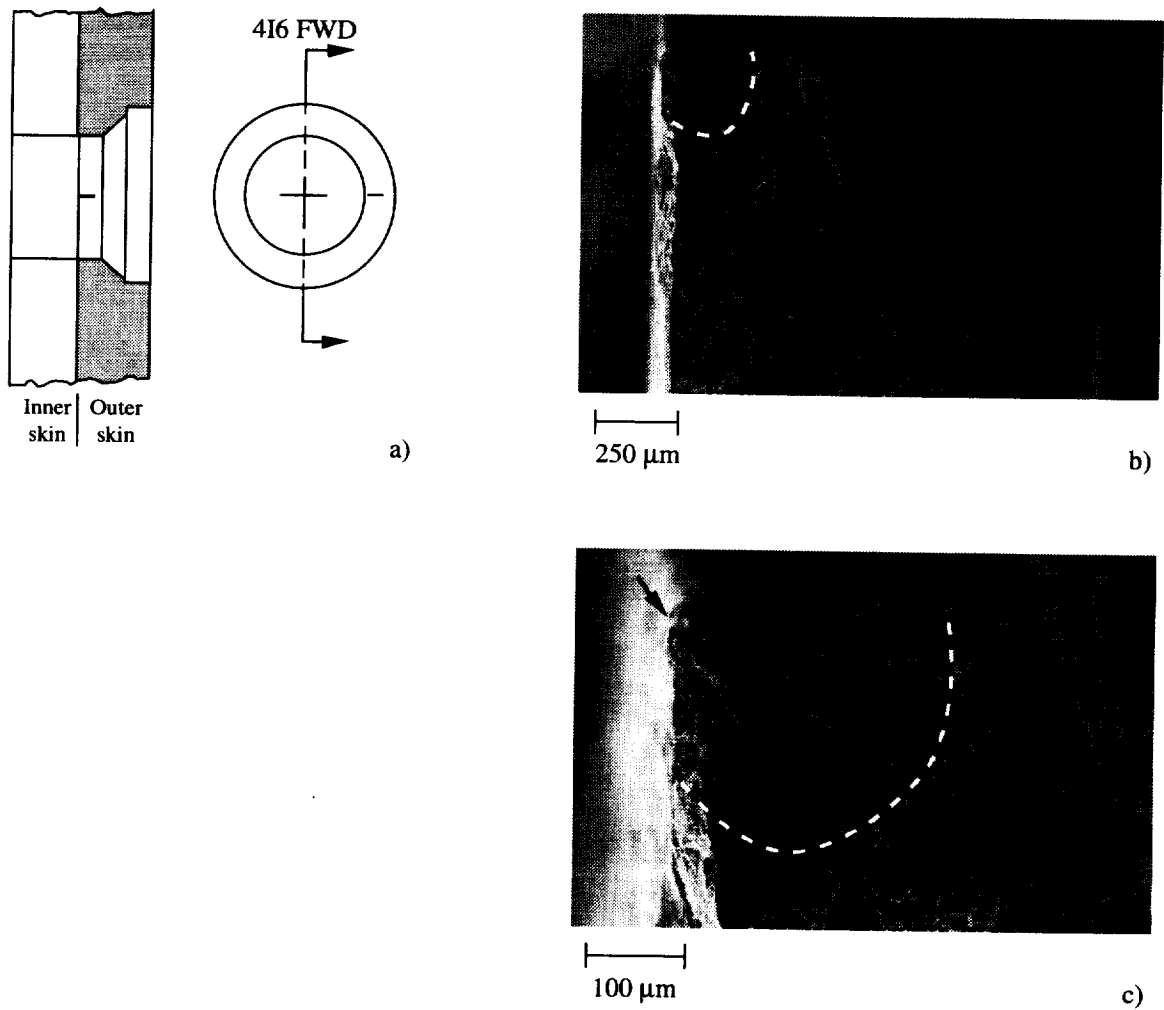
Figures 11.38 through 11.43 describe the fatigue crack morphology in row I.

Figure 11.38 a) The schematic shows the rivet hole 416 configuration and the location of the outer skin fatigue crack oriented in the forward direction and about the 3 o'clock position. b) The SEM micrograph shows the fatigue crack fracture surface located at the outer skin rivet hole (top). The dashed line marks the fatigue crack front. c) The SEM micrograph shows the fatigue crack fracture surface at the rivet hole shank region. The arrow marks the likely site of crack initiation and the dashed line marks the fatigue crack front.

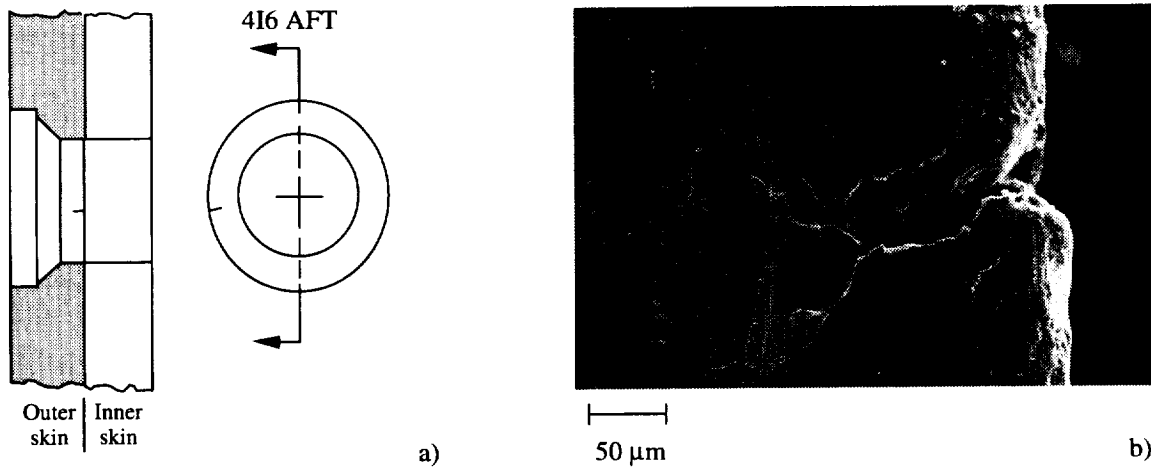
Figure 11.39 a) The schematic shows the rivet hole 4I6 configuration and the location of the outer skin fatigue crack oriented in the aft direction and below the 9 o'clock position. b) The SEM micrograph shows the small partially opened fatigue crack located at the inboard corner of the rivet hole shank region. The crack was partially opened during the destructive examination.

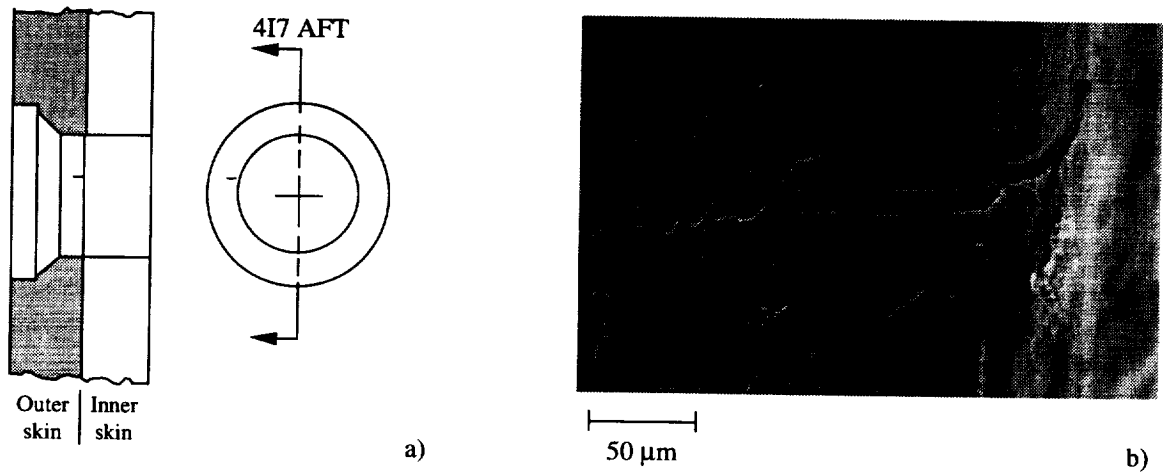
Figure 11.40 a) The schematic shows the rivet hole 4I7 configuration and the location of the outer skin fatigue crack oriented in the aft direction and above the 9 o'clock position. b) The SEM micrograph shows the small partially opened fatigue crack located at the inboard corner of the rivet hole shank region. The crack was partially opened during the destructive examination.

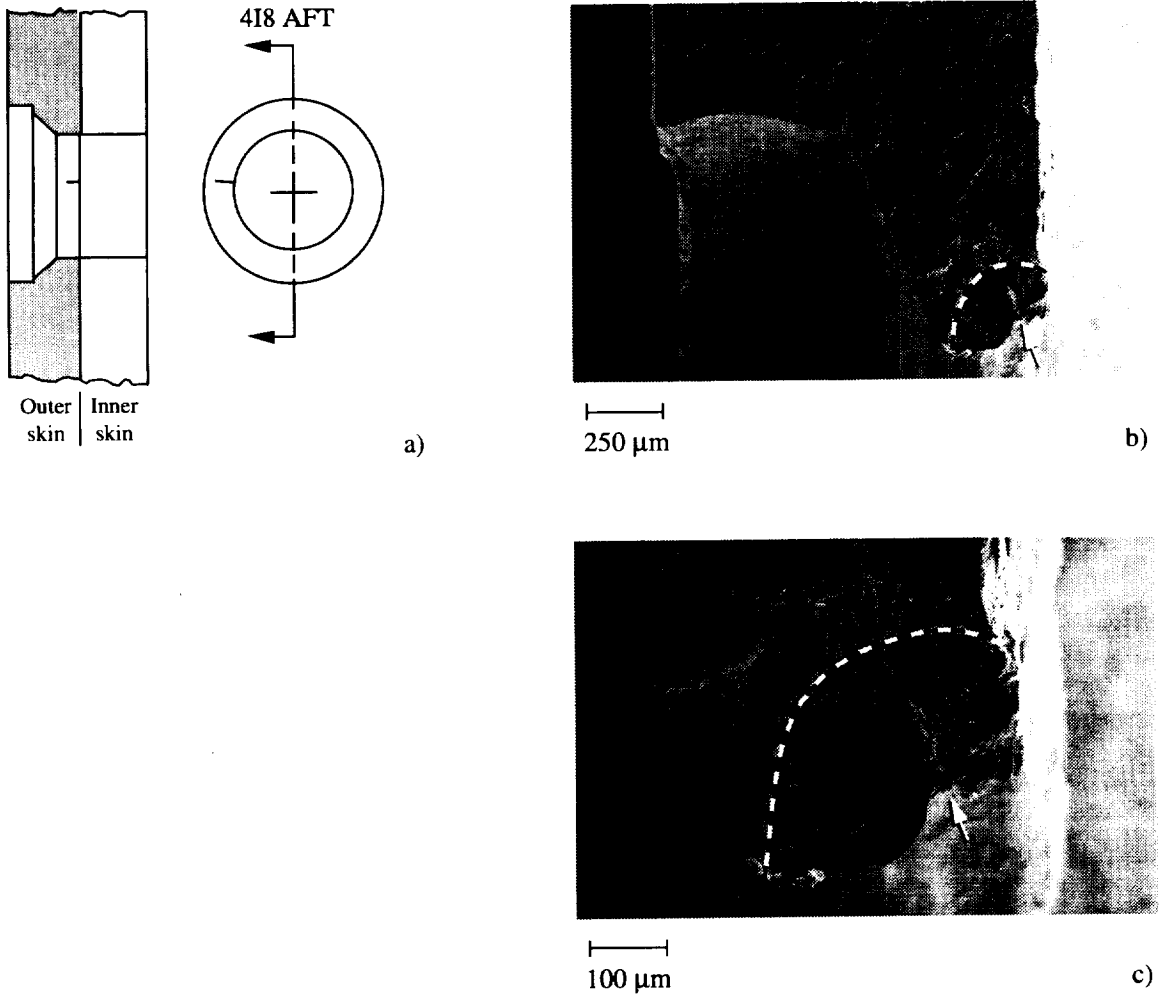
Figure 11.41 a) The schematic shows the rivet hole 4I8 configuration and the location of the outer skin fatigue crack oriented in the aft direction and above the 9 o'clock position. b) The SEM micrograph shows the fatigue crack fracture surface located at the outer skin rivet hole (bottom). The arrow marks the likely crack initiation site and the dashed line marks the fatigue crack front at high magnification. c) The SEM micrograph shows the fatigue crack fracture surface at the rivet hole shank region. The arrow marks the likely site of crack initiation and the dashed line marks the fatigue crack front.

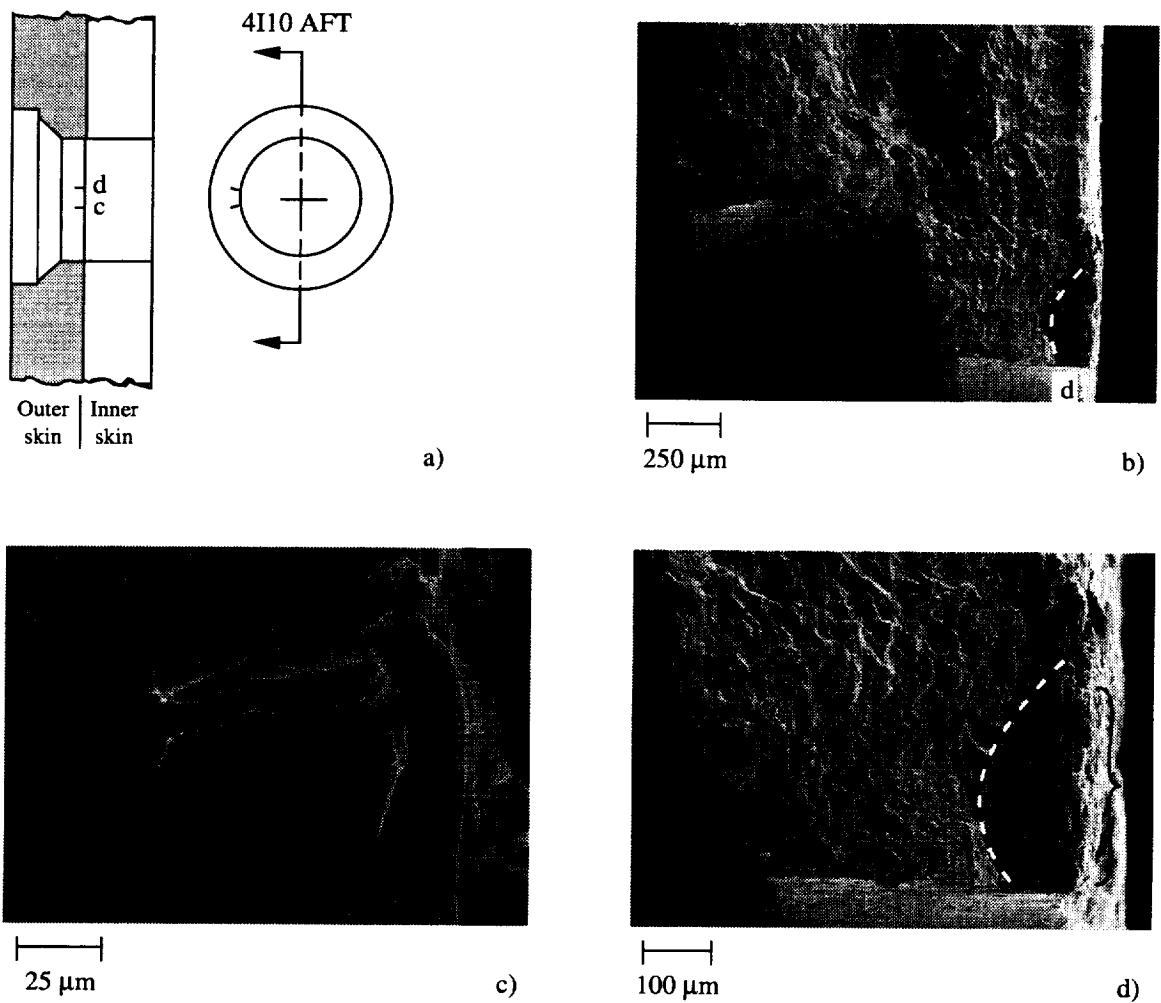
Figure 11.42 a) The schematic shows the rivet hole 4I10 configuration and the location of two outer skin fatigue cracks oriented in the aft direction and about the 9 o'clock position. b) The SEM micrograph shows the fatigue crack fracture surface located at the outer skin rivet hole (bottom). The dashed line marks the fatigue crack front. c) The SEM micrograph shows the inside surface of the rivet hole and a small partially opened fatigue crack (crack "c" in Figure 11.39.a) located at the inboard corner of the rivet hole. d) The SEM micrograph shows the fatigue crack fracture surface (crack "d" in Figure 11.39.a) at the rivet hole shank region at high magnification. The bracket marks the likely region of crack initiation along the faying surface and the dashed line marks the fatigue crack front.

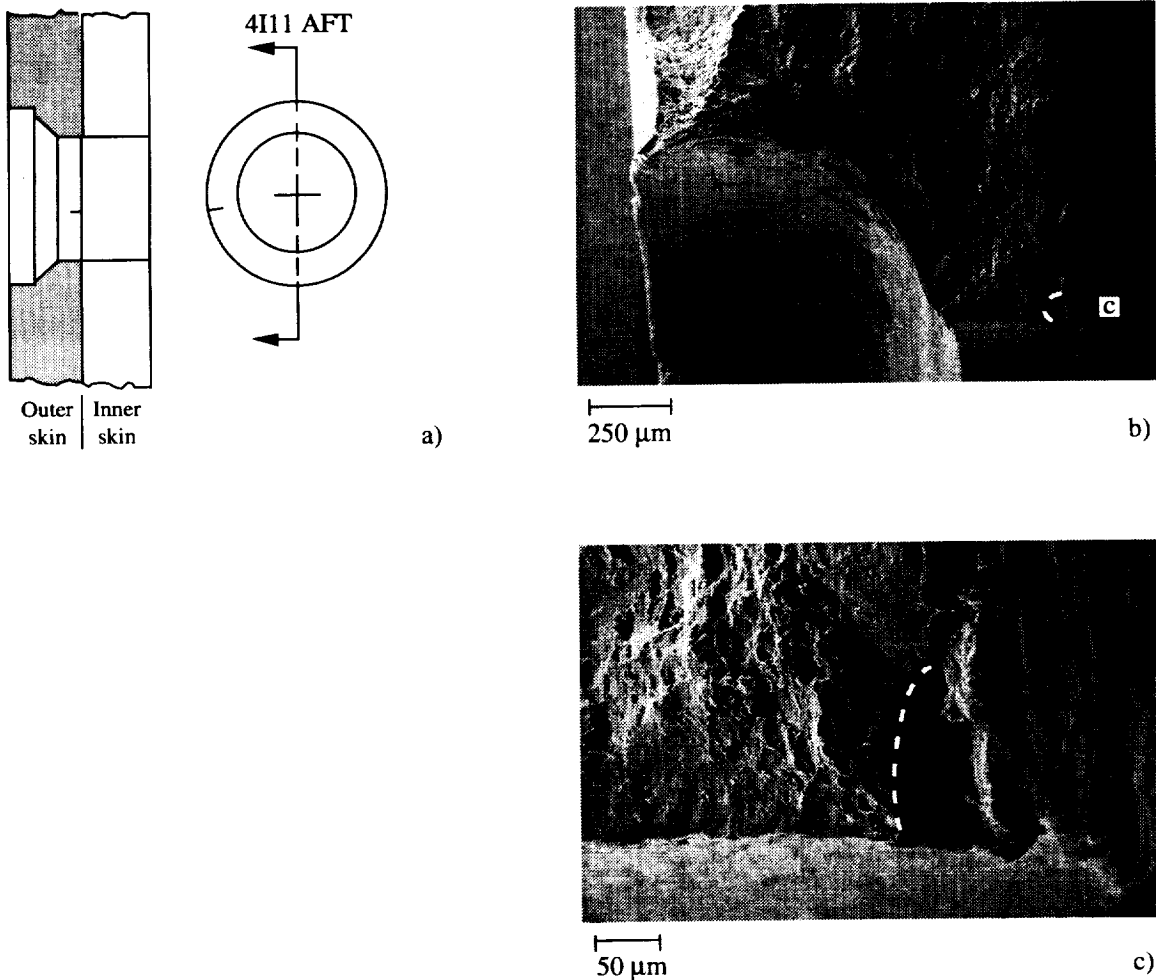
Figure 11.43 a) The schematic shows the rivet hole 4I11 configuration and the location of the outer skin fatigue crack oriented in the aft direction and below the 9 o'clock position. b) The SEM micrograph shows the location of a small fatigue crack (region "c") located at the inboard corner of the outer skin rivet hole. c) The SEM micrograph shows the fatigue crack, region "c" in Figure 11.40.b, located at the rivet hole shank region at high magnification. The dashed line marks the fatigue crack front.
