NASA/TP-97-206257

The Characteristics of Fatigue Damage in the Fuselage Riveted Lap Splice Joint

Robert S. Piascik
Langley Research Center, Hampton, Virginia

November 1997

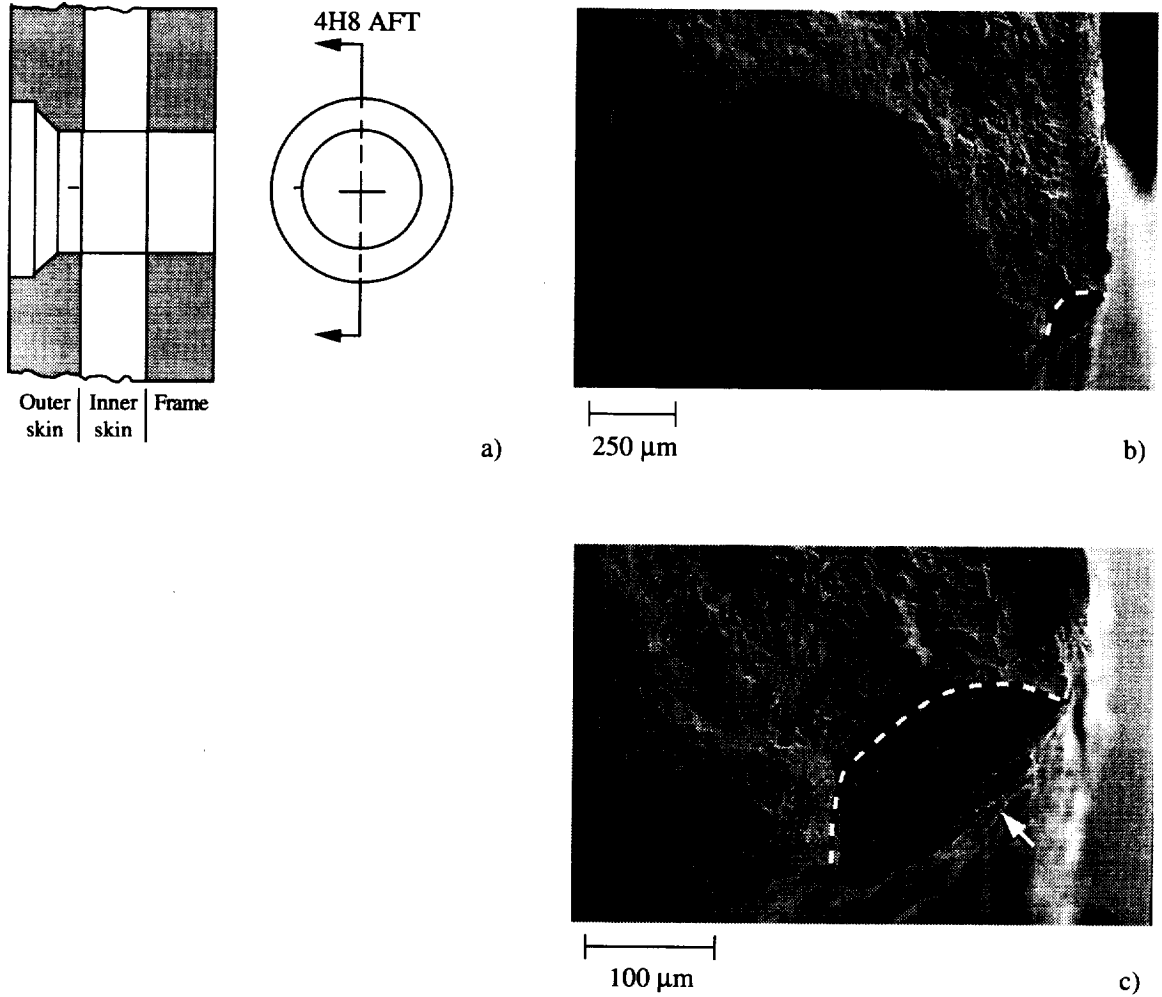
Figures 11.44 through 11.45 describe the fatigue crack morphology in row H.

Figure 11.44 a) The schematic shows the rivet hole 4H8 configuration and the location of the outer skin fatigue crack oriented in the aft direction and about the 9 o'clock position. b) The SEM micrograph shows the location of a small fatigue crack located at the inboard corner of the outer skin rivet hole. The dashed line marks the fatigue crack front. c) The SEM micrograph shows the fatigue crack fracture surface at the rivet hole shank region at high magnification. The arrow marks the likely site of crack initiation and the dashed line marks the fatigue crack front.

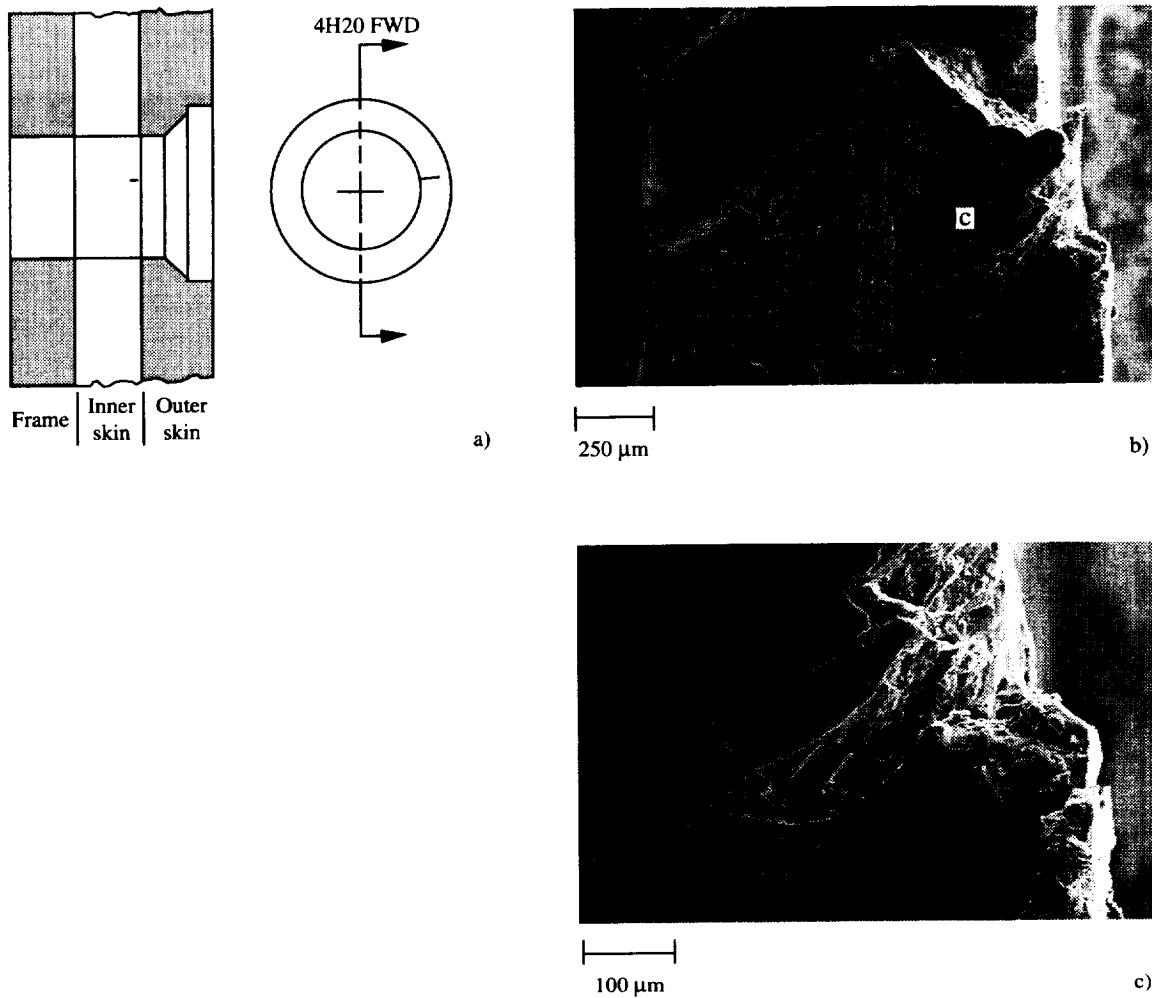
Figure 11.45 a) The schematic shows the rivet hole 4H20 configuration and the location of the inner skin fatigue crack oriented in the forward direction and above the 3 o'clock position. b) The SEM micrograph shows the inside surface of the inner skin rivet hole. A small partially opened fatigue crack is located below the main fracture surface at region "c". The crack was partially opened during the destructive examination. c) The SEM micrograph shows the small partially opened fatigue crack at high magnification at region "c" in Figure 11.42.b. The fatigue crack is located near the outboard corner of the inner skin.

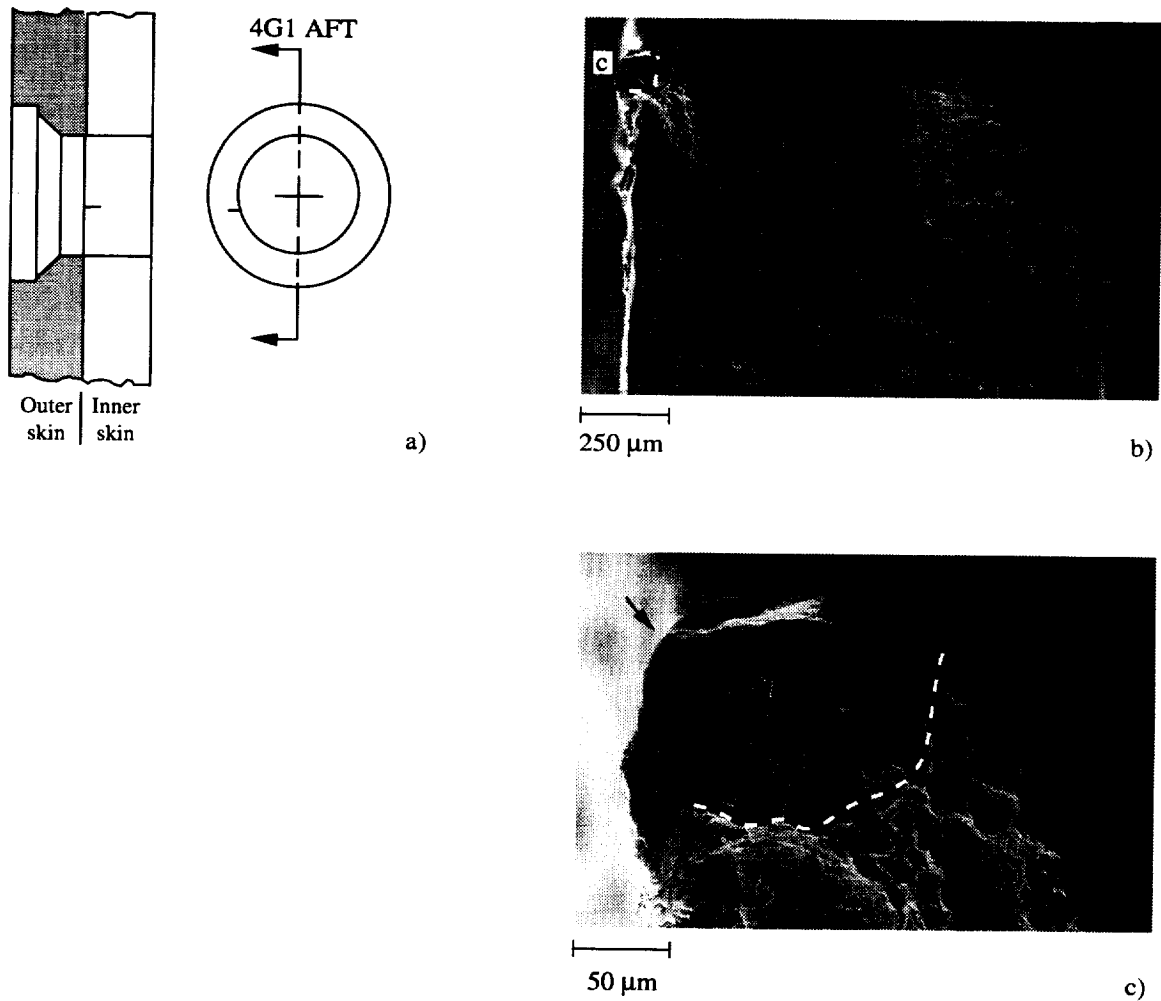
Figures 11.46 through 11.48 describe the fatigue crack morphology in row G.

Figure 11.46 a) The schematic shows the rivet hole 4G1 configuration and the location of the inner skin fatigue crack oriented in the aft direction and below the 9 o'clock position. b) The SEM micrograph shows a small fatigue crack (region "c") located at the outboard corner of the inner skin rivet hole. The dashed line marks the fatigue crack front. c) The SEM micrograph shows the small fatigue crack region at high magnification. The arrow marks the likely site of fatigue crack initiation and the dashed line marks the fatigue crack front.

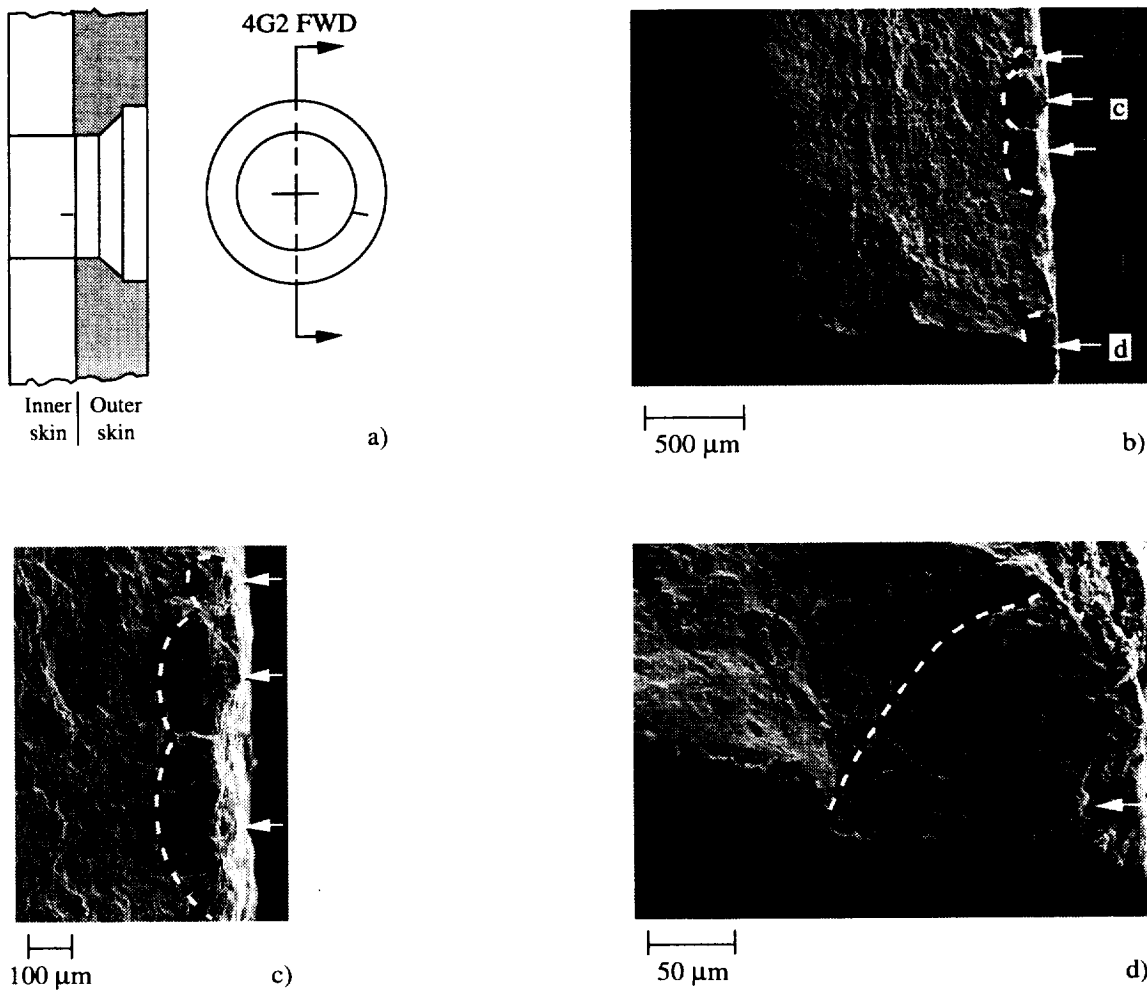
Figure 11.47 a) The schematic shows the rivet hole 4G2 configuration and the location of the outer skin fatigue crack oriented in the forward direction and about the 4 o'clock position. b) The SEM micrograph shows the location of small fatigue cracks located at the outboard corner and faying surface of the inner skin. The arrows mark the likely sites of fatigue crack initiation and the dashed lines mark the fatigue crack fronts. c) The SEM micrograph shows the fatigue crack, region "c" in Figure 11.44.b, along the inner skin faying surface at high magnification. The arrow marks likely sites of crack initiation and the dashed line marks the fatigue crack front. d) The SEM micrograph shows the outboard corner fatigue crack at region "d" in Figure 11.44.b. The arrow marks the crack initiation site and the dashed line marks the crack front.

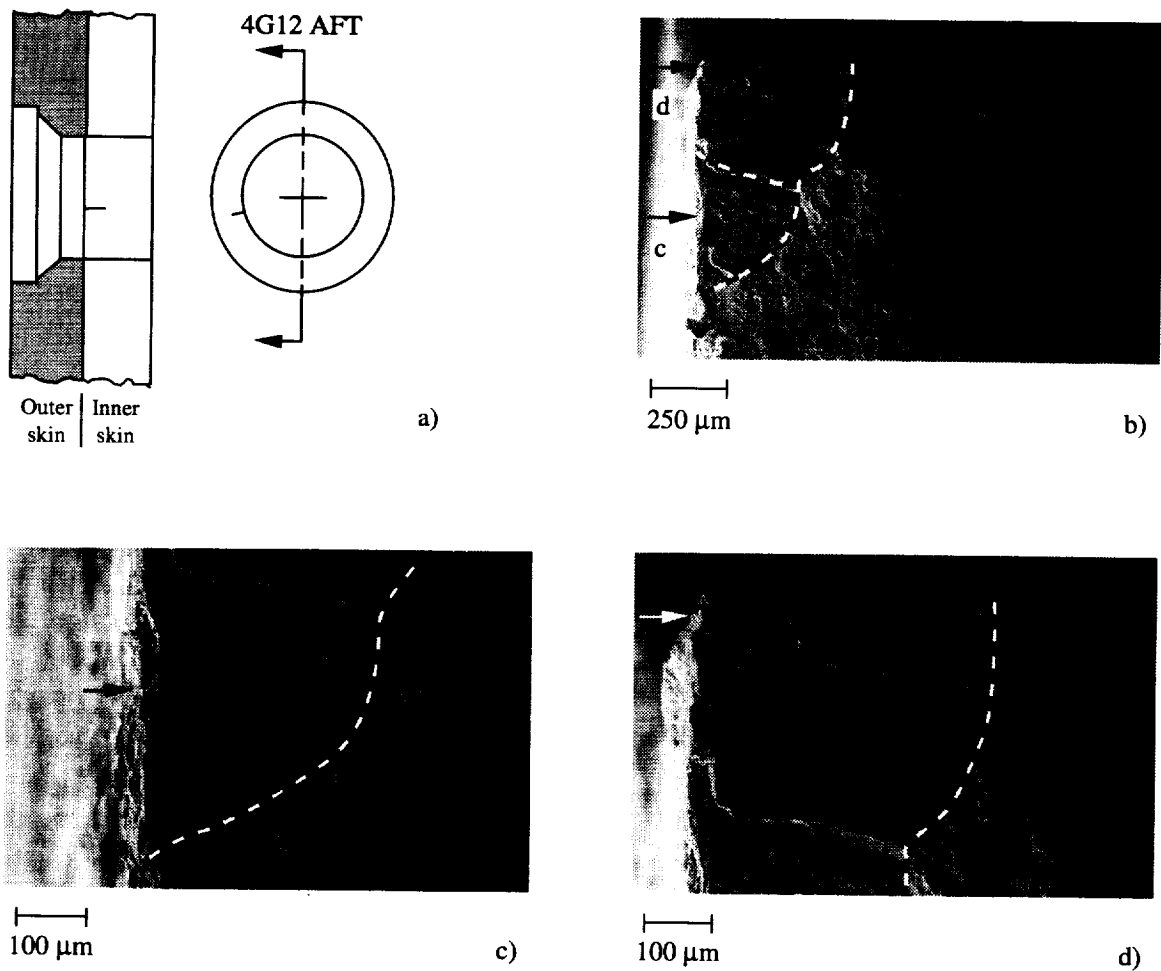
Figure 11.48 a) The schematic shows the rivet hole 4G12 configuration and the location of the inner skin fatigue crack oriented in the aft direction and below the 9 o'clock position. b) The SEM micrograph shows the fatigue crack fracture surface located at the outboard corner of the inner skin rivet hole. The arrows mark likely sites of crack initiation along the faying surface. The irregular shape of the fatigue crack front marked by the dashed lines suggests that two fatigue cracks coalesced at the fracture surface ridge (horizontal dashed line). c) The SEM micrograph shows the fatigue crack, region "c" in Figure 11.45.b, at high magnification. The arrow marks the crack initiation site and the dashed line marks the fatigue crack front. d) The SEM micrograph shows the fatigue crack region "d" in Figure 11.45.b at high magnification. The arrow marks the crack initiation site and the dashed line marks the fatigue crack front.

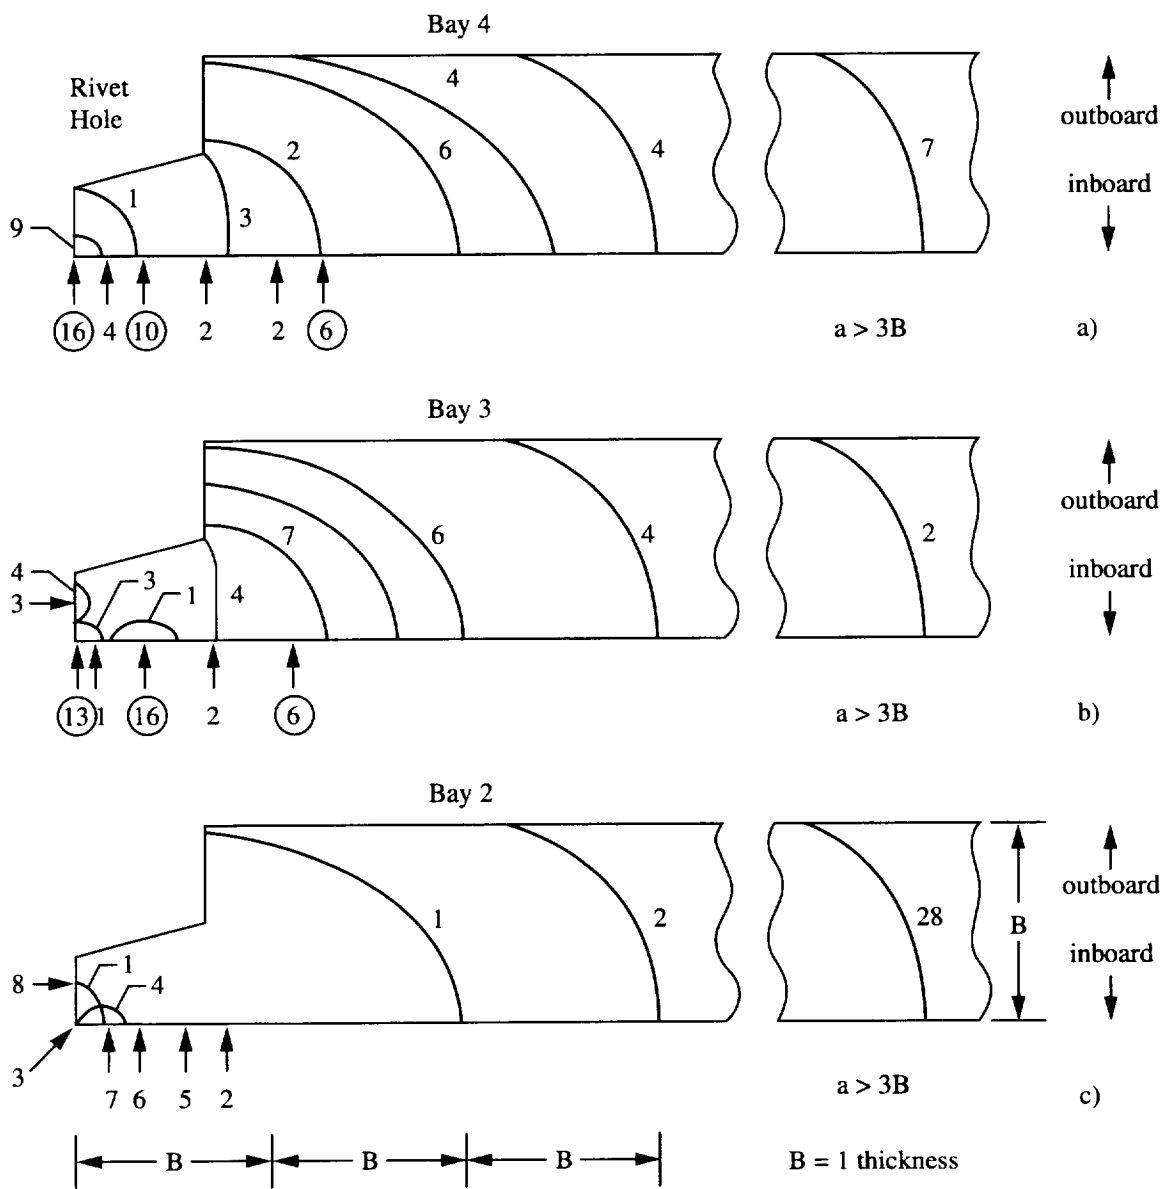
The schematics shown in Figures 12.1 and 12.2 summarize the cracking in lap splice bays 2, 3, and 4. The majority of lap splice outer skin fatigue cracks initiated along the faying surface (Figure 12.1) or at the inboard corner of the rivet hole and propagated as subsurface fatigue cracks for a substantial length before penetrating the outboard surface. Note that bays 3 and 4 exhibited three dominant crack initiation sites (circled numbers) along the faying surface. Most fatigue cracks initiated along the faying surface or near the inboard corner of the rivet hole. Fewer fatigue cracks initiated in the rivet hole shank region. Lap splice inner skin fatigue cracks shown in Figure 12.2 are isolated to the bottom two rivet rows in bays 2, 3, and 4. Most inner skin fatigue cracks initiated at the inboard corner of the rivet hole. The inner skin cracks found in bays 3 and 4 are small compared to those observed in bay 2. Presumably, bay 2 inner skin loads were higher compared to inner skin loads in bays 3 and 4, a likely result of crack link-up that occurred along bay 2 outer skin upper rivet row. A summary of crack initiation sites in bay 2/3 and 3/4 tear strap regions are shown in Figures 12.3, 12.4, 12.5 and 12.6. Most of the fatigue cracks observed in the tear strap region initiated within the rivet hole or at the inboard rivet hole corner.

The summary of crack front shapes from outer skin fatigue cracks is also depicted in Figures 12.1 through 12.6. Indicated adjacent to each crack front is the number of fatigue cracks observed with similar final crack front shape and crack length. For example in Figure 12.1, two bay 2, four bay 3, and four bay 4 cracks exhibited similar crack front shapes at a crack length of 3B, where B is the skin thickness. Note that bay 2 contained 28 fatigue cracks of lengths greater than 3B; these cracks were located in the upper rivet row, where crack link-up occurred, forming the long crack. These results show that all outer skin fatigue cracks grow with similar crack front shapes and crack lengths range from two to three skin thicknesses (2B to 3B) before penetrating the outboard surface of the outer skin. Subsurface cracking noted in the outer skin may result from two effects, (1) out-of-plane bending, and/or (2) residual compressive stress imparted by the radial expansion of the rivet head into the counter bore region. Both effects limit fatigue crack growth in the outboard direction and possibly promote the observed outer skin subsurface fatigue cracking. Different crack front shapes are noted along the inner skin shown in Figure 12.2. The irregular inner skin crack front shape noted in bay 2 is likely due to multiple cracks coalescing along the outboard surface.

Figure 12.1 A schematic of the lap splice outer skin rivet hole region summarizes the location of fatigue crack initiation sites (arrows) and the final fatigue crack front configuration (curved lines) for a) bay 4, b) bay 3, and c) bay 2. The numbers denote the quantity of fatigue cracks or initiation sites found in the given crack front and initiation regions.

All outer skin fatigue cracks exhibit a similar elliptical crack front shape. Figure 12.1 reveals that outer skin fatigue cracks can grow to crack lengths, ranging from two to three skin thicknesses, before penetrating the outboard surface of the outer skin. Subsurface cracking may result from, (1) increased tensile stress along the outer skin inboard surface resulting from lap splice joint bending loads, and/or (2) compressive residual stress along the outer skin outboard surface resulting from rivet head expansion into the countersink region. Inner layer (inner skin, tear strap) fatigue crack front shapes vary; both, semi circular and elliptical crack front shapes were observed.

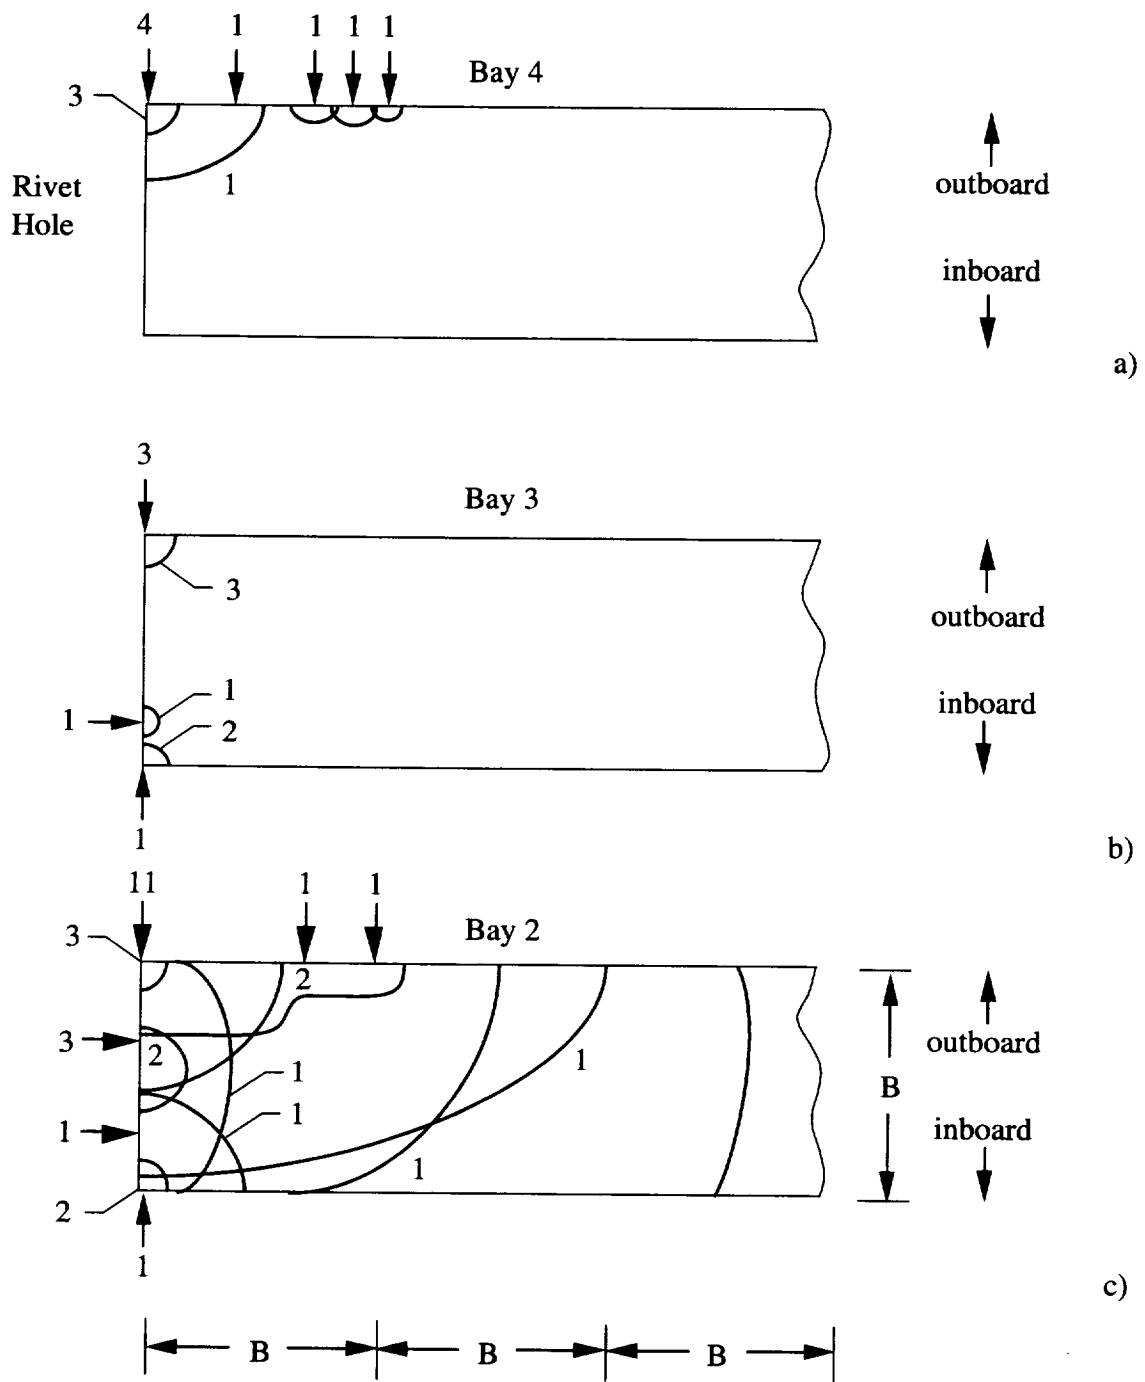
Figure 12.2 A schematic of the lap splice inner skin rivet hole region summarizes the location of fatigue crack initiation (arrows) and the final fatigue crack front configuration (curved lines) for a) bay 4, b) bay 3, and c) bay 2. The numbers denote the quantity of fatigue cracks or initiation sites found in the given crack front and initiation regions.

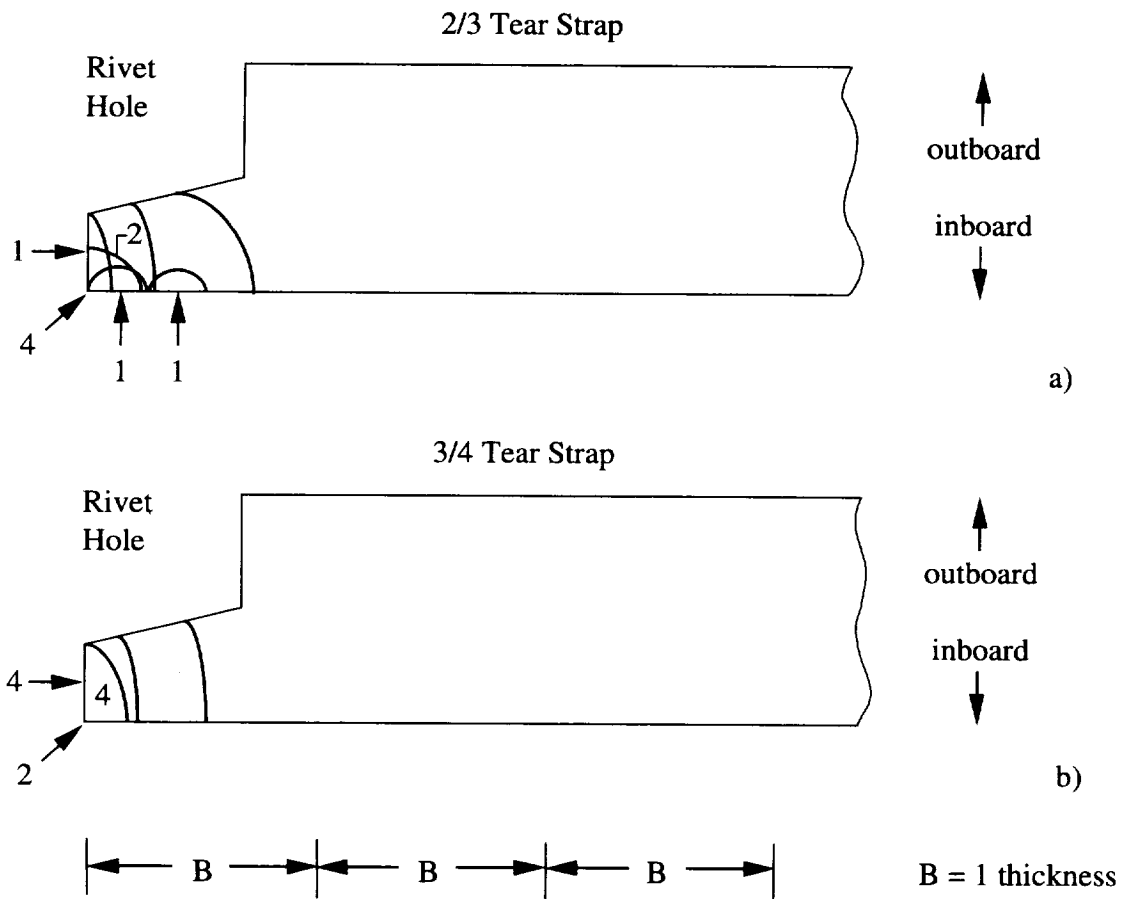
splice outer skin for the 2/3 and 3/4 tear strap regions. All fatigue cracks found in the outer skin were small, although, these limited data suggest similar crack front shapes to those contained in bays 2, 3, and 4. Fatigue cracks contained in the lap splice inner skin, Figure 12.4, and tear straps, Figures 12.5 and 12.6, are nearly semicircular or quarter-circular in shape. This symmetry may suggest minimal out-of-plane loading in the tear strap.

Figure 12.3 A schematic of a) bay 2/3 tear strap and b) bay 3/4 tear strap outer skin rivet hole region and the location of fatigue crack initiation (arrows) and the final fatigue crack front configuration (curved lines). The numbers denote the quantity of fatigue cracks or initiation sites found in the given crack front and initiation regions.

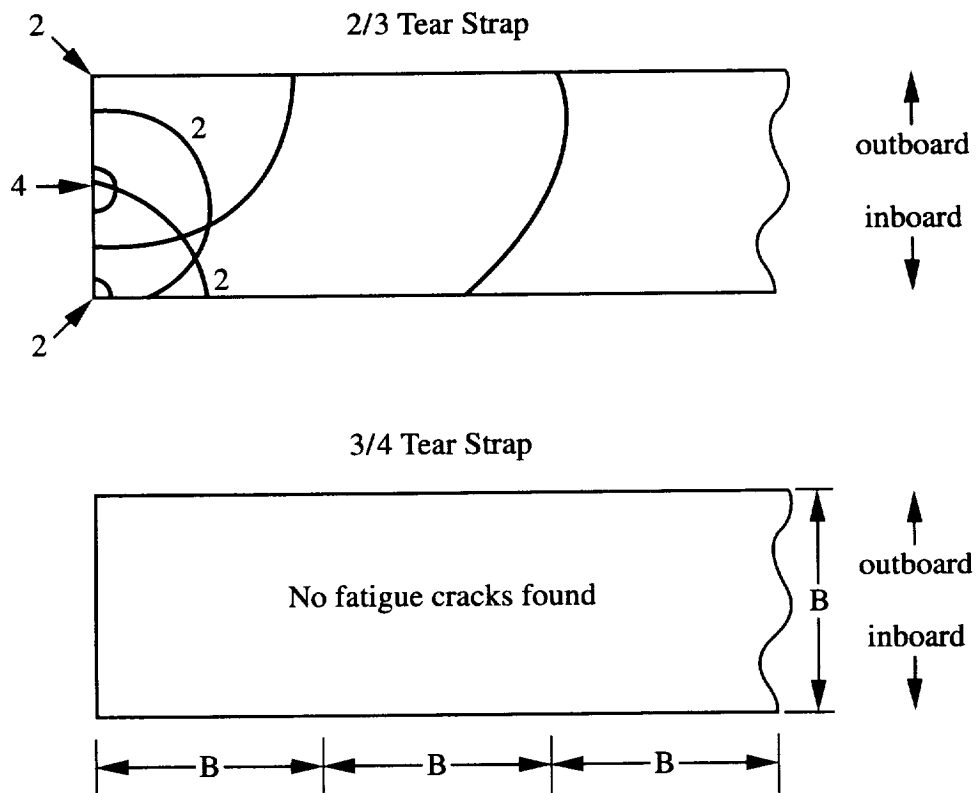
Figure 12.4 A schematic of a) bay 2/3 tear strap and b) bay 3/4 tear strap inner skin rivet hole region and the location of fatigue crack initiation (arrows) and the final fatigue crack front configuration (curved lines). The numbers denote the quantity of fatigue cracks or initiation sites found in the given crack front and initiation regions.

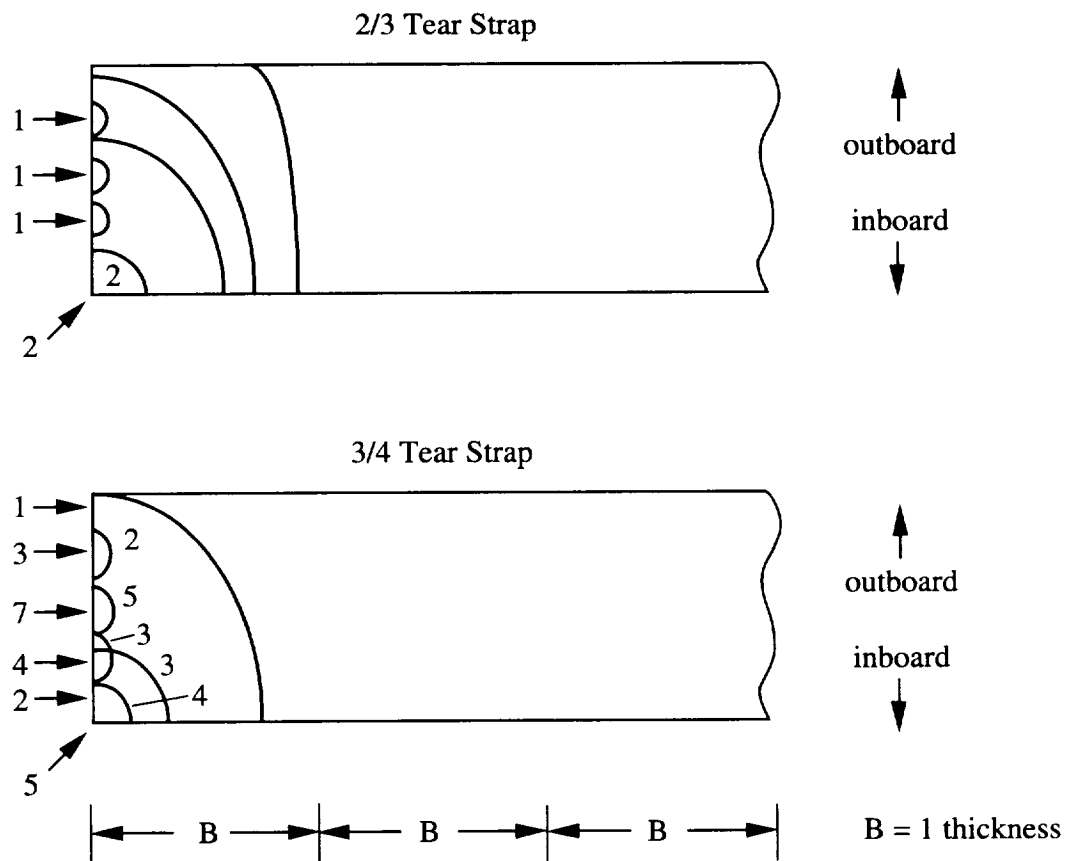
Figure 12.5 A schematic of a) bay 2/3 tear strap and b) bay 3/4 tear strap upper tear strap rivet hole region and the location of fatigue crack initiation (arrows) and the final fatigue crack front configuration (curved lines). The numbers denote the quantity of fatigue cracks or initiation sites found in the given crack front and initiation regions.

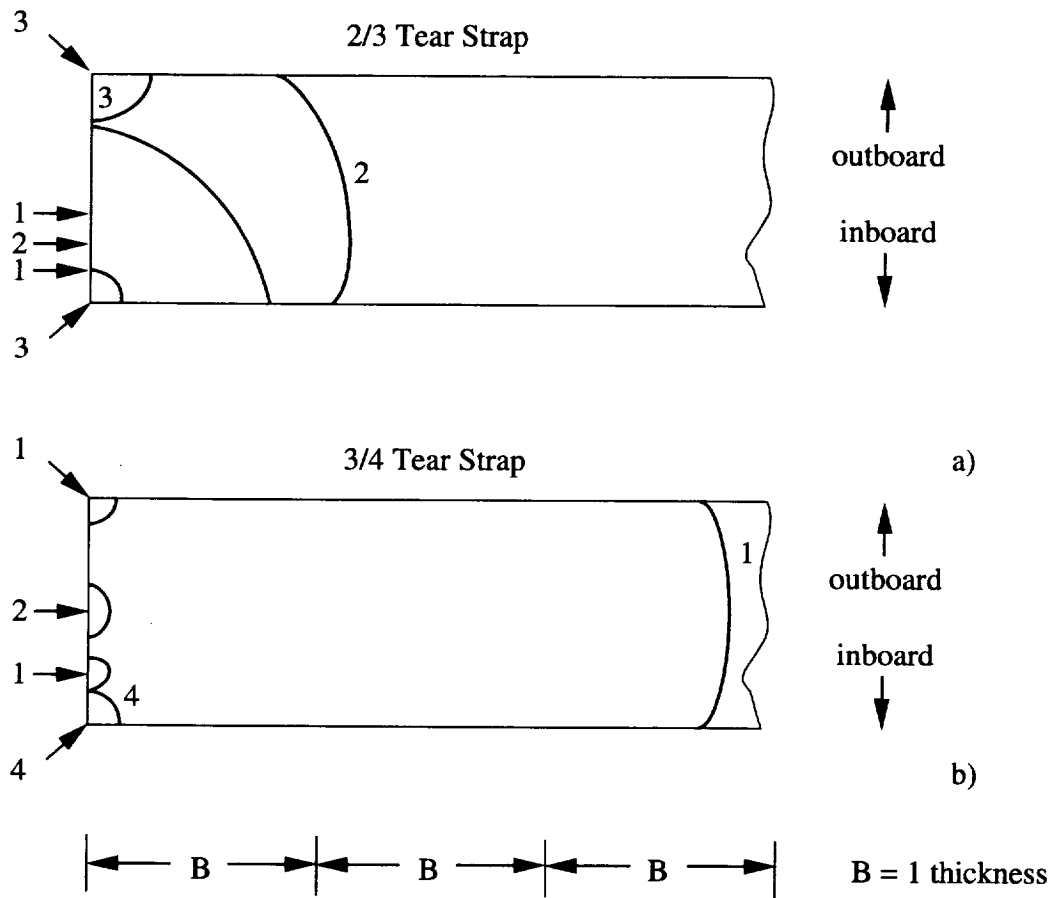
Figure 12.6 A schematic of a) bay 2/3 tear strap and b) bay 3/4 tear strap lower tear strap rivet hole region and the location of fatigue crack initiation (arrows) and the final fatigue crack front configuration (curved lines). The numbers denote the quantity of fatigue cracks or initiation sites found in the given crack front and initiation regions.

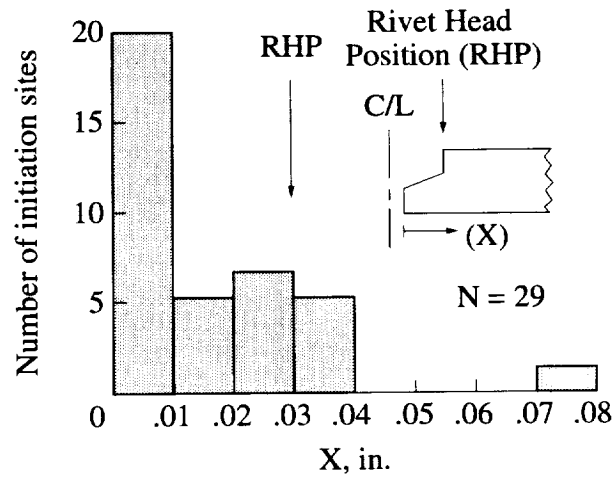
The majority of fatigue cracks found in the outer skin of the lap splice joint initiated along the faying surface under the rivet head. A summary of crack initiation location data for bays 2, 3, and 4 are shown in Figures 12.7, 12.8, and 12.9, respectively. These plots show the frequency of occurrence of outer skin fatigue crack initiation sites as a function of the distance (X) from the rivet hole along the faying surface. The data in Figure 12.7 shows the faying surface crack initiation site distribution for a total twenty-nine fatigue cracks observed in bay 2. Here, the location of 38 crack initiation sites are plotted; the number of initiation sites is larger than the total number of fatigue cracks because many fatigue cracks exhibited multiple initiation sites. It is important to note that a considerable number of cracks initiated a significant distance, ranging from 0.25 mm (0.01 inch) to 2.0 mm (0.08 inch), from the rivet hole. Crack initiation along the faying surface suggest that fretting damage between the inner and outer skin surfaces promote fatigue cracking in the lap splice joint rivet holes. Similar faying surface crack initiation distributions were observed for bays 3 and 4.

Figure. 12.7 The graph shows the distribution of bay 2 fatigue crack initiation sites located along the X-direction (faying surface) defined in the schematic. For orientation purposes the edge of the rivet hole (RHP) is shown at X=0.03" from the edge of the rivet shank.

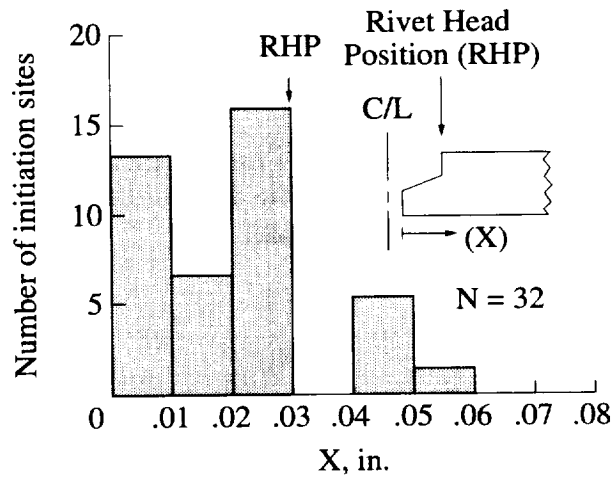
Figure 12.8 The graph shows the distribution of bay 3 fatigue crack initiation sites located along the X-direction (faying surface) defined in the schematic. For orientation purposes the edge of the rivet hole (RHP) is shown at X=0.03" from the edge of the rivet shank.

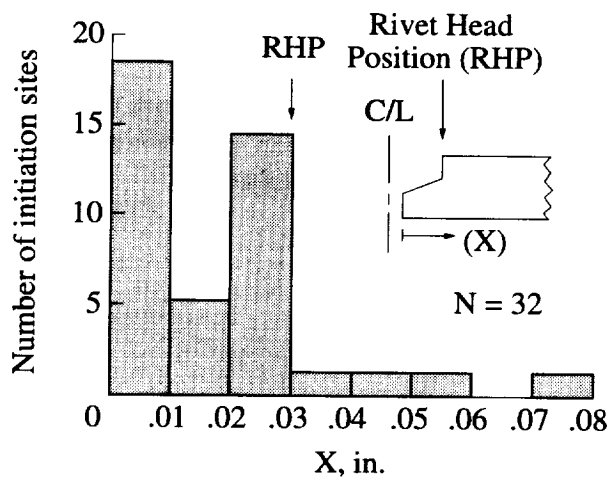
Figure 12.9 The graph shows the distribution of bay 4 fatigue crack initiation sites located along the X-direction (faying surface) defined in the schematic. For orientation purposes the edge of the rivet hole (RHP) is marked at 0.03" from the edge of the rivet shank.

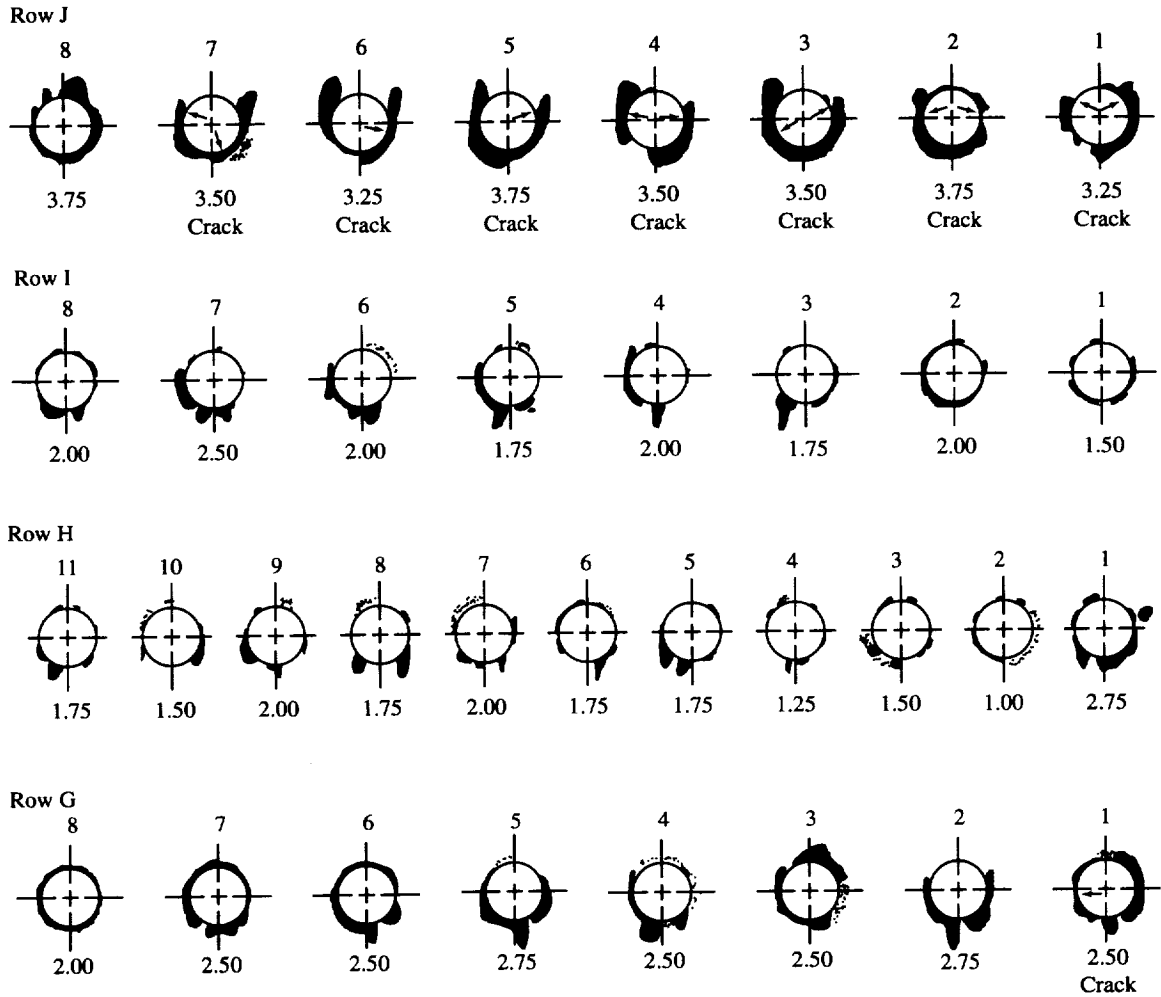
Bay 3 Fretting (RHS)

To relate upper rivet row fatigue cracking to fretting damage, it was necessary to document the extent of black oxide debris. Depicted in Figures 13.1, 13.2, and 13.3 is an estimate (area drawn to scale) of fretting debris (black oxide region) observed on the faying surface of bays 2, 3, and 4, respectively. The rivet hole locations containing fretting initiated fatigue cracks are identified and small arrows mark the approximate location of cracking. To obtain an full understanding of the fretting initiated crack morphology, the reader should refer to the fracture surface micrographs (Sections 7, 9, and 11) for those rivet location containing fretting initiated fatigue cracks. An estimate of the extent of fretting was performed by determining the arithmetic average of fretted area per the procedure shown in Figure 13.4. Here, a scaling factor was assigned to estimate the amount of black oxide area in each quadrant. The value of "0" was assigned when no damage or black oxide was observed and "5" represented the highest degree of fretting. A "fretting average" (FA) was estimated for each rivet position and is summarized for each rivet hole position in the Figures 13.1, 13.2, and 13.3. Correlation's of FA and cracking showed that substantial fretting (FA > 3.0) was present in the majority of regions that contained fatigue cracks that initiated along the faying surface. The following observations were made from the fretting debris estimates.

Figure 13.2a A schematic showing a portion of the inboard surface of the bay 3 lap splice outer skin. Illustrated is the location of black oxide fretting debris, the location of fretting initiated fatigue cracks (arrows), and the fretting average (FA) value defined in Figure 13.4.

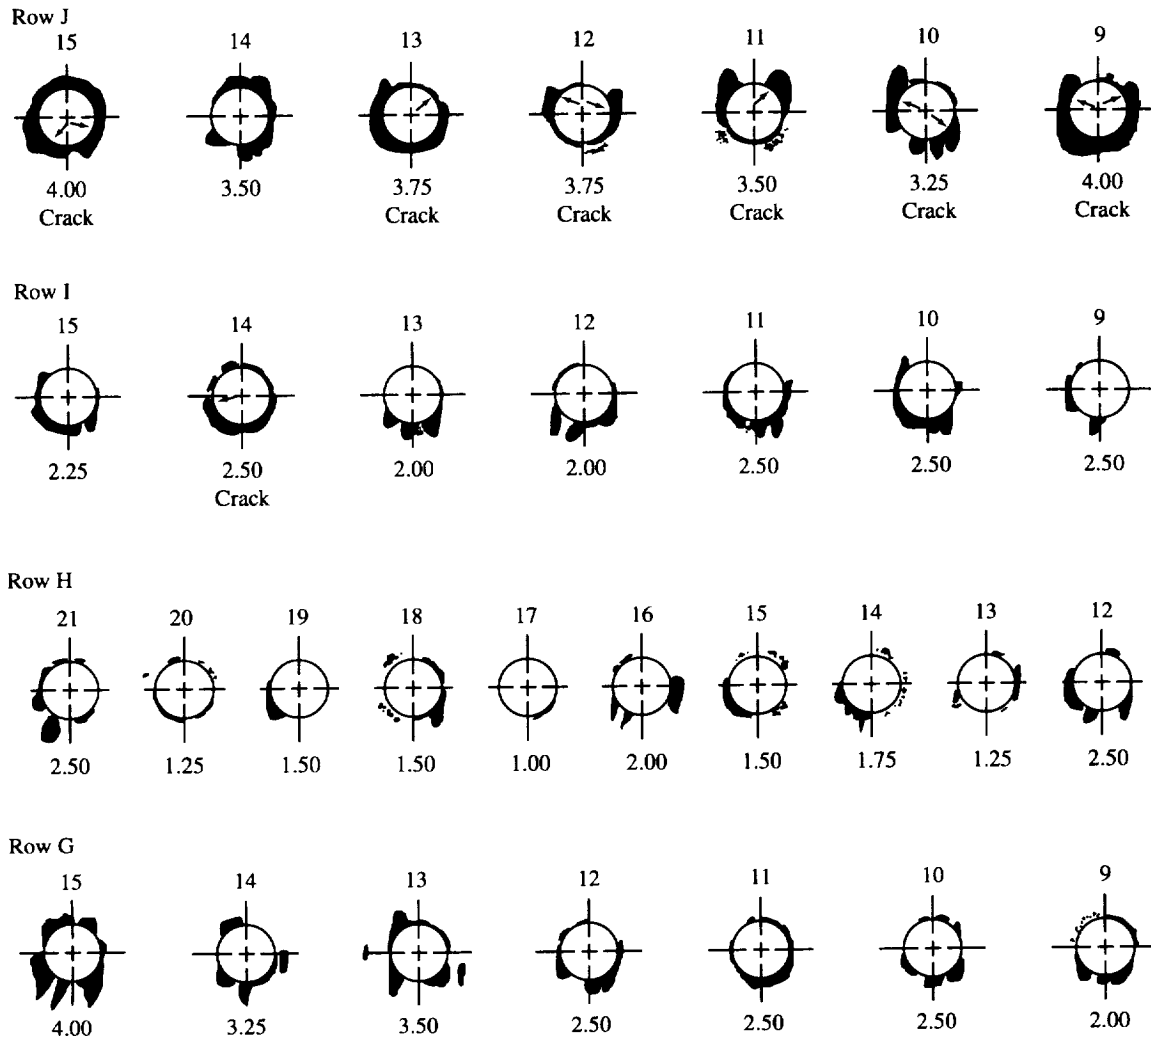
Bay 3 Fretting (L HS)

Figure 13.2b A schematic showing a portion of the inboard surface of the bay 3 lap splice outer skin. Illustrated is the location of black oxide fretting debris, the location of fretting initiated fatigue cracks (arrows), and the fretting average (FA) value defined in Figure 13.4.

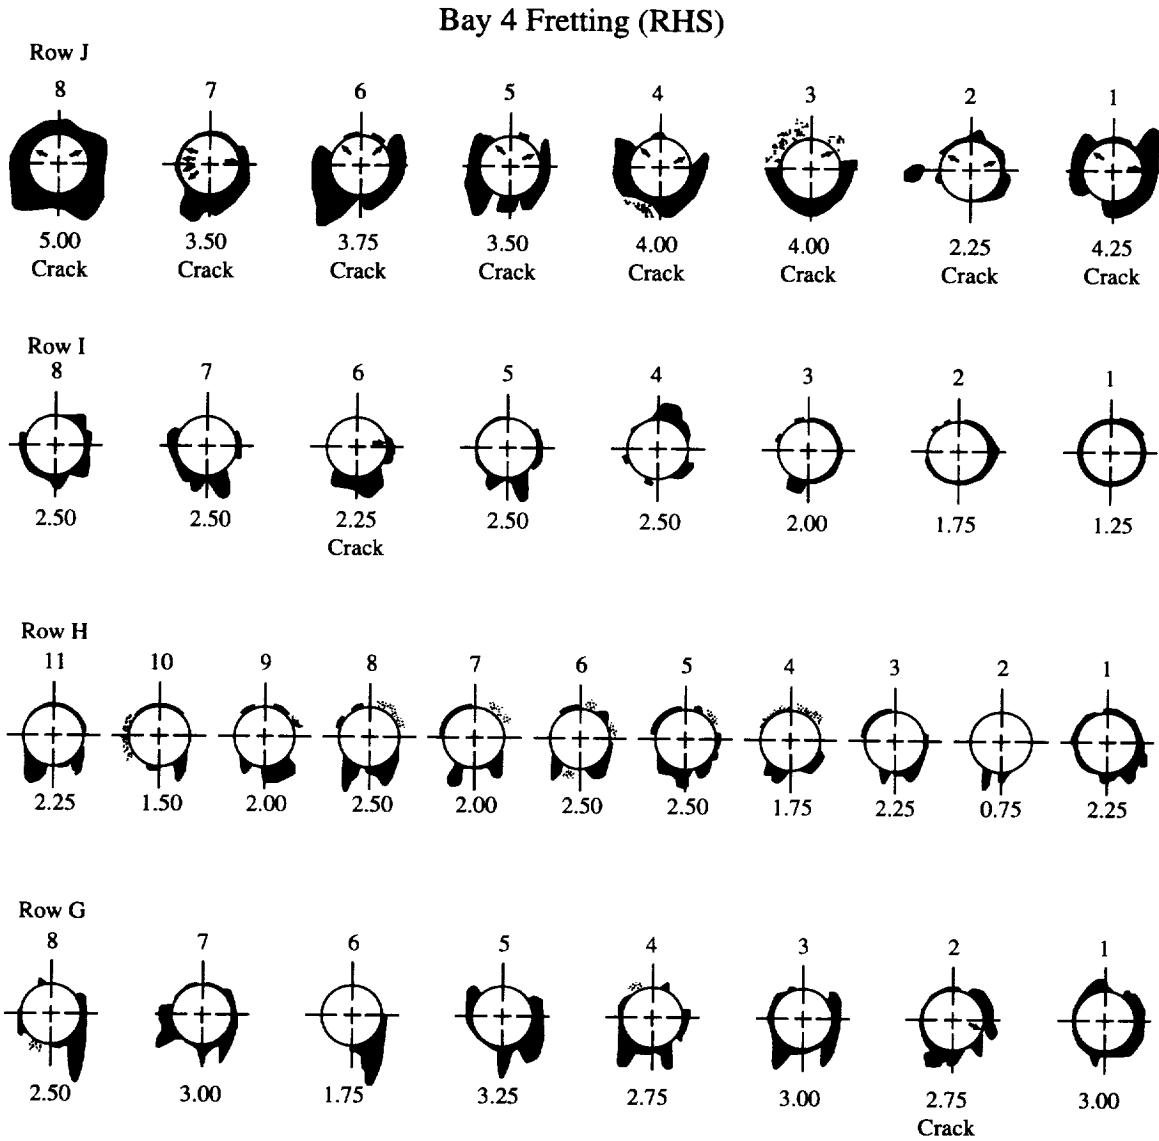
Figure 13.3a A schematic showing a portion of the inboard surface of the bay 4 lap splice outer skin. Illustrated is the location of black oxide fretting debris, the location of fretting initiated fatigue cracks (arrows), and the fretting average (FA) value defined in Figure 13.4.

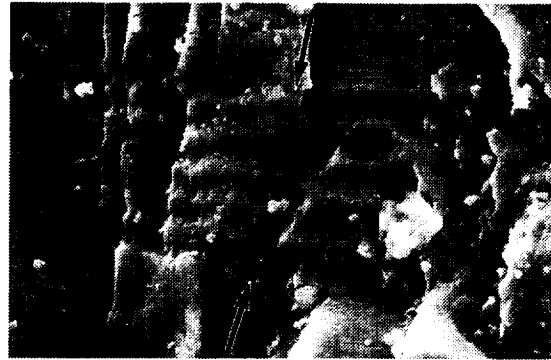
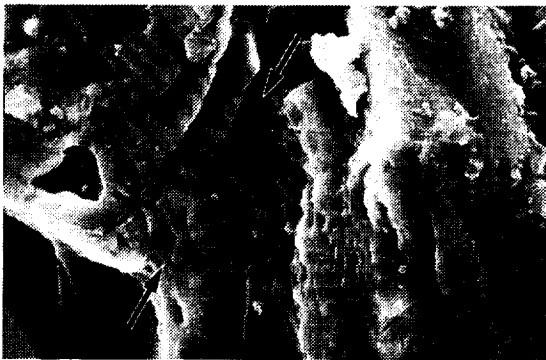
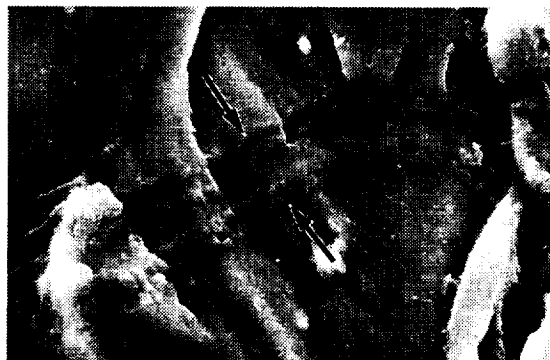
Figure. 14.1 SEM micrographs of: a) 6 marker bands between arrows comprising a 30 K set of marker bands. b) 10 marker bands between arrows comprising a 40 K set of marker bands. c) 4 marker bands between arrows comprising a 50 K set of marker bands.

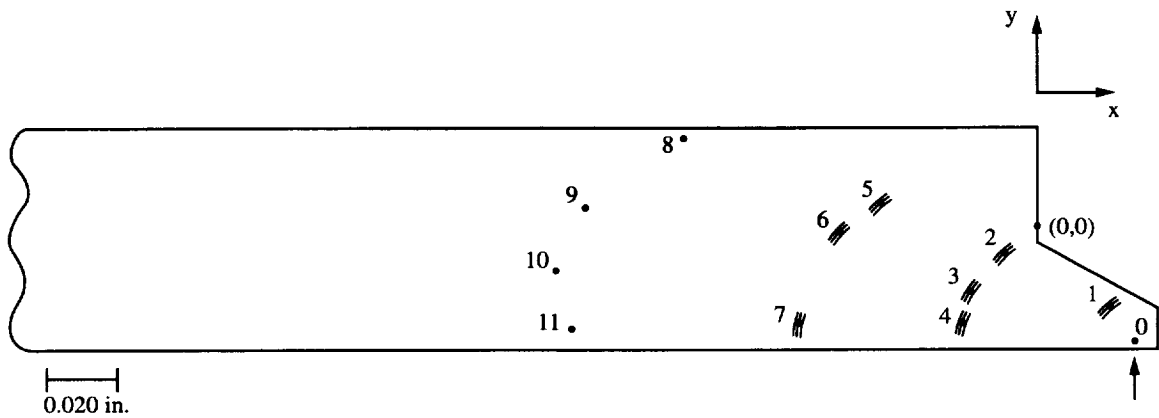
Figure 14.2 The schematic shows the initiation site, marker band and final crack front locations for the fatigue crack in rivet hole 3J1 that grew in the aft direction. Three sets of marker bands were found. The fatigue crack initiation region is marked with an arrow. The table summarizes the X-Y marker band coordinates relative to the origin (0,0), and the cycle count for each set of marker bands.

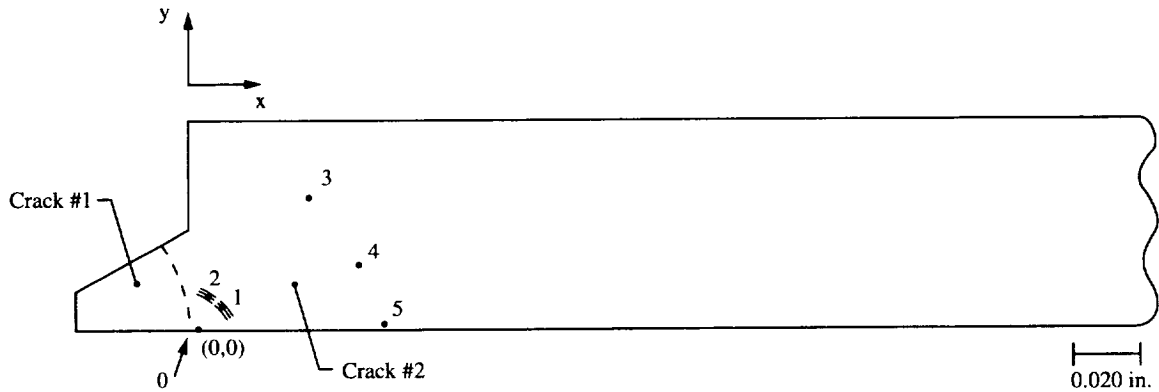
Figure 14.3 The schematic shows the initiation site, marker band and final crack front locations for the fatigue crack in rivet hole 3J1 that grew in the forward direction. This specimen contained two fatigue cracks. A set of marker bands was found radiating from the initiation region of crack #2. The fatigue crack initiation regions for cracks #1 and 2 are marked with a bracket and an arrow, respectively. The table summarizes the X-Y marker band coordinates relative to the origin (0,0), and the cycle count for each set of marker bands.
