NASA/TP-97-206257

The Characteristics of Fatigue Damage in the Fuselage Riveted Lap Splice Joint

Robert S. Piascik
Langley Research Center, Hampton, Virginia

November 1997

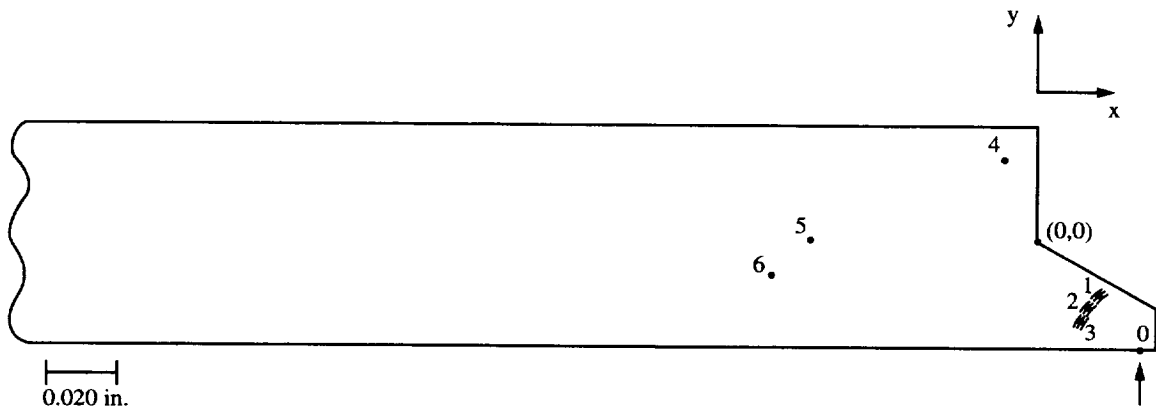
Figure 14.4 The schematic shows the initiation site, marker band and final crack front locations for the fatigue crack in rivet hole 3J2 that grew in the aft direction. One set of marker bands was found. The fatigue crack initiation region is marked with an arrow. The table summarizes the X-Y marker band coordinates relative to the origin (0,0), and the cycle count for each set of marker bands.

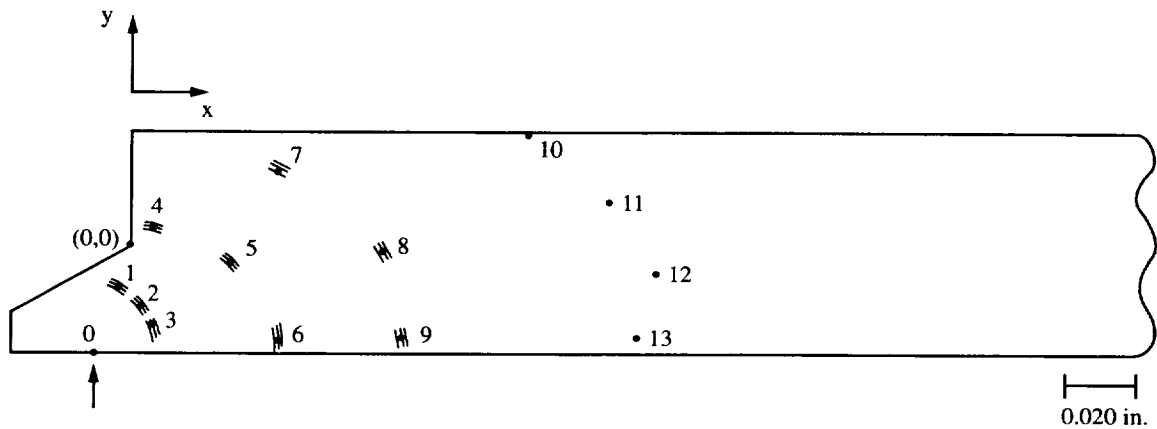
Figure 14.5 The schematic shows the initiation site, marker band and final crack front locations for the fatigue crack in rivet hole 3J2 that grew in the forward direction. Three sets of marker bands were found. The fatigue crack initiation region is marked with a bracket. The table summarizes the X-Y marker band coordinates relative to the origin(0,0), and the cycle count for each set of marker bands.

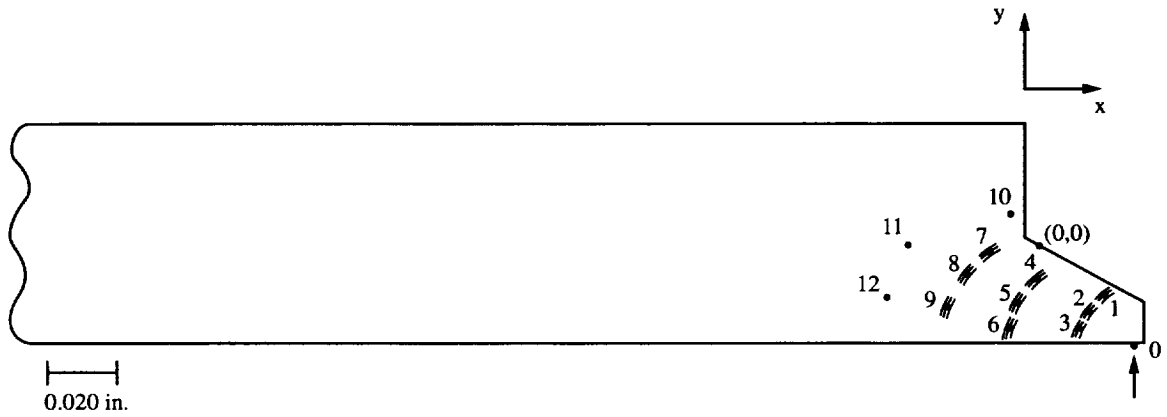
Figure 14.6 The schematic shows the initiation site, marker band and final crack front locations for the fatigue crack in rivet hole 3J4 that grew in the aft direction. Three sets of marker bands were found. The fatigue crack initiation region is marked with an arrow. The table summarizes the X-Y marker band coordinates relative to the origin (0,0), and the cycle count for each set of marker bands.

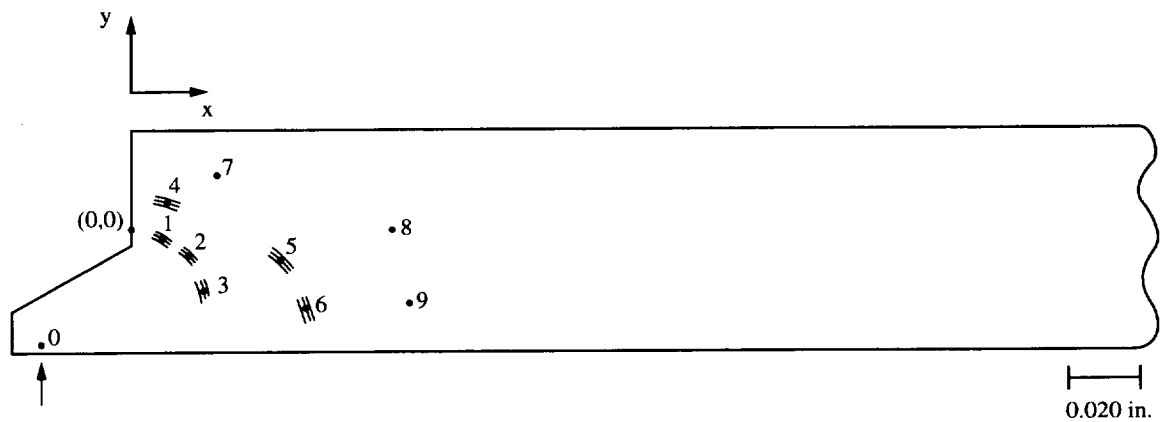
Figure 14.7 The schematic shows the initiation site, marker band and final crack front locations for the fatigue crack in rivet hole 3J4 that grew in the forward direction. Two sets of marker bands were found. The fatigue crack initiation region is marked with a bracket. The table summarizes the X-Y marker band coordinates relative to the origin (0,0), and the cycle count for each set of marker bands.

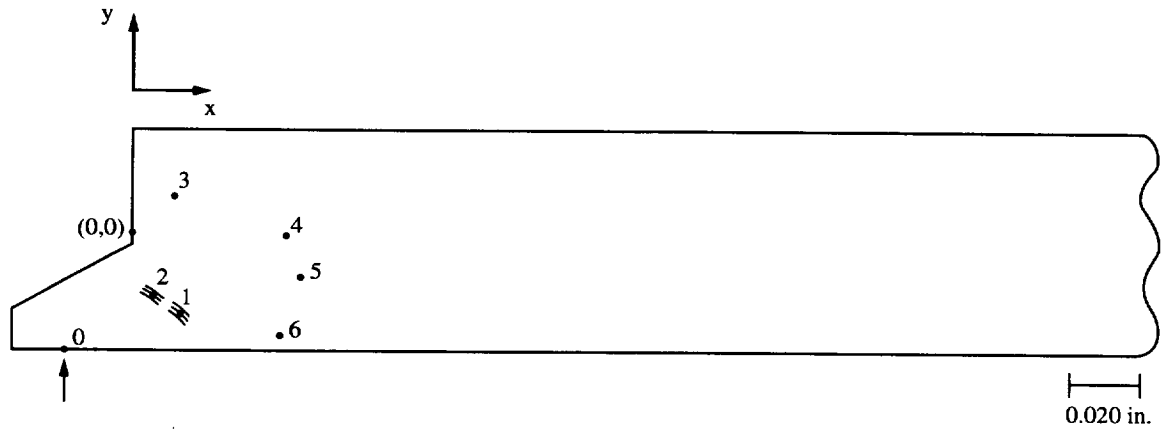
Figure 14.8 The schematic shows the initiation site, marker band and final crack front locations for the fatigue crack in rivet hole 3J5 that grew in the forward direction. One set of marker bands was found. The fatigue crack initiation region is marked with a bracket. The table summarizes the X-Y marker band coordinates relative to the origin (0,0), and the cycle count for each set of marker bands.

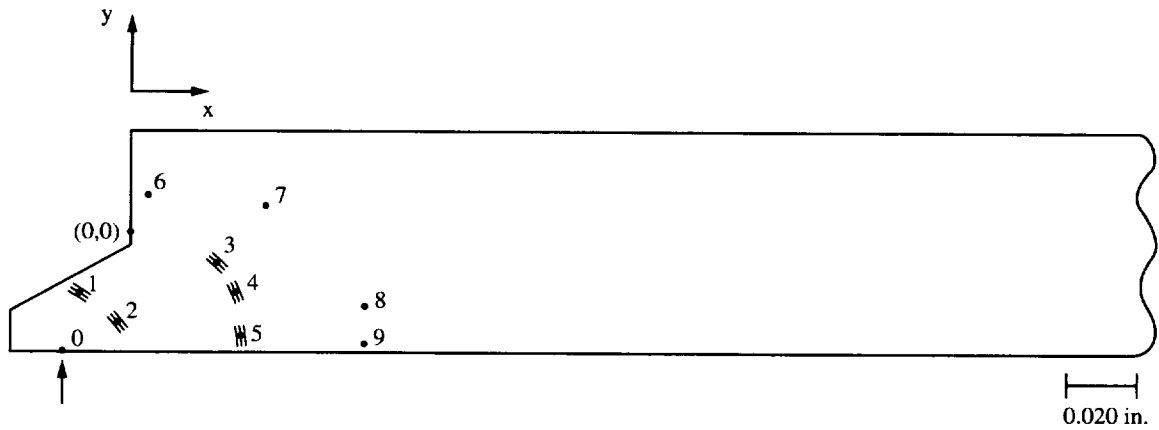
Figure 14.9 The schematic shows the initiation site, marker band and final crack front locations for the fatigue crack in rivet hole 3J7 that grew in the forward direction. Two sets of marker bands were found. The fatigue crack initiation region is marked with a bracket. The table summarizes the X-Y marker band coordinates relative to the origin (0,0), and the cycle count for each set of marker bands.

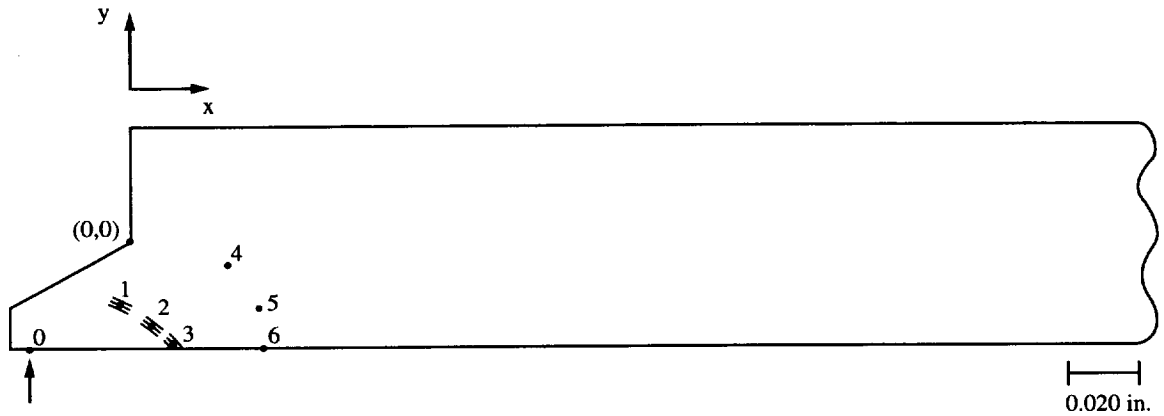
Figure 14.10 The schematic shows the initiation site, marker band and final crack front locations for the fatigue crack in rivet hole 3J9 that grew in the aft direction. One set of marker bands was found. The fatigue crack initiation region is marked with a bracket. The table summarizes the X-Y marker band coordinates relative to the origin (0,0), and the cycle count for each set of marker bands.

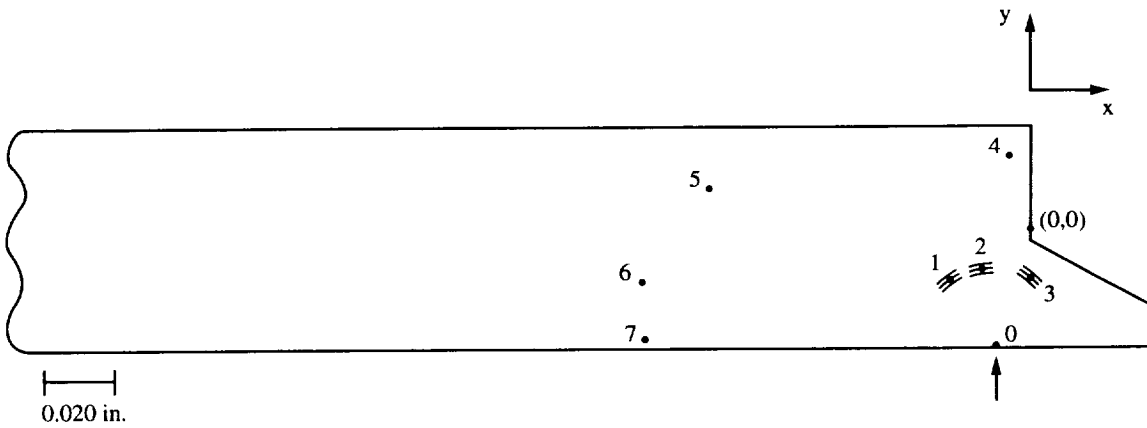
Figure 14.11 The schematic shows the initiation site, marker band and final crack front locations for the fatigue crack in rivet hole 3J11 that grew in the forward direction. One set of marker bands found. The fatigue crack initiation region is marked with a bracket. The table summarizes the X-Y marker band coordinates relative to the origin (0,0), and the cycle count for each set of marker bands.

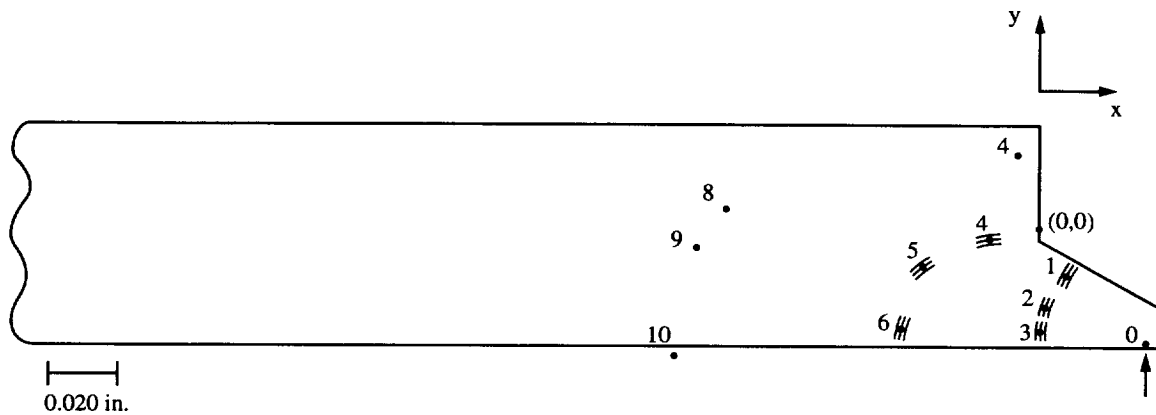
Figure 14.12 The schematic shows the initiation site, marker band and final crack front locations for the fatigue crack in rivet hole 3J12 that grew in the aft direction. Two sets of marker bands were found. The fatigue crack initiation region is marked with an arrow. The table summarizes the X-Y marker band coordinates relative to the origin (0,0), and the cycle count for each set of marker bands.

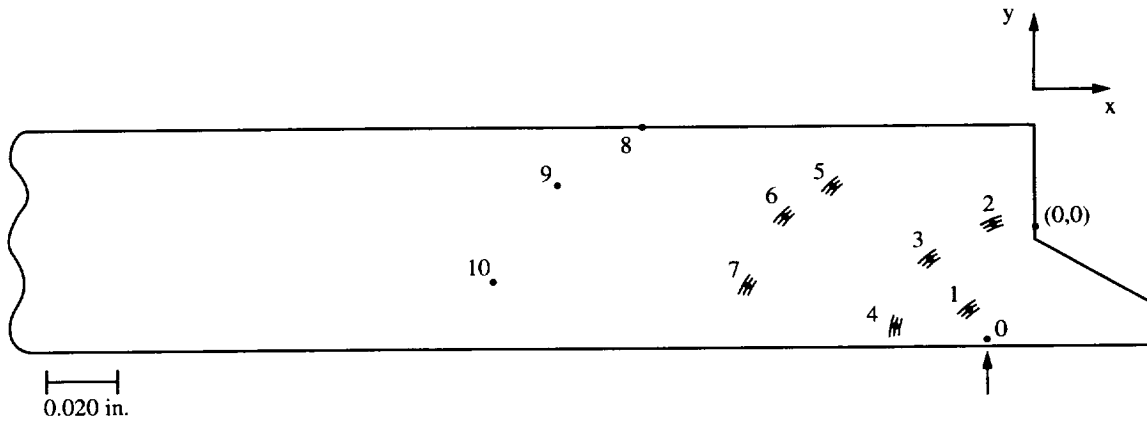
Figure 14.13 The schematic shows the initiation site, marker band and final crack front locations for the fatigue crack in rivet hole 3J12 that grew in the forward direction. Three sets of marker bands were found. The fatigue crack initiation region is marked with a bracket. The table summarizes the X-Y marker band coordinates relative to the origin(0,0), and the cycle count for each set of marker bands.

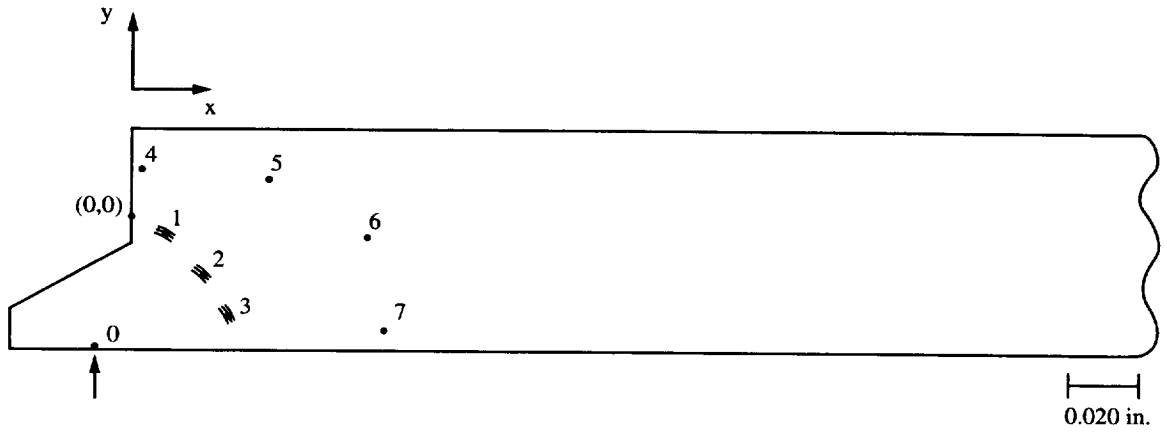
Figure 14.14 The schematic shows the initiation site, marker band and final crack front locations for the fatigue crack in rivet hole 3J13 that grew in the forward direction. One set of marker bands was found. The fatigue crack initiation region is marked with a bracket. The table summarizes the X-Y marker band coordinates relative to the origin (0,0), and the cycle count for each set of marker bands.

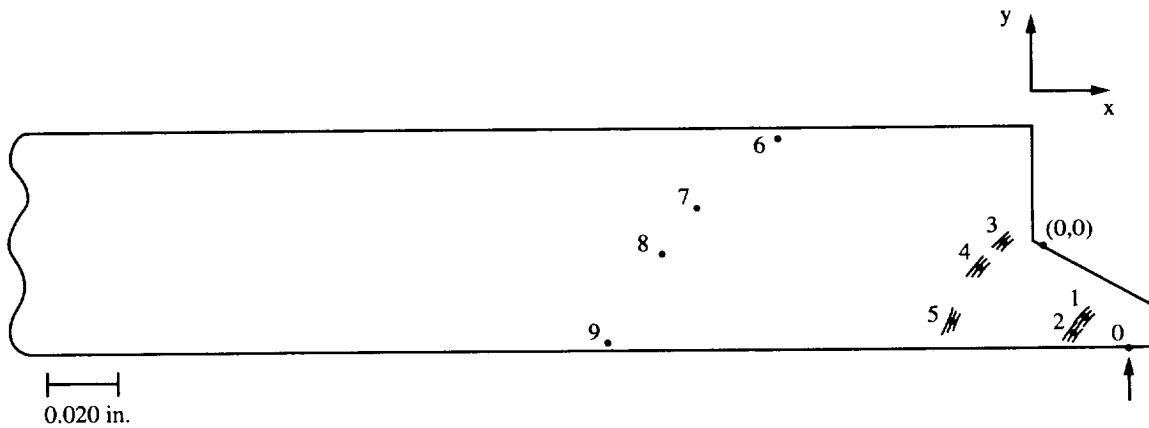
Figure 14.15 The schematic shows the initiation site, marker band and final crack front locations for the fatigue crack in rivet hole 3J15 that grew in the aft direction. Two sets of marker bands were found. The fatigue crack initiation region is marked with a bracket. The table summarizes the X-Y marker band coordinates relative to the origin (0,0), and the cycle count for each set of marker bands.

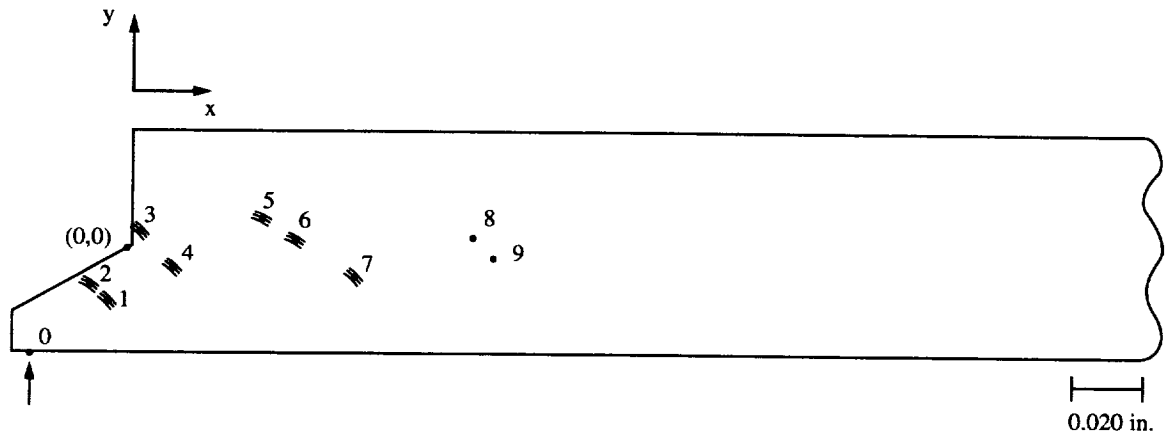
Figure 14.16 The schematic shows the initiation site, marker band and final crack front locations for the fatigue crack in rivet hole 3J15 that grew in the forward direction. Three sets of marker bands were found. The fatigue crack initiation region is marked with a bracket. The table summarizes the X-Y marker band coordinates relative to the origin (0,0), and the cycle count for each set of marker bands.

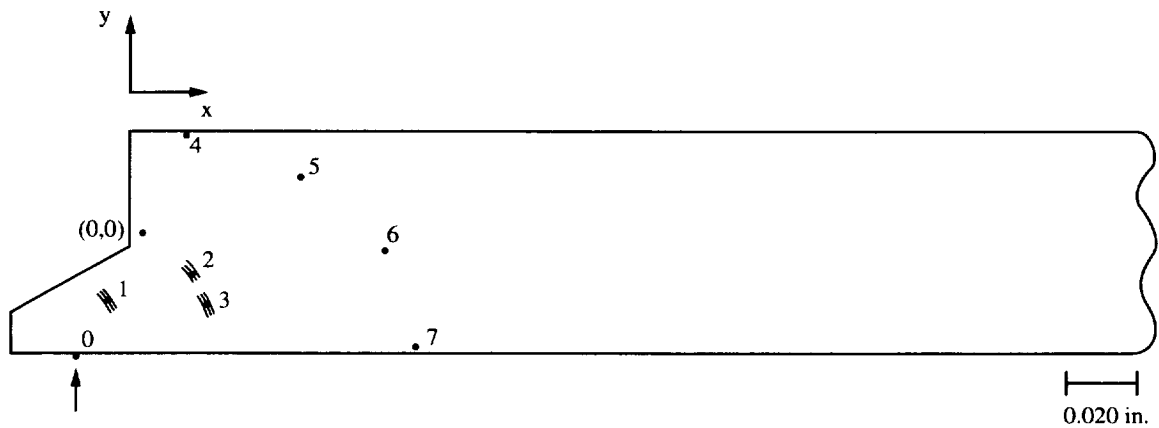
Figure 14.17 The schematic shows the initiation site, marker band and final crack front locations for the fatigue crack in rivet hole 4J1 that grew in the aft direction. Two sets of marker bands were found. The fatigue crack initiation region is marked with an arrow. The table summarizes the X-Y marker band coordinates relative to the origin (0,0), and the cycle count for each set of marker bands.

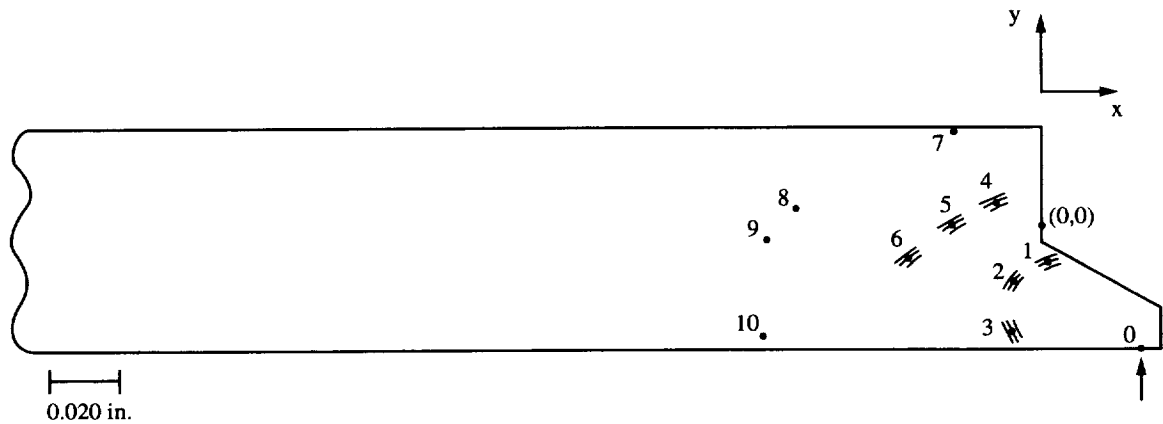
Figure 14.18 The schematic shows the initiation site, marker band and final crack front locations for the fatigue crack in rivet hole 4J2 that grew in the forward direction. Two sets of marker bands were found. The fatigue crack initiation region is marked with a bracket. The table summarizes the X-Y marker band coordinates relative to the origin (0,0), and the cycle count for each set of marker bands.

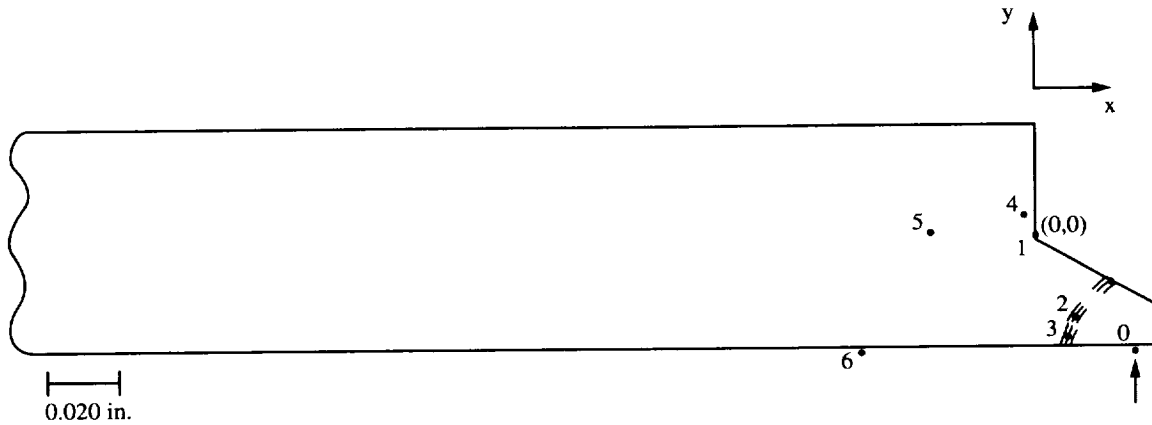
Figure 14.19 The schematic shows the initiation site, marker band and final crack front locations for the fatigue crack in rivet hole 4J2 that grew in the aft direction. One set of marker bands was found. The fatigue crack initiation region is marked with an arrow. The table summarizes the X-Y marker band coordinates relative to the origin (0,0), and the cycle count for each set of marker bands.

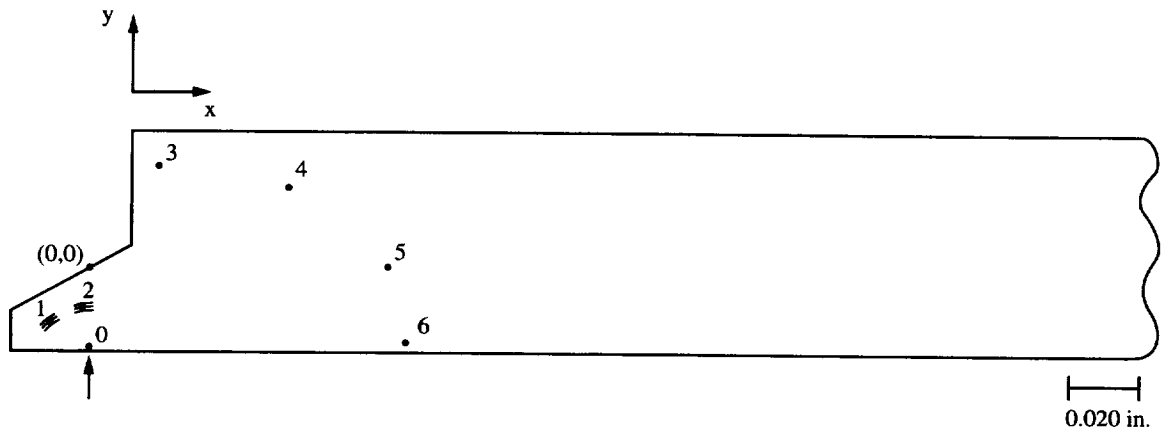
Figure 14.20 The schematic shows the initiation site, marker band and final crack front locations for the fatigue crack in rivet hole 4J3 that grew in the forward direction. One set of marker bands was found. The fatigue crack initiation region is marked with an arrow. The table summarizes the X-Y marker band coordinates relative to the origin (0,0), and the cycle count for each set of marker bands.

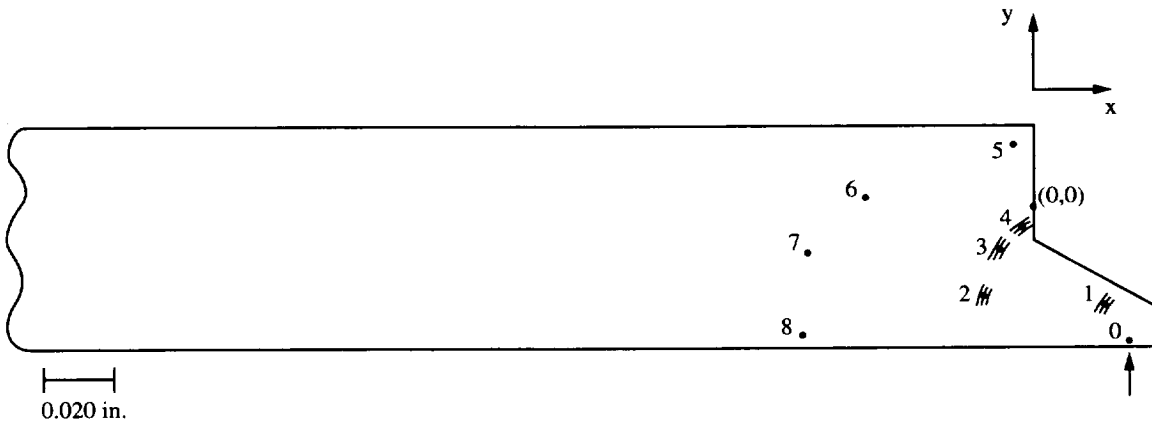
Figure 14.21 The schematic shows the initiation site, marker band and final crack front locations for the fatigue crack in rivet hole 4J4 that grew in the forward direction. Two sets of marker bands were found. The fatigue crack initiation region is marked with a bracket. The table summarizes the X-Y marker band coordinates relative to the origin (0,0), and the cycle count for each set of marker bands.

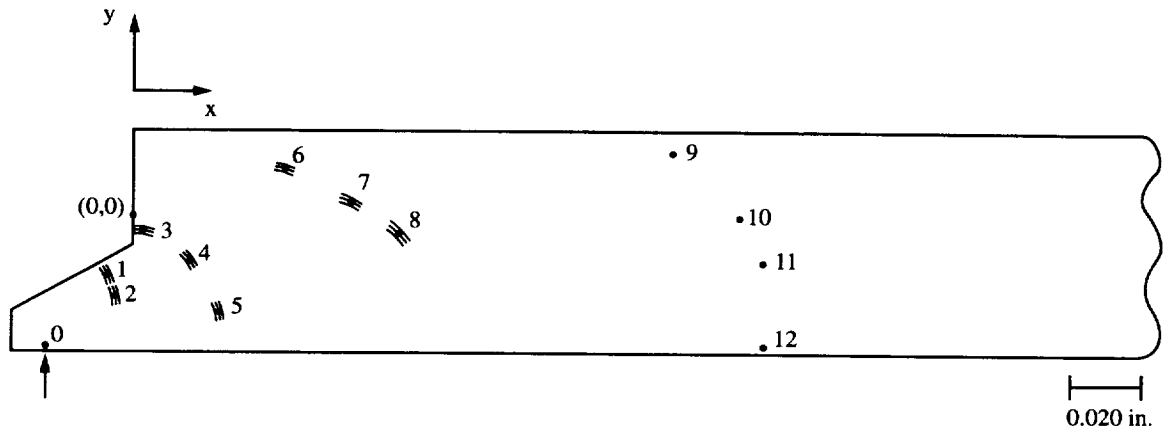
Figure 14.22 The schematic shows the initiation site, marker band and final crack front locations for the fatigue crack in rivet hole 4J5 that grew in the aft direction. There were 3 sets of marker bands found. The fatigue crack initiation region is marked with a bracket. The table summarizes the X-Y marker band coordinates relative to the origin (0,0), and the cycle count for each set of marker bands.

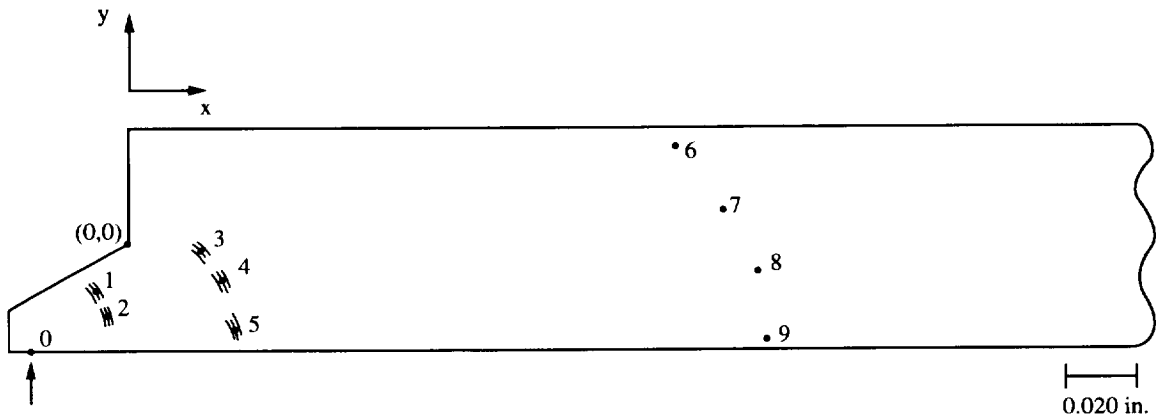
Figure 14.23 The schematic shows the initiation site, marker band and final crack front locations for the fatigue crack in rivet hole 4J5 that grew in the forward direction. There were 2 sets of marker bands found. The fatigue crack initiation region is marked with an arrow. The table summarizes the X-Y marker band coordinates relative to the origin (0,0), and the cycle count for each set of marker bands.

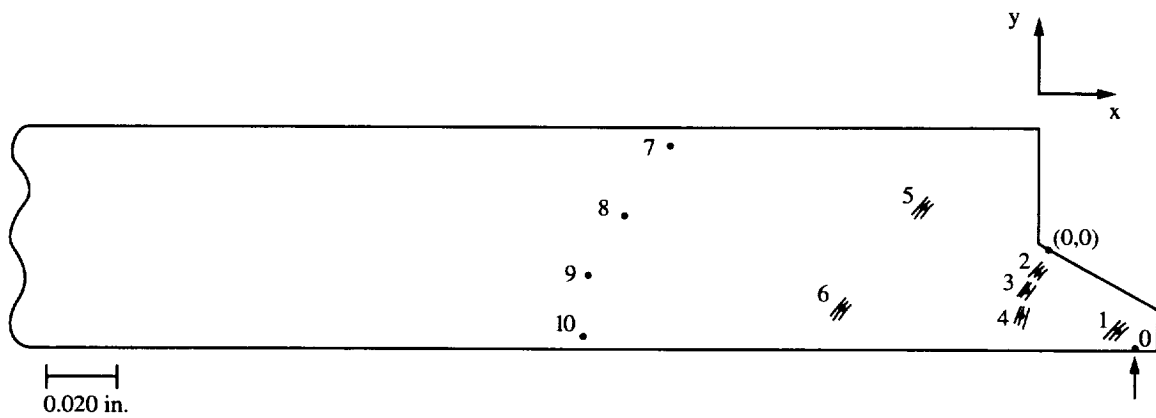
Figure 14.24 The schematic shows the initiation site, marker band and final crack front locations for the fatigue crack in rivet hole 4J6 that grew in the forward direction. There were 3 sets of marker bands found. The fatigue crack initiation region is marked with an arrow. The table summarizes the X-Y marker band coordinates relative to the origin (0,0), and the cycle count for each set of marker bands.

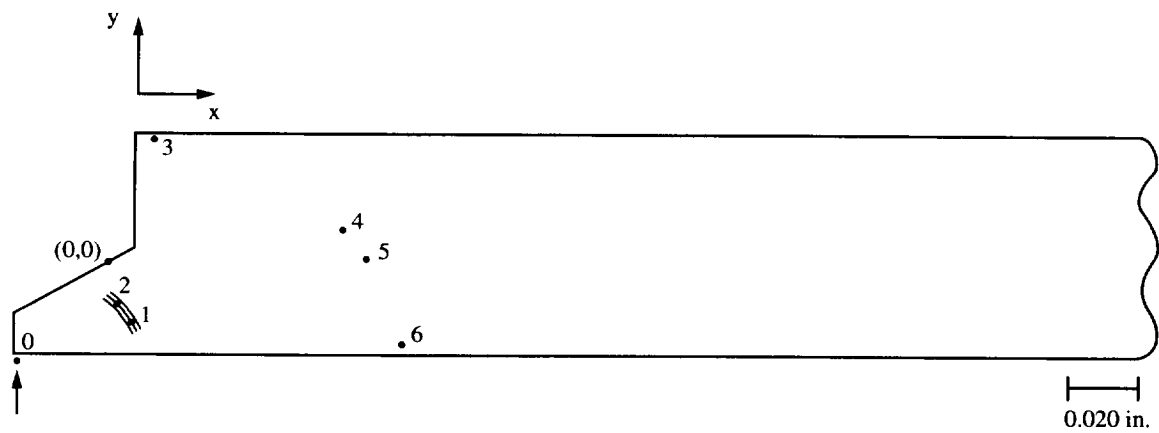
Figure 14.25 The schematic shows the initiation site, marker band and final crack front locations for the fatigue crack in rivet hole 4J6 that grew in the aft direction. Only one set of marker bands was found. The fatigue crack initiation region is marked with an arrow. The table summarizes the X-Y marker band coordinates relative to the origin (0,0), and the cycle count for each set of marker bands.

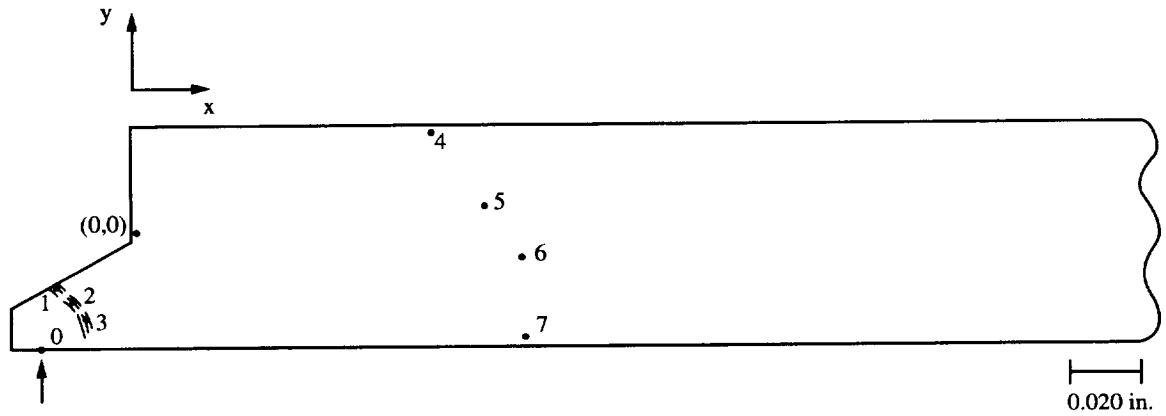
Figure 14.26 The schematic shows the initiation site, marker band and final crack front locations for the fatigue crack in rivet hole 4J7 that grew in the forward direction. Two sets of marker bands were found. The fatigue crack initiation region is marked with an arrow. The table summarizes the X-Y marker band coordinates relative to the origin (0,0), and the cycle count for each set of marker bands.

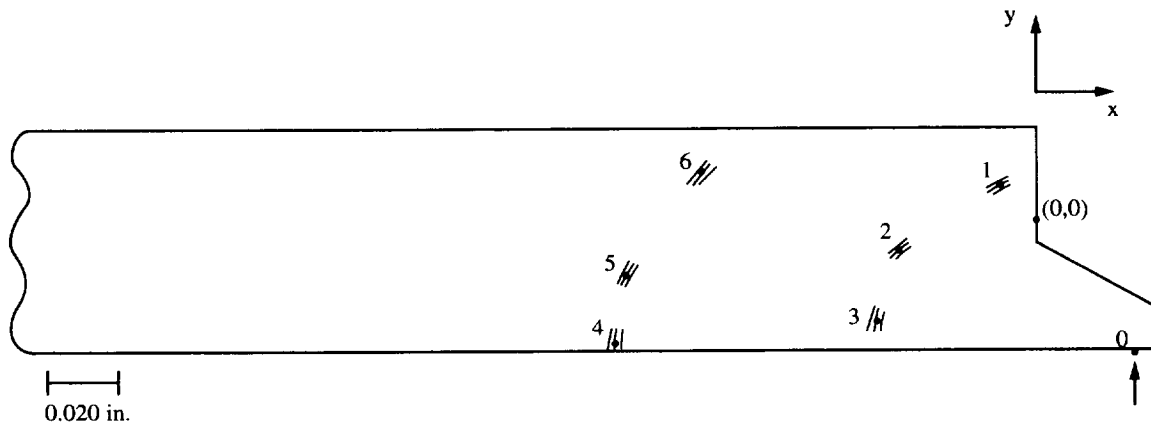
- Crack front not available.

Figure 14.27 The schematic shows the marker band locations for the fatigue crack in rivet hole 4J8 that grew in the forward direction. Two sets of marker bands were found. The fatigue crack initiation region is marked with an arrow. The table summarizes the X-Y marker band coordinates relative to the origin (0,0), and the cycle count for each set of marker bands.

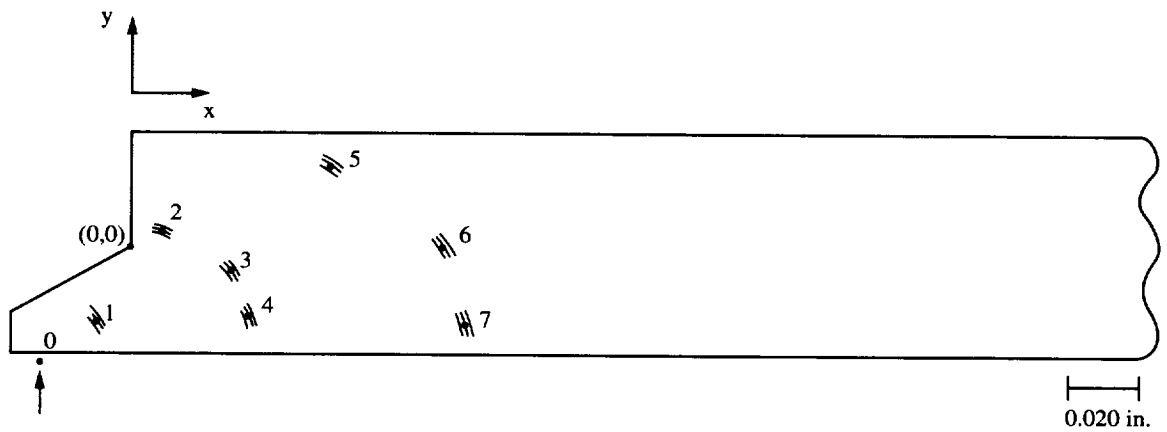
- No crack front. Crack linked up with 4J9B.

Figure 14.28 The schematic shows the marker band locations for the fatigue crack in rivet hole 4J8 that grew in the aft direction. Three sets of marker bands were found. The fatigue crack initiation region is marked with an arrow. The table summarizes the X-Y marker band coordinates relative to the origin (0,0), and the cycle count for each set of marker bands.

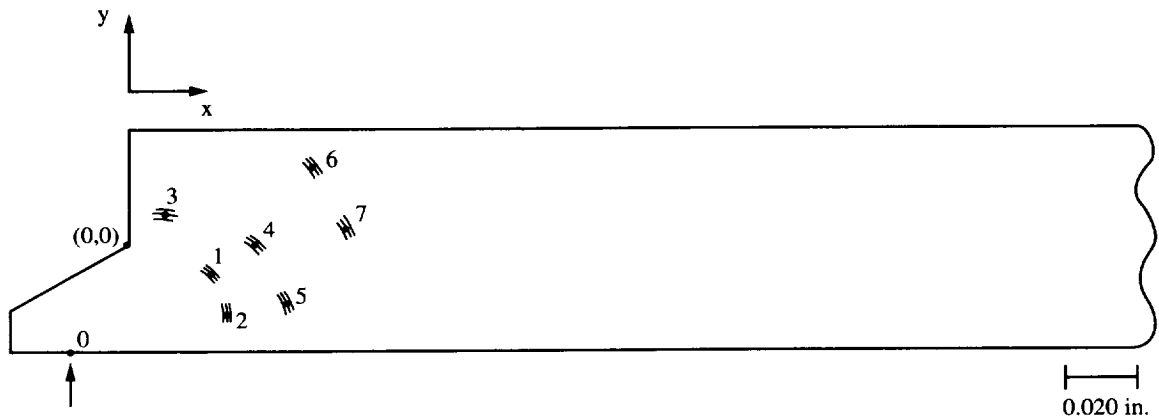
- No Crack front. Crack linked up with 4J8A.

Figure 14.29 The schematic shows the marker band locations for the fatigue crack in rivet hole 4J9 that grew in the forward direction. There were 3 sets of marker bands found. The fatigue crack initiation region is marked with an arrow. The table summarizes the X-Y marker band coordinates relative to the origin (0,0), and the cycle count for each set of marker bands.

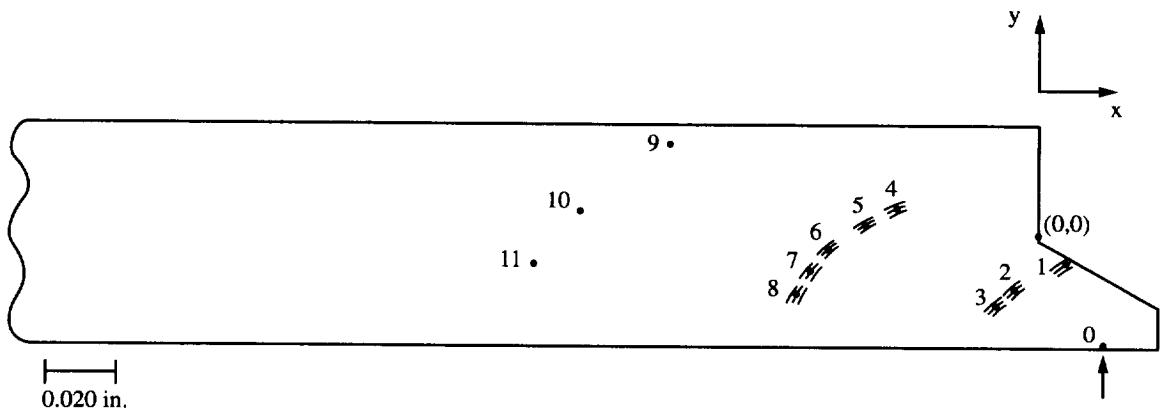
Figure 14.30 The schematic shows the initiation site, marker band and final crack front locations for the fatigue crack in rivet hole 4J10 that grew in the aft direction. Two sets of marker bands were found. The fatigue crack initiation region is marked with a bracket. The table summarizes the X-Y marker band coordinates relative to the origin (0,0), and the cycle count for each set of marker bands.

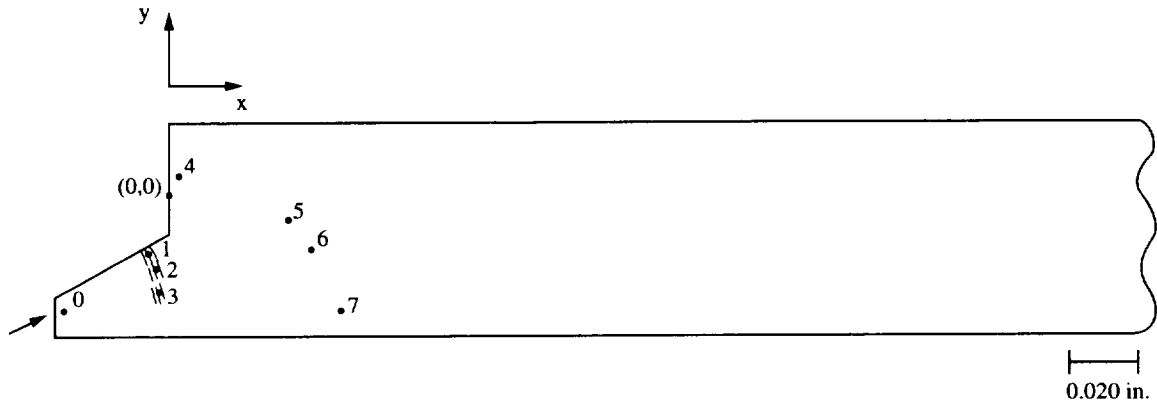
Figure 14.31 The schematic shows the initiation site, marker band and final crack front locations for the fatigue crack in rivet hole 4J12 that grew in the aft direction. One set of marker bands was found. The fatigue crack initiation region is marked with an arrow. The table summarizes the X-Y marker band coordinates relative to the origin (0,0), and the cycle count for each set of marker bands.

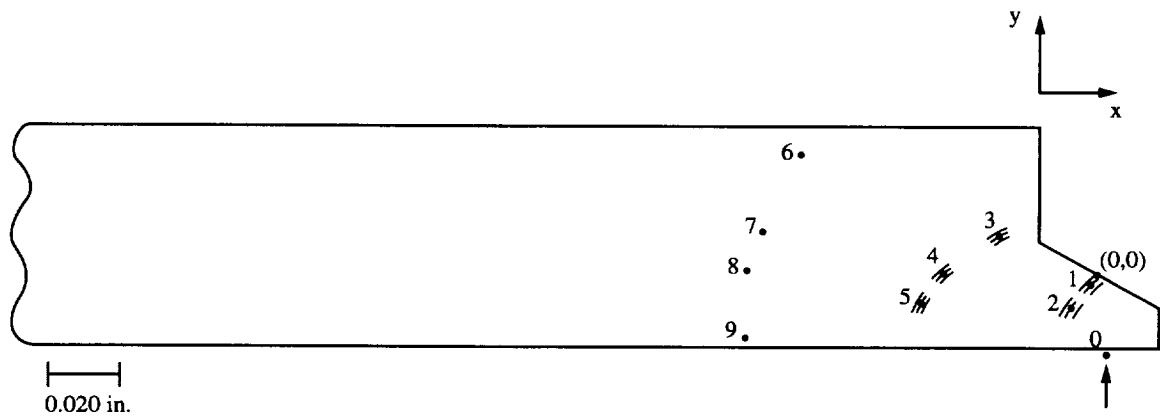
Figure 14.32 The schematic shows the initiation site, marker band and final crack front locations for the fatigue crack in rivet hole 4J14 that grew in the aft direction. Two sets of marker bands were found. The fatigue crack initiation region is marked with a bracket. The table summarizes the X-Y marker band coordinates relative to the origin (0,0), and the cycle count for each set of marker bands.

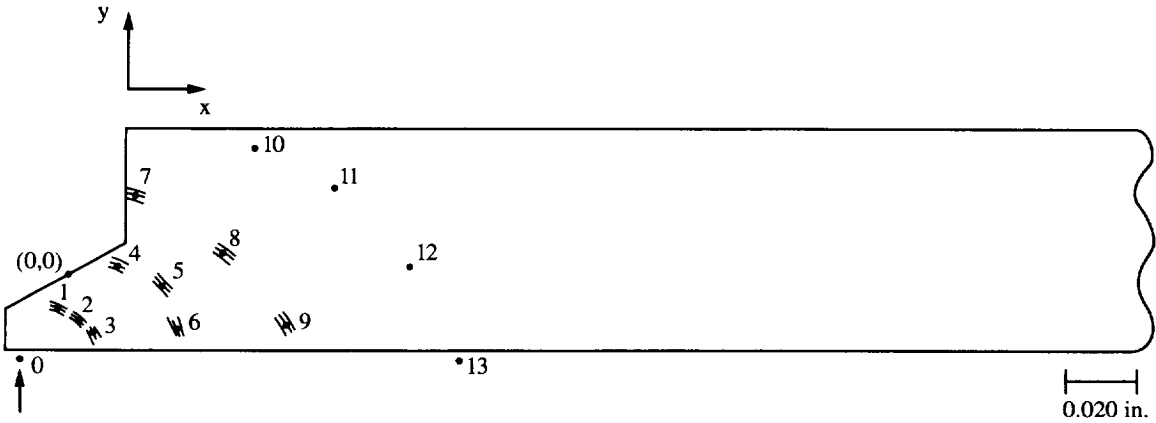
Figure 14.33 The schematic shows the initiation site, marker band and final crack front locations for the fatigue crack in rivet hole 4J14 that grew in the forward direction. Three sets of marker bands were found. The fatigue crack initiation region is marked with an arrow. The table summarizes the X-Y marker band coordinates relative to the origin (0,0), and the cycle count for each set of marker bands.

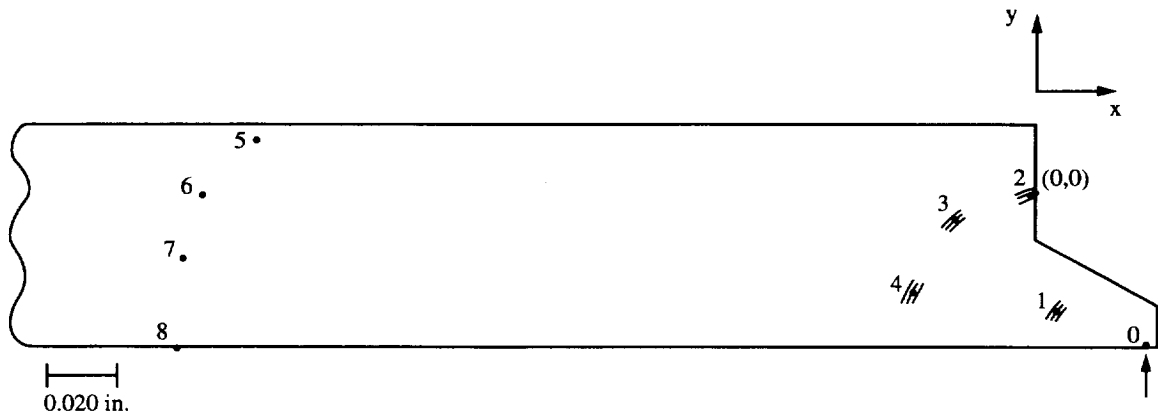
Figure 14.34 The schematic shows the initiation site, marker band and final crack front locations for the fatigue crack in rivet hole 4J15 that grew in the forward direction. Two sets of marker bands were found. The fatigue crack initiation region is marked with an arrow. The table summarizes the X-Y marker band coordinates relative to the origin (0,0), and the cycle count for each set of marker bands.

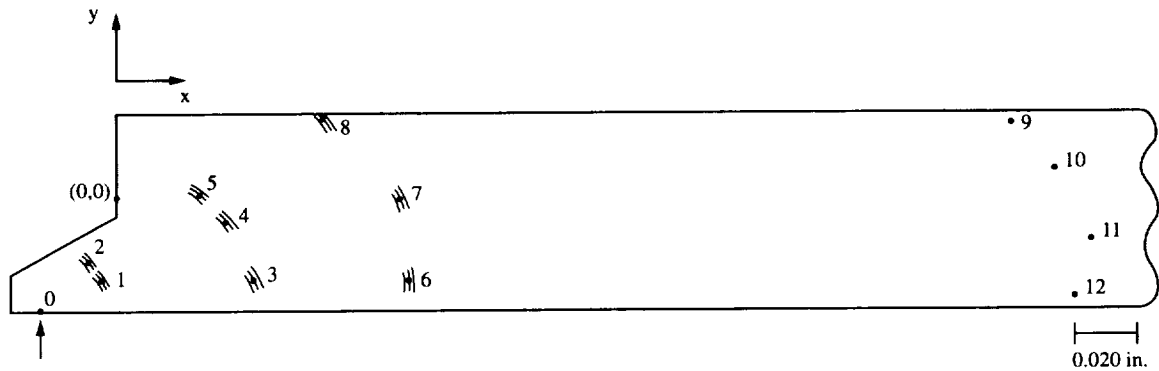
Figure 14.35 The schematic shows the marker band locations for the fatigue crack in rivet hole 4J15 that grew in the aft direction. Three sets of marker bands were found. The fatigue crack initiation region is marked with a bracket. The table summarizes the X-Y marker band coordinates relative to the origin (0,0), and the cycle count for each set of marker bands.

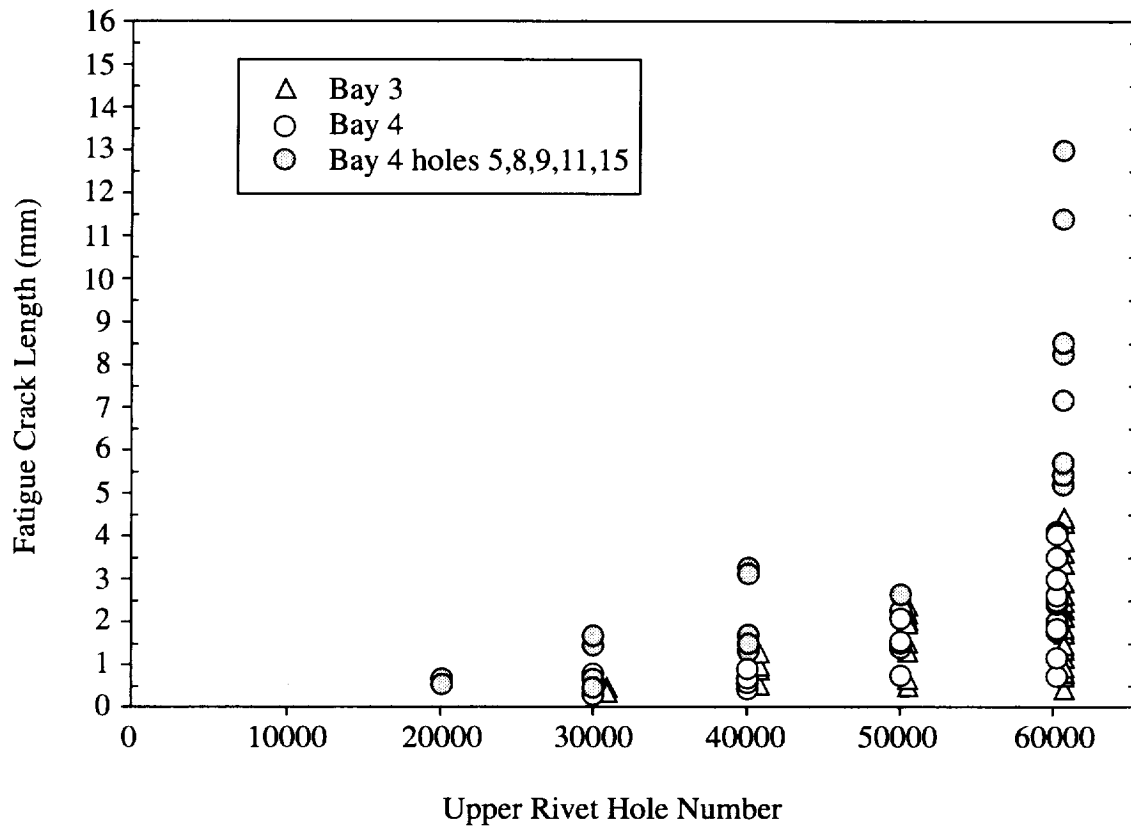
Figure 14.37 Bays 3 and 4 upper rivet row outer skin fatigue crack length history.

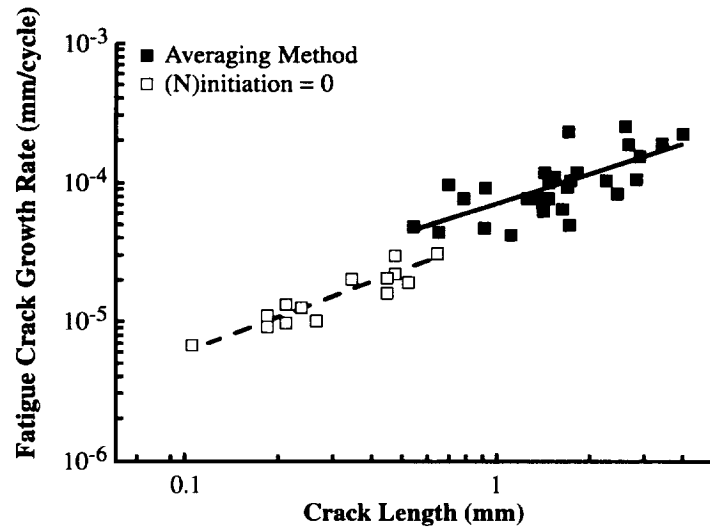
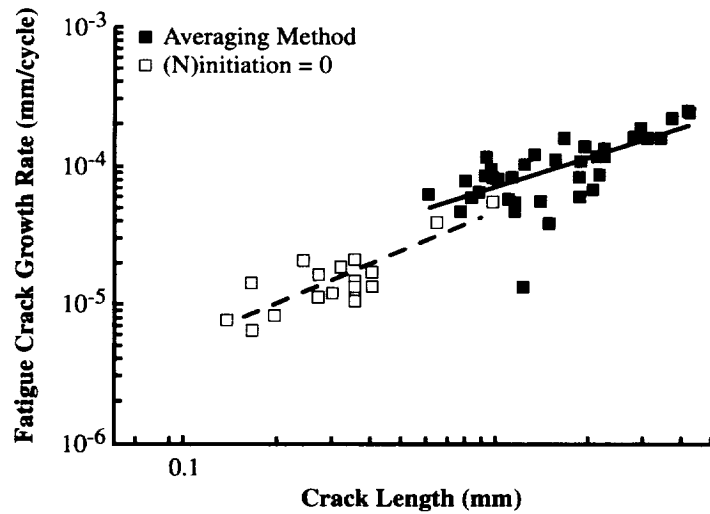
Figure 14.38 The growth characteristics of small fatigue cracks contained in the upper rivet row outer skin in a) bay 3 and b) bay 4.

The outer skin fatigue crack growth characteristics of short cracks, 0.1 mm to 4 mm in length, contained in the upper rivet row were determined by marker band analysis. The results shown in Figure 14.38 reveal that all upper rivet cracks contained in bays 3 and 4 exhibit similar fatigue crack growth characteristics. The da/dN estimates shown in Figure 14.38 for crack lengths between 0.1 mm to 1 mm (open square symbols) are based on the position of a single marker band and the assumption that fatigue cracks initiated at the start of the pressure test ($N_{\text{initiation}} = 0$). A more reasonable estimate of $N_{\text{initiation}}$ can be made based on the crack length history plot shown in Figure 14.37. Extrapolating the crack length versus N plot suggests that the first crack initiation in bay 3 occurred between 10,000 and 15,000 pressure

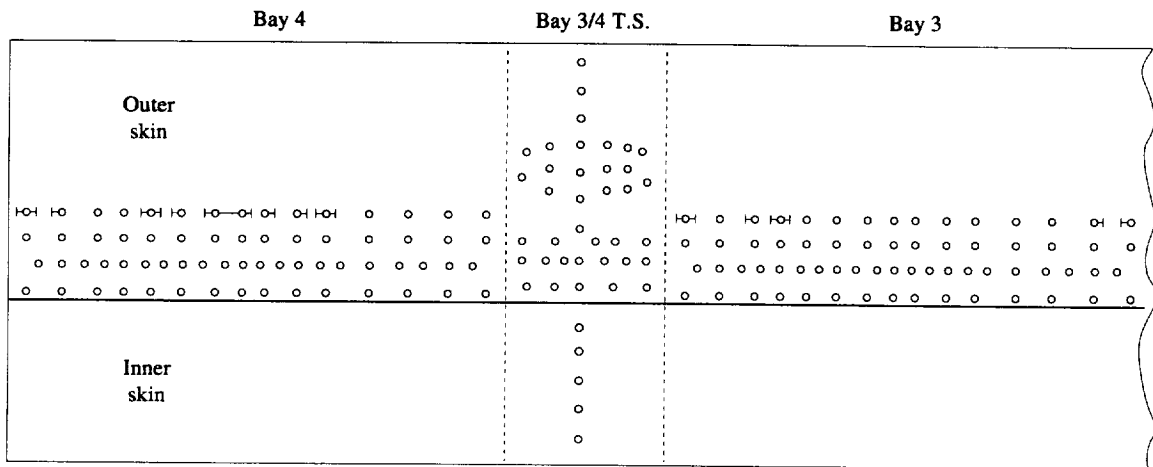
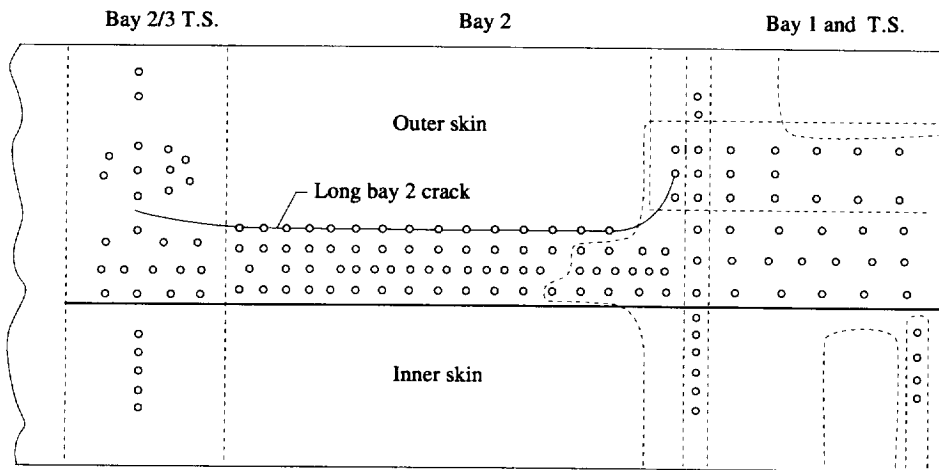
The complete characterization of fatigue cracks contained in the fuselage lap splice was achieved by a detailed teardown and fractographic characterization of the damaged regions. Figures 15.1 and 15.2 show the location of fuselage lap splice joint fatigue cracks as determined by NDE (visual and eddy current inspections) and Figure 15.3 shows the results of the destructive examinations. A comparison of the NDE results in Figures 15.1 and 15.2 show that (1) nearly all upper rivet row hole locations in bays 2, 3, and 4 contained evidence of cracking and (2) the majority of outer skin upper rivet row cracks found by within-hole eddy current inspection in bays 3 and 4 are subsurface and not detected by visual inspection. In addition, surface probe EC inspections revealed subsurface fatigue cracks in the bay 1 tear strap region, the 2/3 and 3/4 tear strap regions, and one indication along the second rivet row in bay 4. A comparison of Figures 15.1 and 15.2 with the destructive examination results shown in Figure 15.3 reveal that visual and EC methods detected cracks at approximately one-half of the rivet hole locations that contained fatigue cracks. Many of the fatigue cracks not detected by NDE were small (below the detection limit of surface probe EC), located under the rivet head, located along the faying surface, and/or contained in interior structure (inner skin, tear strap, or frame).

Figure 15.1 The results of the visual examination are shown for bays 2-4 and tear straps.
