NASA/TP-97-206257

The Characteristics of Fatigue Damage in the Fuselage Riveted Lap Splice Joint

Robert S. Piascik
Langley Research Center, Hampton, Virginia

November 1997

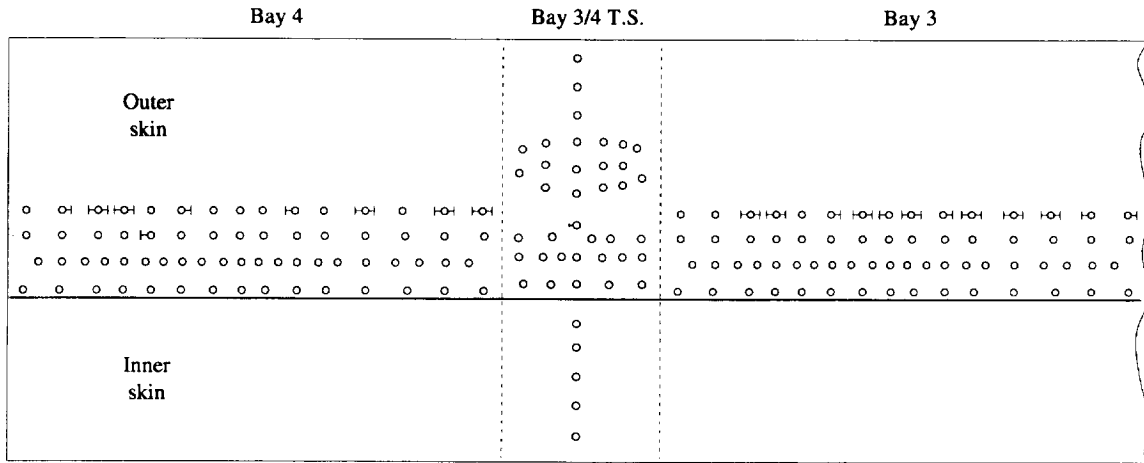
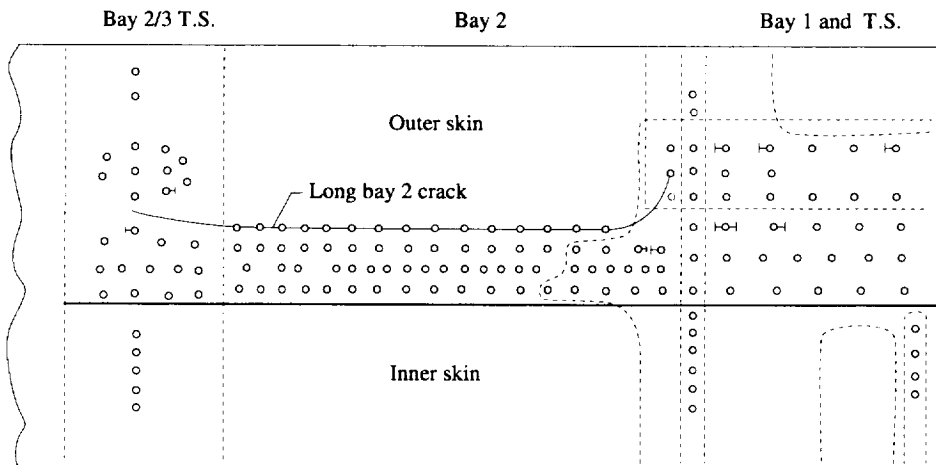
Figure 15.2 The results of the eddy current inspection are shown for bays 2-4 and tear straps. Shown are the locations of non-visible cracks detected by eddy current. All upper rivet holes contained in bays 2, 3, and 4 were examined using a “within” hole EC probe. All other locations were examined using a “sliding” surface EC probe.

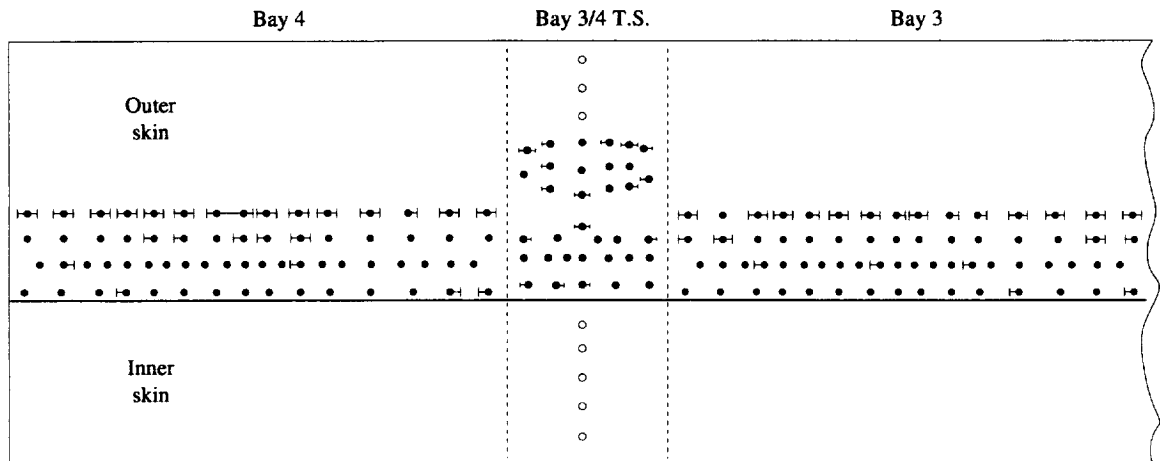
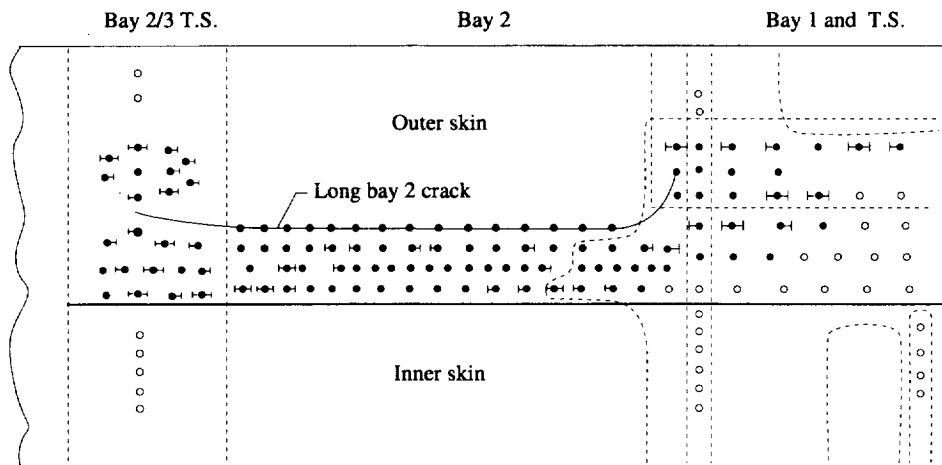
Figure 15.3 The results of the fractographic examination for bays 2-4 and tear straps. Solid rivet holes were destructively examined.

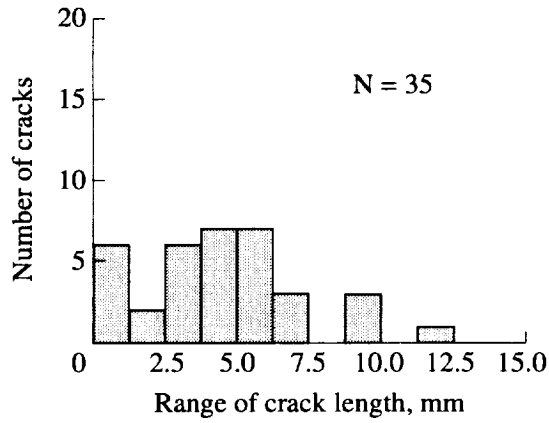
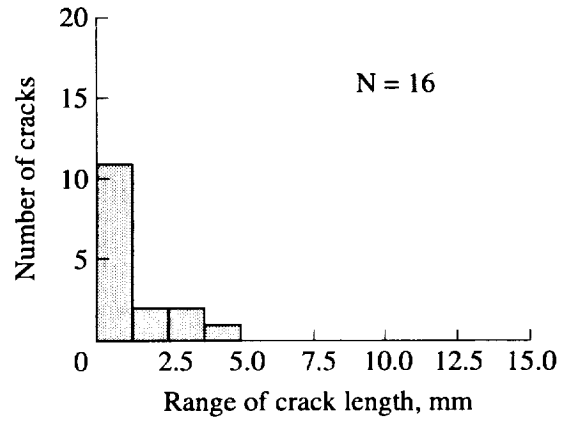
The results of the destructive examination show that lap splice joint MSD is characterized by a wide distribution of crack sizes. Figures 15.4, 15.5, and 15.6 summarize the size distribution of fatigue cracks contained in the outer and inner skin of the bay 2, 3, and 4 lap splice joint. Outer skin fatigue cracks contained in bays 2 and 4 grew to a maximum length of approximately 14 mm (0.55 inch) prior to crack link-up. Inner skin fatigue cracks grew to a length of less than 5.6 mm (0.2 inch) in bay 2 and less than 1.3 mm (0.05 inch) in bays 3 and 4. Presumably, the formation of the long, 47.6 cm (18.75 inch), upper rivet row crack in the outer skin of bay 2 led to a redistribution of load to the inner skin which resulted in significantly more inner skin cracking in bay 2 compared to bays 3 and 4.

Figure 15.4 The fatigue crack size distribution is shown for bay 2 a) outer skin and b) inner skin.

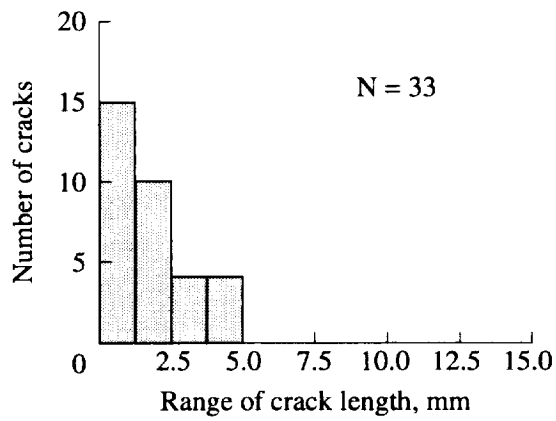
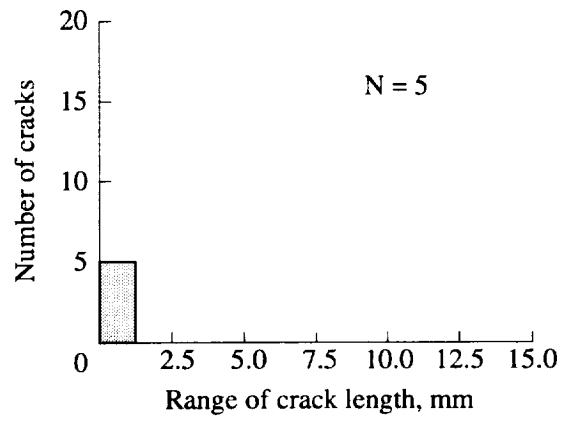
Figure 15.5 The fatigue crack size distribution is shown for bay 3 a) outer skin and b) inner skin.

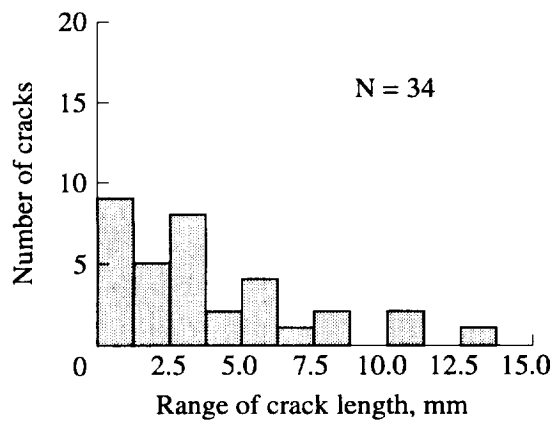
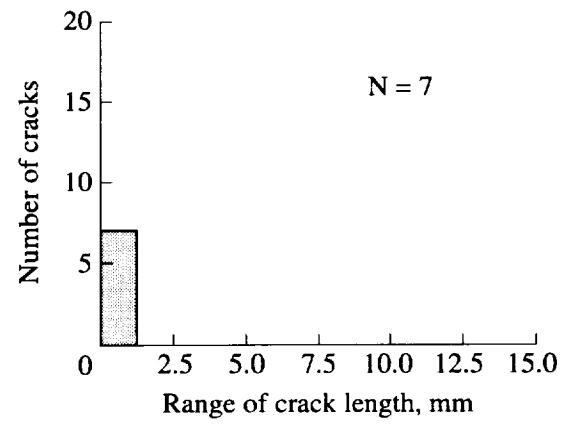
Figure 15.6 The fatigue crack size distribution is shown for bay 4 a) outer skin and b) inner skin.

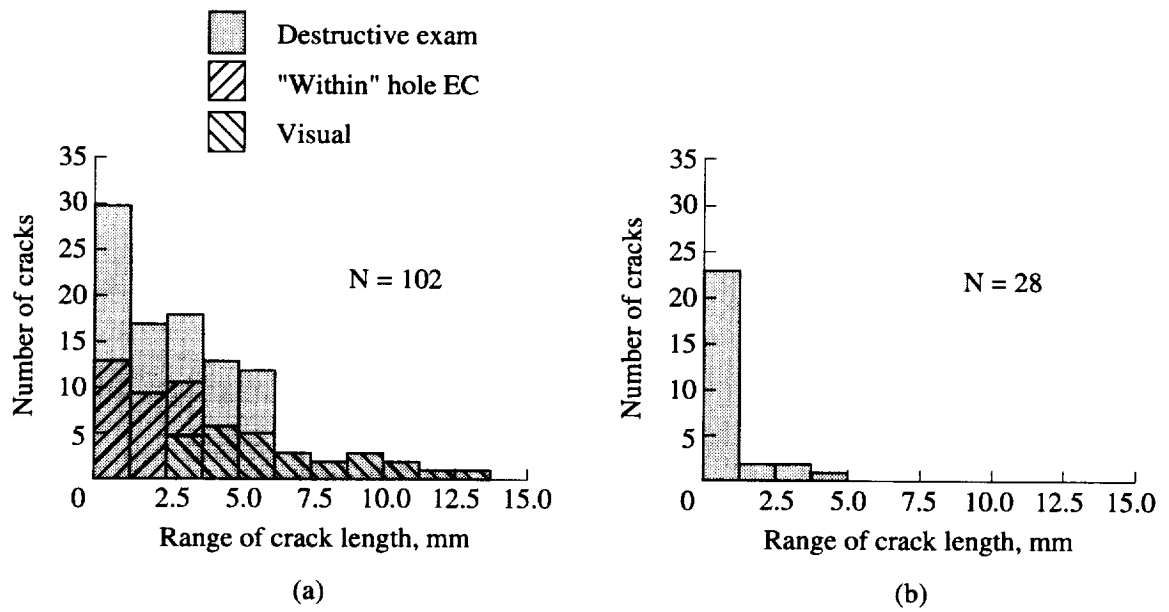
A summary of all fatigue cracks found in bays 2, 3, and 4 lap splice joints is shown in Figure 15.7. Noted in Figure 15.7a are the results of the visual and eddy current outer skin inspections. All outer skin fatigue cracks were detected by “within hole” eddy current inspection. Only outer skin cracks greater than 2.54 mm (0.10 inch) in length were detected by visual examination. The six fatigue cracks not detected by NDE, refer to Figure 15.7a, were located at “filled” hole rivet locations in the second rivet row (row I). Here, the sliding surface probe eddy current technique was unable to detect the presence of these outer skin fatigue cracks. The cracks not detected by surface EC probe ranged in size, four cracks having lengths ranging from 0 to 1.3 mm (0.05 inch), one crack of length ranging between 3.8 mm (0.15 inch) and 5.1 mm (0.20 inch), and one crack of length ranging between 5.1 mm (0.20 inch) and 6.4 mm (0.25 inch). Many of the inner skin cracks were small and were located in filled holes. Here, the within hole EC probe was not used and the surface probe was an inadequate technique to detect inner skin cracks.

Figure 15.7 The total crack size distribution is shown for bays 2, 3, and 4 a) outer skin and b) inner skin.

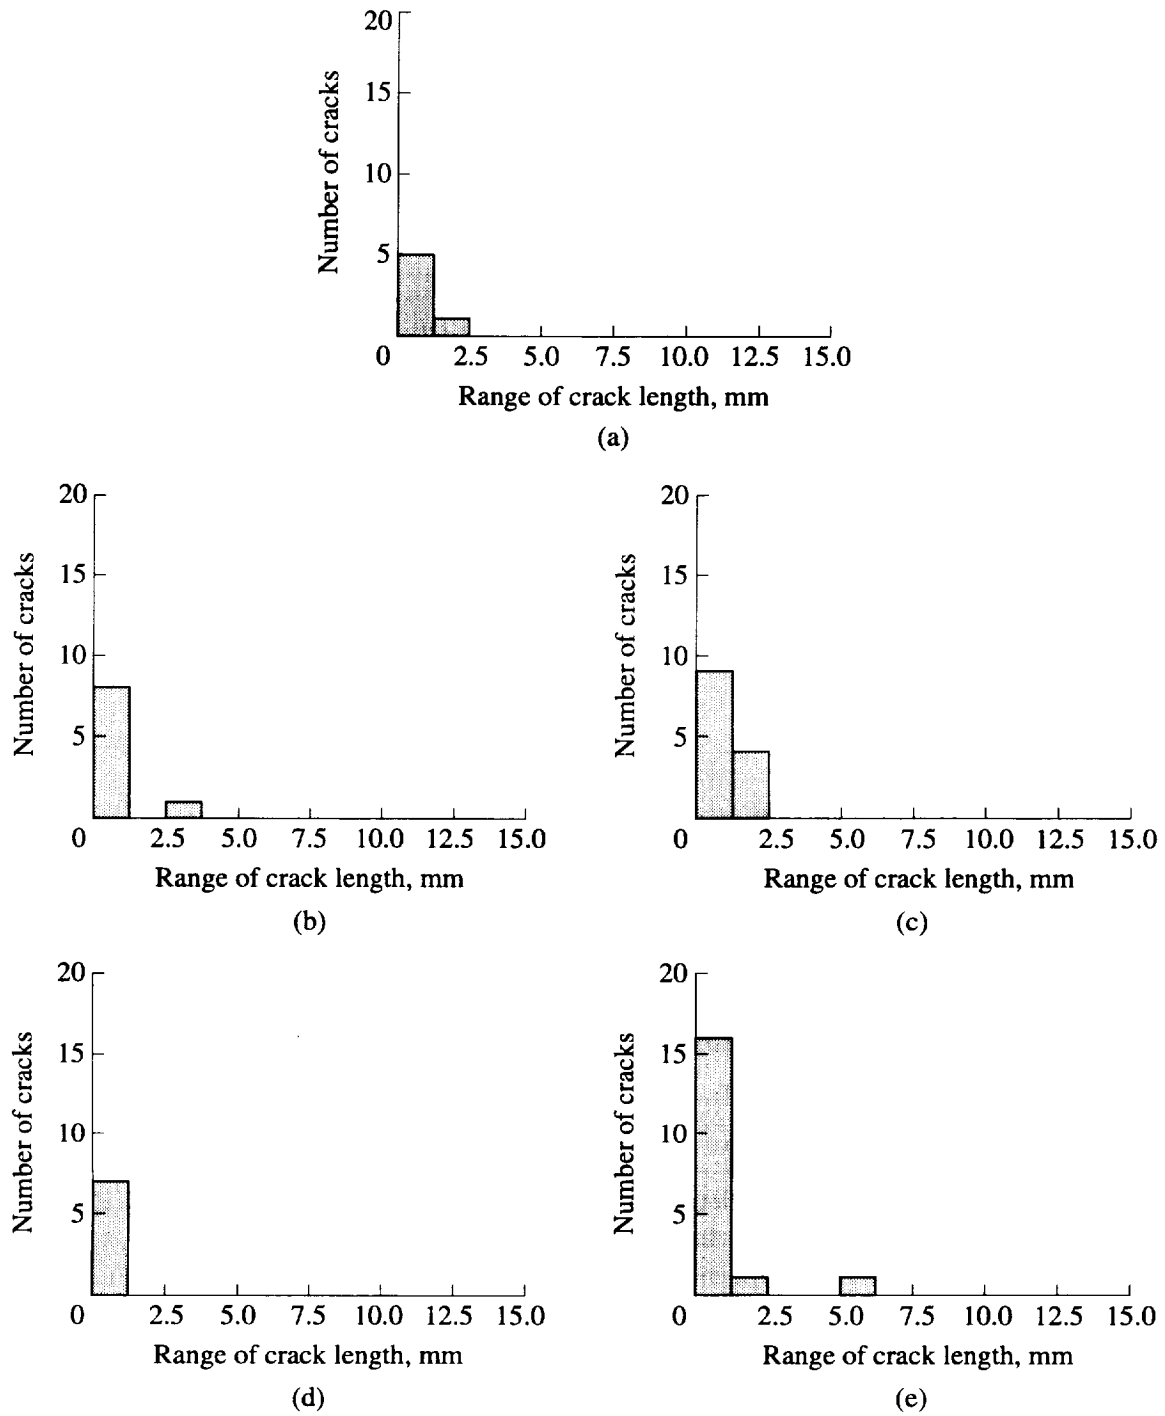
The fatigue cracking in the 2/3 and 3/4 tear strap regions are summarized in Figure 15.8. Here, cracks are generally small, less than 1.3 mm (0.05 inch) in length. A total of eight fatigue cracks having lengths between 1.3 mm (0.05 inch) to 6.4 mm (0.25 inch) were noted in the outer skin, inner skin and tear strap. Tear 3/4 strap region was found to contain the greatest number of fatigue cracks.

Figure 15.8 The crack size distribution is shown for the a) 2/3 TS outer skin, b) 2/3 TS inner skin, c) 2/3 upper and lower TS, d) 3/4 outer skin, and e) 3/4 upper and lower TS.

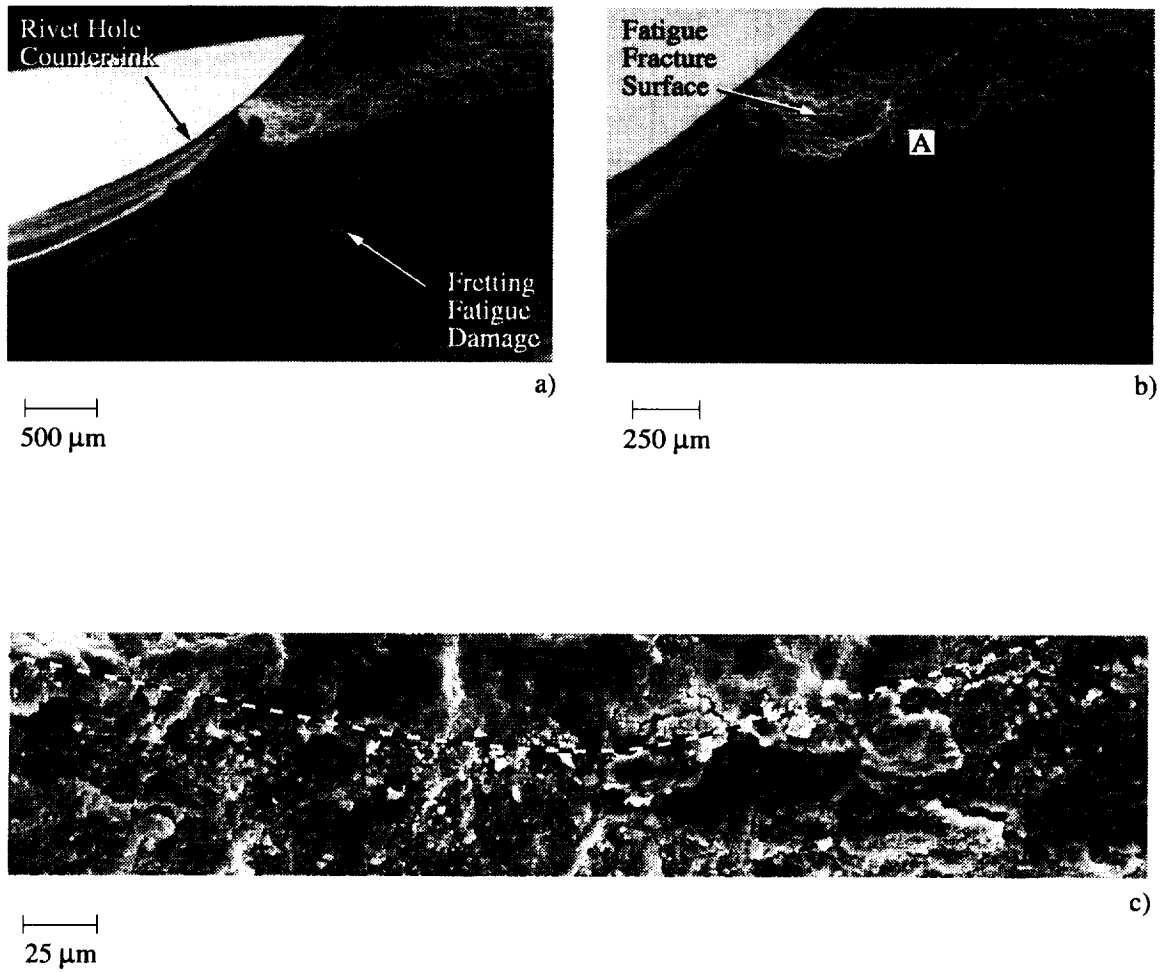
Figure 15.9 a) Scanning electron micrograph showing the location of faying surface fretting damage at rivet hole location 3J3 in the forward direction. b) SEM micrograph showing fretting damage at higher magnification. c) SEM micrograph showing microcracks and debris at location "A" in Figure 15.9b. The dashed line approximates the location of the fatigue fracture surface (above dashed line) and the faying surface edge (below dashed line).

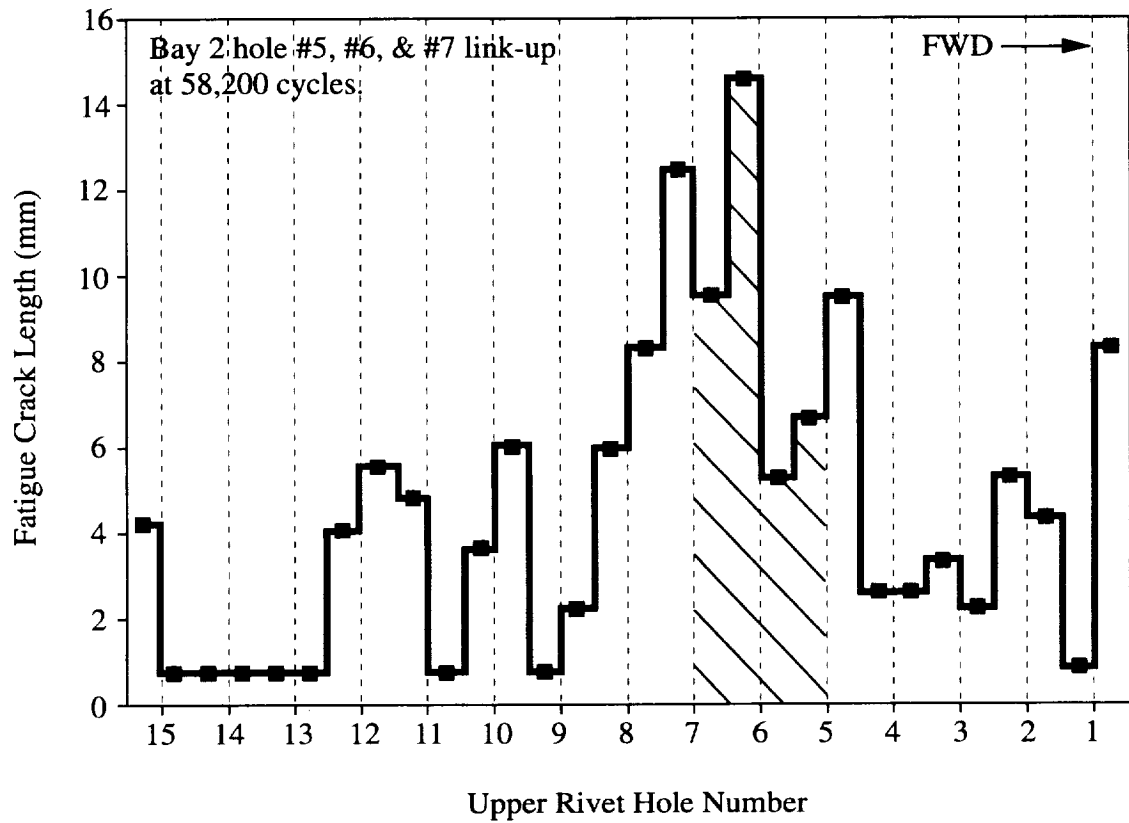
Bays that exhibited crack link-up (bays 2 and 4) contain a similar distribution of fatigue crack lengths. Figures 15.10, 15.11, and 15.12 show the outer skin fatigue crack length at each upper rivet hole location in bays 2, 3, and 4, respectively. These figures represent the condition of each bay very near the end of the full scale fatigue test and immediately prior to crack link-up¹. The bay 2 crack length data plotted in Figure 15.10 are based on *in situ* visual examinations conducted at fix pressure cycles; here, first link-up was observed between 58,040 and 58,200 pressure cycles and the remainder of the fatigue cracks linked between 58,200 and 58,500 pressure cycles. Figure 15.12 shows bay 4 fatigue crack lengths prior to crack link-up at 59,900 cycles. The fatigue crack distribution shown in Figure 15.11 for bay 3 at 60,000 pressure cycles

¹Crack link-up occurred in bays 2 and 4. Because of fracture surface oxide debris, the exact location of the final fatigue crack front was not determined by fractography in bay 2. *In situ* visual crack length data are plotted in Figure 15.10. These results estimate the location of the crack front within 160 to 300 cycles prior to crack link-up (58,200 cycles). The fractographic based results for bay 4, shown in Figure 15.12, represent the condition of bay immediately prior to crack link-up (59,900 cycles). The fractographic based for bay 3 in Figure 15.11 represent the condition of the bay at the end of the pressure test (60,000 cycles).

Figure 15.10 A plot of fatigue crack length prior to link-up for outer skin upper rivet row cracks contained in bay 2. Crack link-up occurred between rivet holes 5-7 (shaded region) between pressure cycles 55,500 and 58,000. Link-up occurred at other hole locations between pressure cycles 58,200 and 60,000.

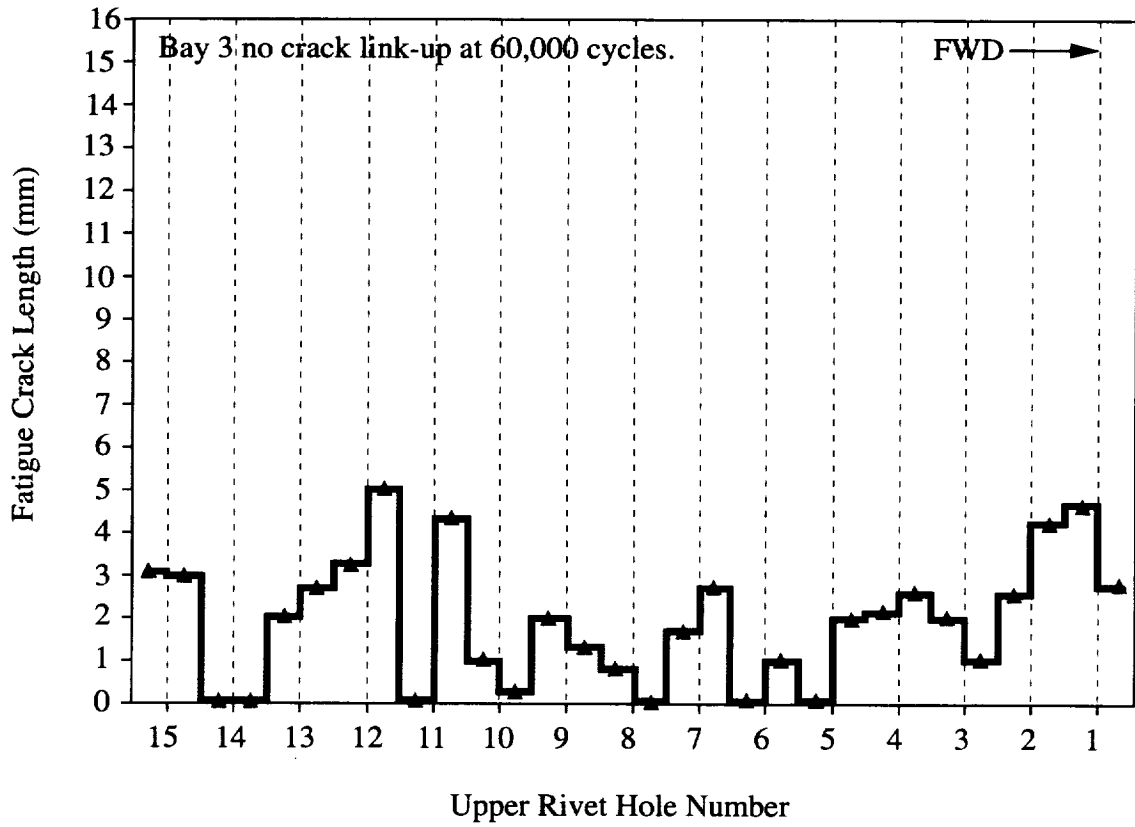
is different than that observed for bays 2 and 4. Here, bay 3 exhibits a relatively flat crack length distribution compared to the adjacent bays (bays 2 and 4) that exhibited crack link-up.

Figure 15.11 Shows bay 3 fatigue crack lengths at 60,000 cycles; no crack link-up occurred in bay 3.

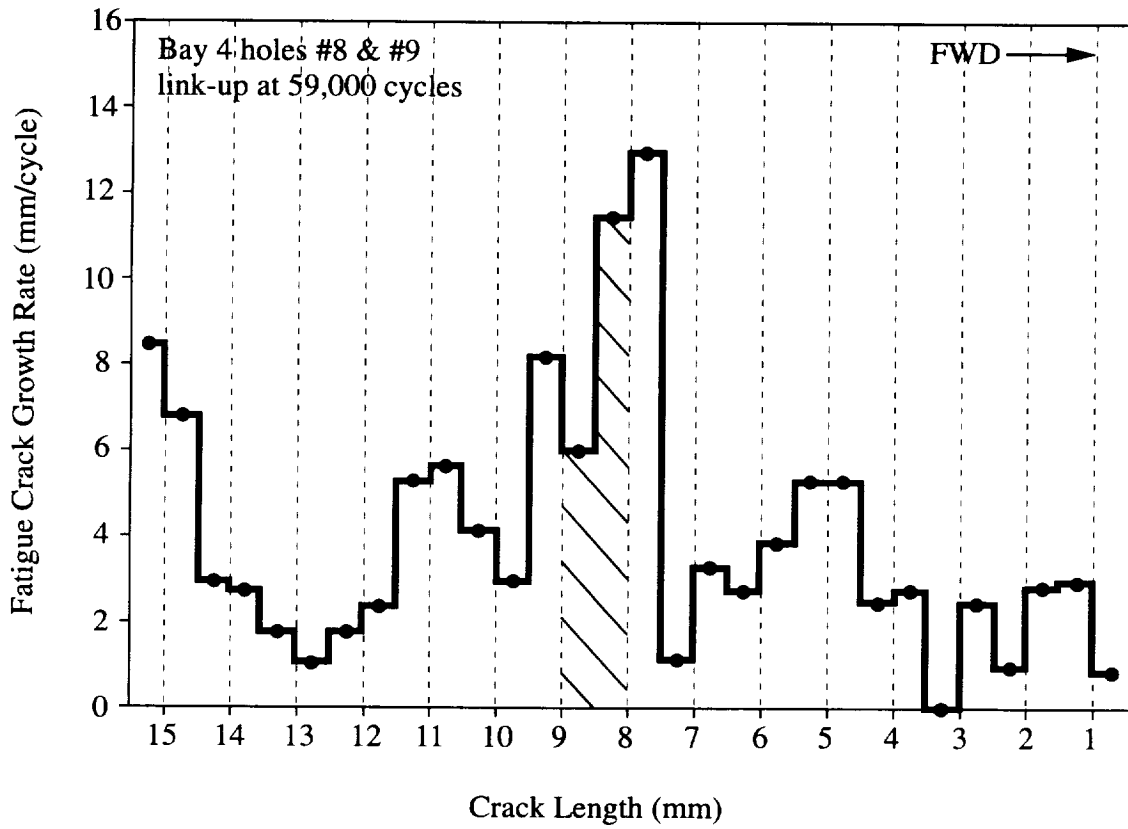
Figure 15.12 A plot of fatigue crack length prior to link-up for outer skin upper rivet row cracks contained in bay 4. Crack link-up occurred between rivet holes 8 and 9 (shaded region) at 59,900 pressure cycles

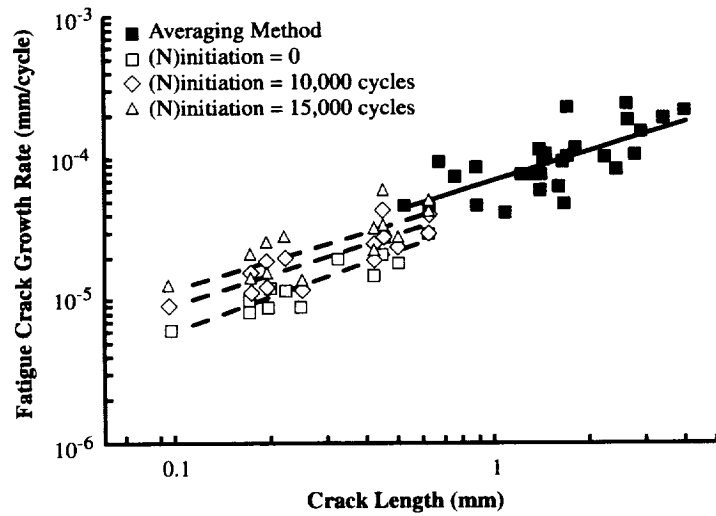
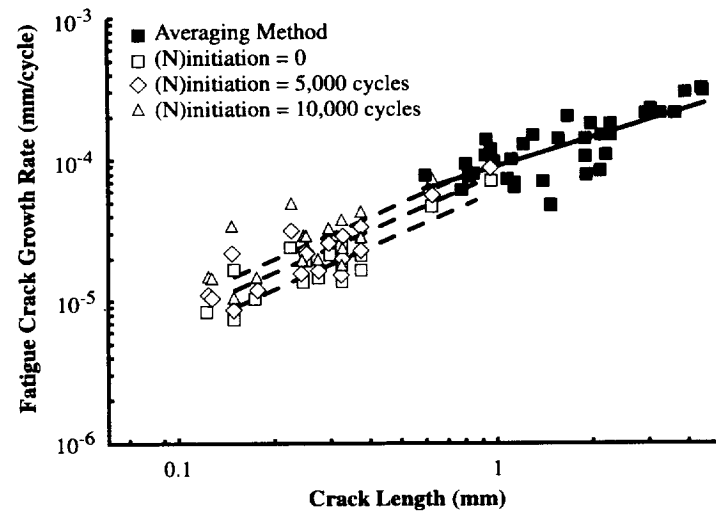
cycles and bay 4 crack initiation occurred between 5,000 and 10,000 pressure cycles. Plotted in Figure 15.13 are the estimated short crack da/dN results (open triangles and diamonds) for extrapolated values of $N_{\text{initiation}}$. A comparison of the linear regression analysis lines for bays 3 and 4 ($N_{\text{initiation}} = 15,000$ and 10,000 cycles, respectively) with the long crack data (solid square symbols) strongly suggests that a single curve describes the growth behavior of upper rivet row fatigue cracks in each lap splice joint bay. A comparison of the fatigue crack growth characteristics for bays 3 and 4 is shown in Figure 15.14. Here, the linear regression analysis lines for bays 3 and 4 are in good agreement. This important result suggests that all outer skin fatigue cracks contained in the lap splice joint upper rivet row propagate at the same rate. The linear behavior of the log da/dN versus log a plot may suggest that complex local stresses, such as that resulting from rivet fit-up, have little effect on da/dN for fatigue cracks greater than 1 mm in length. If local stresses were significant, a non-linear da/dN versus a response would be expected as the crack grew out of a local stress environment into the remote stress dominated regime.

Figure 15.13 The growth characteristics of small fatigue cracks contained in the upper rivet row outer skin in a) bay 3 assuming $N_i=0$, $N_i=10,000$ cycles, and $N_i=15,000$ cycles and b) bay 4 assuming $N_i=0$, $N_i=5,000$ cycles and $N_i=10,000$ cycles.

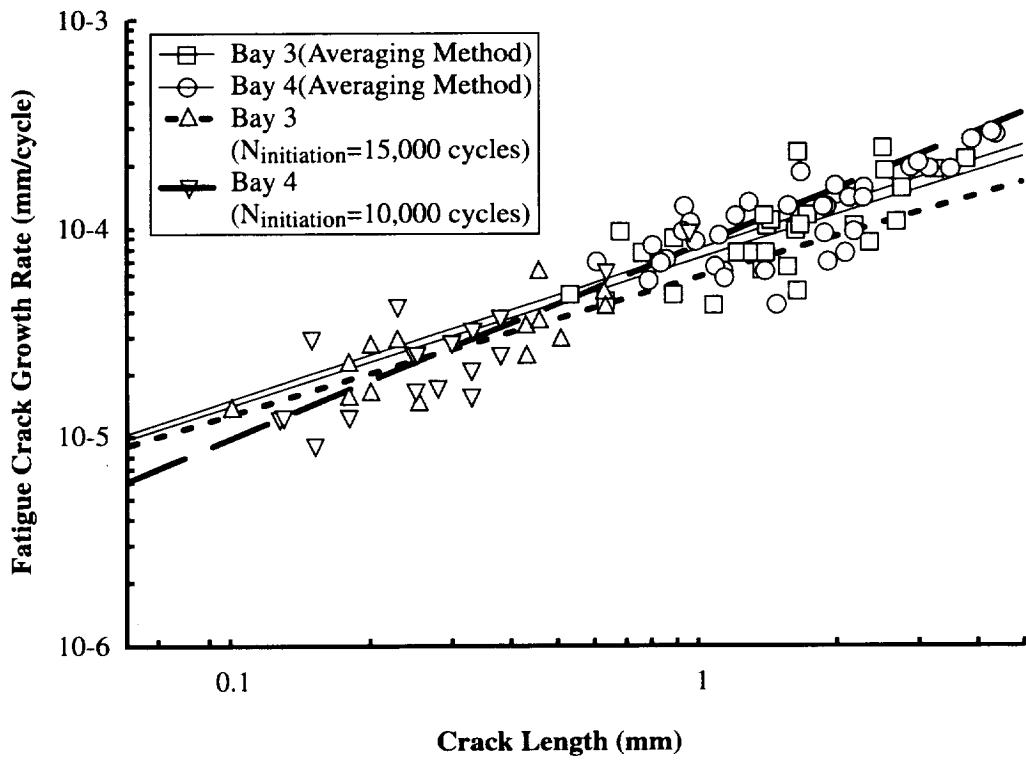
Figure 15.14 A comparison of the growth characteristics of outer skin fatigue cracks contained in bays 3 and 4 lap splice joint upper rivet row.
