Comparison of Spacecraft Contamination Models with Well-Defined Flight Experiment

NAS8-40581

Progress Report for May 15, 1997 to August 15, 1997

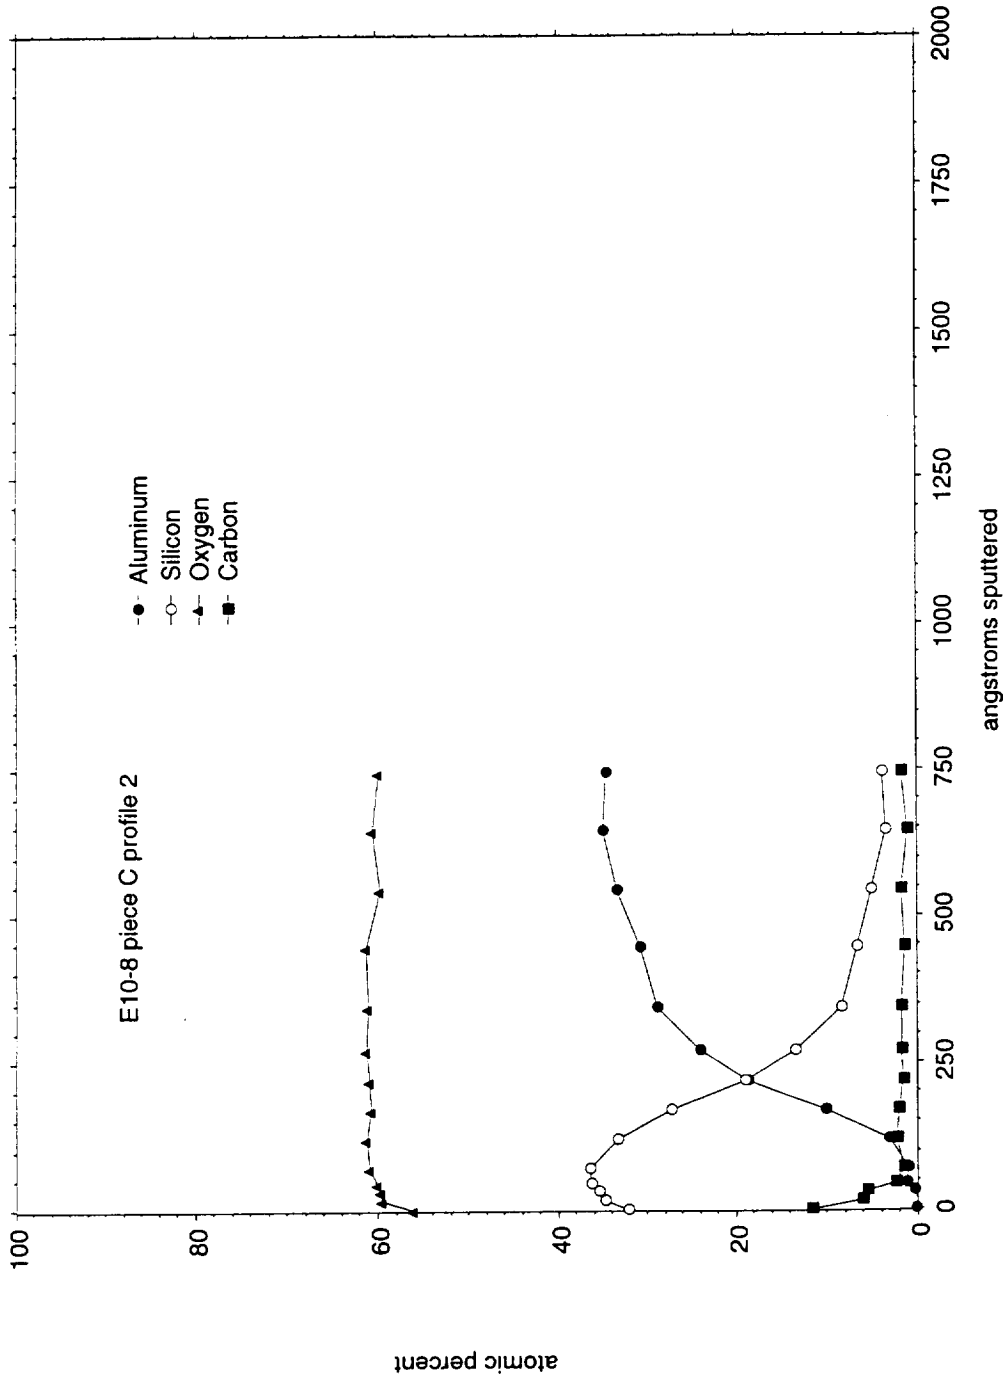
Figure 6. Depth Profile showing Silicon, Carbon, Aluminum, and Oxygen elemental %'s at location "C-2" from tray surface E10-8.

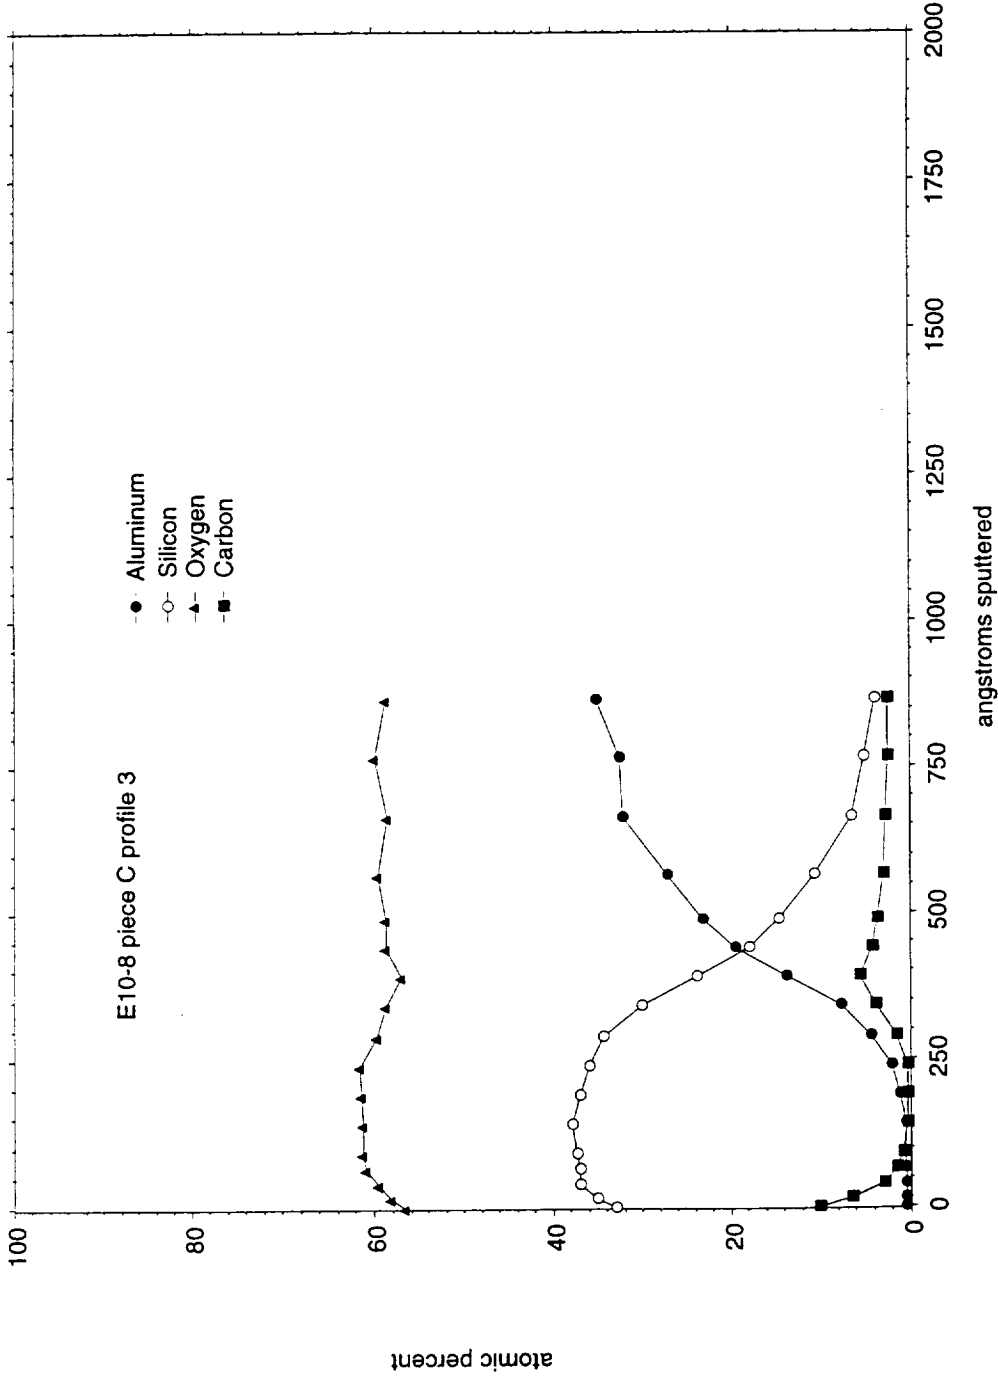
Figure 7. Depth Profile showing Silicon, Carbon, Aluminum, and Oxygen elemental %'s at location "C-3" from tray surface E10-8.

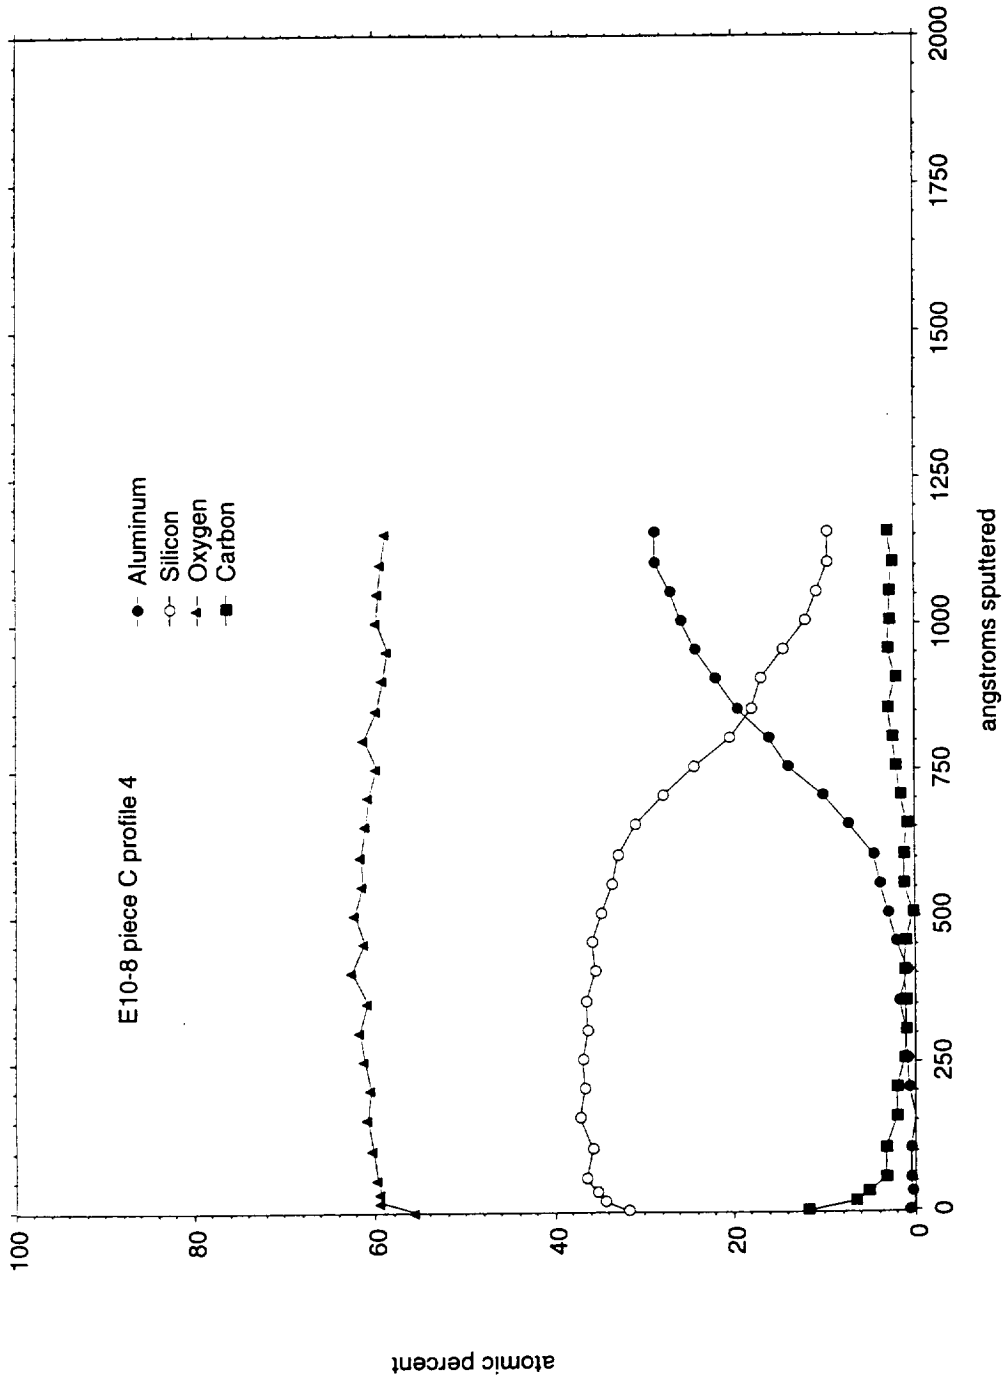
Figure 8. Depth Profile showing Silicon, Carbon, Aluminum, and Oxygen elemental %'s at location "C-4" from tray surface E10-8.

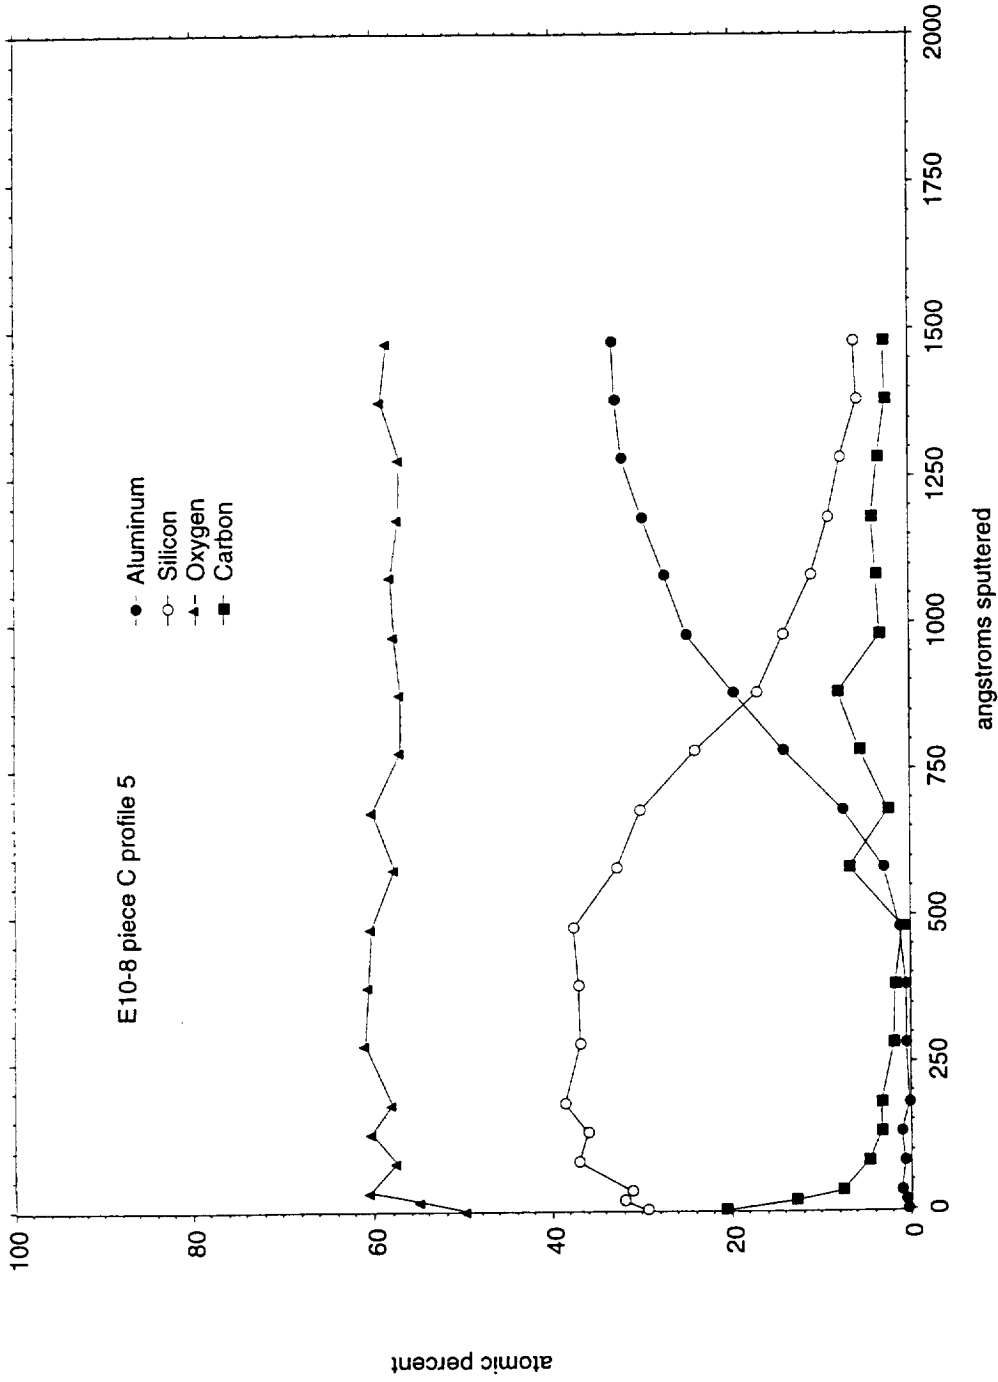
Figure 9. Depth Profile showing Silicon, Carbon, Aluminum, and Oxygen elemental %'s at location "C-5" from tray surface E10-8.

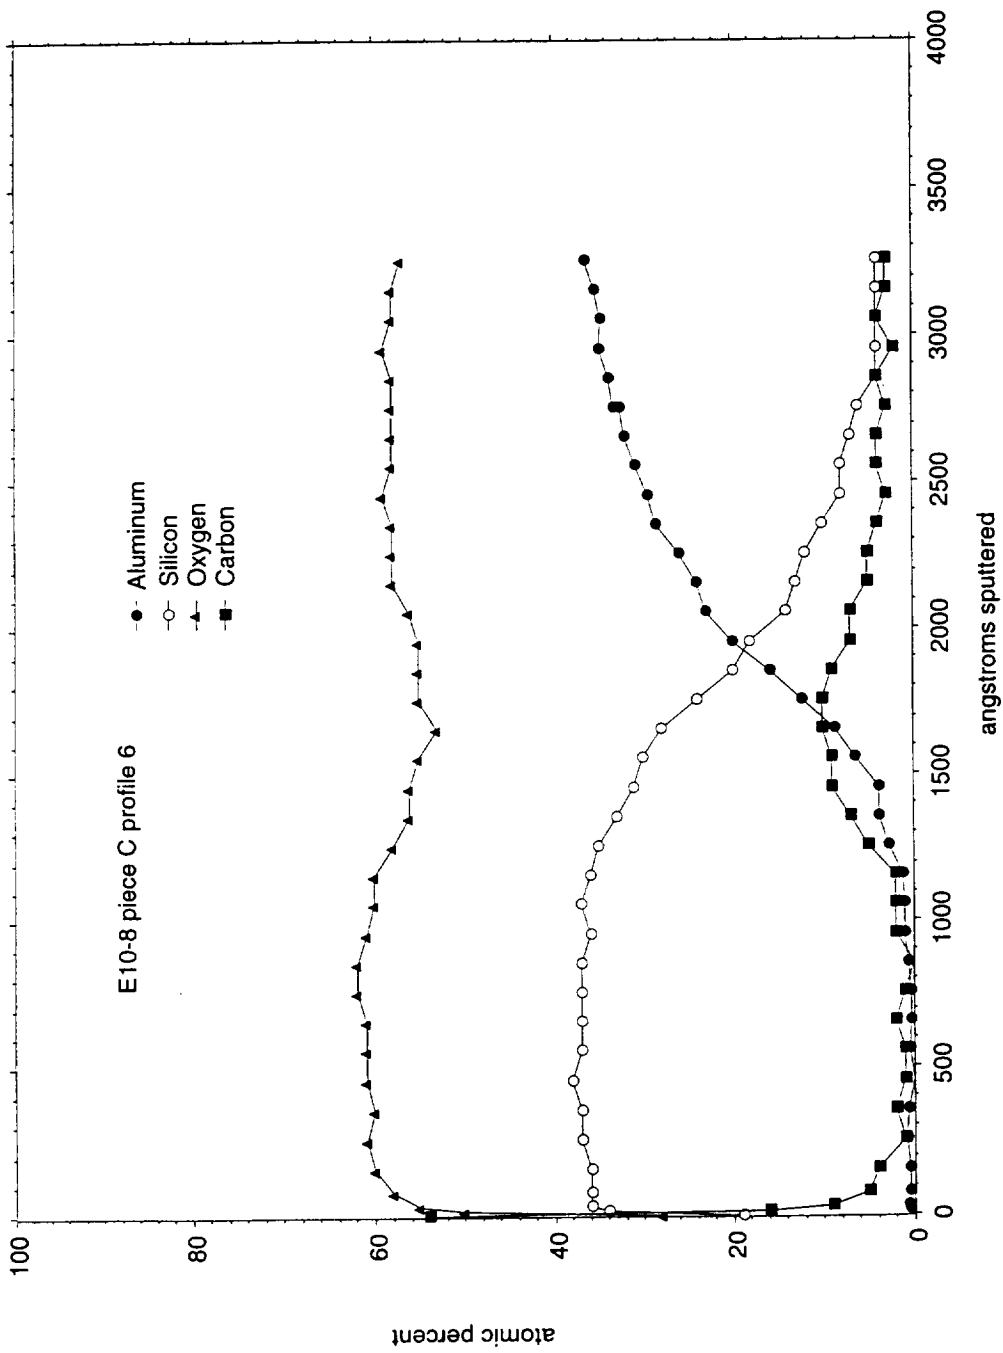
Figure 10. Depth Profile showing Silicon, Carbon, Aluminum, and Oxygen elemental %'s at location "C-6" from tray surface E10-8.

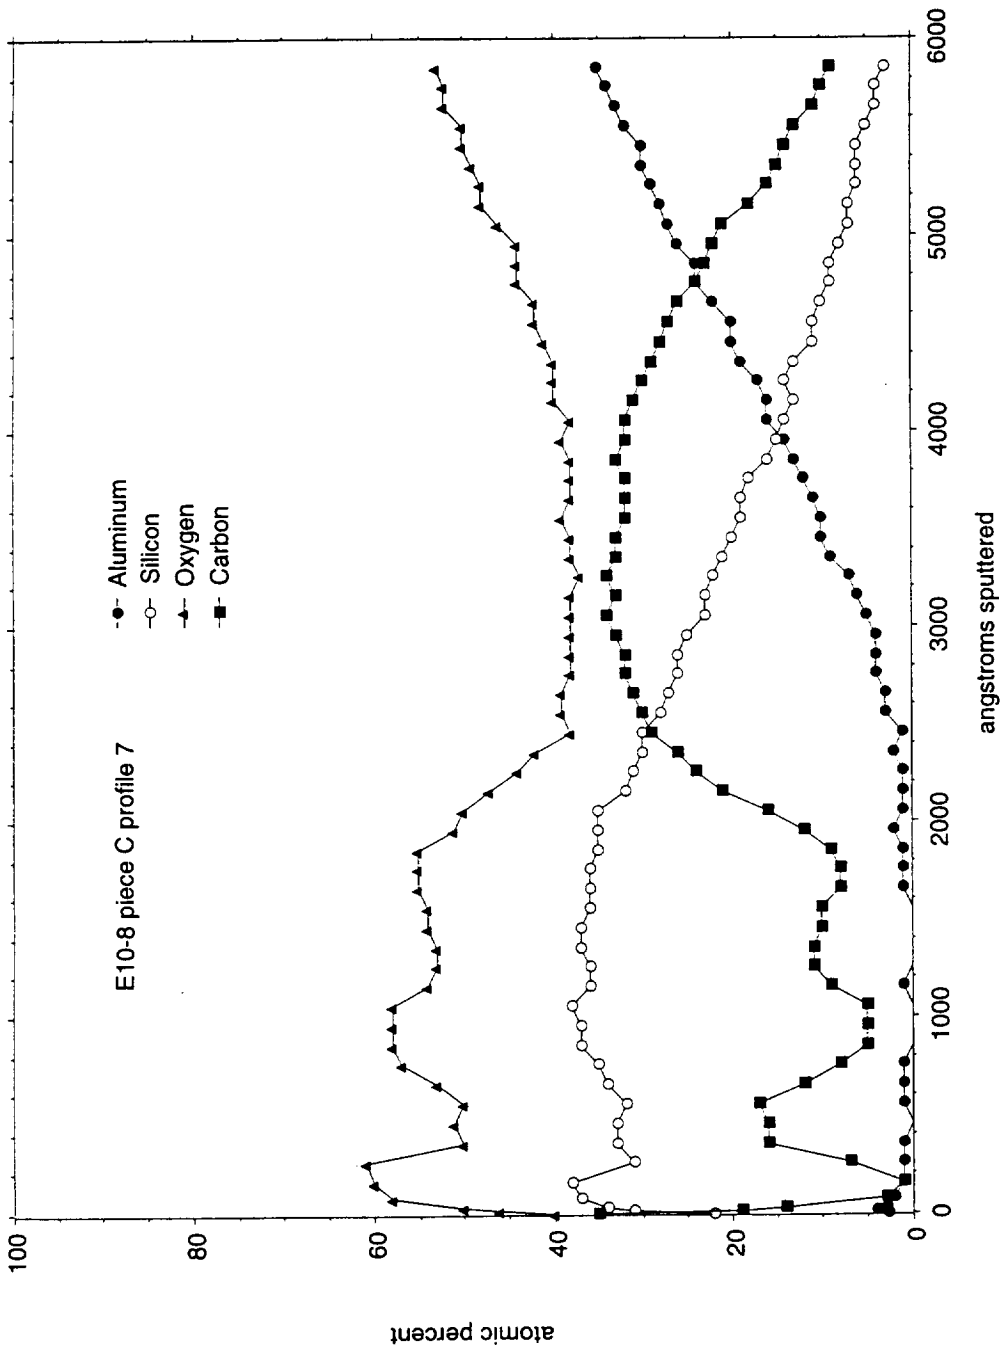
Figure 11. Depth Profile showing Silicon, Carbon, Aluminum, and Oxygen elemental %'s at location "C-7" from tray surface E10-8.

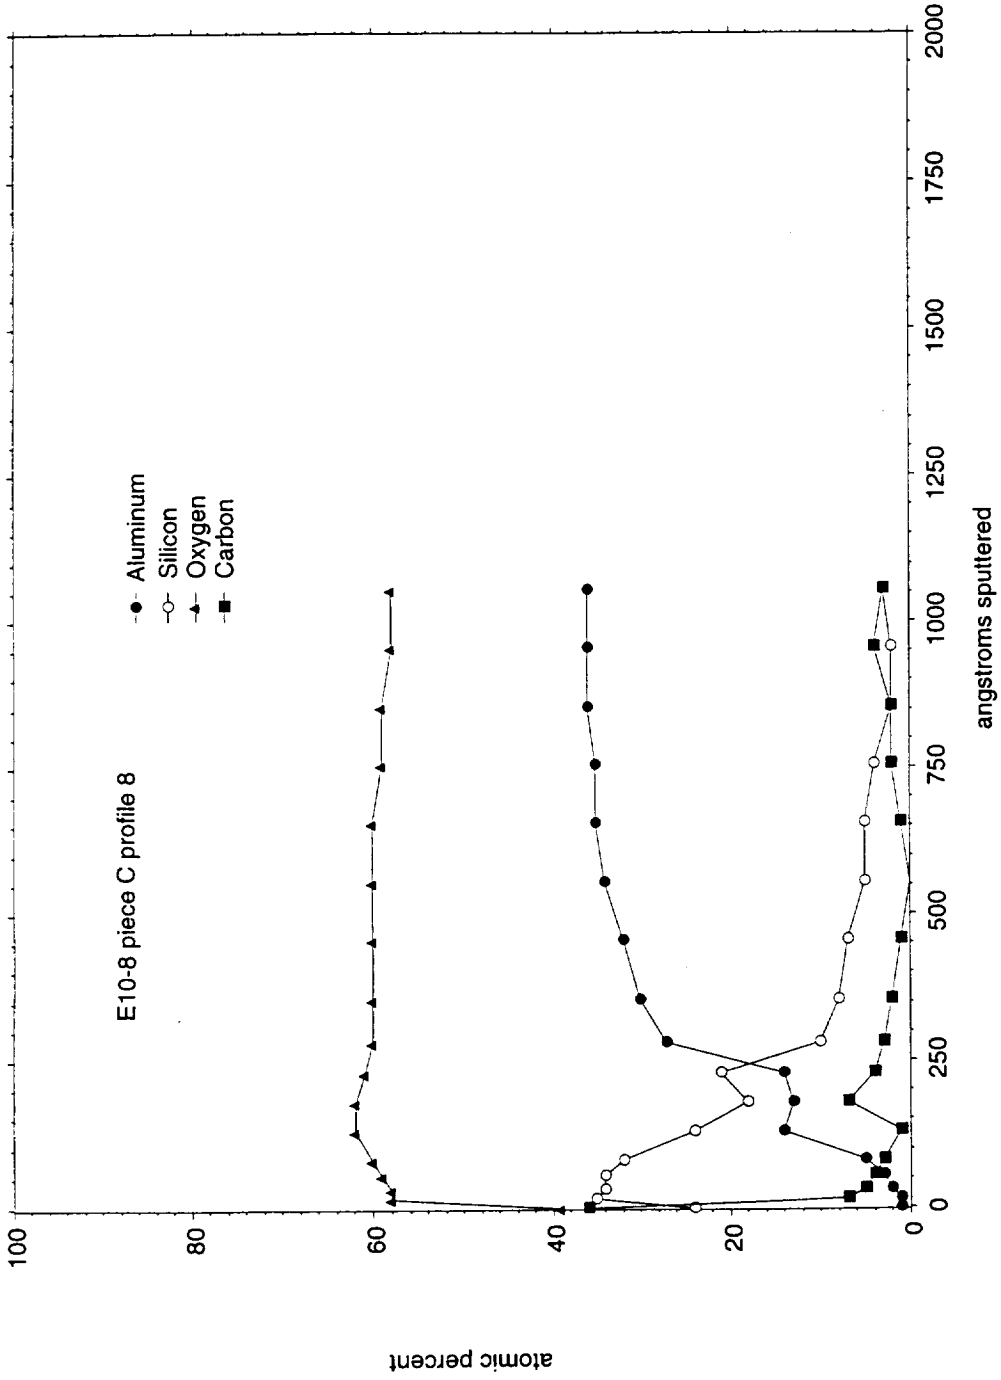
Figure 12. Depth Profile showing Silicon, Carbon, Aluminum, and Oxygen elemental %'s at location "C-8" from tray surface E10-8.

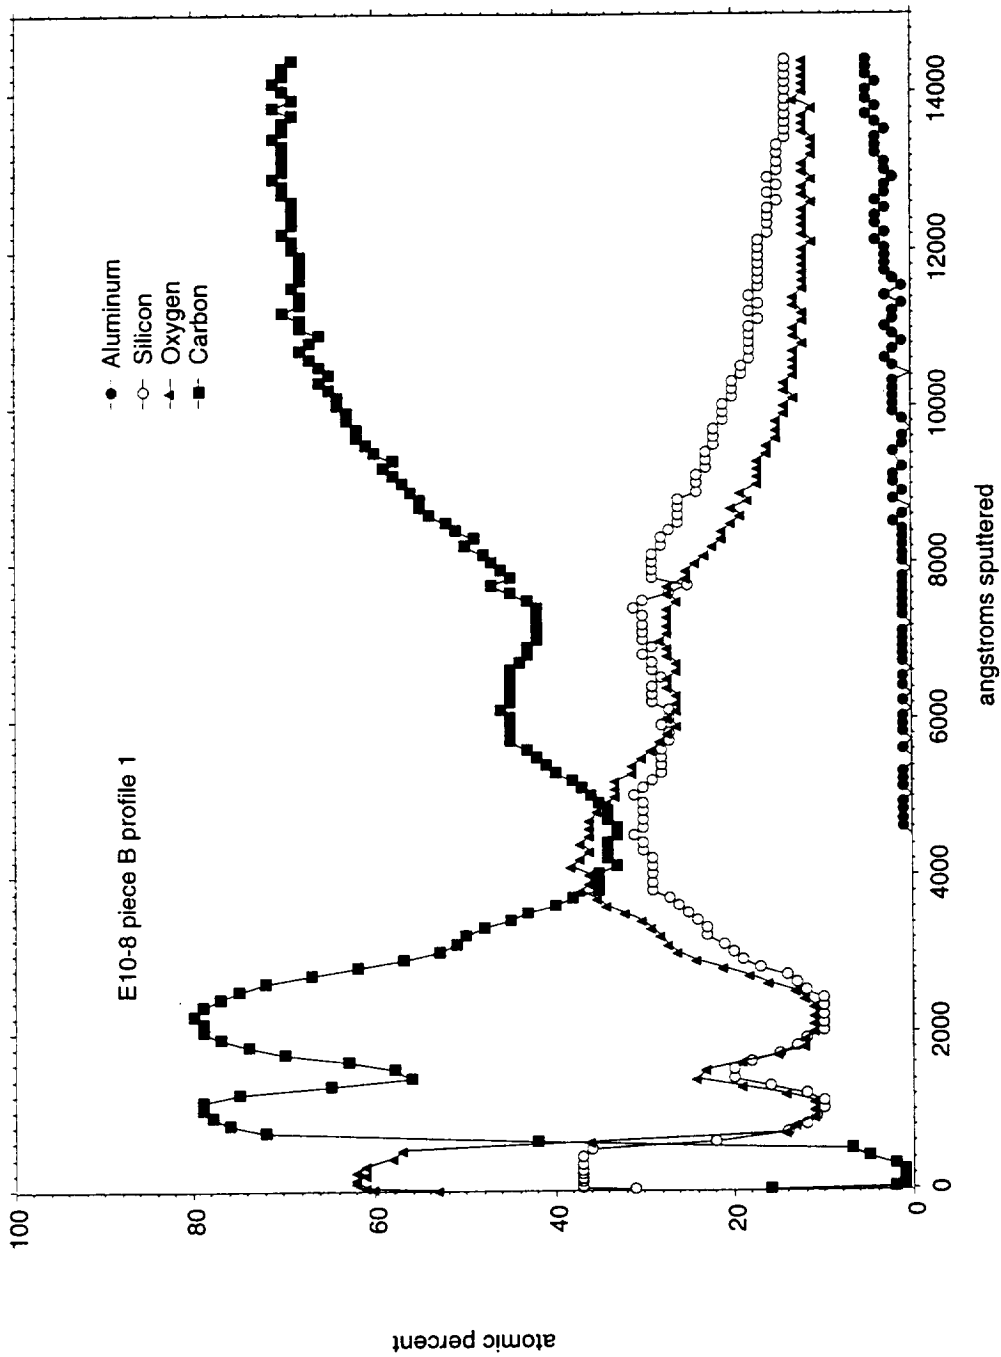
Figure 13. Depth Profile showing Silicon, Carbon, Aluminum, and Oxygen elemental %'s at location "B-1" from tray surface E10-8.
