Debris/Ice/TPS Assessment and Integrated Photographic Analysis of Shuttle Mission STS-94

*Process Engineering/Mechanical System Division/ET-SRB Branch,
Kennedy Space Center, Florida*

**DEBRIS/ICE/TPS ASSESSMENT
AND
INTEGRATED PHOTOGRAPHIC ANALYSIS
OF
SHUTTLE MISSION STS-94**

1 July 1997

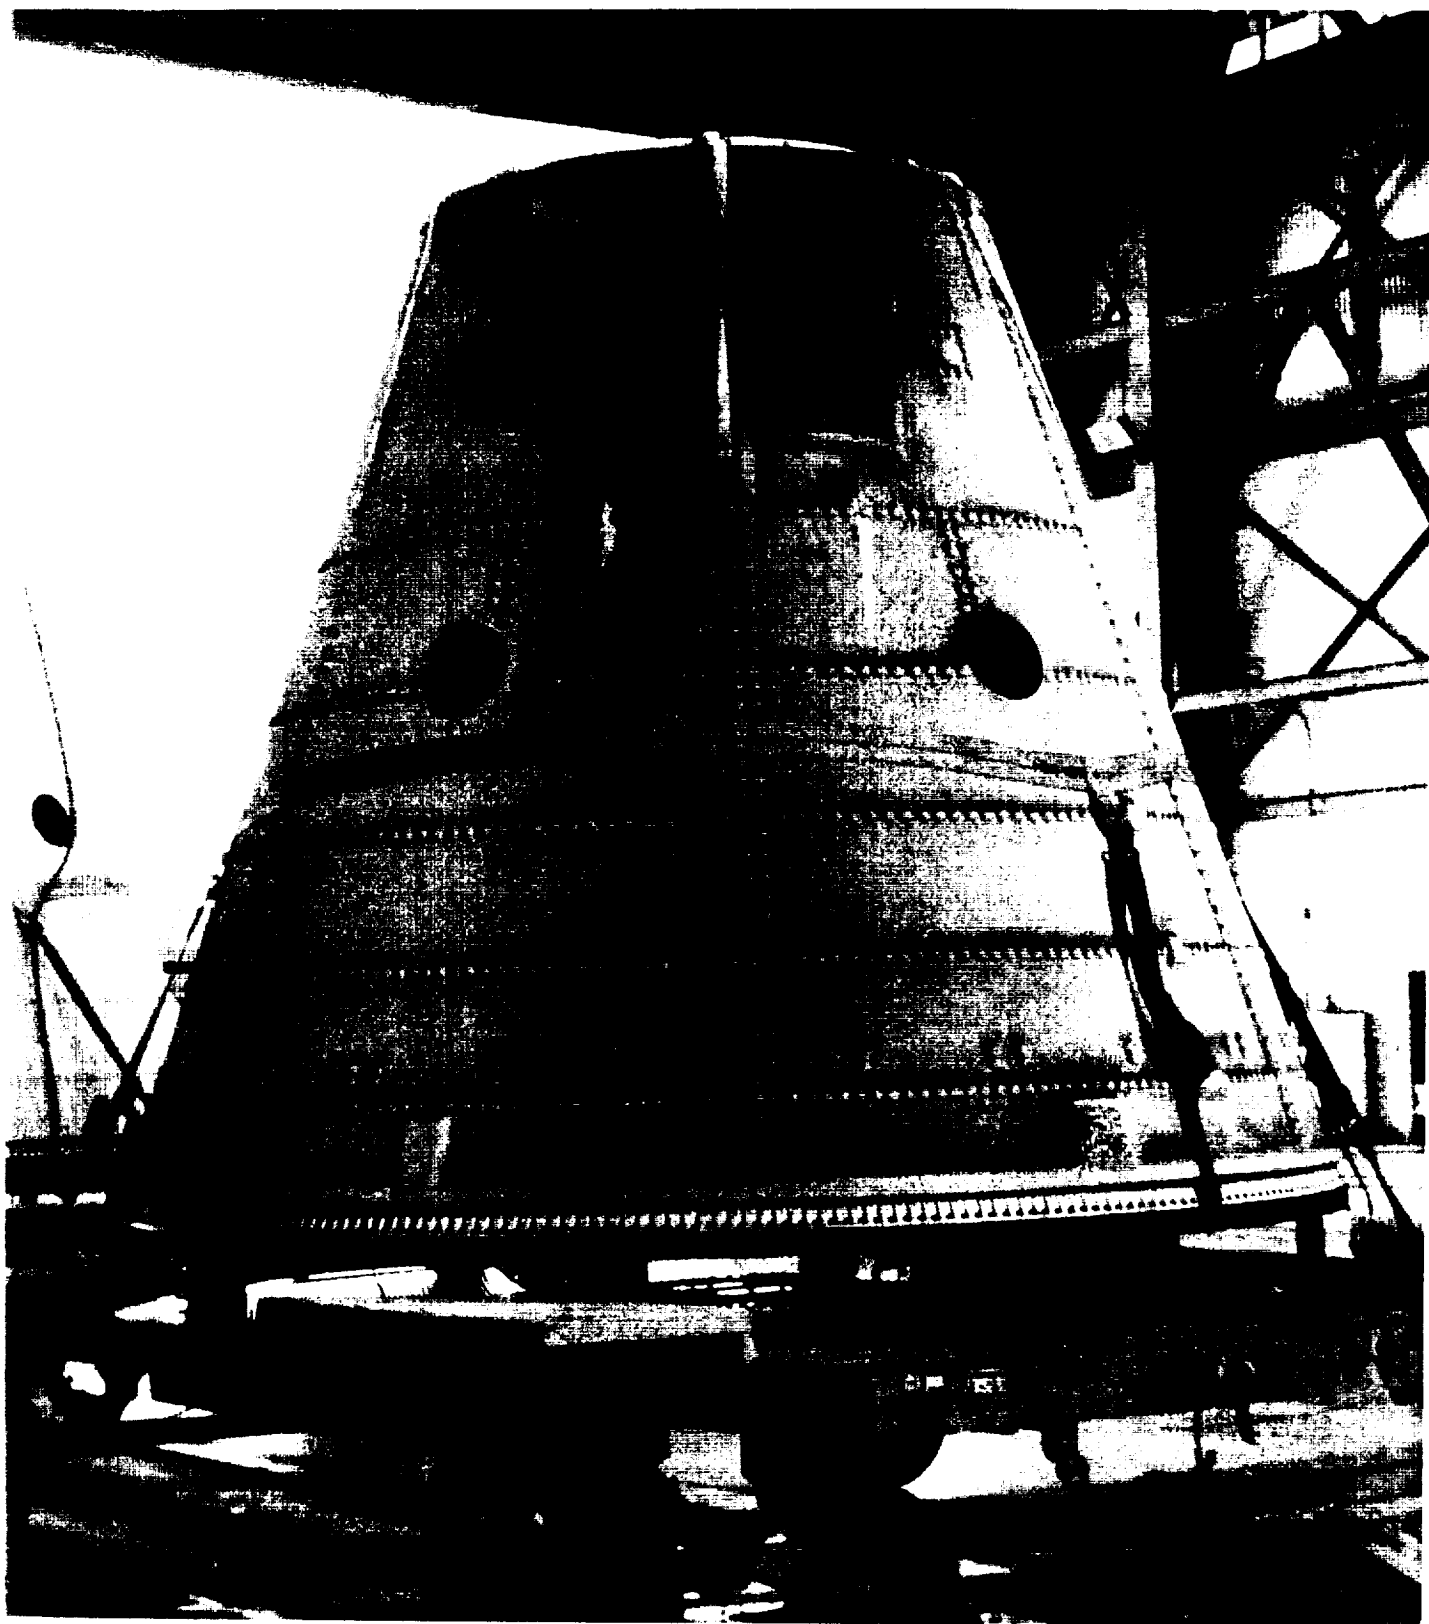
Photo 15: Right Frustum

Both frustums were in excellent condition. No TPS was missing and no debonds were detected over fasteners on either frustum. None of the Hypalon paint had blistered. All four BSM aero heat shield covers on the right frustum were locked in the fully opened position. The lower right BSM aero heat shield cover on the left frustum was locked in the fully opened position; the remaining covers were bent. The BSM aero heat shield cover attach rings had been bent by parachute riser entanglement after splashdown.

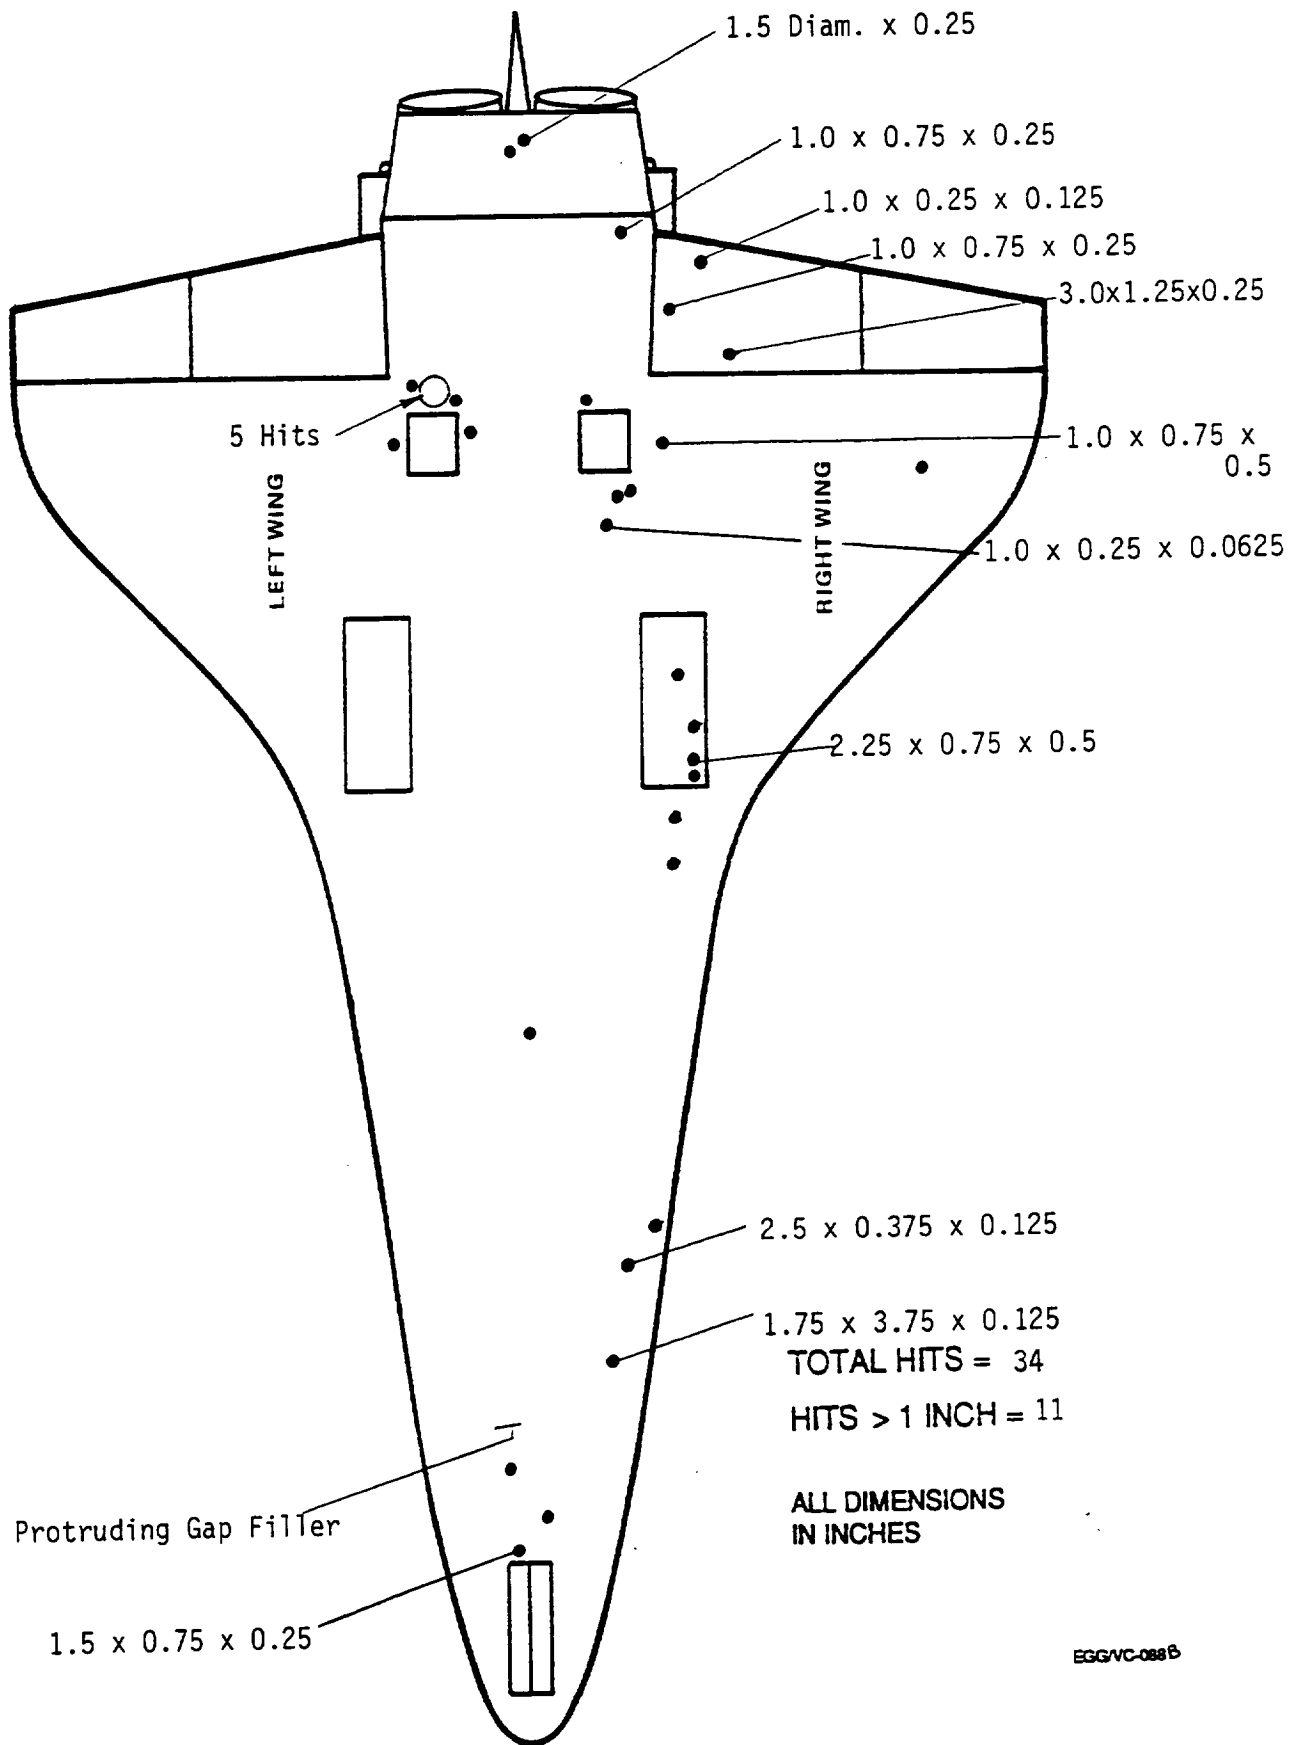
Figure 1: Orbiter Lower Surface Debris Damage Map

The Orbiter lower surface sustained a total of 34 hits, of which 11 had a major dimension of 1-inch or larger. The largest lower surface tile damage site was located on the right chine. The site measured 3.75 inches long by 1.75-inches wide by 0.125-inches deep.

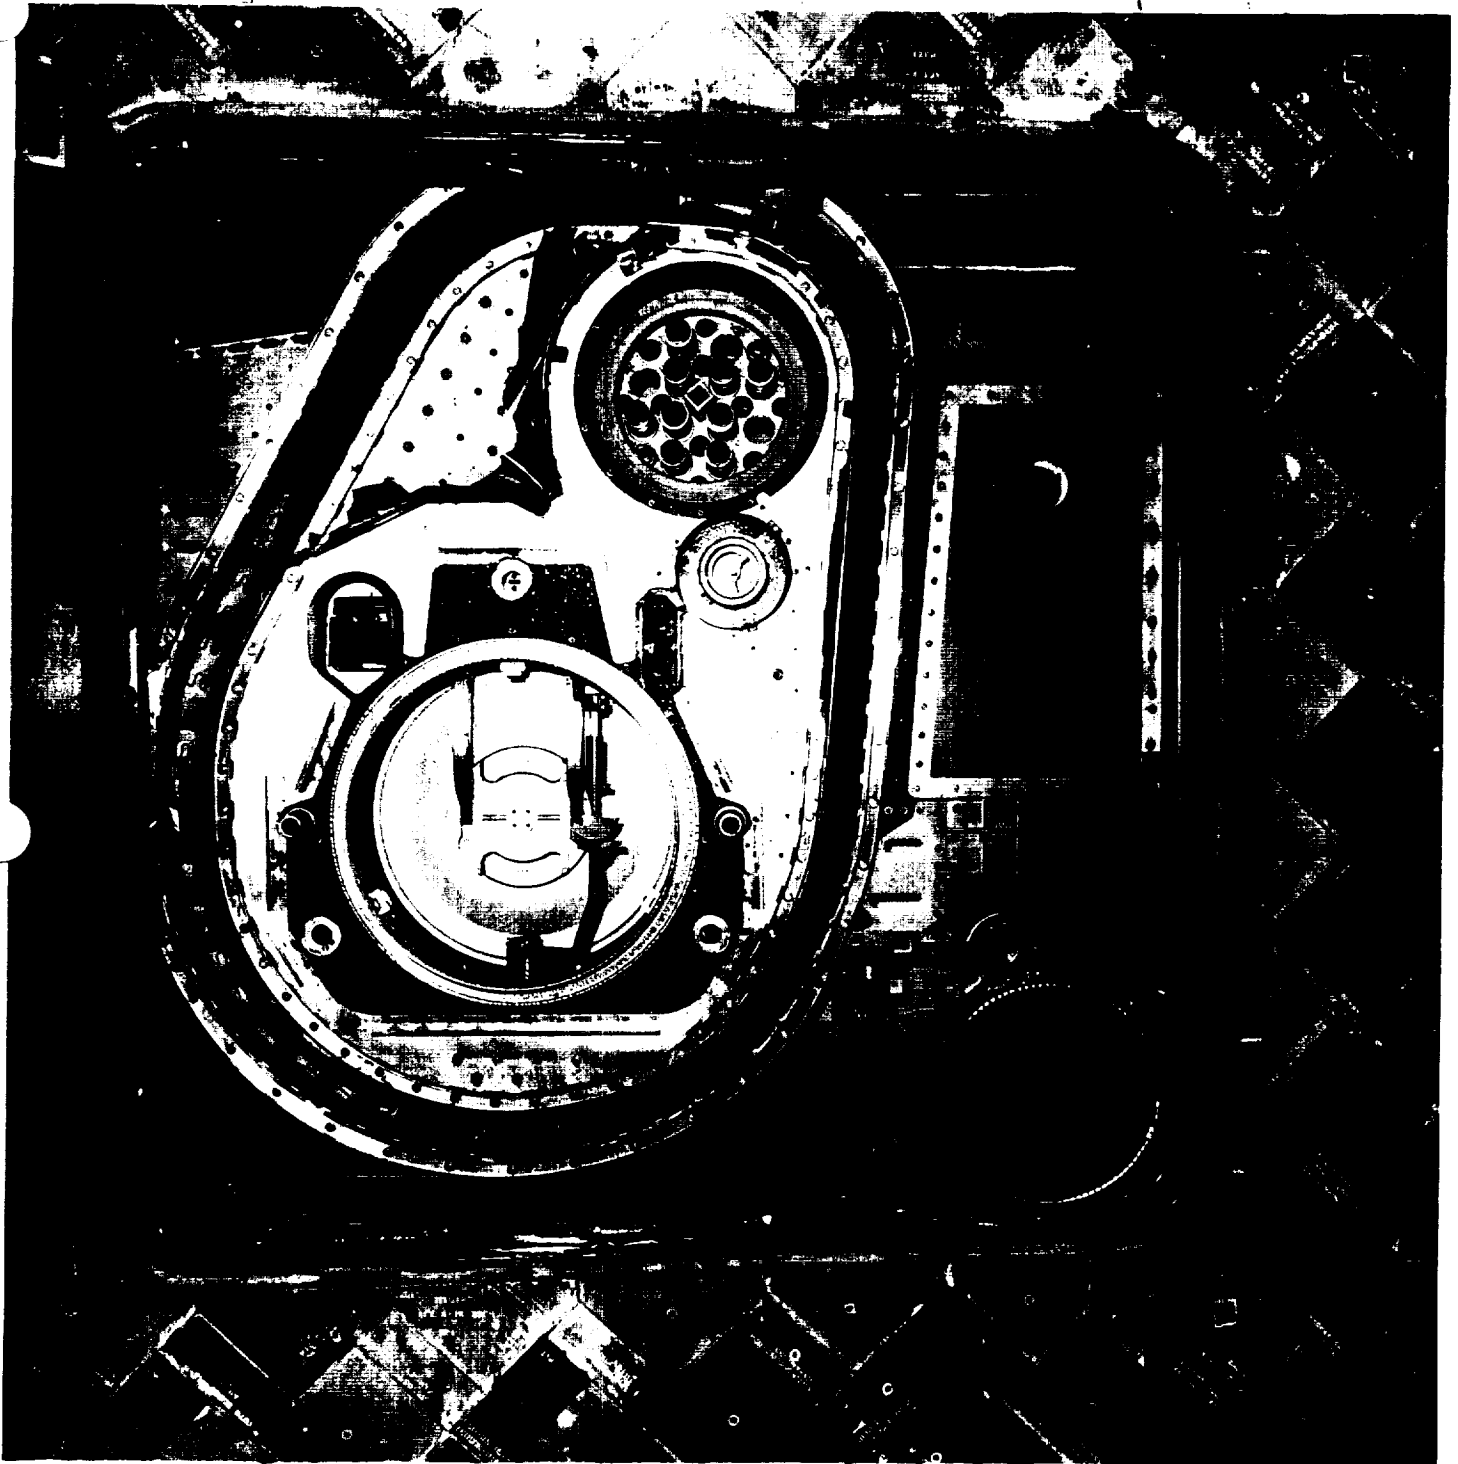
Photo 28: LO2 ET/ORB Umbilical

The LO2 ET/ORB umbilical sustained no visible TPS damage during separation. Numerous divots and eroded areas were visible on the horizontal and vertical sections of the cable tray. The red barrier around the EO-3 fitting was dislodged.

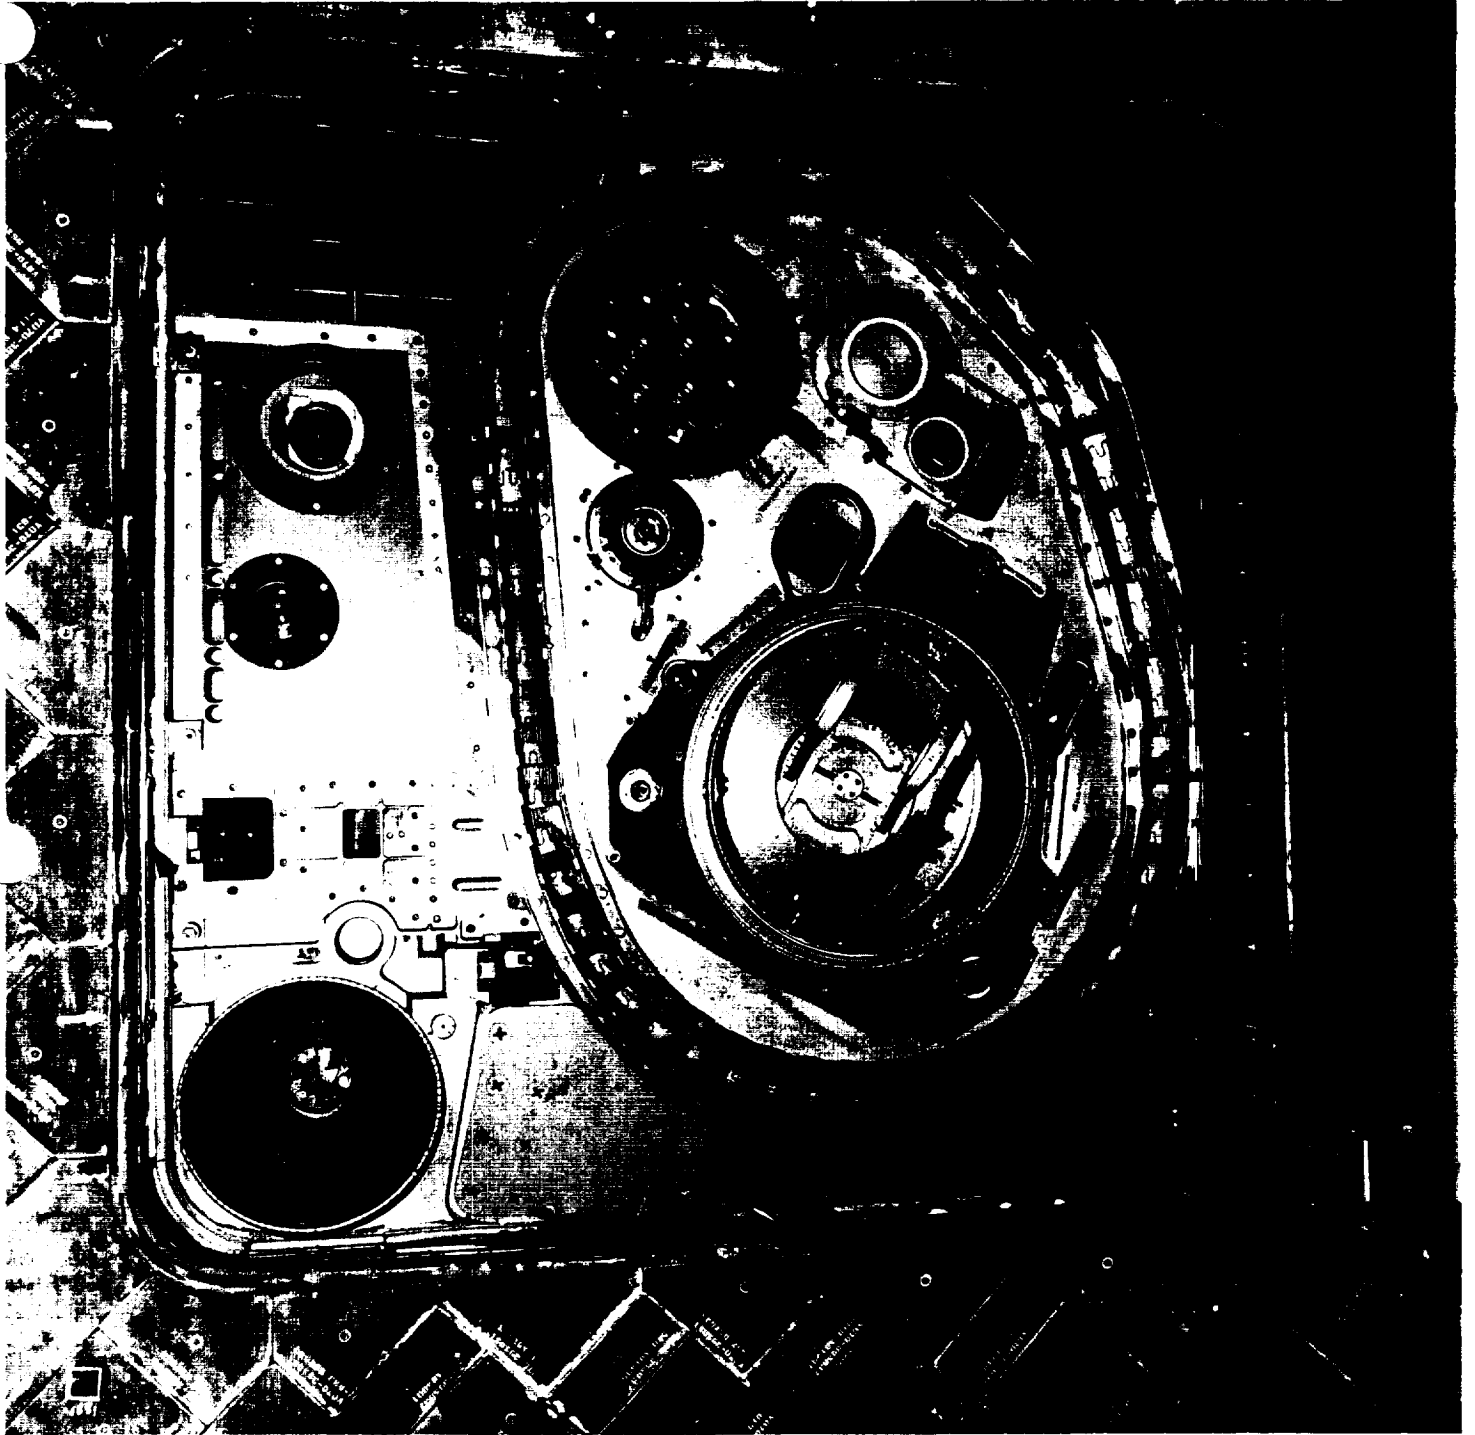
Photo 29: LH2 ET/ORB Umbilical

The LH2 ET/ORB umbilical appeared to be in good condition after separation with no TPS damage. Frozen hydrogen adhered to the 17-inch disconnect and parts of the separation interface. Typically, foam had eroded from the horizontal (clamshell) section of the cable tray and the LH2 feedline support arm.

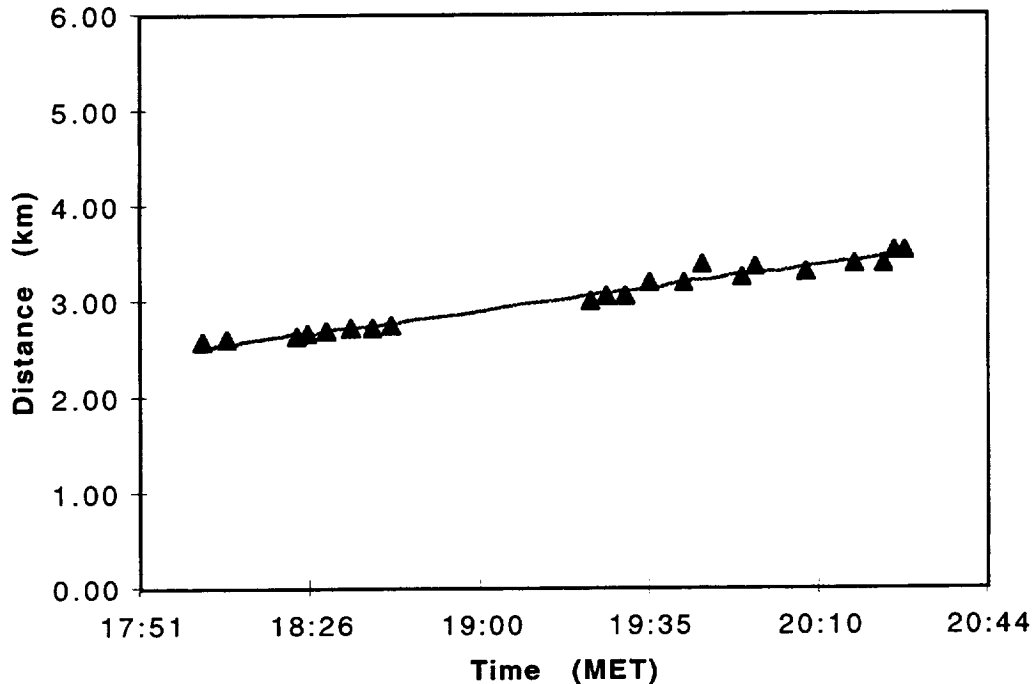
Figure 2.5.2 (B) ET Separation Velocity

The distance of the external tank was calculated on twenty frames. On the first usable view, the external tank was calculated to be at a distance of 2.6 kilometers away from the Orbiter at 18:04 MET. On the last view, 2 minutes and 23 seconds after the first view, the tank was calculated to be at a distance of 3.5 kilometers (18:06:23 MET). The tank separation average velocity was determined to be 6.6 meters/second (m/s), with an uncertainty of approximately 1 m/s. The tank tumble rate was approximately 1.8 degrees/second. The tank roll rate was 0.3 degrees/second.

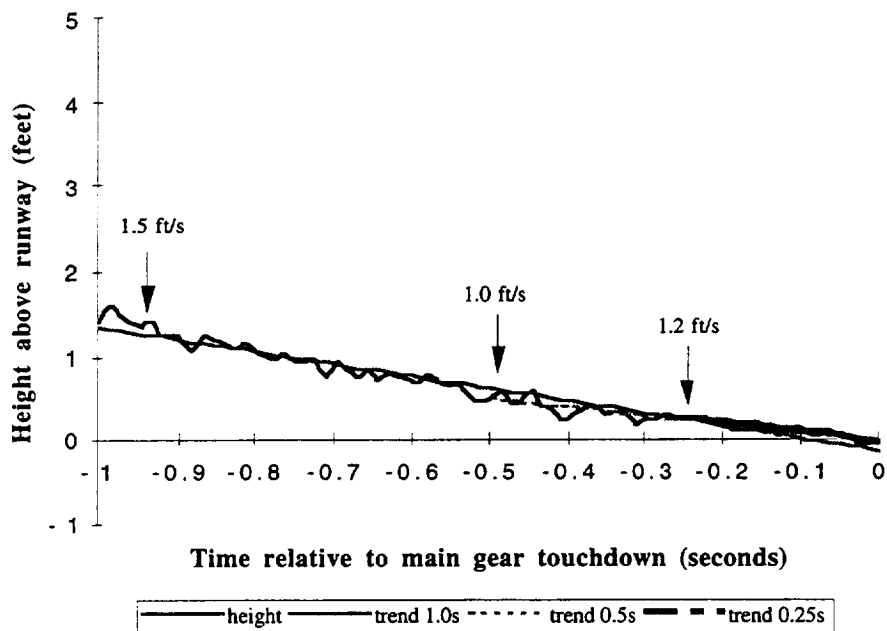
Figure 2.6.1 (A) Main Gear Height versus Time Prior to Touchdown

The measured main gear sink rate values were found to be below the maximum allowable values of 9.6 ft/sec for a 211,000 lb. vehicle and 6.0 ft/sec for a 240,000 lb. vehicle. The landing weight of the STS-94 Orbiter was reported to be 230,911 lb. The sink rate measurements for STS-94 are given in Table 2.6.1. In Figure 2.6.1(A), and 2.6.1(B), the trends of the measured data points for the image data are illustrated.
