NASA Technical Memorandum 110204

Structural Test Documentation and Results for the McDonnell Douglas All-Composite Wing Stub Box

Dawn C. Jegley and Harold G. Bush
Langley Research Center, Hampton, Virginia

April 1997

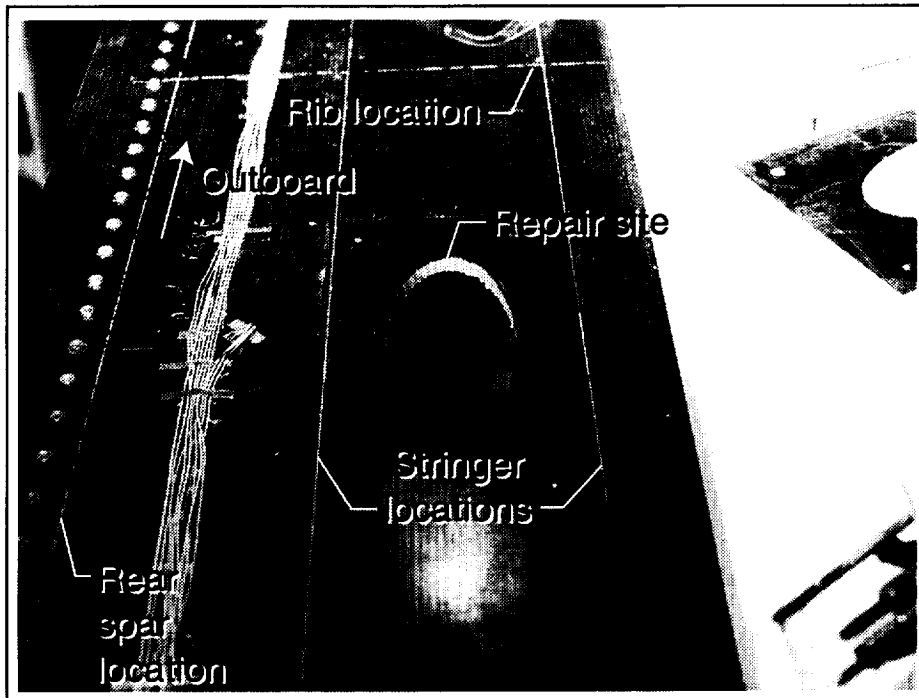
Figure 21. Upper cover panel prior to installation of repair.

A bolt-on metal patch was used to repair the upper cover panel. All materials for the patch were supplied by McDonnell Douglas Aerospace and personnel from American Airlines installed the patch. The structure was prepared for patch installation by cutting out the damaged section of skin, as shown in figure 21. The cutout was in the shape of an ellipse with dimensions 7.5 inches by 3.75 inches. The cutout was in the skin between stringers, as illustrated in figure 22. Bolt holes were drilled through the stringer flanges and skin. A 3/8-inch-thick aluminum plate was bolted to the external skin to cover the cutout. The plate dimensions were 11.7 inches by 7.28 inches. The completed repair is shown in figure 23.

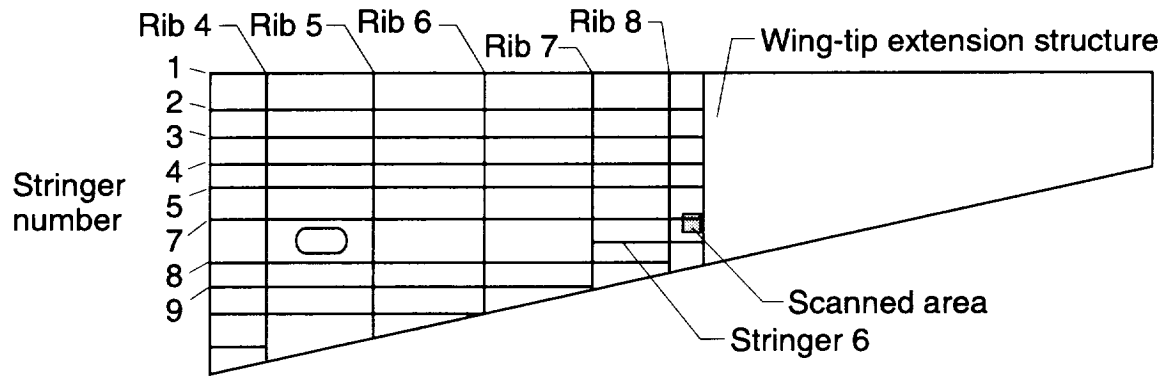
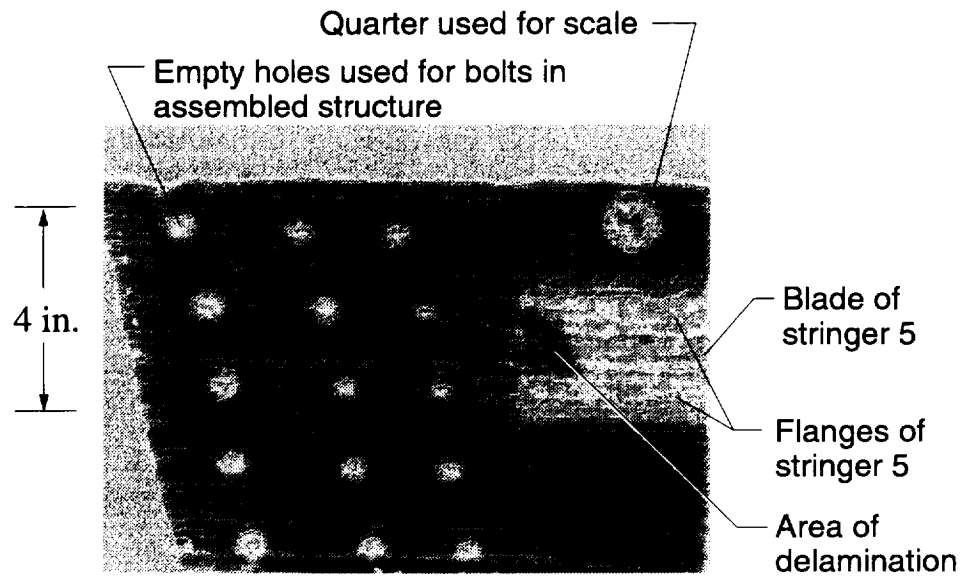
Figure 43. Damage area for upper cover splice on stringer 5.

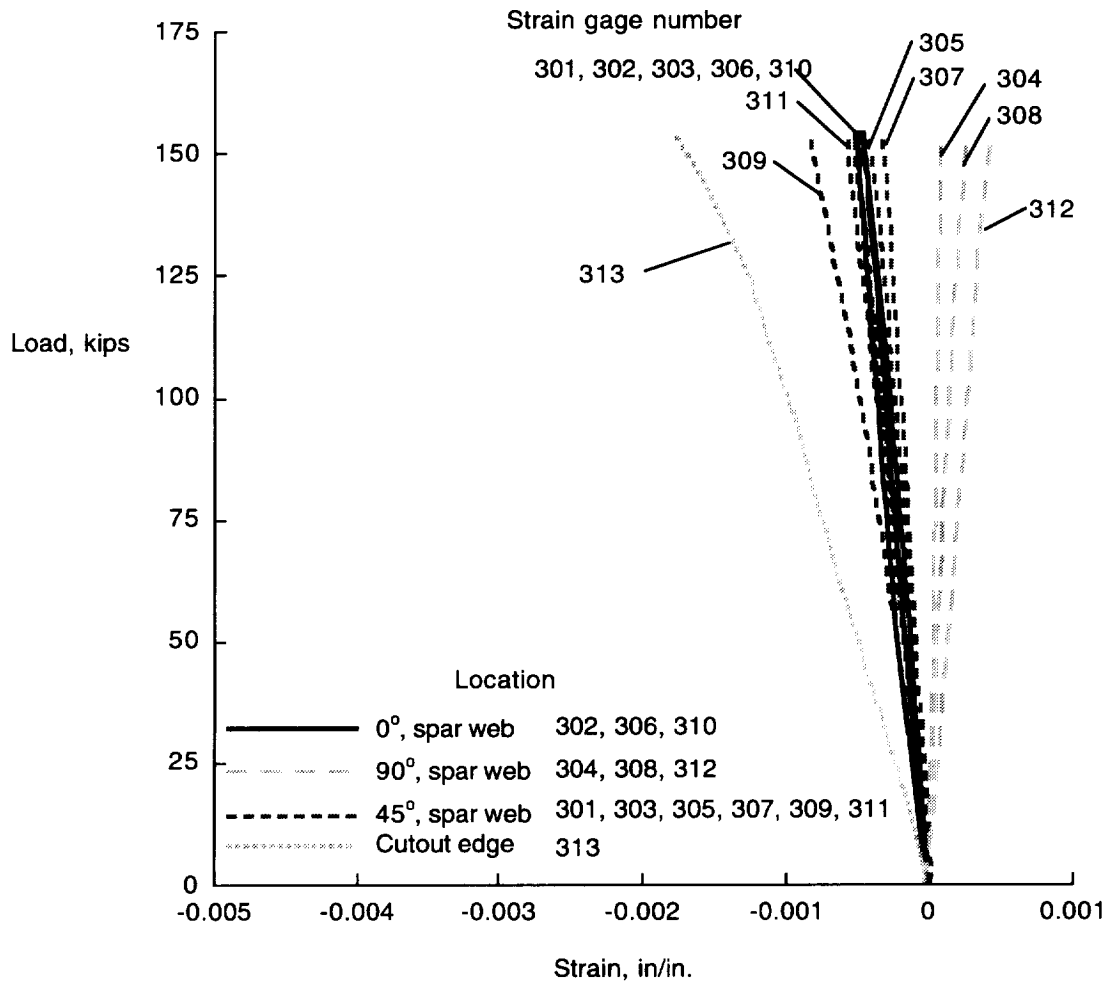
Only strain gage 313 on the rear spar recorded nonlinear strains, as shown in figure 49. There was one cutout in the rear spar and strain gage 313 was located on the upper edge of that cutout. No strains with magnitudes greater than 0.002 in/in. were recorded on the rear spar.

Figure 49. Strain in rear spar.

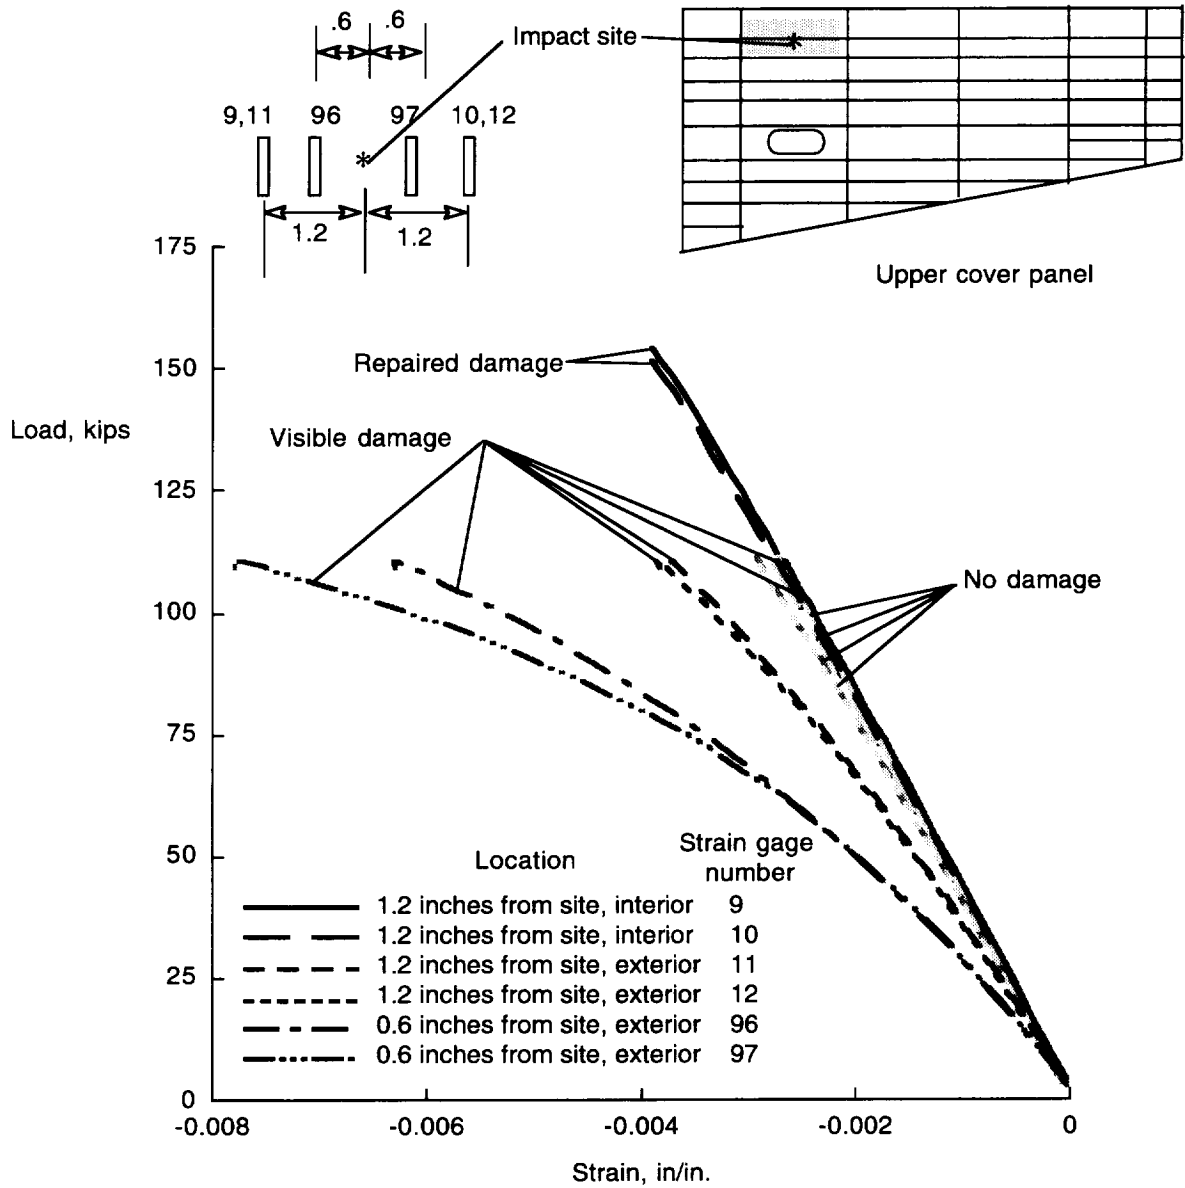
The strains in the impact-damaged regions are presented in figures 57-61. The strains recorded for the upper cover panel skin in the region of detectable impact damage during three tests of the structure are shown in figure 57. Results are shown for the structure loaded to DLL prior to inflicting damage, the structure loaded to DLL after inflicting damage and the structure loaded to failure after the repair was installed. The strains for the skin and the repair for the final test only are shown in figure 58.

During the loading prior to inflicting damage, the strains in the skin are linear and reach a maximum magnitude of approximately 0.003 in/in. All strain gages in the region to be repaired recorded approximately the same strain. In the loading after visible damage was inflicted, the strains in the skin closest to the damage site were nonlinear in behavior for the entire load range. The maximum strain recorded in the region of visible impact damage is approximately 0.0073 in/in. in a strain gage which is 0.6 inches away from the impact site (strain gage 97). Interior strain gages 1.2 inches away from the impact site (strain gages 9 and 10) recorded the same strains with and without impact damage and with repair. The repair of the structure required the removal of the exterior strain gages closest to the impact site (strain gages 11, 12, 96 and 97). Axial strains measured during the final loading in the repaired bay and the bay adjacent to the repaired bay are shown in figure 58. Strain gages 5, 8, 9 and 10 on the skin recorded approximately the same strain. Strains recorded in the metallic repair are less than half the strains recorded

Figure 57. Strains in detectable-damage and repair region during last three tests. All dimensions are in inches.

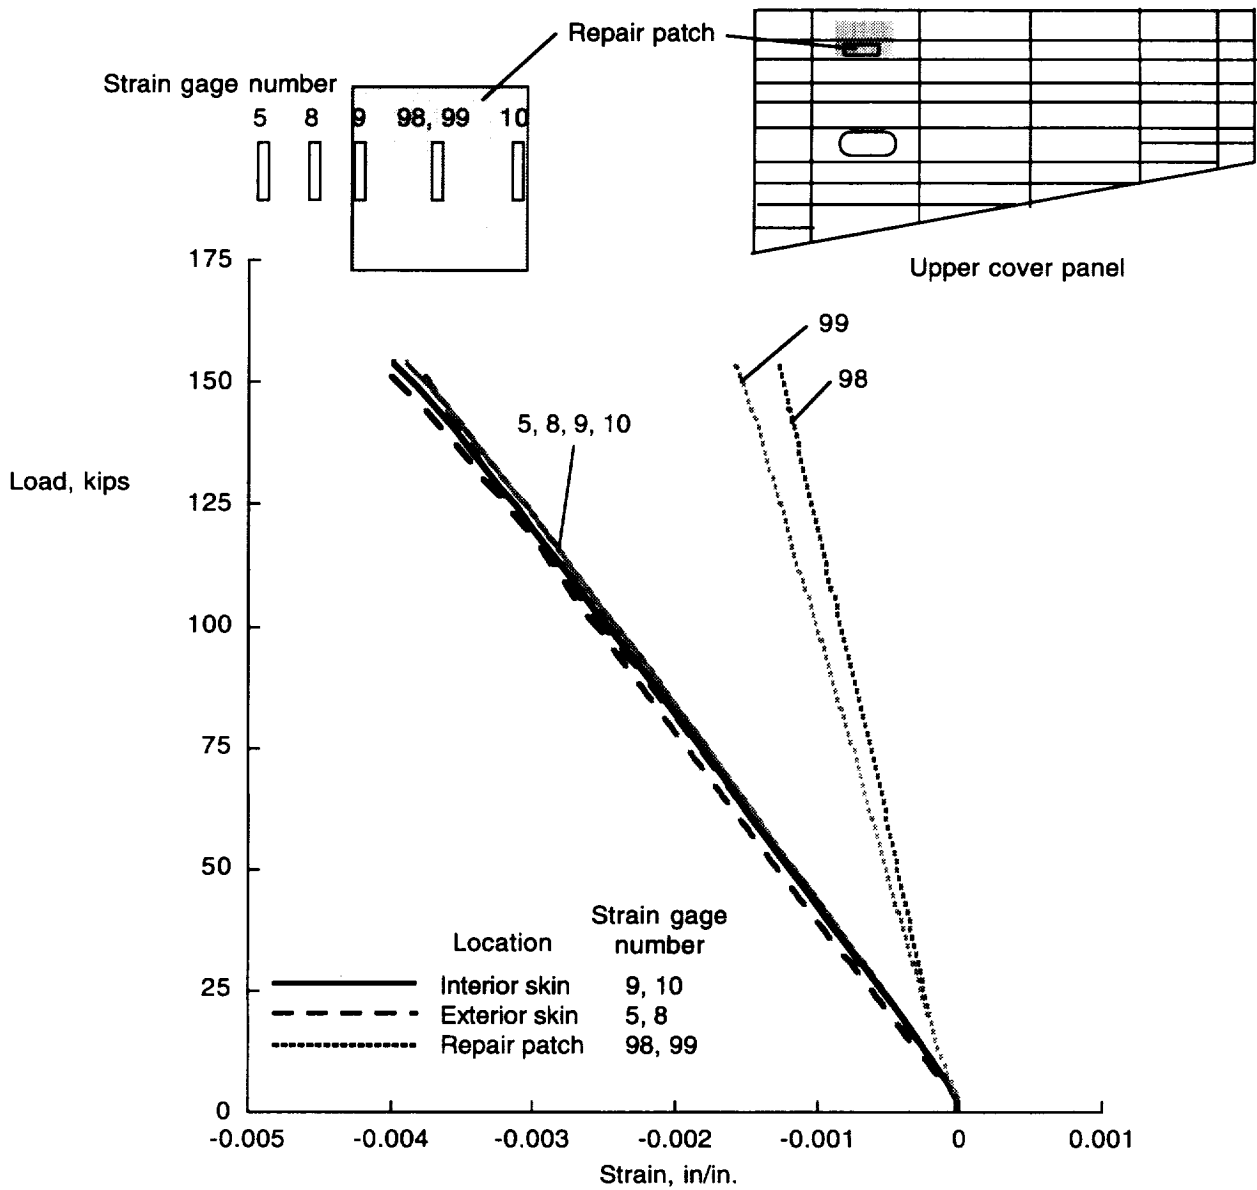
Figure 58. Strains for region of repair.

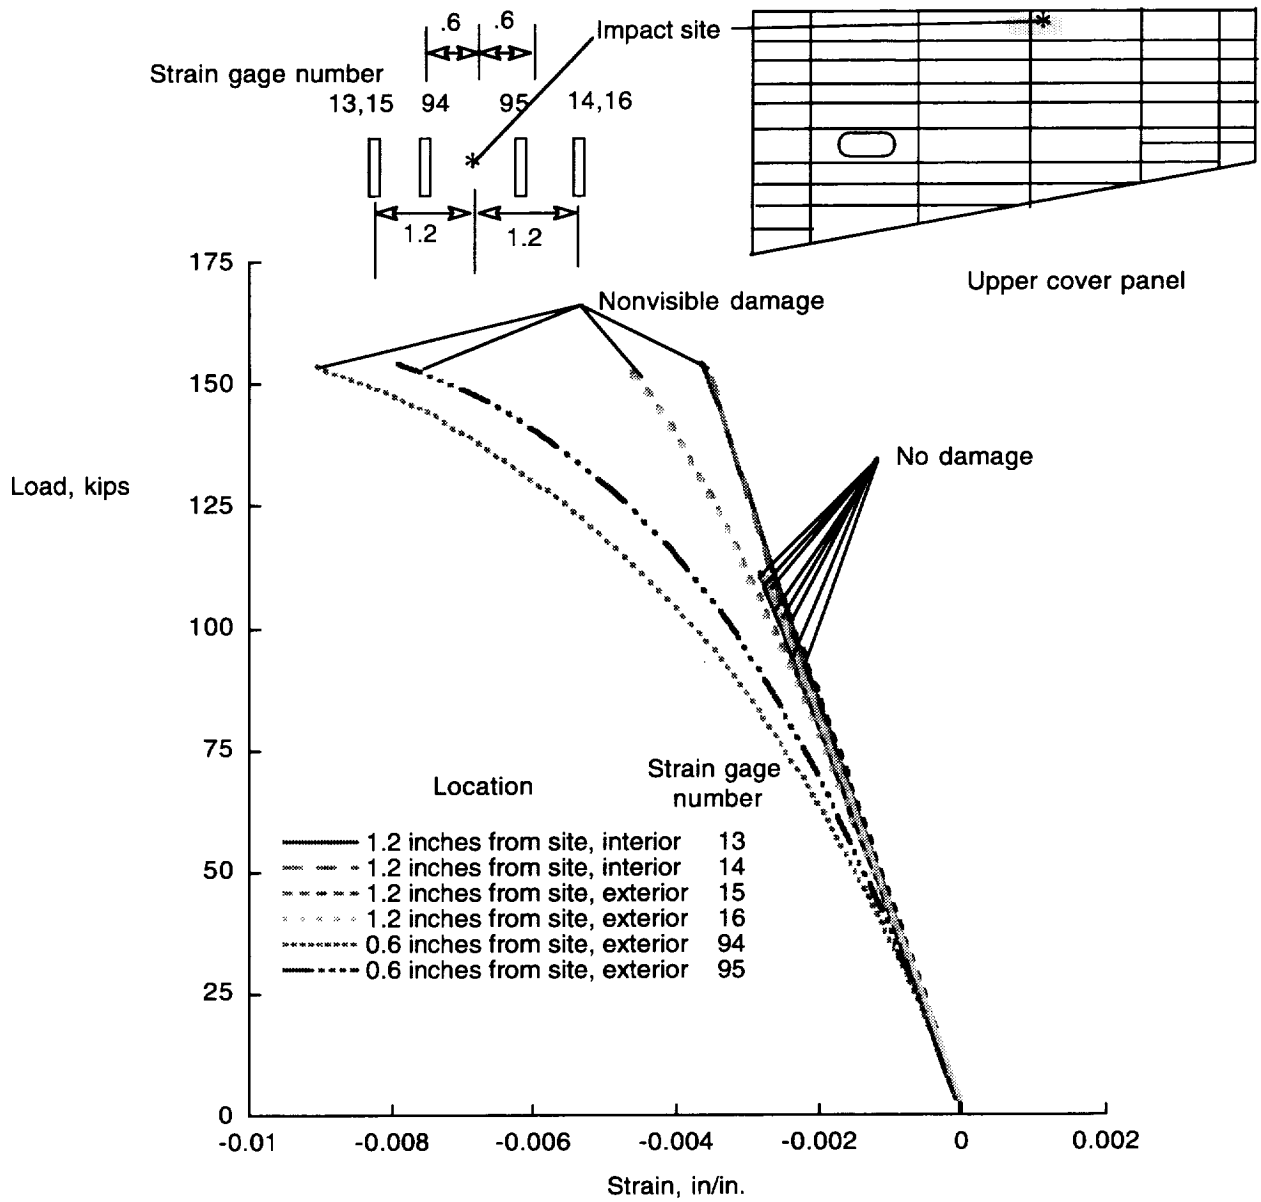
Two locations on the upper cover panel were subjected to nonvisible impact damage prior to the final test. The strains recorded during the last three tests near the location labeled NDT1 in figure 5 are shown in figure 59 and the strains around the location labeled NDT2 in figure 5 are shown in figures 60 and 61. Impact site NDT1 is located at the edge of an intercostal flange half way between the rear spar and stringer 1. Strain gages 13, 14, 15 and 16 are located 1.2 inches from impact site NDT1 and strain gages 94 and 95 are located 0.6 inches from site NDT1. Prior to impact, the strains 1.2 inches from NDT1 are linear and all strain gages recorded approximately the same values. The strain 1.2 inches from NDT1 at DLL is -0.003 in/in. After impact, the strains on the interior surface of the skin 1.2 inches from the NDT1 show the same linear behavior as they did prior to impact and remain linear to failure. A small amount of nonlinearity can be seen in the exterior strain gages 1.2 inches from the impact site and significant nonlinearity can be seen 0.6 inches from the impact site. At the maximum load of 154 kips, the largest compressive strain recorded in this region is -0.009 in/in. There were no failures detected in this region, and post-test evaluation of the site indicated no growth in the size of the damaged skin region.

Figure 59. Strains at nonvisible damage site 1 for last three tests. All dimensions are in inches.

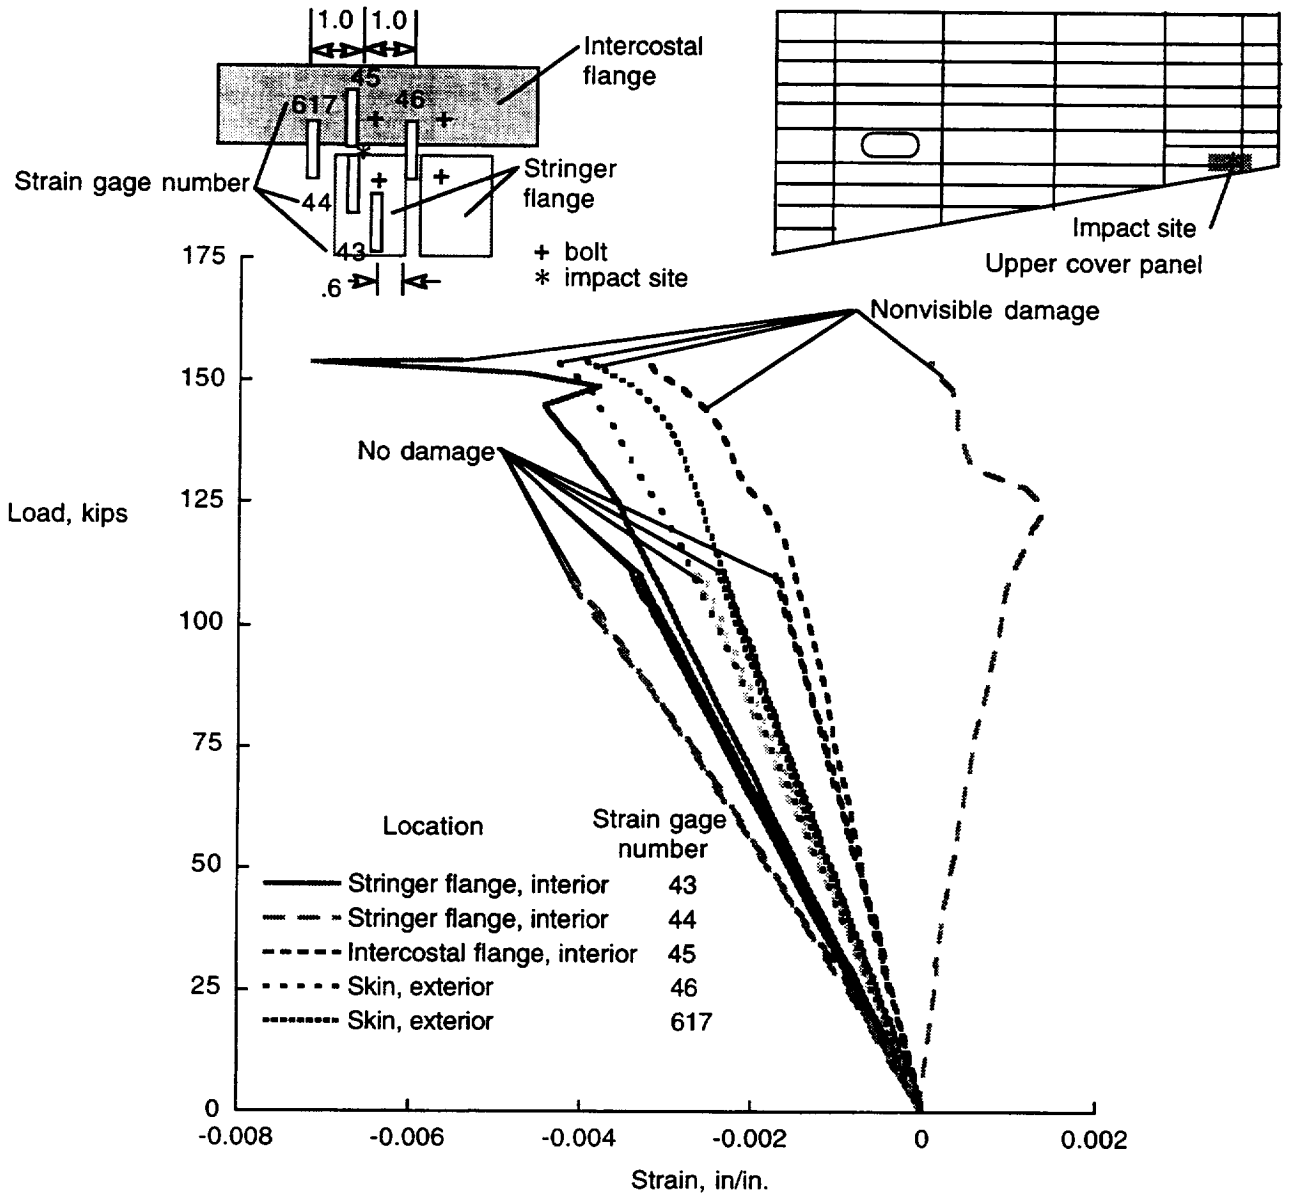
Impact site NDT2 is located at the edge of an intercostal flange and at the edge of the flange of a stringer runout. Strain gages were placed on the skin, on the stringer, and on the intercostal. Results from strain gages on the skin, the intercostal flange and the stringer flange for the last three tests are shown in figure 60. Results from these strain gages and from strain gages farther away from the impact site on the intercostal and on the stringer runout for the last test are shown in figure 61. The most obvious difference between the strains for the last test and the strains for the previous tests is in strain gage 44. Strain gage 44 is located on the stringer flange slightly inboard of the impact site. During the first tests this location was in compression. During the last test, this location was in tension. However, strain gages on the external surface (strain gages 46 and 617) are in compression for all of the tests. The most likely explanation for this difference is that the impact caused separation between the skin and stringer flange, allowing the stringer flange and skin to deform independently at that location. At a short distance from the impact site

Figure 60. Strains in area around nondetectable damage site 2 for last three tests. All dimensions are in inches.

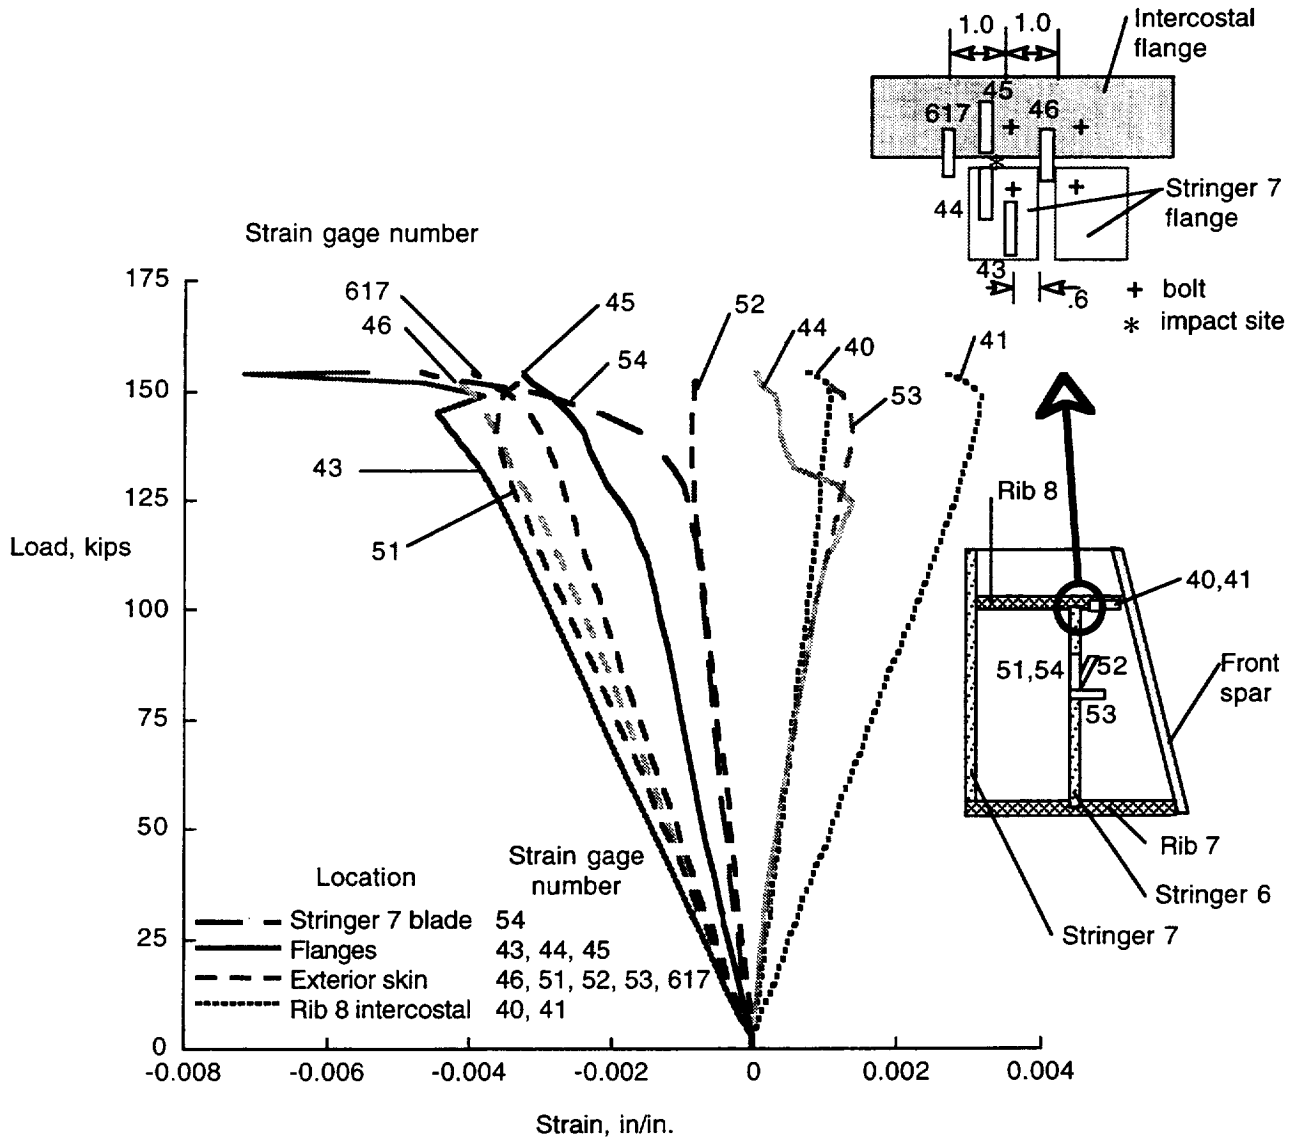
Figure 61. Strain in region of nondetectable impact damage site 2. All dimensions are in inches.

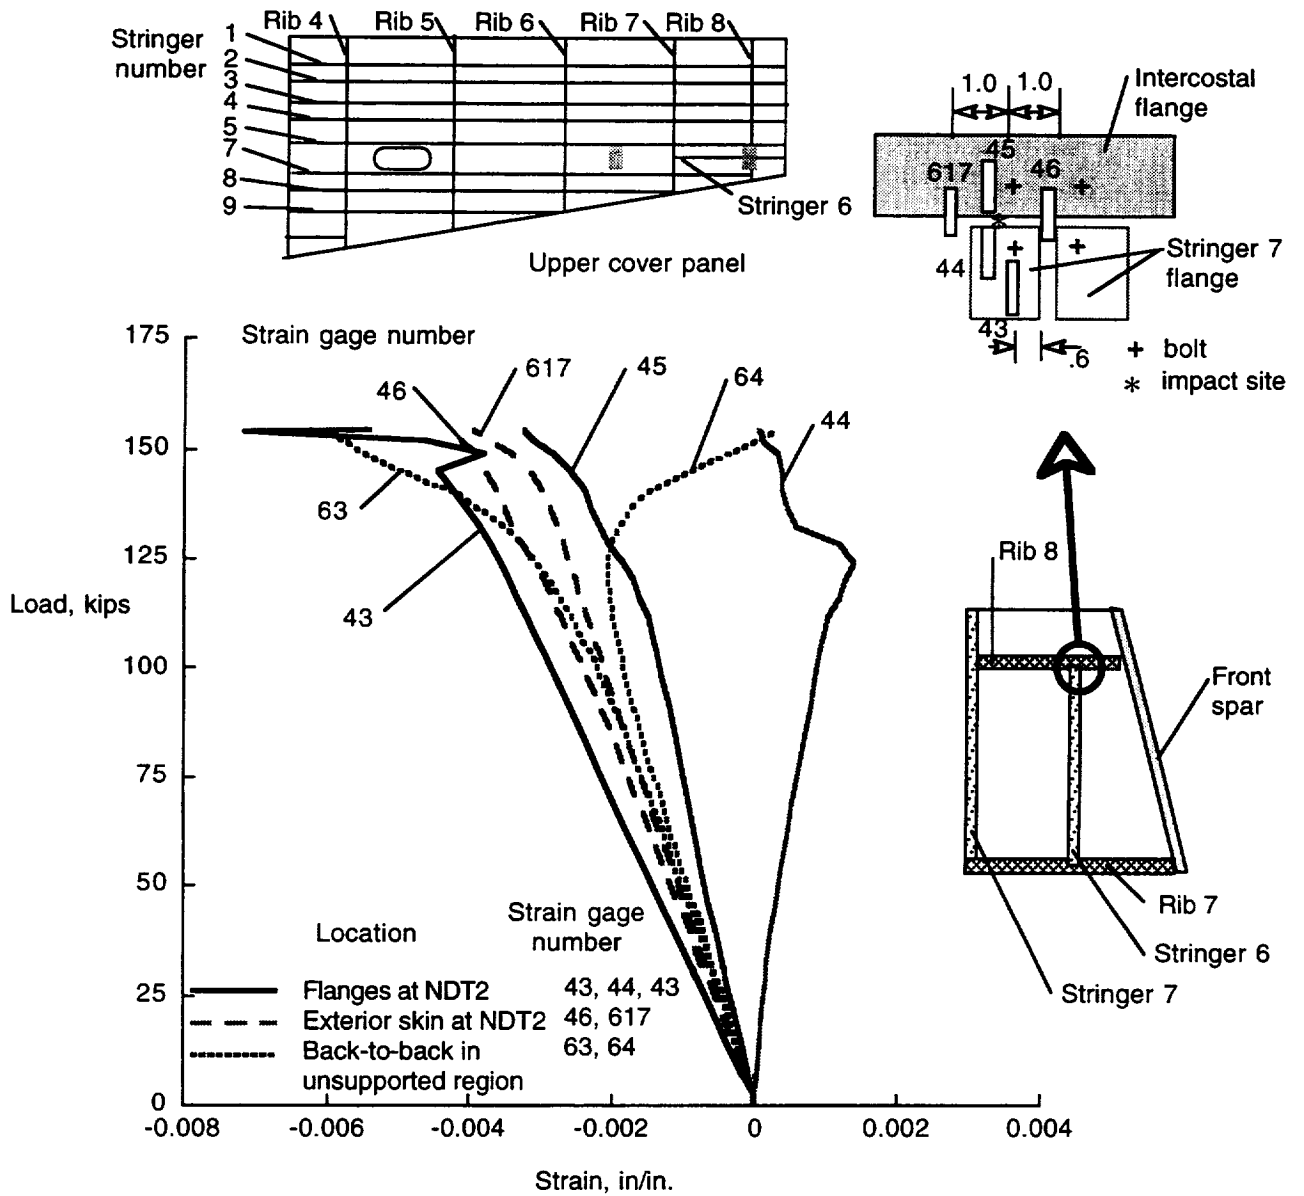
Results from strain gages closest to the impact damage site NDT2, (strain gages 43, 44, 45, 46 and 617), and back-to-back strain gages in the unsupported skin region, (strain gages 63 and 64), are shown in figure 62. C-scans of the damaged region made immediately after impact indicate the presence of damage at strain gages 44 and 45, so the structure may not perform as an undamaged structure at these locations. Nonlinear material behavior caused by the impact damage would explain the behavior of gage 45. Strain gages 43 and 46 at the impact damage site show linear behavior at higher loads than strain gages in the unsupported skin region which show linear behavior. The fact that the strain in the unsupported skin region becomes nonlinear before the strain at the impact damage site become nonlinear indicates that the behavior at the impact damage site was not influenced significantly by the buckling of the unsupported skin region.

Figure 62. Strains in region of nondetectable impact damage site 2 and in unsupported skin region. All dimensions are in inches.
