TSS-1R Mission Failure Investigation Board

Final Report

National Aeronautics and Space Administration

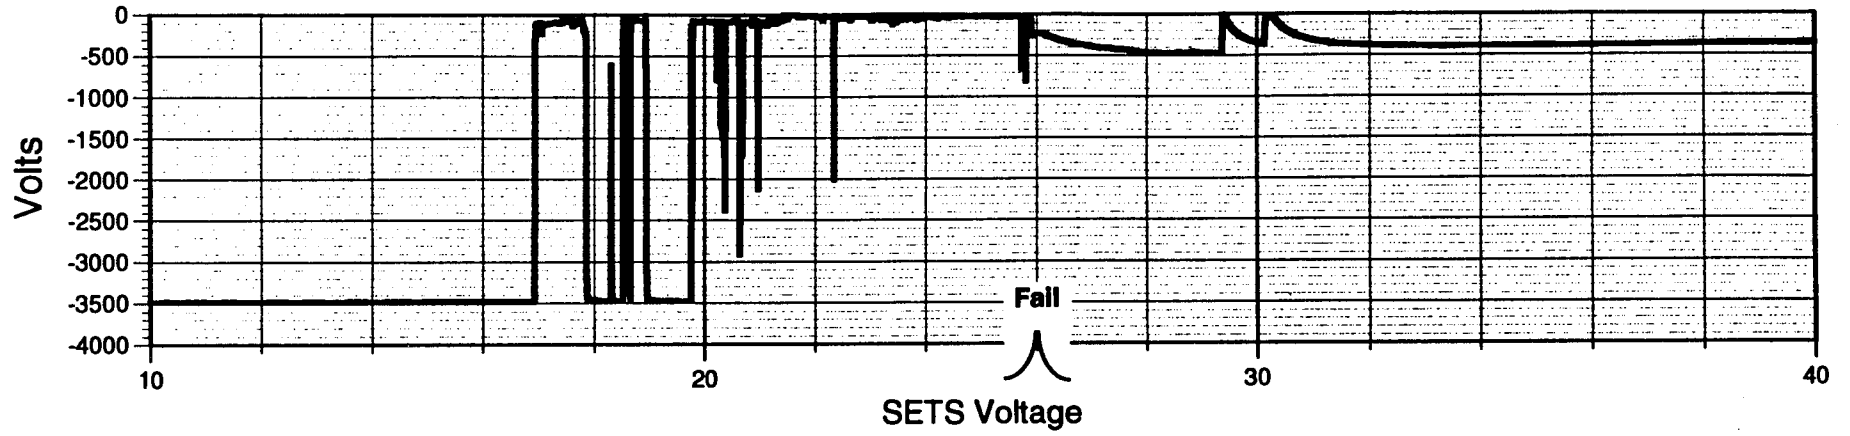
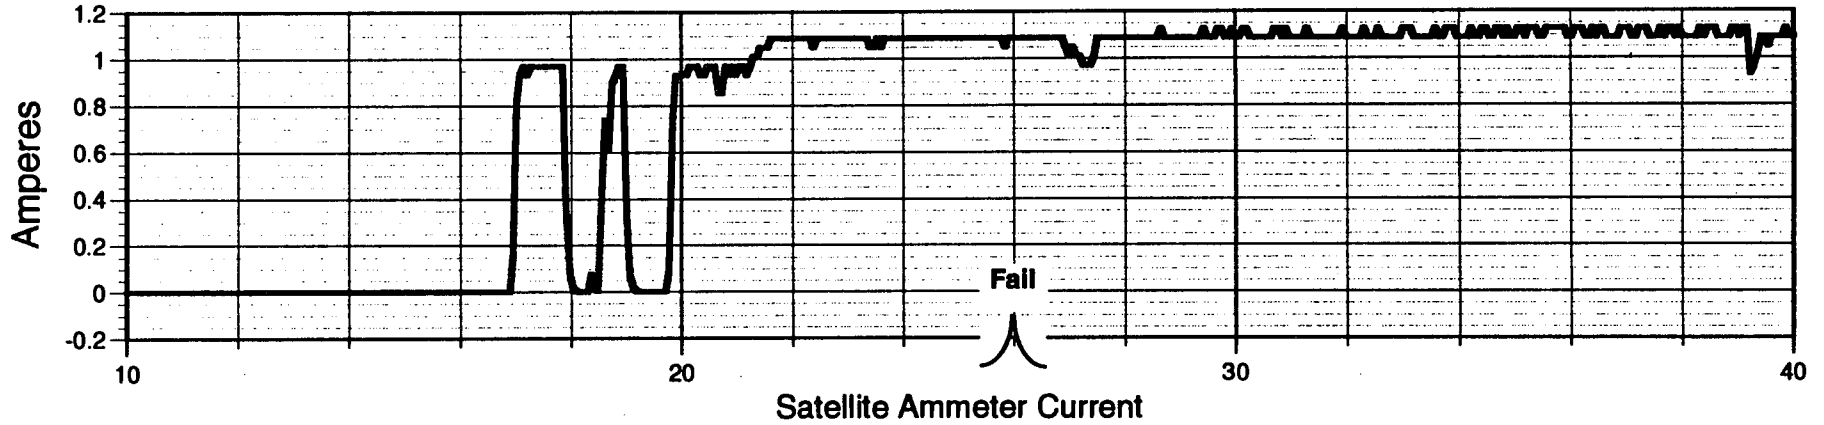
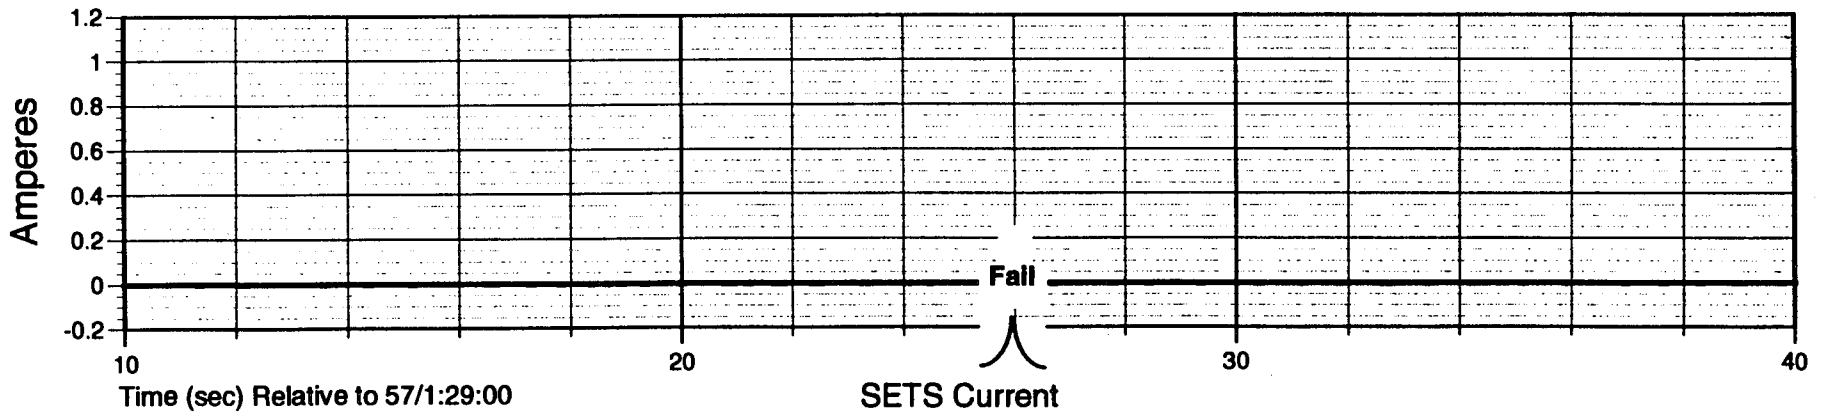
Figure 2.0-2 — History of Key Parameters

Time histories of key parameters are shown in figure 2.0-2. The SETS Voltage, the SETS current, and the satellite current are presented from approximately 15 s prior to the tether failure to 15 s after the failure. The failure at 57/01:29:26 is indicated on the figure.

These measurements provided the data that the Board used to establish that arcing was the primary cause of the ultimate failure of the tether. Based on the measured deployment rate of the tether at this time (1.04 m/s), and the length of the tether retrieved on orbit, it was possible to determine that the arcing started in the LTCM.

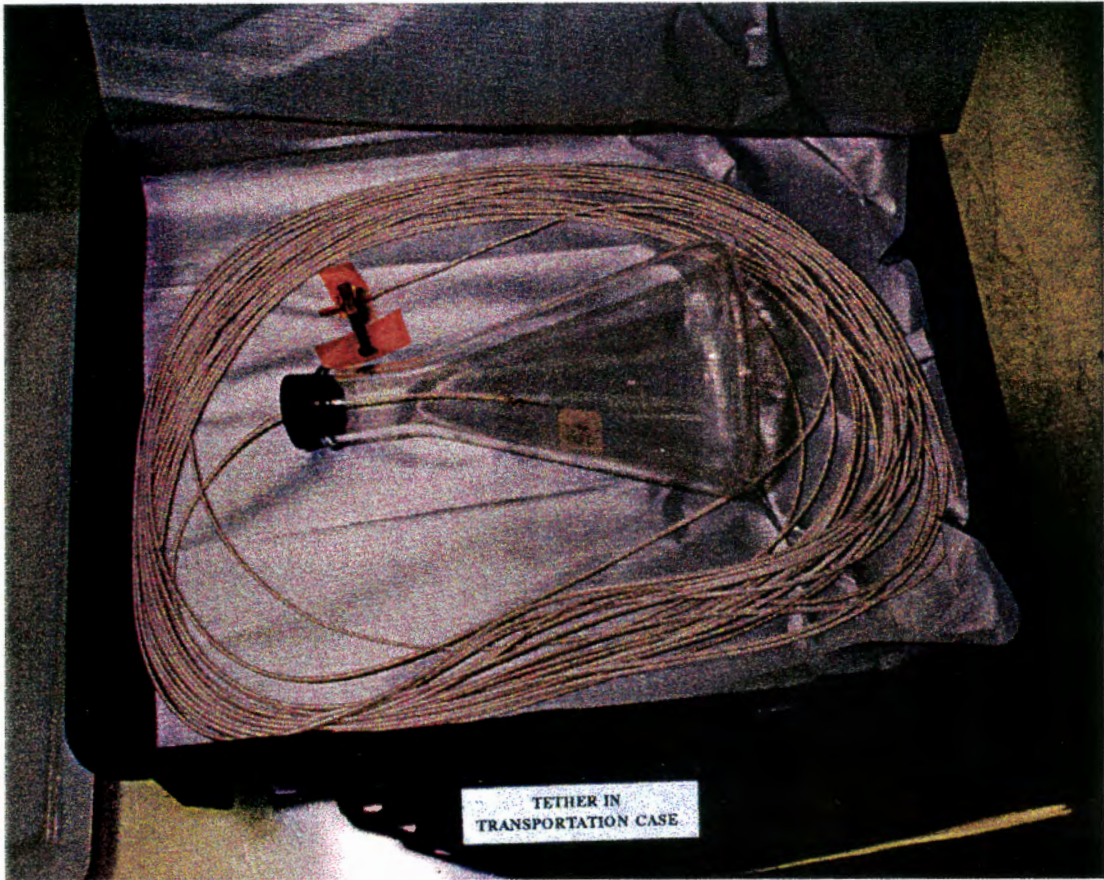
Transporting Failed End of Tether
Figure 3.2-3

During the deintegration of the TSS-1R after landing at KSC, approximately 27 m of tether containing the separated end was cut from the reel for detailed examination. This particular length was selected to capture the maximum length of tether that could have gone through the deployer mechanisms, and to have an equal reference length immediately adjacent to this section which had not gone through the deployer. The failed end of the tether was placed in a flask for

protection and the 27 m section with flask was packaged as shown in figure 3.2-3 for shipment to the laboratory. Approximately 1,989 m of tether remained on the reel. It was later removed for examination.

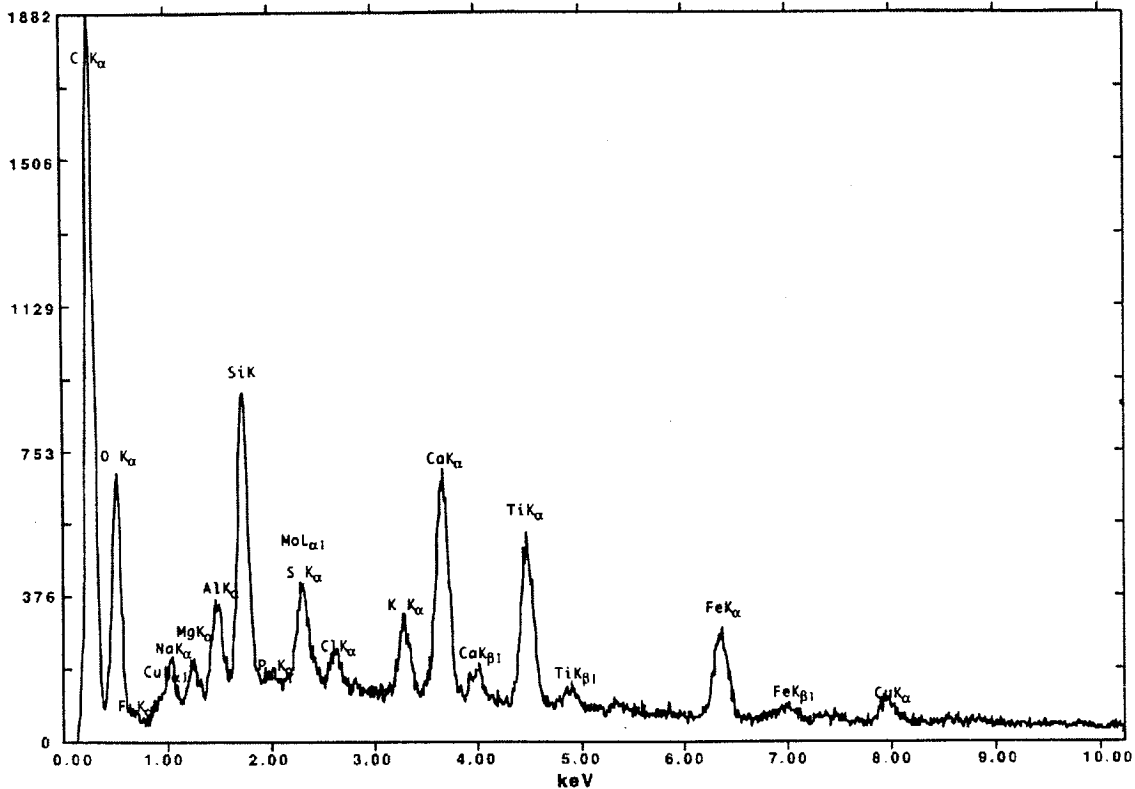
Figure 3.2-6 — Elemental Analysis at Failed End of Tether

Metallic and non-metallic contamination was found within the FEP insulation layer of flight tether, including the 9 m that had gone through the lower deployer mechanisms prior to the failure. Non-metallic and metallic contamination was also found between the Nomex and insulator layers of several samples of flight tether. EDS analysis revealed foreign material near the failed end.

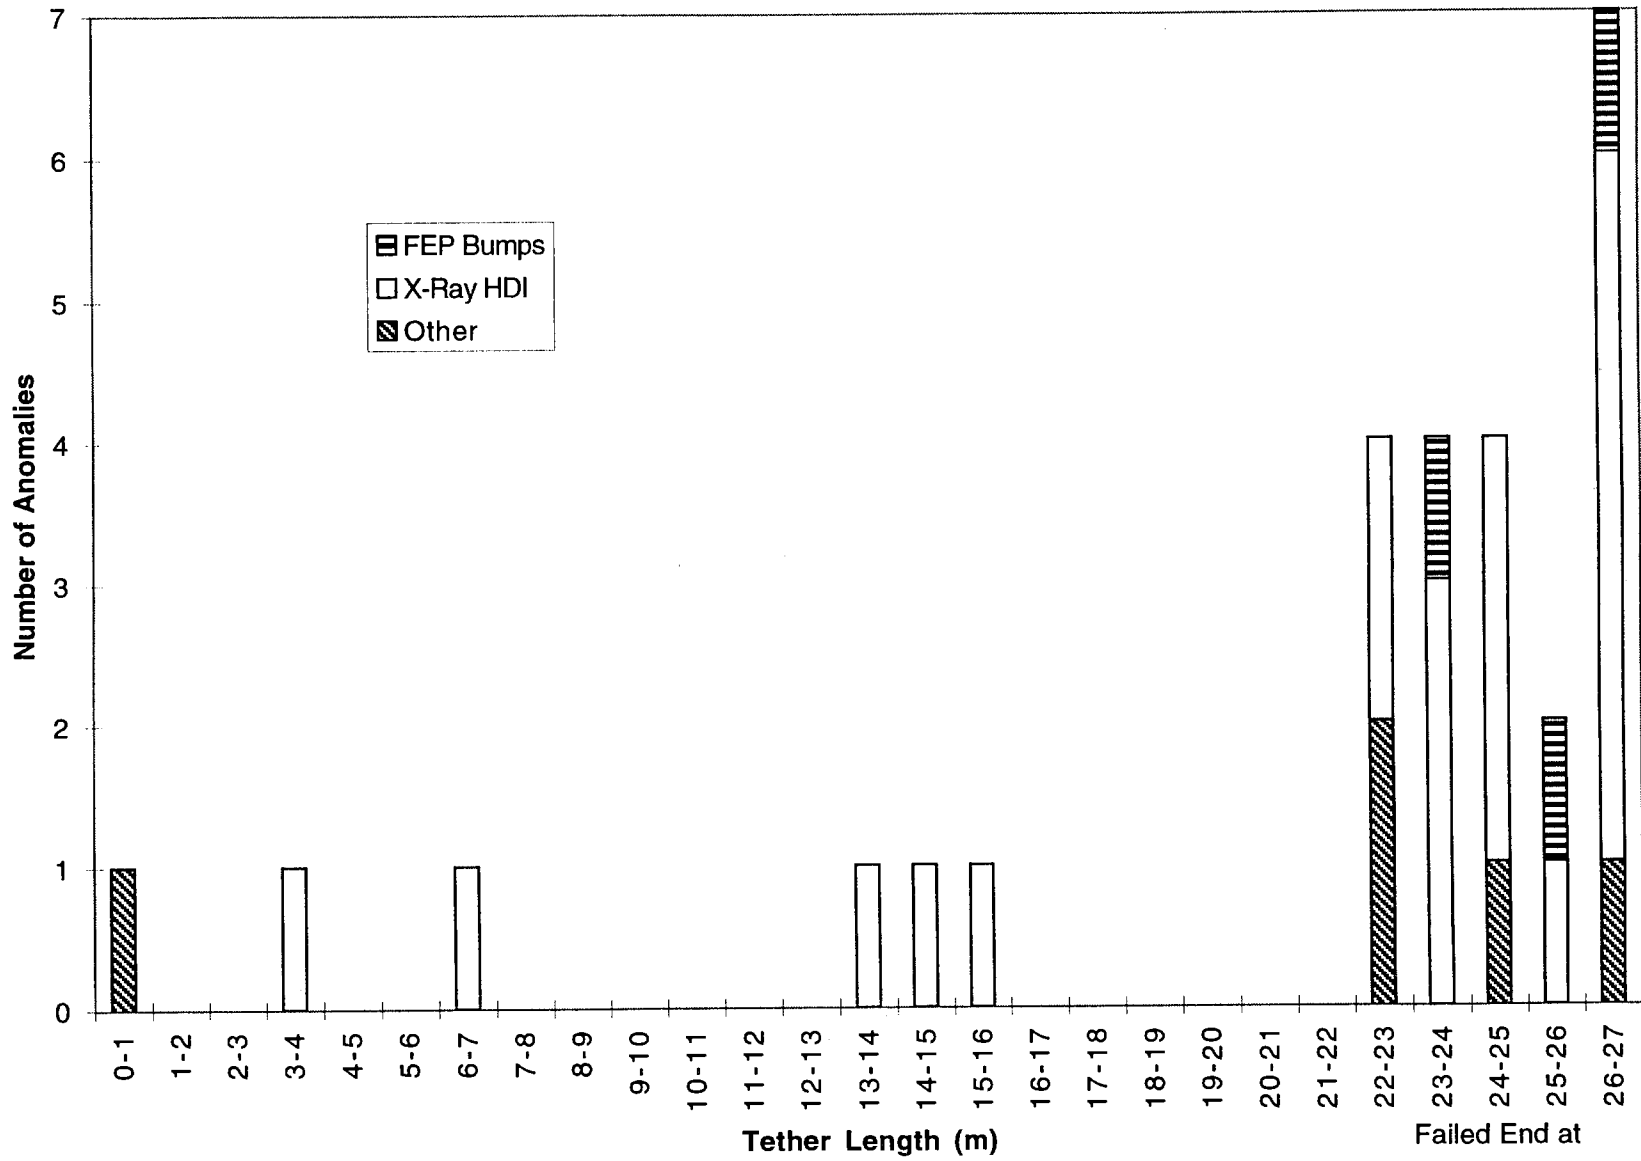
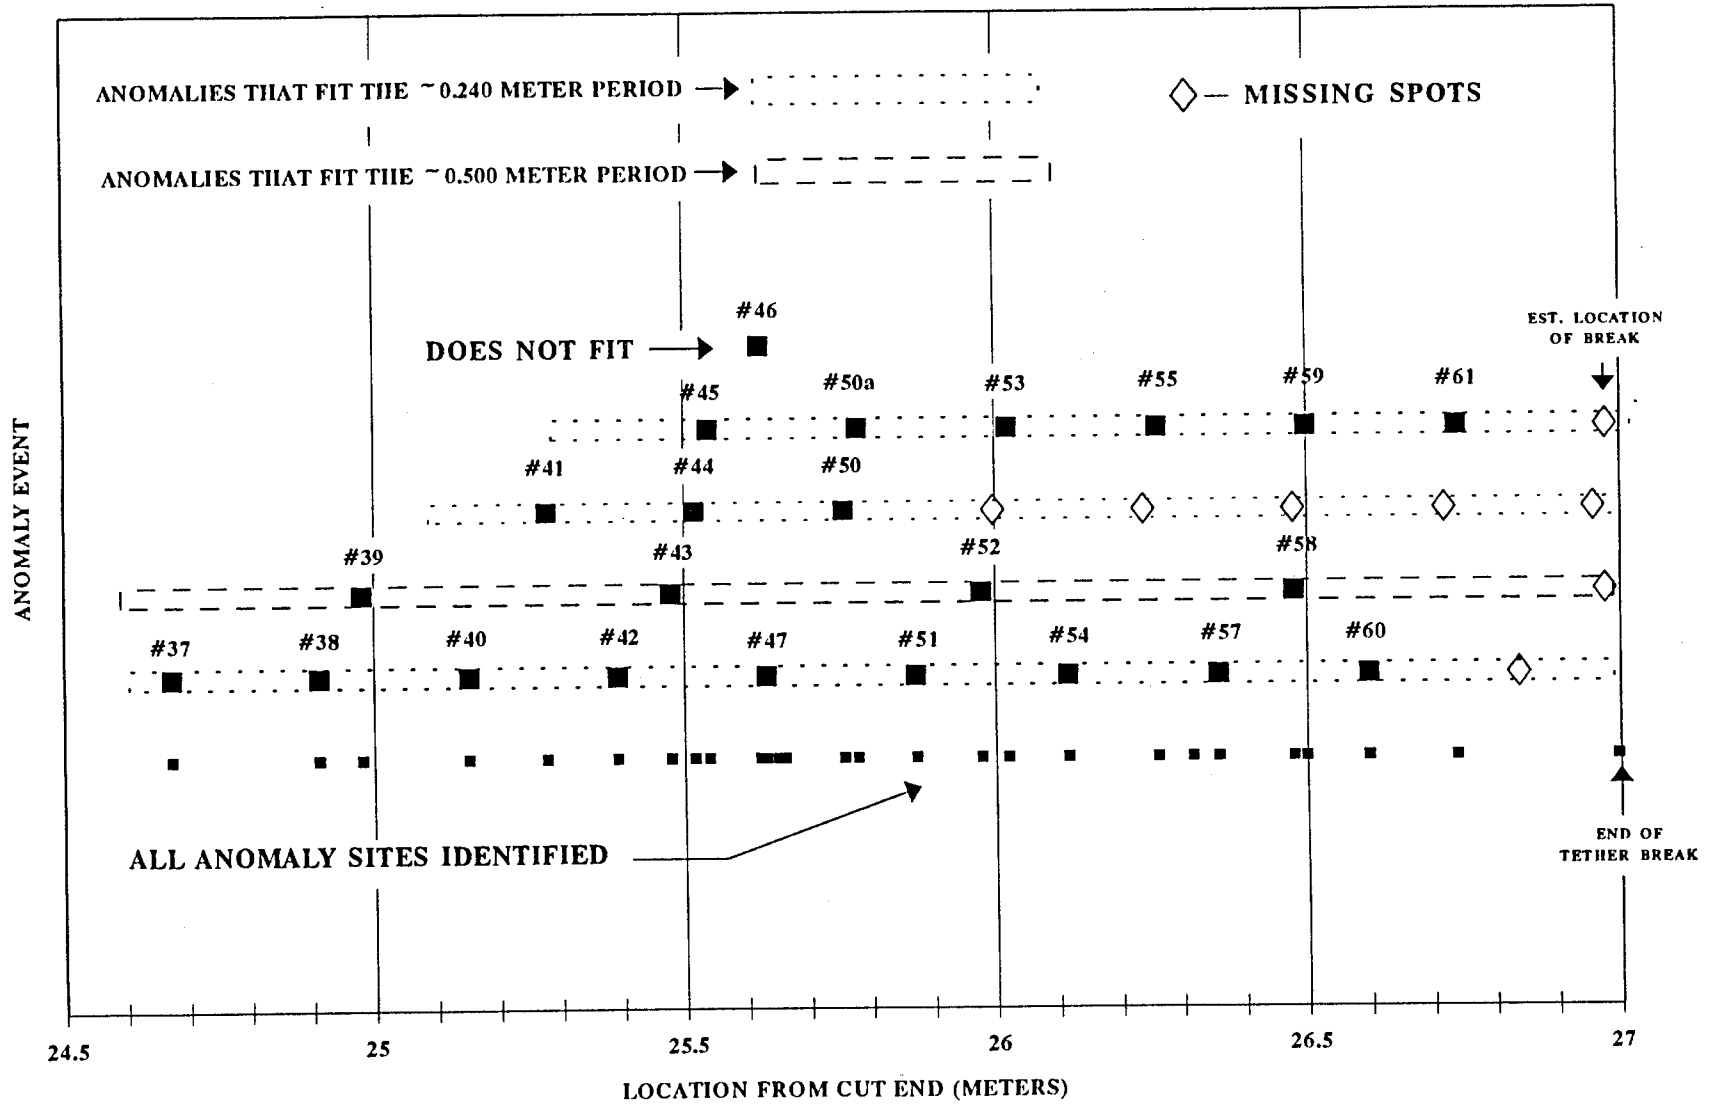
Figure 3.2-9 — Black Spot Anomalies

An analysis of the spot locations revealed that all but one of the spots were within a definite linear pattern of finite spacings. Sets of these spots matched up perfectly with the linear distance (circumference) around the 4 pulleys located in the LTCM. The 2 idler pulleys and the tensiometer pulley all have the same circumference of 0.24 m and the encoder pulley has a circumference of 0.50 m. As discussed in section 3.3 each of these pulleys have one pyrolyzed spot on its circumference; therefore the conclusion is that as the tether traveled through the pulleys, each pulley repeatedly deposited some of the carbon on the tether as it rotated. This process continued for approximately 9 m (or 9 s) from the failed/burned tether end. Figure 3.2-9 summarizes the analysis showing the set of spots for each of the 4 pulleys. Figure 3.2-10 is a picture of a typical spot.

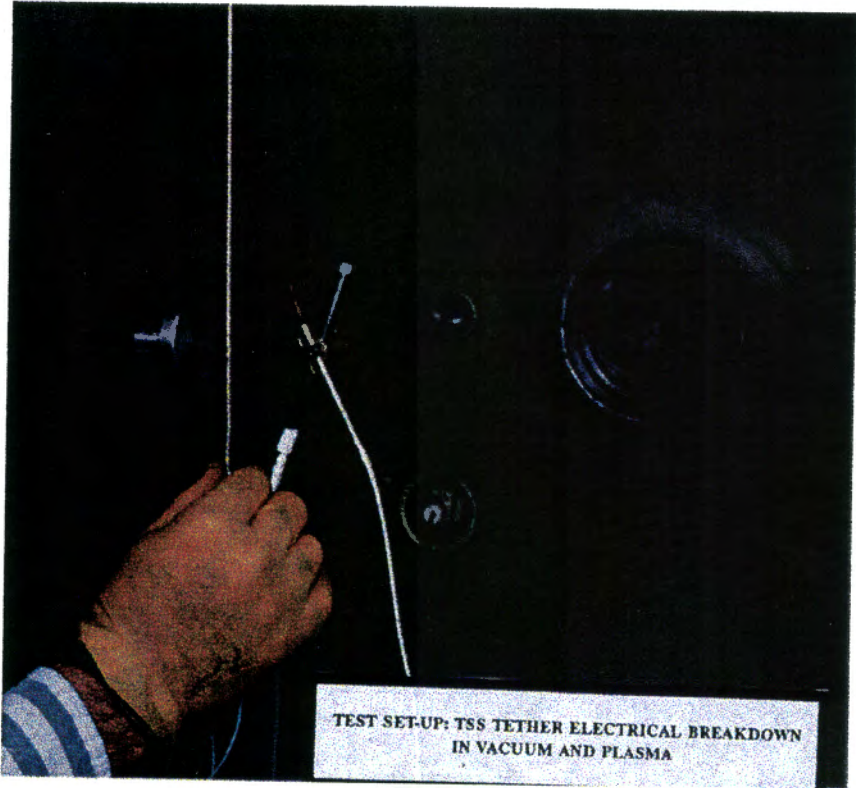
Figure 3.2-18 — Voltage Breakdown Test Setup

Grounded pointed end pushed through FEP; -3500 VDC; variable pressure; tension at 15 lb.

Arcing started at 5×10^{-3} Torr; tether broke in 6 sec.

In summary, the voltage breakdown tests reveal that a tether with undamaged FEP insulation will not break down (flow significant current) even for very high voltage conditions and ground planes in close proximity. Breakdown readily occurred when there was a thin cut or hole (breach) through the FEP to the copper wire conductor. When there was an insulation breach, the breakdown voltage ranged from approximately -2 kVDC to -4.5 kVDC, depending on the hole size and distance from the ground plane.

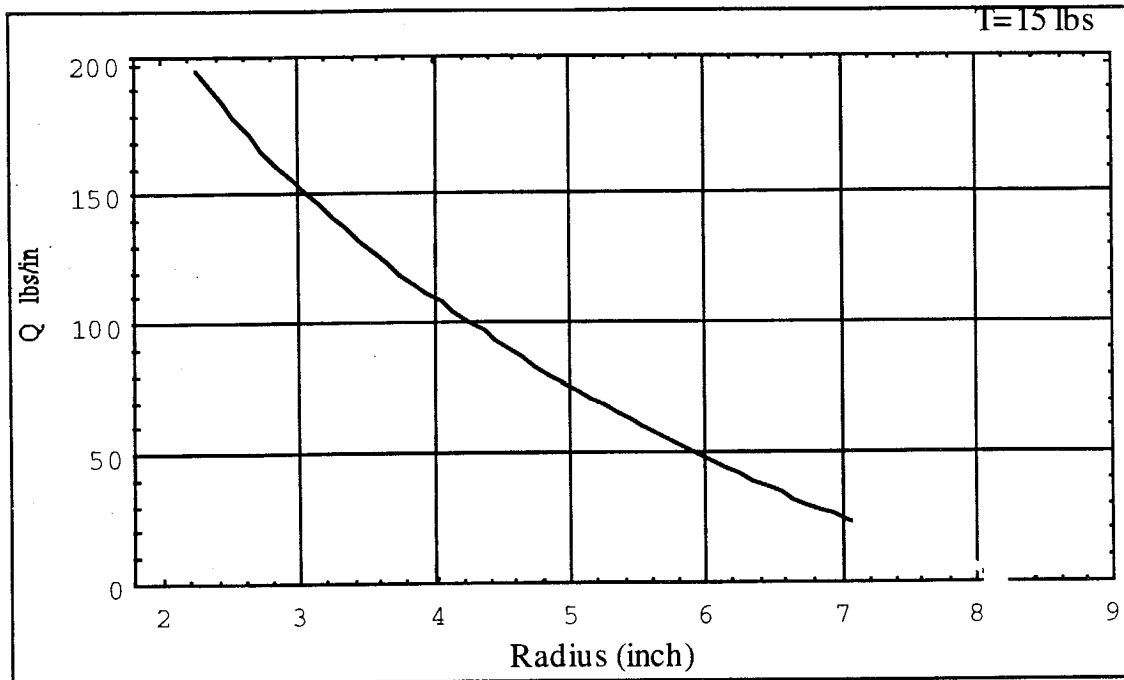
Figure 3.2-23 — Load per Unit Tether Length vs Reel Radius

It is apparent that the deeper in the wrap (i.e. smaller radius) the higher the compression load due to the wrap. At the location where the failed section of tether was stored, (i.e. $R=2.25$ in.), the load due to wrapping is:

$$Q_{R=2.25} = 197.3 \text{ lbs / in} \quad \text{or} \quad Q_{R=2.25} = 345.5 \text{ N / cm}$$

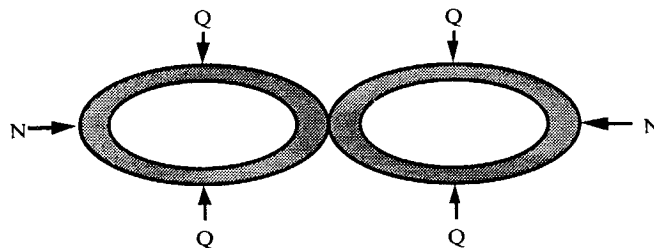
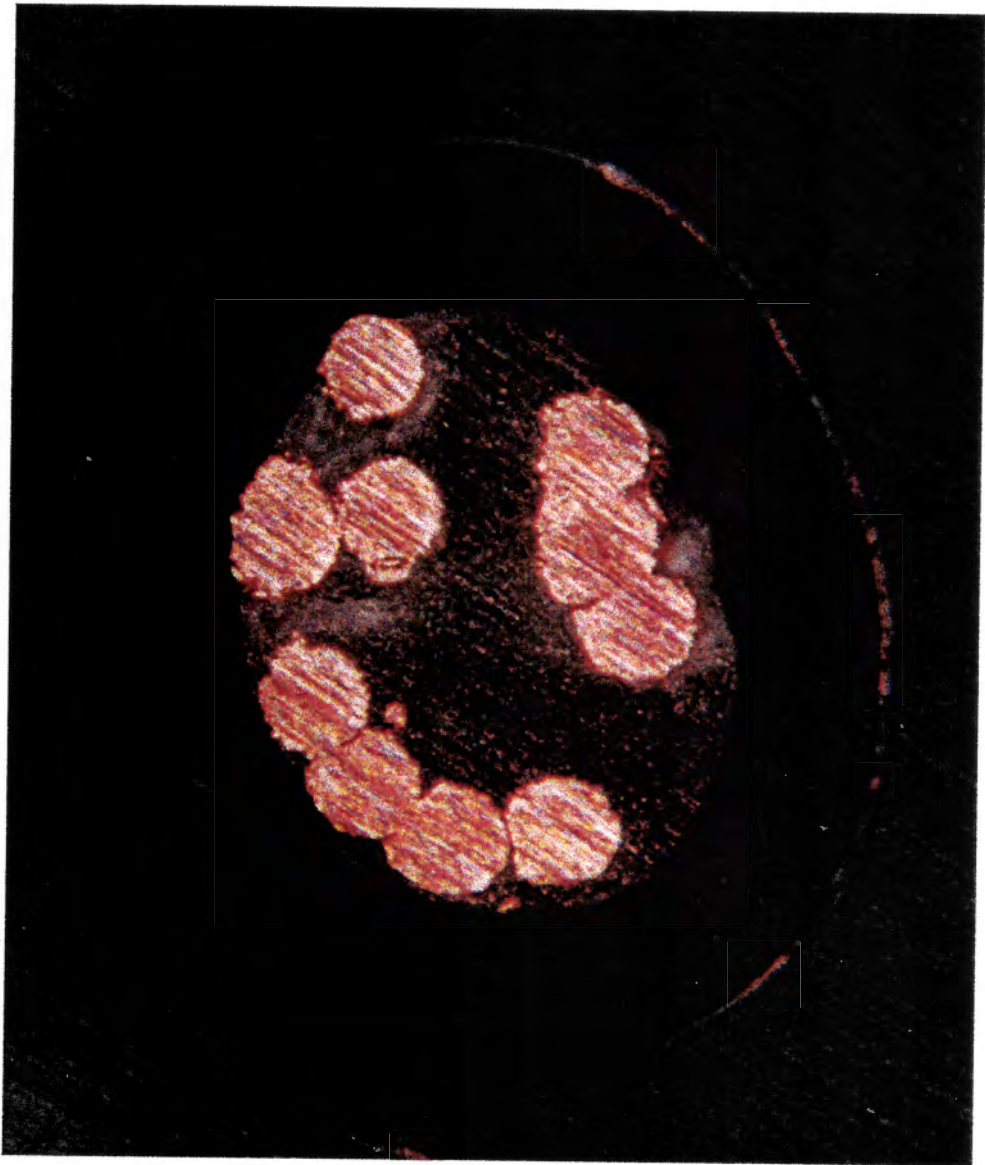
Figure 3-24a — Cross section Two Adjacent Tethers

The result of this load would be to flatten (see figure 3.2-24a and figure 3-24b) the cross section (make oval) but, more importantly, it would tend to force any debris into the tether, especially, if it were present at the Kevlar FEP interface. This very high load is later reduced somewhat due to cold flow and copper flattening. But by then, debris present would have already been pushed into the FEP insulation.

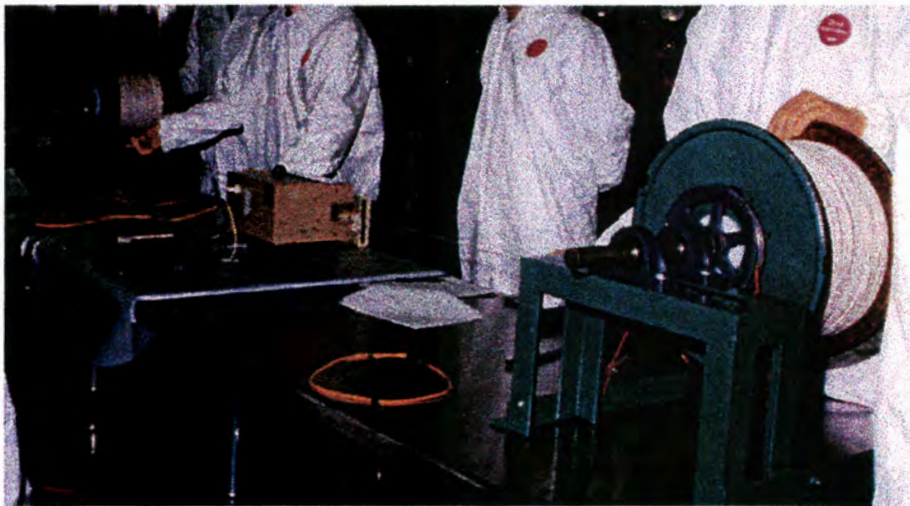
Figure 3.2-25 — Spark Test Set-up

The spark tester was re-verified by placing holes of specific sizes in the tether at various locations along the length. The set up is shown in Figure 3-25

The spark tests revealed each flaw (artificially induced) even the closed slit was detected easily. The entire 1989 m was spark tested using this very sensitive test setup. No breaches in the FEP insulation were found.

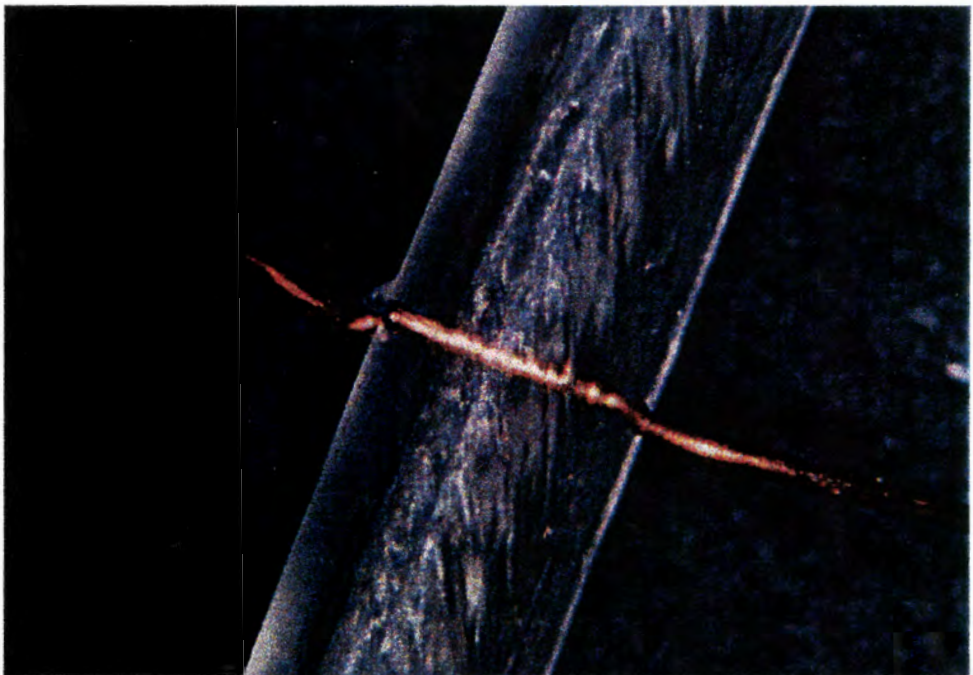
Figure 3.2-27 — Test to Determine the Ease of FEP Penetration

To establish the relative ease with which a small piece of debris can be made to penetrate the FEP insulation a qualitative test was performed. A small piece of #34 (.16 mm/.0063 in) wire, serving as debris, was pushed against FEP insulation and held. The wire did not penetrate at first but, after holding the force for a short time the, FEP parted and allowed the wire to penetrate. The result of this test can be seen in figure 3.2-27. A confirmation and further approximate quantification of those initial result is shown in figure 3.2-28

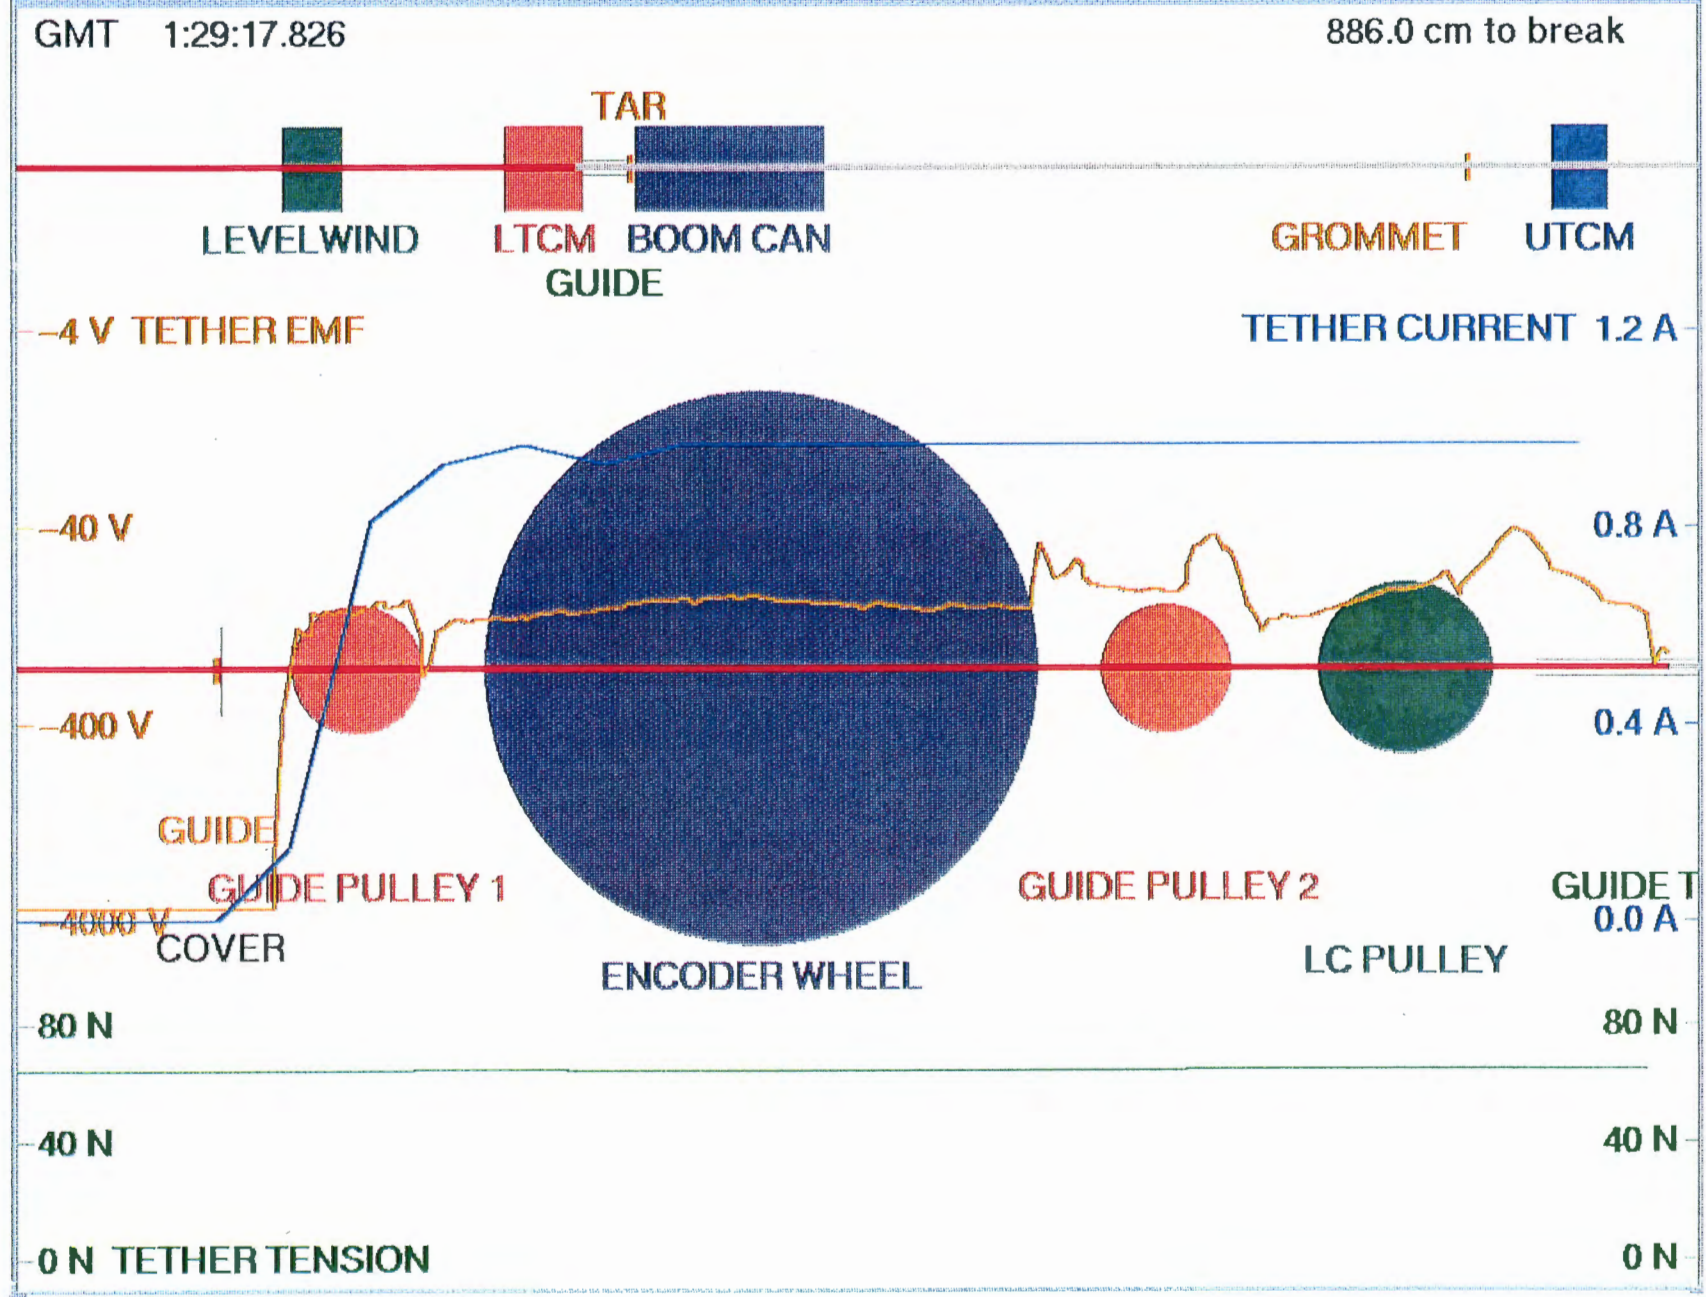
Figure 3.6-1

Figure 3.6-1: As the damaged point of the tether entered the LTCM and contacted the first pulley, at 57/01:29:16.9, the tether voltage decreased in magnitude from -3500 VDC to approximately -200 VDC and the current increased from 0.0 A to approximately 0.8 A as the initial arc began.

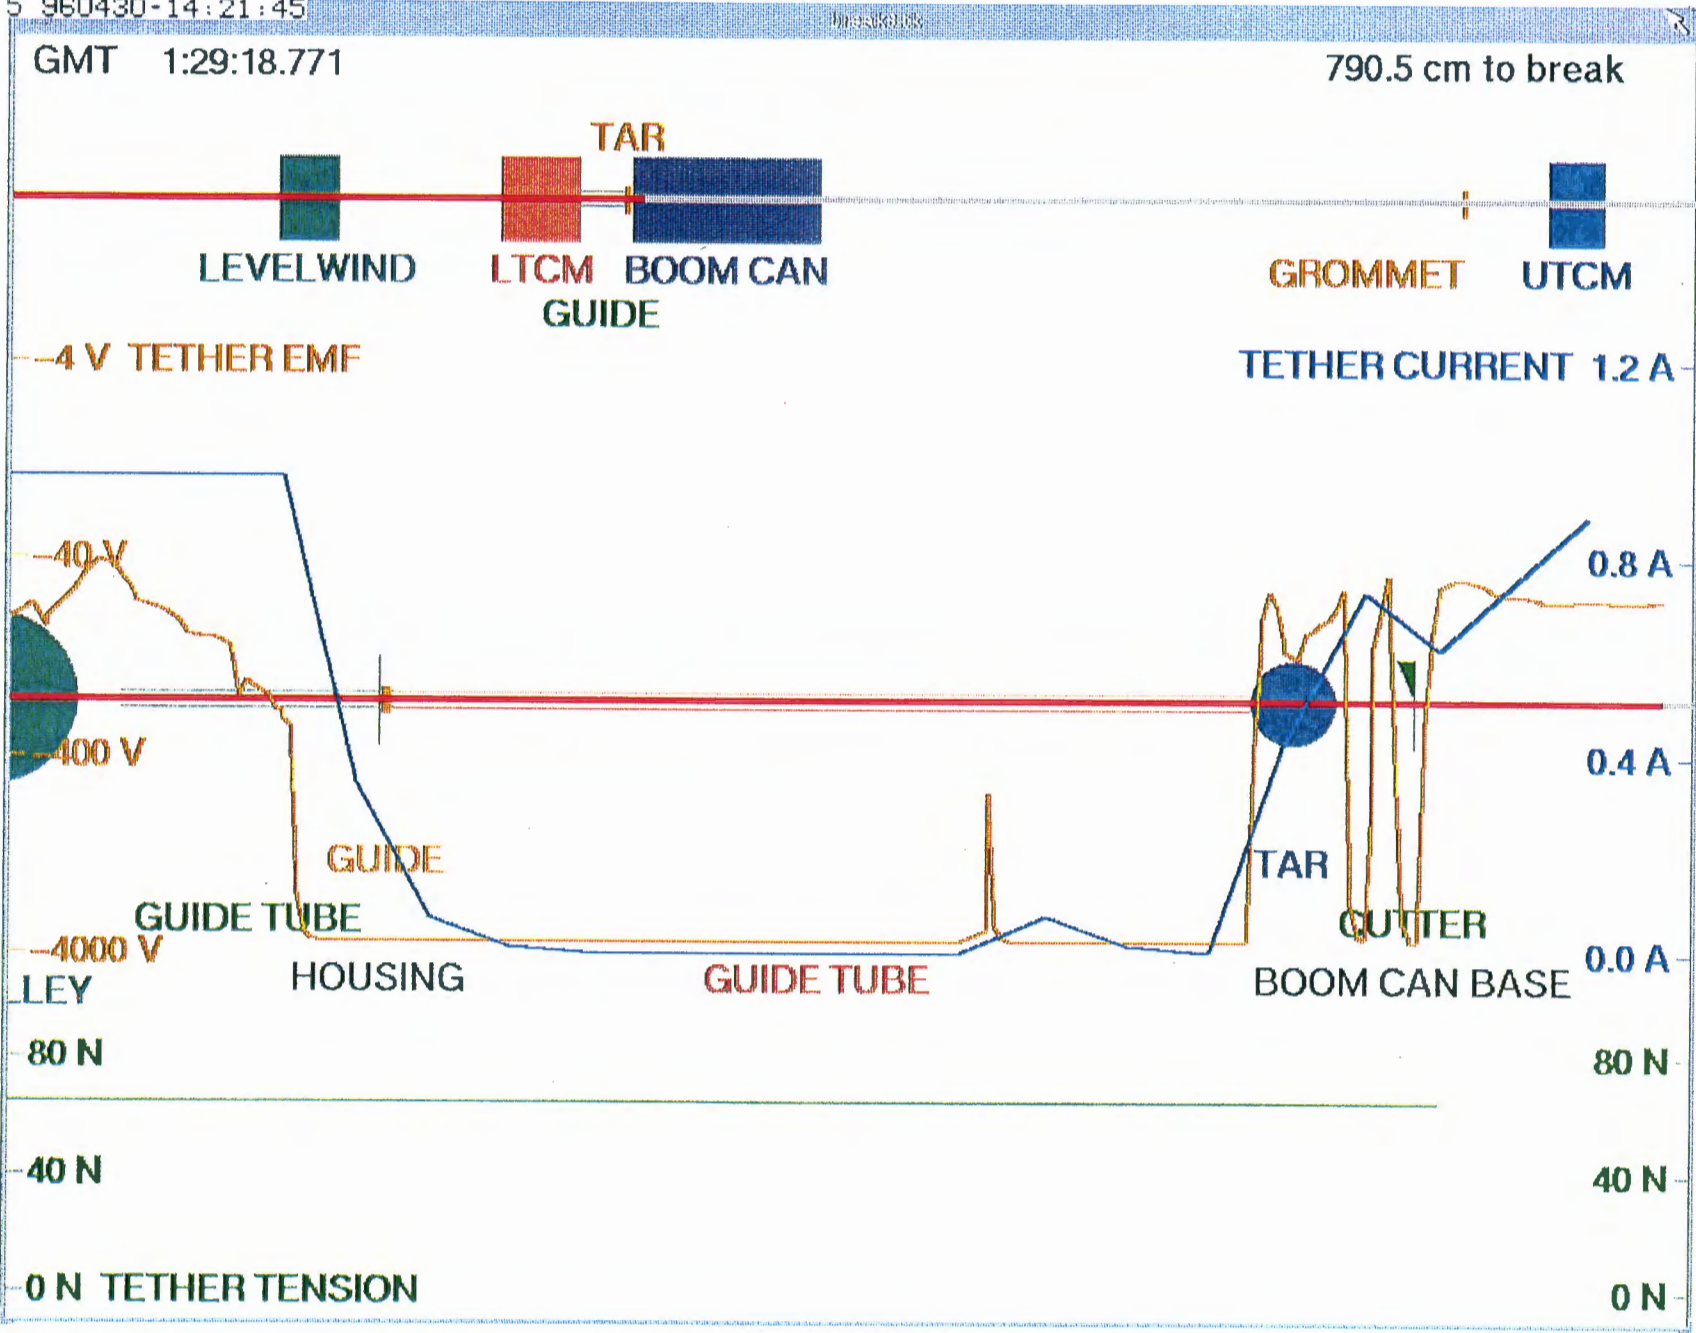
Figure 3.6-2

Figure 3.6-2: At 57/01:29:17.9, the damaged tether point leaves the LTCM exit guide tube. The current remains steady at 0 A and the voltage at -3500 VDC.

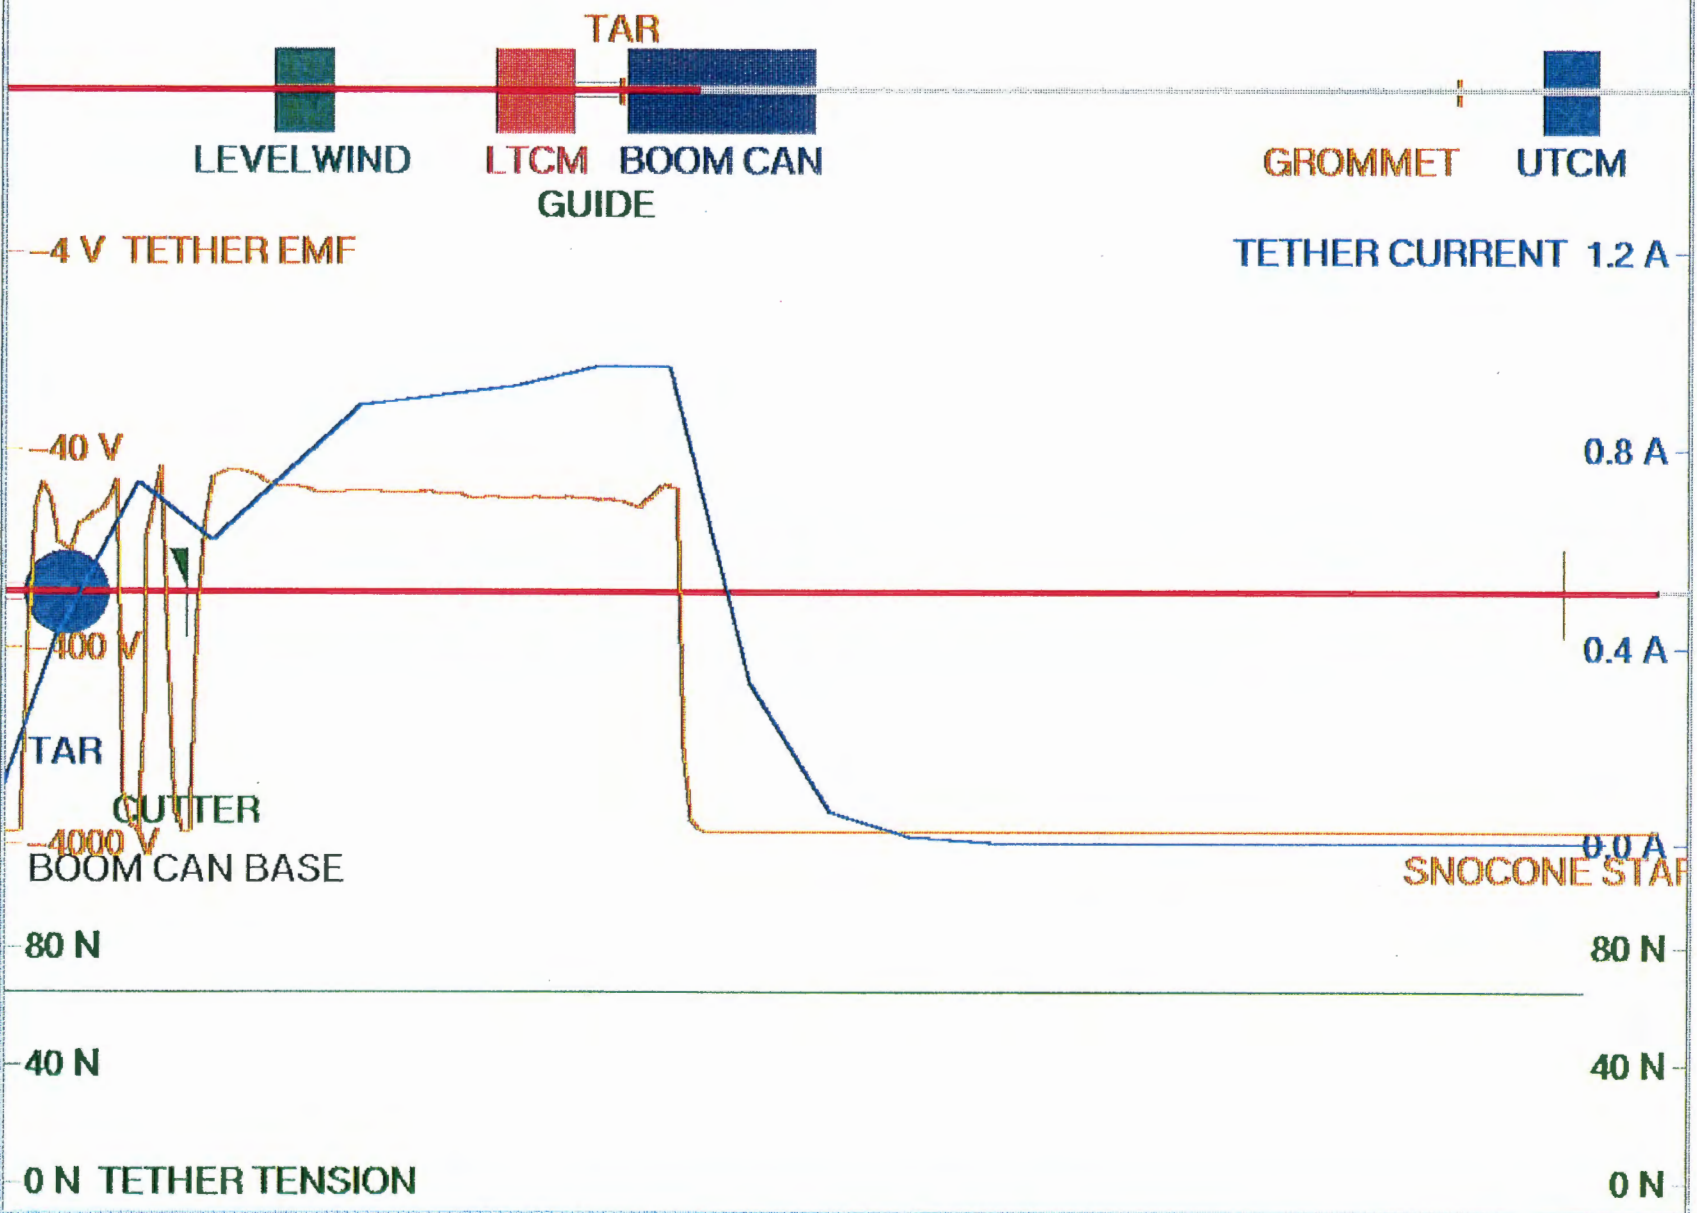
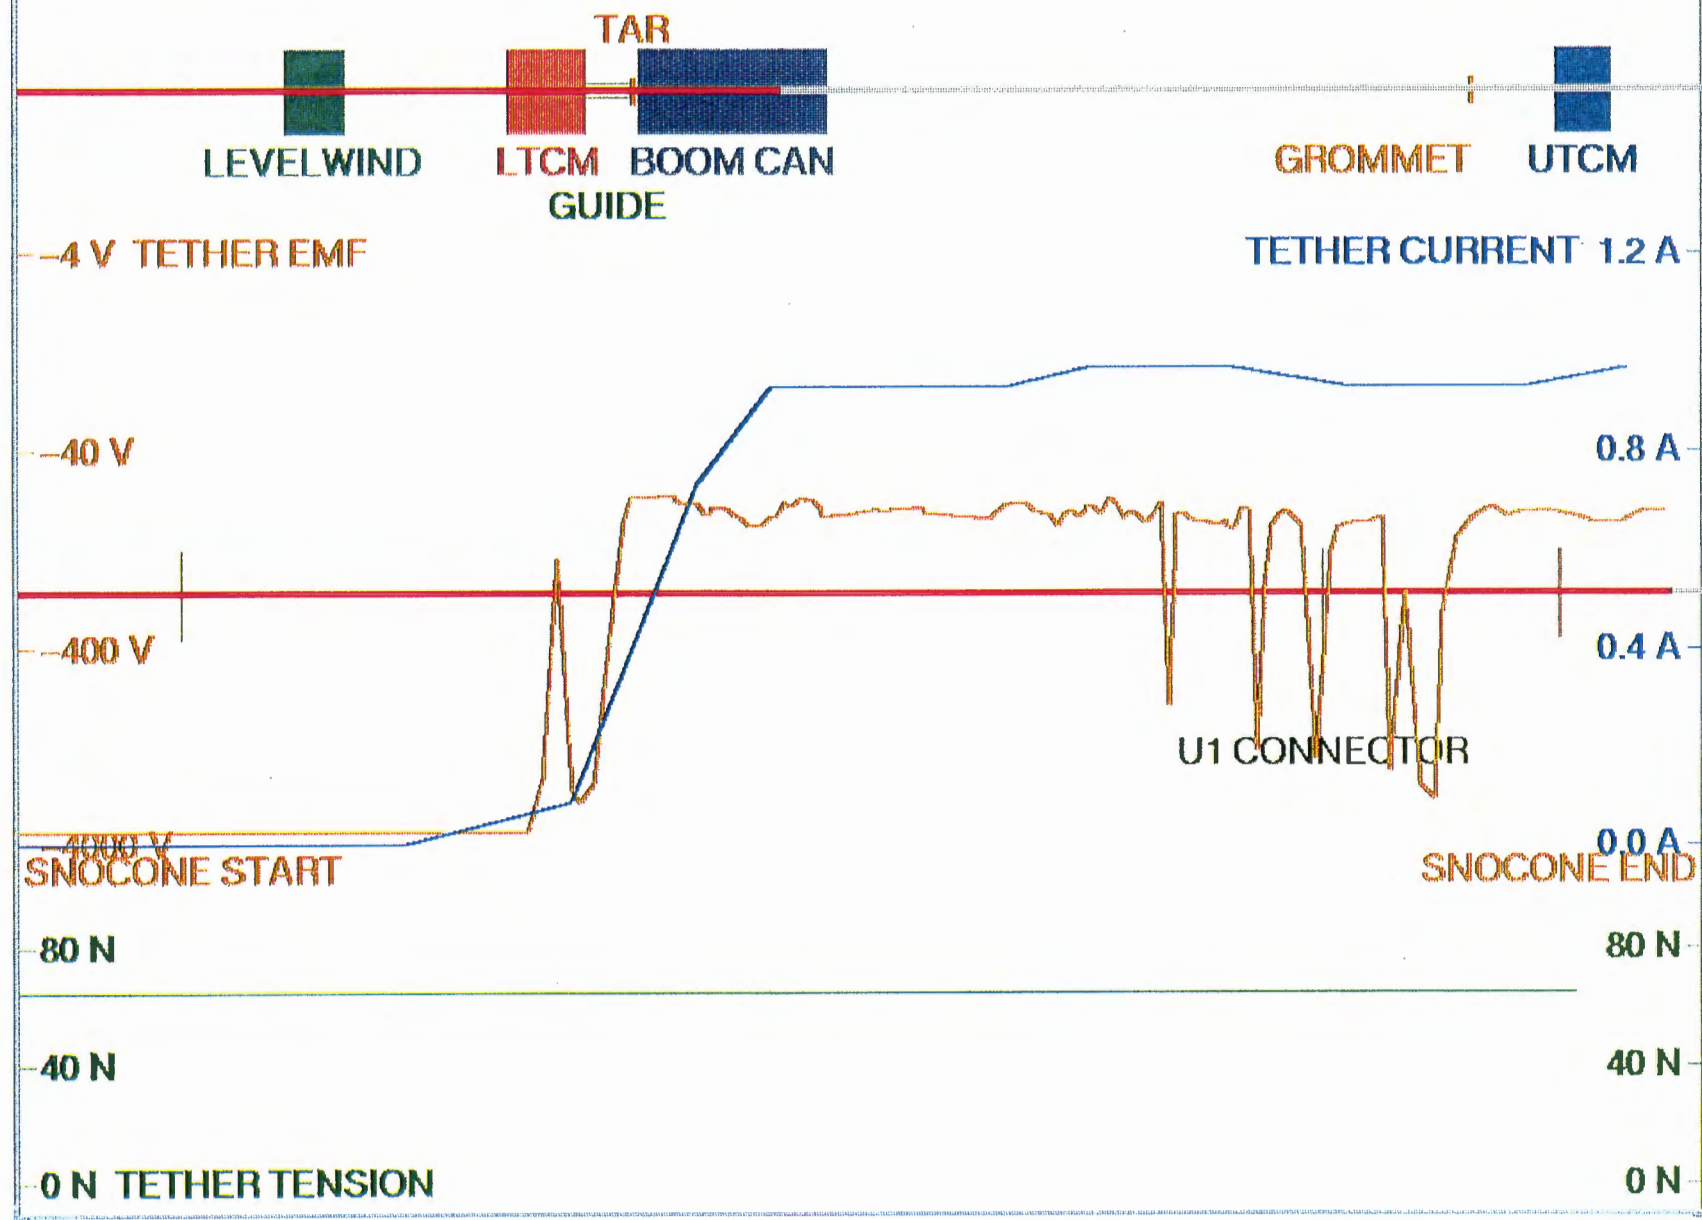
Figure 3.6-3 and 3.6-4: At 57/01:29:19.5, the damaged tether point entered the snocone. The voltage decreased in magnitude from -3500 VDC to approximately -300 VDC with a short recovery to -3000 VDC. The current increased to 1.0 A and stayed steady. While the damaged tether point was in the snocone (part of the housing structure for the 12 m deployer boom assembly), there were at least five spikes and recoveries of the voltage before it dropped to -100 VDC and remained steady. This was while the damaged tether point was passing the U1 connector. At 57/01:29:20, the battery heater current
