TSS-1R Mission Failure Investigation Board

Final Report

National Aeronautics and Space Administration

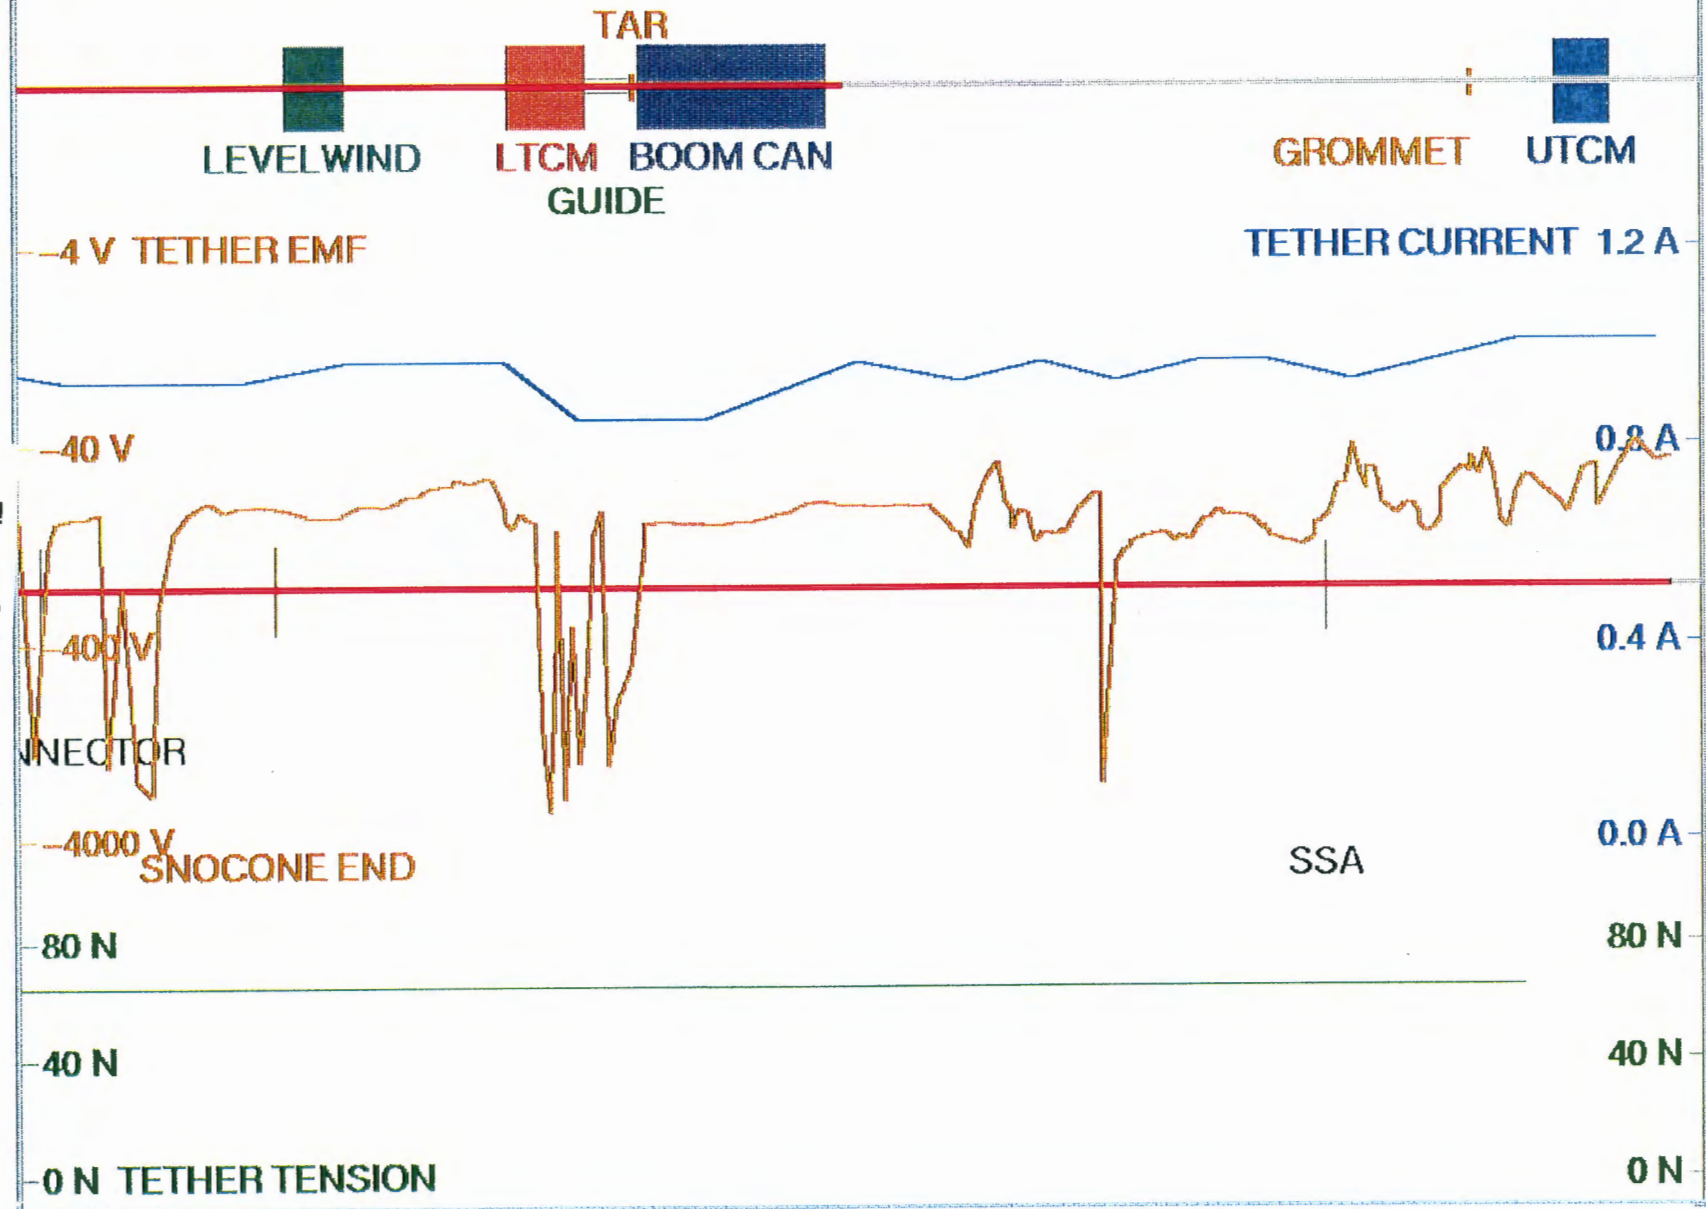
Figure 3.6-5

Figure 3.6-5: At 57/01:29:20.4, the damaged tether point exited the snocone, and the current remained steady at 1 A. The voltage remained at approximately -100 VDC, except for five or more spikes/recoveries until the damaged tether point exited the SSA and entered the boom.

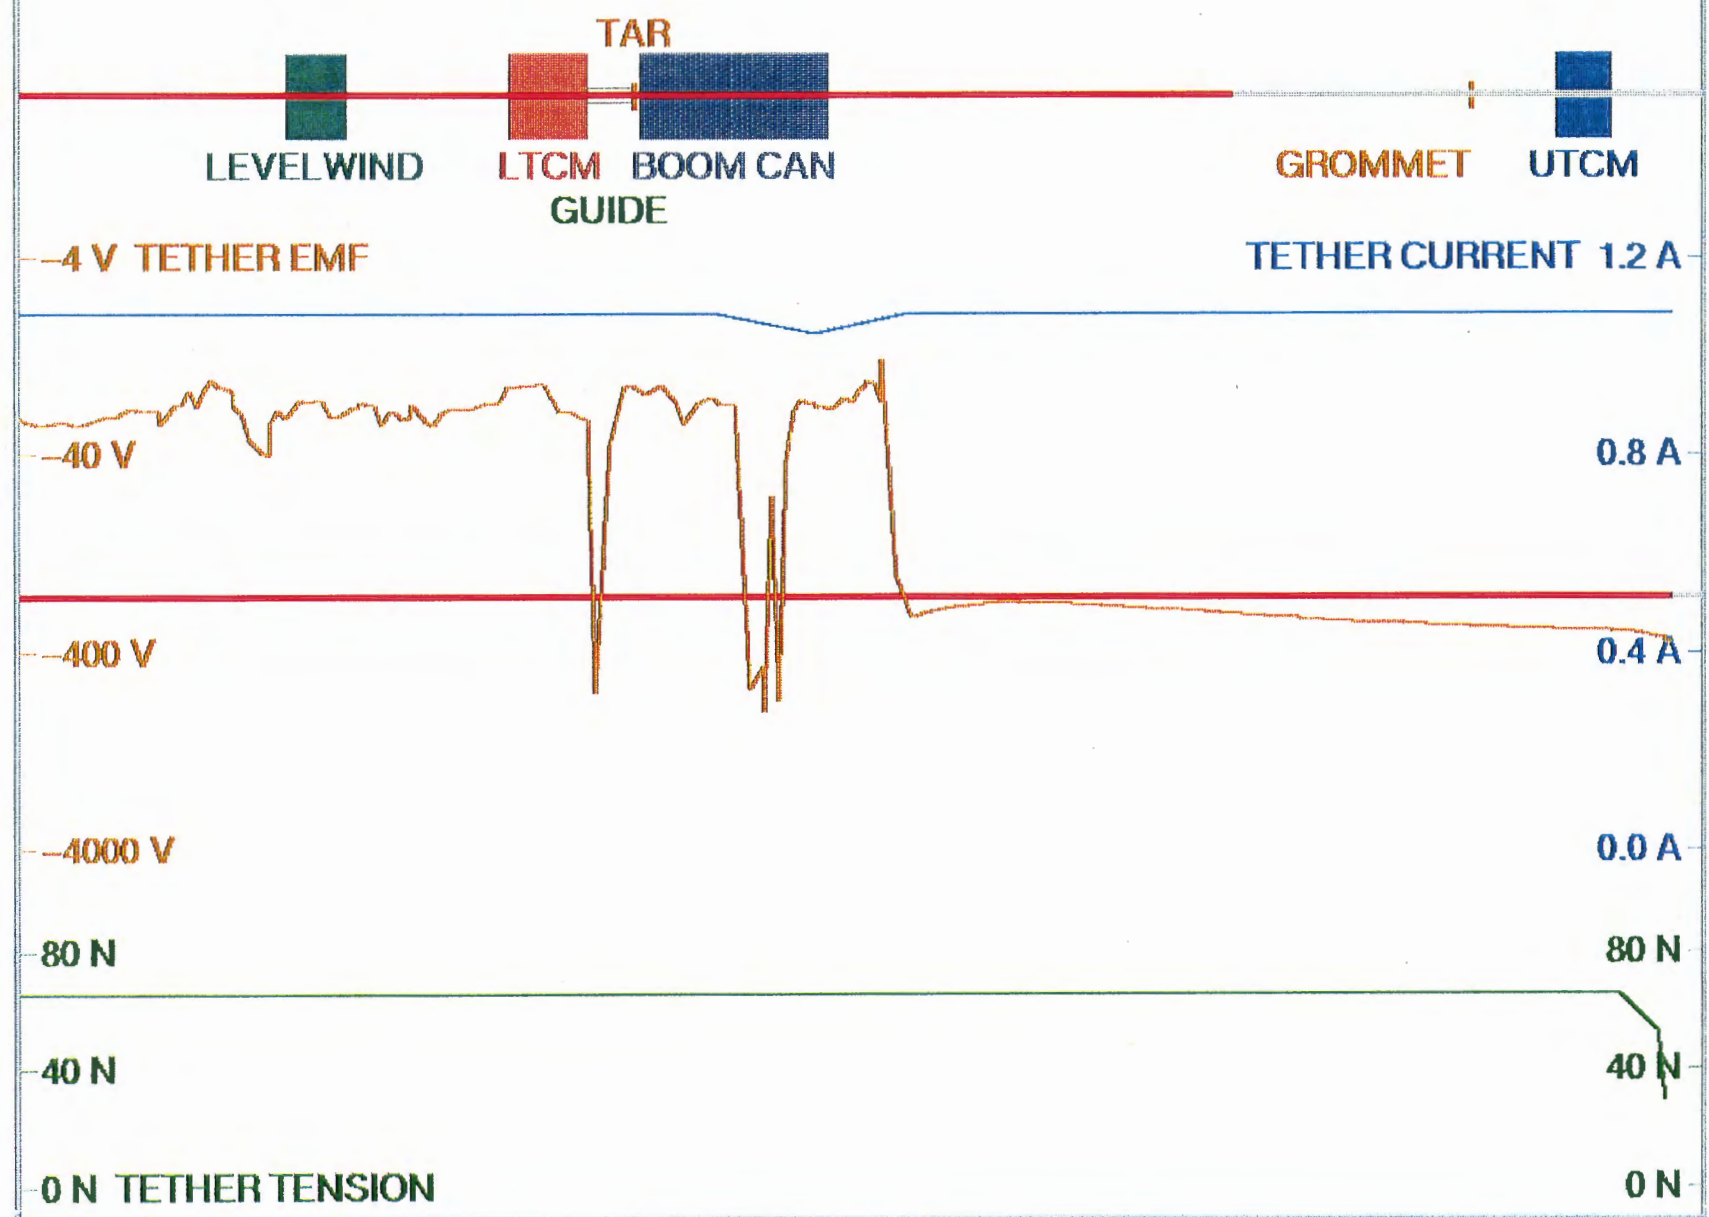
3-79
Figure 3.6-6

Figure 3.6-6: The current remained at approximately 1 A after the damaged tether reached the space plasma and entered the 12 m open boom assembly. The arcing burned away sufficient Kevlar, that the normal tension load of 65 N was enough to fail the tether. The tether separation is indicated by the drop in tension .

This sequence of events indicates that numerous arcing paths existed for the current to flow from the tether conductor directly to orbiter ground, until it entered the boom area. Then, the current discharge could be to the boom, or to the space plasma itself.

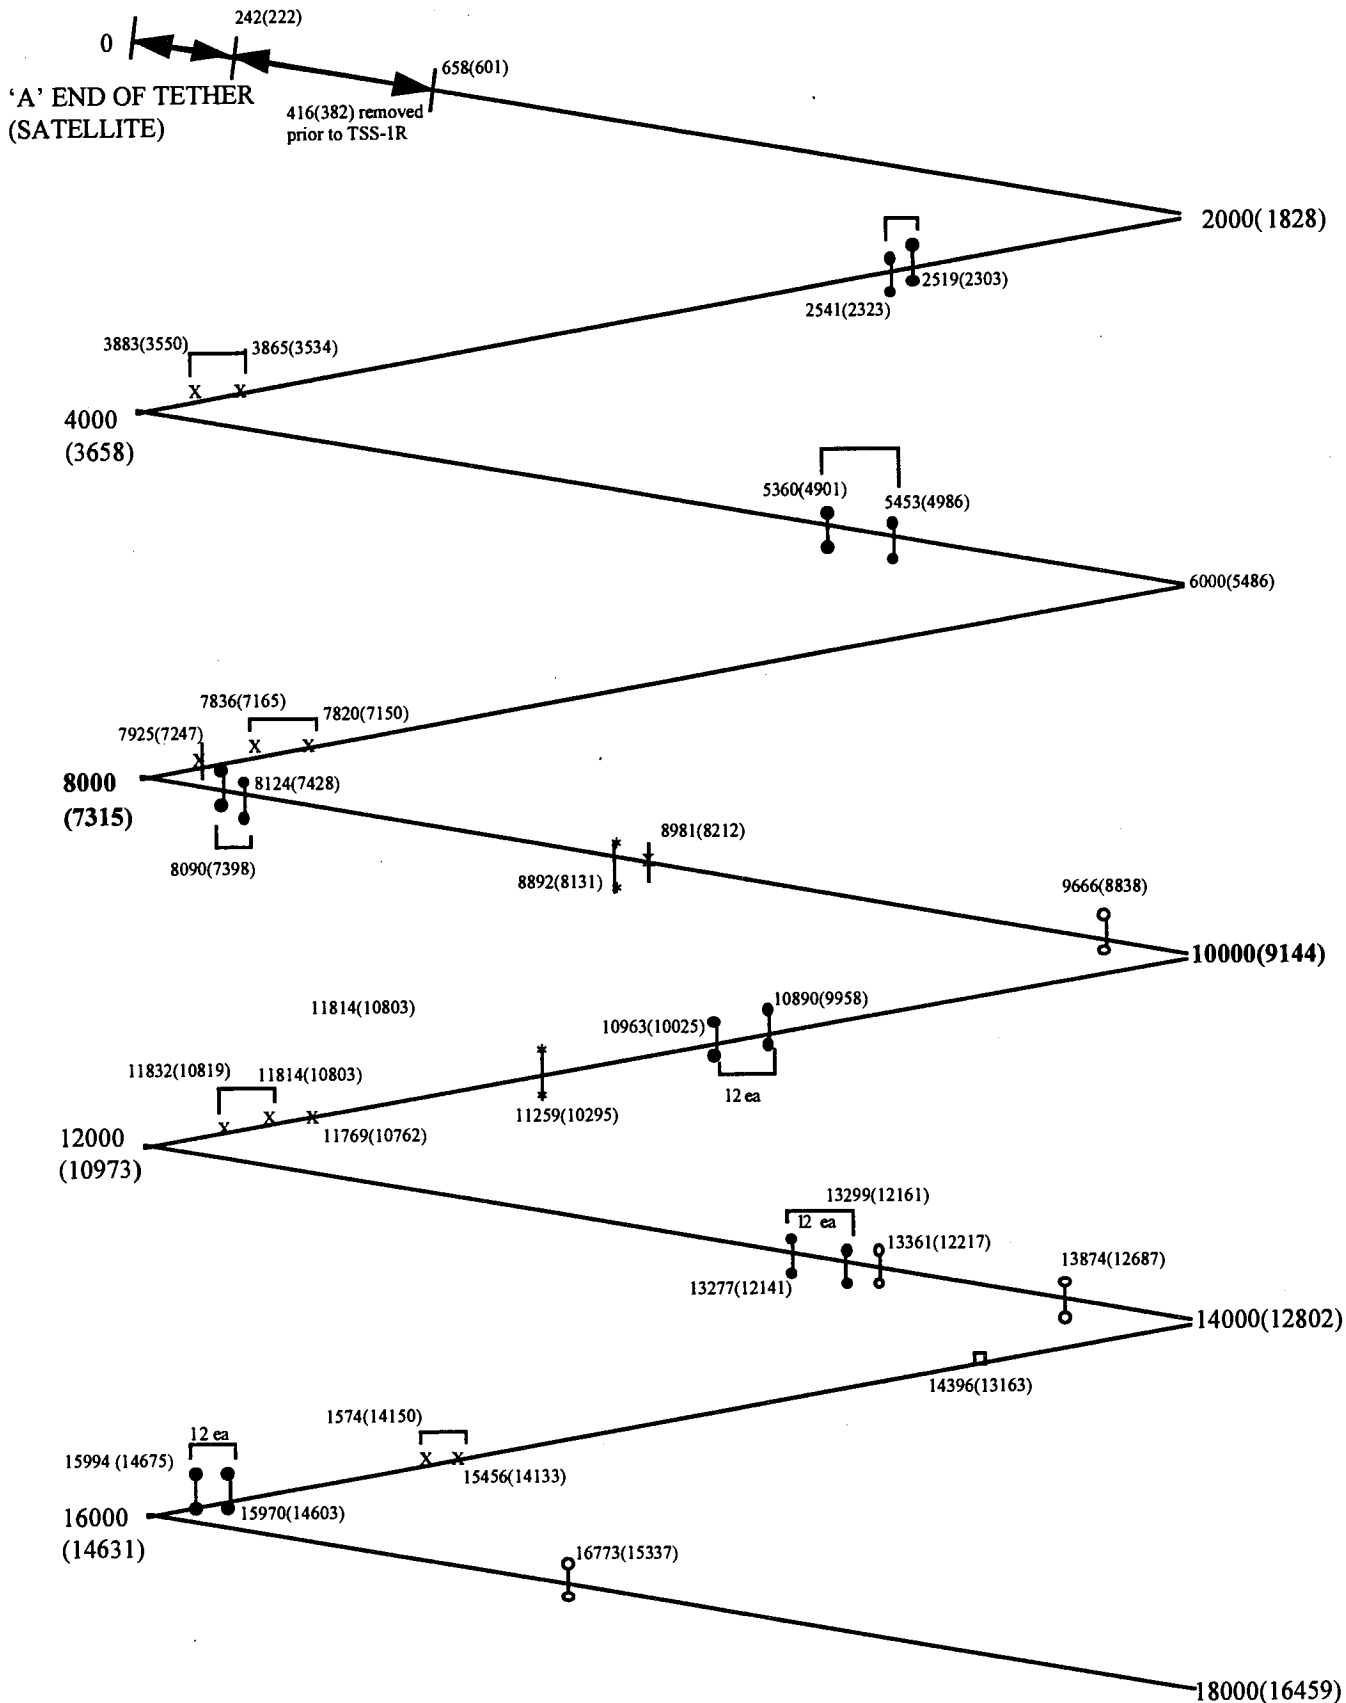
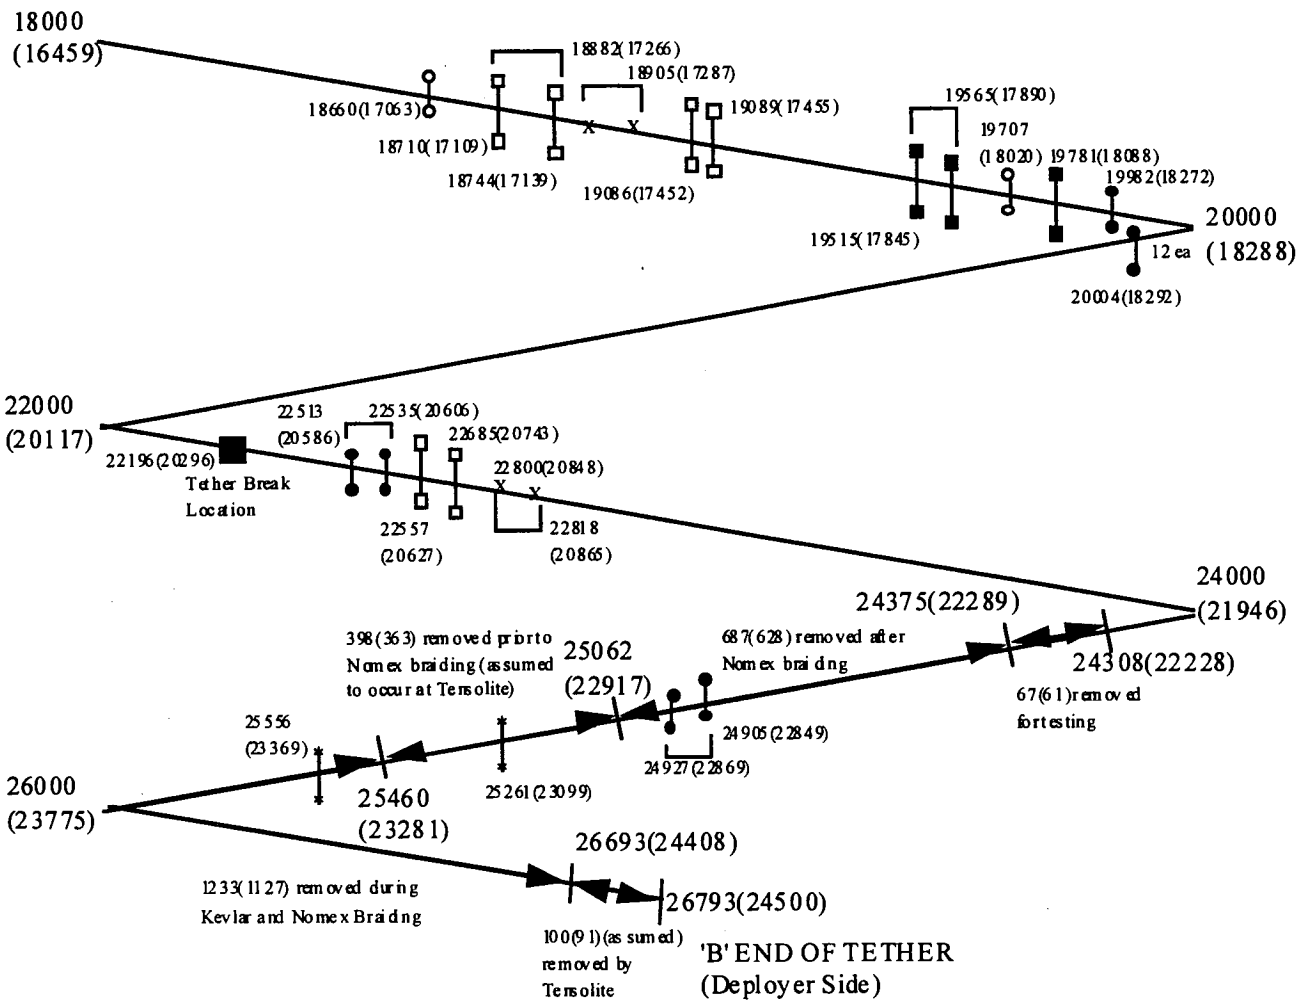
TSS TETHER MANUFACTURING MAPPING DATA

242(222) removed as follows:
 3(2.75) by Tensolite (assumed)
 172(158) during Kevlar and Nomex Braiding
 67(61) for final testing

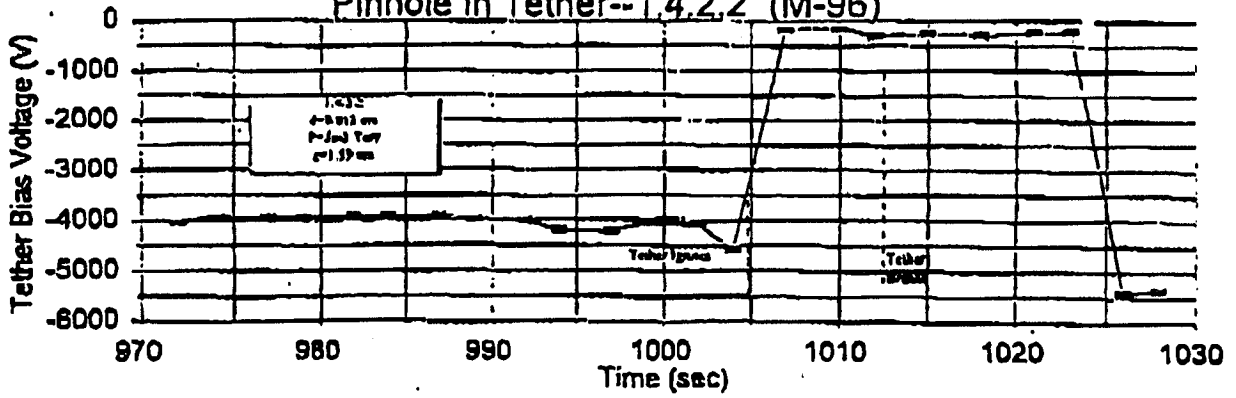
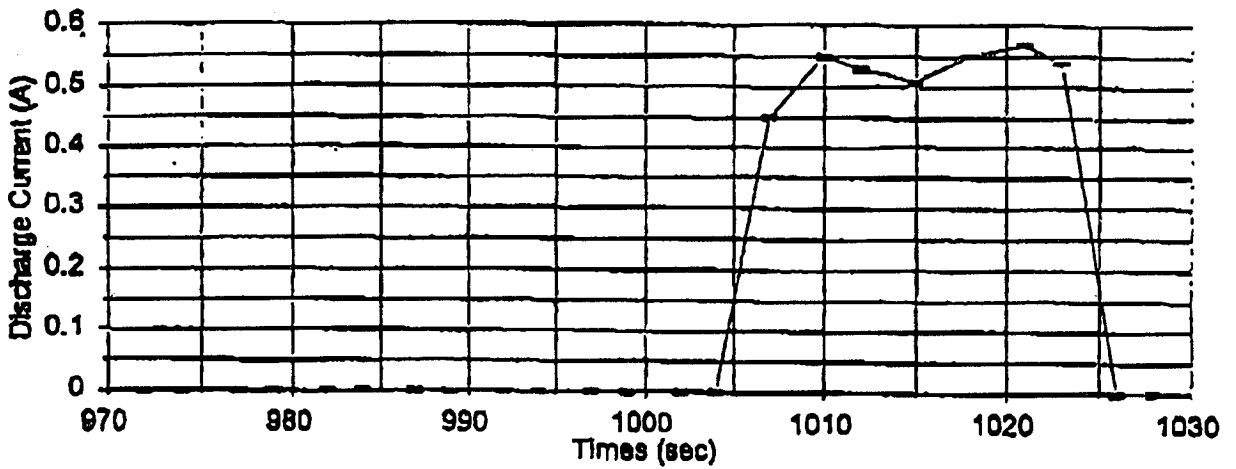
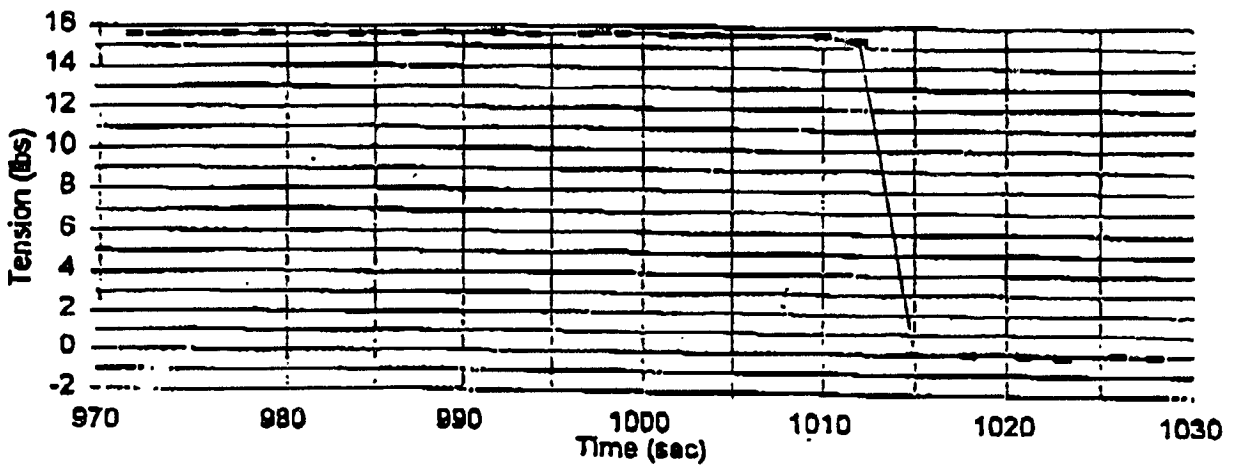
Pinhole in Tether--1.4.2.2 (M-96)

TSS Tether Investigation

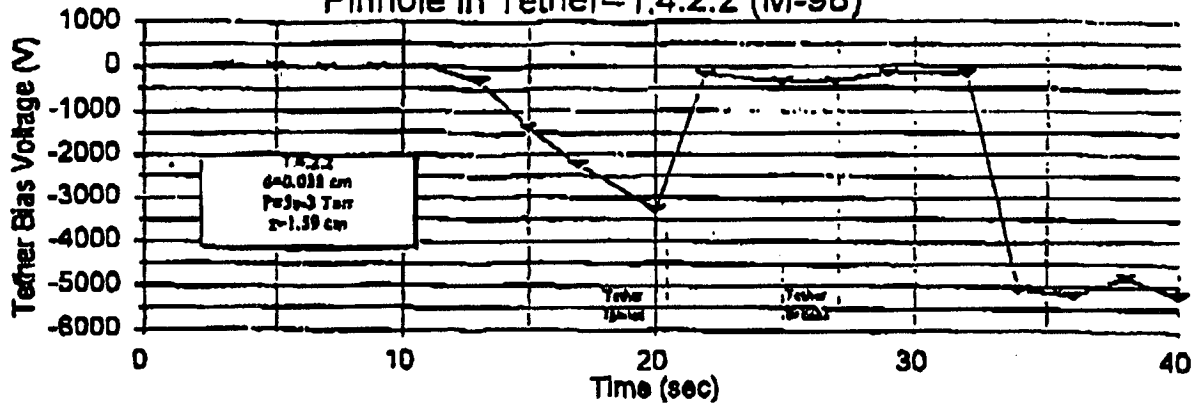
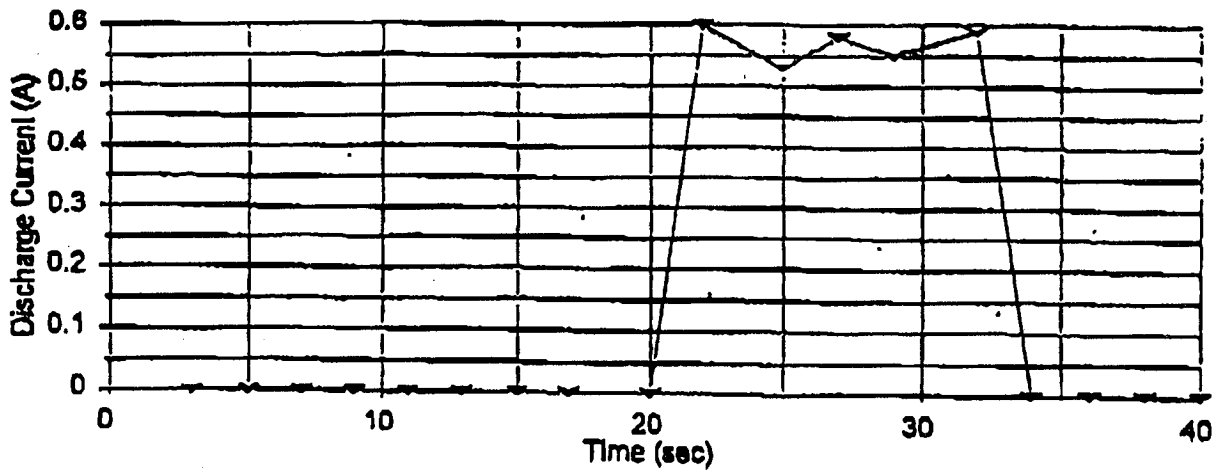
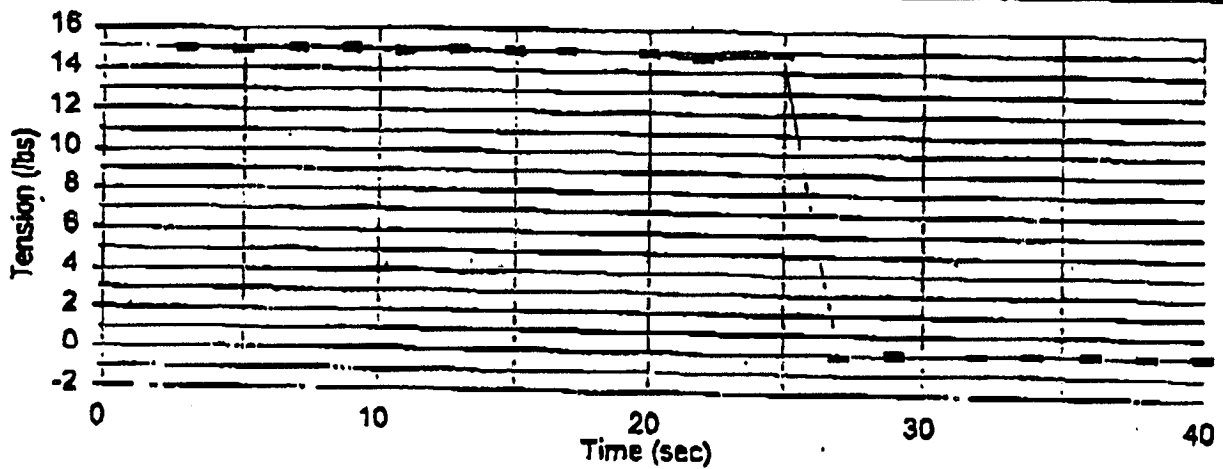
Pinhole in Tether-1.4.2.2 (M-96)

TSS Tether Investigation

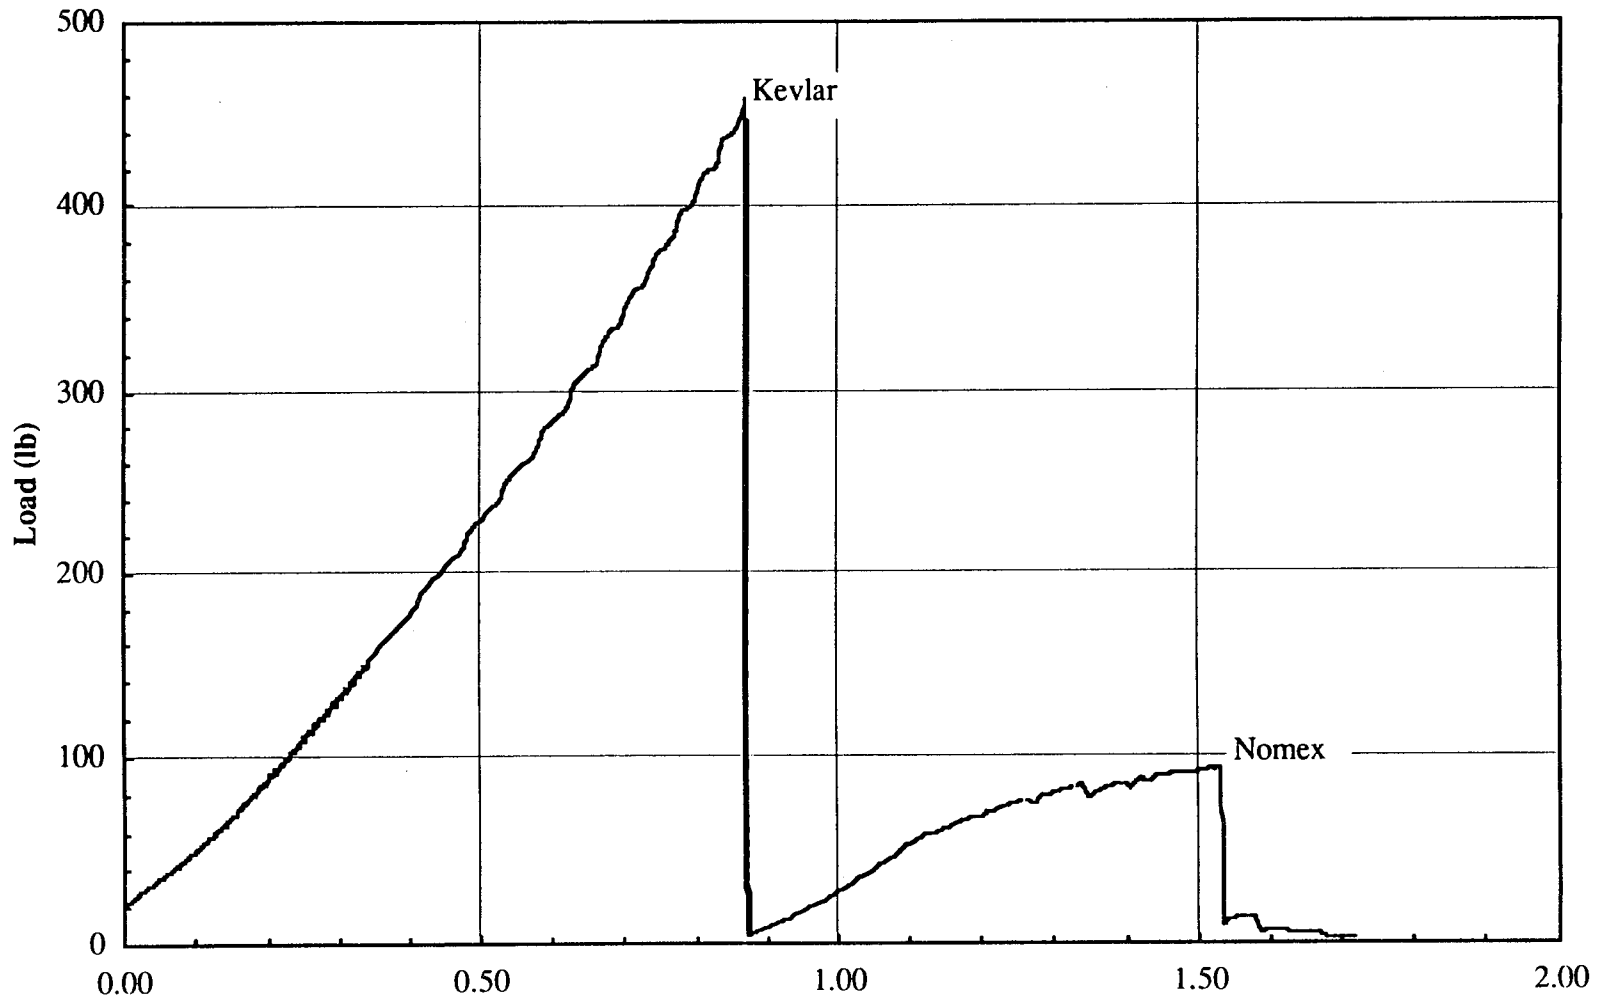
F-19

- Objectives: Pull standard specimen lengths of tether in tension until breakage occurs, (1) to establish a baseline for all other mechanical testing, (2) for comparison to tether qualification data to assess aging effects, (3) to provide visual evidence of fracture modes and appearance, valuable for comparison to actual flight tether failure(s), and (4) to verify tether tensile strengths at design temperature extremes
- Results: Thirty specimens pulled at room temperature
Statistically no different from tether qualification data

Tether Tensile Characterization

Temperature is not an issue (tether was operating at ~5 °C at time of failure) - recommend no additional testing at temperatures other than room temperature

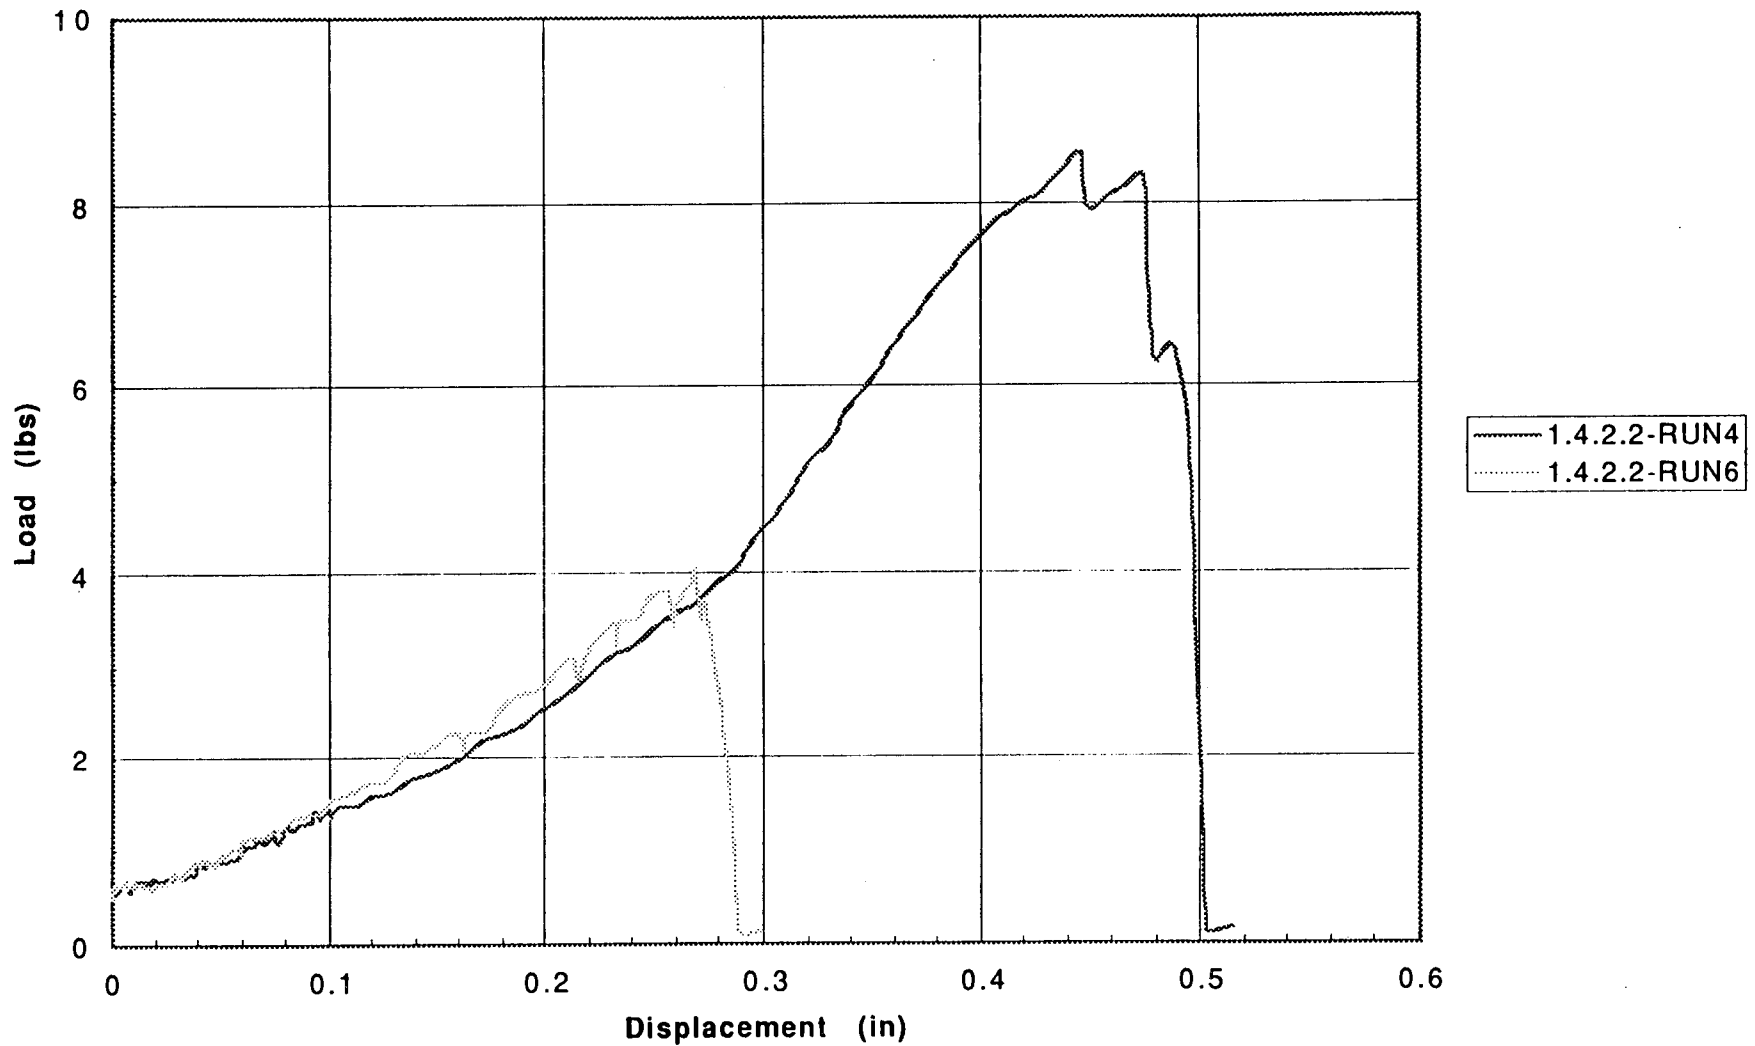
F-20

- **Objective:** Simulate arcing on standard specimen lengths of tether, then pull in tension until breakage occurs - compare breaking load to known capability of tether
- **Results:** Two test specimens tested
Significant charring on tether specimens
Failures occurred at less than ten pounds force
- **Observations:** Recommend closure of this test series - electrical testing under simulated flight loads are better indicators of tether performance

Electrical Discharge Tether Specimens

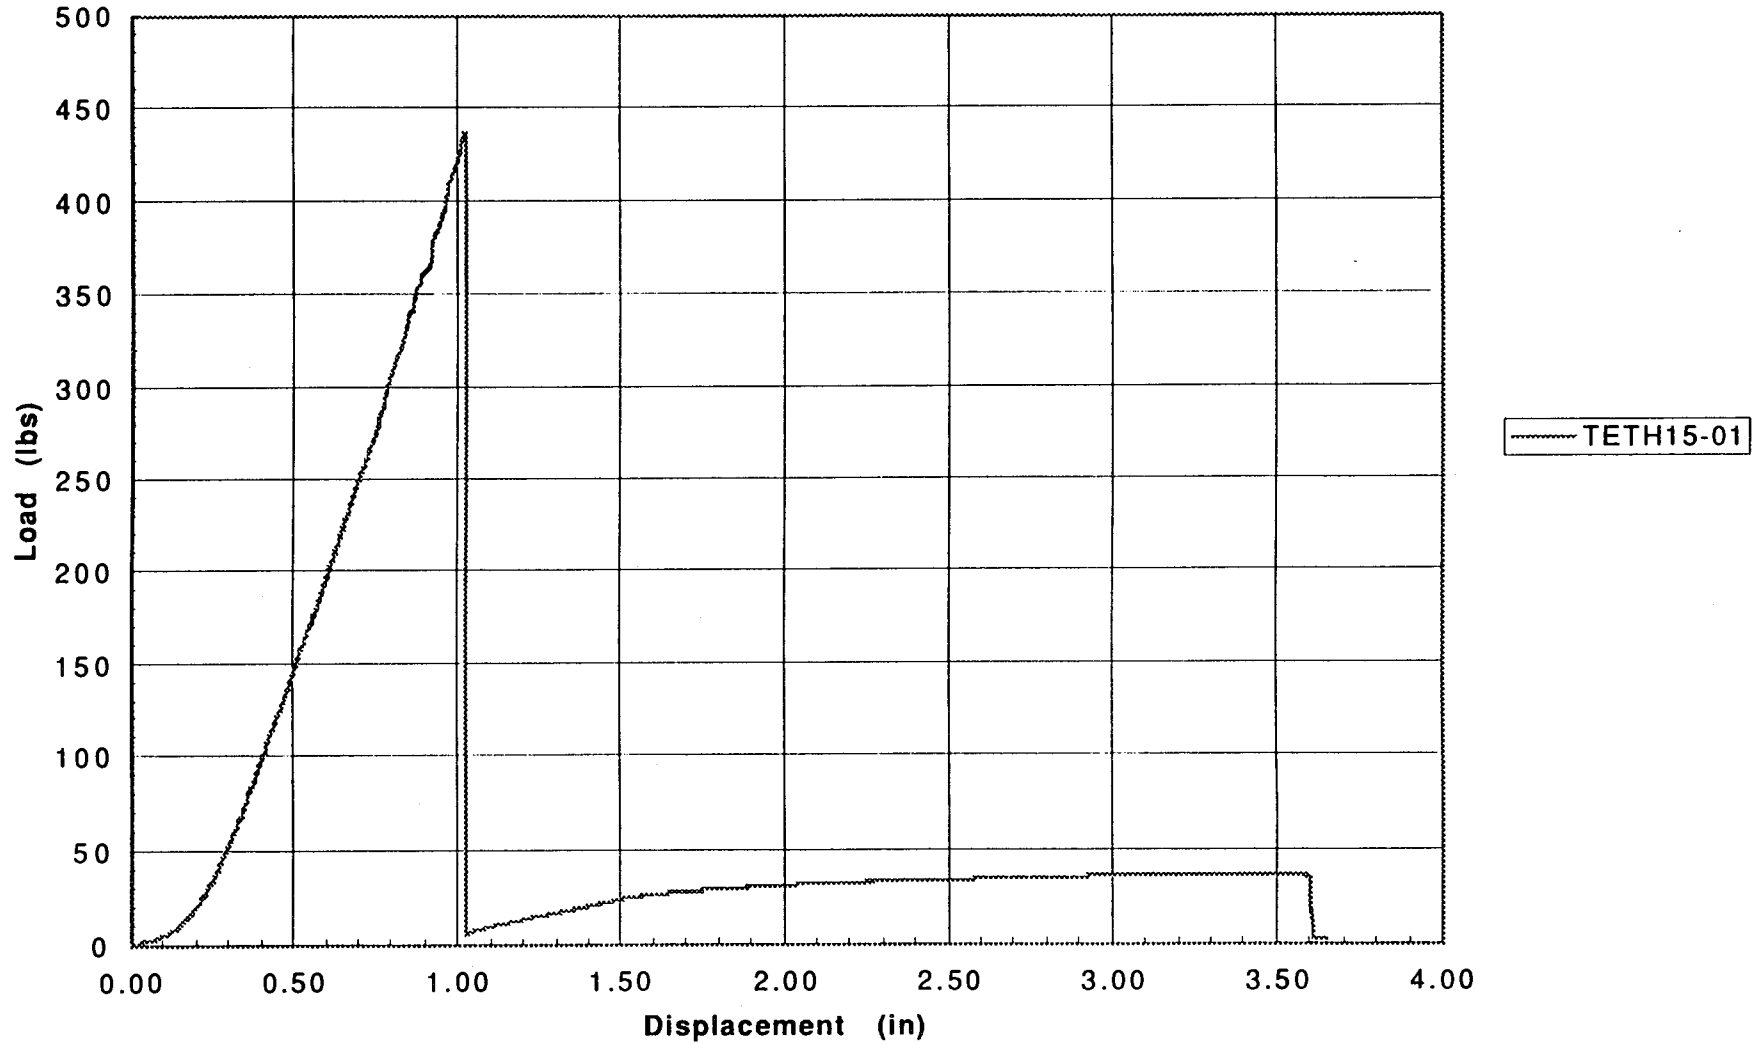
F-22

Twelve Strands of Kevlar and Core

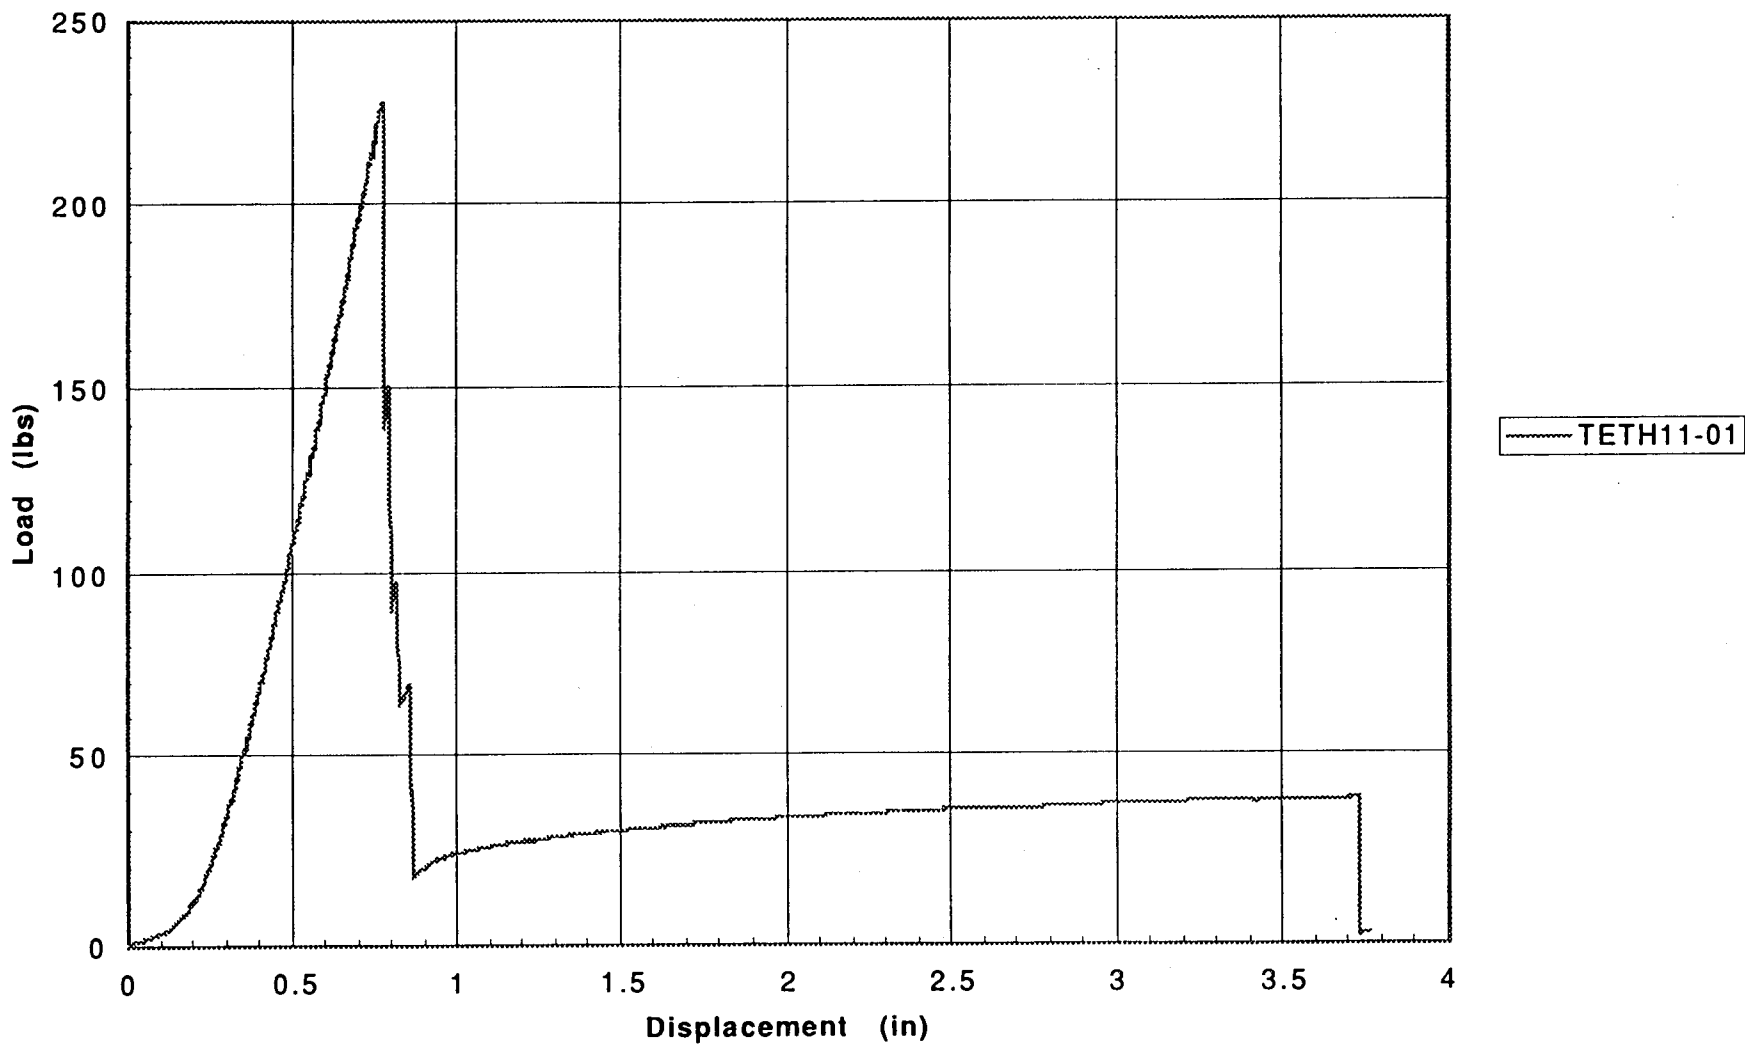
F-23

Six Strands of Kevlar

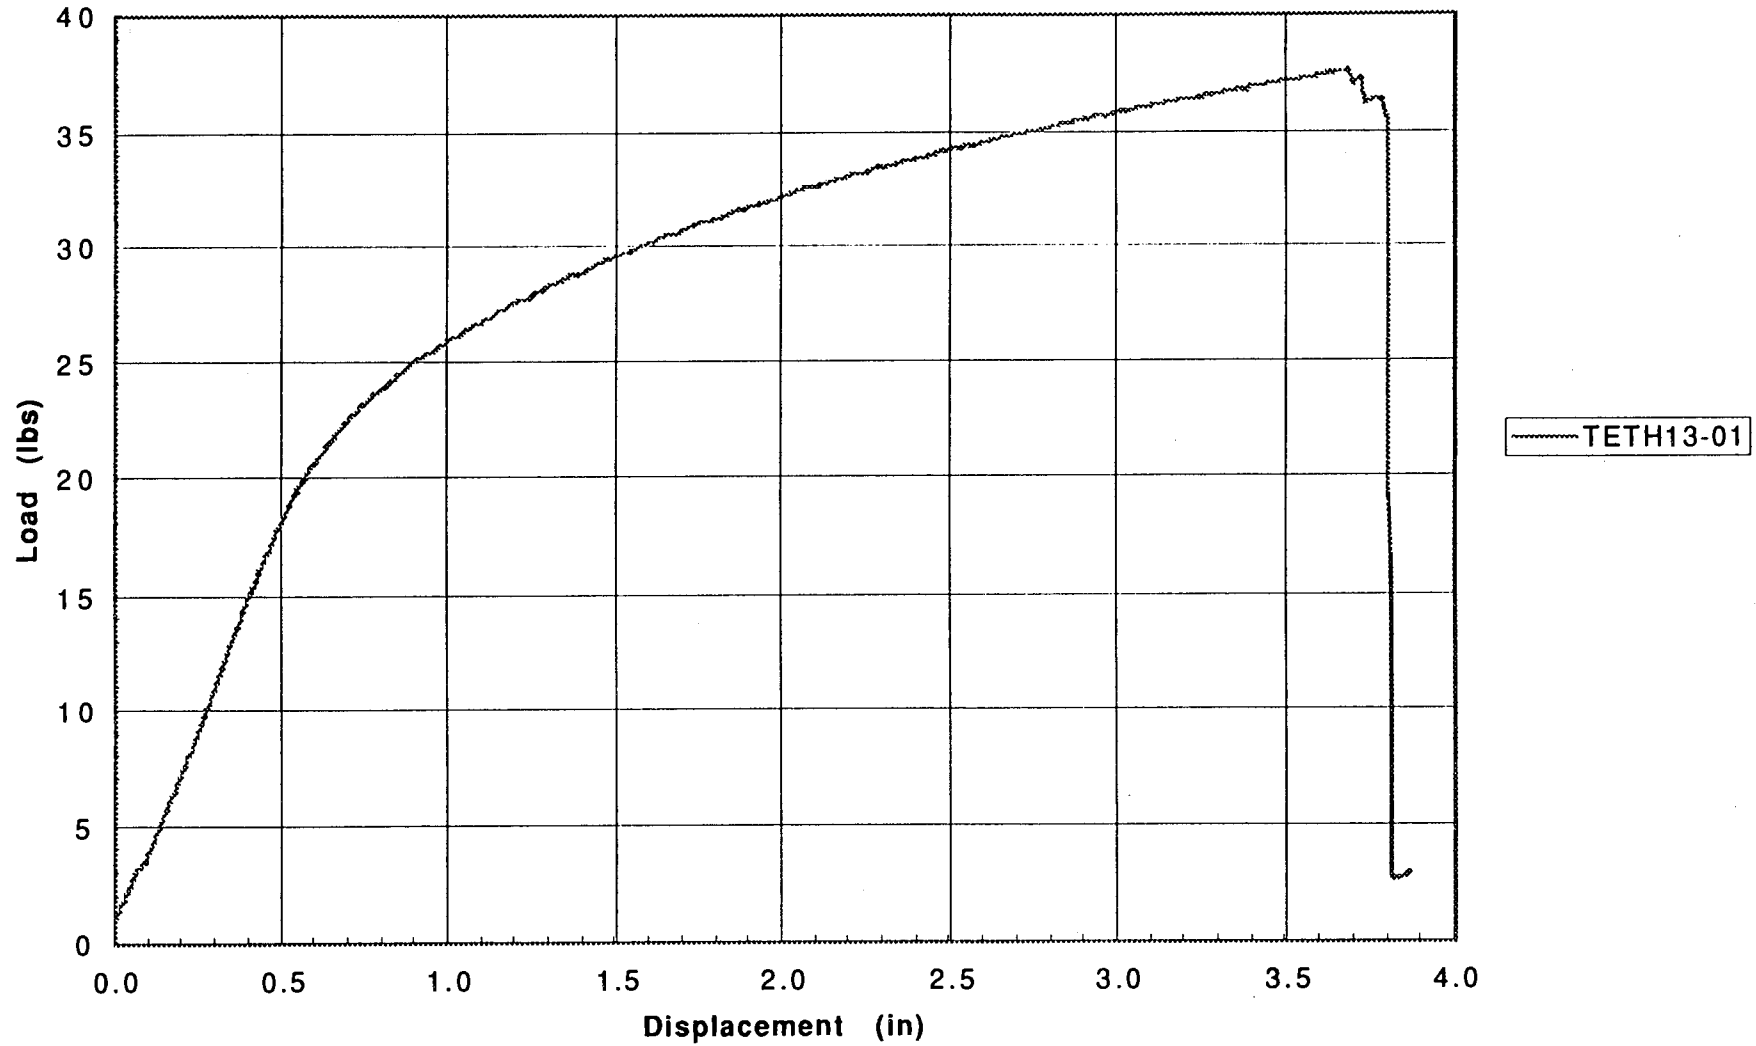
F-24

FEP/Conductor

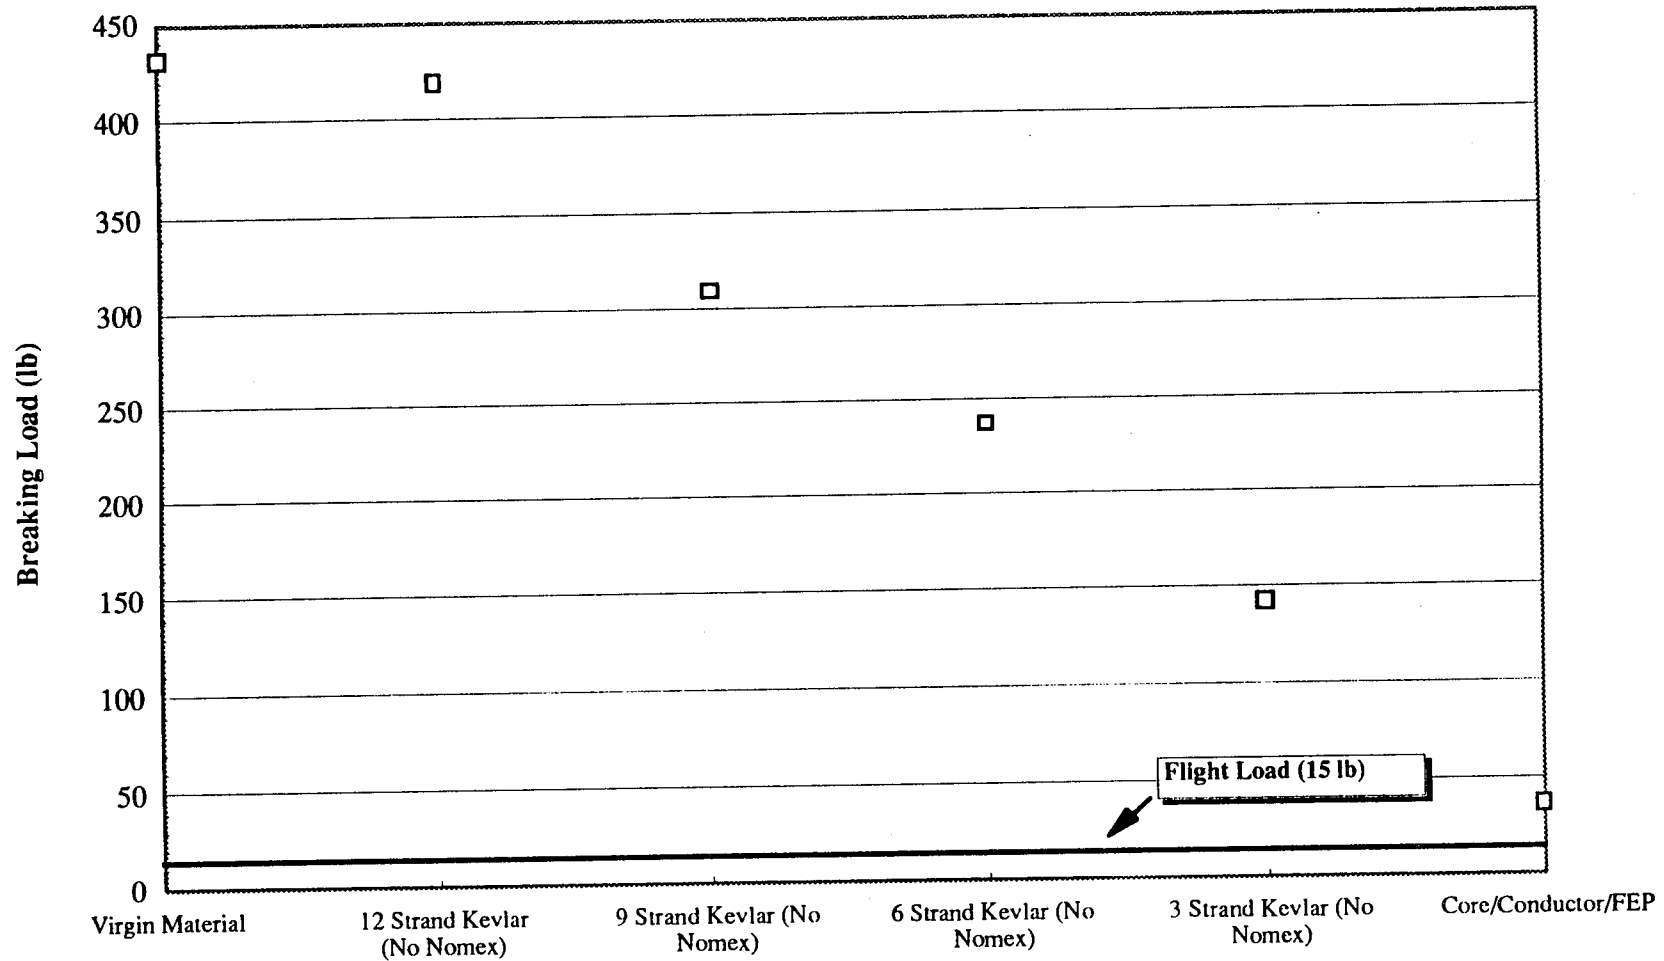
F-25

- **Objective:** Remove known quantities of material from tether specimens, then pull in tension until breakage occurs - compare breaking load to known capability of tether
- **Results:** Three test specimens per condition tested
Successive material removal led to lower strength
All failures occurred well above known flight loads
- **Observations:** Recommend closure of this test series

Effect of Material Removal on Tether Strength
@ Room Temperature
