TSS-1R Mission Failure Investigation Board

Final Report

National Aeronautics and Space Administration

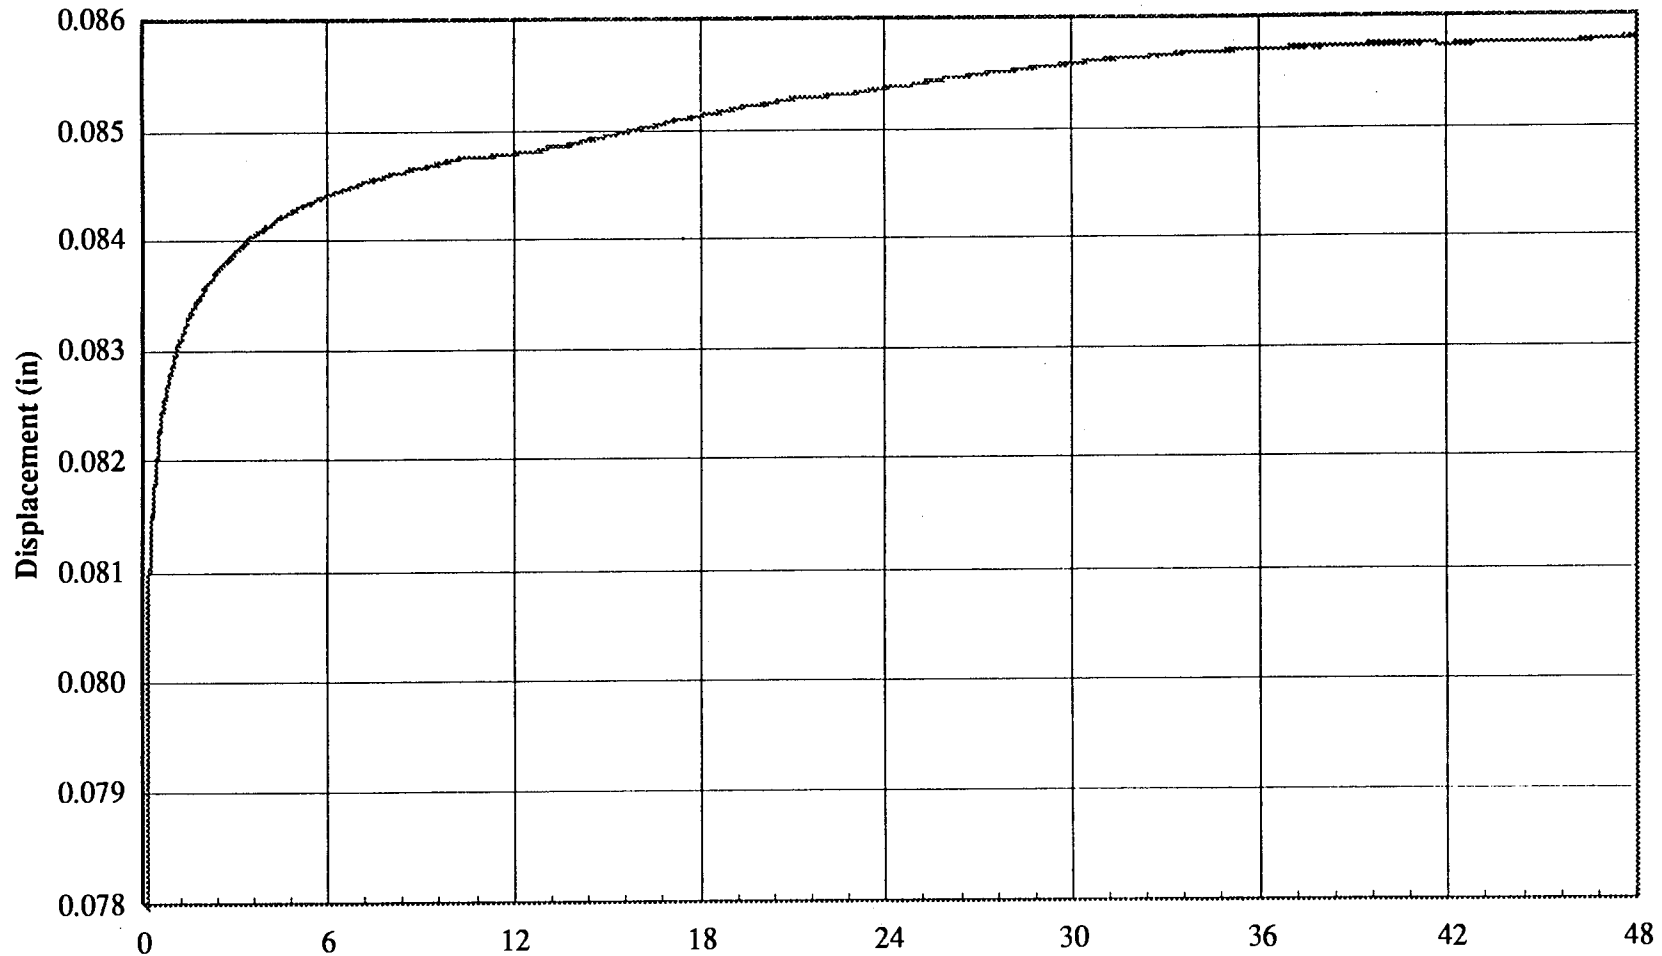
F-28

Remaining specimens to be subjected to electrical breakdown, X-ray, and cross-sectional examination
- **Observations:** Creep alone does not appear to be an issue
Additional tests pending Board actions/recommendations

Compressive Creep Test (254 lbs)

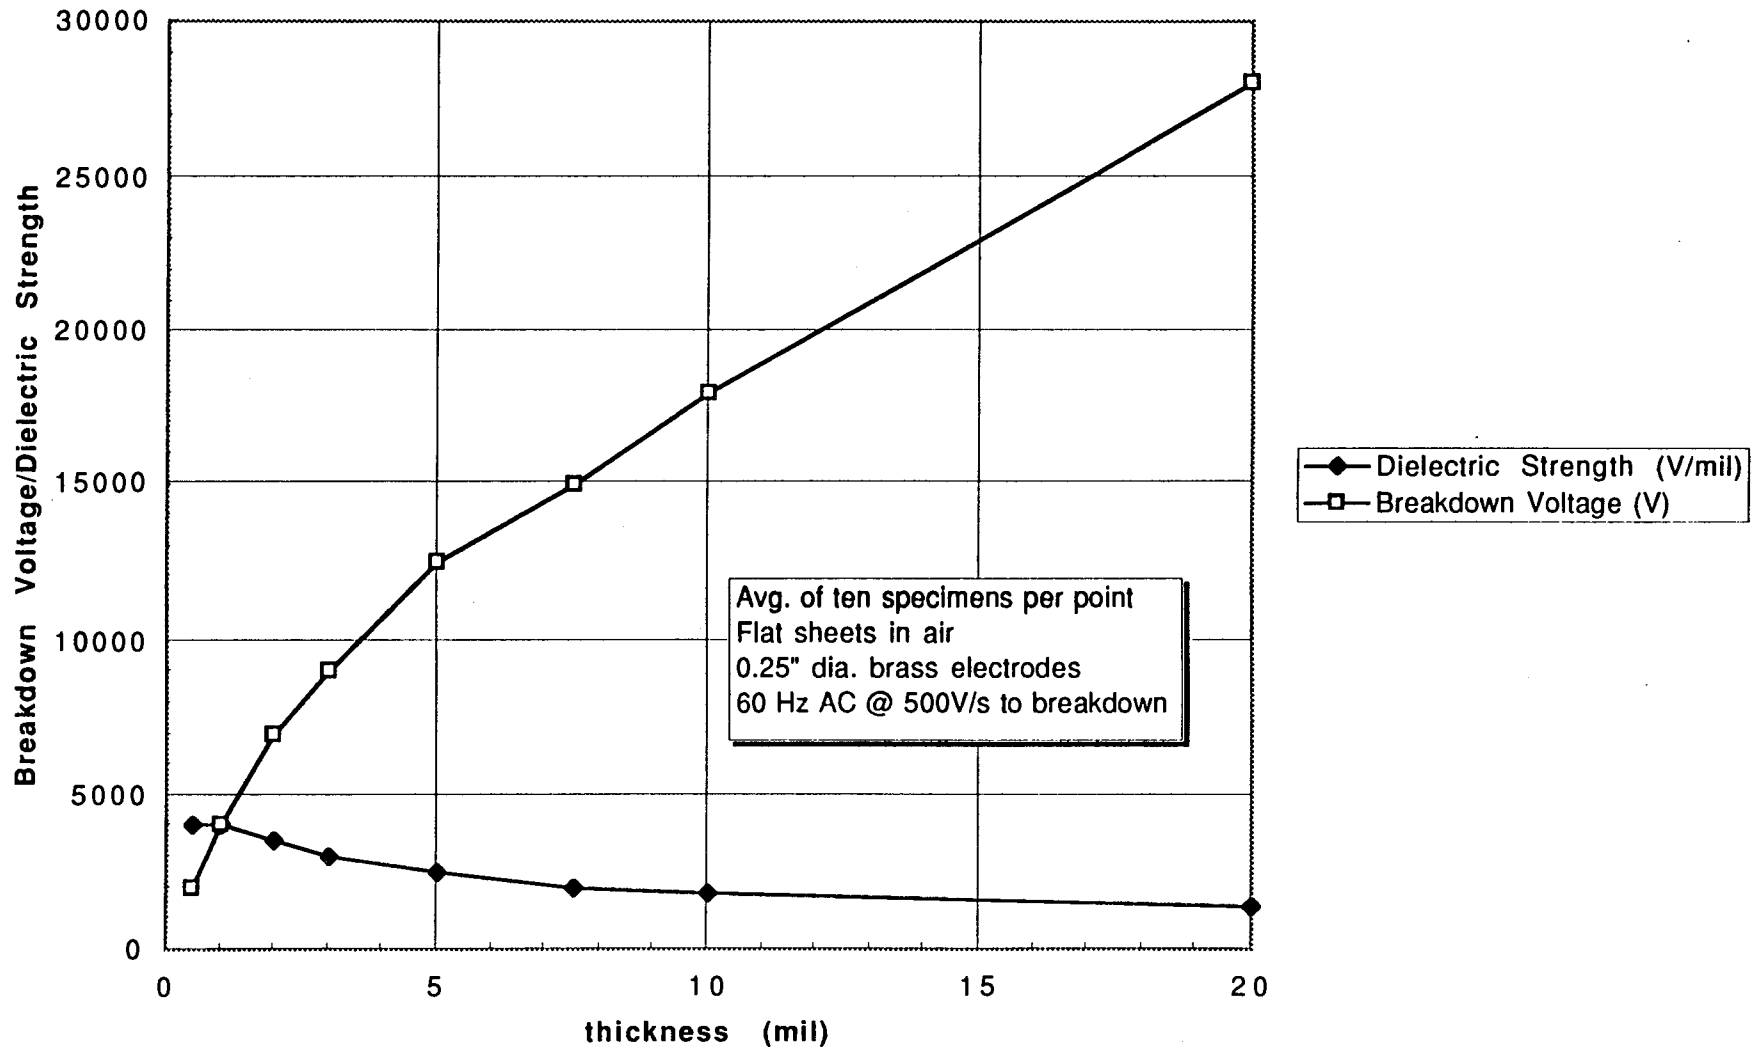
F-29

Breakdown Voltage vs Thickness, FEP film

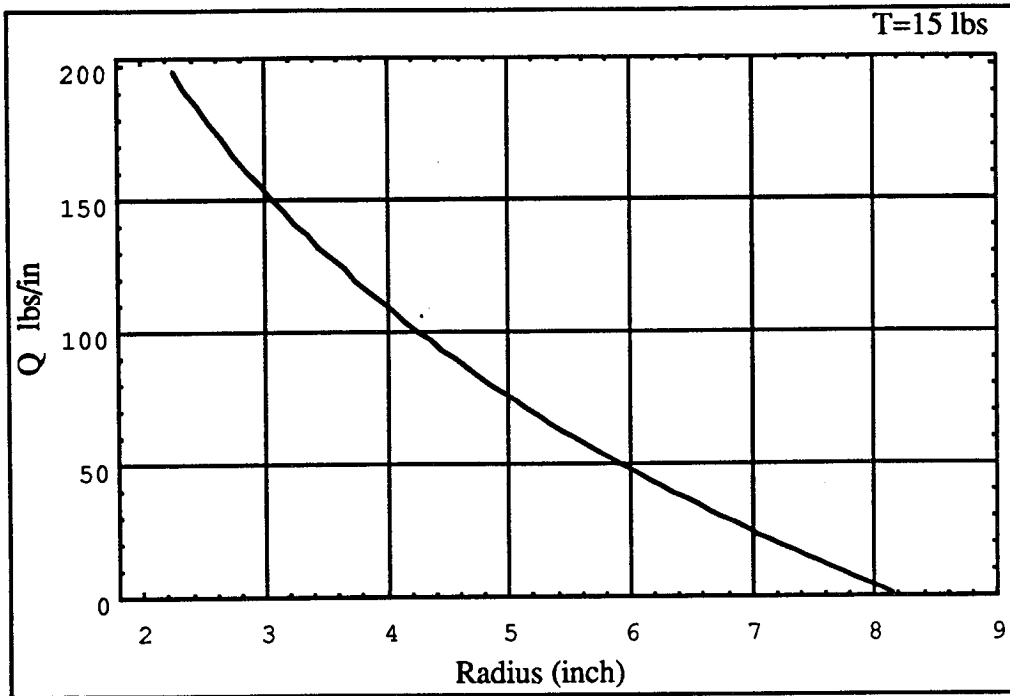
At location where failed tether was stored ($R = 2.25 \text{ in}$)

$$Q_{R=2.25} = 197.3 \text{ lbs / in} \quad \text{or} \quad Q_{R=2.25} = 345.5 \text{ N / cm}$$

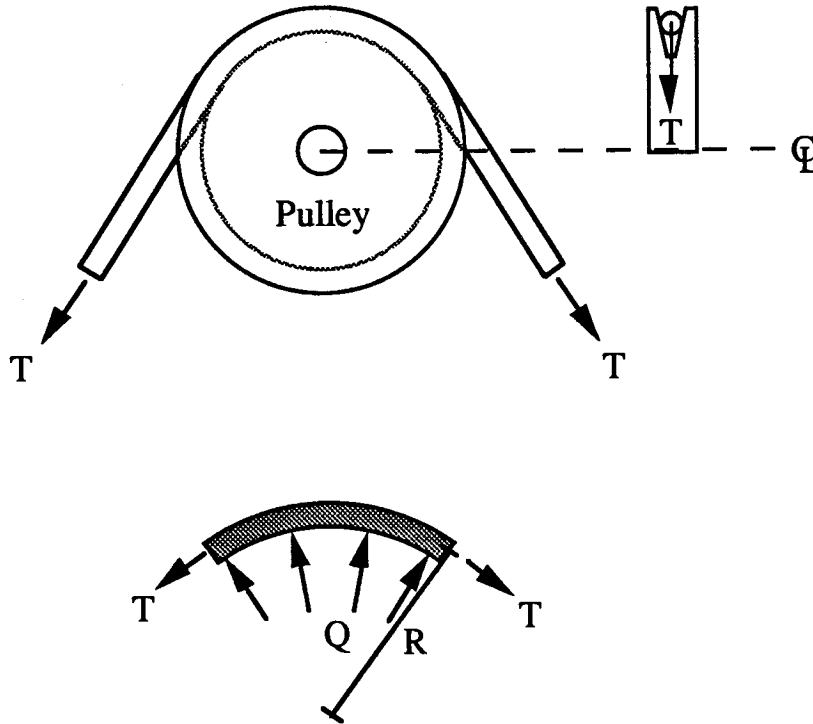
The above is a free body diagram of the a tether section with tension T over a pulley of radius R being reacted by a force/ unit length Q. The derivation is similar to that of the over wrap which proceeds from equilibrium. The result is given by:

$$Q = \frac{T}{R}$$

$$Q = 10.3 \text{ lbs / in} \quad \text{or} \quad Q = 18.0 \text{ N / cm}$$
