Debris/Ice/TPS Assessment and Integrated Photographic Analysis of Shuttle Mission STS-72

**DEBRIS/ICE/TPS ASSESSMENT
AND
INTEGRATED PHOTOGRAPHIC ANALYSIS
OF
SHUTTLE MISSION STS-72**

11 January 1996

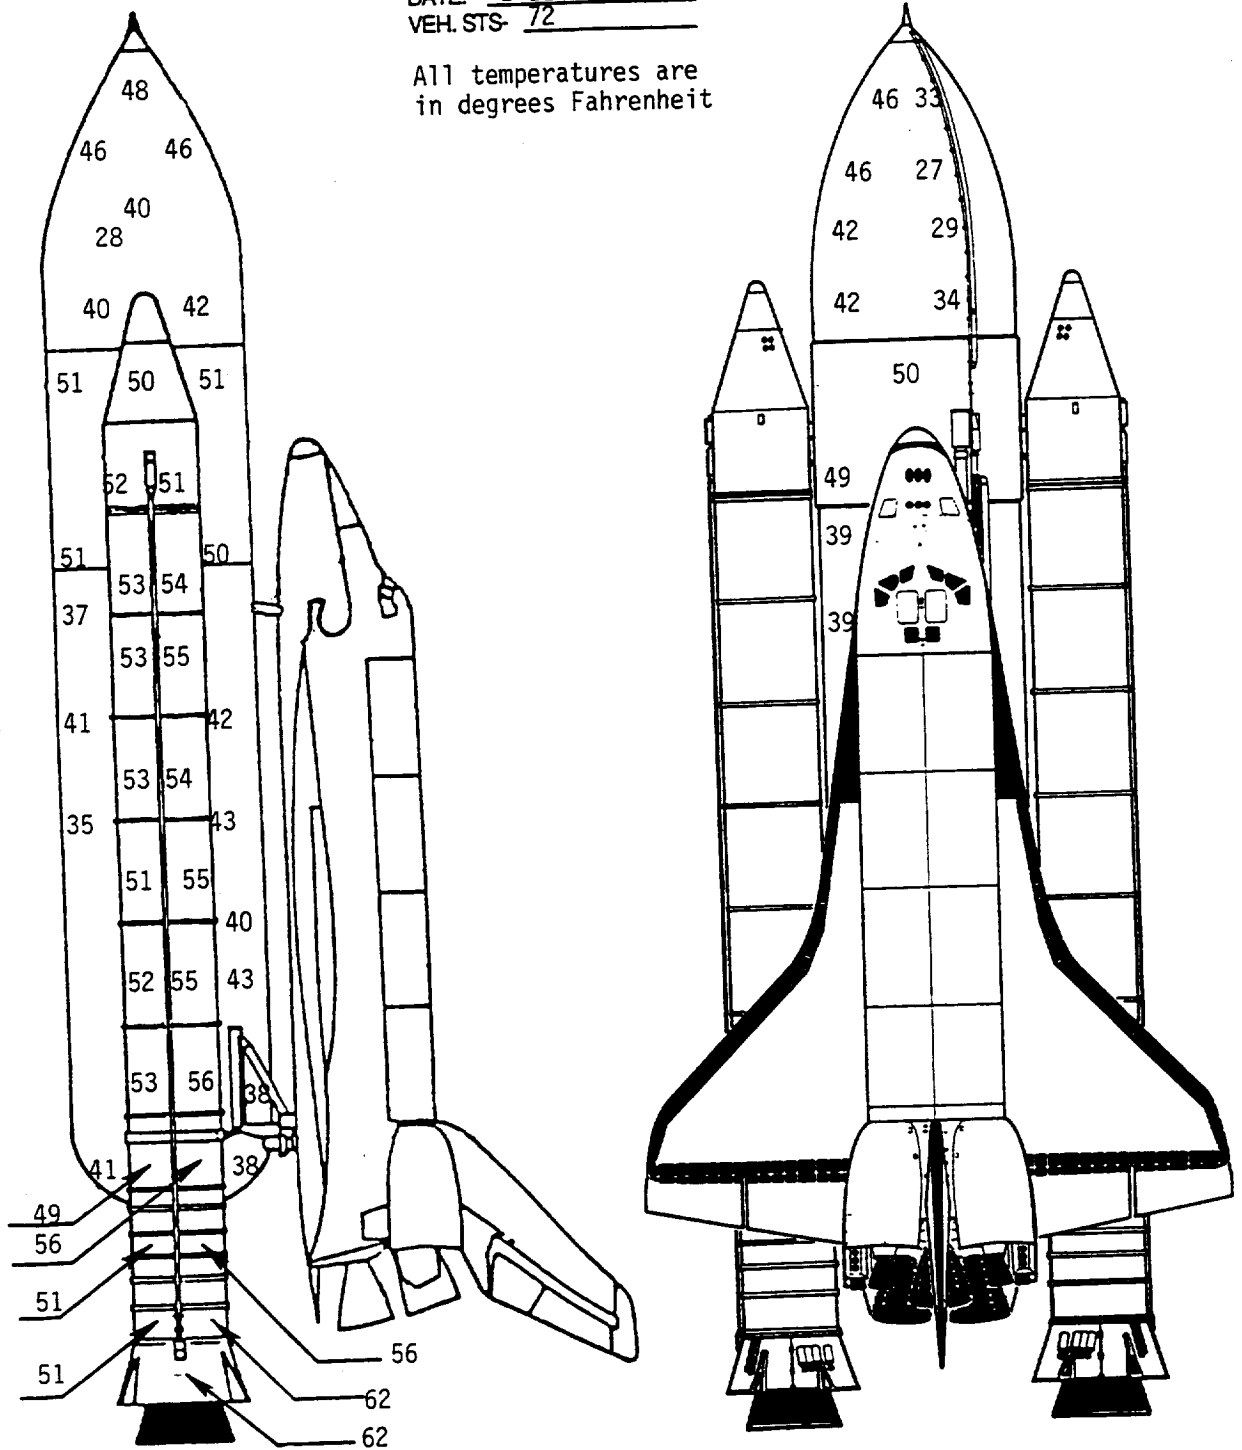
Figure 1: Vehicle Surface Temperature STI Measurements

A portable Shuttle Thermal Imager (STI) infrared scanning radiometer was utilized to obtain vehicle surface temperature measurements for an overall thermal assessment of the vehicle, particularly those areas not visible from remote fixed scanners, and to scan for unusual temperature gradients (Figures 1 and 2).

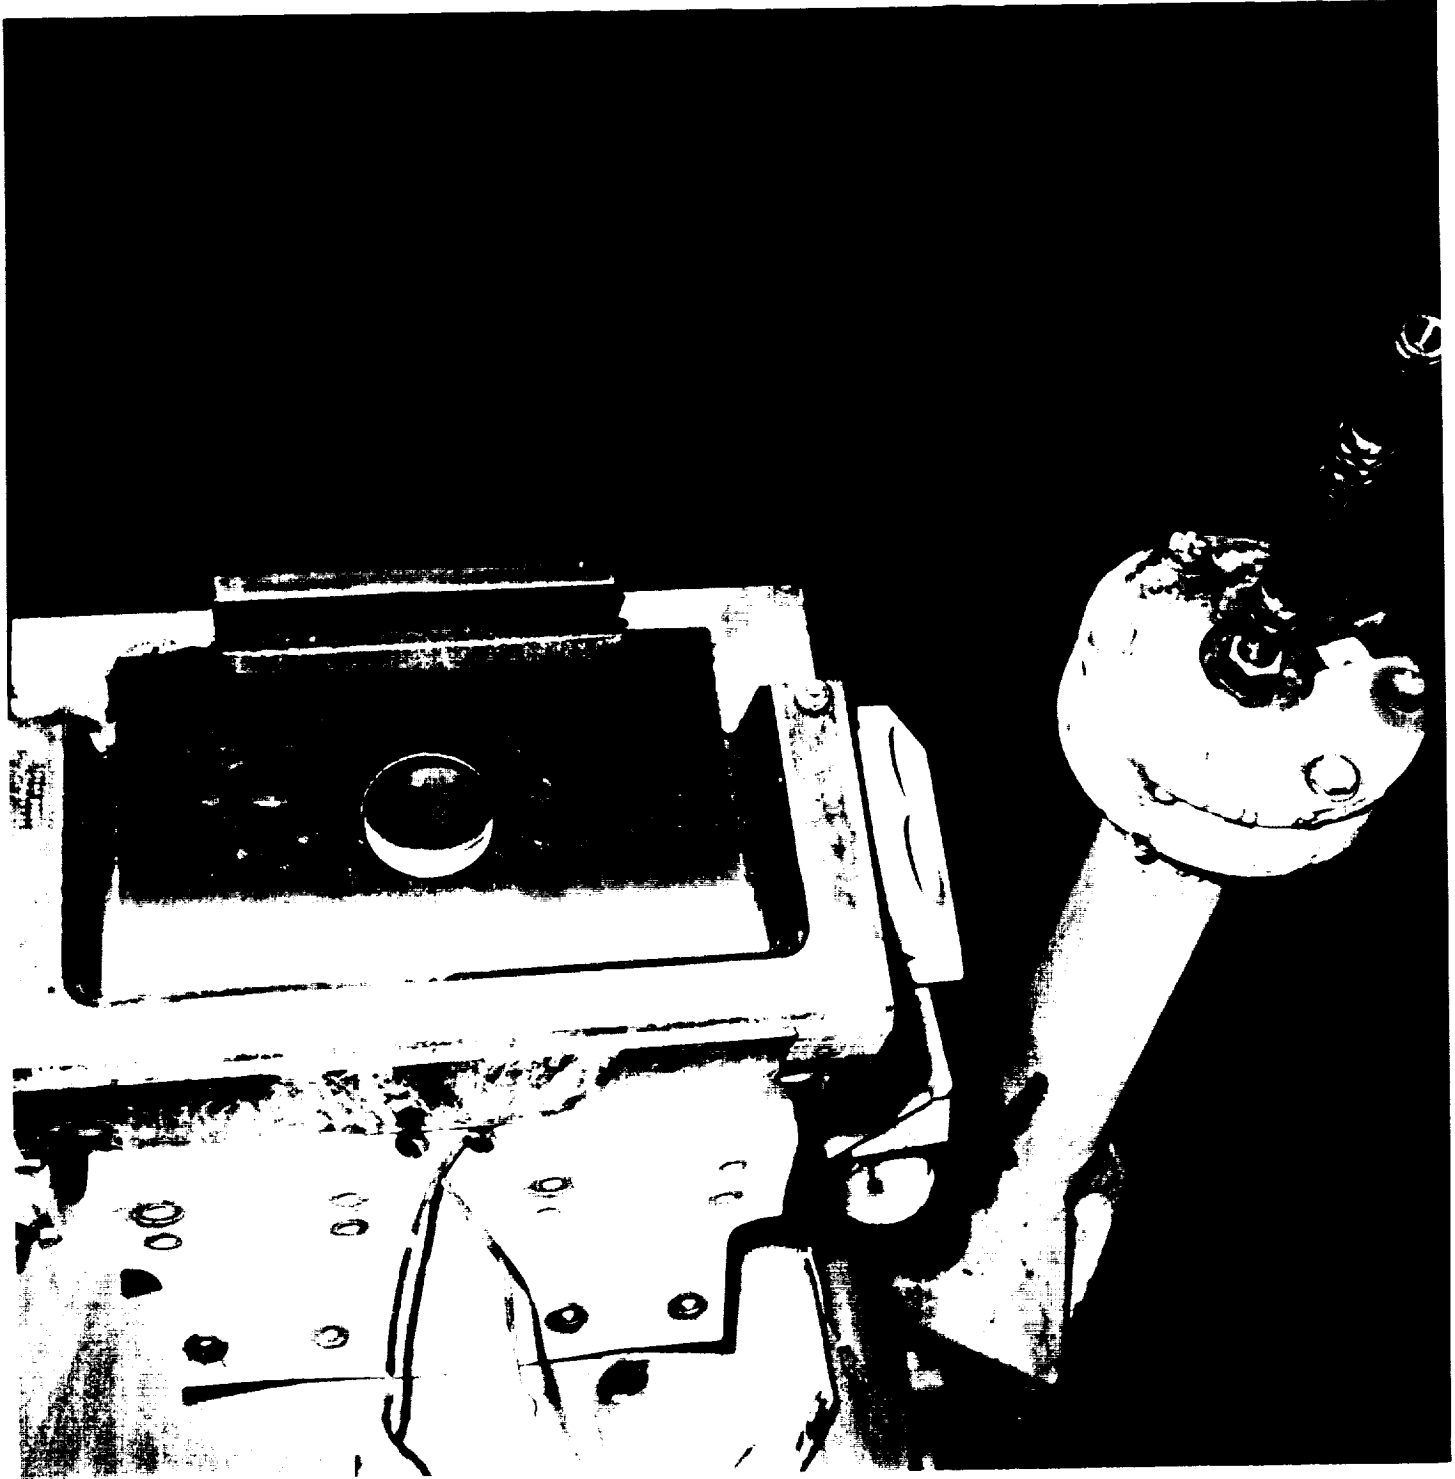
Photo 10: Aft Skirt Shoe Shim

Although the aft skirt shoe shim material was intact, the new material, which is somewhat darker than the material used prior to BI-074, exhibited a bubbled appearance after launch

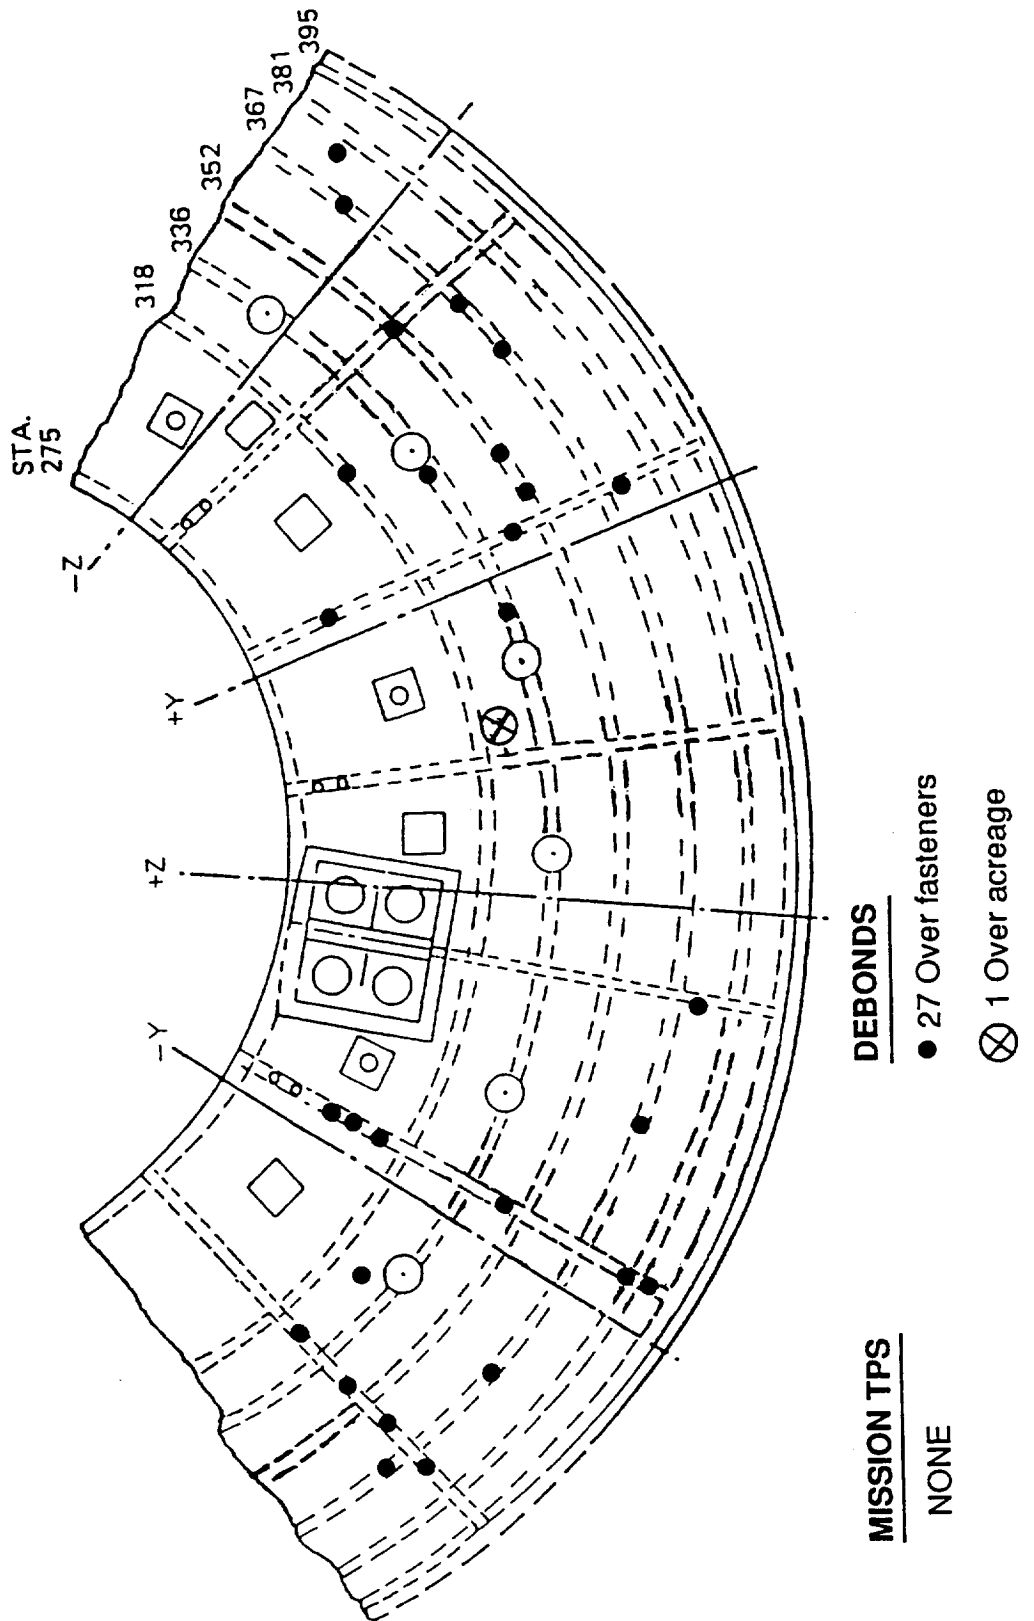
Figure 4: RH SRB Frustum

The RH frustum was missing no TPS. The number of debonds over fasteners (27) and over acreage (1) was close to the average (Figure 4). Hypalon paint was blistered/missing along the XB-395 ring frame where BTA closeouts had been applied. However, most of the exposed BTA substrate was not sooted. The BSM aero heat shield covers had locked in the fully opened position though the two lower cover attach rings had been bent slightly by parachute riser entanglement.

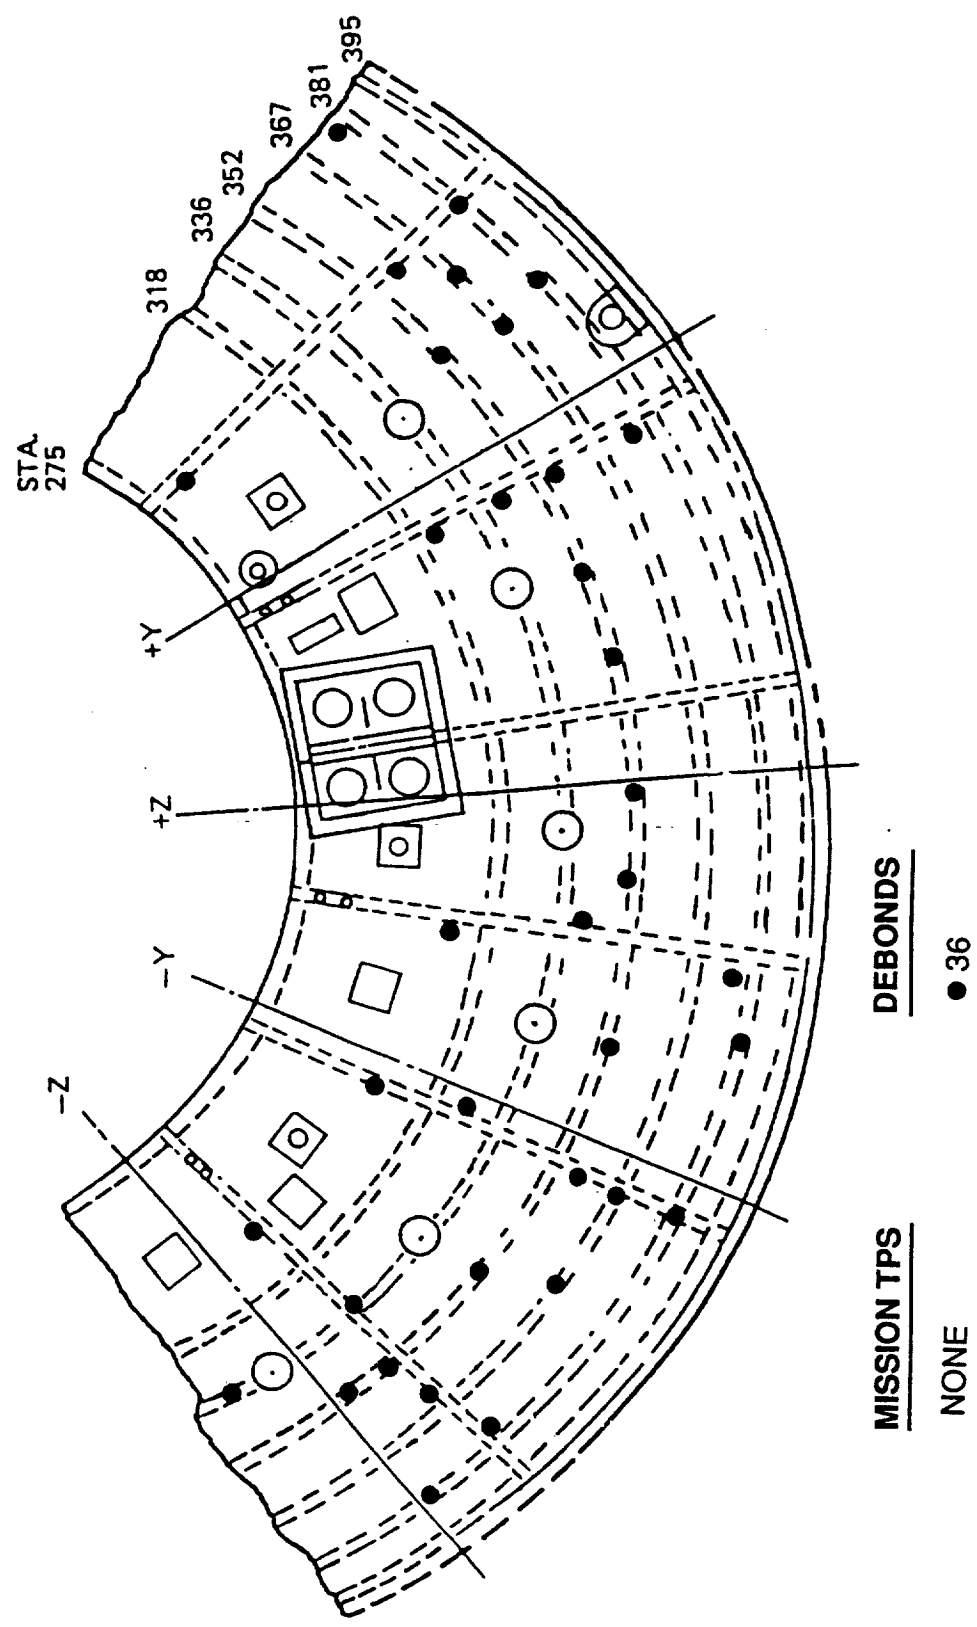
Figure 5: LH SRB Frustum

The LH frustum was missing no TPS. The number of MSA-2 debonds over fasteners (36) was average (Figure 5). Hypalon paint was blistered/missing along the XB-395 ring frame where BTA closeouts had been applied. However, most of the exposed BTA substrate was not sooted. The BSM aero heat shield covers had locked in the fully opened position.

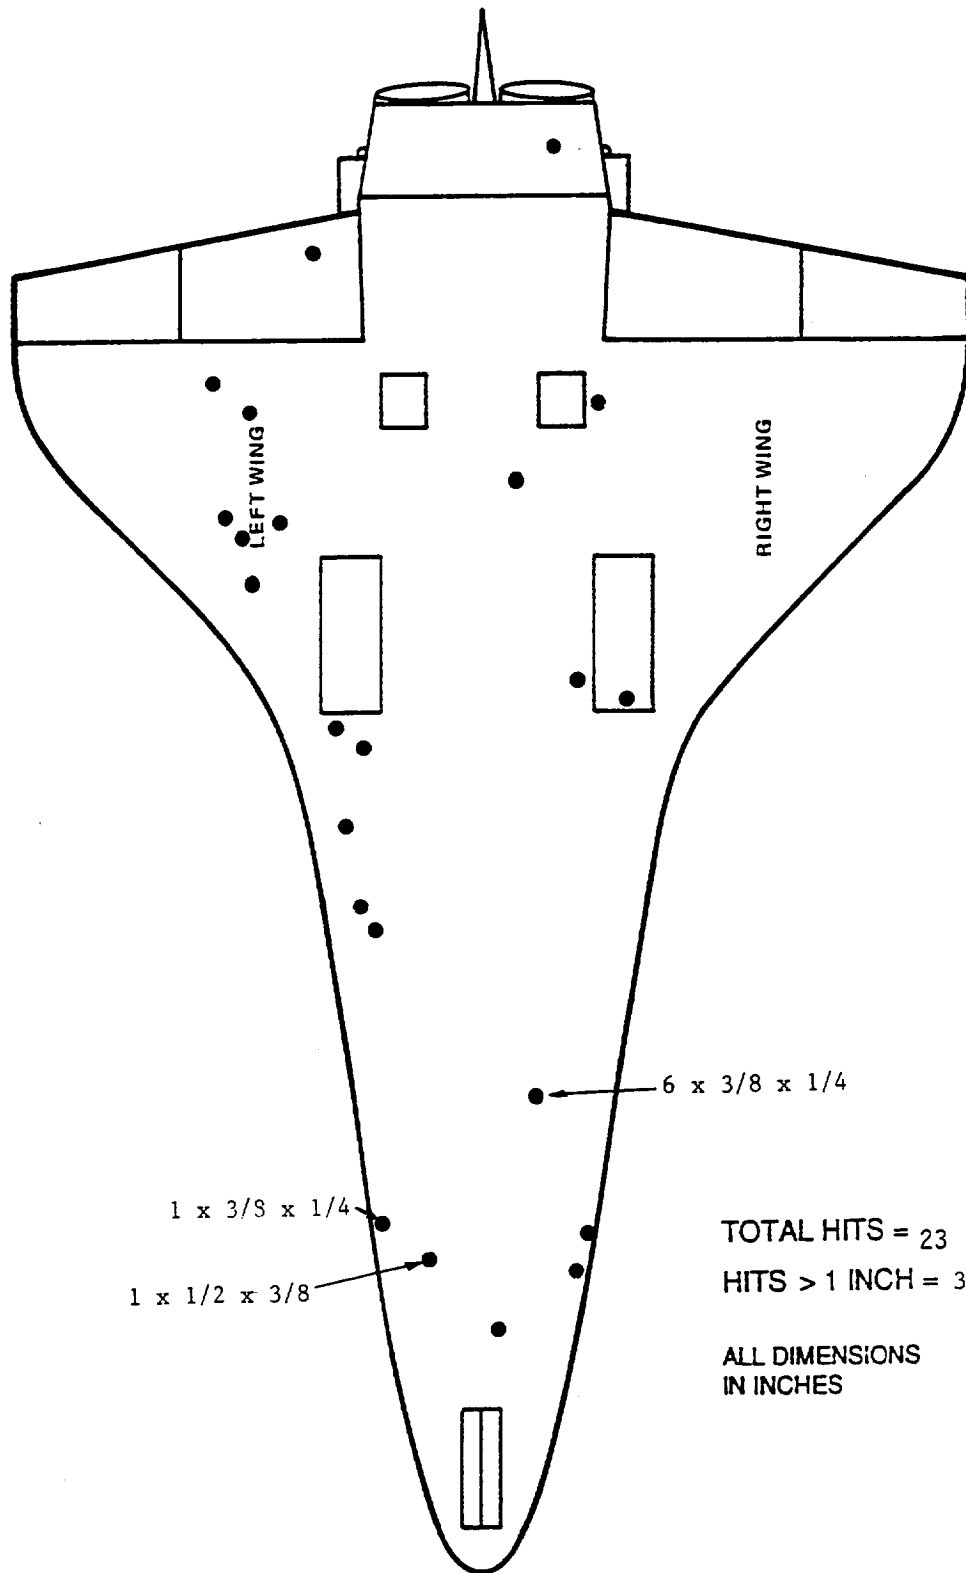
Figure 6: Orbiter Lower Surface Debris Map

The Orbiter lower surface sustained a total of 23 hits, of which 3 had a major dimension of 1-inch or larger. The largest lower surface tile damage site occurred approximately 15 feet forward of the RH MLG wheel well and measured 6.0-inches long by 0.375-inches wide by 0.25-inch maximum depth. The only debris found on the runway under the umbilical cavities (LH2) consisted of a bolt 0.875-inches long by 0.1875-inches in diameter with a red coating on the head. The bolt, stamped with the number MS 21279-7, is used in the Orbiter aft compartment SSME wire bundle clamps. A post flight inspection of the aft revealed no missing bolts (Ref. Lost and Found PR LAF-5-11-0199).

A post landing debris inspection of OV-105 Endeavour was conducted 20-21 January 1996 at the Kennedy Space Center on SLF runway 15 and in the Orbiter Processing Facility bay #3. This inspection was performed to identify debris impact damage and, if possible, debris sources. The Orbiter TPS sustained a total of 55 hits, of which 6 had a major dimension of 1-inch or larger. This total does not include the numerous hits on the base heat shield attributed to SSME vibration/acoustics and exhaust plume recirculation. A comparison of these numbers to statistics from 57 previous missions of similar configuration (excluding missions STS-23, 25, 26, 26R, 27R, 30R, and 42, which had damage from known debris sources), indicates both the total number of hits and the number of hits 1-inch or larger was exceptionally less than average (reference Figures 6-9).

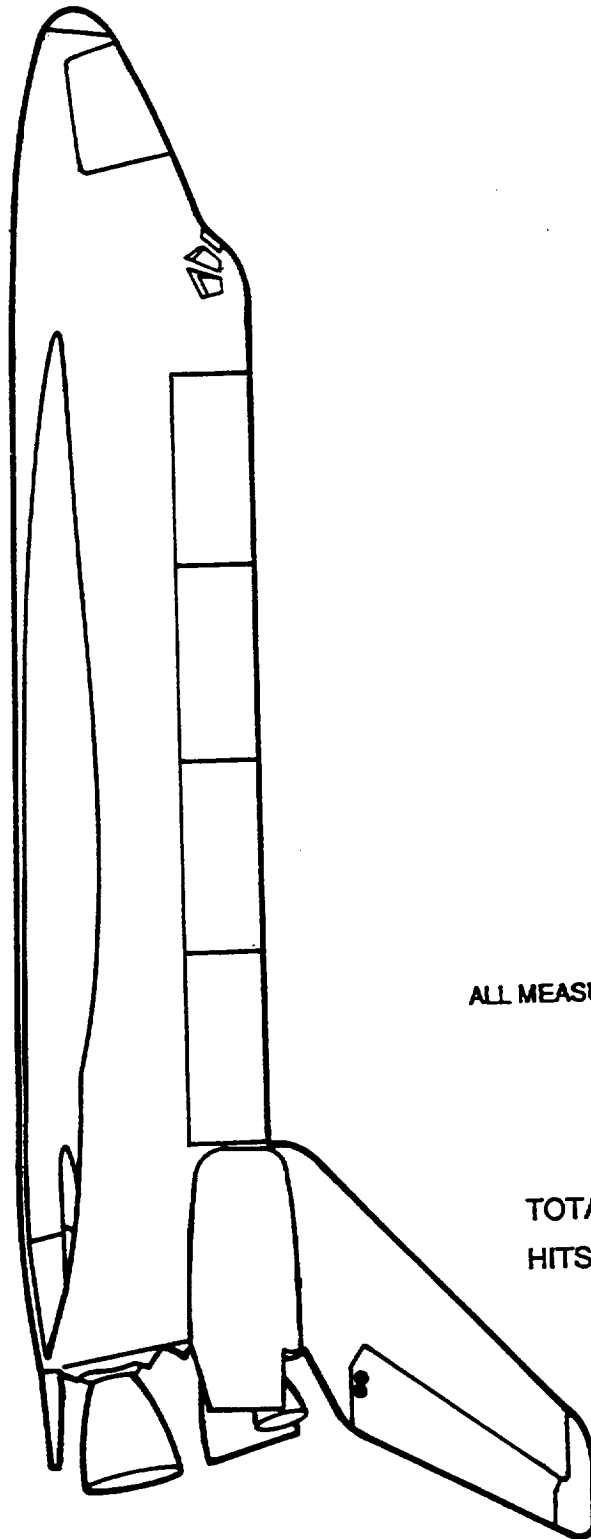
Figure 8: Orbiter Left Side Debris Map

TOTAL HITS = 2

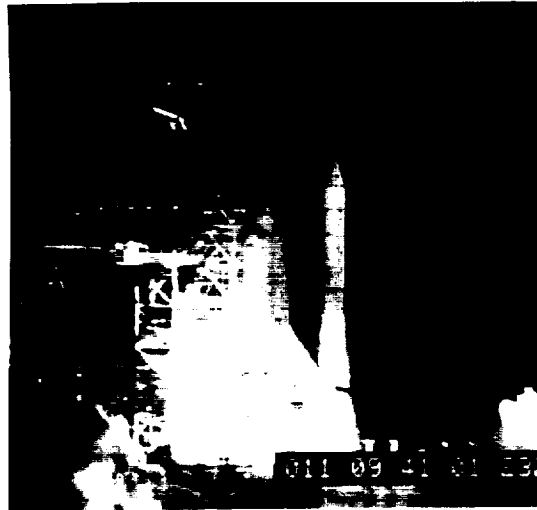
Figure 2.1.2.2 Flame Trench Debris

Several pieces of flame trench debris were seen north of the vehicle at SRB ignition (011:09:41:01.232 UTC). The debris moved north away from the vehicle and was not seen to strike the vehicle.

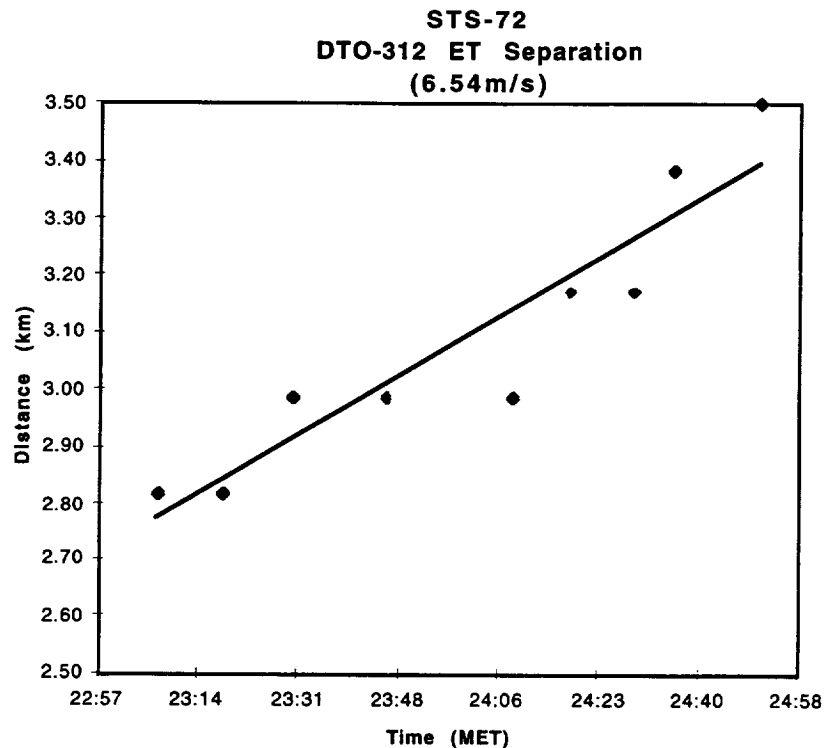
Figure 2.4.1(A) ET Separation Velocity.

Using the 35mm handheld (Nikon F4) camera film, the external tank distance was calculated over a 9 frame sequence. The external tank was calculated to be a distance of 2.8km away from the Orbiter at 23:07 MET; 104 seconds later at 24:51 MET the tank was calculated to be at 3.5km. The tank separation velocity was determined to be 6.54 m/s. Roll rate was estimated at 0.6°/sec, and tumble rate was estimated at 0.4°/sec. The separation velocity and roll/tumble rates were similar to previous mission measurements.

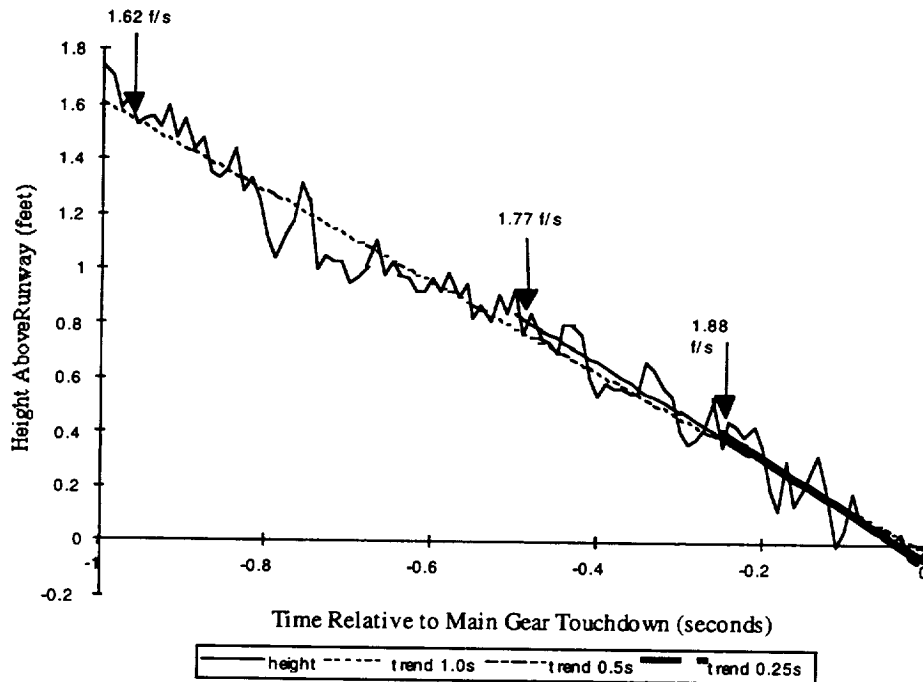
Figure 2.5.1 Main Gear Height Versus Time Prior to Touchdown (Film)

The measured main gear values were found to be below the maximum allowable values of 9.6 ft/sec for a 211,000 lb. vehicle and 6.0 ft/sec for a 240,000 lb. vehicle (the landing weight of the STS-72 Orbiter was reported to be 220,000 lb.). The sink rate measurements for STS-72 are given in Table 2.5.1. In Figure 2.5.1 the trend of the measured data points for film image data are illustrated.
