NASA Technical Paper 3583

# Impact Damage Resistance of Carbon/Epoxy Composite Tubes for the DC-XA Liquid Hydrogen Feedline

*A.T. Nettles*

September 1995

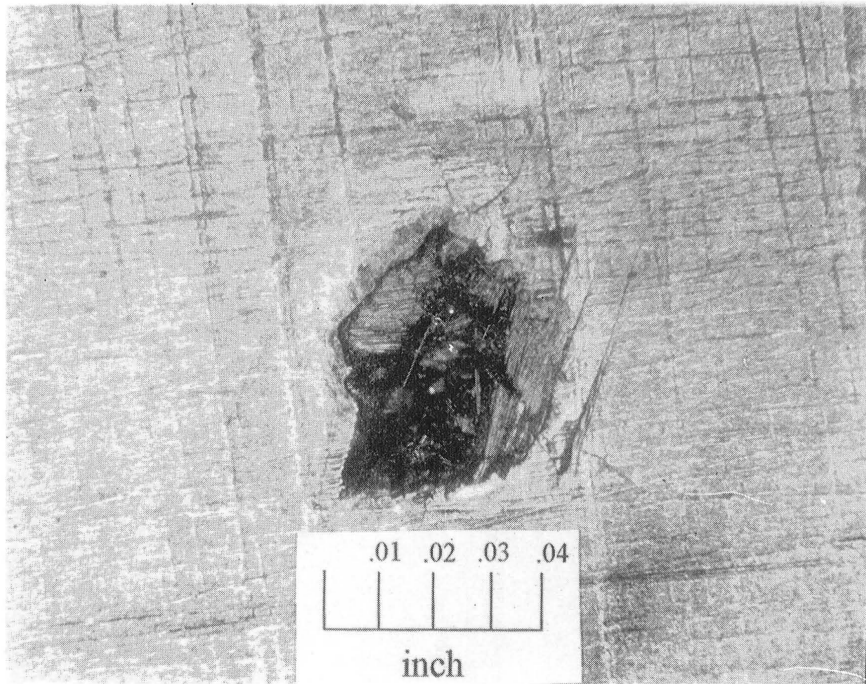
Hit No. 9

The surface damage can be seen in the cross-sectional photograph of hit No. 9. The typical conical region of damage observed in impact damaged composites can be seen in this, and most other, photomicrographs. This type of damage consists of heavy matrix damage below the impact site, with delaminations spreading out further away from this point as the specimen gets deeper.

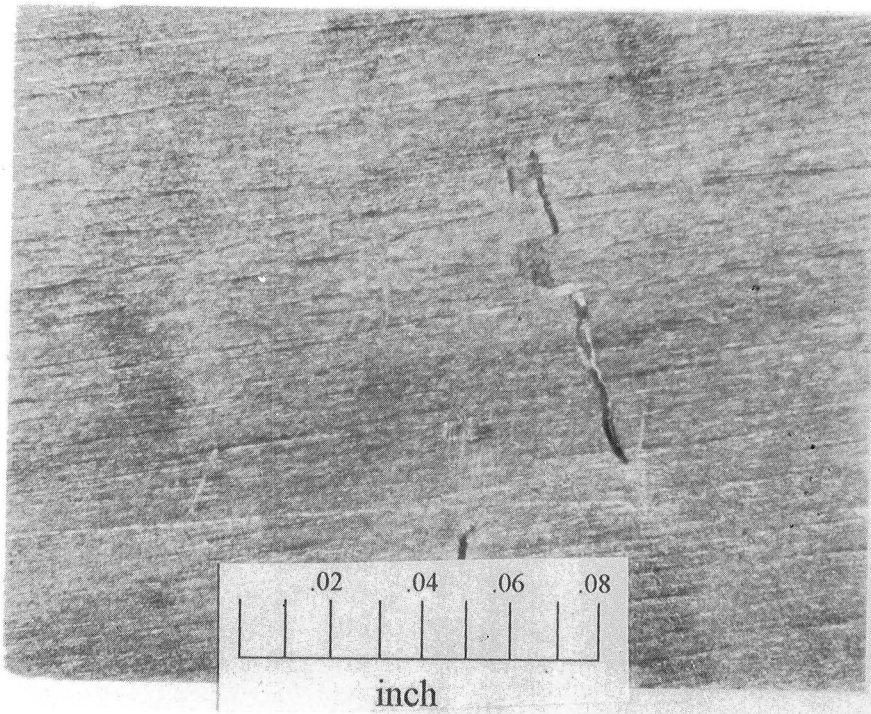
Hit No. 12

11	2-mm tup	0.96	676	Barely visible nick/small leak
12	2-mm tup	1.27	774	Barely visible dent with small crack/medium leak rate
13	2-mm tup	1.56	819	Visible dent with cracks/medium leak rate
14	2-mm tup	1.76	828	Visible dent with large crack/heavy leak rate
15	2-mm tup	2.03	890	Visible dent with long crack/heavy leak rate
16	2-mm tup	1.00	716	Visible dent with cracks/medium leak rate
17	2-mm tup	1.00	716	Visible dent with crack/medium leak rate
18	2-mm tup	0.81	681	Barely visible dent with small split/medium leak rate
19	2-mm tup	0.75	708	Barely visible dent with very small split/low leak rate

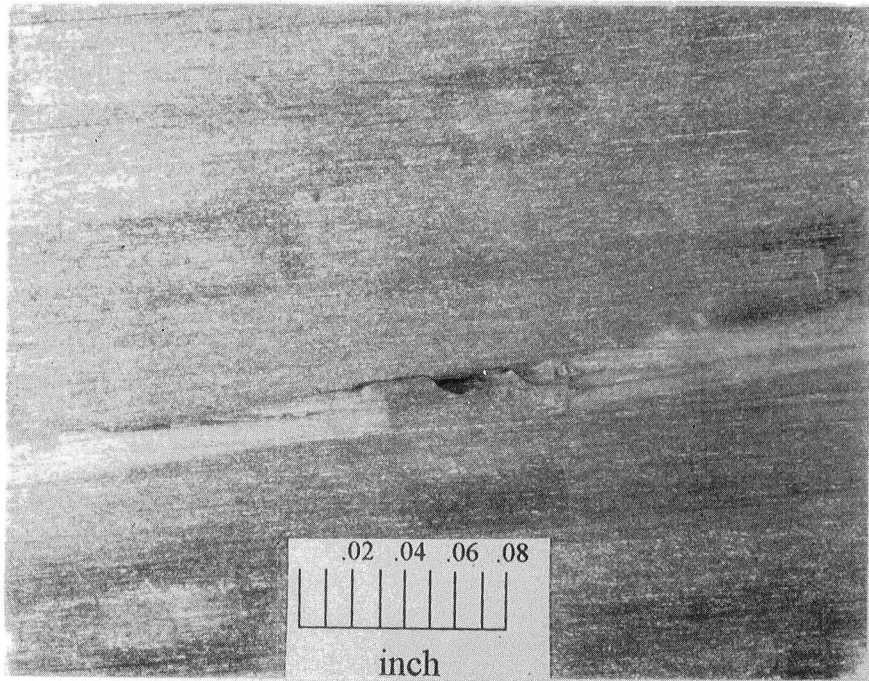
Hit No. 2

Hit No.	Impact Energy (J)	Maximum Load (N)	Visible damage/Leak
1	2.66	850	Crack visible/leak easily detectable at 5 lb/in <sup>2</sup> gauge
2	1.52	890	Very slight split on surface/leak easily detectable at 5 lb/in <sup>2</sup> gauge
3	0.60	663	No visible damage/no leak at 60 lb/in <sup>2</sup> gauge
4	0.83	716	No visible damage/leak at 25 lb/in <sup>2</sup> gauge
5	0.88	846	No visible damage/no leak at 60 lb/in <sup>2</sup> gauge
6	0.87	859	Surface cracking visible under microscope/leak at 7 lb/in <sup>2</sup> gauge
7	0.88	912	No visible damage/leak at 20 lb/in <sup>2</sup> gauge
8	0.83	841	No visible damage/no leak at 60 lb/in <sup>2</sup> gauge
9	0.84	903	No visible damage/no leak at 60 lb/in <sup>2</sup> gauge
10	0.88	921	No visible damage/no leak at 60 lb/in <sup>2</sup> gauge
11	0.88	854	No visible damage/no leak at 60 lb/in <sup>2</sup> gauge
12	0.88	957	No visible damage/no leak at 60 lb/in <sup>2</sup> gauge

1. Surface Damage. Surface photomicrographs of the damage that caused leaks are given in appendix D. All of the photographs show matrix gel coat cracking in the region near the impact site with no localized damage present. This is due to the large diameter striker being used, which helps

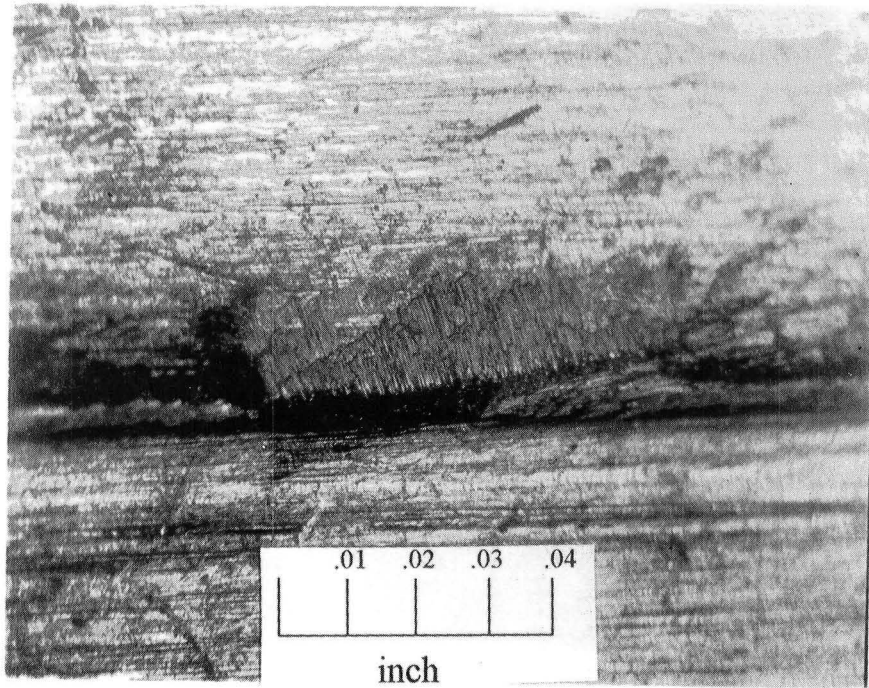
Hit No. 13

13	1.03	No data	Very small surface crack/leak at 15 lb/in <sup>2</sup> gauge
14	1.03	908	No visible damage/no leak at 60 lb/in <sup>2</sup> gauge
15	1.06	899	Small split visible under microscope/leak at 10 lb/in <sup>2</sup> gauge
16	1.06	810	Very small split visible under microscope/leak at 10 lb/in <sup>2</sup> gauge

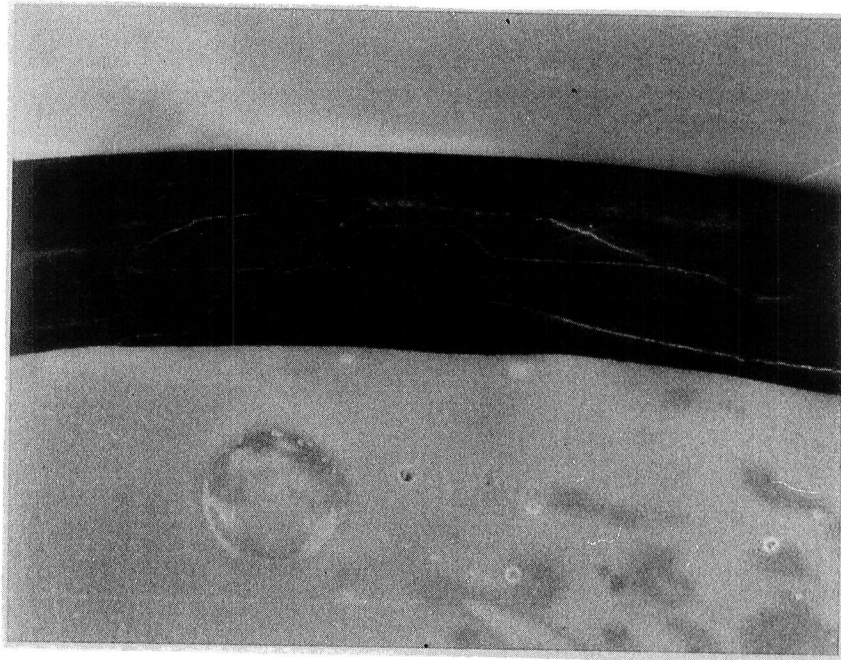
Hit No. 13

2. Cross-Sectional Examination. Cross-sectional photomicrographs of the impacted areas that caused leaks are given in appendix E. Extensive delaminations and matrix cracking are evident on specimens No. 1 and 2 as might have been expected due to the high leak rates observed. Specimens No. 4 and 6, which had surface damage confined to the "seam" area of the tube, show typical delaminations and matrix cracking, indicating that subsurface damage is not effected by the visible damage being restricted to the "seam" area. Specimen No. 15 shows the typical conical type damage mentioned in the previous section on sharp impacts.
