# Debris/Ice/TPS Assessment and Integrated Photographic Analysis of Shuttle Mission STS-64

**DEBRIS/ICE/TPS ASSESSMENT  
AND  
INTEGRATED PHOTOGRAPHIC ANALYSIS  
OF  
SHUTTLE MISSION STS-64**

**9 August 1994**

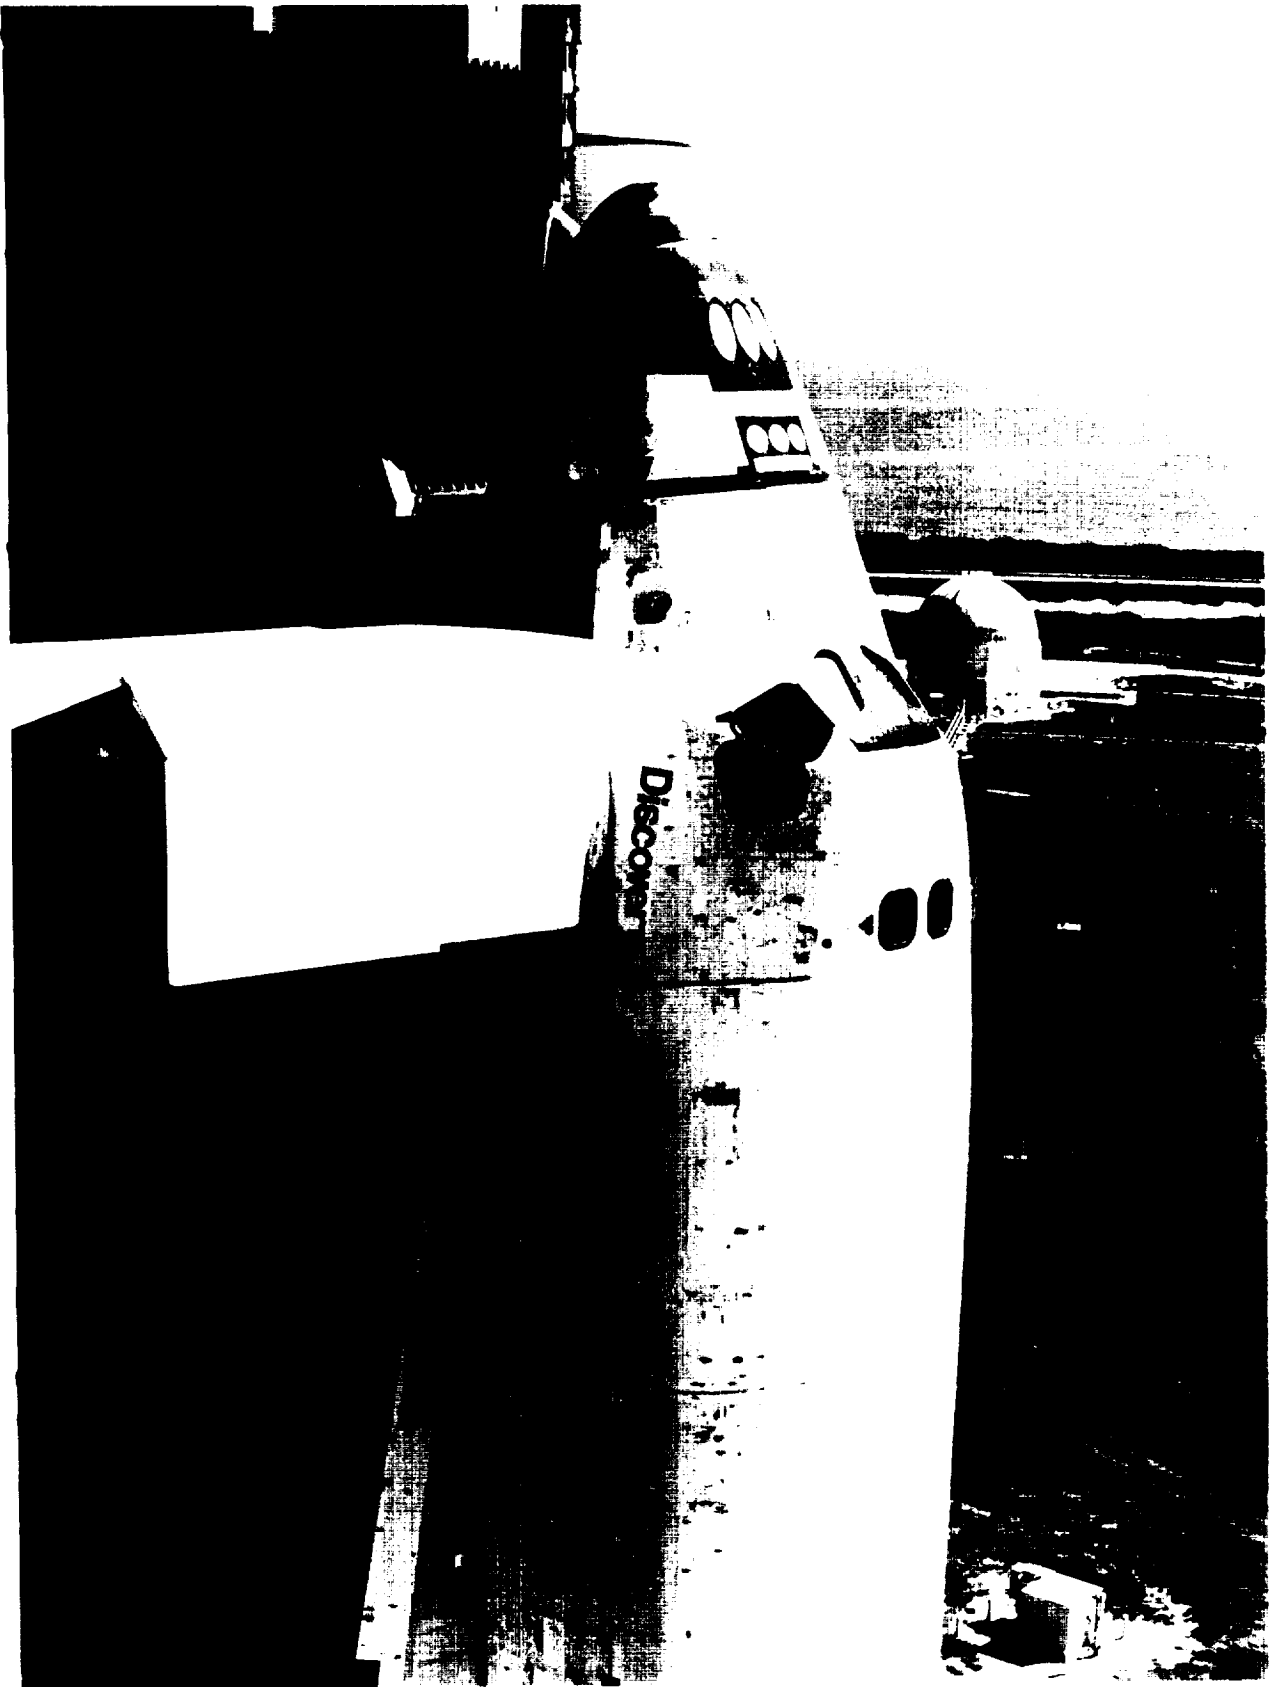
**Photo 2 : Overall View of STS-64 Vehicle**

OV-103 Discovery (19th flight), ET-66 (LWT 59), and BI-068 SRB's

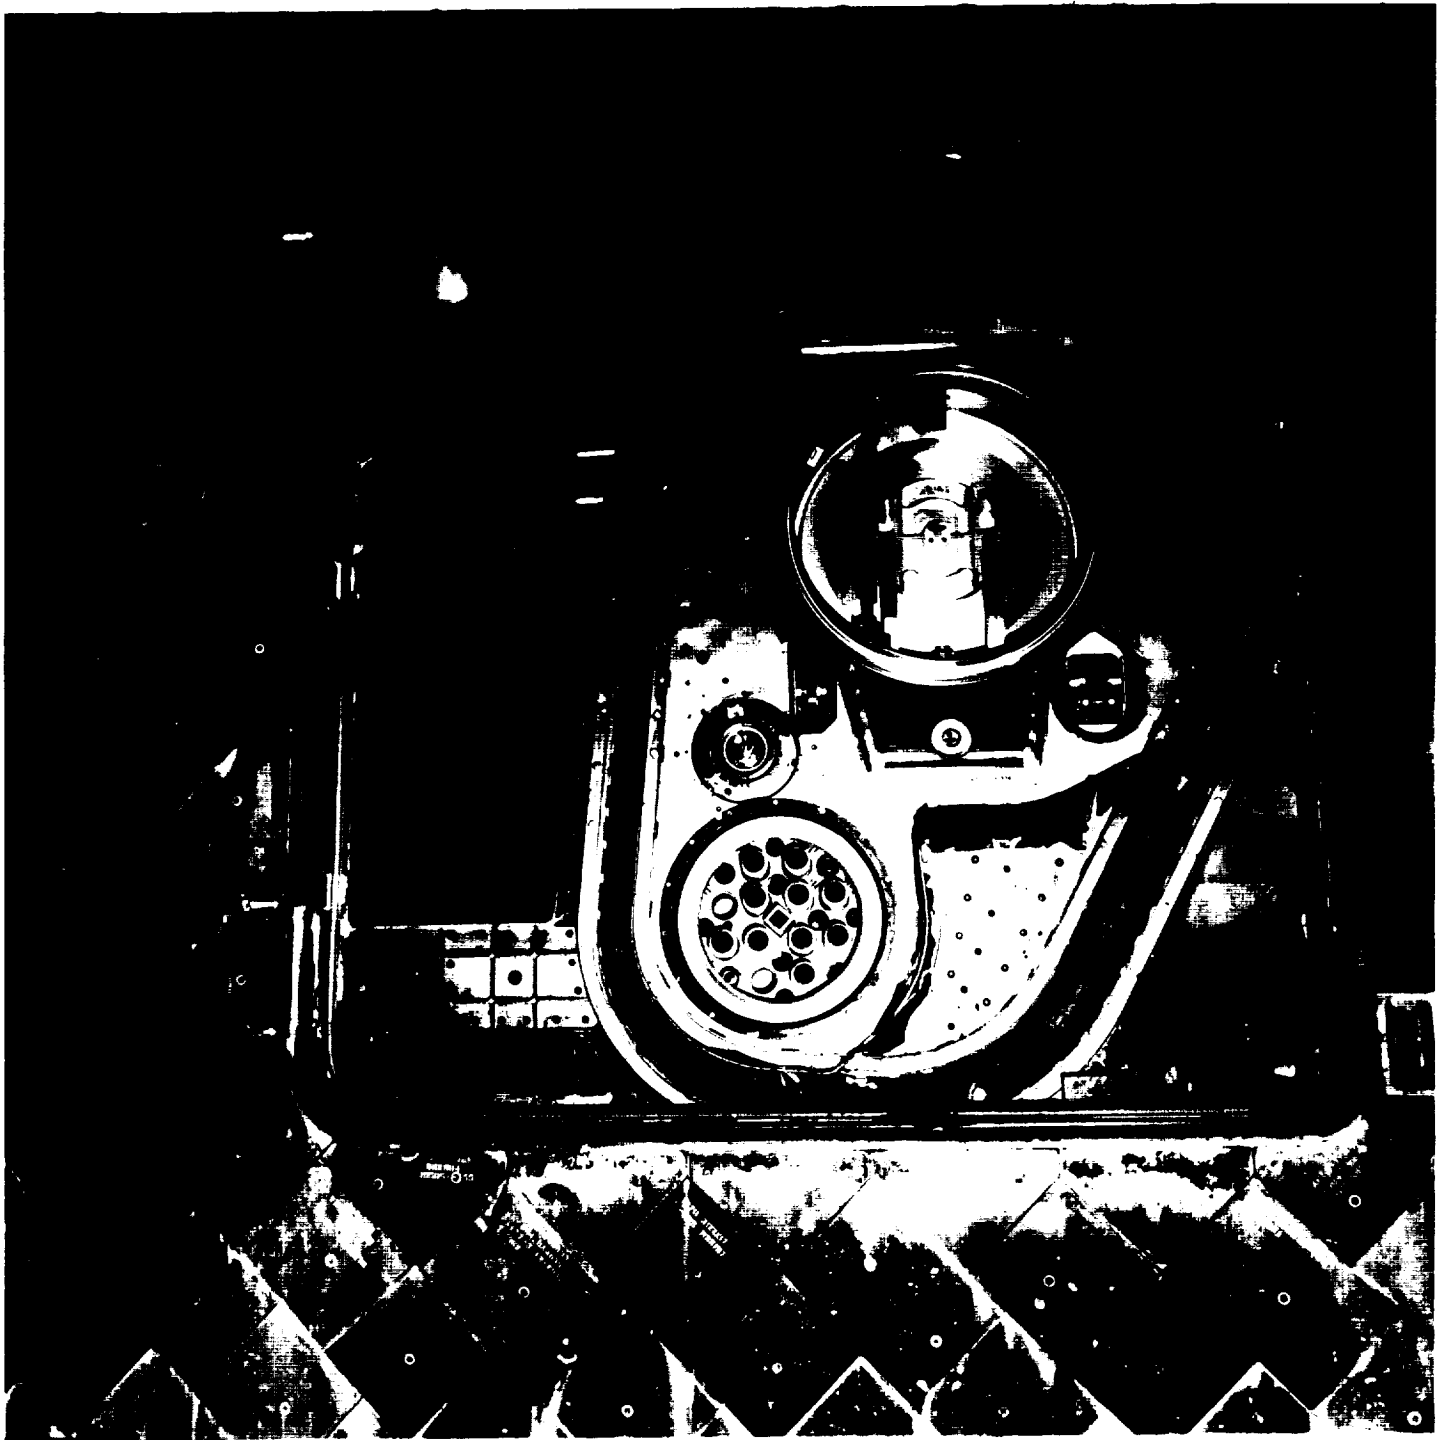
Photo 20 : LO2 ET/ORB Umbilical

There were no TPS anomalies on the LO2 ET/ORB umbilical. Ice/frost fingers on the separation bolt pyrotechnic canister purge vents were typical.

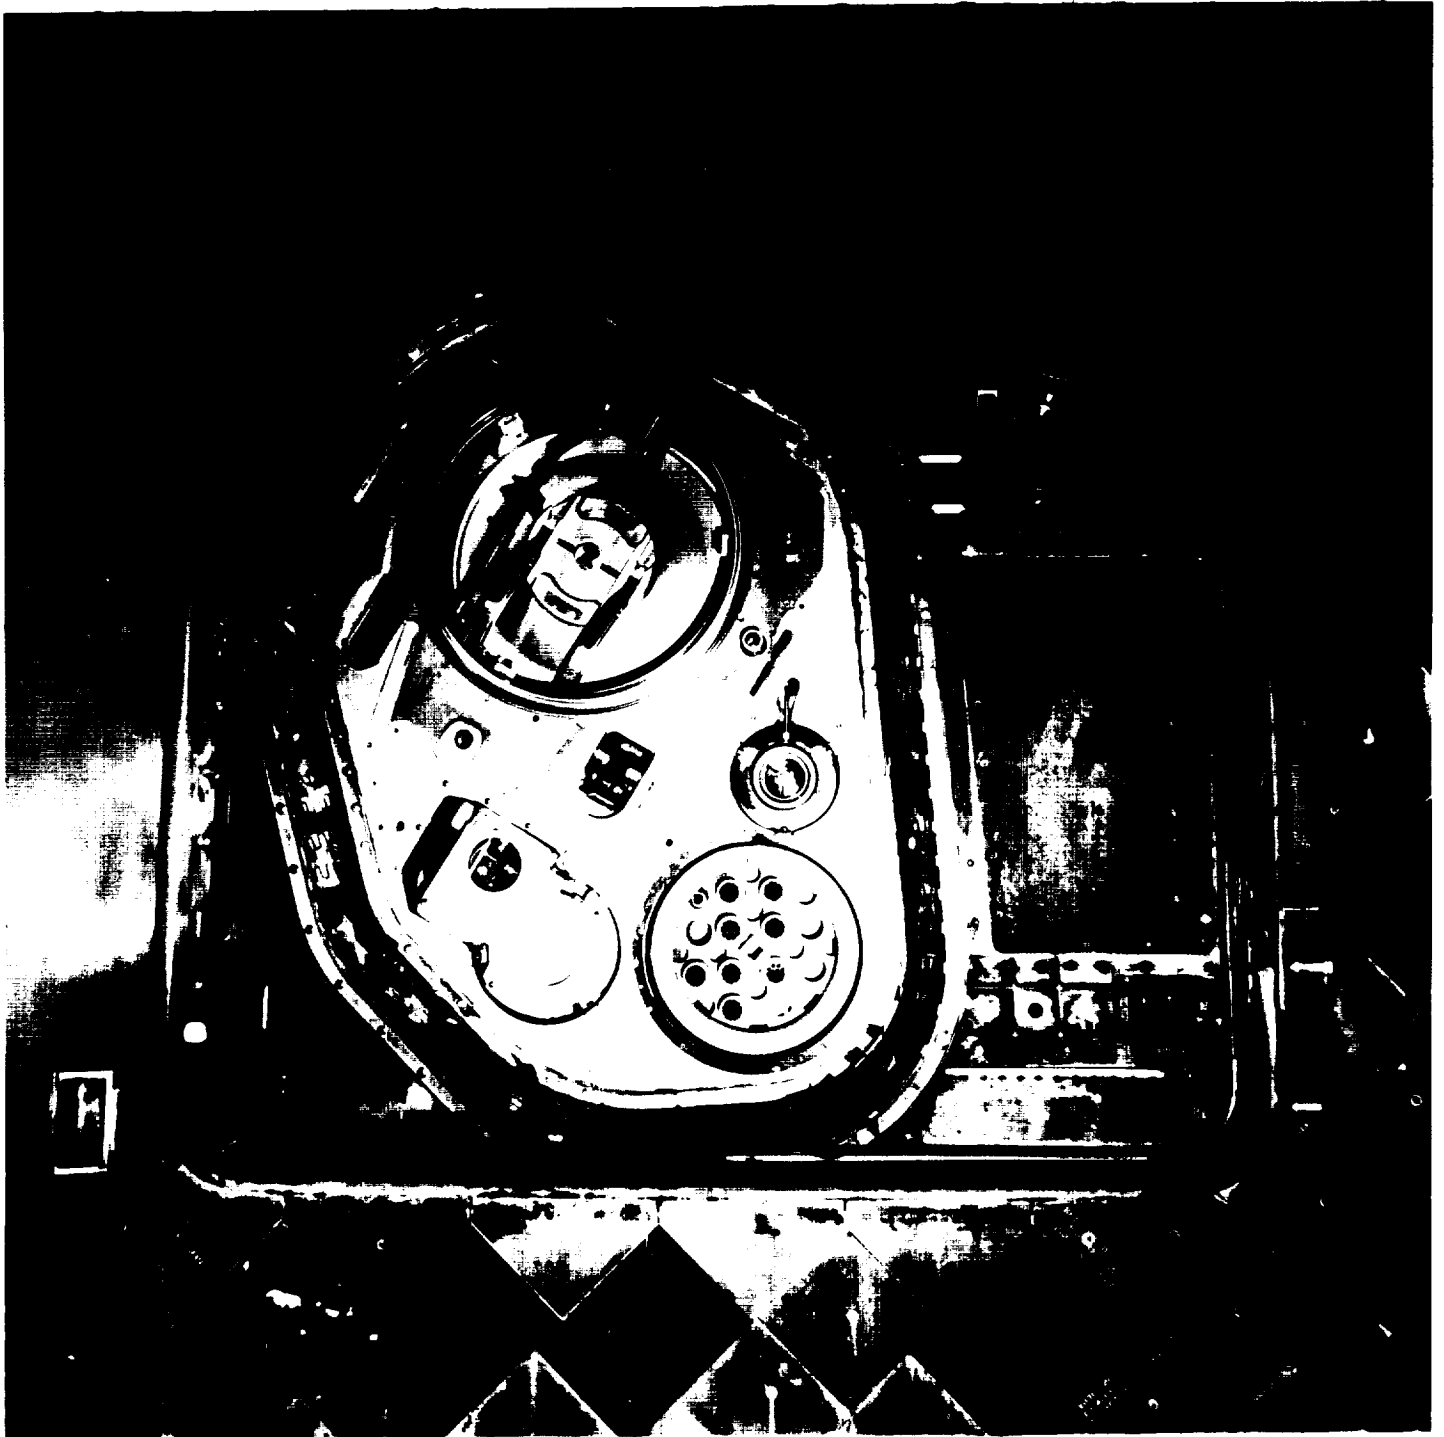
Photo 21 : LH2 ET/Orbiter Umbilical

ET/Orbiter separation devices EO-1, EO-2, and EO-3 functioned properly and the debris plungers were seated. All ET/Orbiter umbilical separation ordnance retention shutters were closed properly. No significant amounts of foam or red purge seal adhered to the LH2 ET/ORB umbilical near the 4-inch flapper valve. No debris was found on the runway beneath the ET/ORB umbilical cavities.

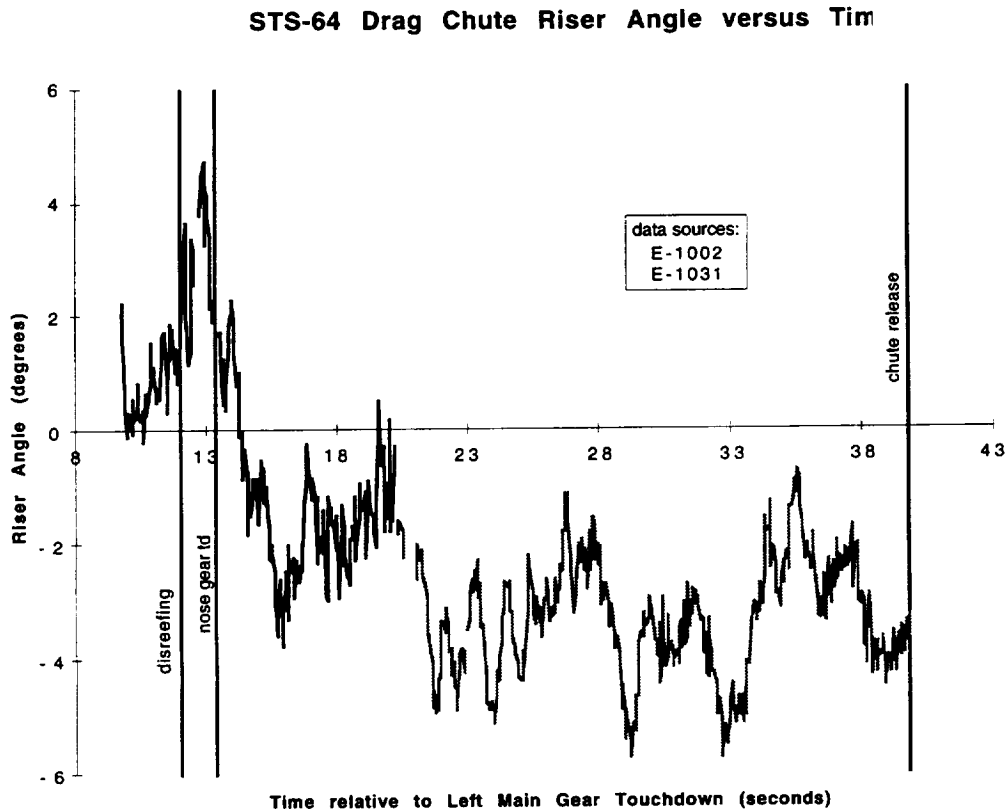
**Figure 2.6.2 (b) Riser Angle Versus Time**

Standard analysis of the drag chute angles as a function of time was performed using the views from the film cameras E-1002 and E-1031. This analysis is used to support the improvement of the aerodynamic math models currently in use. Figure 2.6.2b presents the measured heading angle versus time. Figure 2.6.2c presents the measured riser angle versus time. The maximum measured horizontal chute deflection (heading angle) was approximately 6.9 degrees to the starboard side of the vehicle. The vertical chute deflection (riser angle) ranged from -5.7 to +4.7 degrees relative to the Orbiter coordinate system.
