NASA Technical Memorandum 109142

# The Characterization of WideSpread Fatigue Damage in Fuselage Structure

September 1994

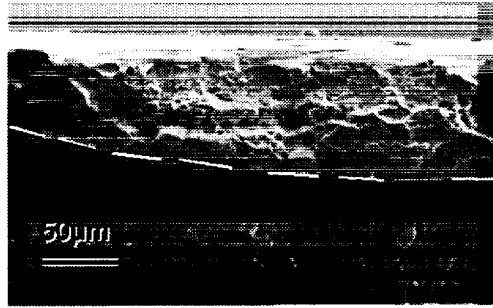
Laboratory fatigue tests conducted at LaRC has confirmed that the fatigue crack morphology shown in Figure 6 is indicative of out-of-plane bending loads. Tension-bending (T/B) constant amplitude fatigue tests were conducted using 2.1 mm thick center-cracked alloy 2024T3 sheet specimens. The fatigue crack fracture morphology from a specimen tested at a T/B ratio of 1.5 is shown in Figure 7. Figure 7a is a SEM micrograph showing the fatigue crack front (dashed line) at region A in Figure 7b. The remaining ligament, shown in Figure 7a, exhibits a ductile tearing morphology produced when breaking the specimen by overload after fatigue testing. The fatigue crack/ligament morphology was formed on the compressively-loaded surface while substantial fatigue crack growth continued on the tension surface, thus forming a crack geometry similar to that observed along the lap splice upper row rivet holes.

Figure 7. SEM micrograph illustrating the fatigue crack path produced as a result of tension/bend constant amplitude testing.
