THE EFFECTS OF PITTING ON FATIGUE CRACK NUCLEATION  
IN 7075-T6 ALUMINUM ALLOY

Li Ma and David W. Hoepfner \*  
University of Utah  
Salt Lake City, UT

SUMMARY

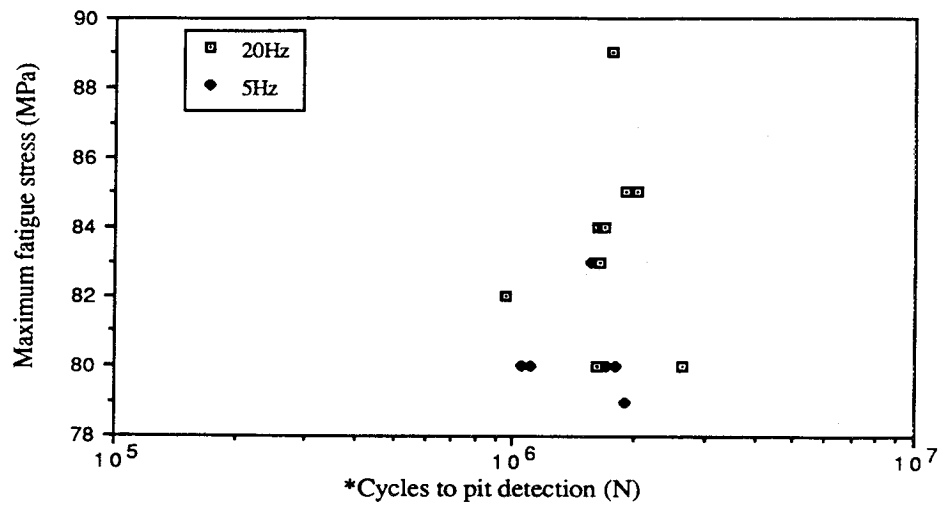
Fig. 3. Stress Vs. life plot of pit detection data.

The pit size life in terms of number of cycles, plotted against the maximum stress level is shown in Fig. 3. Here, the pit detection life is defined as the number of cycles to the "first observed" pit at the length of about 0.02 mm on the exposed surface. Thus, the pit detection life includes the nucleation phase as well as some pit growth. It should be noted that fairly large scatter (between 9,52,800 and 2,621,300 cycles) in the pit detection life data was observed at both frequencies (5 and 20 Hz). This scatter is believed to be related to the distribution of constituent particles, inclusions, as well as grain shape, size, and orientation.

The data shown in Fig. 3 indicate that pitting generally was detected after approximately one million cycles. The reason for the delay in pit formation is that pitting corrosion is a time (or cycles) dependent process. It takes time for aggressive anions ( $\text{Cl}^-$ ) contained in the solution to penetrate the passive film and locally destroy it. It was observed that, in 3.5% NaCl solution, the exposed surfaces of the specimens were corroded over whole areas in the very early stages of the test. Then corrosion pits were generated within the heavily corroded region. A typical series of video photographs showing the change in surface state of a specimen exposed to 3.5% NaCl solution are shown in Fig. 4. Within 68,900 cycles of exposure, the surface was obscured. The formation of a continuous corrosion product layer formed with progressive cycling, and the pits nucleated at localized attack sites. This observation is consistent with previous observation of Hoepfner[2] and Cox.[3]

The data shown in Fig. 3 also indicated that no appreciable frequency effect was identified at frequencies between 5 and 20 Hz. However, it is probable that lower frequencies would have a significant effect. This aspect is under further study. In addition, the life to detection of a corrosion pit is hardly affected by stress levels between 79 and 89 MPa. The average pit detection life was about 35% of total corrosion fatigue life.

\* Cycles to pit detection means the cycles at which the "first pit" was observed at the length of about 0.02 mm. Thus, this length includes pit nucleation plus some growth.

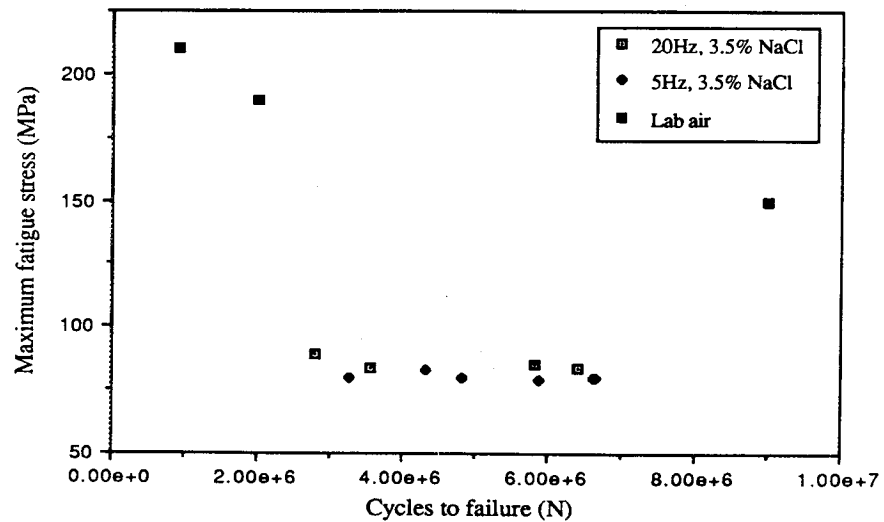
Fig. 5. Plot of maximum stress vs. number of cycles to failure for pitting corrosion fatigue tests. Lab air data[2] is used for comparison.

An S/N plot of maximum fatigue stress versus cycles to failure is shown in Fig. 5. Only the results of the specimens tested in 3.5% NaCl solution are shown in this plot. The specimen tested in laboratory air at a stress level of 80 MPa ran out at 7,811,500 cycles, which is the highest number of cycles of survival for all tested specimens. For comparison, some of the results presented by Antolovich and Saxena [5] are also shown in Fig. 5. These results are from specimens of 7075-T6 aluminum alloy that were tested in laboratory air. Cracks nucleated at the corners of the specimen in all cases and the detectable crack size for the nucleation was about 0.4 mm. Since the period between crack detection and final failure was only several thousand cycles, it was difficult to observe crack propagation during testing. Therefore, the effect of environment is considered to contribute mainly to the fatigue crack nucleation and early propagation processes. Additional studies of this aspect also are underway. It should be mentioned here that the life spent to detect the fatigue crack means the life from the beginning of the experiment until the detection of a 0.4 mm crack. The detection of the crack at a length of 0.4 mm includes the pit nucleation and growth stages as well as crack formation at the pits plus some growth. Clearly, to completely model this process additional detailed studies are needed. Indeed, portions of these studies are underway.

As shown in Fig. 5, a 3.5% NaCl environment lowers about 60% the fatigue strength of aluminum 7075-T6 specimens. For these conditions, since corrosion pits were found on the exposed surfaces of
