NASA Technical Memorandum TM 109203

# Debris/Ice/TPS Assessment and Integrated Photographic Analysis for Shuttle Mission STS-59

June 1994

Shuttle Mission STS-59 was launched at 7:05 a.m. local 4/9/94

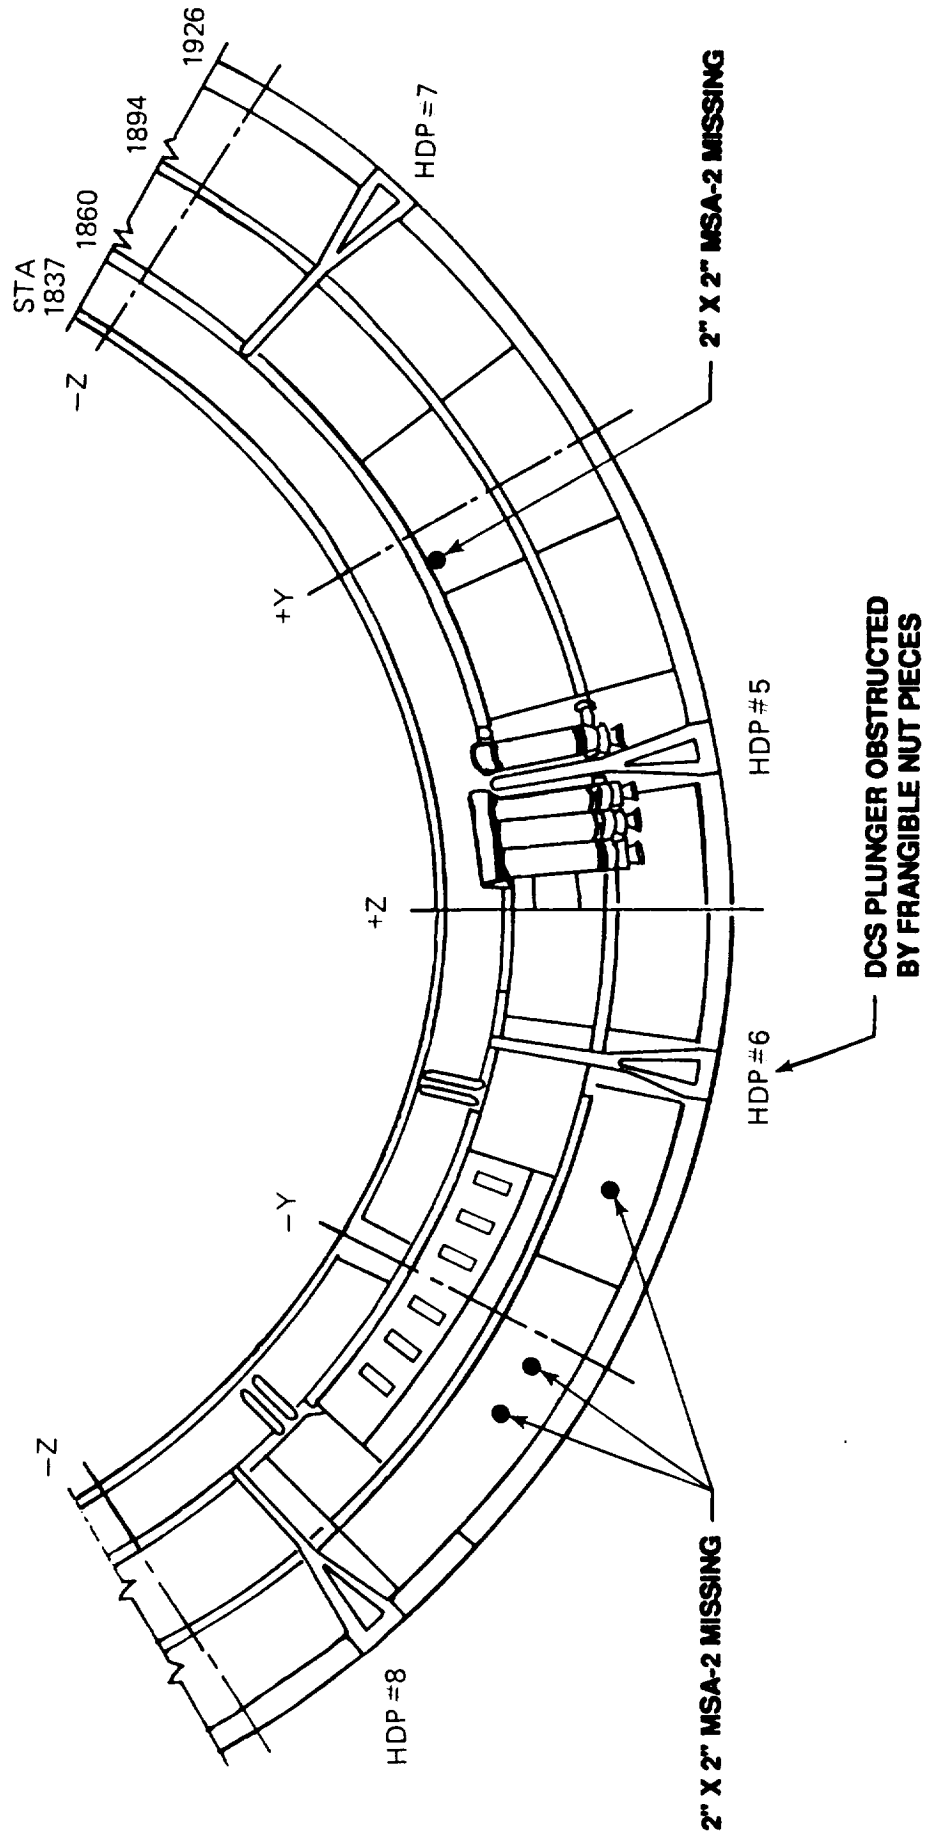
**STS-59**  
**FIGURE 9. LEFT SRB AFT SKIRT EXTERIOR TPS**

The phenolic material on the kick ring was delaminated. Aft skirt acreage TPS was generally in good condition (Figure 9). Two by two inch pieces of MSA-2 were missing from fasteners near the hydrazine servicing ports (3 places) and on the 1860 ring frame near the +Y axis (1 place). Hypalon paint was blistered over areas where BTA had been applied. The underlying BTA was generally not sooted.

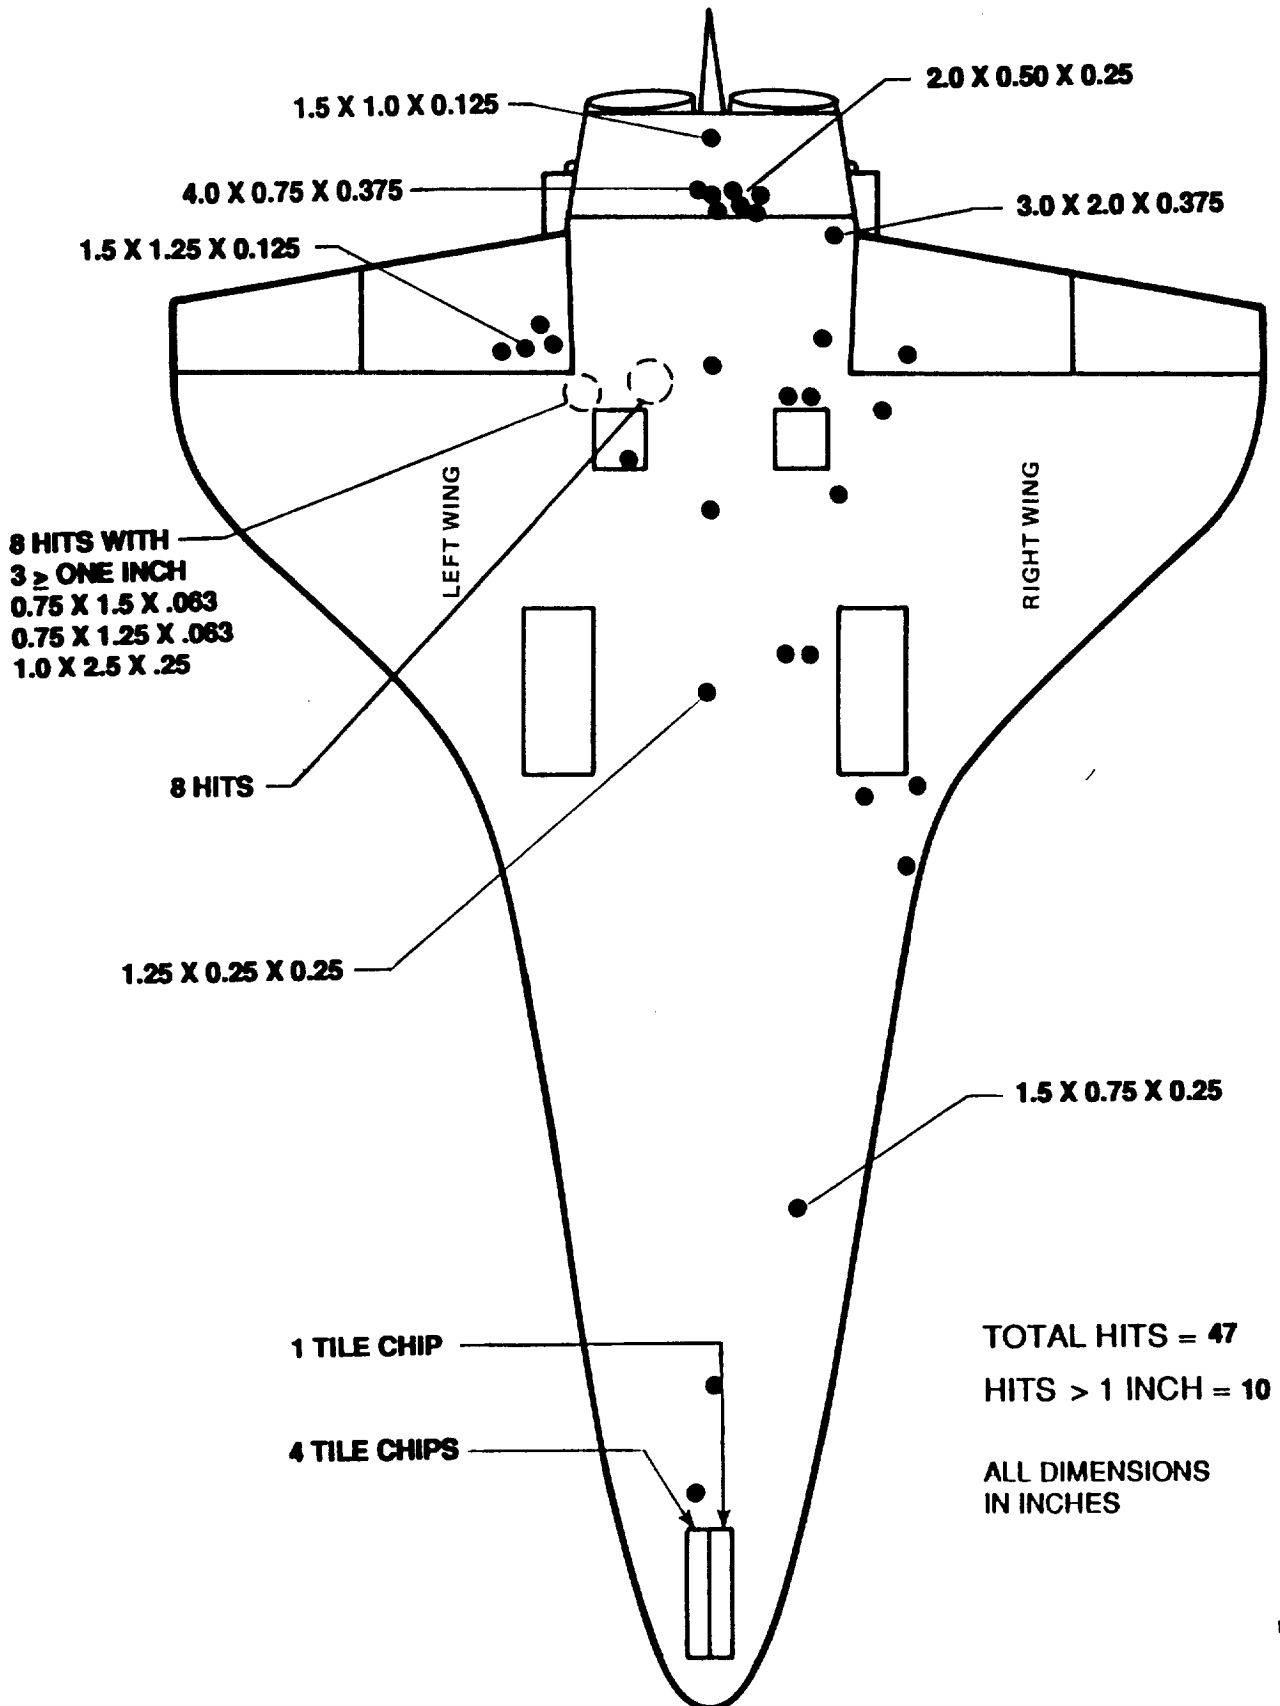
## FIGURE 10. DEBRIS DAMAGE LOCATIONS

A post landing debris inspection of OV-105 (Endeavour) was conducted 20-21 April 1994 at the Dryden Flight Research Center (DFRC) on runway 22 and in the Mate/Demate Device (MDD). This inspection was performed to identify debris impact damage and, if possible, debris sources. The Orbiter TPS sustained a total of 77 hits, of which 19 had a major dimension of one inch or larger. This total does not include the numerous hits on the base heat shield attributed to SSME vibration/acoustics and exhaust plume recirculation. A comparison of these numbers to statistics from 46 previous missions of similar configuration (excluding missions STS-23, 25, 26, 26R, 27R, 30R, and 42, which had damage from known debris sources), indicates both the total number of hits and the number of hits 1-inch or larger was less than average (Figures 10-13).

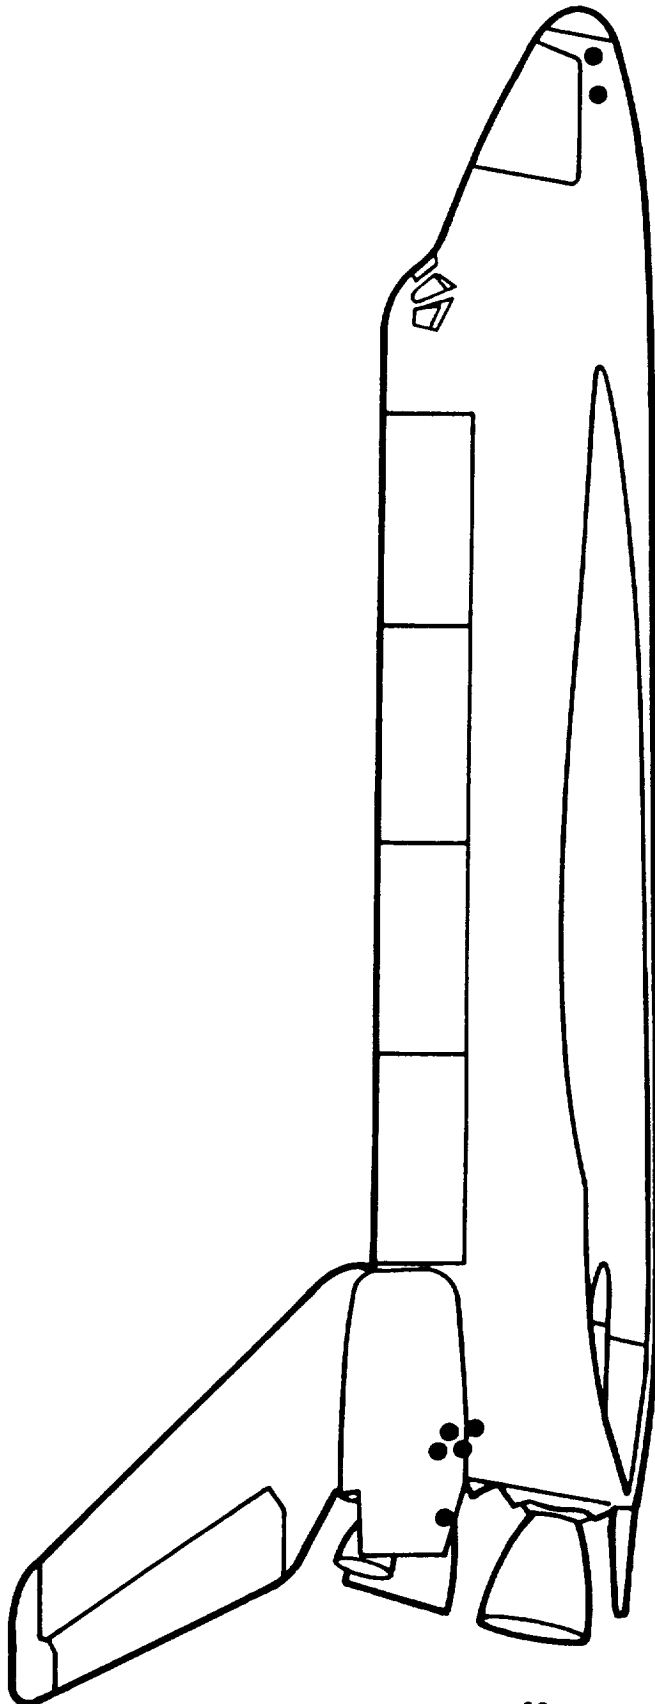
FIGURE 11. DEBRIS DAMAGE LOCATIONS

TOTAL HITS = 7  
HITS > 1 INCH = 0

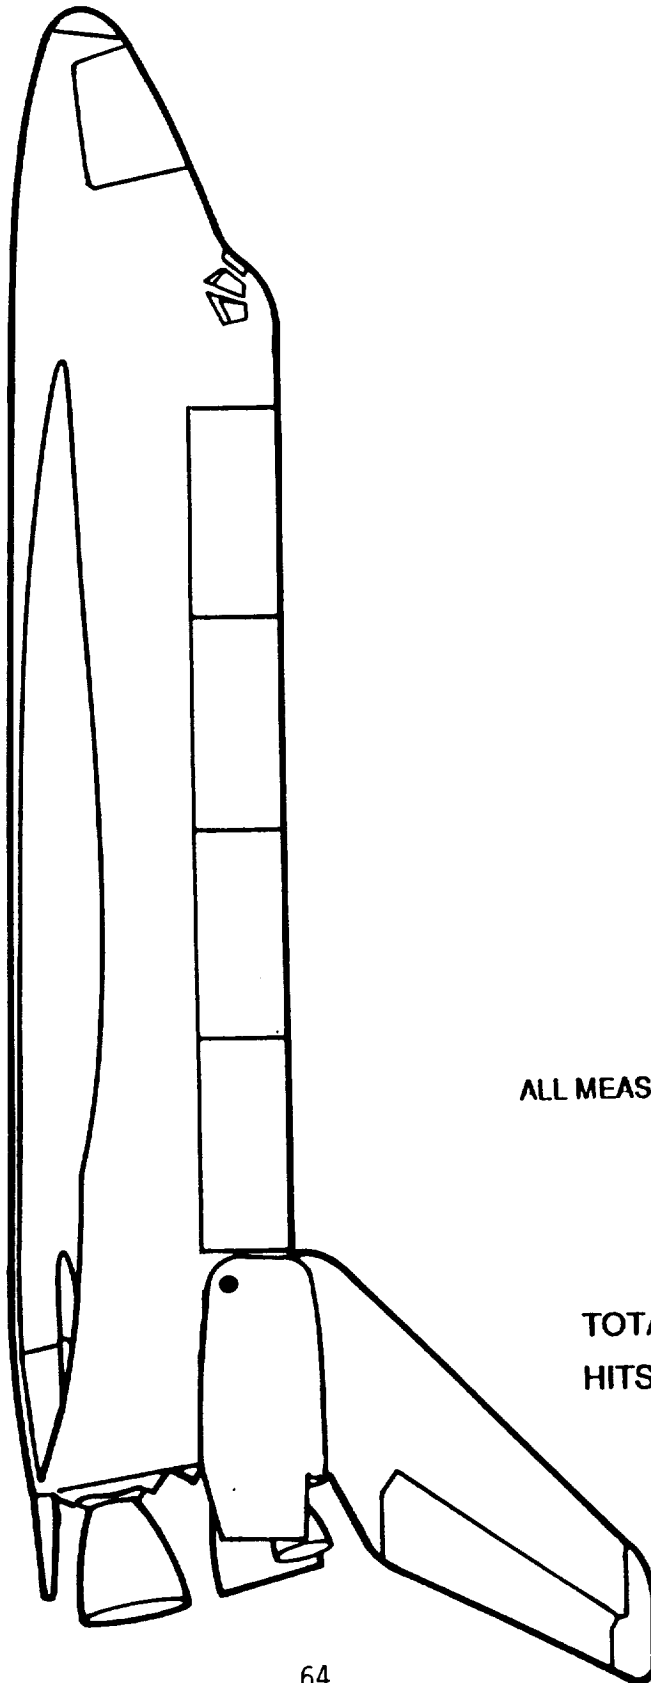
FIGURE 12. **DEBRIS DAMAGE LOCATIONS**

TOTAL HITS = 1  
HITS > 1 INCH = 0

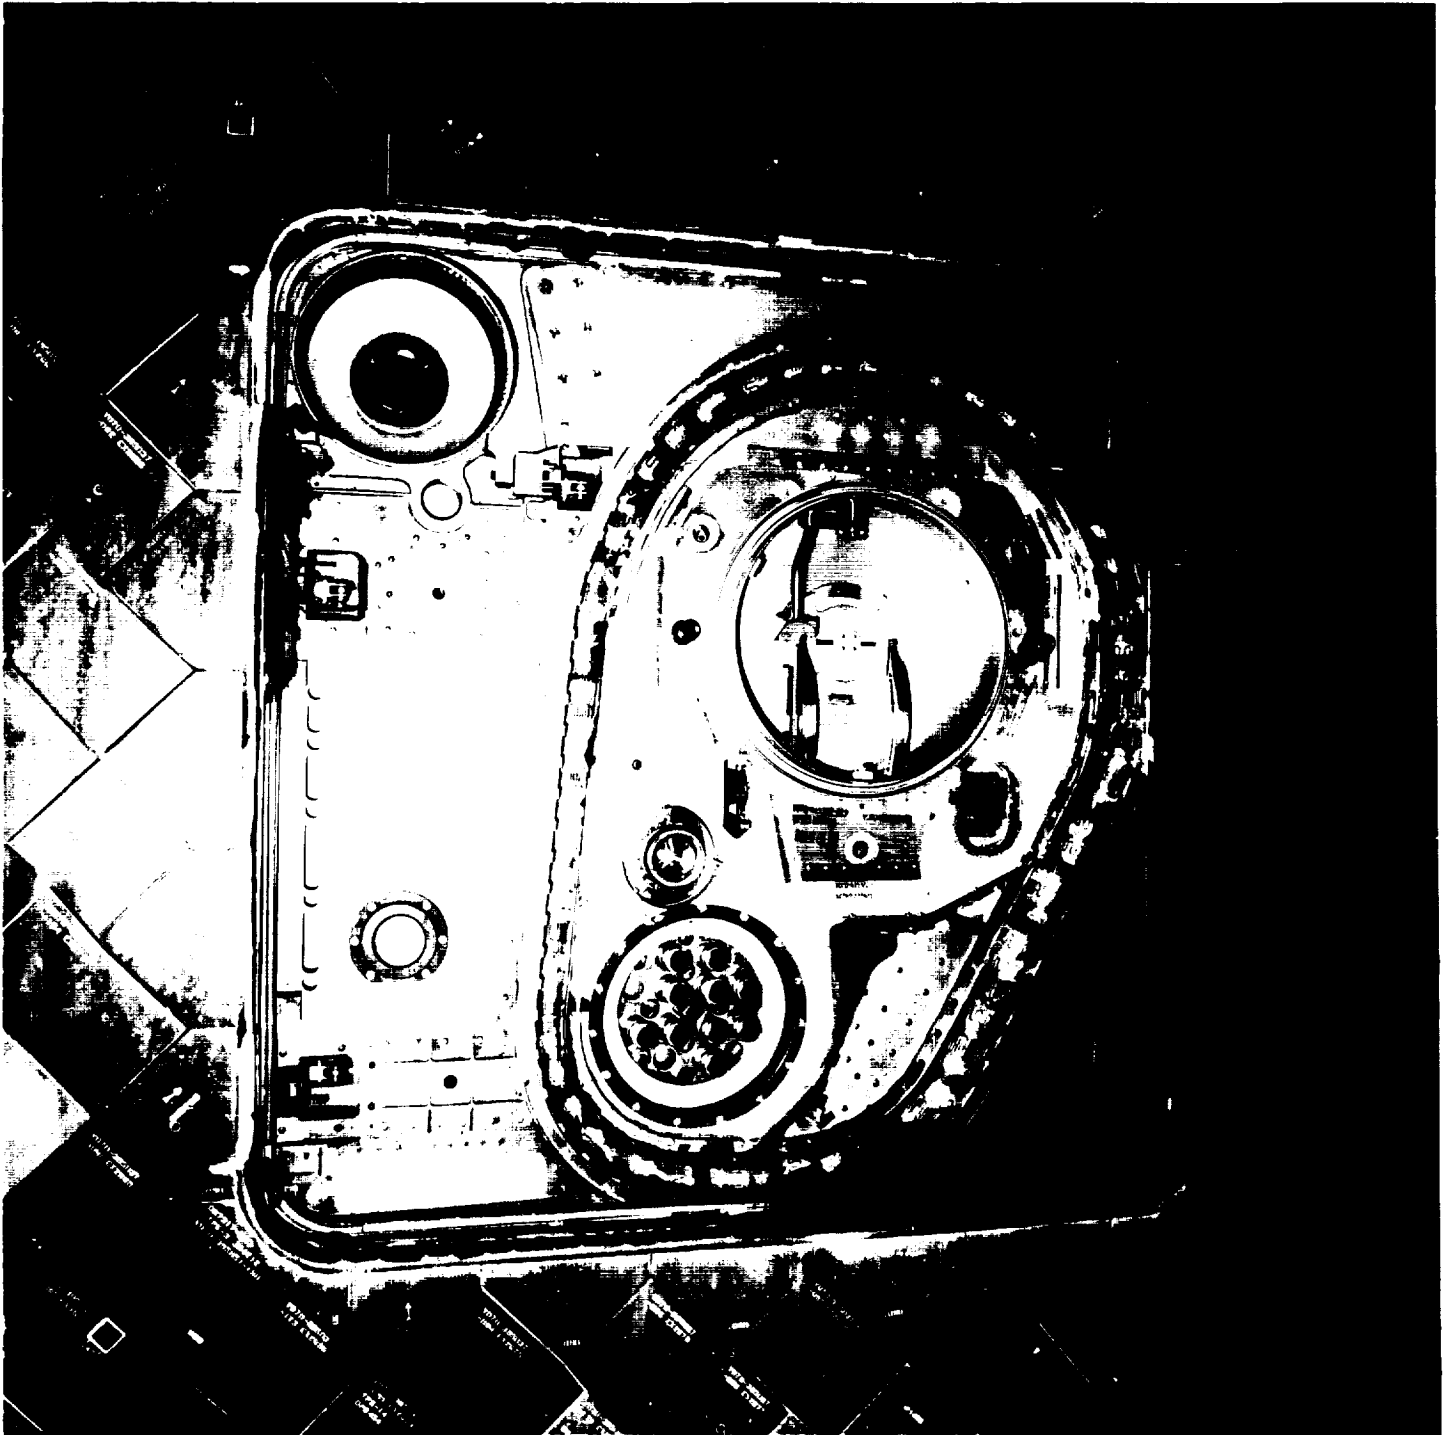
Overall view of the L02 ET/ORB umbilical. All separation ordnance devices functioned properly. No flight hardware was found on the runway below the umbilical when the ET door was opened.

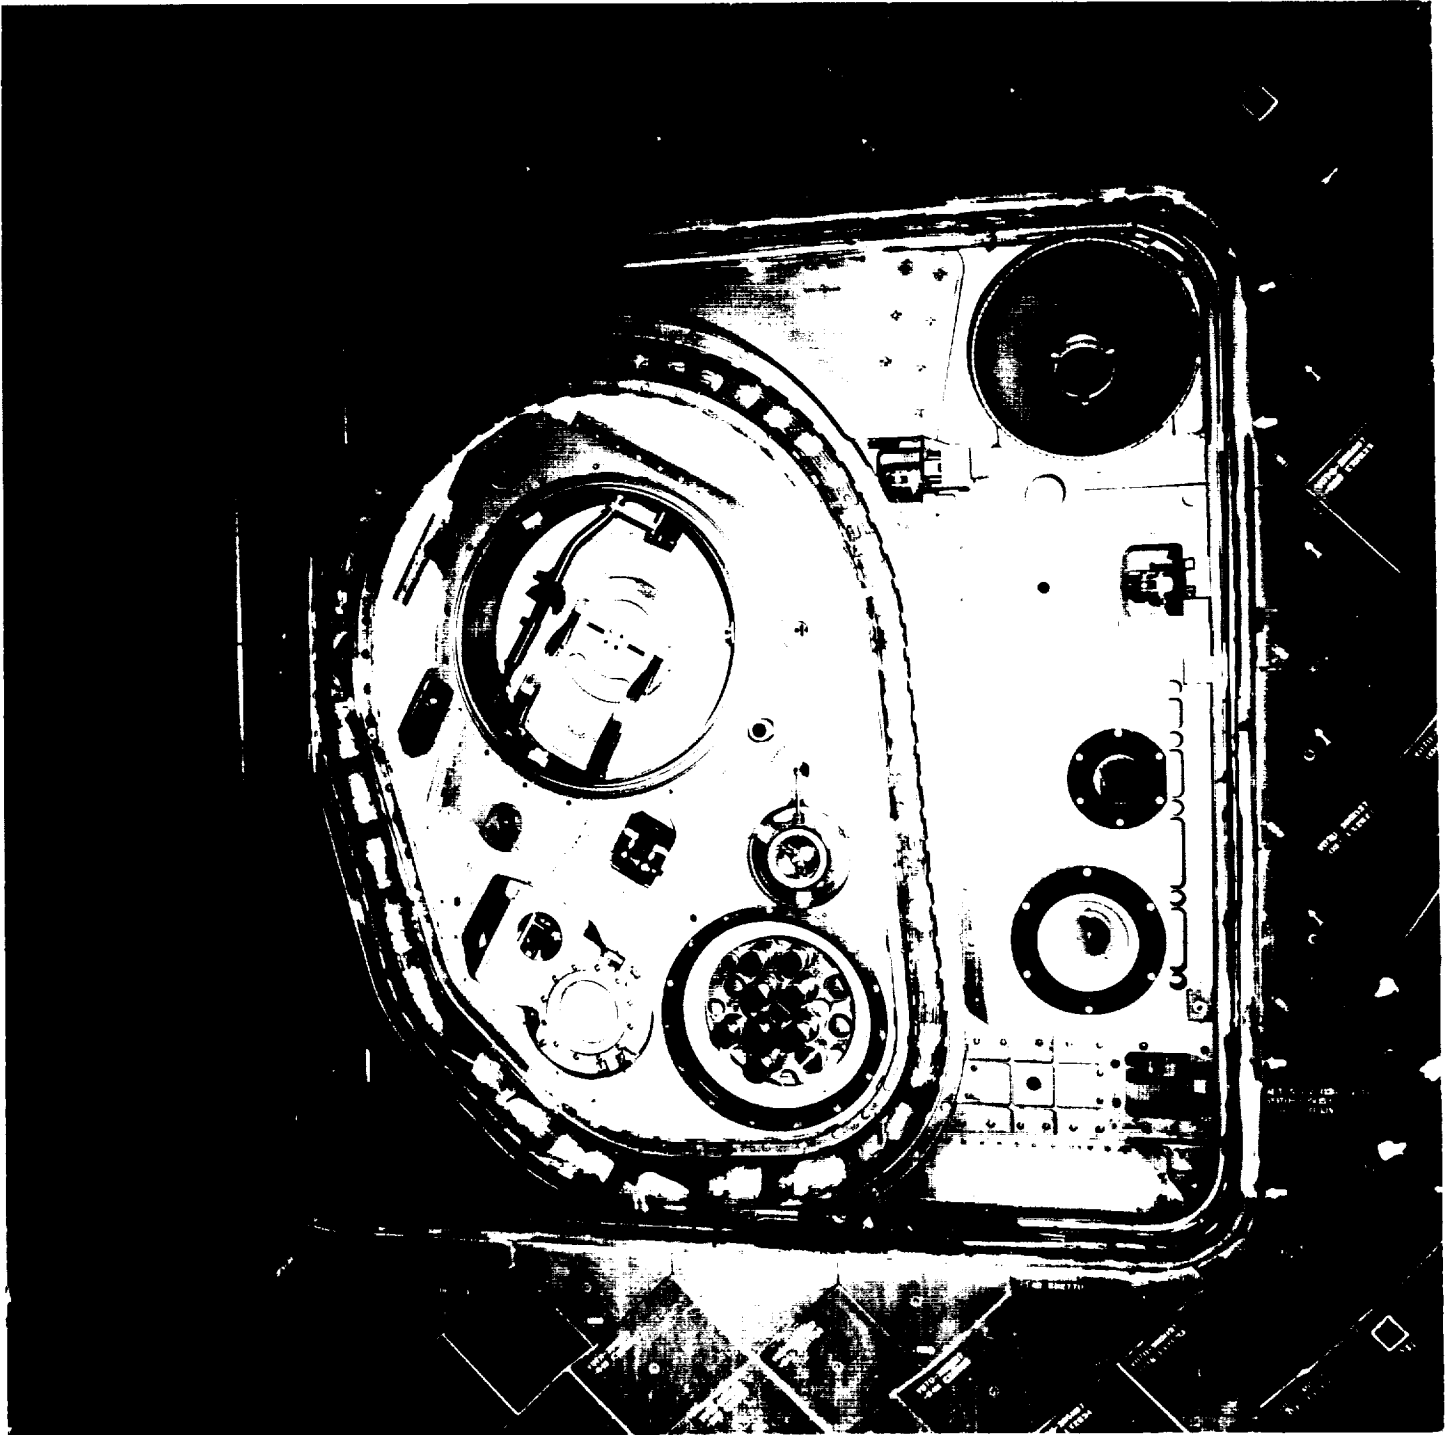
Overall view of the LH2 ET/ORB umbilical. All three umbilical separation ordnance devices functioned properly.

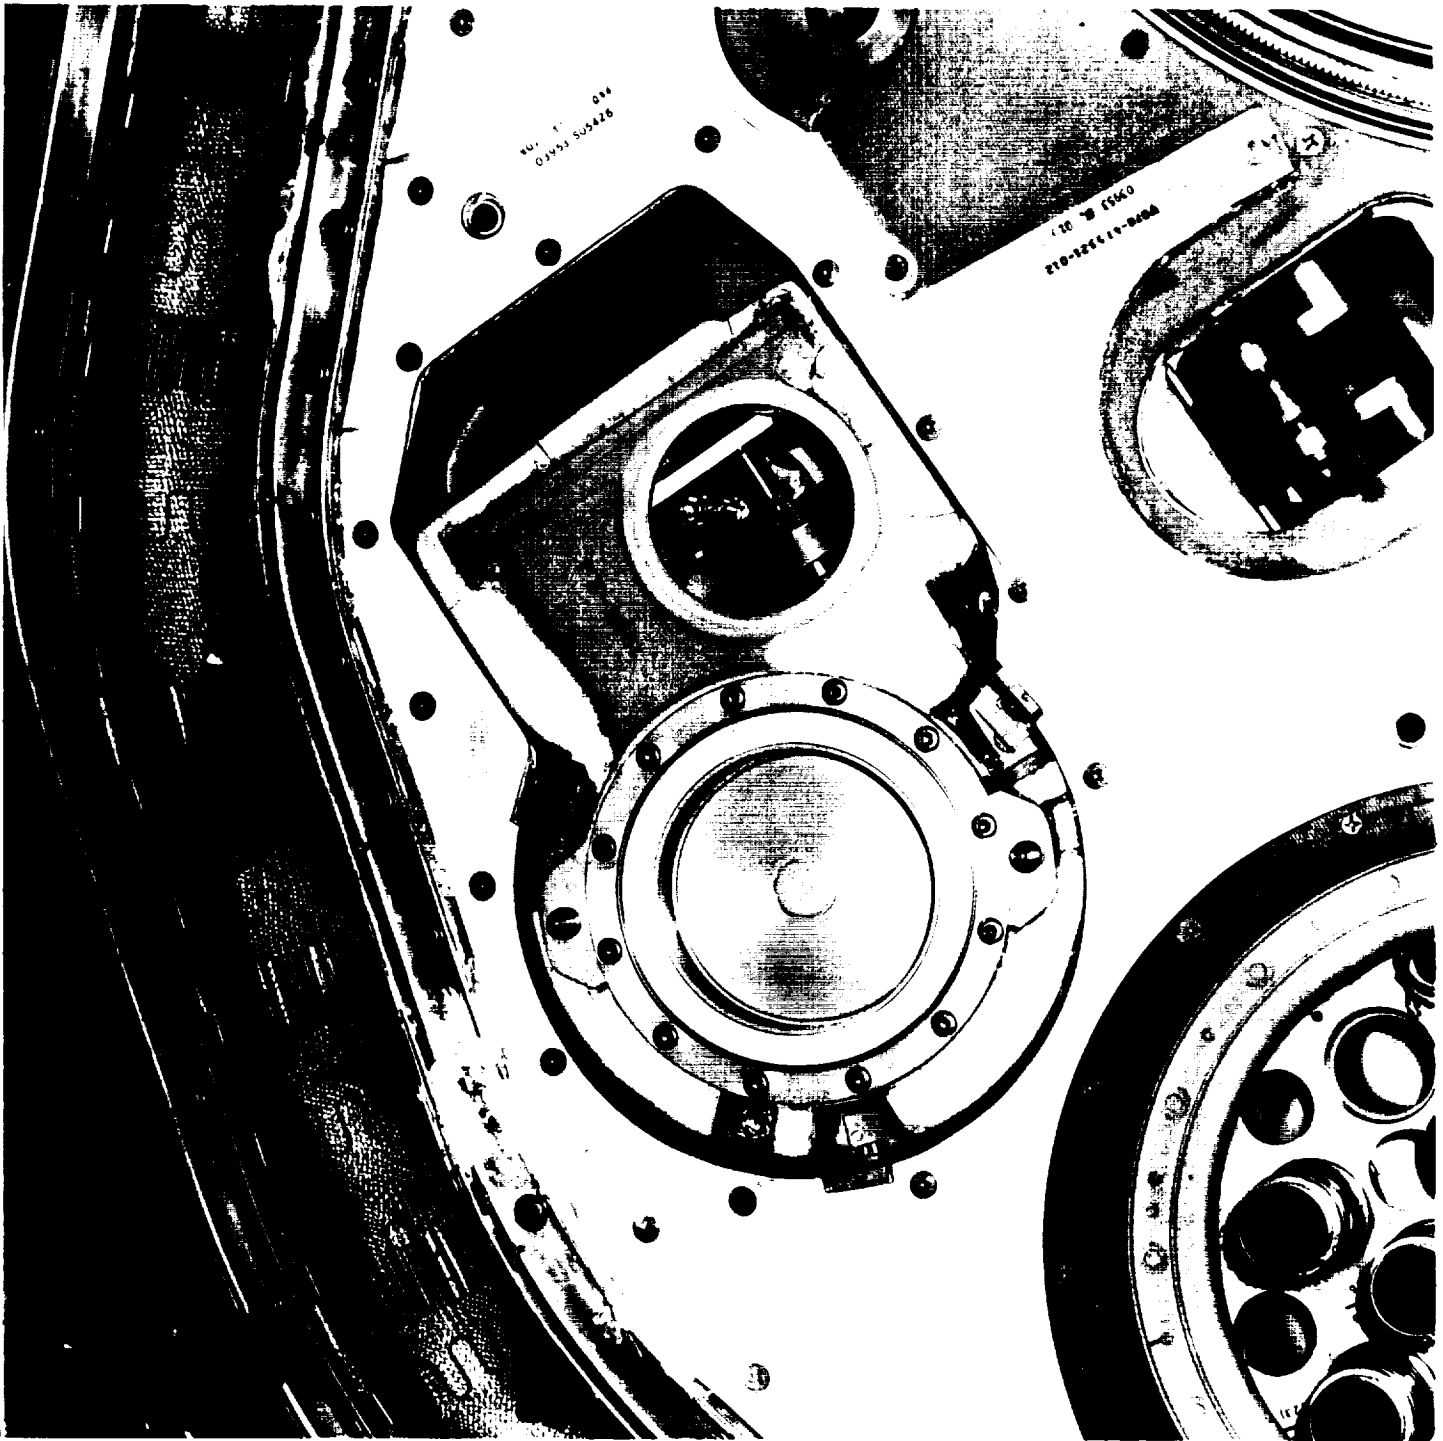
A small amount of white RTV and ET foam, but no red purge seal, adhered to the LH2 ET/ORB umbilical plate near the 4-inch line.

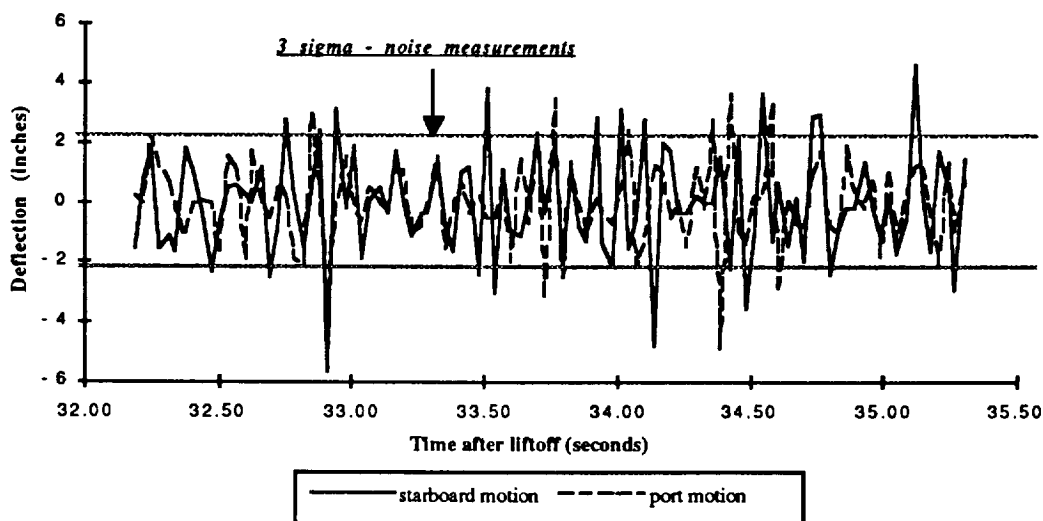
Figure 2.3.1 Body Flap Motion Versus Time between 32.0 and 35.5 Seconds MET

The time of apparent maximum deflection (between 32 and 35 seconds MET) was visually chosen from camera E-207. The motion of the aft port and aft starboard edges were plotted as a function of time. One of two control points on the fuselage was used as a measure of the noise. Note that some of the apparent deflection exceeded the noise component. A frequency domain analysis revealed identifiable modes of vibration.
