# Debris/Ice/TPS Assessment and Integrated Photographic Analysis for Shuttle Mission STS-62

May 1994

DEBRIS/ICE/TPS ASSESSMENT  
AND  
INTEGRATED PHOTOGRAPHIC ANALYSIS  
OF  
SHUTTLE MISSION STS-62

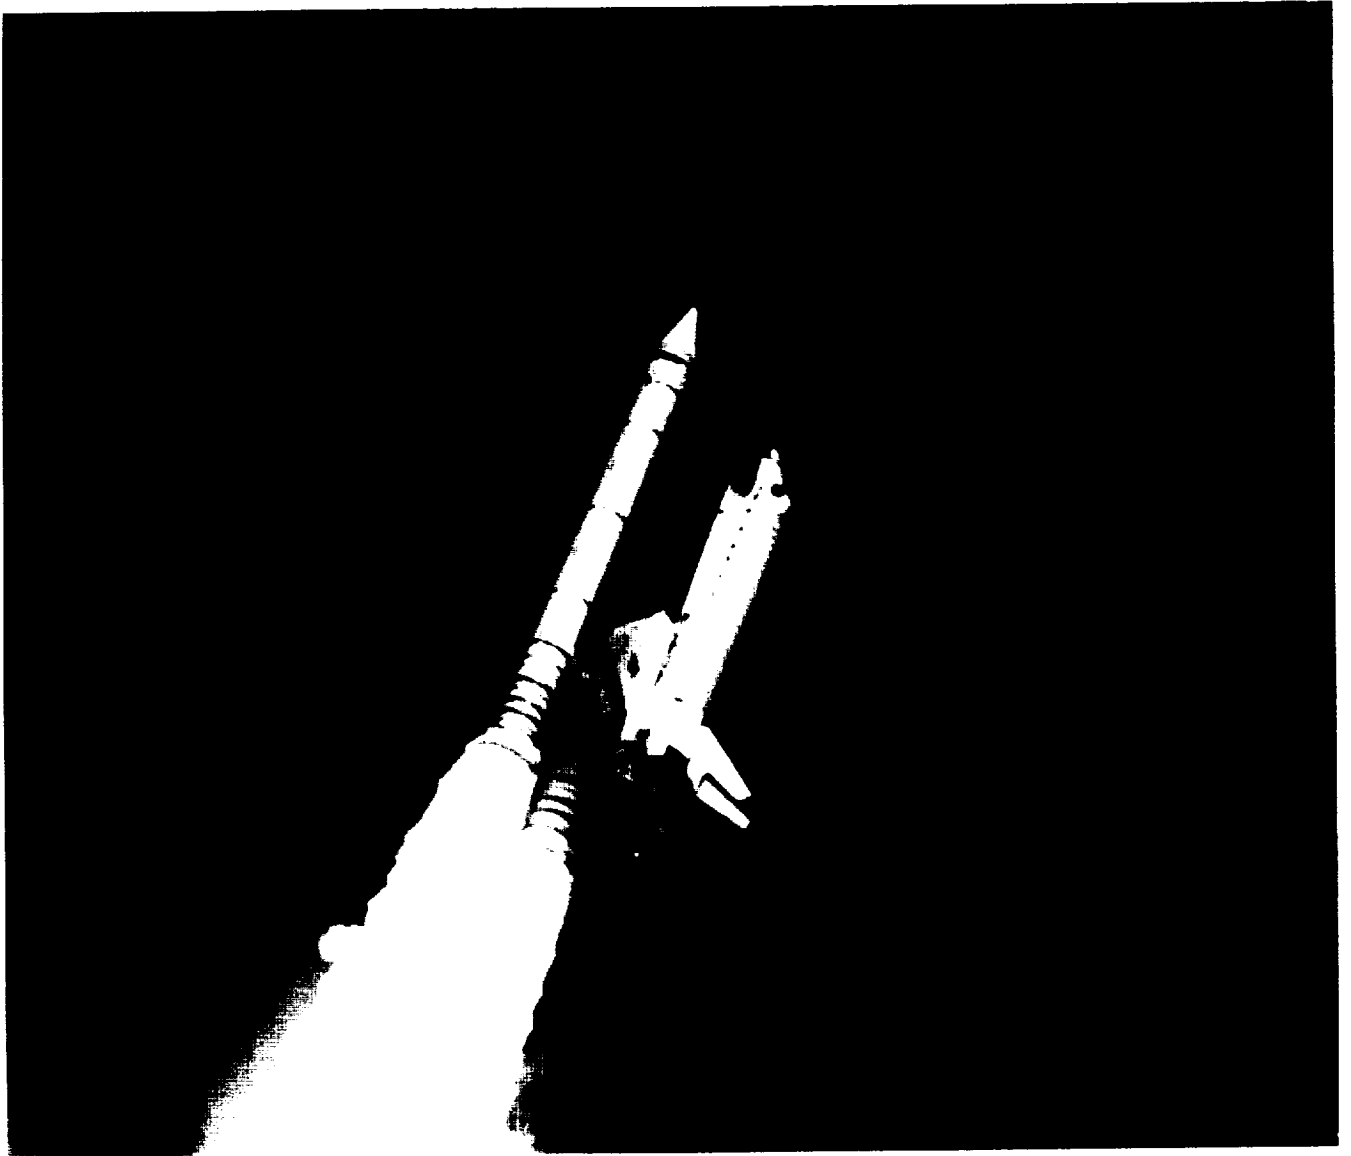
One of the large, oblong paper covers from the forward RCS thrusters passed over the wing and first appeared near SSME #1 at T+28 seconds MET. Although RCS paper covers typically tear into smaller pieces in the airflow, this cover remained intact while falling aft of the vehicle.

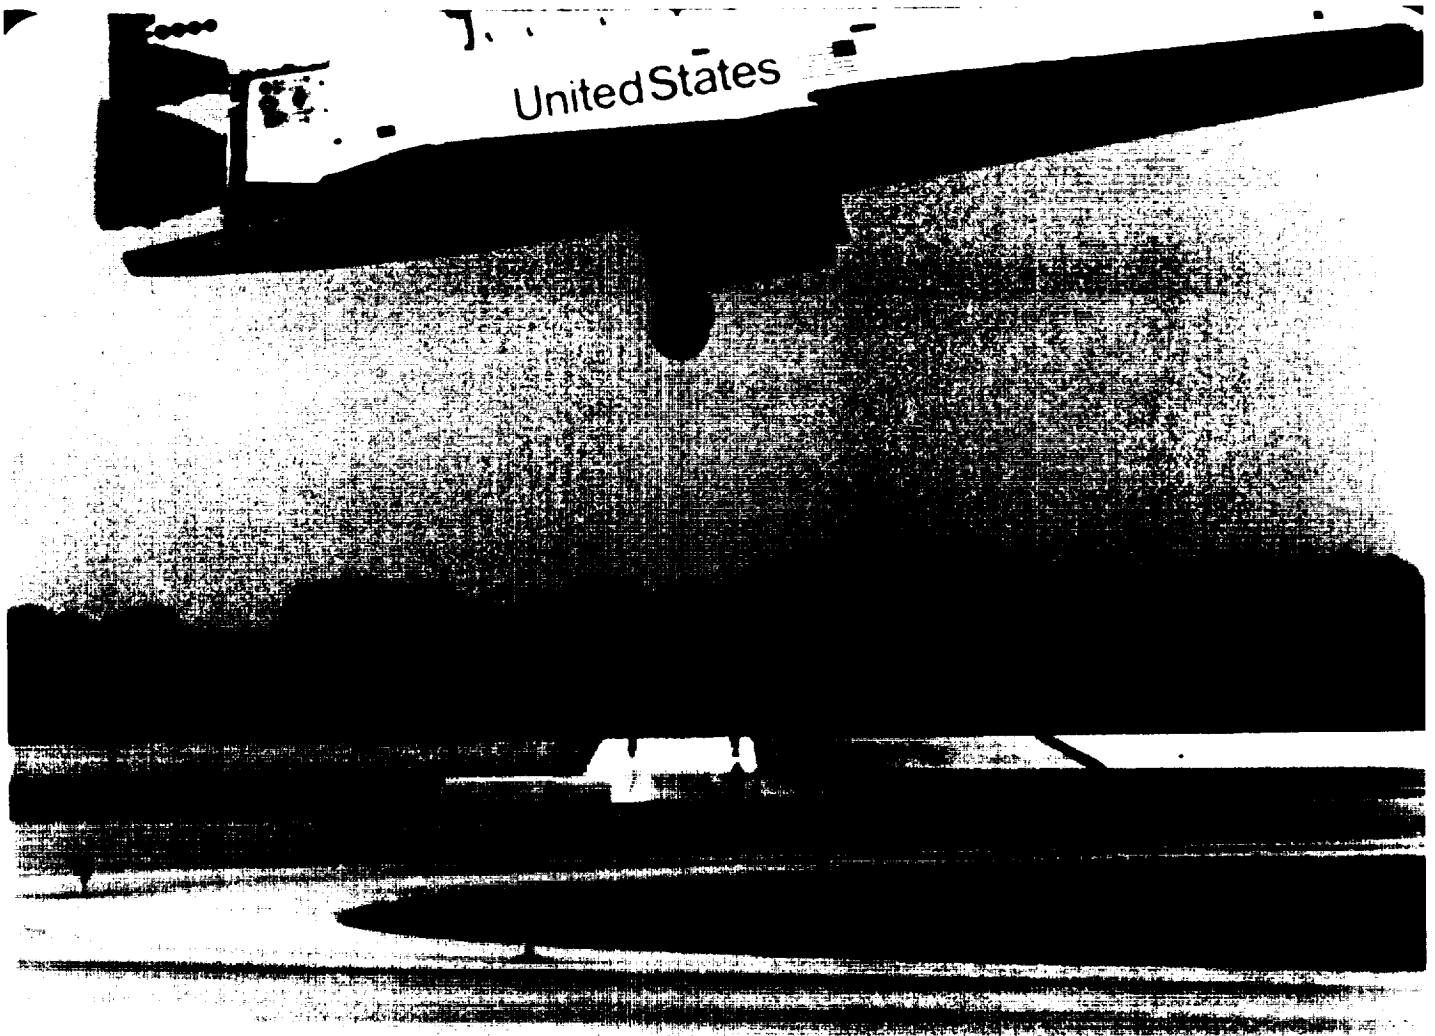
Film analysis determined the Orbiter right main landing gear tire was 28.94 feet above the runway surface. In comparison, the Orbiter flight computer showed an altitude of 23 feet above the runway when crossing the threshold line.

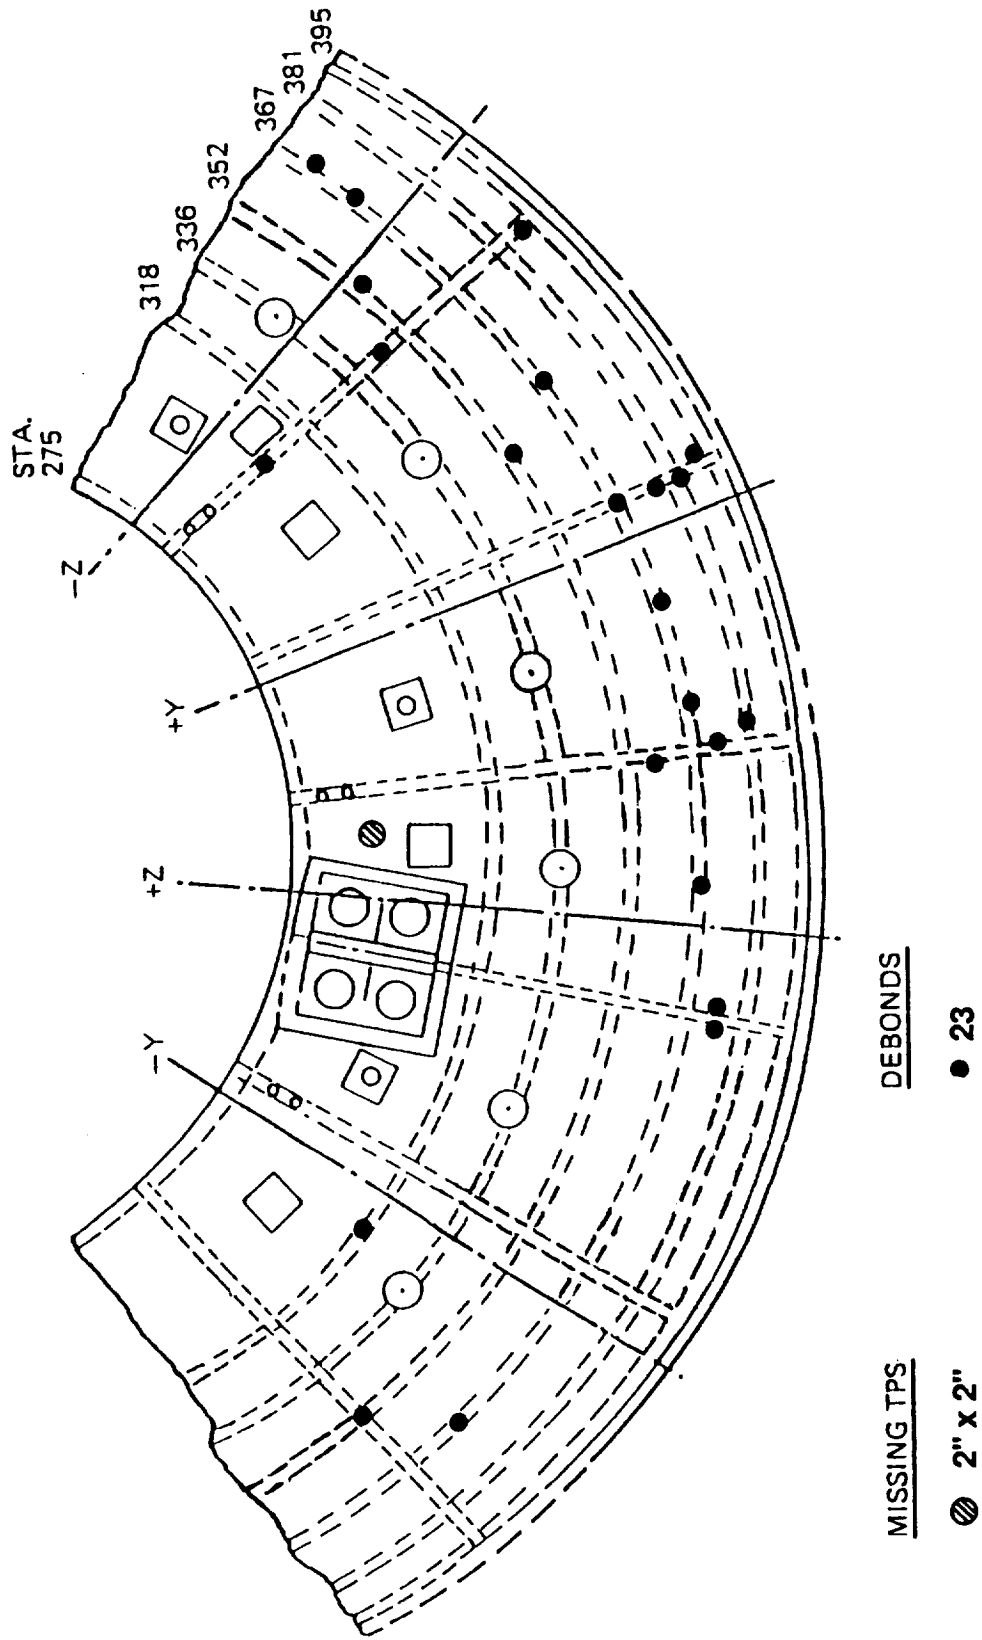
FIGURE 4. RIGHT SRB FRUSTRUM

The RH frustum was missing one 2" x 2" area of TPS near the BSM's and had 23 MSA-2 debonds over fasteners. Significant amounts of BTA had been applied to closeouts on this frustum. Hypalon paint was blistered/missing from areas where the BTA had been applied. The underlying BTA was not sooted except along the 395 ring aft of the BSM cluster. The soot pattern indicated some of the blisters may have formed prior to SRB separation (IFA STS-62-B-1). Investigation of this condition concluded there was insufficient heat rates to cause blistering of the Hypalon until late in the ascent phase. Testing has shown that Hypalon blisters burn off rather than become detached debris sources. The BSM aero heat shield covers had locked in the fully opened position though three of the attach rings had been bent by parachute riser entanglement (Figure 4).

The RH frustum had 23 MSA-2 debonds over fasteners. Hypalon paint was blistered/missing from the areas where BTA had been applied. The BSM aero heat shield covers had locked in the fully opened position.

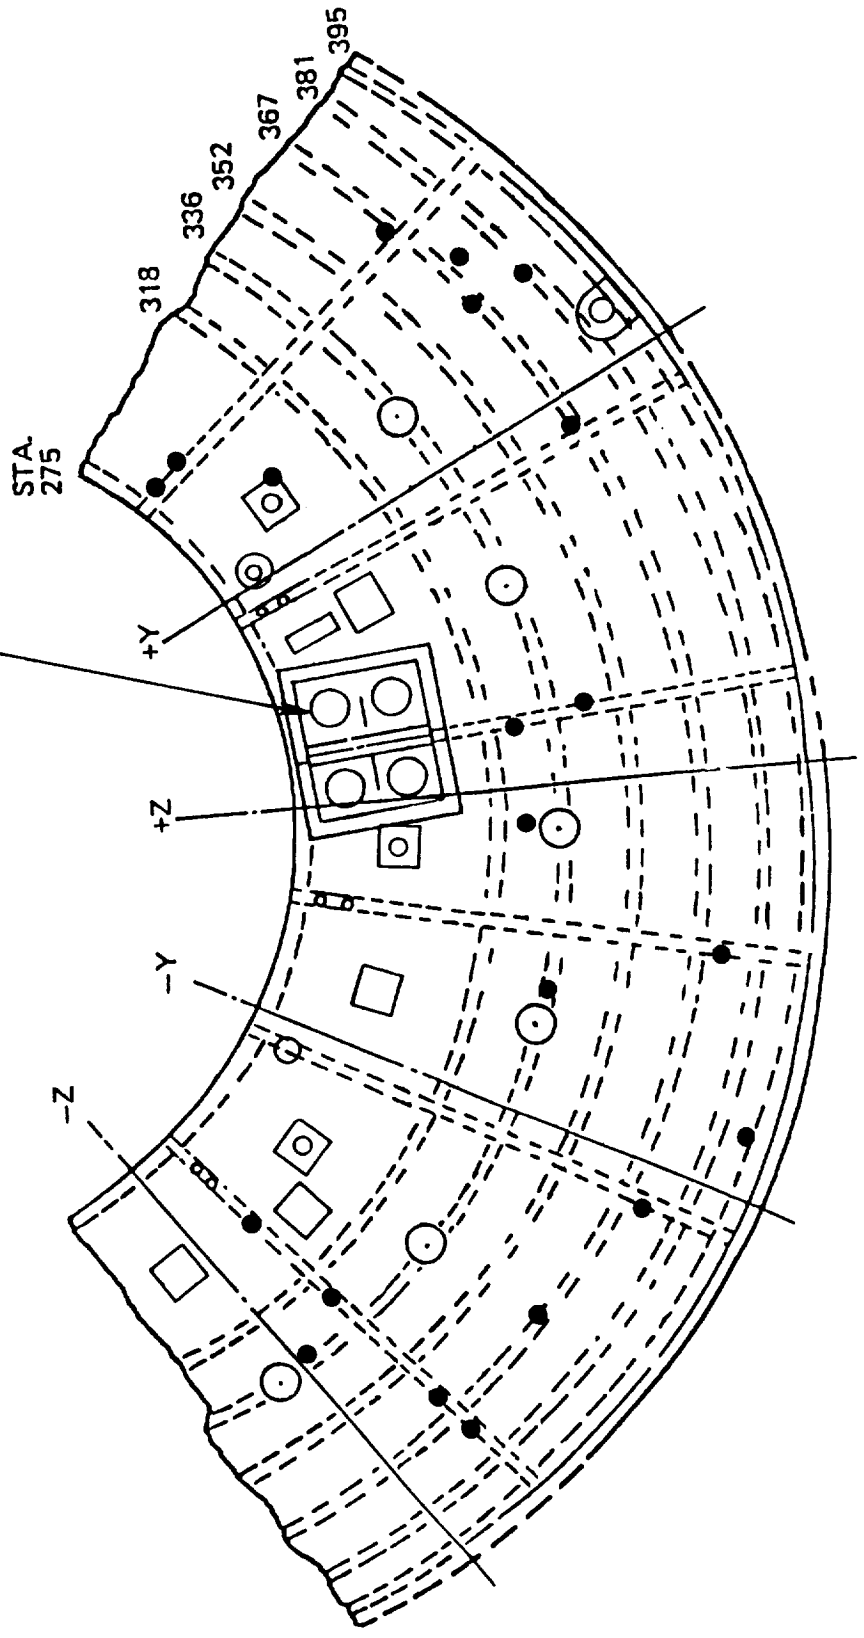
FIGURE 5. LEFT SRB FRUSTUM  
COVER ROTATED APPROXIMATELY  
20 DEGREES CCW

MISSING TPS  
○ 1

DEBONDS  
● 21

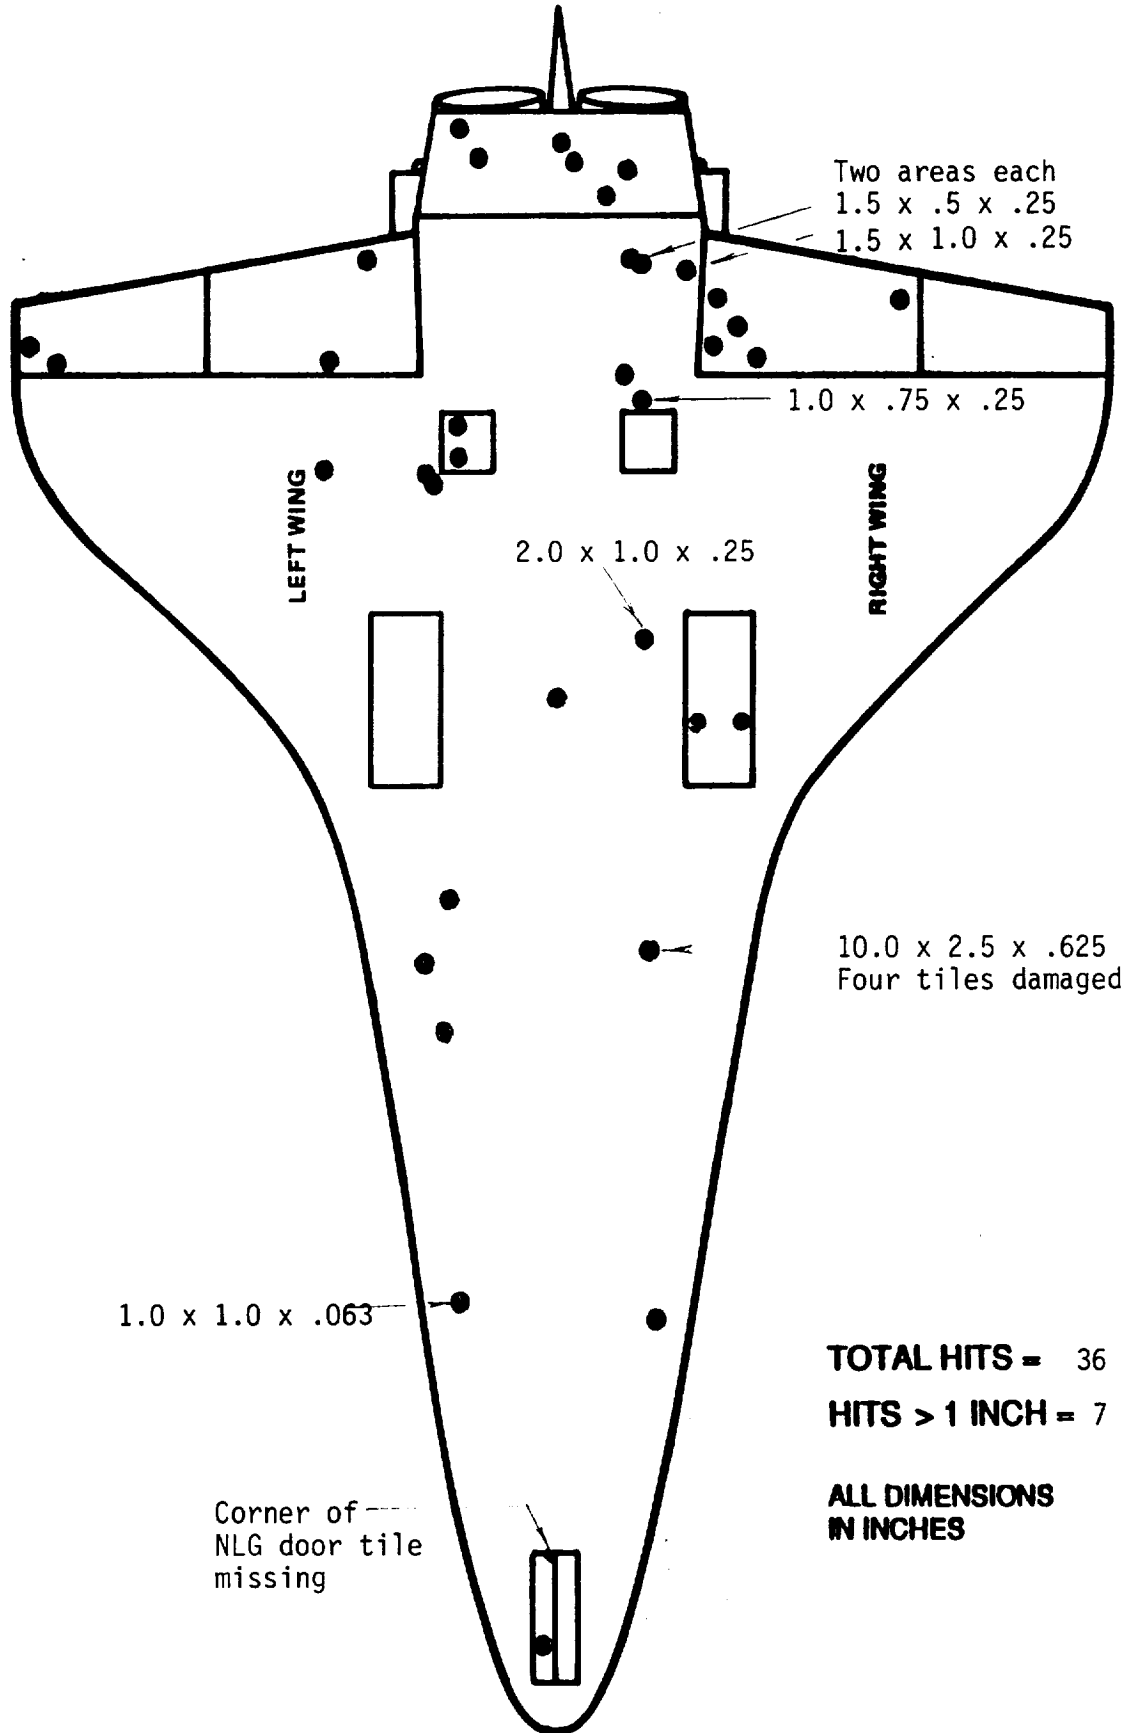
FIGURE 6. **DEBRIS DAMAGE LOCATIONS**

Cluster of hits aft of the LH2 and LO2 ET/ORB umbilicals are believed to be impacts from umbilical ice.

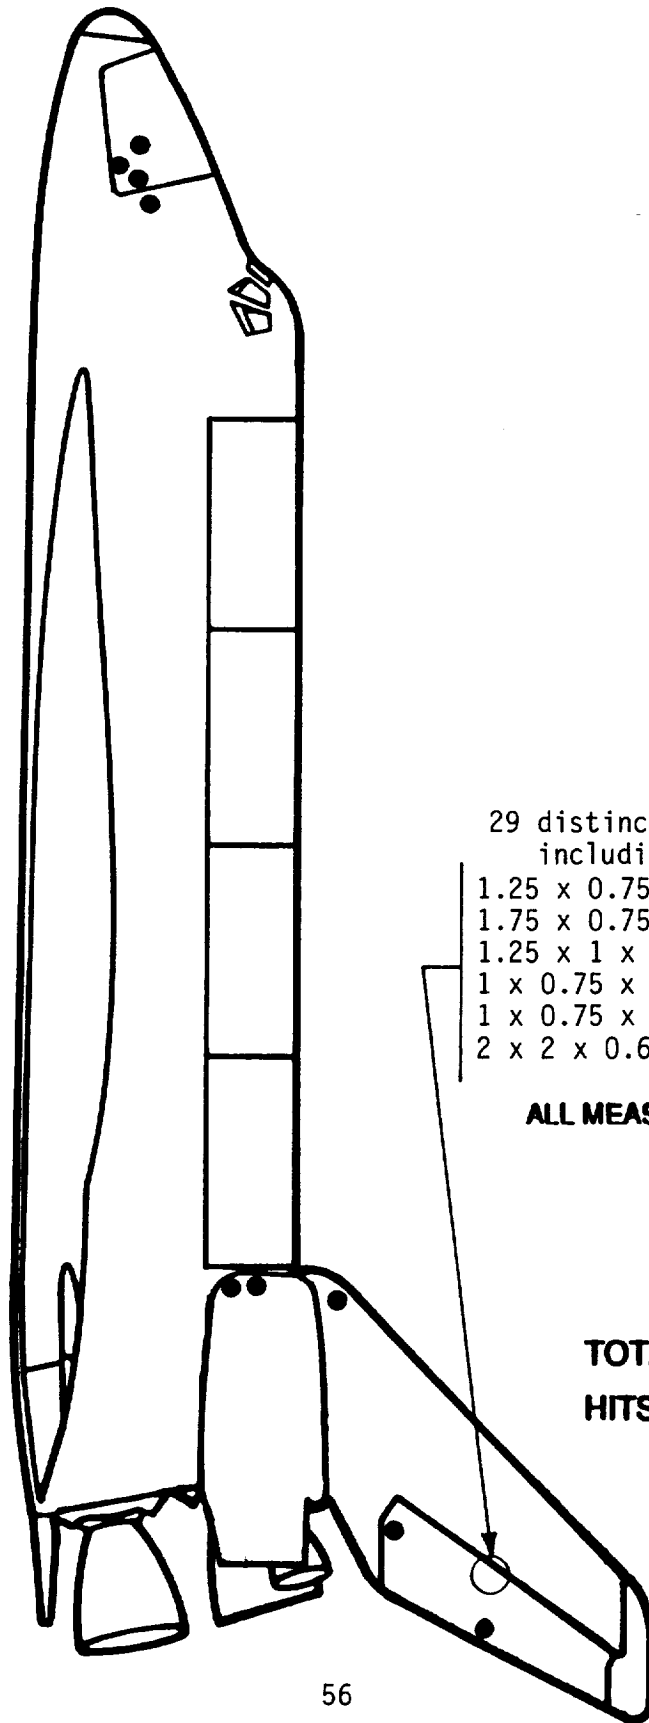
FIGURE 8. **DEBRIS DAMAGE LOCATIONS**

29 distinct hits  
including:

- 1.25 x 0.75 x 0.5
- 1.75 x 0.75 x 0.5
- 1.25 x 1 x 0.375
- 1 x 0.75 x 0.675
- 1 x 0.75 x 0.5
- 2 x 2 x 0.675

A cluster of 29 damage sites spanned three tiles on the rudder black edge tiles (left side) along the hinge line below the split in the speed brake. Six of the damage sites had a major dimension of 1-inch or larger while three of the damage sites were deep enough to expose the substrate. Three small hits occurred in this same general area on the right side of the rudder/speed brake.

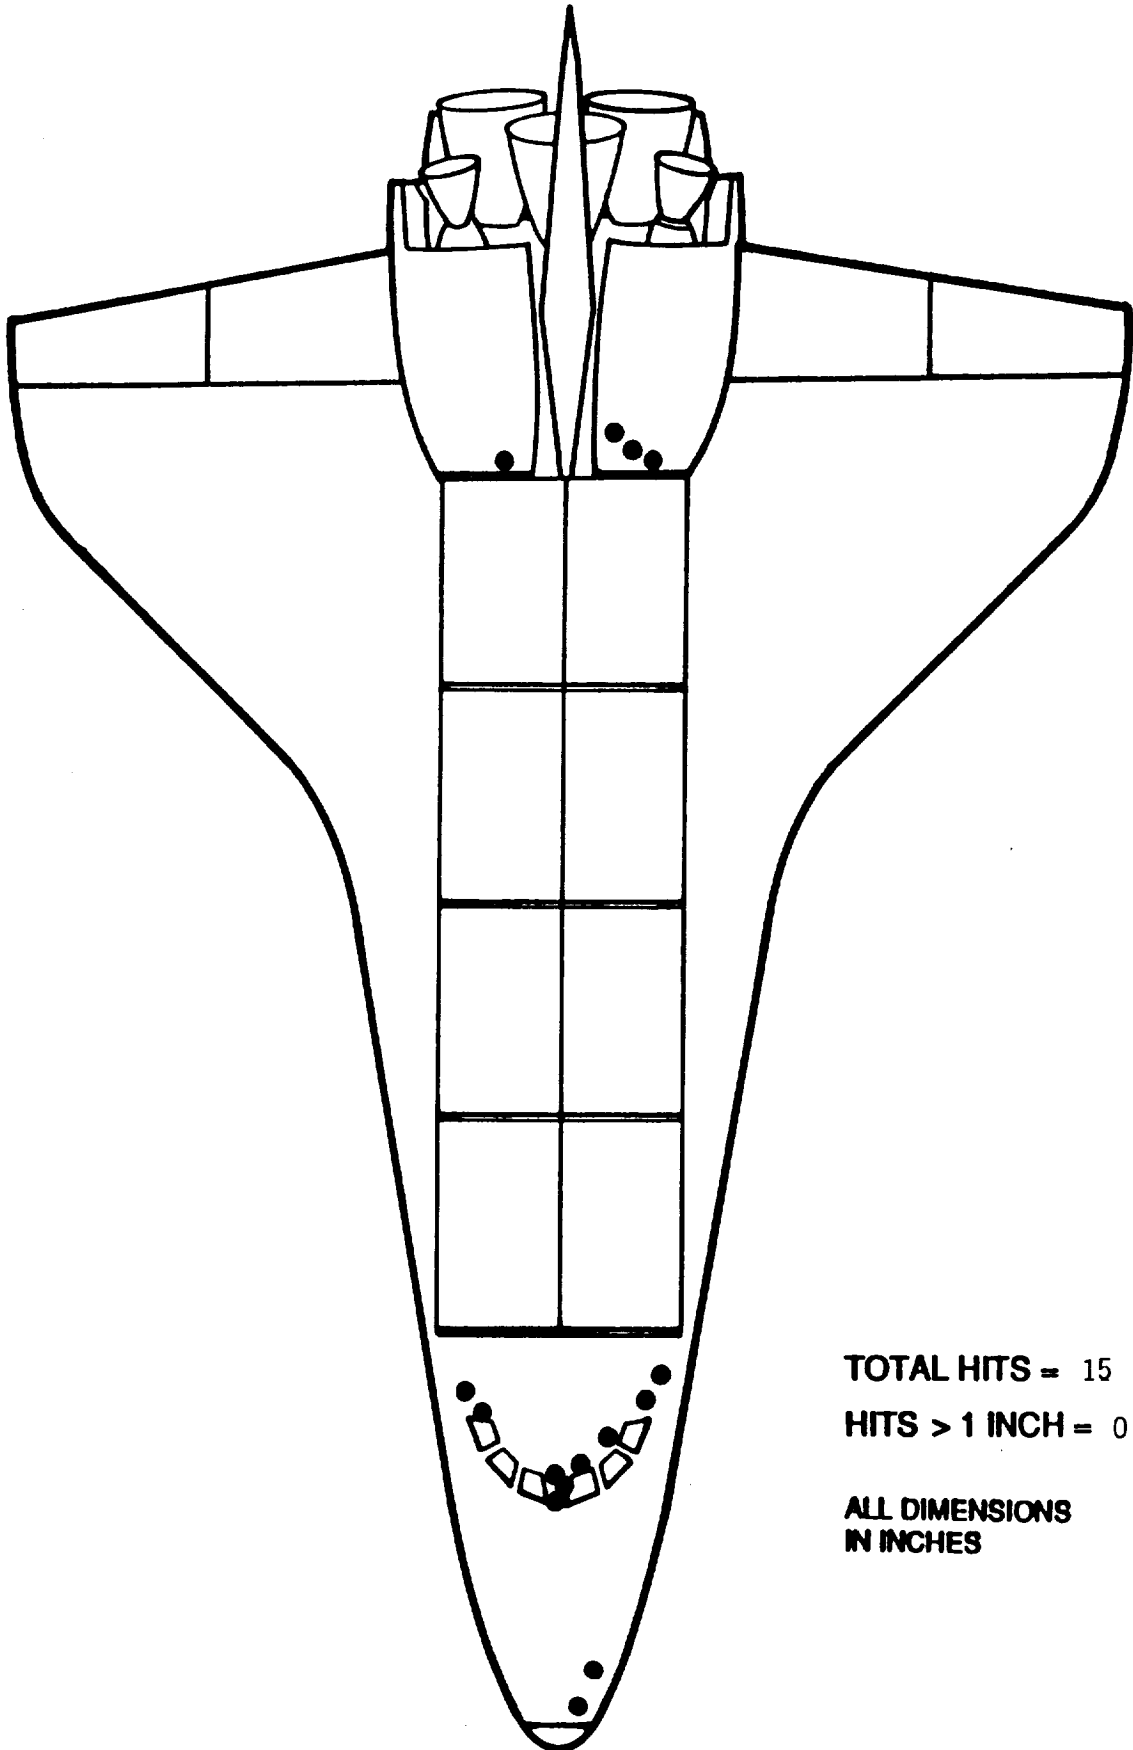
FIGURE 9. **DEBRIS DAMAGE LOCATIONS**

**TOTAL HITS = 15**  
**HITS > 1 INCH = 0**

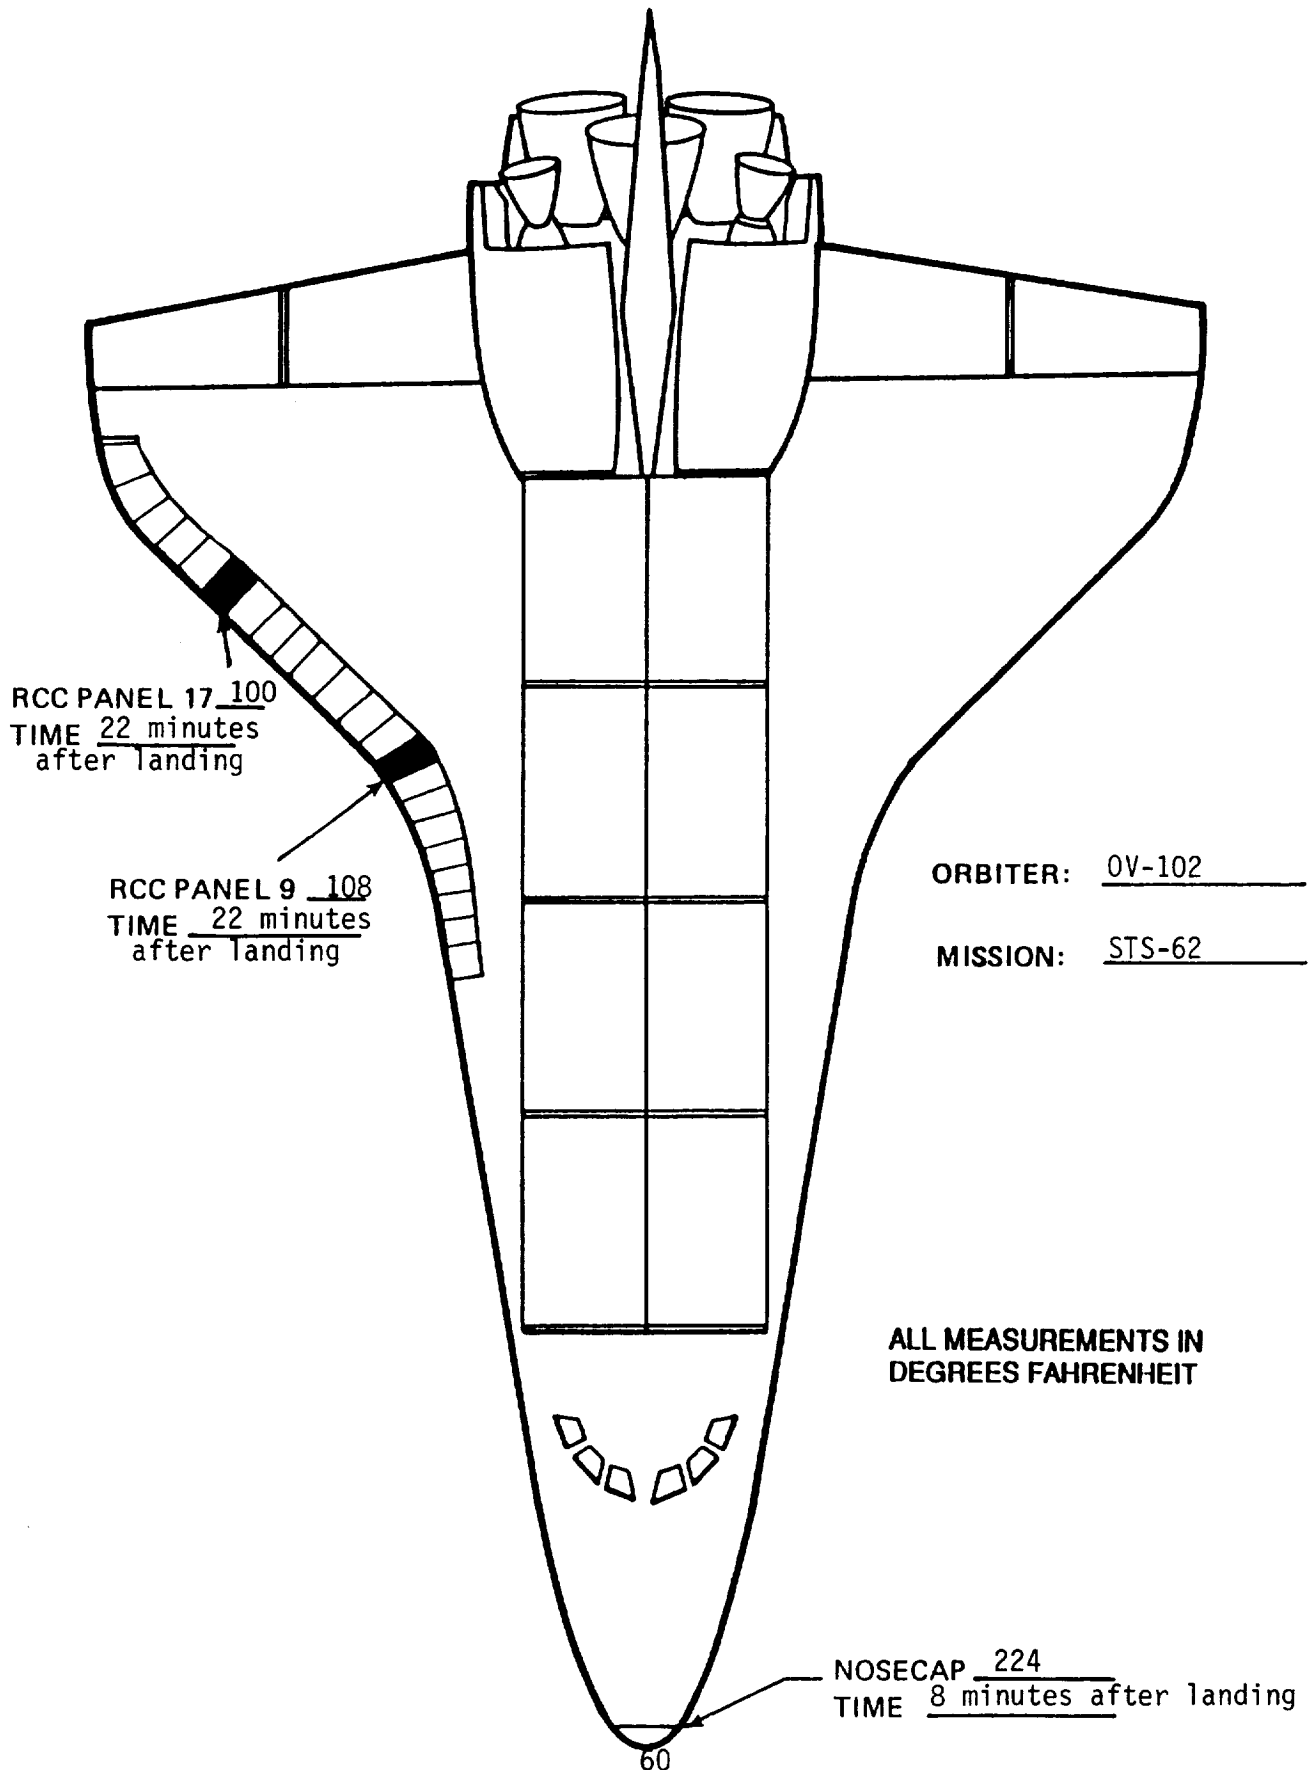
FIGURE 10. **STS- 62RCC TEMPERATURE MEASUREMENTS AS  
RECORDED BY THE SHUTTLE THERMAL IMAGER**

The Shuttle Thermal Imager (STI) was used to measure the surface temperatures of several areas on the vehicle (per OMRSD V09AJ0.095). Eight minutes after landing, the Orbiter nose cap RCC was 224 degrees F. Twenty-two minutes after landing, the RH wing leading edge RCC panel #9 was 108 degrees F and panel #17 was 100 degrees F (Figure 10).

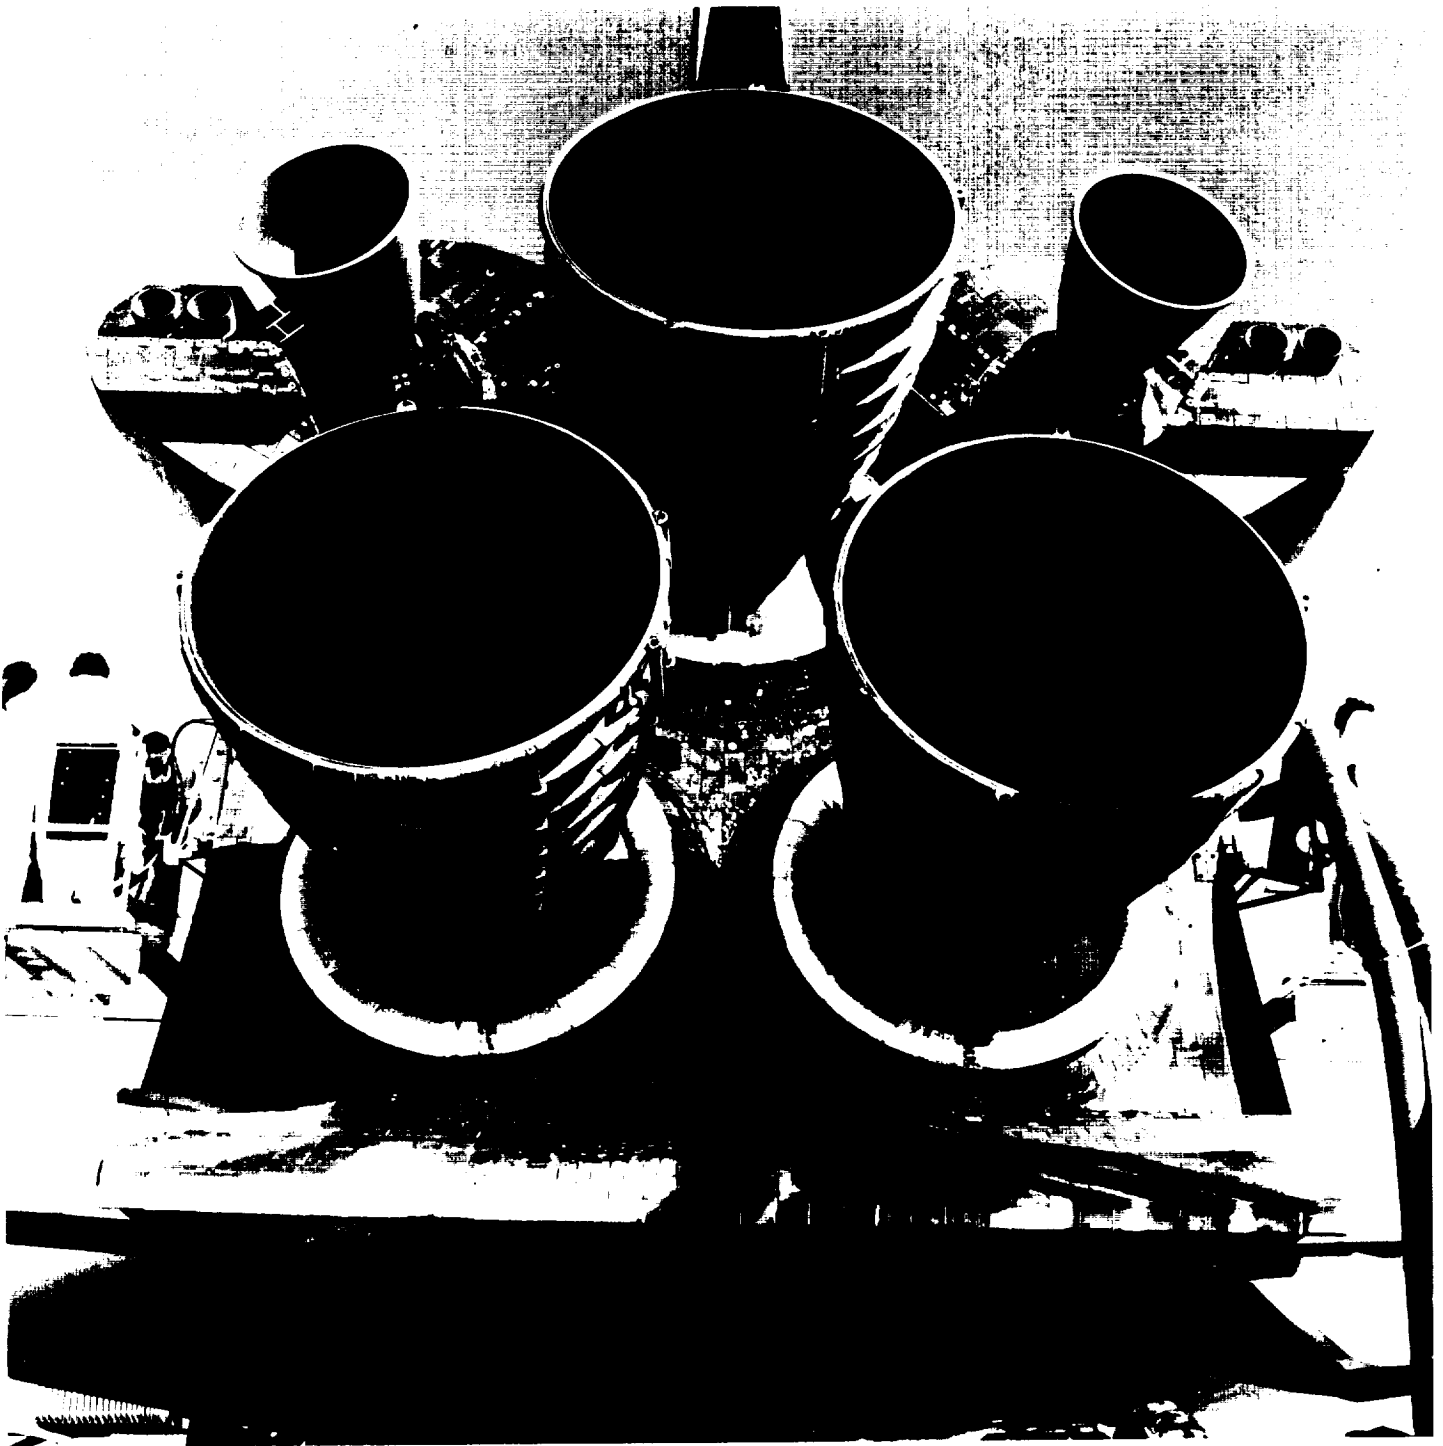
Tile damage on the base heat shield was typical. The Dome Mounted Heat Shield (DMHS) closeout blankets on all three SSME's were in excellent condition and no material was missing.

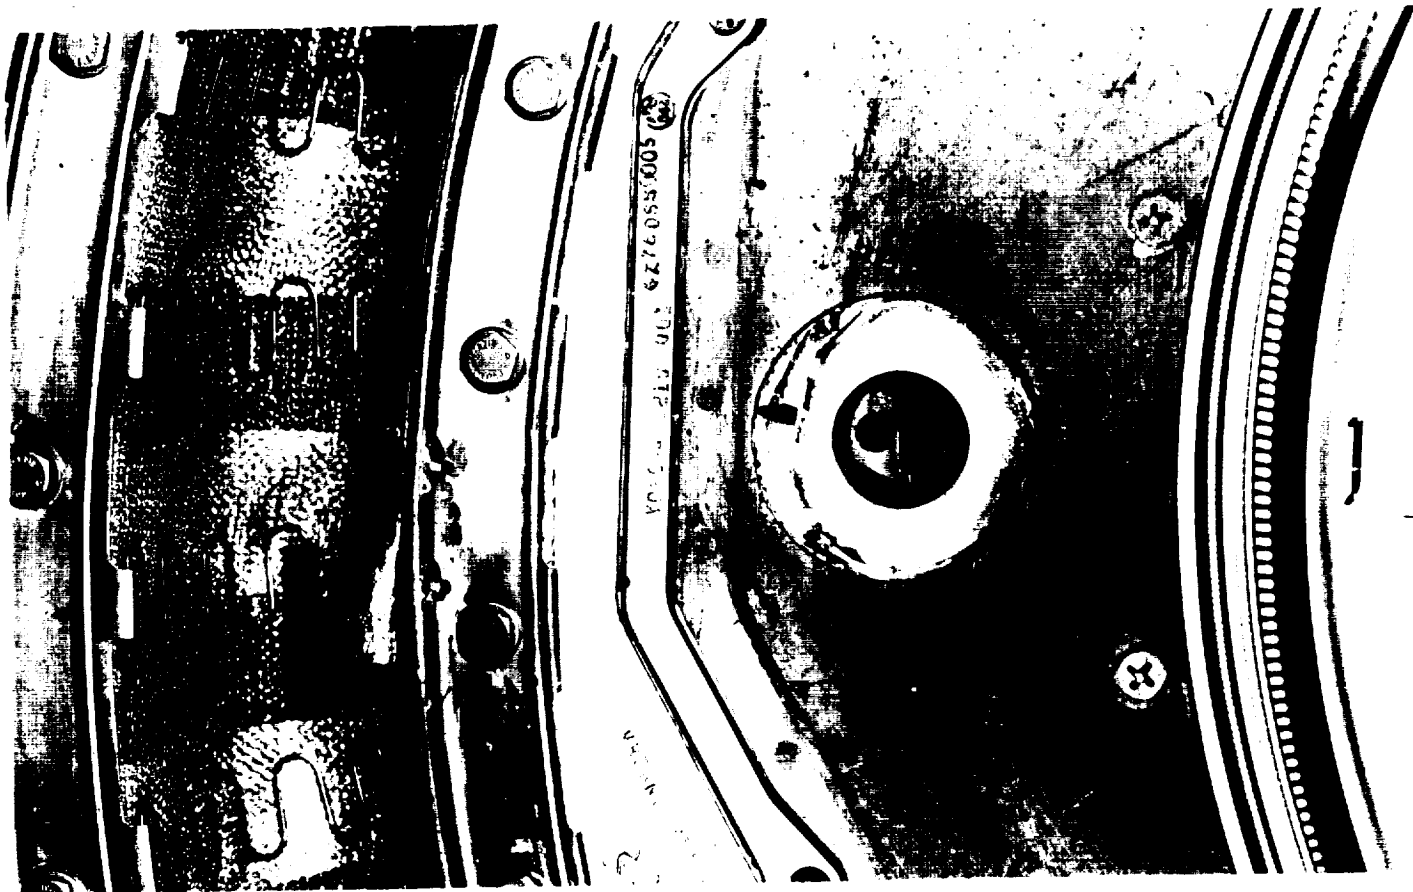
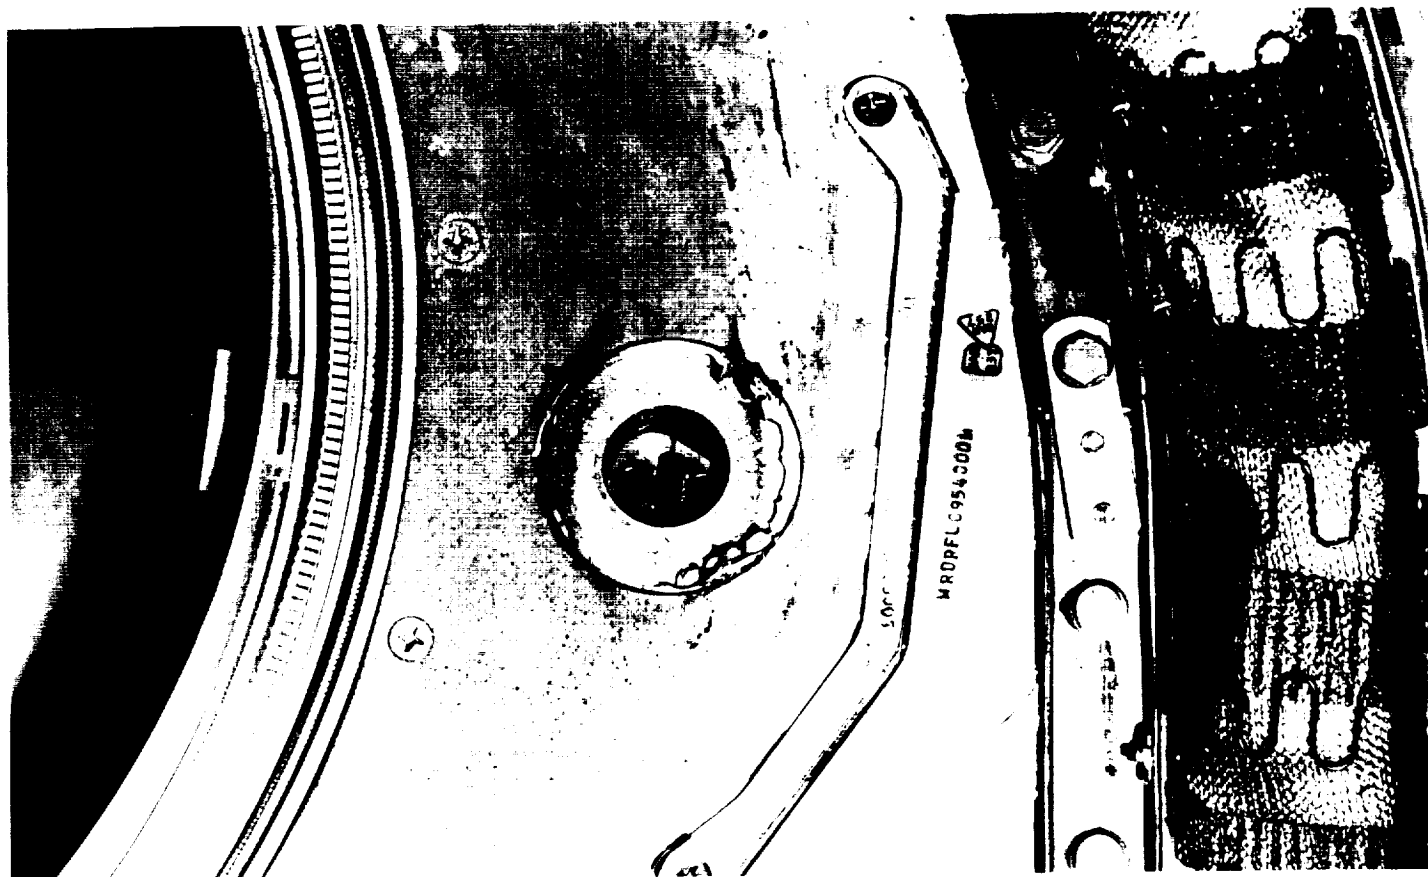
Charred white RTV protruded from the LH2 ET/ORB umbilical forward outboard and forward inboard pyrotechnic canister to umbilical plate interfaces.

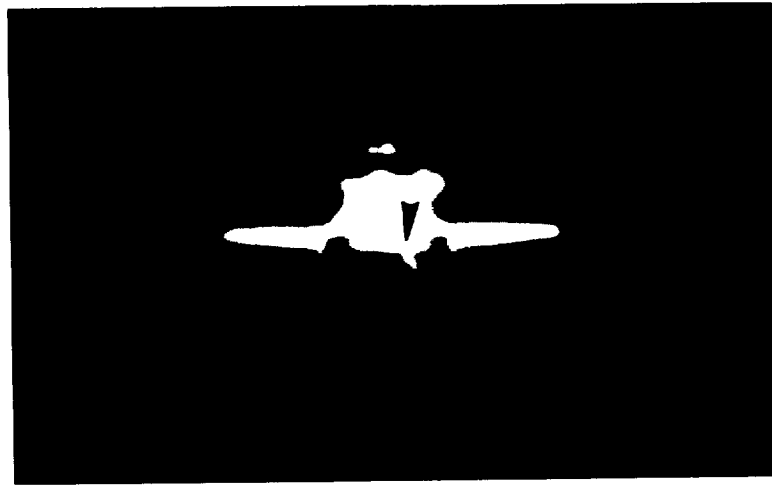
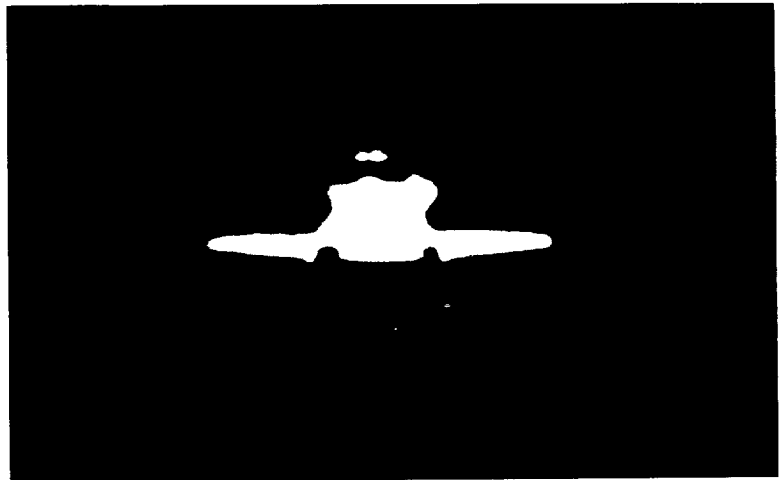
Thermal barrier, as large as 36 inches in length, fell from the Orbiter nose wheel well as the landing gear door opened on final approach. The thermal barrier, which was still at an elevated temperature from re-entry, was clearly visible in the infrared views but virtually invisible in the landing films.

2. Six thermal barriers, total size approximately 36" x 3" x 1.5", and one corner tile piece 4" x 4", were missing from the nose landing gear doors. Runway infrared cameras recorded these objects falling from the Orbiter when the nose landing gear doors were opened on final approach.

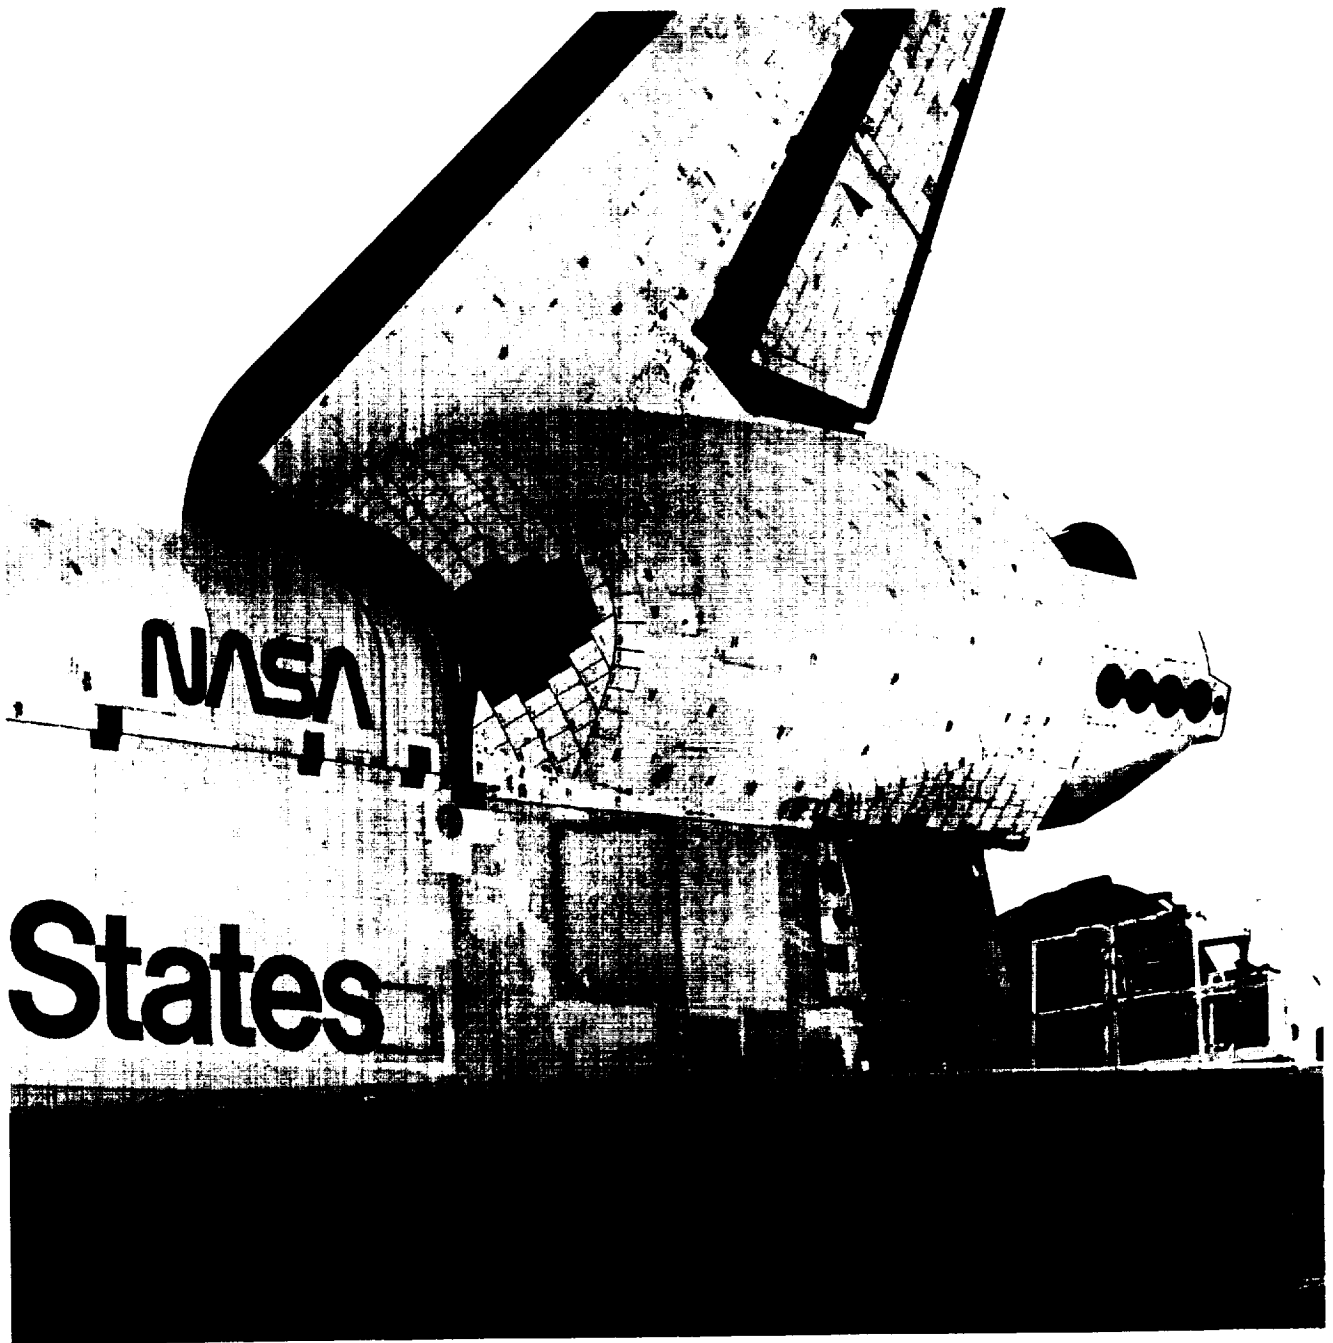
A cluster of 29 damage sites spanned three tiles on the rudder black edge tiles along the hinge line below the split in the speed brake. Three hits occurred in this same general area on the right side of the rudder/speed brake.

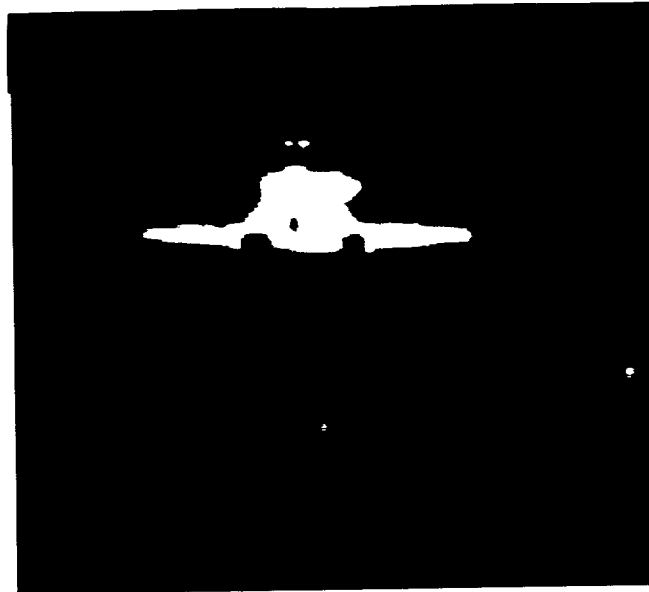
**Figure 1.3 Debris at Landing Gear Deploy**

Four pieces of debris fell from the vehicle at landing gear deploy as seen on infrared video views EL-17 and EL-18. Two of the items appeared to originate from the main gear doors (most visible at 77:13:09:20.991 UTC). The other two pieces appeared to originate from the nose gear area (most visible at 77:13:09:22.721 UTC). These debris items are believed to be the missing nose gear door thermal barrier material noted on the walk around video. (Debris was seen to fall from the nose gear area on infrared views of the landing gear deploy on STS-56. The STS-56 debris objects were reported by KSC to be gap fillers from the landing gear doors.)

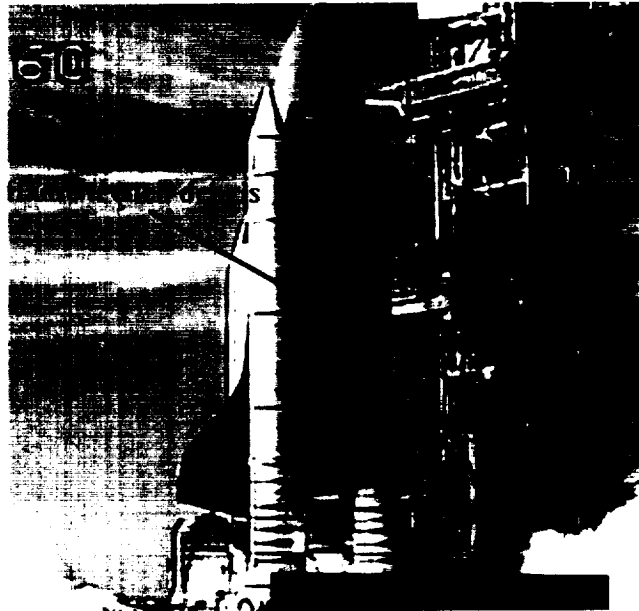
**Figure 2.1.2.2 Flame Trench Debris at Liftoff**  
(Camera OTV-160)

On camera OTV-160, a light colored piece of debris was seen north of the launch pad in the exhaust cloud at 0.718 seconds MET. The debris appeared to move toward the vehicle in the OTV-160 view. This debris was not seen from other cameras so its direction of travel could not be confirmed. Additional debris was seen falling toward the flame trench on the OTV-160 view at 3.054 seconds MET and 3.54 seconds MET. The OTV-141 and OTV-148 views of the north side of the SLV were examined for debris moving toward the vehicle. No indication of debris moving toward the vehicle was found on the OTV-141 and OTV-148 views. On camera E-60, a single piece of light colored debris traveled from the SRB flame trench south toward the vehicle. On camera E-62, a single piece of SRB flame trench debris traveled away from the vehicle. None of the debris was seen to strike the vehicle. No follow up action was requested.
