# Debris/Ice/TPS Assessment and Integrated Photographic Analysis for Shuttle Mission STS-62

May 1994

DEBRIS/ICE/TPS ASSESSMENT  
AND  
INTEGRATED PHOTOGRAPHIC ANALYSIS  
OF  
SHUTTLE MISSION STS-62

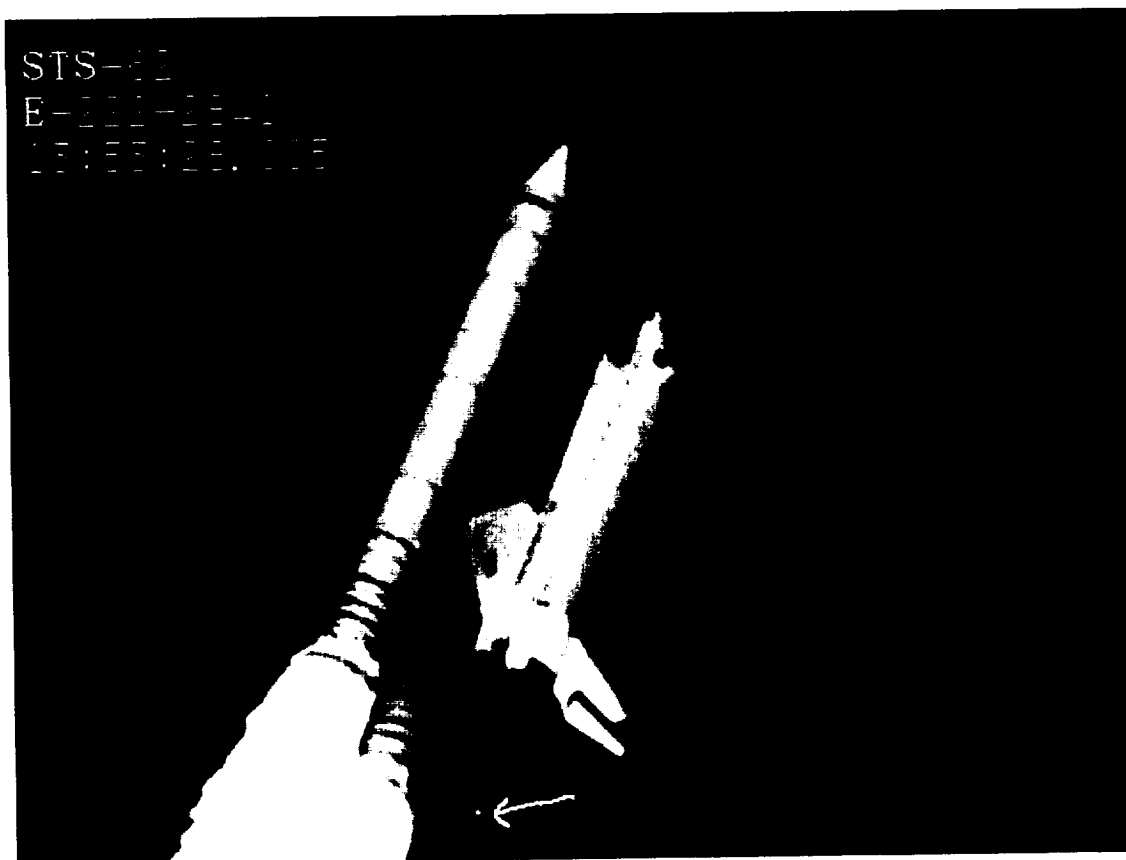
**Figure 2.1.3.4 Debris at 28 Seconds MET**

A fast moving light colored piece of debris first seen over the right wing and traveled aft into the SSME plume at 28.0 seconds MET. This debris was tentatively identified by KSC personnel as

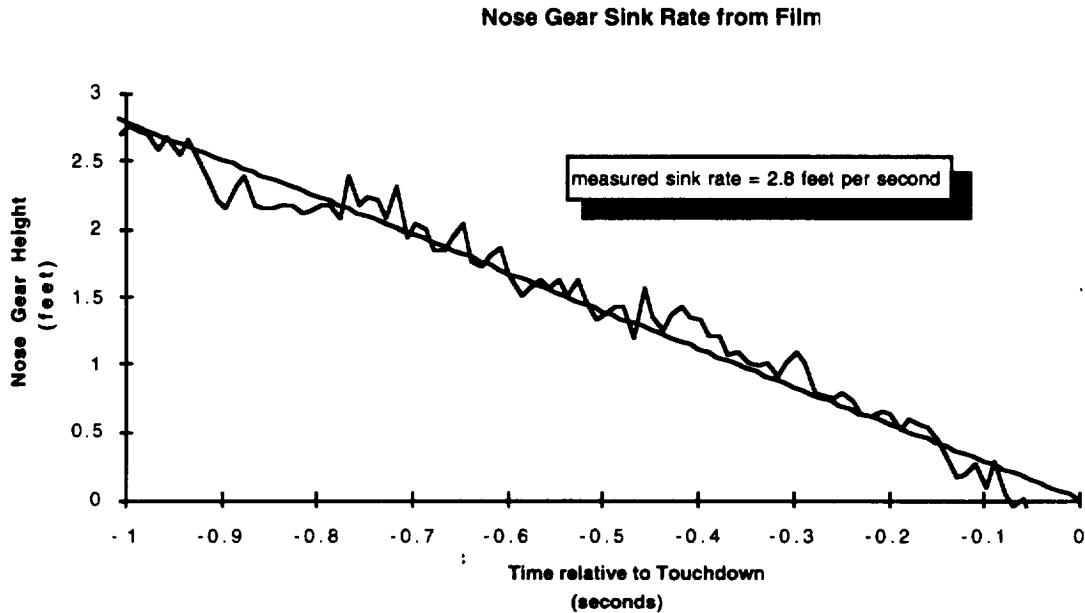
**Figure 2.5.2b** Graph of Nose Gear Height Versus Time During Rollout

Camera EL-7 was used to determine the landing sink rate of the nose gear. The analysis considered approximately one second of imagery immediately prior to touchdown. Data was gathered at a sample rate of 100 frames per second. An assumption was made that the line of sight of the camera was perpendicular to the Orbiter y-axis. Scaling information was determined by using the distance between the main gear struts. The vertical difference of the digitized nose gear point from the average of the main gear points was multiplied by the scaling factor to find the height of the nose gear for a single frame. An empirical offset correction was made to produce a calculated height at main gear touchdown of 0 feet. These heights were then regressed with respect to time. Sink rate equals the slope of this regression line. The nose gear sink rate was determined to be 2.8 feet per second.

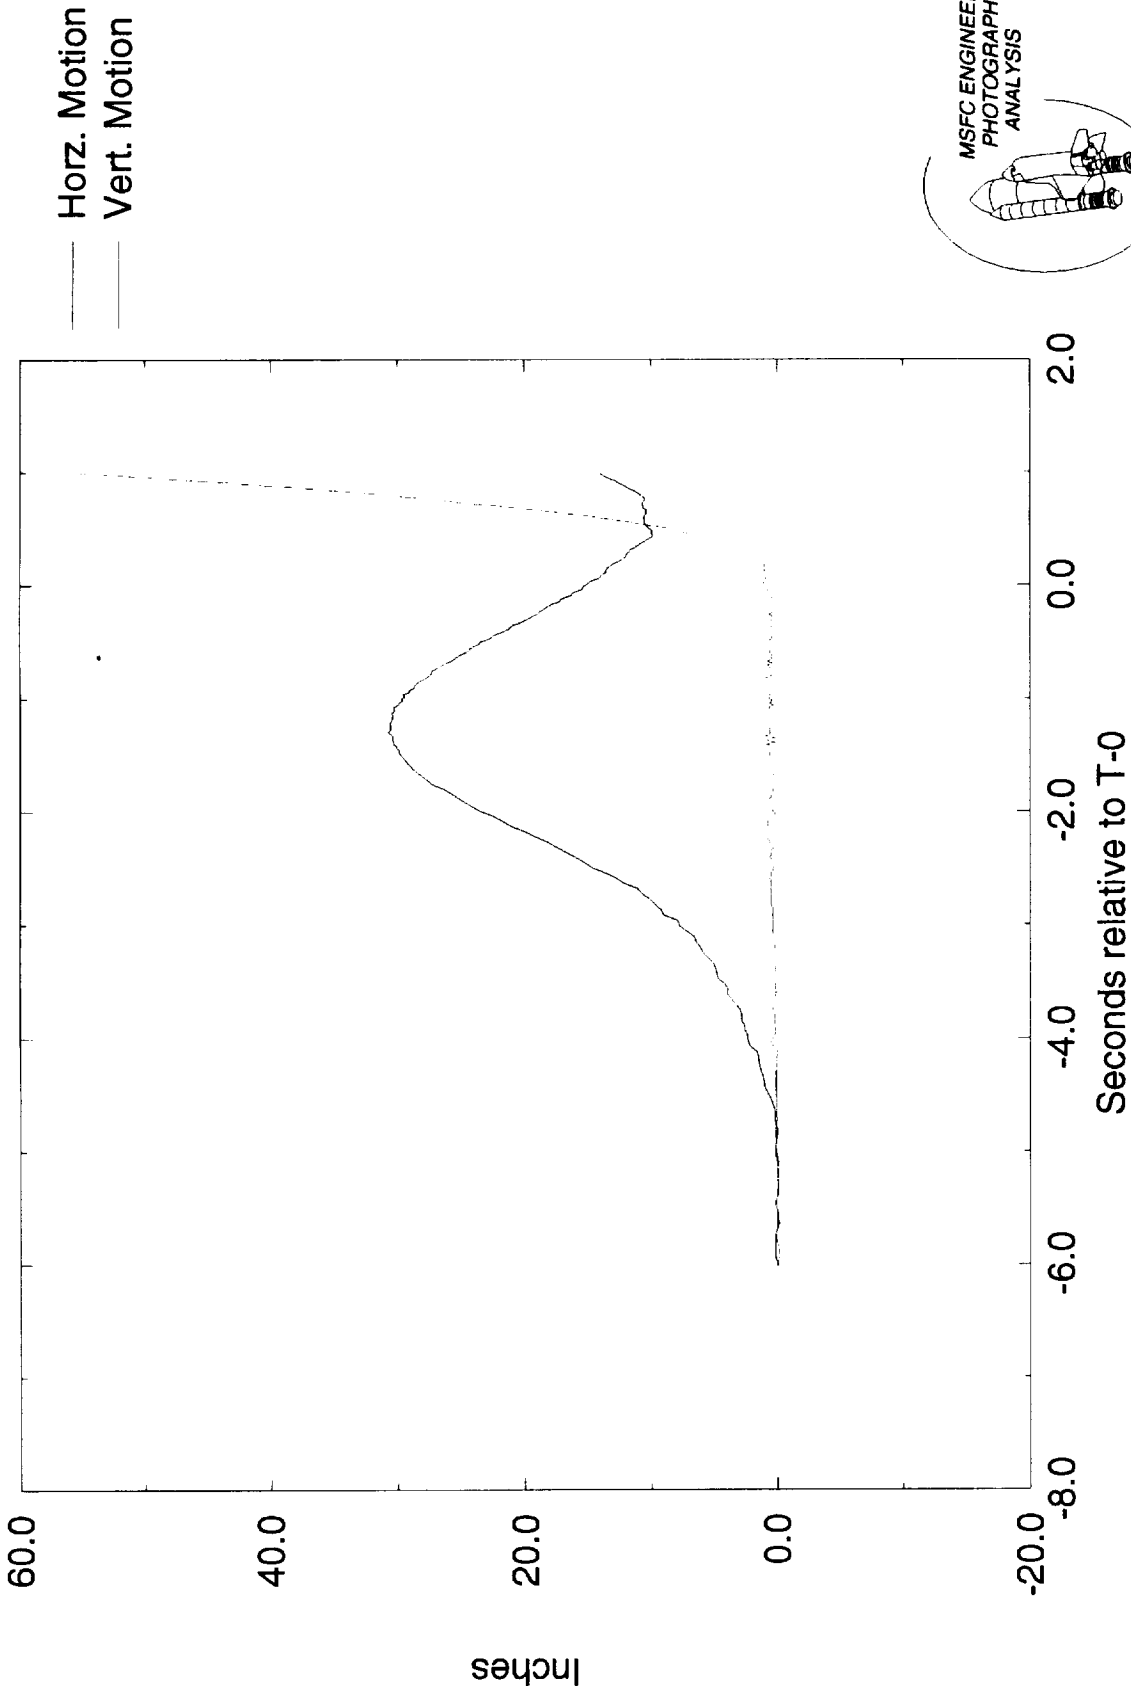
Figure 7 ET Tip Deflection

Maximum ET tip deflection for this mission was determined to be approximately 31 inches. Figure 7 is a data plot showing the measured motion of the ET tip in both the horizontal and vertical directions. A positive horizontal displacement represents motion in the -Z direction. These data were derived from film camera E-79.
