BRUSH SEAL BRISTLE FLEXURE AND HARD-RUB CHARACTERISTICS

Robert C. Hendricks, Julie A. Carlile, and Anita D. Liang
National Aeronautics and Space Administration
Lewis Research Center
Cleveland, OH 44135

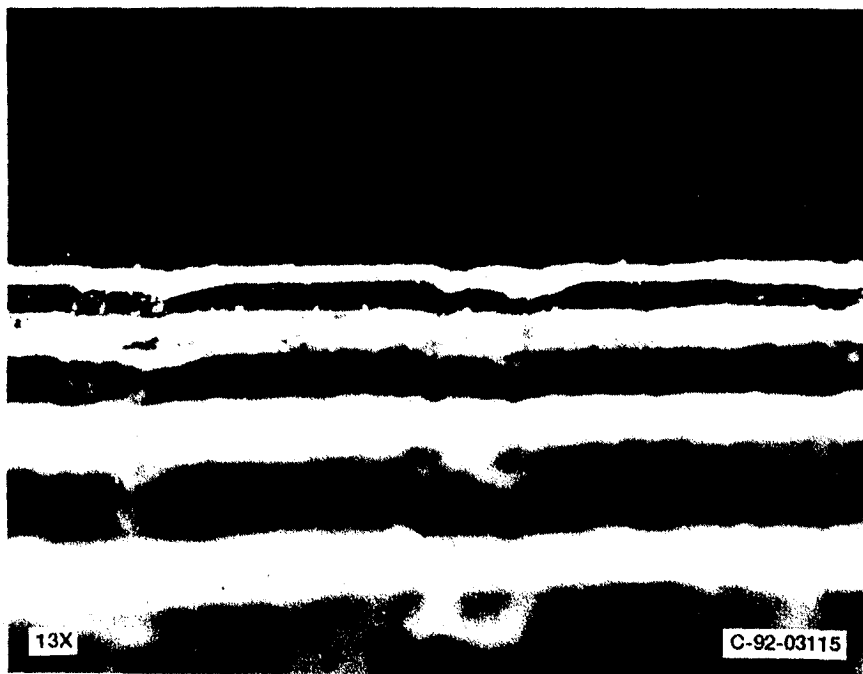
The trailing edge of the land was "cut" clean by the brush in all three tests (fig. 18) in stark contrast to the erratic leading-edge surface, which was whipped by the bristles (fig. 19). Of interest is the contrast between the land surface cuts. Test 1 surface cuts were a simple wear scar; those of tests 2 and 3 were multiple grooves with complex surfaces and burnishing (fig. 20). The most rotor damage appeared from test 2 and the most brush damage from test 3, where the rotor was set eccentric.

Figure 20.—Rotor trailing edge (tests 1, 2, and 3).
