Debris/Ice/TPS Assessment and Integrated Photographic Analysis for Shuttle Mission STS-57

July 1993

Gregory N. Katnik
NASA/Kennedy Space Center

DEBRIS/ICE/TPS ASSESSMENT
AND
PHOTOGRAPHIC ANALYSIS
OF
SHUTTLE MISSION STS-57

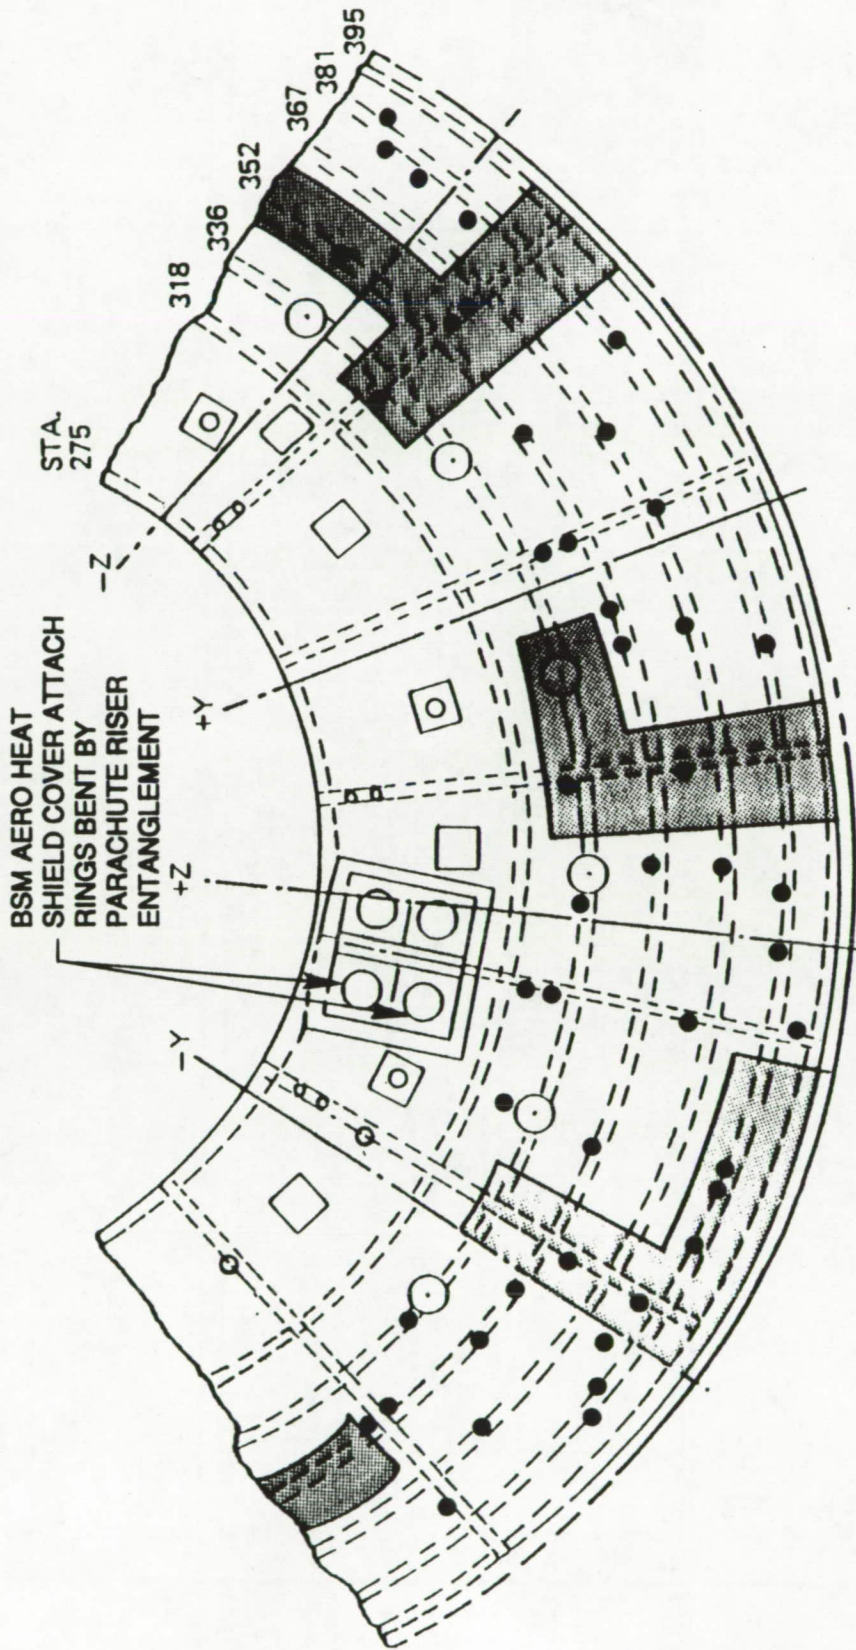
FIGURE 5. RIGHT SRB FRUSTUM

The RH frustum had 46 MSA-2 debonds over fasteners and two areas of missing MSA-2 (between the 275 and 318 ring frames near the -Y axis). Minor blistering of the Hypalon paint had occurred in localized areas (Figure 5). All BSM aero heat shield covers were locked in the fully opened position, though the two left cover attach rings had been bent by parachute riser entanglement.

MISSING TPS
2 ○

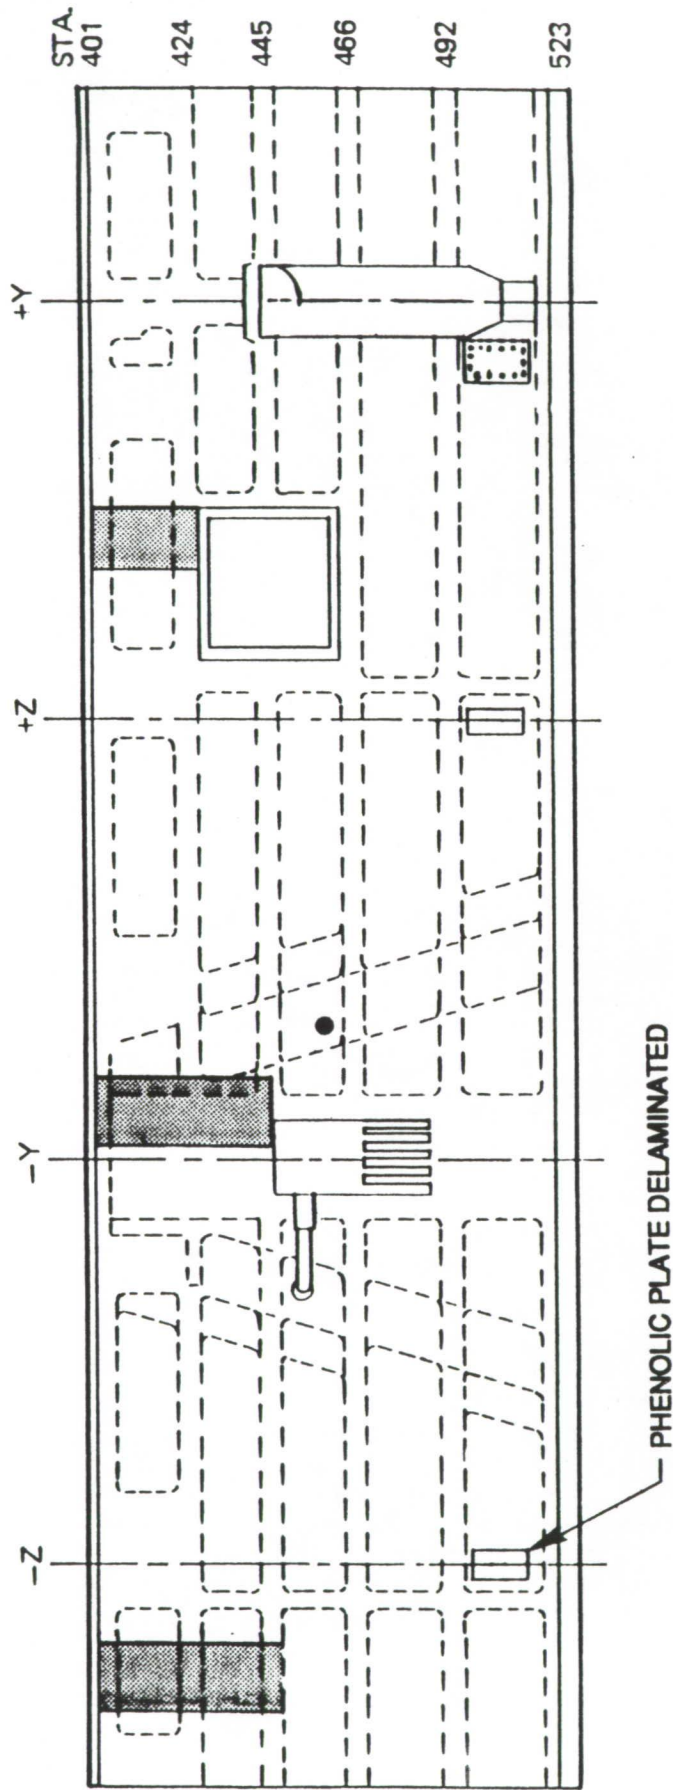
FIGURE 6. RIGHT SRIB FWD SKIRT

The RH forward skirt acreage was missing no TPS, but had one MSA-2 debond near the forward attach fitting. Both RSS antennae covers/phenolic base plates were intact though the -Z plate had delaminated (Figure 6). Minor blistering of the Hypalon paint occurred on the systems tunnel cover and around the ET/SRB attach point. No pins were missing from the frustum severance ring. The forward separation bolt appeared to have separated cleanly.

TPS MISSING
NONE

DEBONDS
1 ●

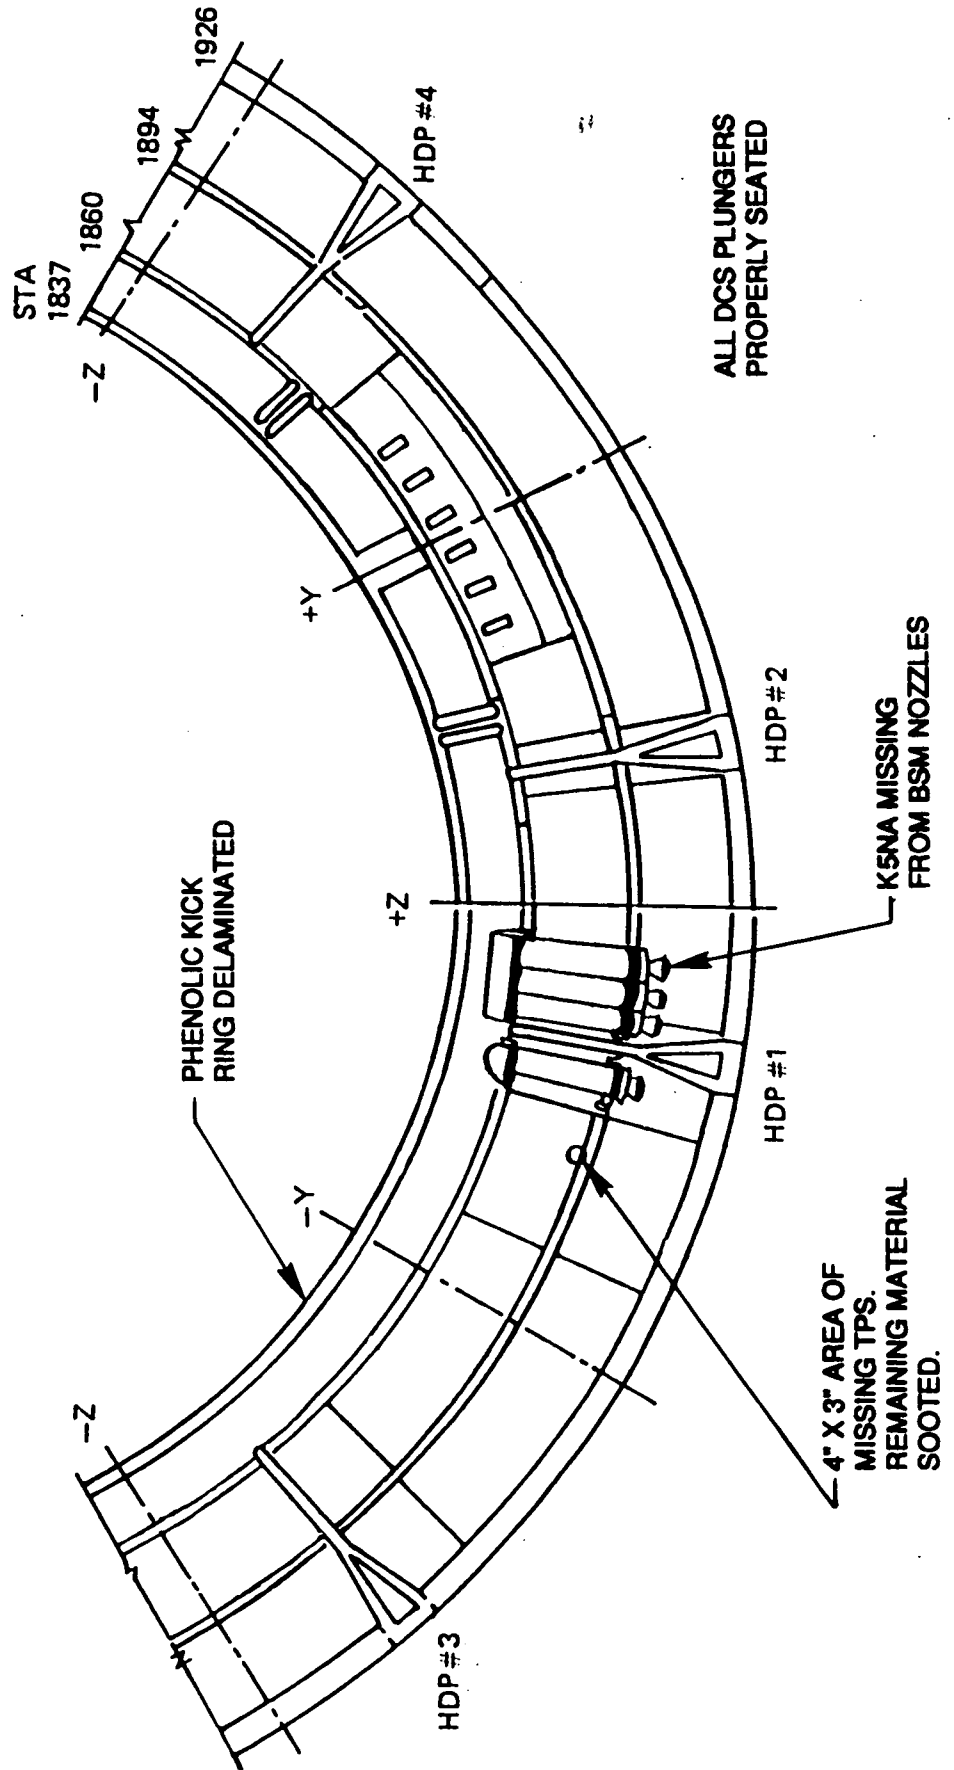
FIGURE 7. RIGHT SRB AFT SKIRT EXTERIOR TPS

The phenolic material on the kick ring was delaminated. The K5NA closeouts (protective domes) on the kick ring forward and aft fasteners are no longer used. RTV-133 has replaced the K5NA over the forward fasteners. The aft skirt acreage TPS was generally in good condition but was missing a 4"x3" piece of MSA-2 on ring frame 1894 fasteners near the single BSM (Figure 7).

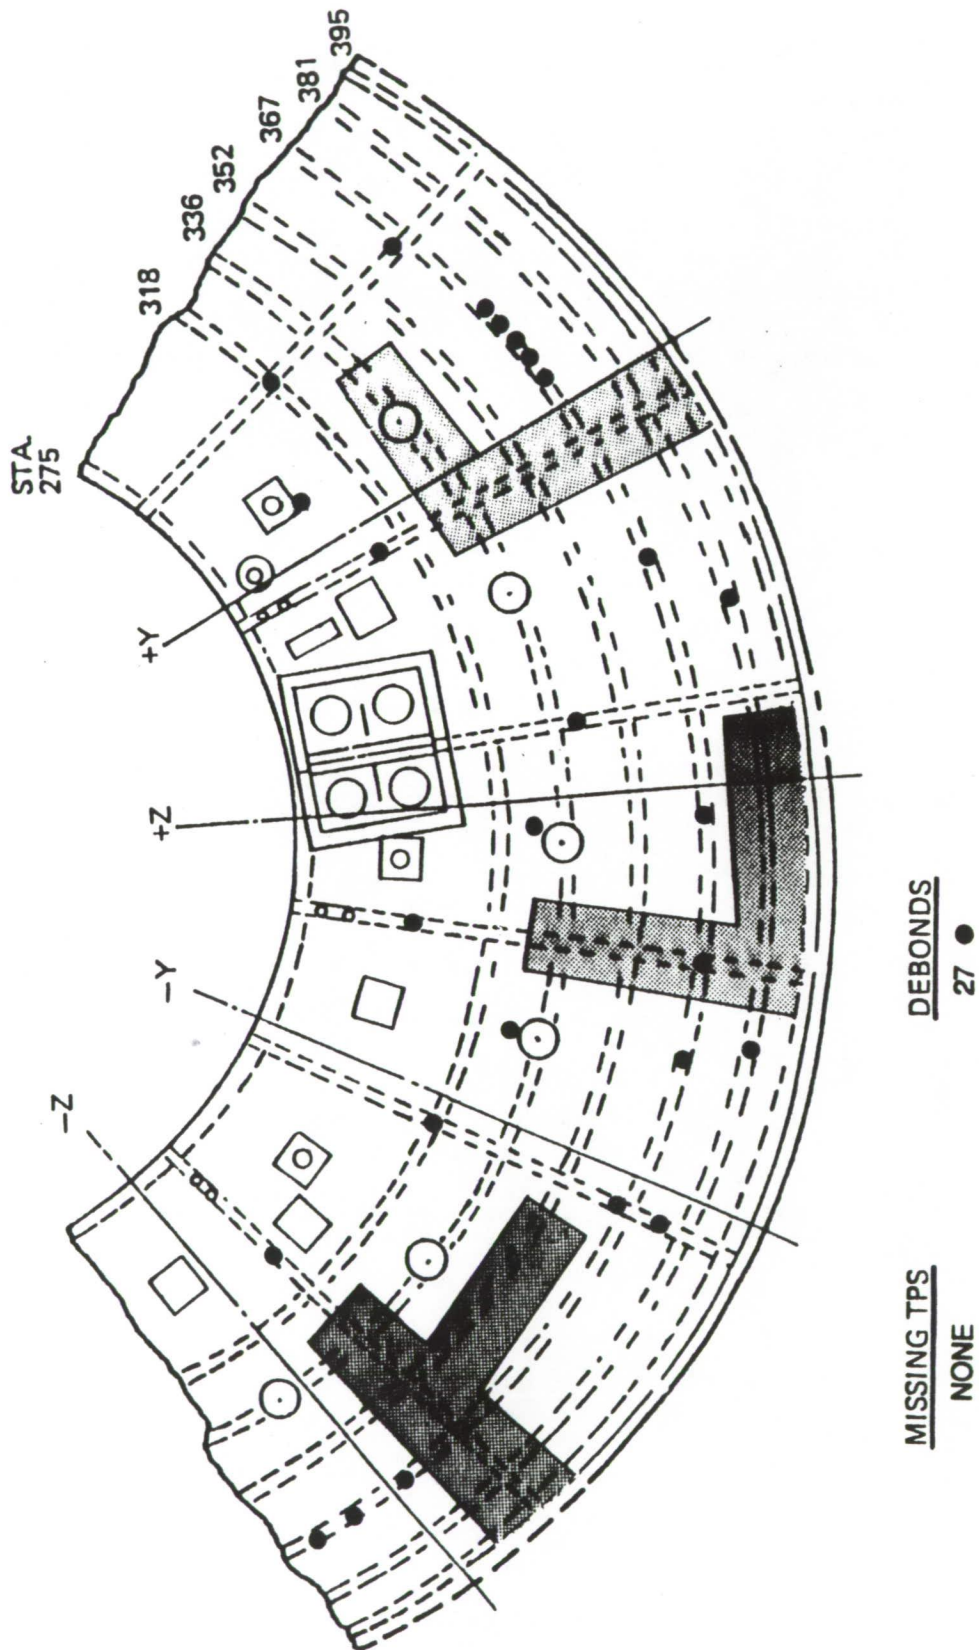
FIGURE 8. LEFT SRB FRUSTRUM

The LH frustum was missing no TPS, but had 27 MSA-2 debonds over fasteners. Minor localized blistering of the Hypalon paint had occurred along the 395 ring (Figure 8). The BSM aero heat shield covers were locked in the fully opened position.

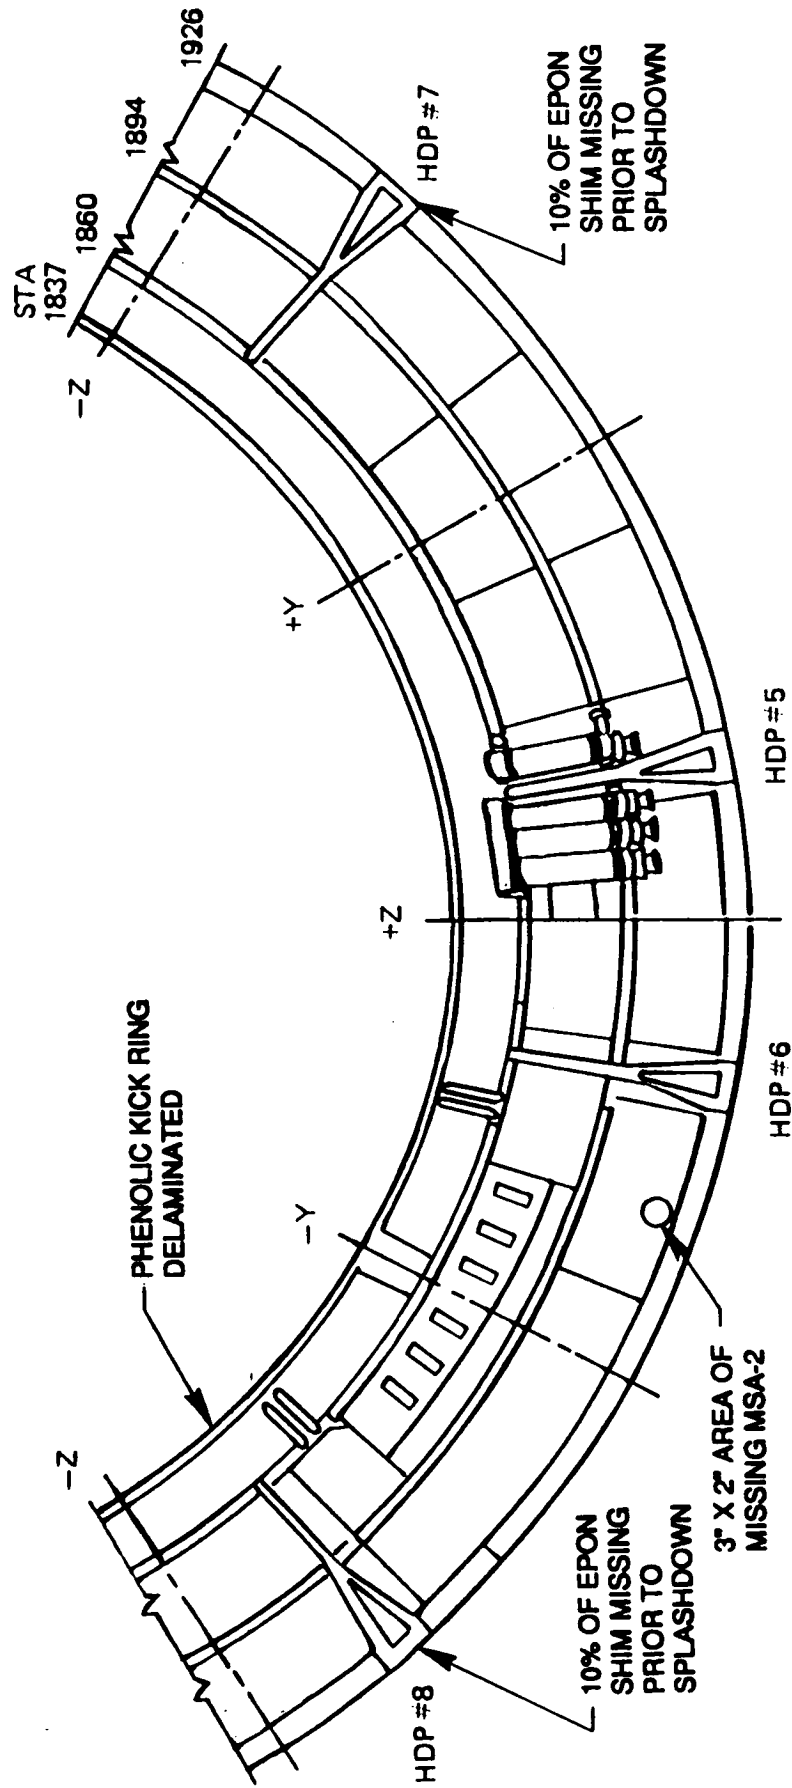
FIGURE 9. LEFT SRB AFT SKIRT EXTERIOR TPS

The phenolic material on the kick ring was delaminated. The K5NA closeouts (protective domes) on the kick ring forward and aft fasteners are no longer used. RTV-133 has replaced the K5NA over the forward fasteners. One 3"x2" area of MSA-2 was missing from the aft skirt acreage TPS near the 1926 ring frame between the -Y and +Z axes. The remaining material was slightly sooted (Figure 9).

ALL DCS PLUNGERS
PROPERLY SEATED

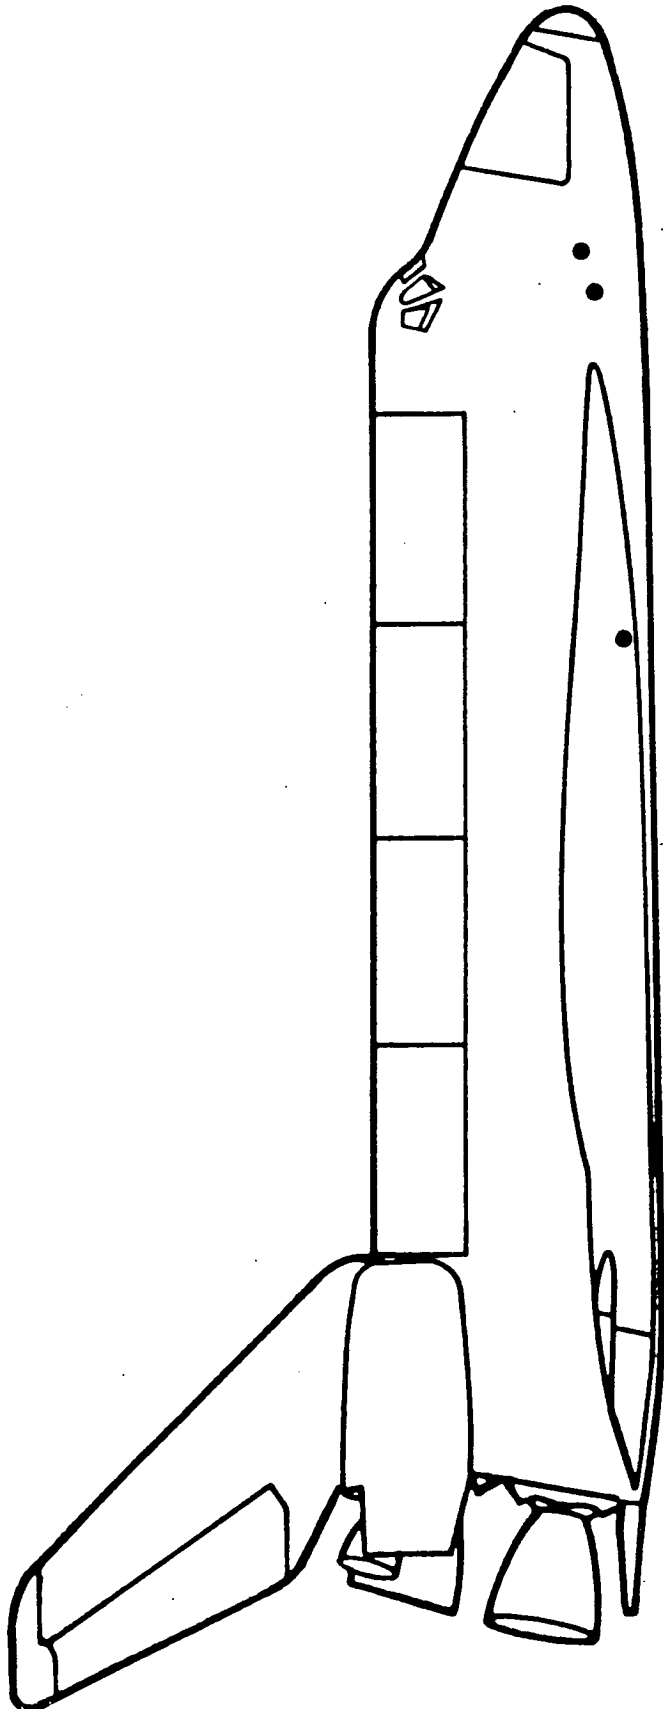
FIGURE 12

TOTAL HITS = 3
HITS > 1 INCH = 0

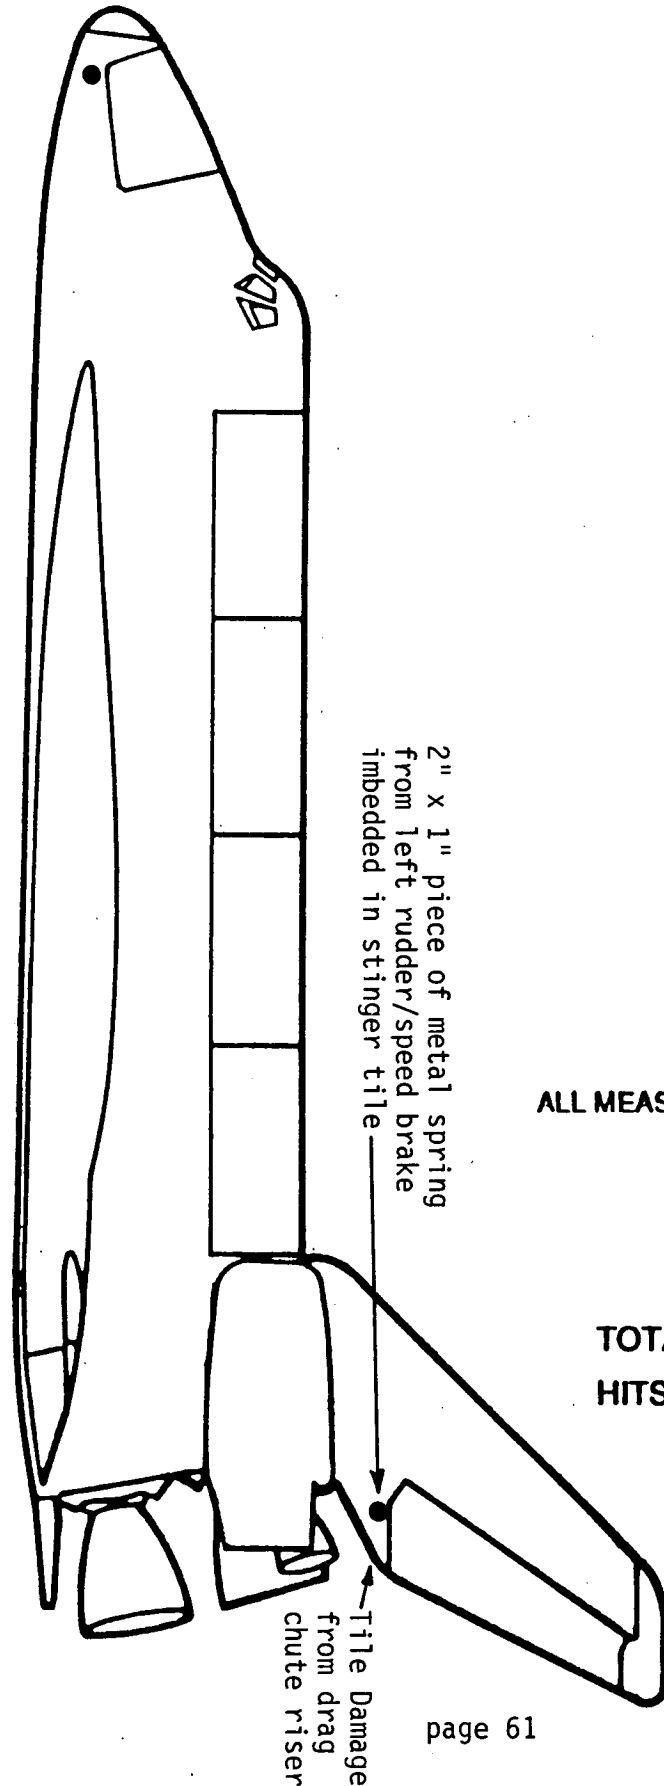
FIGURE 13

TOTAL HITS = 2
HITS > 1 INCH = 1

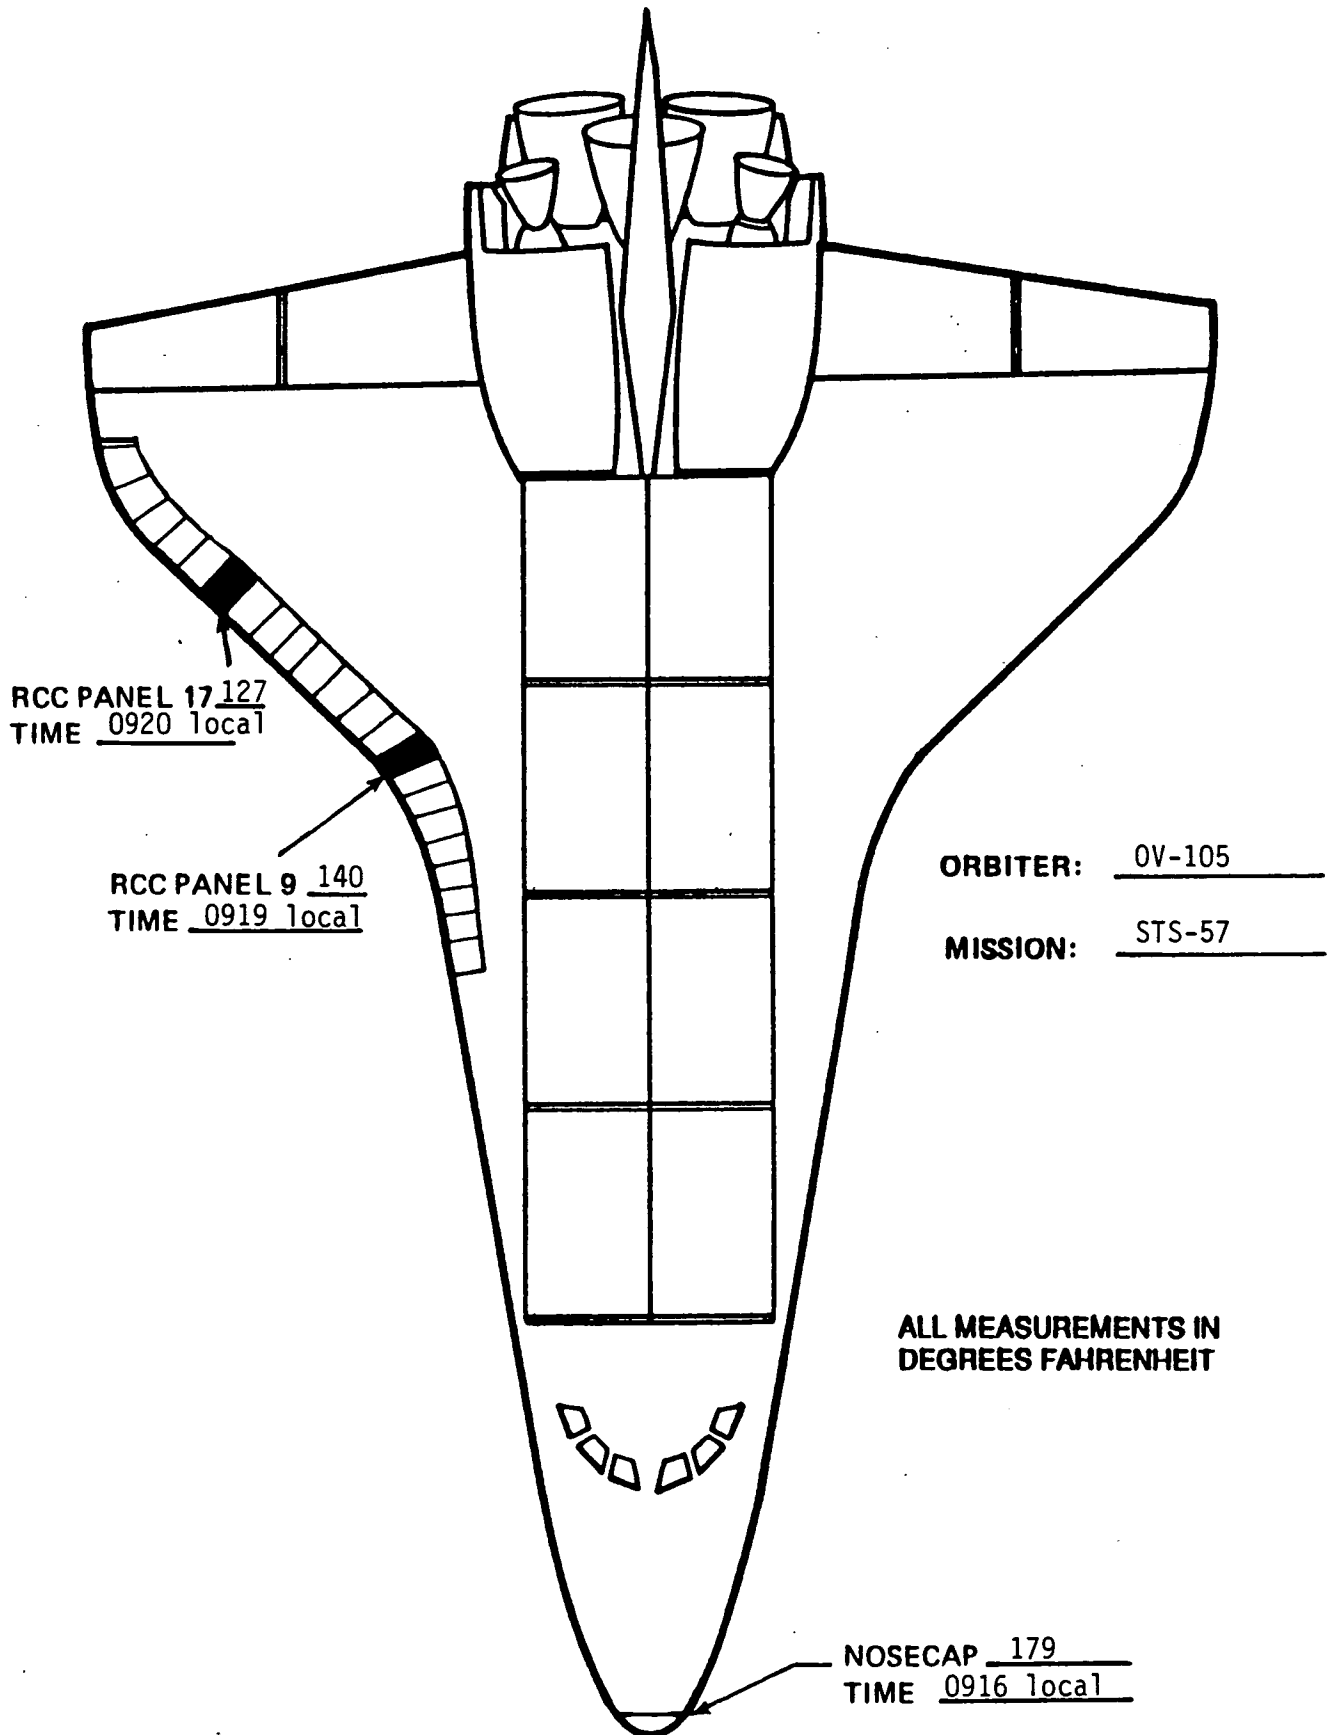
The Shuttle Thermal Imager (STI) was used to measure the surface temperatures of several areas on the vehicle (per OMRSD V09AJ0.095). Twenty-one minutes after landing, the Orbiter nose cap RCC was 179 degrees F. Twenty-four minutes after landing, the RH wing leading edge RCC panel #9 was 140 degrees and panel #17 was 127 degrees F (reference Figure 14).

FIGURE 14. **STS-57 RCC TEMPERATURE MEASUREMENTS AS RECORDED BY THE SHUTTLE THERMAL IMAGER**

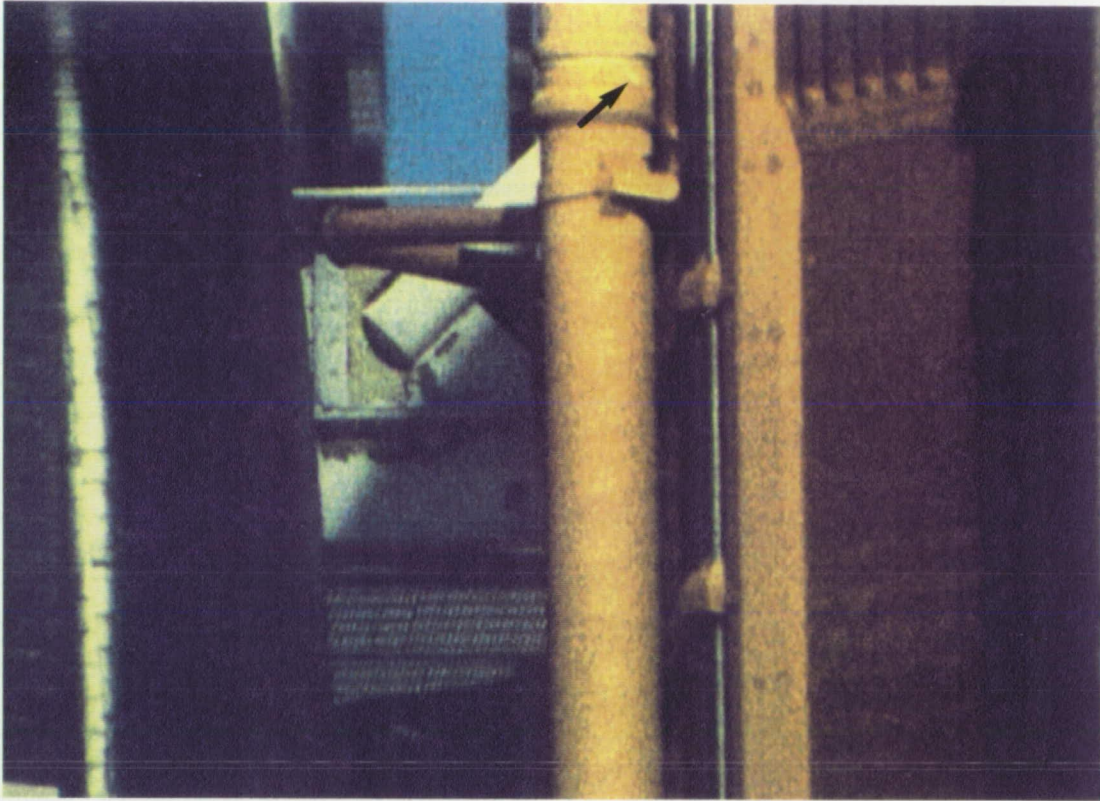
Figure 2.1.2.5 Debris from LO2 Feedline Joint

A white piece of debris (probably ice, approximately 3 inches in length) appeared to originate from the joint on the LO2 feedline near the forward bipod (see Figure 2.1.2.4) and fall along the LO2 feedline during liftoff on camera E-65. A smaller piece of debris was seen falling along the LO2 feedline at a lower location during liftoff on camera E-79. Neither debris item was seen to contact the vehicle.

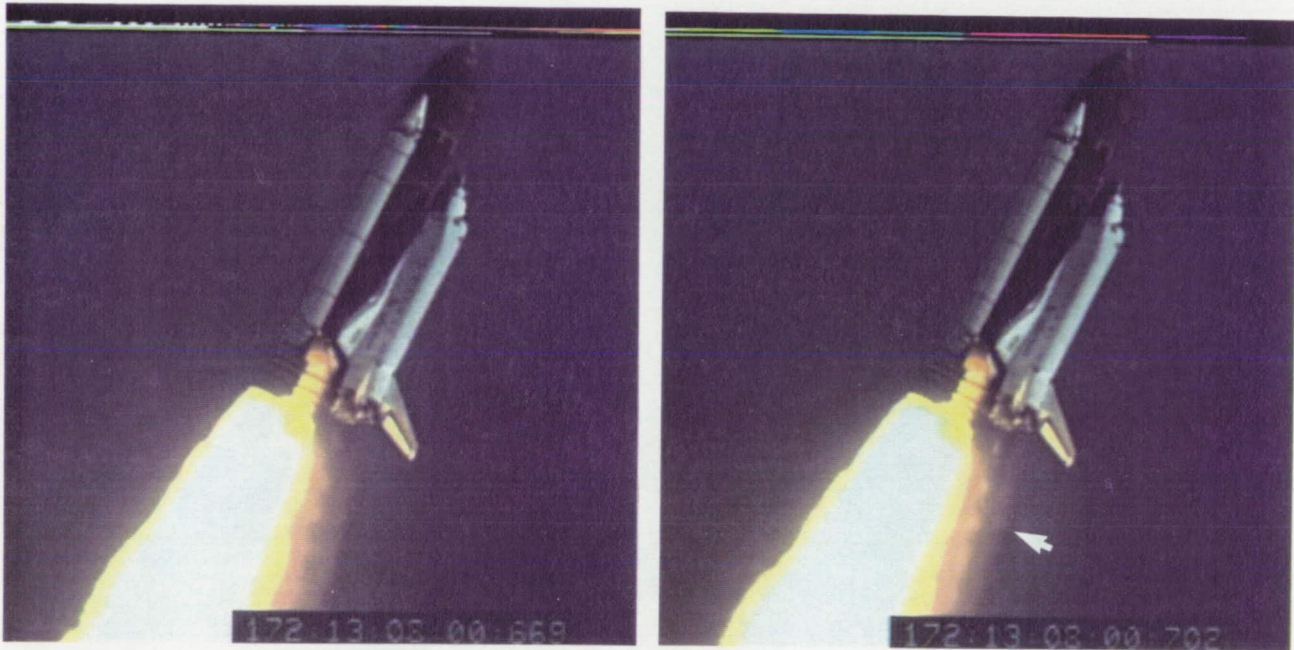
Figure 2.3.2 Light Colored Streak in SSME plume at 38 seconds MET and Reference Image

A light colored streak was noted in the SSME plume at approximately 38 seconds MET on ET-212. Figure 2.3.2 provides an image of the streak along with an image of an earlier time without the streak. A white puff (believed to be the same event seen from a different perspective) was noted at the same time and similar position on camera ET-204.

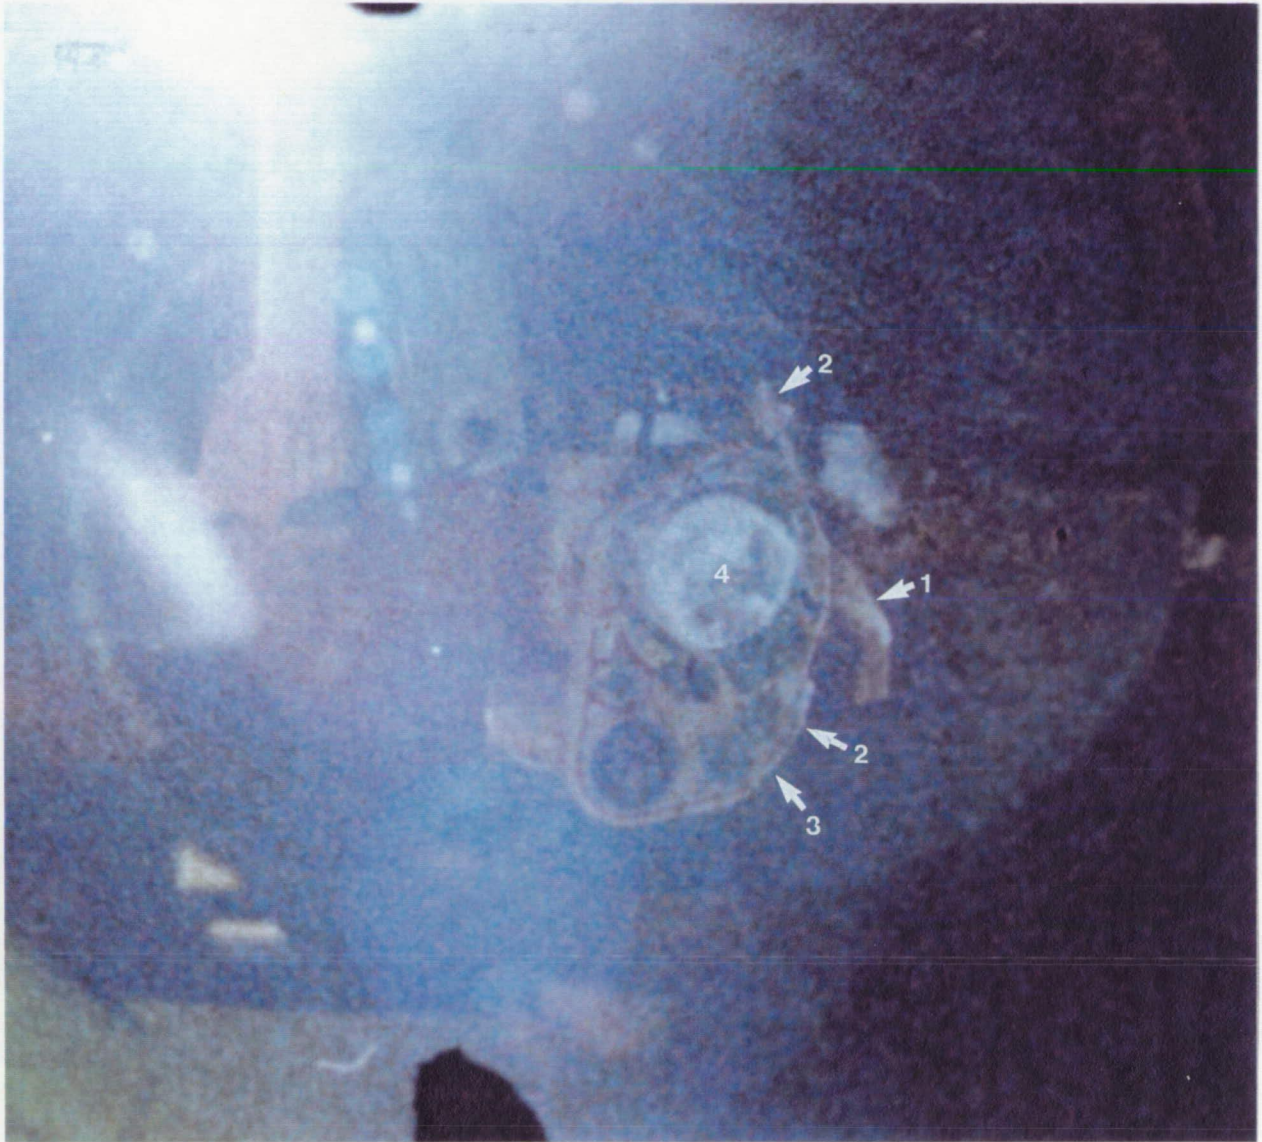
Figure 2.4.3a **16 mm Camera View of the ET LH2 Umbilical**

After the external tank separated from the Orbiter, a piece of loose insulation or foam was visible on the view of the inboard side of the ET LH2 umbilical. This piece of foam was over 20 inches long and 4 inches wide as determined by comparison to known structures on the face of the LH2 umbilical (1). Two possible pieces of detached white RTV were visible on the inboard and forward sides of the LH2 umbilical (2). A segment of the red RTV seal that surrounds the outer border of the LH2 umbilical appeared to be missing near the four inch line connect (3). The large circle of ice in the LH2 seventeen inch line orifice is an expected occurrence and has been seen on the previous mission umbilical well films (4).

A slender piece of white debris that appeared to be flexing was visible on the left side of the film view of the ET LH2 umbilical after ET separation. This may be a piece of white RTV that came from the LH2 umbilical.

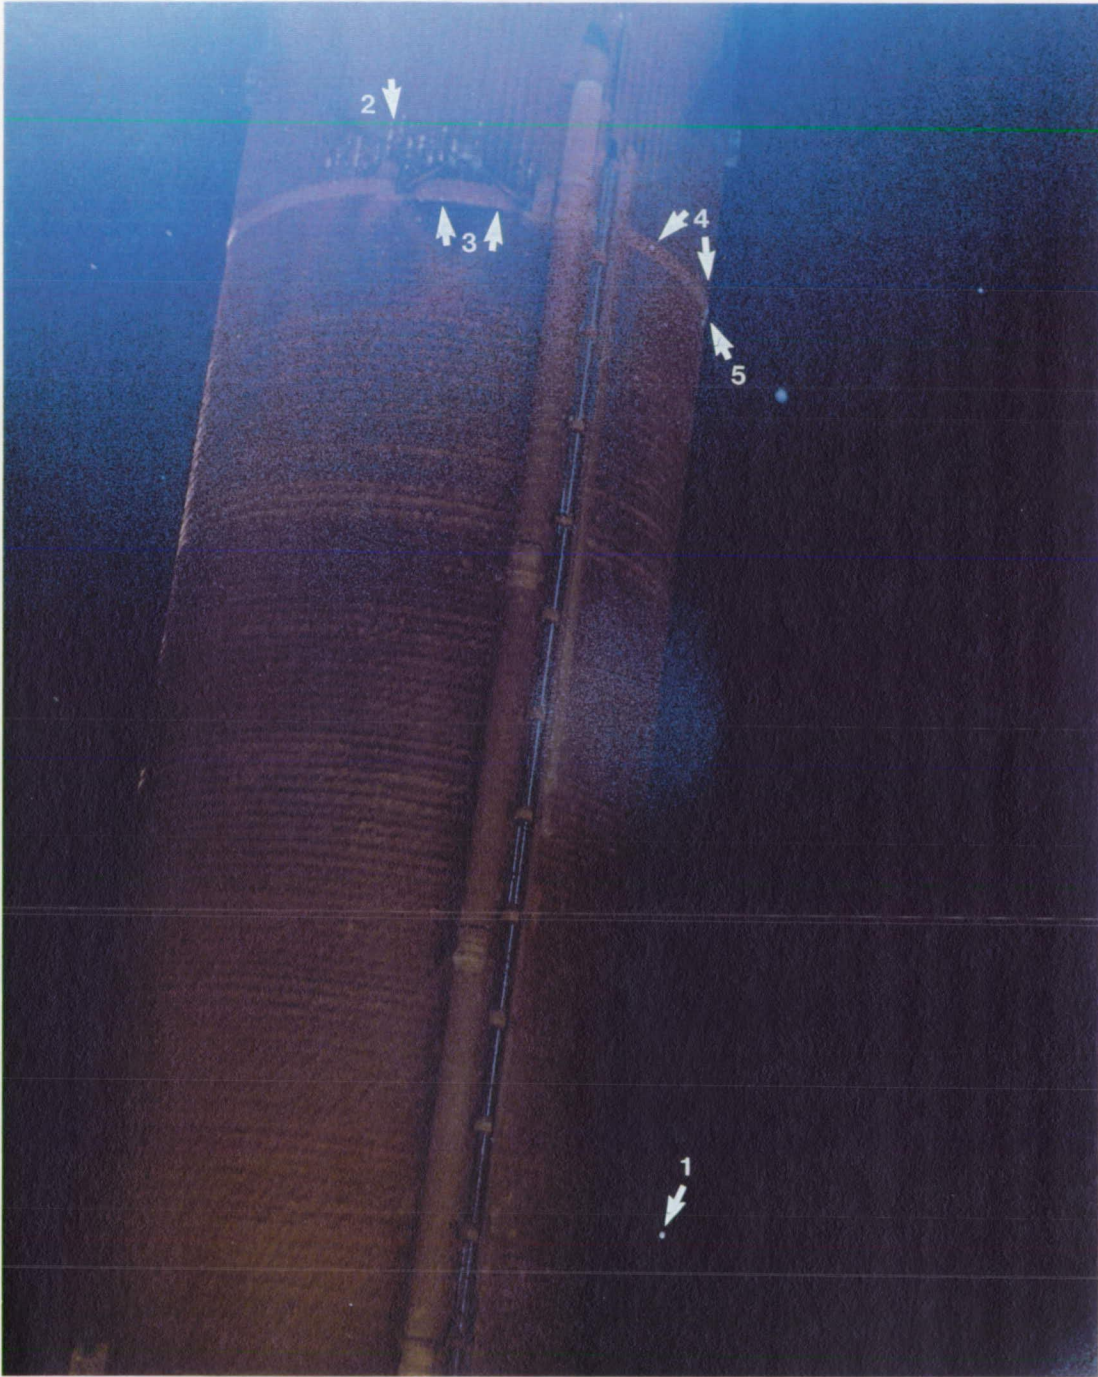
Figure 2.4.4b 35 mm Camera View of the Bipod and LH2 Tank/Intertank Region of the External Tank

Multiple pieces of white debris were imaged between the camera and the external tank. The white debris appeared to be ice (1). Multiple white "popcorn" marks were visible on the intertank stringers forward of the bipod (2). Several small white marks or divots were visible between the bipod legs on the LH2 tank/intertank closeout flange (3). Two divots less than six inches in size were visible on the intertank closeout flange to the right of the

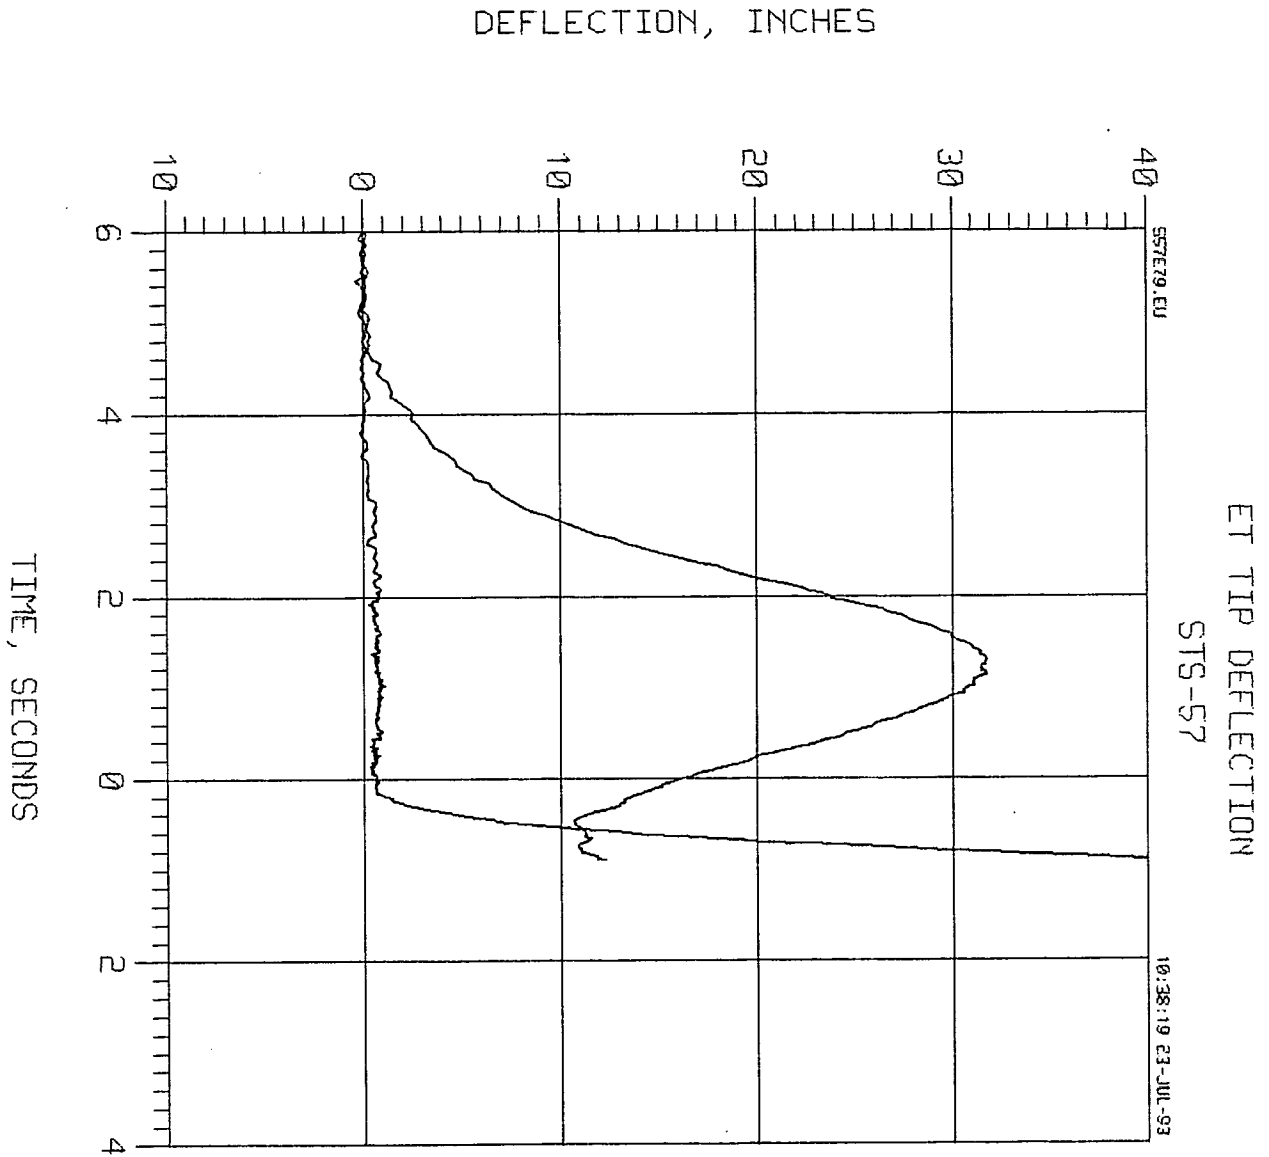
Maximum ET tip deflection for this mission was determined to be approximately 32 inches. Figure 5 is a data plot showing the measured motion of the ET tip in both the horizontal and vertical directions. These data were derived from camera E-79.
