# WARTIME REPORT

FLIGHT TESTS OF THE THERMAL ICE-PREVENTION  
EQUIPMENT ON THE B-17F AIRPLANE

By Bonne C. Look

Ames Aeronautical Laboratory  
Moffett Field, California

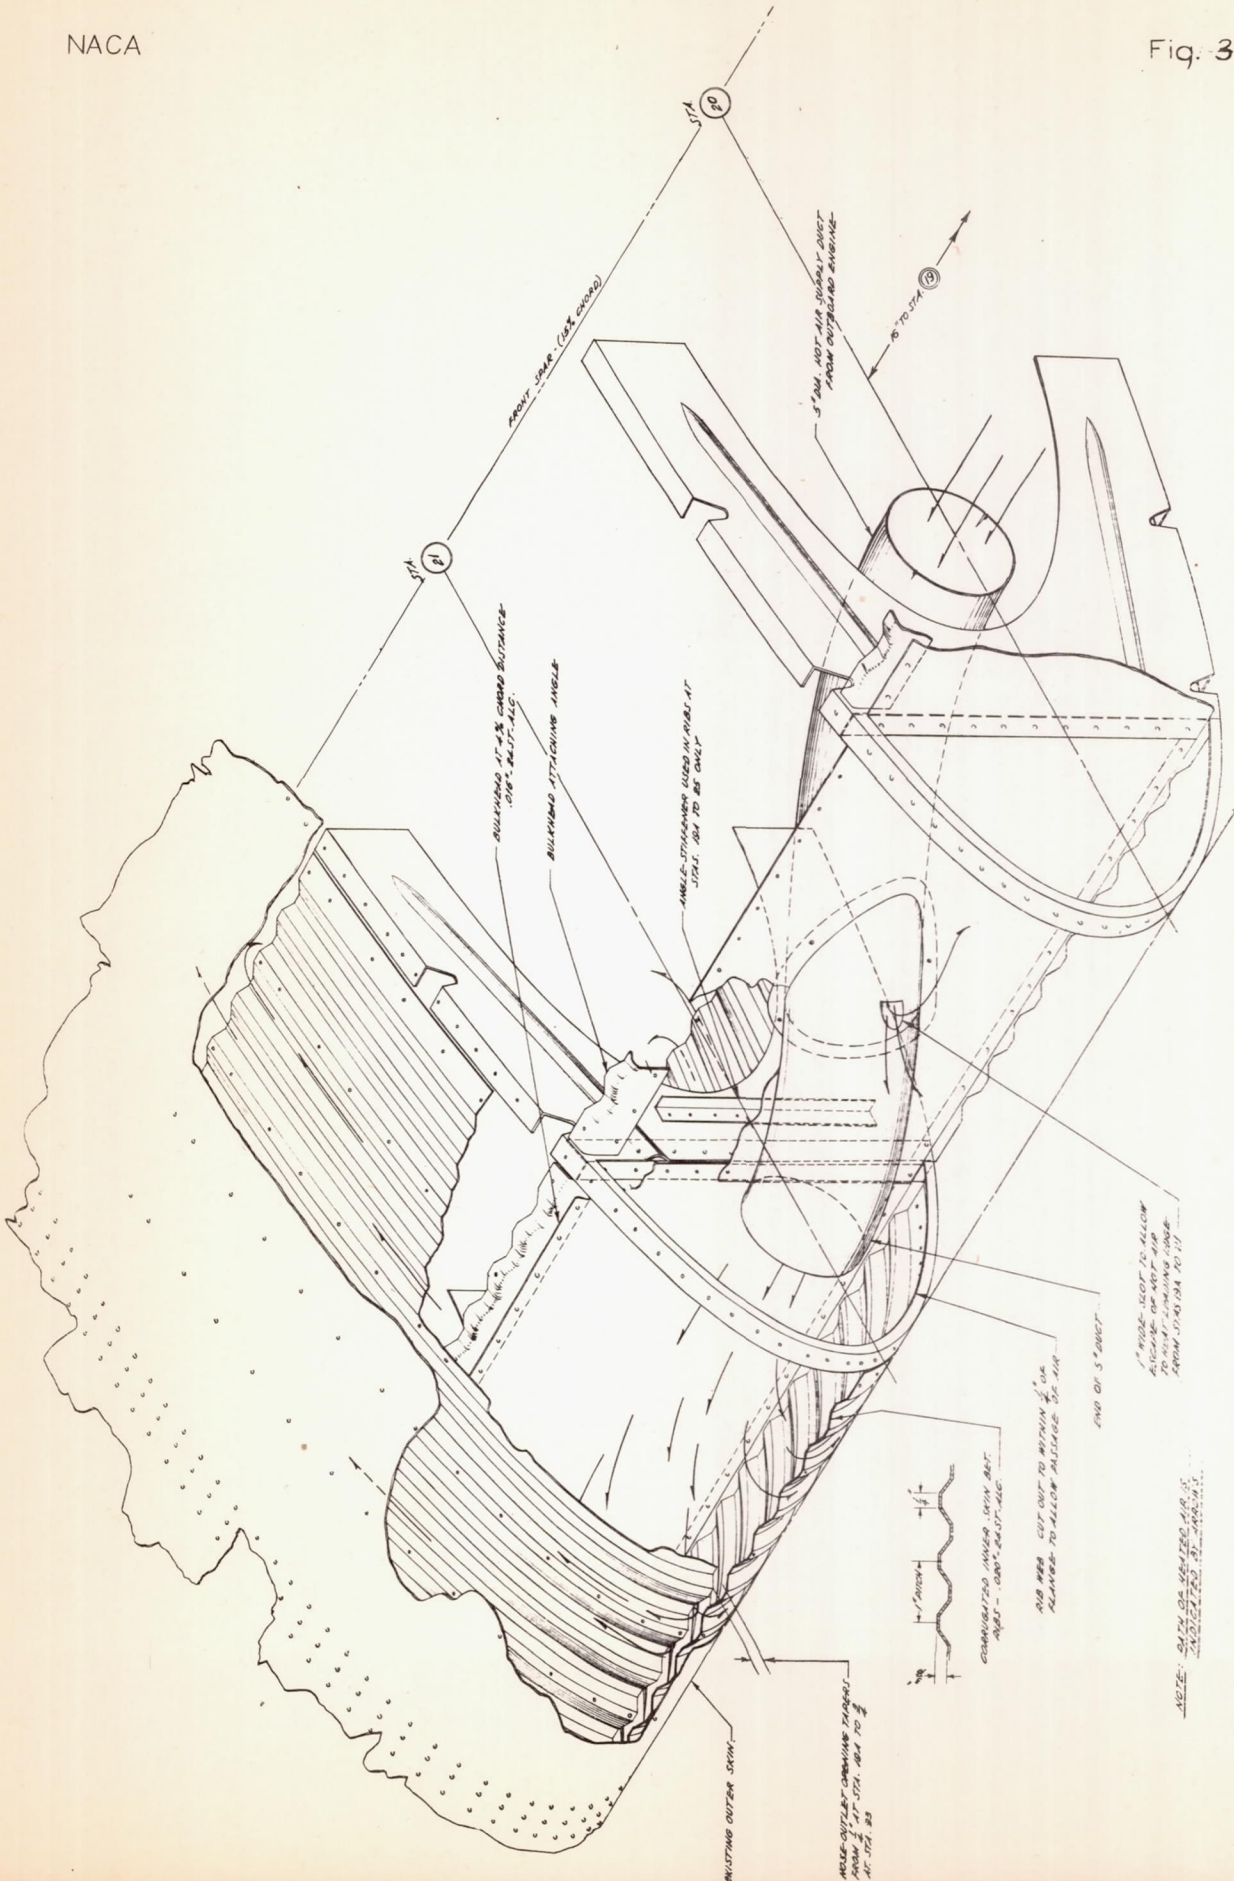
The design of the ice-prevention system was based upon a spanwise air temperature drop of  $40^{\circ}$  F. For the icing flights the average spanwise air temperature drop between stations  $22\frac{1}{2}$  and 33 was  $49^{\circ}$  F and for the dry-air flights was  $34^{\circ}$  F. The reversal of the spanwise gradient of the heated air and skin temperatures between stations  $22\frac{1}{2}$  and 20 was probably due to the method by which the heated region between stations 20 and 21 was supplied with heated air (fig. 3).

FIGURE 3 - DETAILS OF WING OUTER-PANEL LEADING-EDGE DESIGN FOR B-17F THERMAL ICE-PREVENTION SYSTEM.

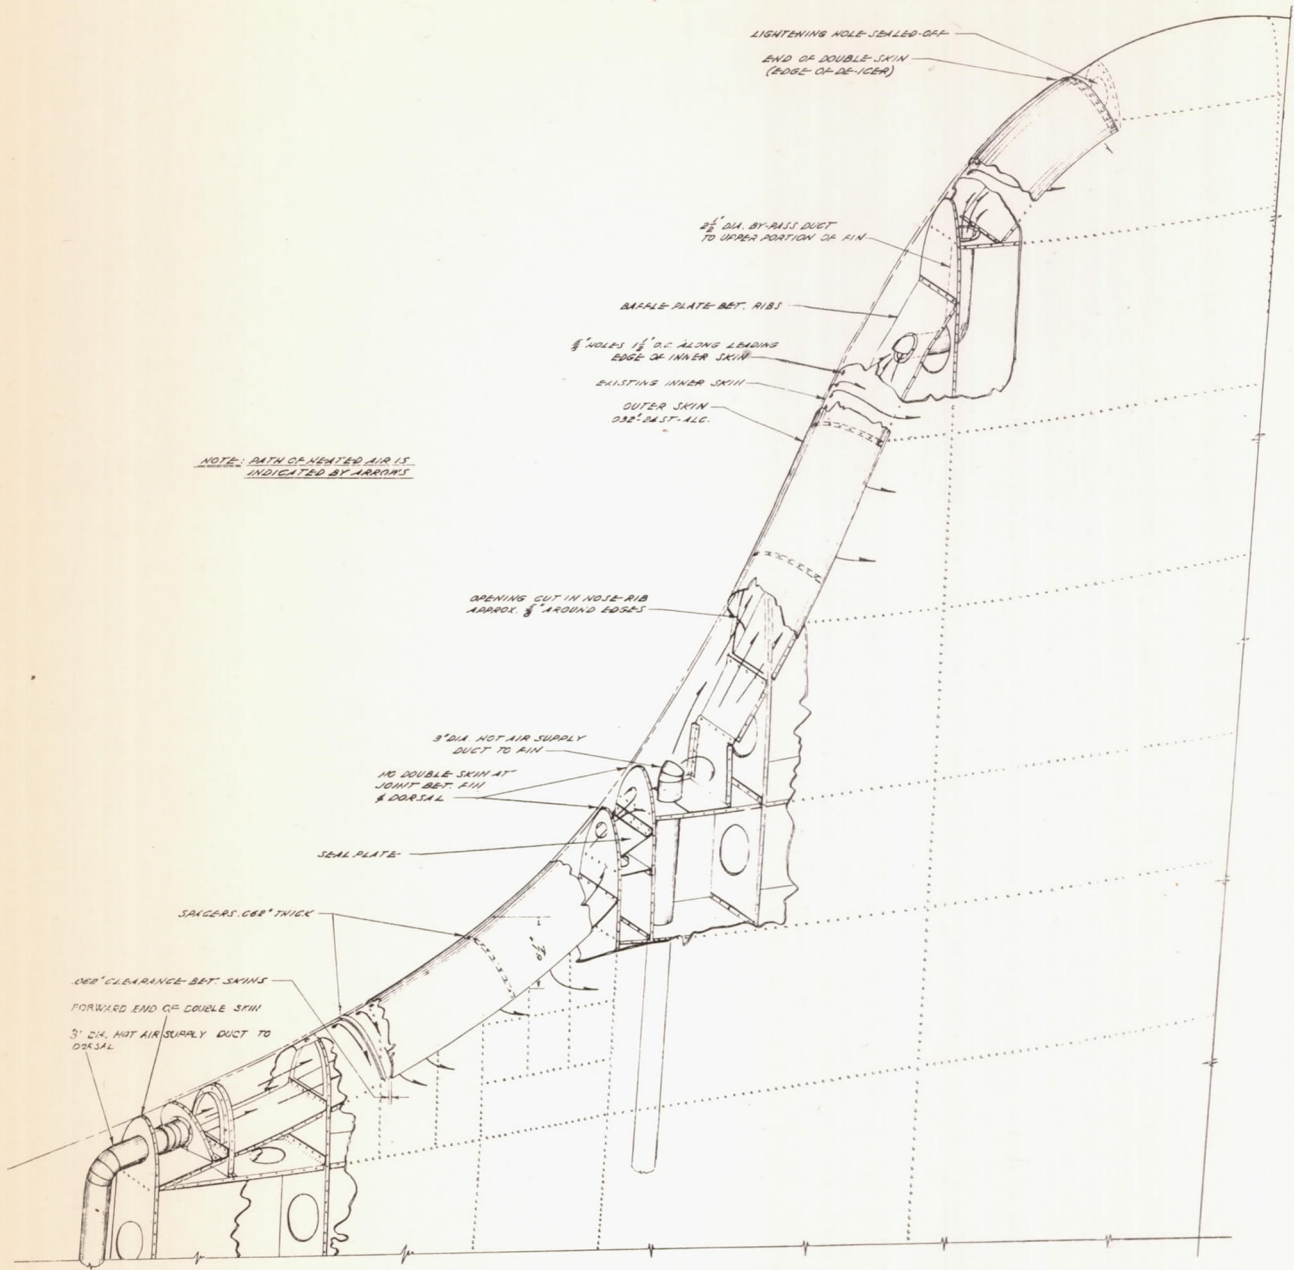
The vertical stabilizer leading edge was heated in a manner similar to the horizontal stabilizer. Heated air was admitted into a gap, formed by the vertical stabilizer skin and an added outer skin, through holes in the leading edge of the inner skin and discharged from the gap at the end of the double-skin region on both sides of the stabilizer. The dorsal and fin systems were essentially separate, being divided at their junction which was not provided with a double skin (fig. 7).

FIGURE 7.- DORSAL AND FIN DESIGN FOR B-17F THERMAL ICE-PREVENTION SYSTEM.
