FLIGHT MEASUREMENTS OF HORIZONTAL TAIL LOADS ON A
TYPICAL PROPELLER-DRIVEN PURSUIT AIRPLANE DURING
STALLED PULL-OUTS AT HIGH SPEED

By Lawrence A. Clousing and William N. Turner

Ames Aeronautical Laboratory
Moffett Field, California

MEMORANDUM REPORT

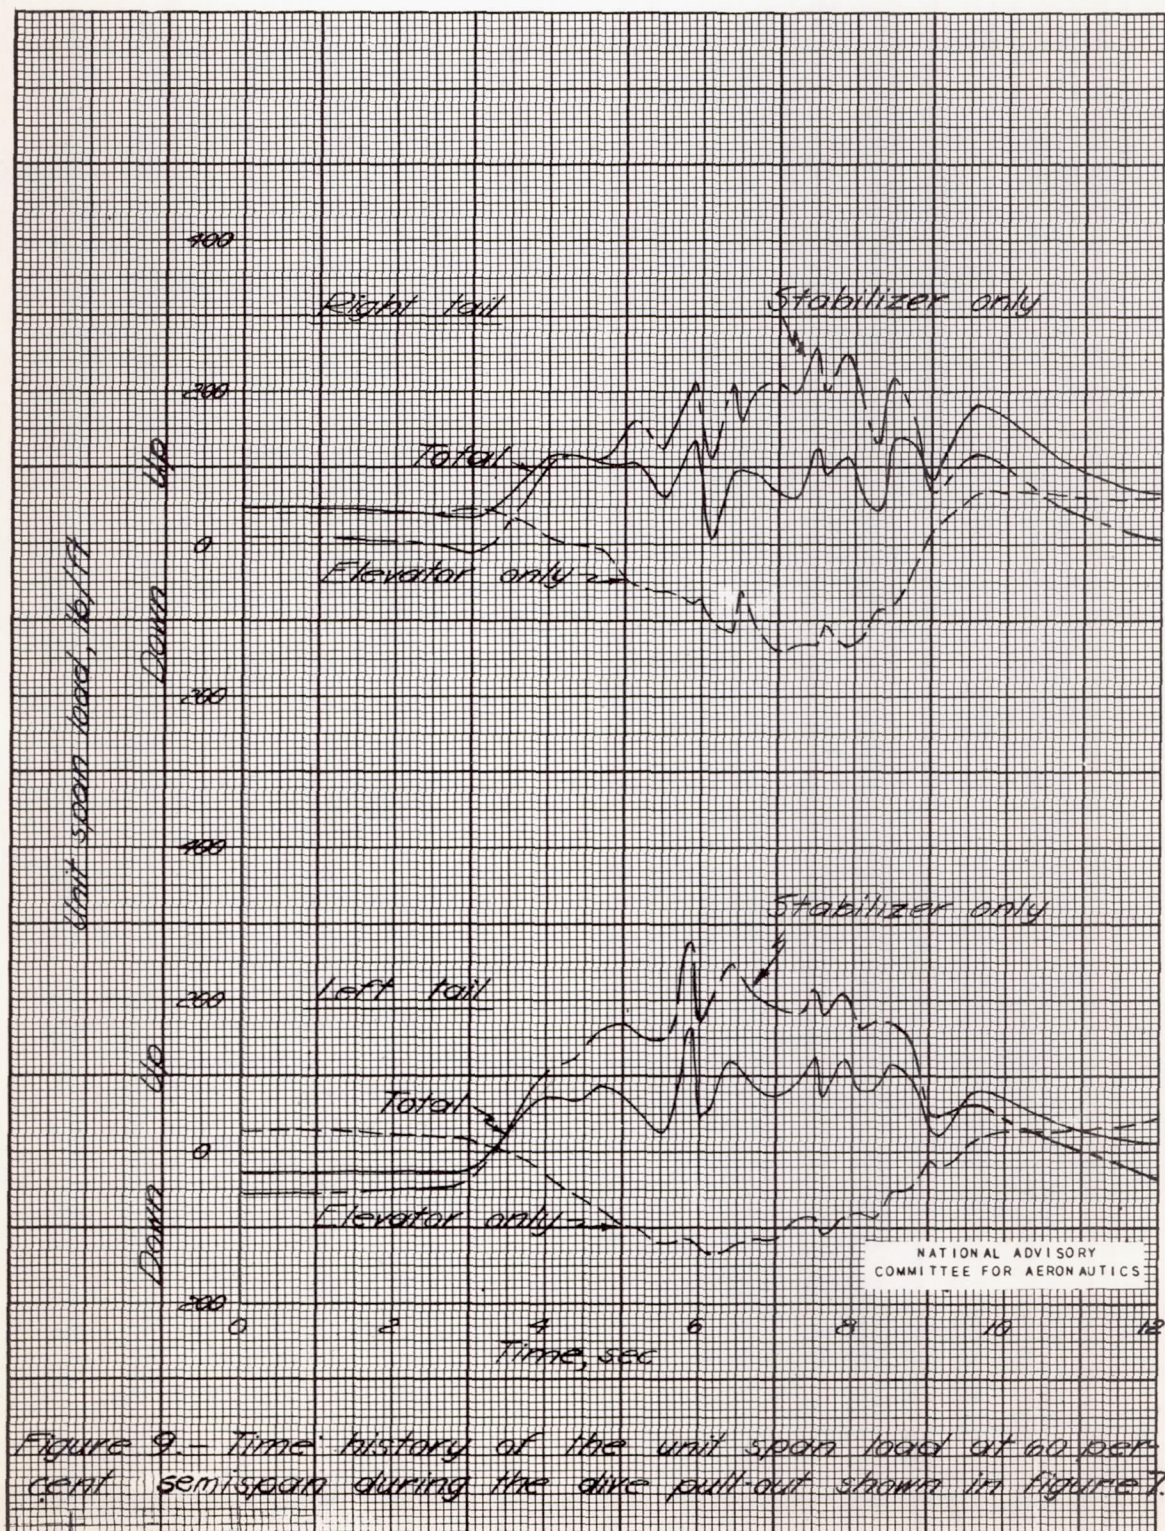
Inasmuch as the elevator loads at the time of failure did not appear to have been in excess of those for which the surface was designed, the reasons for the failure of the elevator are not entirely clear. Also, higher elevator down loads had been encountered on a previous flight (fig. 9) at least at the spanwise location at which measurements were made.

Figure 9.- Time history of the unit span load at 60 per cent semispan during the dive pull-out shown in figure 7.

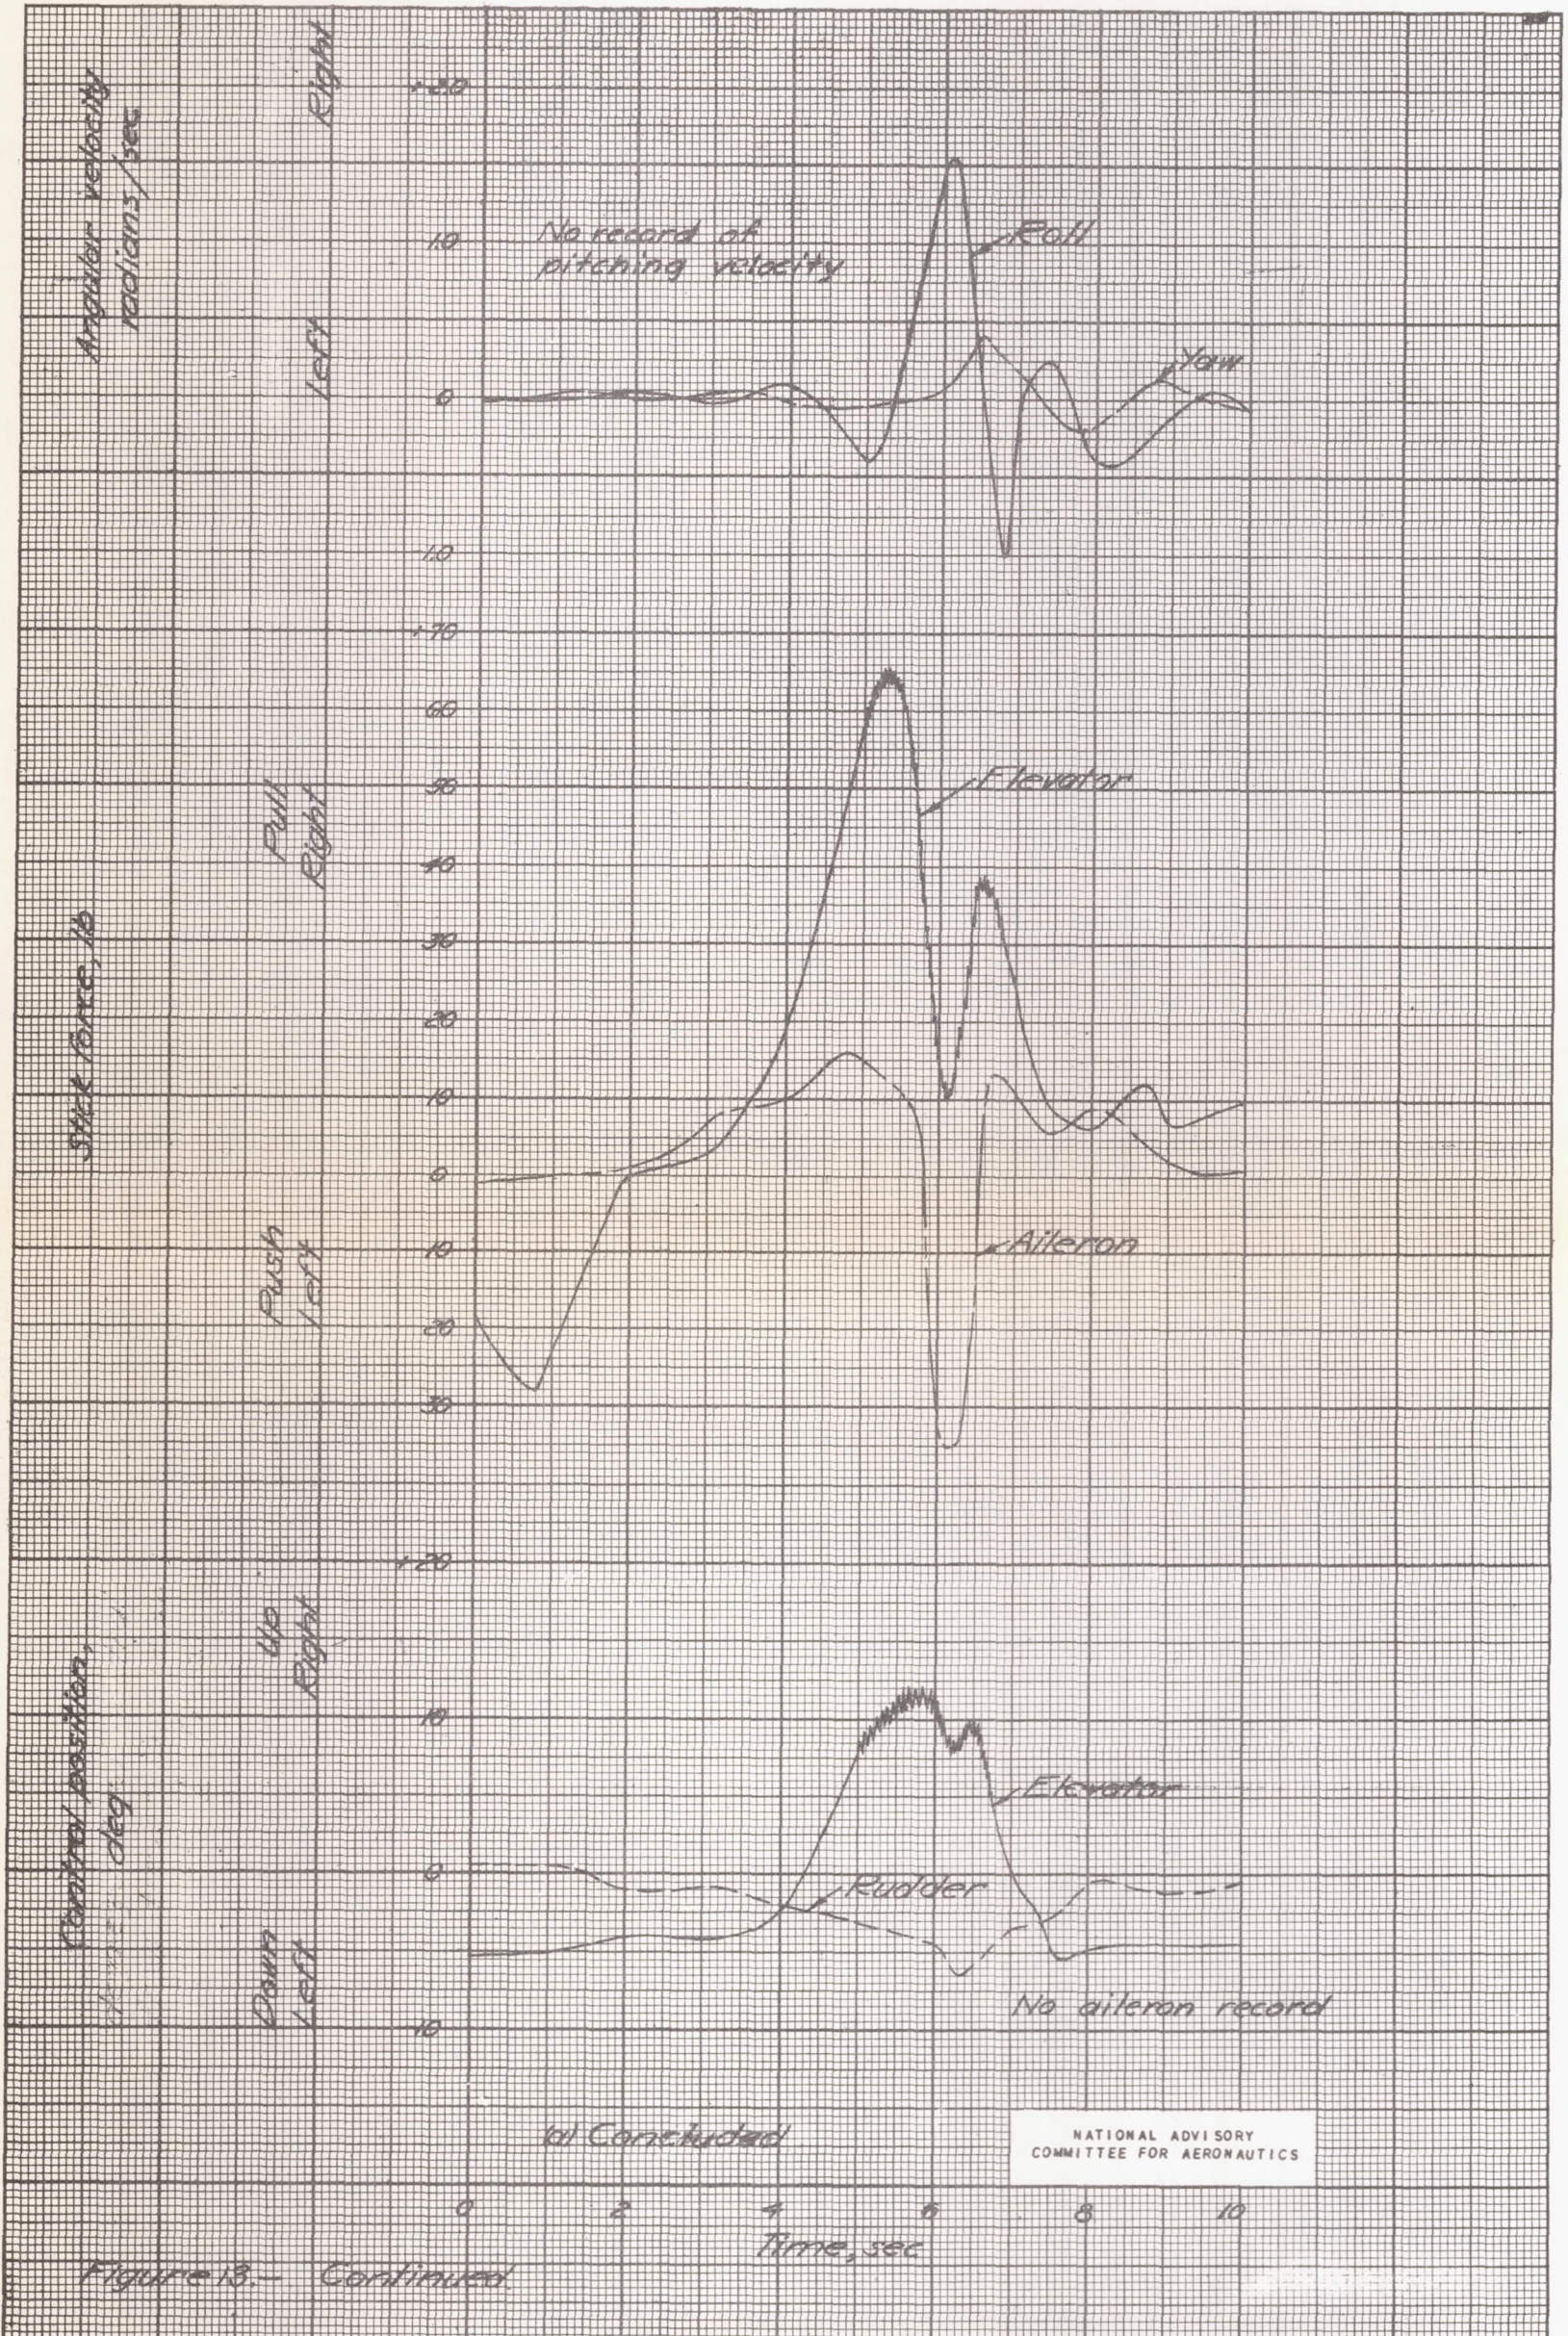
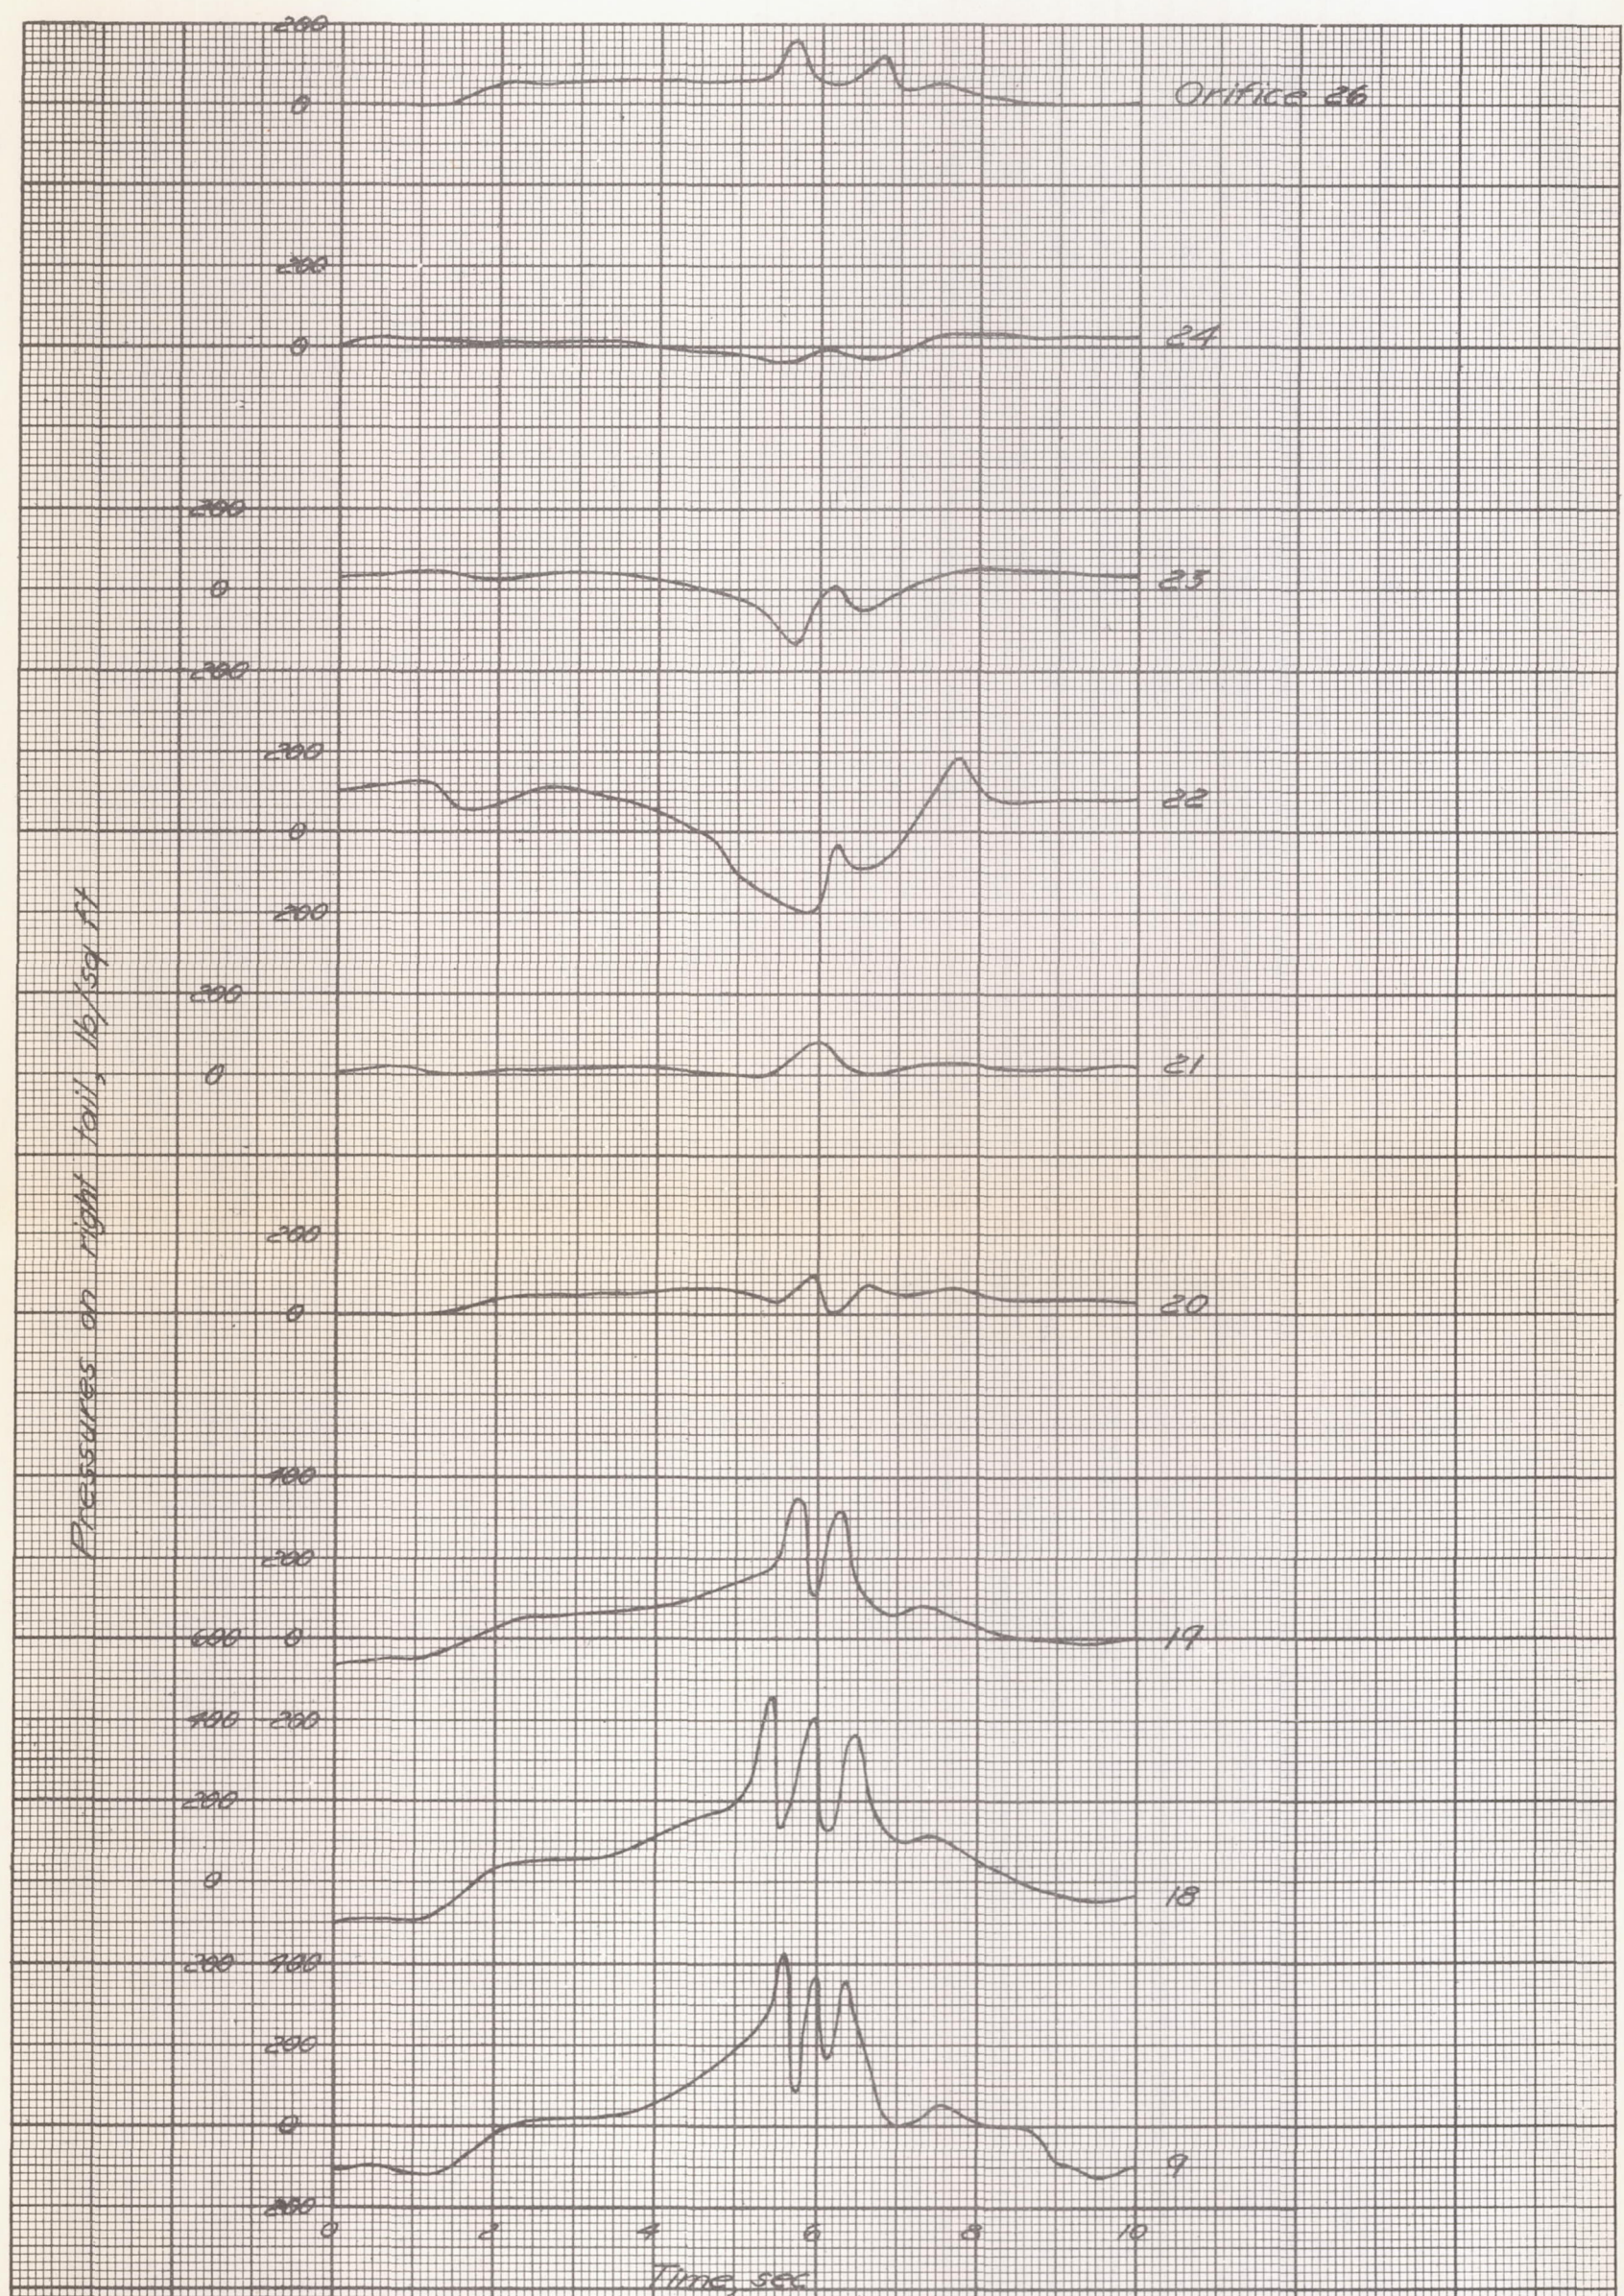
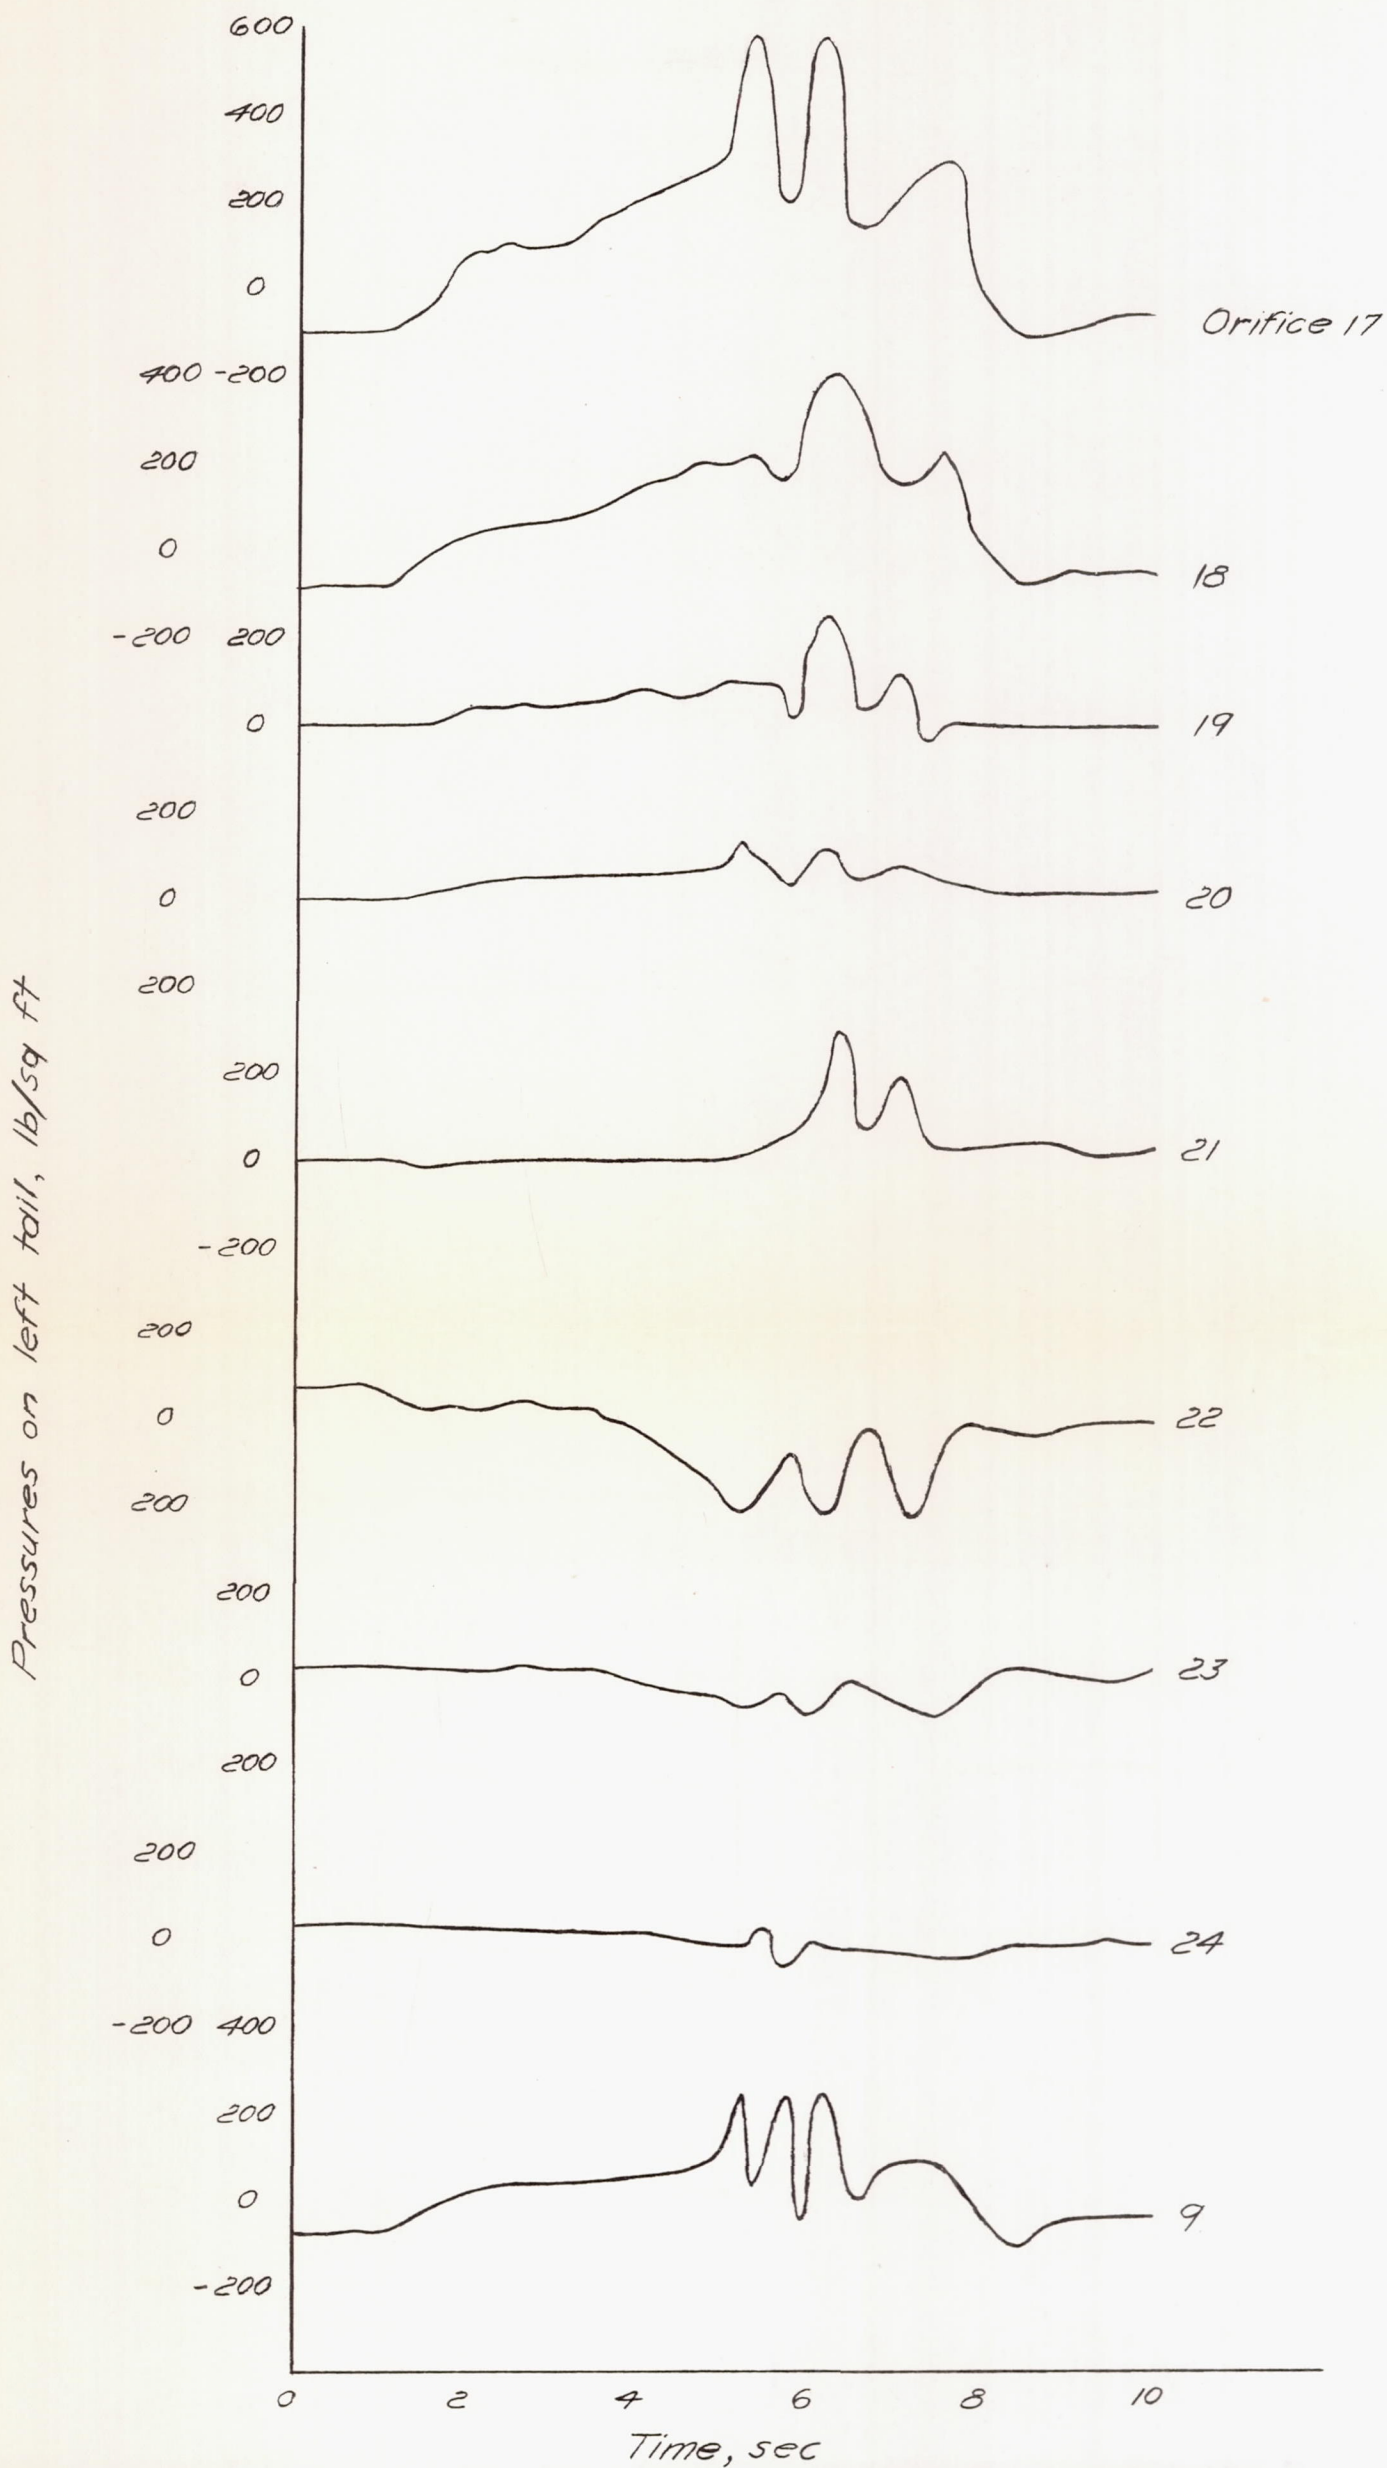
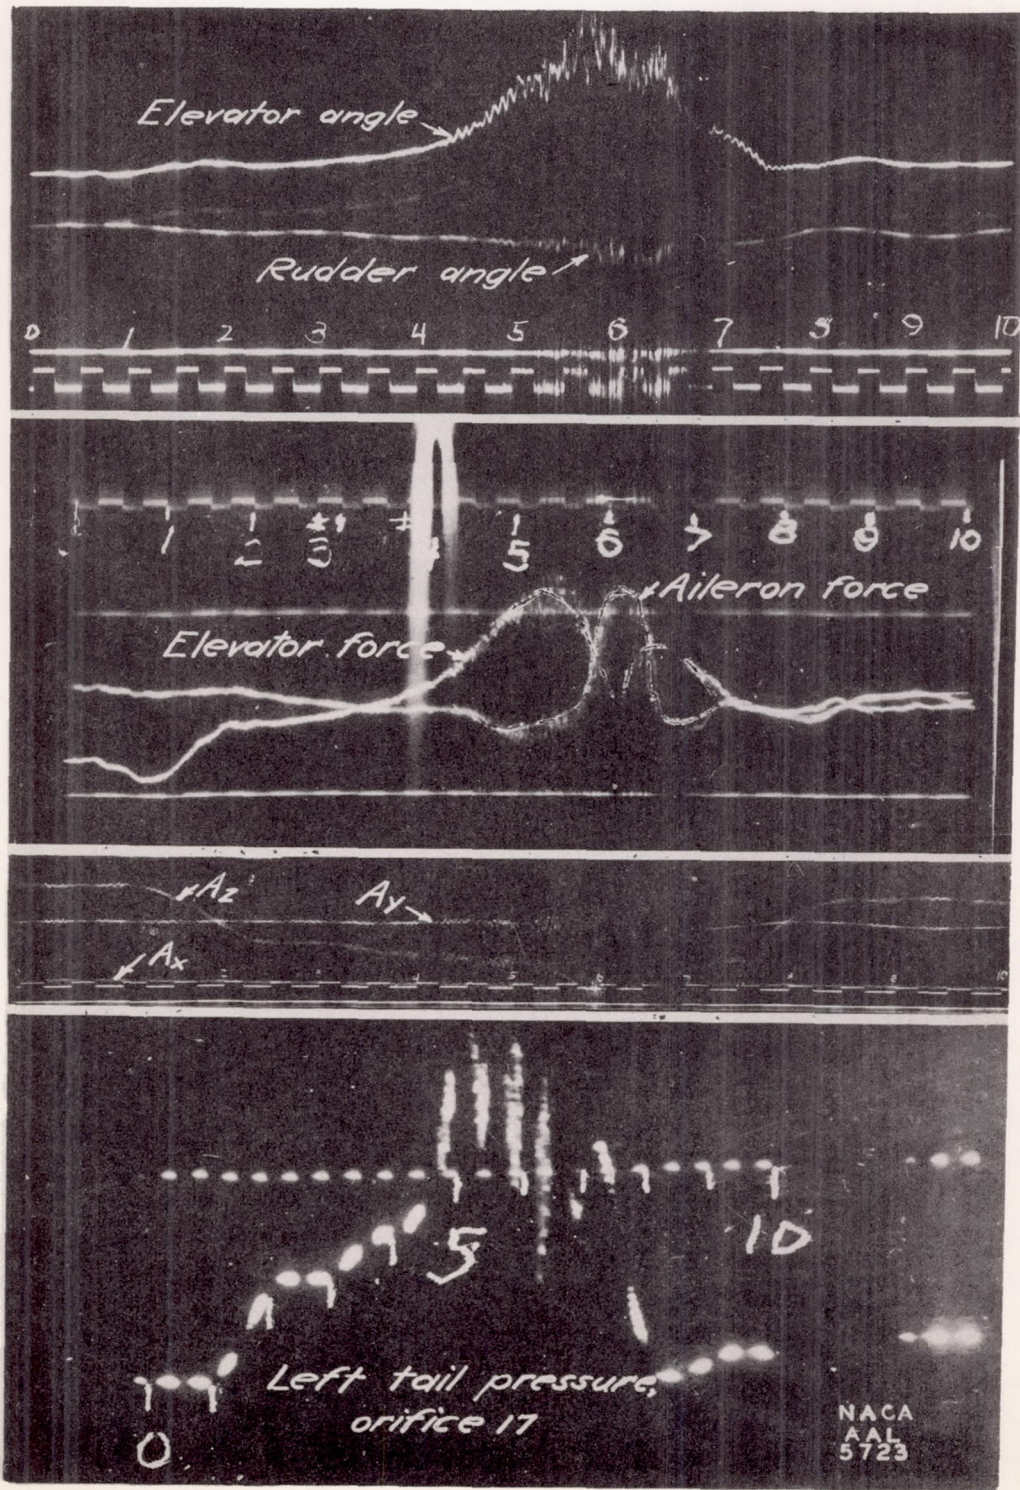
During this run structural failure of the horizontal tail occurred. Since the airplane was operating within maneuvering limits which were considered safe by design specifications in use at the time the airplane was designed, it is of interest to examine the nature of the tail failure in relation to the loads measured, and in relation to the necessity for revision of air load requirements and the manner of specifying safe maneuverability limits to a pilot.

It is difficult to ascertain at just what time in the pull-out the structural failure occurred. Its effect was not noticeable until after steady straight flight had been re-established. Then it was noticed that the longitudinal balance and stability characteristics of the airplane had altered. Figure 13 shows that a sudden decrease of elevator control force occurred at 5.3 seconds while the elevator angle and normal acceleration continued to rise; figure 15 shows a numerical decrease in the elevator load curve at this point also. Again, at 6.2 seconds, as the acceleration is decreasing, there is a sudden increase in elevator control force and recorded elevator angle. It appears, however, that the elevator control at 6.2 seconds may have been applied inadvertently as the ailerons were being deflected to counteract the roll-off occurring during the stall. The lack of effect of the elevator control on the value of the acceleration factor of the airplane was probably due to the stalled attitude of the wing. The increase of acceleration factor at 7.0 seconds, as the elevator control force and elevator angle were decreasing, was probably due to the re-establishment of normal flow over the wing, although the possibility that it was caused by the buckling of the elevator should not be completely discounted.

loads caused much more severe structural strain than the same loads would have caused if applied under static conditions. In the last pull-out, in which the structural failure occurred (figs. 13, 14, and 15), the buffeting was more severe than in any previous maneuver. In this pull-out an attempt had been made to insure absolutely that the maximum acceleration factor possible to attain had been obtained. A strong pull force was exerted on the stick even after heavy buffeting had set in. A slightly greater elevator angle was used than in the previous pull-outs. It should be realized, too, that the loads which were measured during the buffeting condition may actually have been somewhat greater than those recorded, due to lag in the pressure lines.

Figure 13 - Time history of a power-off dive pull-out at $M \approx 0.67$ in which partial failure of the reinforced horizontal tail structure occurred.

Revision of the tail-load design requirements and of the manner of specifying safe maneuverability limits to pilots appears necessary.

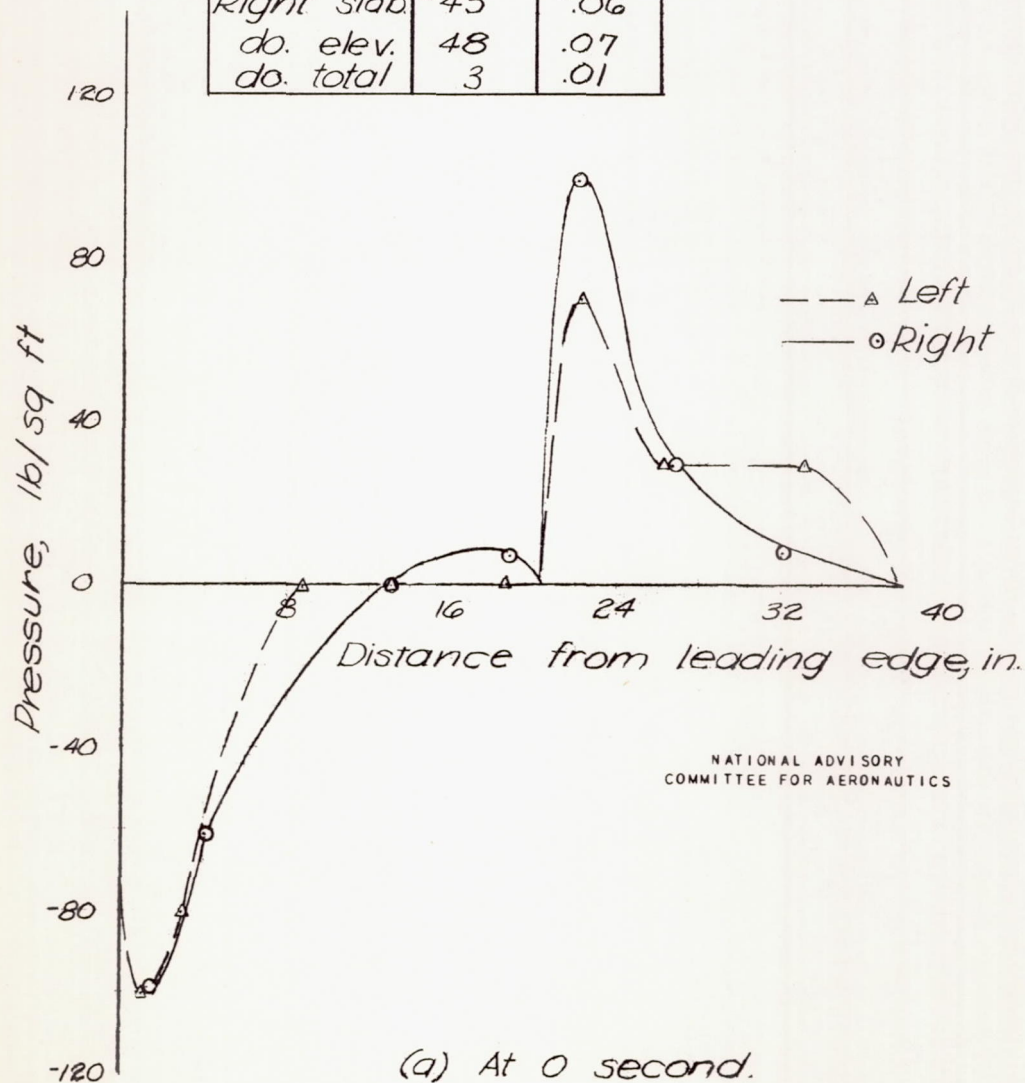
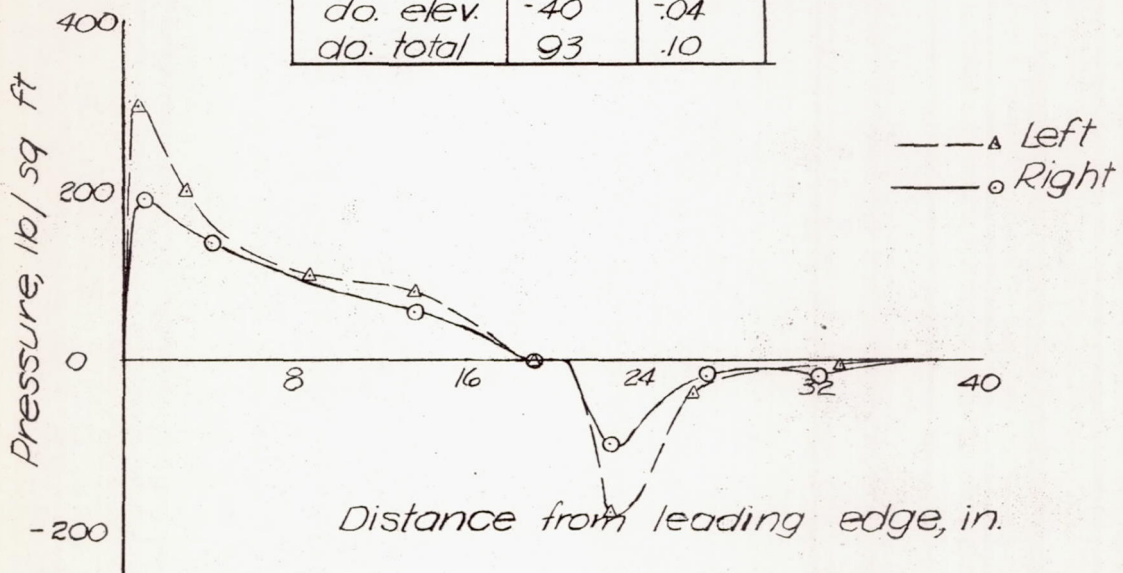
Figure 24 shows the loading conditions for which the horizontal tail surface was designed. Comparison of this figure with the actual flight measurements (figs. 5, 8, 11, and 14) shows that in many instances the unit loads actually measured on the stabilizer in flight were not only considerably in excess of the design unit loads, but that they occurred in a direction opposite to the design loads. At the leading edge of the elevator, the design unit loads were not exceeded in the pull-outs, at least not at the particular spanwise stations at which measurements were made. However, it was the elevator and a fitting supporting the elevator that failed and not the stabilizer.

Figure 14. - Chordwise load distribution at 60 percent of semispan in the dive pull-out shown in figure 13.

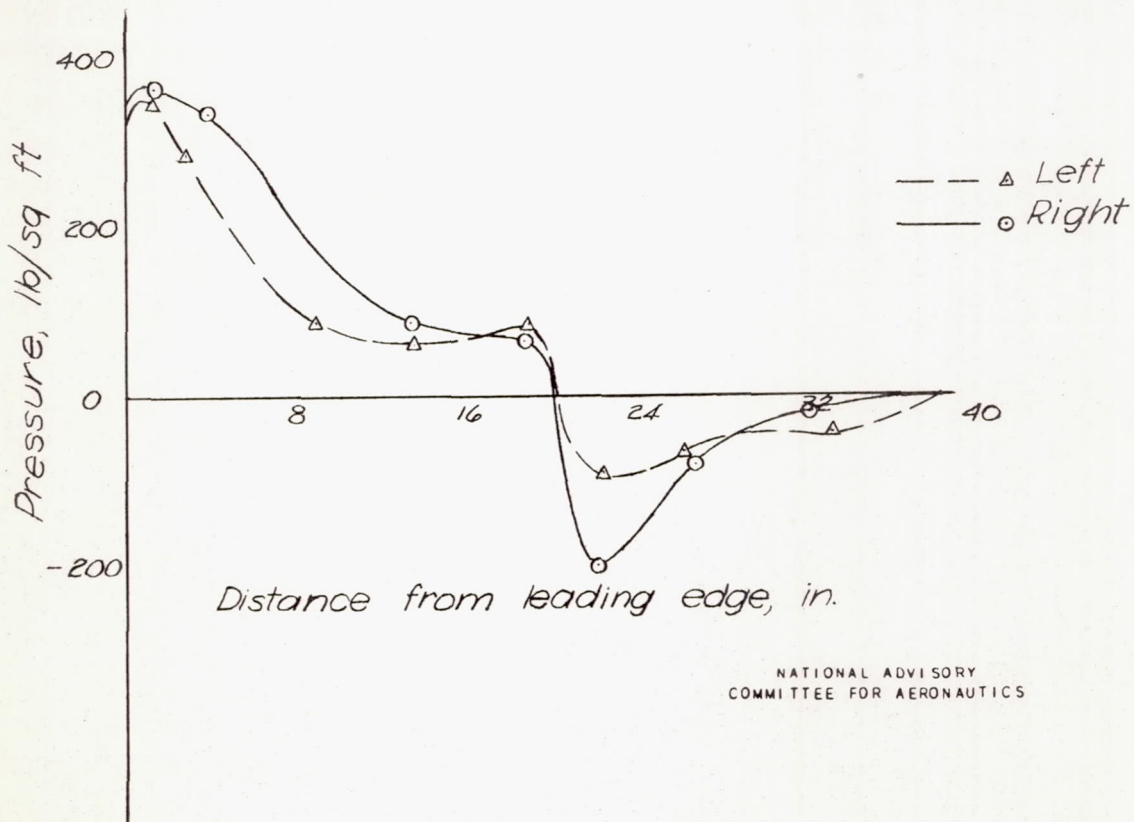
(c) At 5.9 seconds.

$V_i = 336 \text{ mph}$
 $M = 0.670$
 Altitude 23,500ft

Chord	lb/ft	C_l
Left stab.	227	.26
do. elev.	-79	-.09
do. total	148	.17
Right stab.	308	.36
do. elev.	-118	-.14
do. total	190	.22

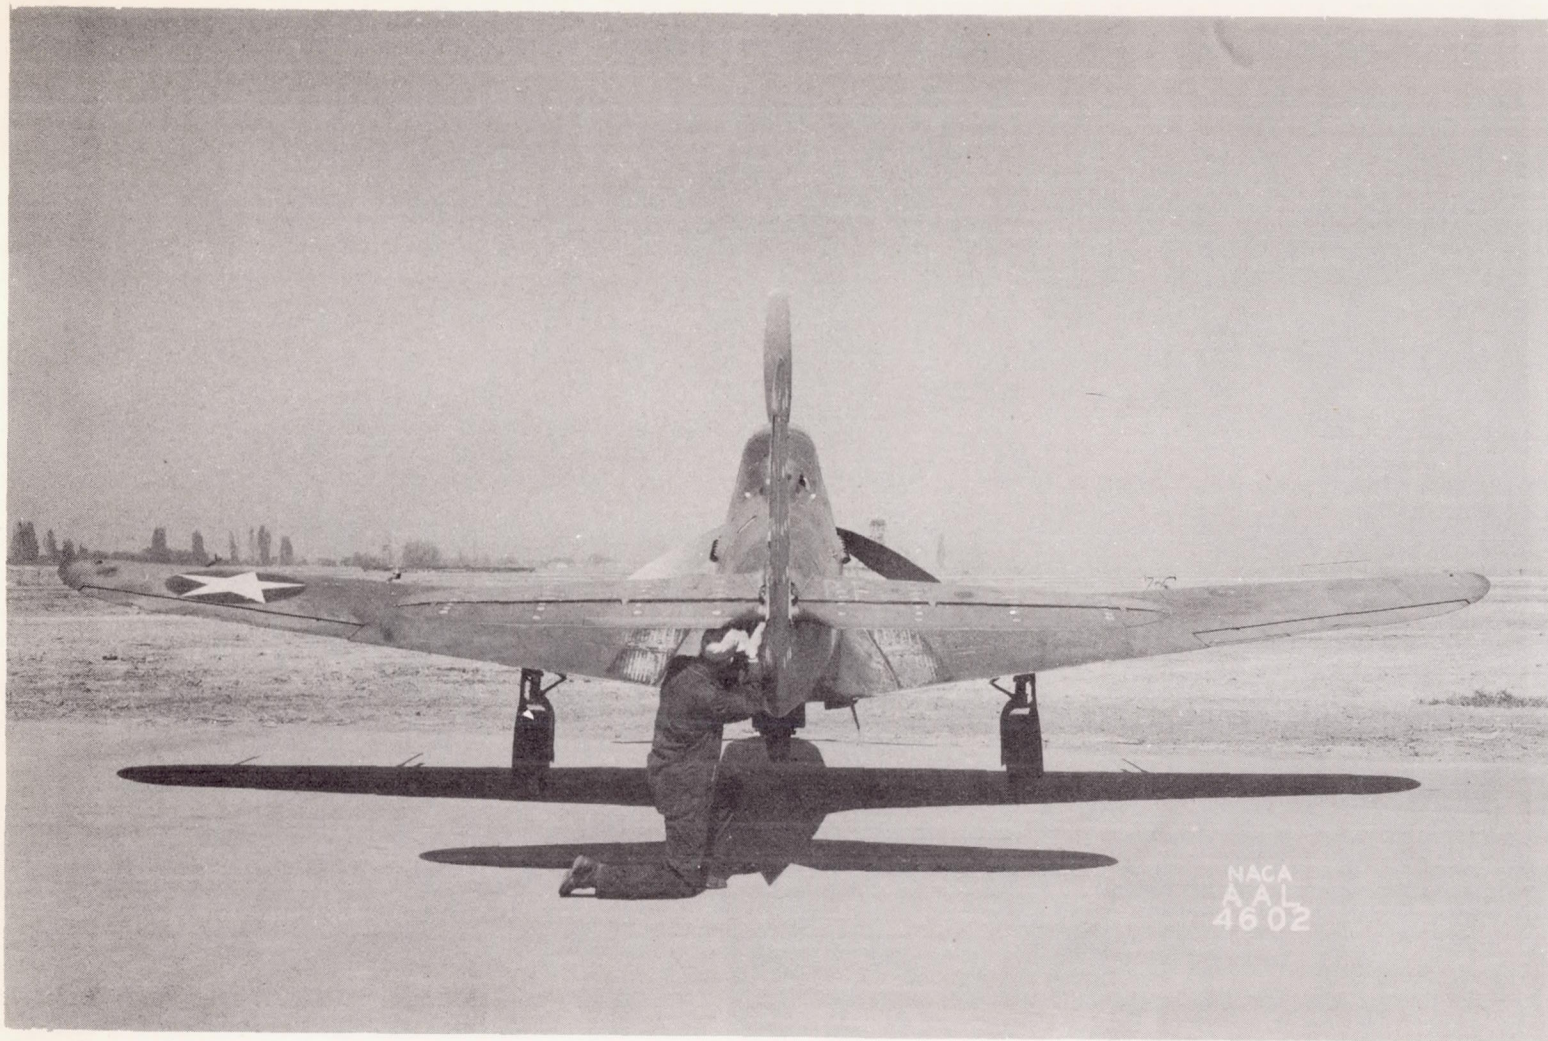
Figure 16.- Rear view, test airplane as instrumented for tail-load flight tests, showing undamaged tail surfaces.

The principal failures were on the left side of the tail, although failure had also started on the right side. A rear view of the airplane with undamaged tail is shown in figure 16, and views of the principal failures are presented in figures 17 to 23. The left elevator had buckled downward at about the third outboard row of orifices (figs. 17, 18, and 19), cracking the elevator spar (fig. 20). The elevator nose balance had been forced downward severely enough to break the elevator nose rib on each side of the tail just inside the outboard hinge fitting (figs. 21 and 22). The left stabilizer rear beam was cracked at the inboard hinge bracket, and the two top bolts holding the bracket to the stabilizer rear beam had been sheared completely (fig. 23). Other miscellaneous failures of various degrees of severity occurred to both the stabilizer and elevator structure in the immediate vicinity of all the hinge brackets.
