RESEARCH MEMORANDUM

ENGINE PERFORMANCE OF PRECISION-FORGED, ELECTROPOLISHED
AND MACHINED BLADES OF NIMONIC 80 AND 80A ALLOYS

By Paul F. Sikora and James R. Johnston

April 5, 1955
Declassified February 8, 1957

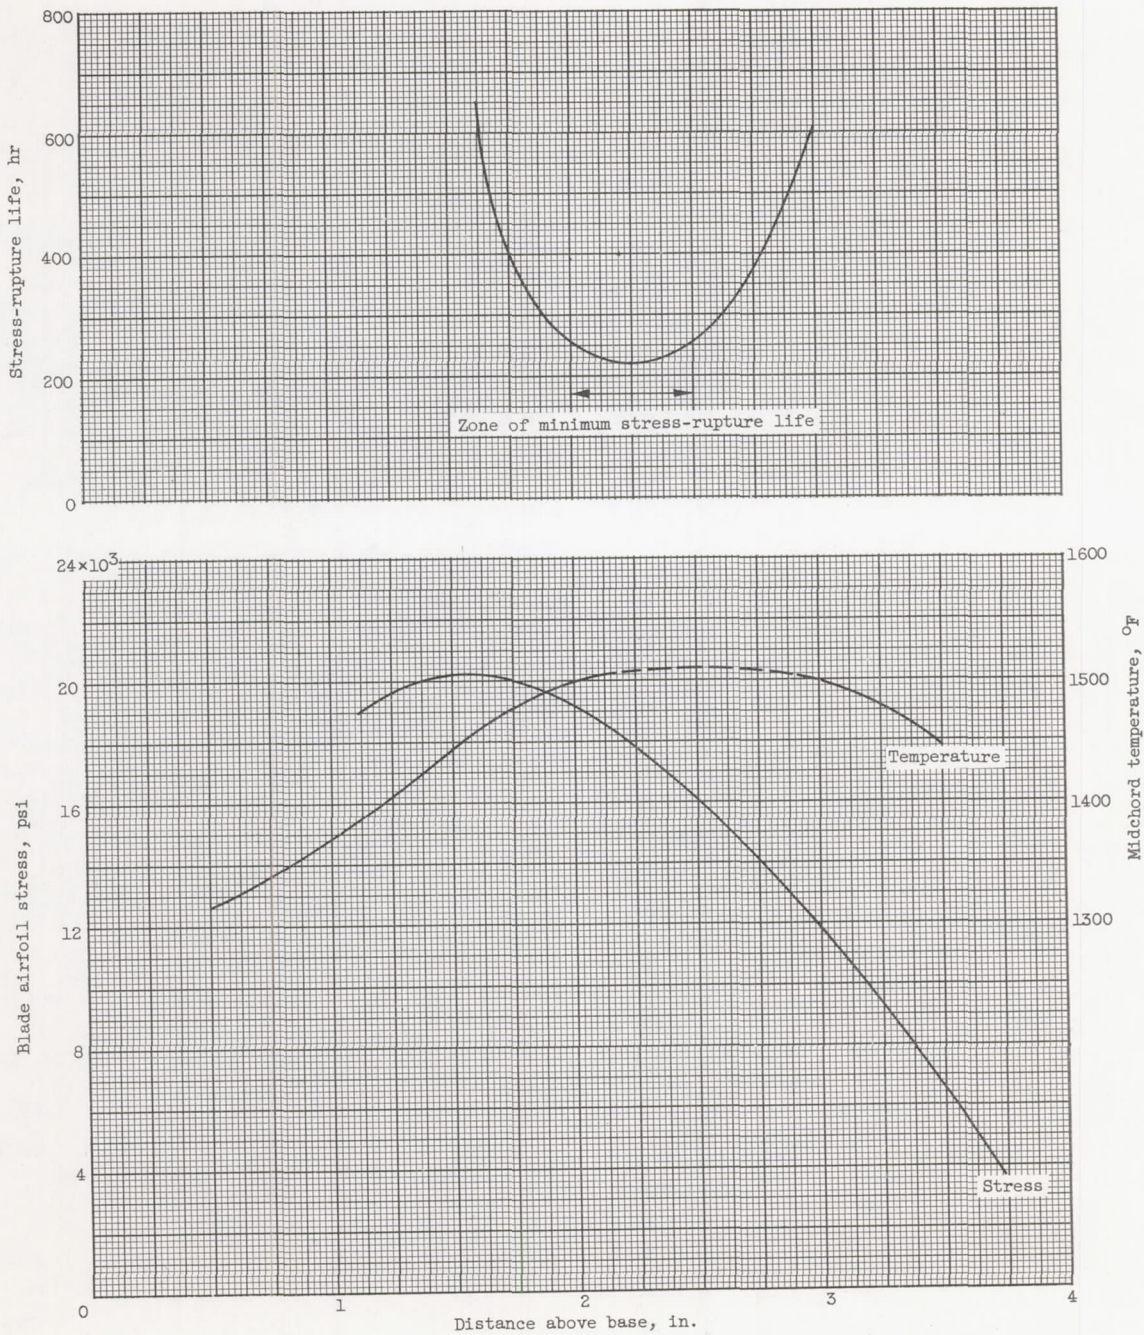
Figure 1. - Typical stress and temperature distribution of airfoil of J33-9 turbine blade of Nimonic 80 alloy.

On the basis of the stress and temperature distribution, a plot of stress-rupture life was determined for the conditions at each increment of blade length as shown in figure 1. From this stress-rupture plot, it may be seen that a zone of the blade, if subjected to stress-rupture conditions alone, exists where the blade life should be a minimum. This zone lies between 2 and $2\frac{1}{2}$ inches above the base.

approximately 18,000 pounds per square inch since the Nimonic 80 alloys are not sensitive to notches under these conditions (ref. 9). However, on the basis of the temperature distribution along the blade (fig. 1), there is a notch-sensitive region 1 to $1\frac{1}{2}$ inches above the base. In this area of the blade, the temperature ranges from 1370° to 1450° F and the stress is approximately 20,000 pounds per square inch. In reference 9, it was shown that Nimonic 80A is notch-strengthened in rupture tests at 1200° F for times to rupture up to 1000 hours, and that at 1500° F no notch weakening should be observed at any time to rupture over 5 hours. In contrast, at 1300° and 1400° F pronounced notch weakening is observed at rupture times over 100 hours.

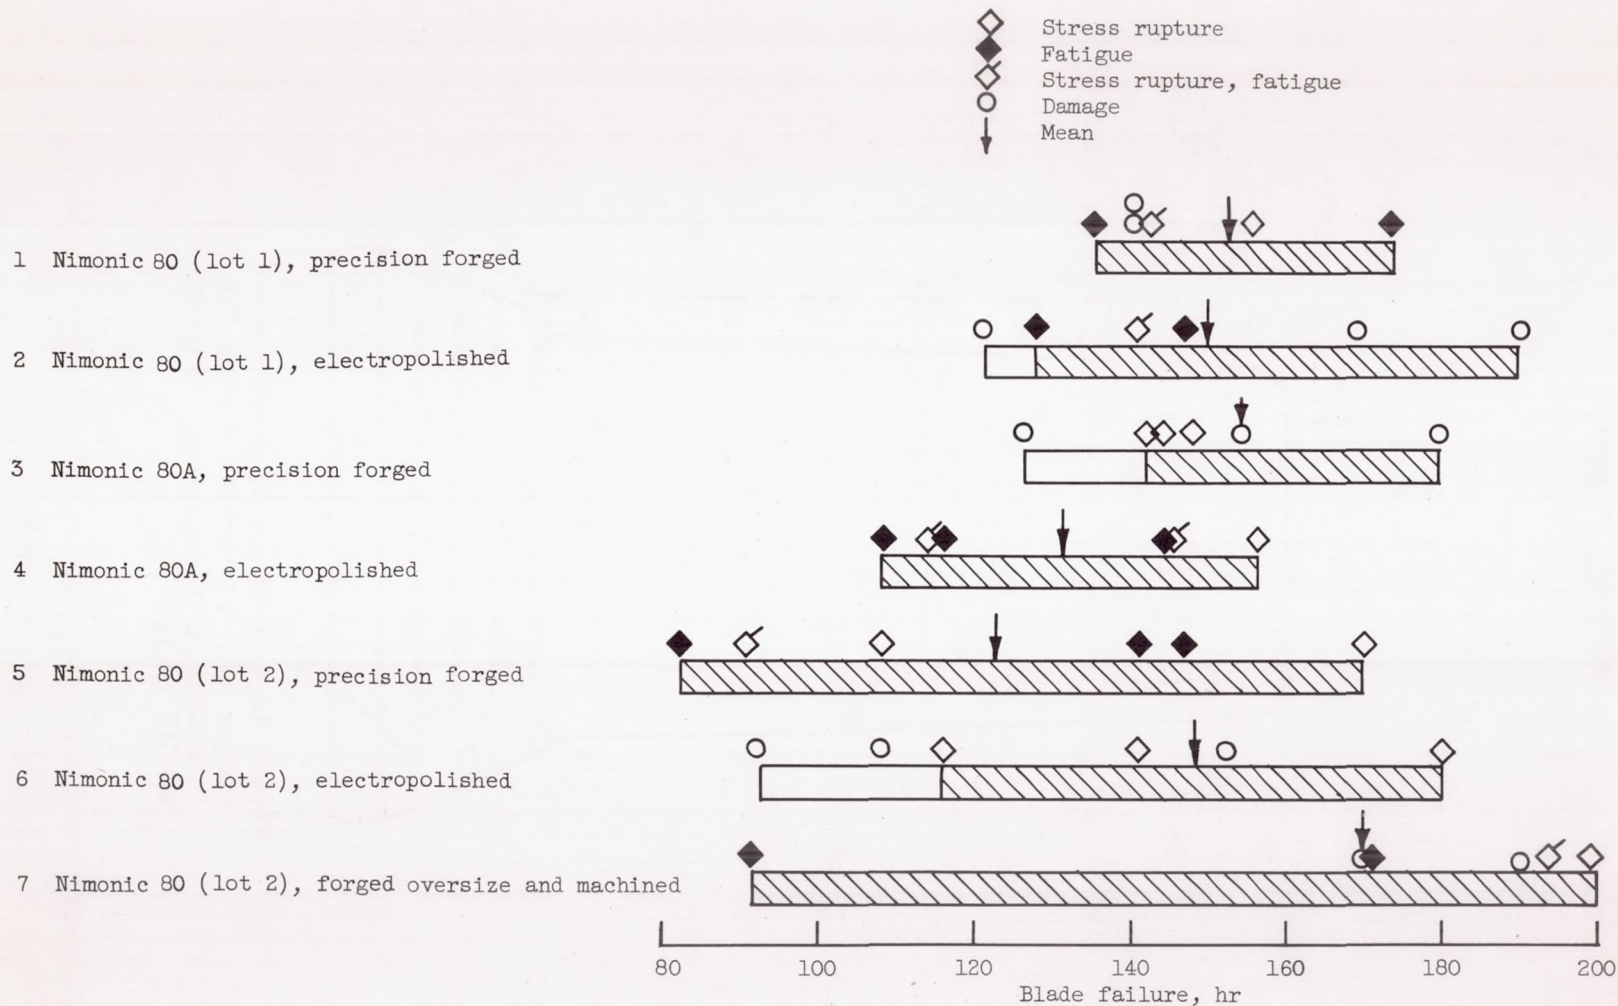
Figure 4. - Results of engine operation.

The results of the cyclic engine test are presented in table III and figure 4. On the basis of the total range of blade life and the mean blade life of each group shown in figure 4, no appreciable improvement resulted from electropolishing precision-forged blades or machining oversize forged blades. Furthermore, no appreciable difference in the engine performance of the various lots of blades resulted.

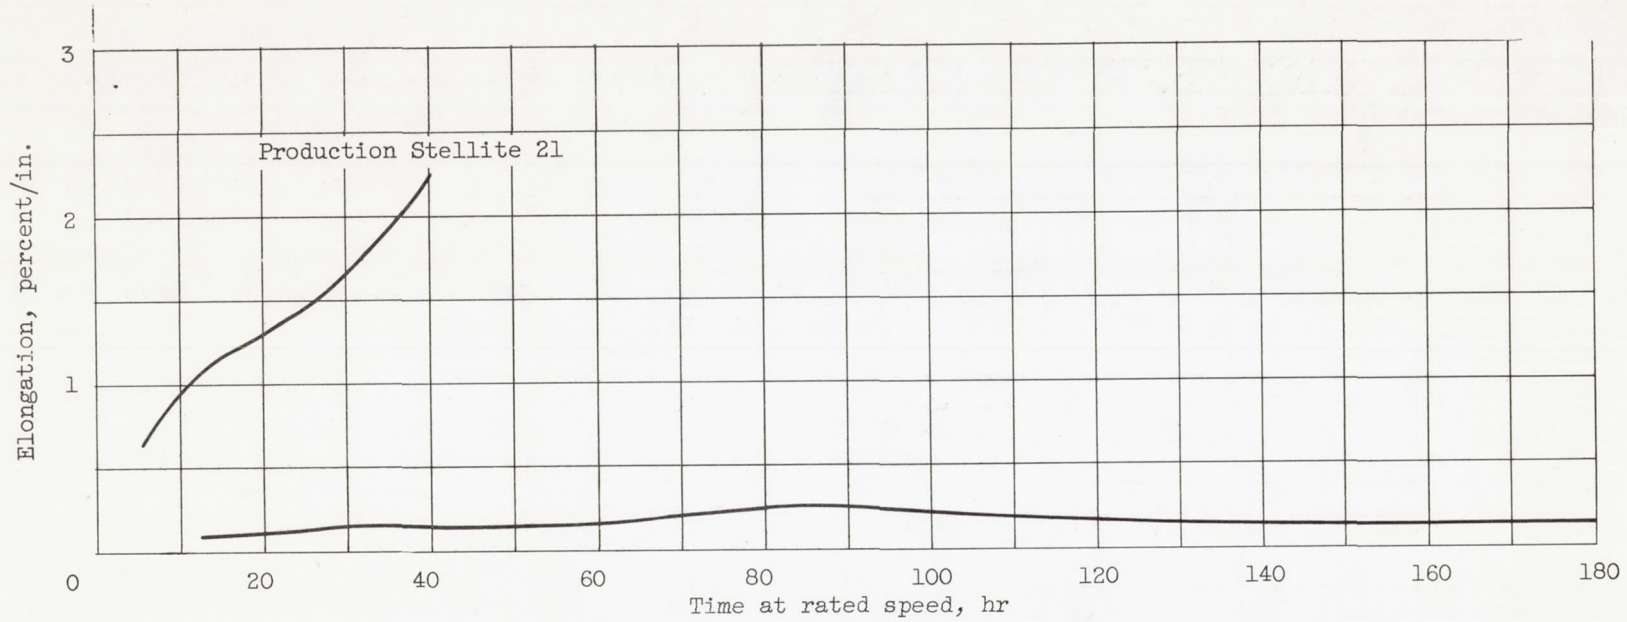
Figure 5. - Typical elongation in zones 3 and 4 of Nimonic 80 alloy blades.

Blade elongation during engine operation ranged up to a maximum of 0.5 percent in the middle portion of the blades. A typical blade-elongation curve is presented in figure 5 along with a typical curve of Stellite 21 for comparison. The creep in the Nimonic blades is negligible.

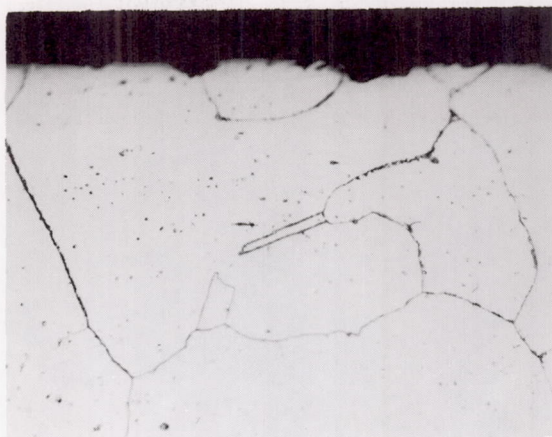
(d) Nimonic 80 (lot 1); commercial electropolish.

Photomicrographs of the edges of the various groups of blades prior to engine operation are presented in figure 7. The blades that were precision forged show a slightly oxidized, irregular surface 0.0005 inch thick (figs. 7(a) to (c)). These irregularities appear to be the result of external oxidation rather than intergranular oxidation. Typical edges of commercially electropolished blades of each lot are shown in figures 7(d) to (f). These blades were not sufficiently electropolished to remove the oxides completely and to smooth out the irregular surface. However, when the same blades were further electropolished (figs. 7(g) to (i)), the oxide was completely removed and the surface was smooth. The blades that were machined from oversize forgings had a clean and smooth surface free of distortion (fig. 7(j)).
