EFFECT OF FORGING TEMPERATURE AND HEAT TREATMENT
ON THE PERFORMANCE OF INCONEL 700 BUCKETS AT
1625° F IN A J33-9 TURBOJET ENGINE

By C. A. Gyorgak, D. F. Springsteen, and J. R. Johnston

Lewis Flight Propulsion Laboratory
Cleveland, Ohio

February 18, 1958
Declassified March 18, 1960

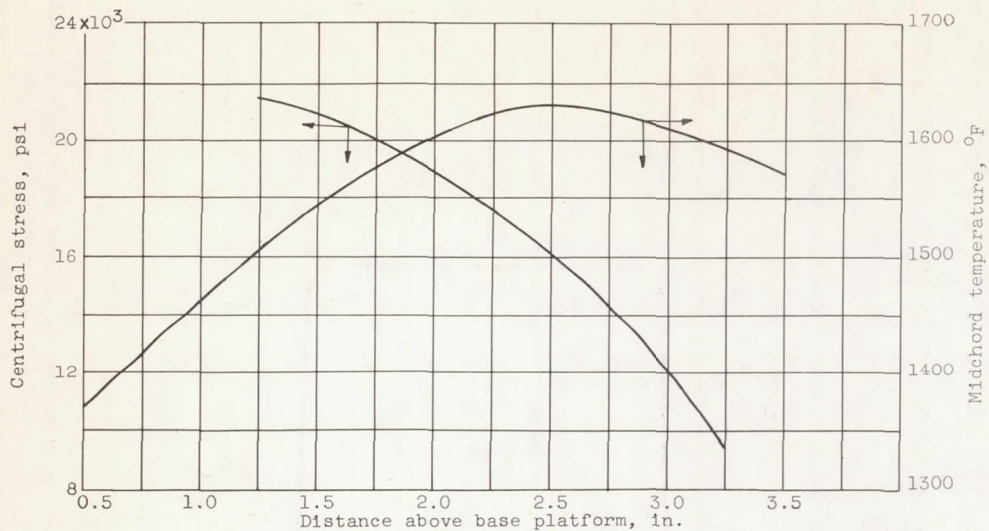
Stress and temperature distributions in buckets during engine operation. - The centrifugal-stress distribution in the turbine buckets for rated-speed operation was determined by a graphical method that utilizes bucket geometry, density, radius of rotation, and angular velocity. The results of these calculations are shown in figure 2.

buckets placed 180° apart. The midspan temperature was maintained by controlling the temperature of the exhaust gases. All temperatures were recorded on a fast-action electronic potentiometer. The average temperature distribution in the buckets during rated-speed operation is also shown in figure 2.

Figure 2. - Centrifugal-stress and midchord-temperature distributions in Inconel 700 turbine buckets during rated-speed operation (11,500 rpm) in J33-9 turbojet engine. Total airfoil length, 4 inches.

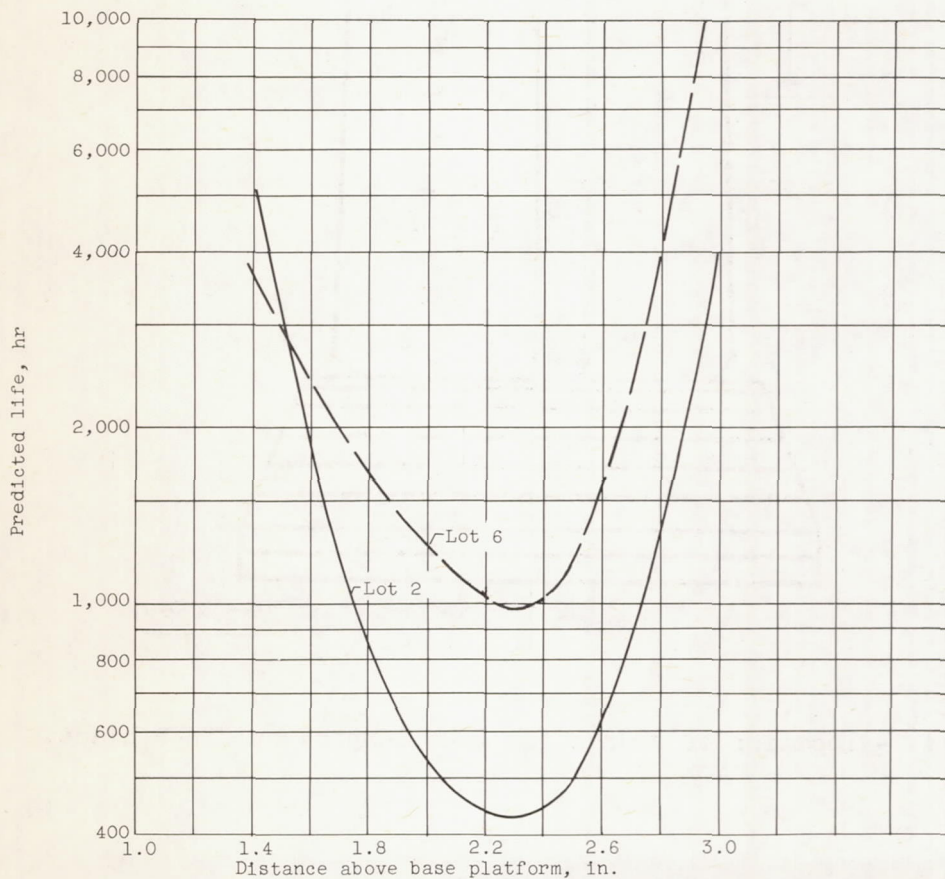
Predicted bucket life based on stress-rupture considerations. - By using the stress- and temperature-distribution data determined for the buckets (fig. 2) in conjunction with stress-rupture values for the material, it is possible to approximate the life expectancy of a bucket material in an engine if the sole cause of failure is assumed to be the combination of centrifugal stress and temperature. Predicted lives for two lots of Inconel 700 buckets (lots 2 and 6, table I) were determined and are presented in figure 3. Predicted-life curves were not determined for the remaining lots of material because of lack of reliable stress-rupture data for those specific conditions of heat treatment. The curves of figure 3 were obtained by interpolating between isothermals of the manufacturer's stress-rupture data for the stress and temperature conditions existing at incremental distances along the span of the buckets. The data show that the minimum expected life of a lot 2 bucket is 430 hours, and the minimum expected life of a lot 6 bucket is 960 hours. Since the minimum is at 2.3 inches above the base platform, it would be expected that failures should occur in a region near this point. This region is considered the critical zone. Experience has shown that factors other than stress-rupture, such as vibrational stress, thermal shock, and corrosion, decrease the life expectancy of the buckets and may cause failure outside the critical zone (ref. 1).

Figure 3. - Predicted engine life of lot 2 and lot 6 buckets if centrifugal stress and temperature were the only factors causing bucket failure.

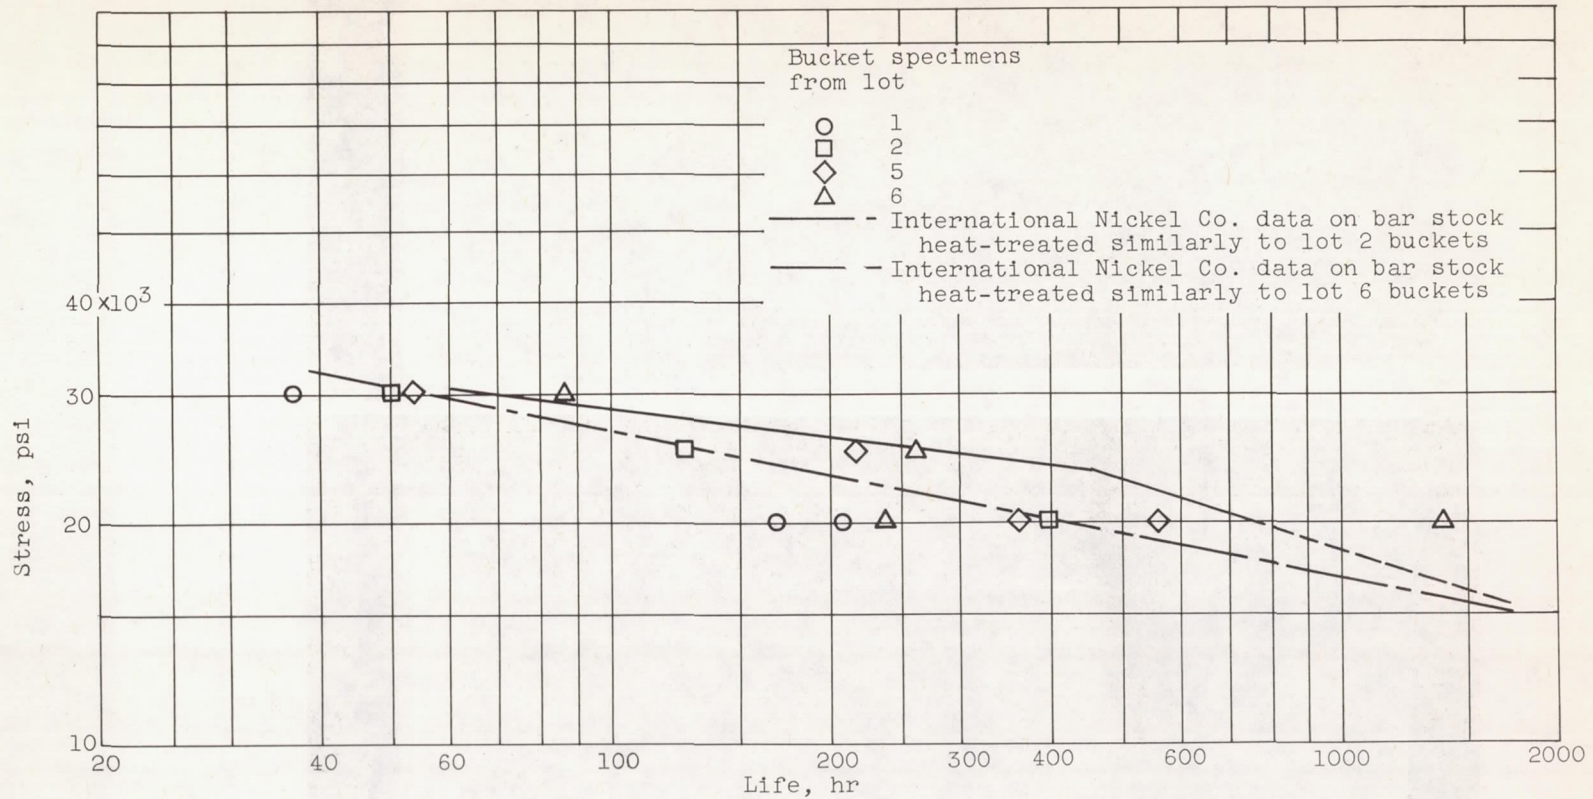
Although some of the stress-rupture data obtained from airfoil specimens were questionable, the remaining data compare favorably with the manufacturer's data, as shown in figure 7. It is interesting to note that one specimen from the lot 6 buckets had a stress-rupture life of nearly 1400 hours when stressed at 20,000 psi at 1600° F. This stress is comparable to that encountered in the critical zone of the buckets during rated-speed operation, and the temperature is within 25° F of the temperature in the critical zone of the bucket.

Figure 7. - 1600° F Stress-rupture life of Inconel 700 specimens taken from airfoils of buckets.

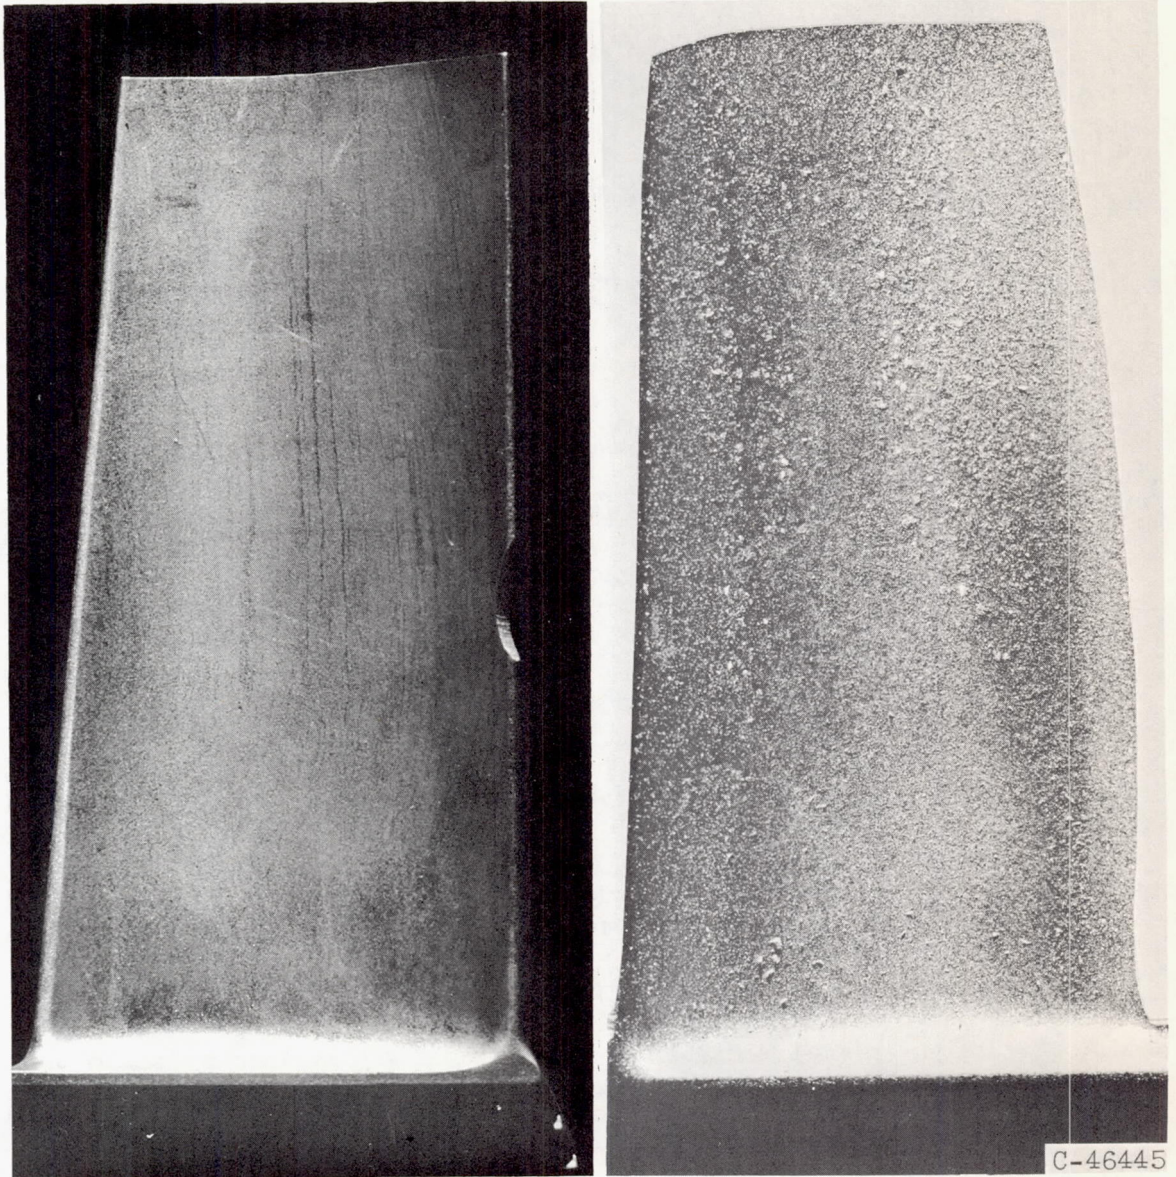
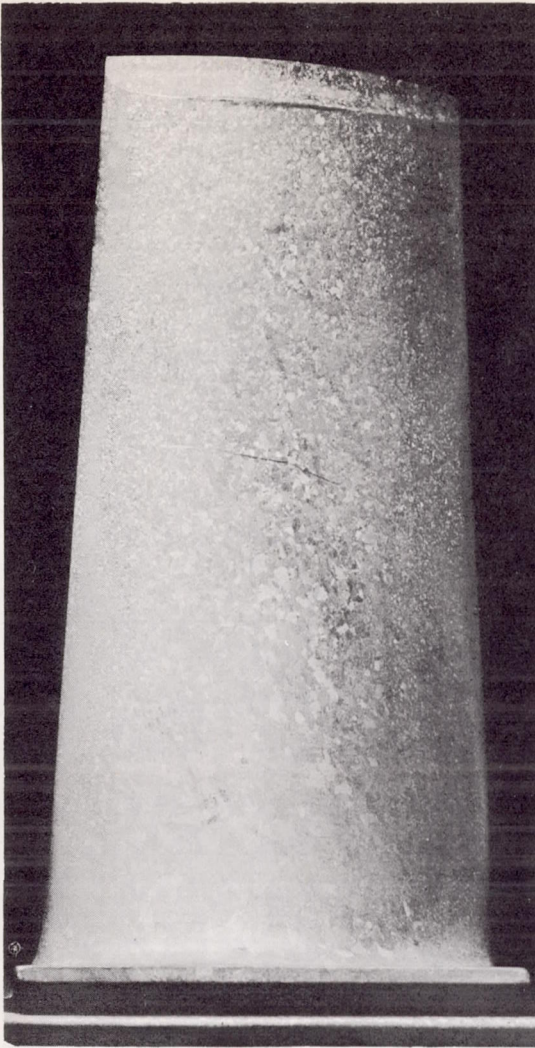
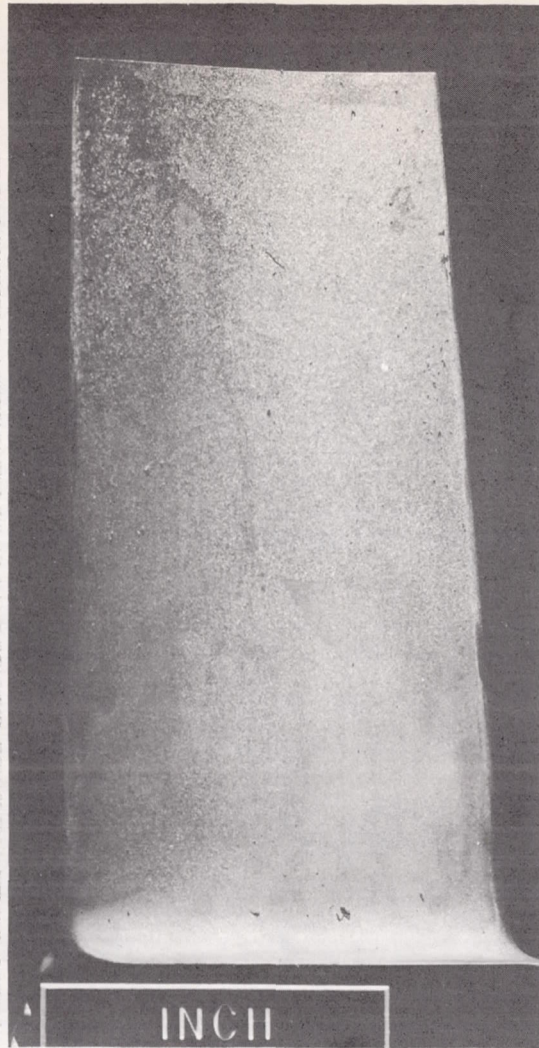
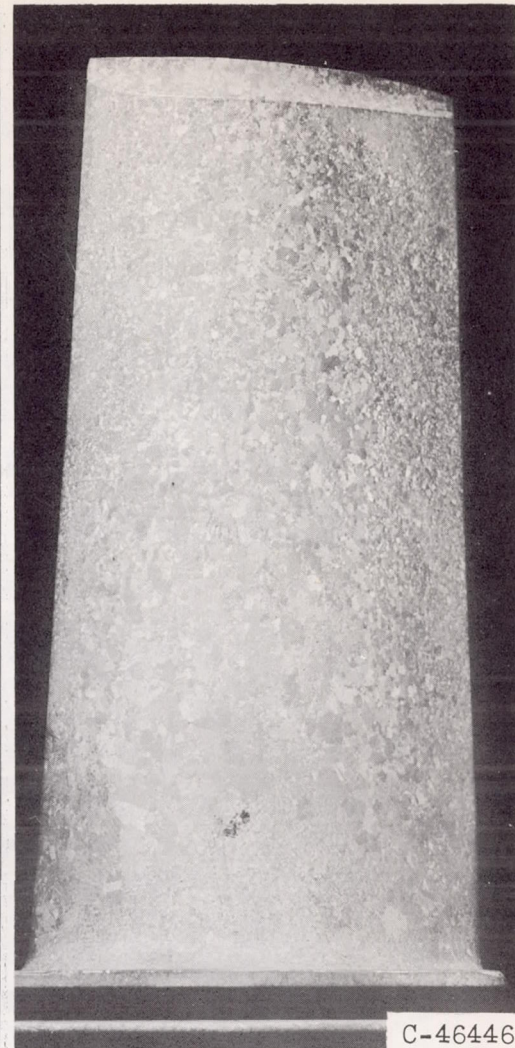
The macrograin sizes of the various lots of buckets are shown in figure 8. The macrograin sizes were relatively uniform within each bucket. The grain sizes of lots of the solution-treated and aged buckets were slightly larger than those in the buckets that were not solution-treated. The grain measurements taken on microsections showed that the ASTM grain sizes ranged from 5 to 6 for the as-forged and aged (non-solution-treated) lot 1 buckets to -2 to 1 for the solution-treated lot 6 buckets, as shown in table VI and figure 9. Elongated grains, indicating the presence of cold-working, were detected in the two lots of buckets (1 and 5) that were not solution-treated.

Figure 8. - Comparison of grain sizes of macroetched buckets.

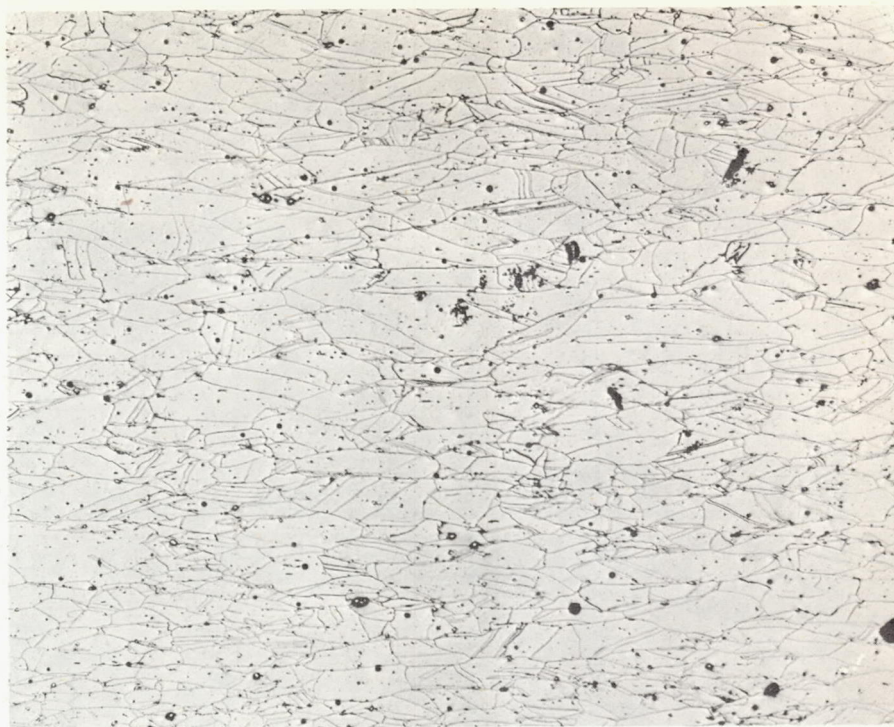
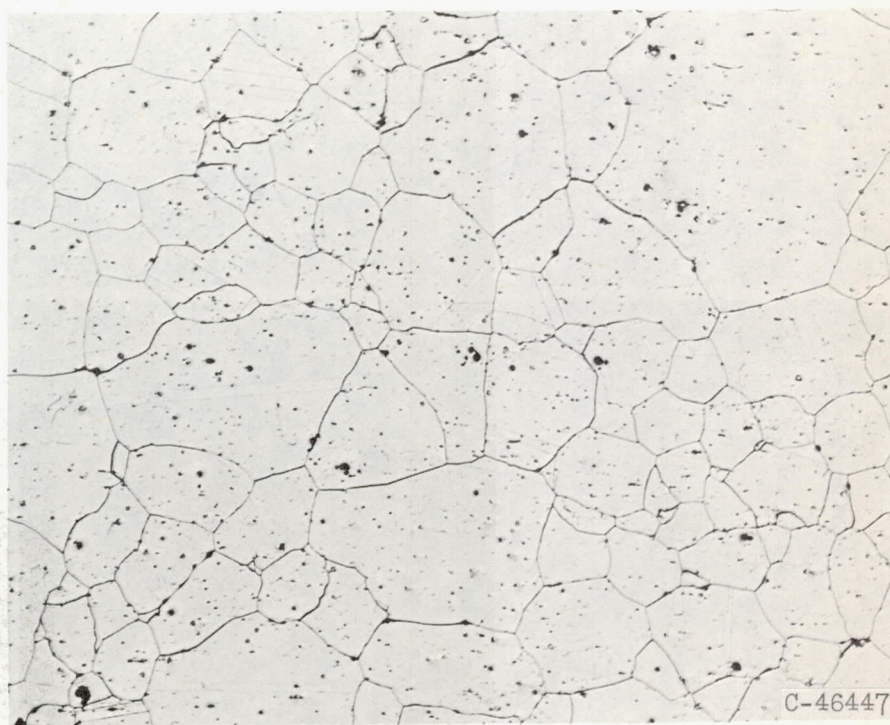
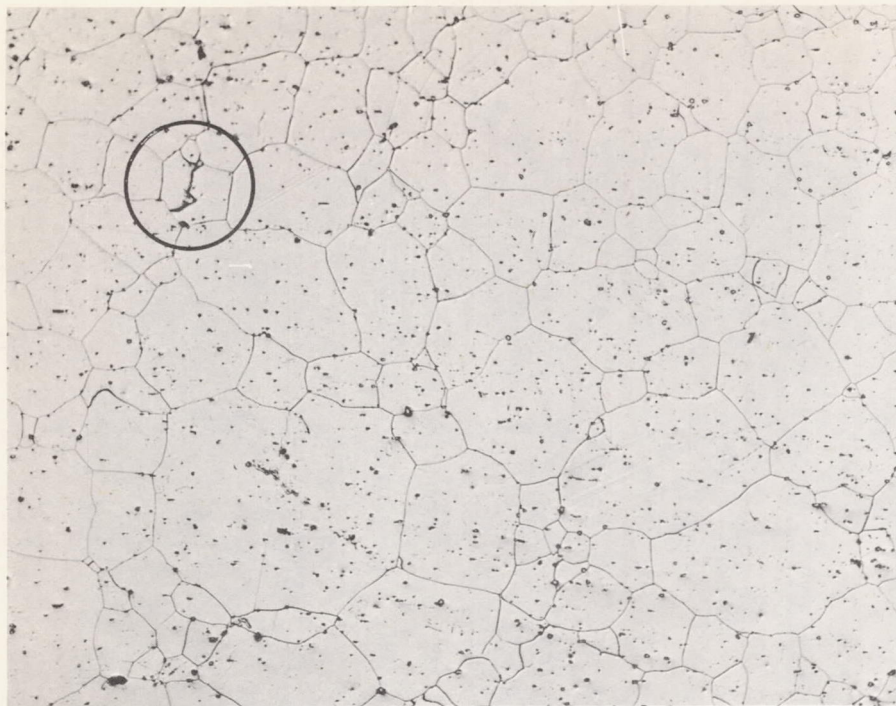
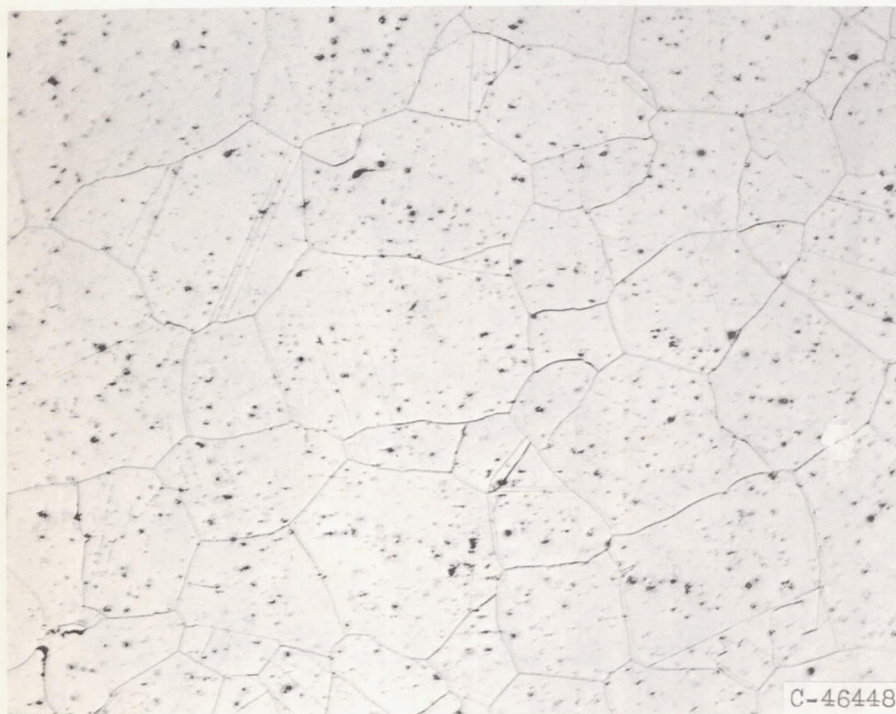
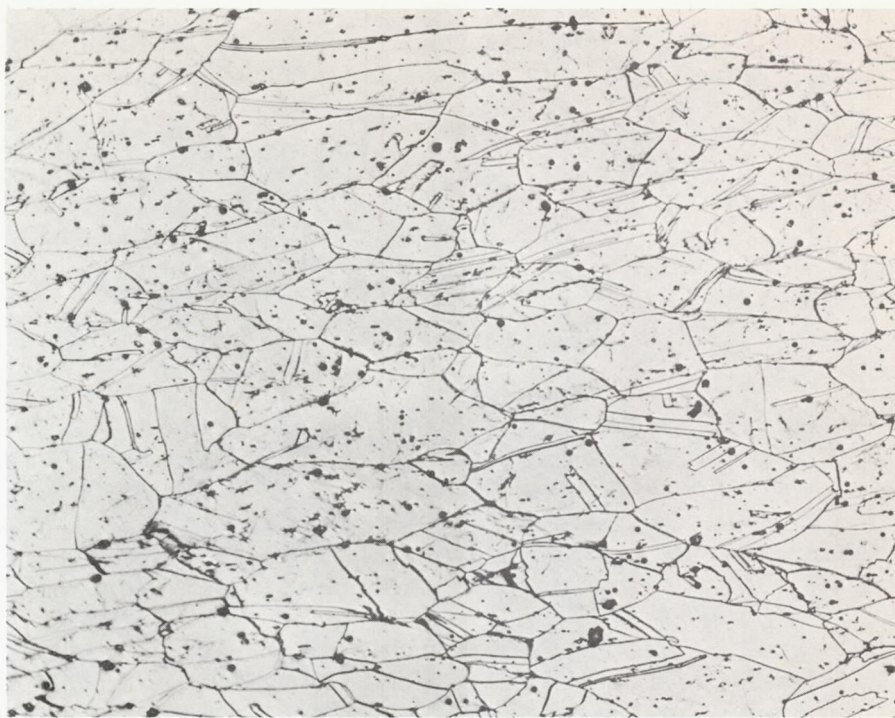
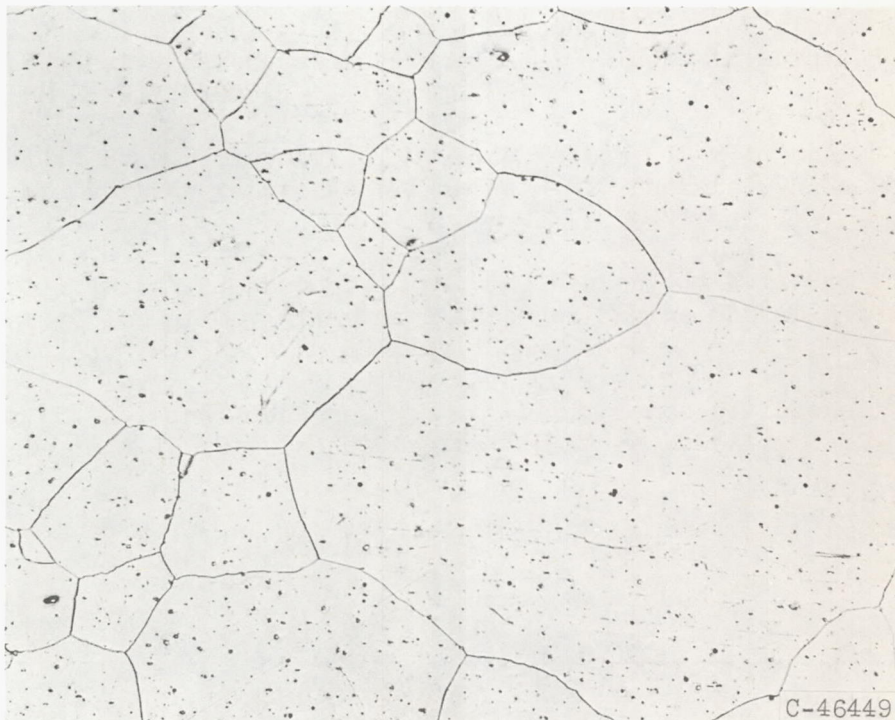
Figure 9. - Photomicrographs showing grain-size differences among various lots of Inconel 700 buckets. Original magnification, X100.

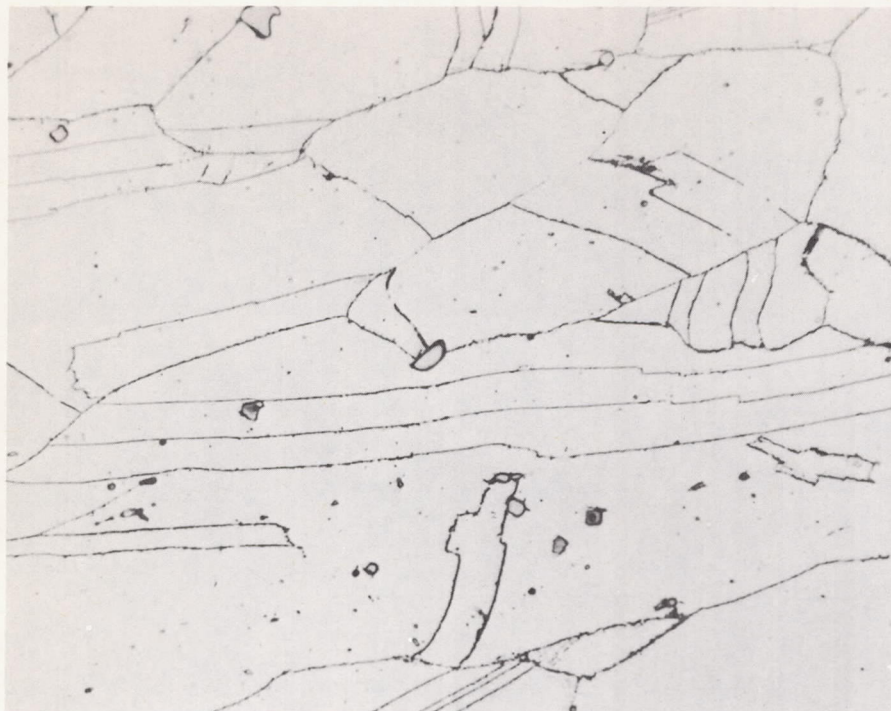
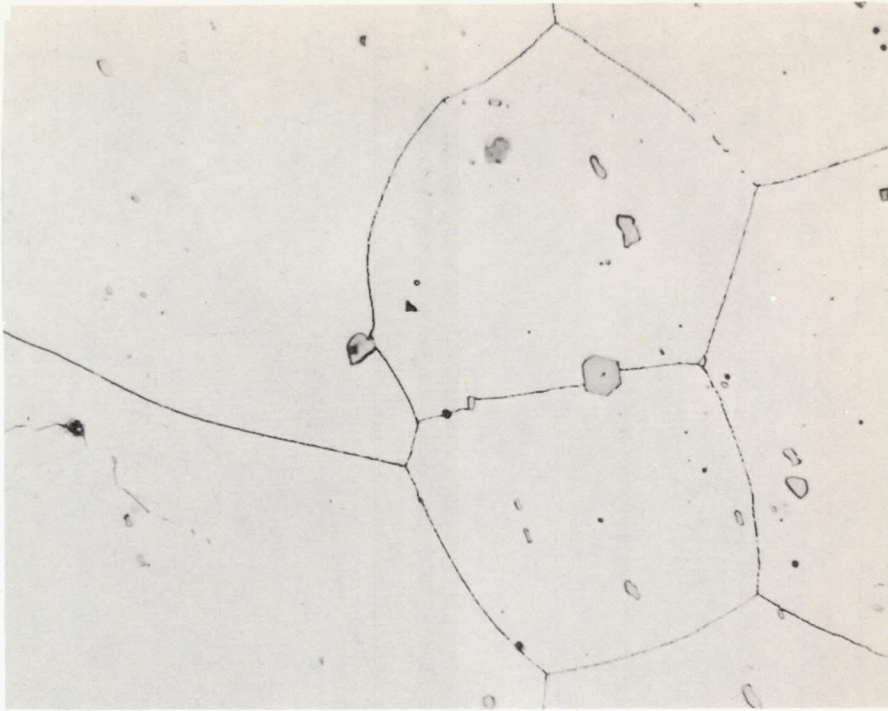
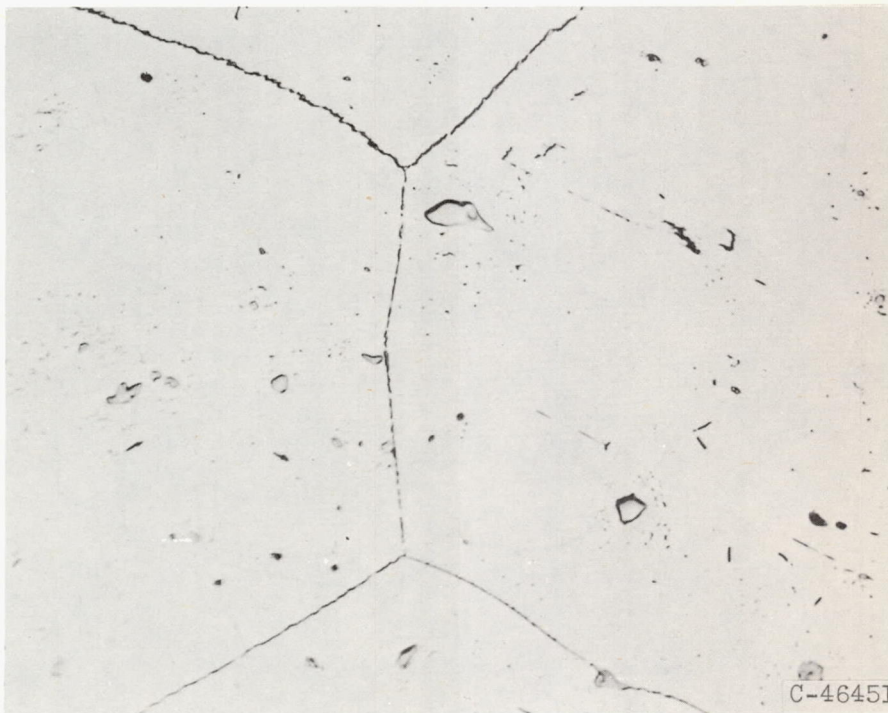
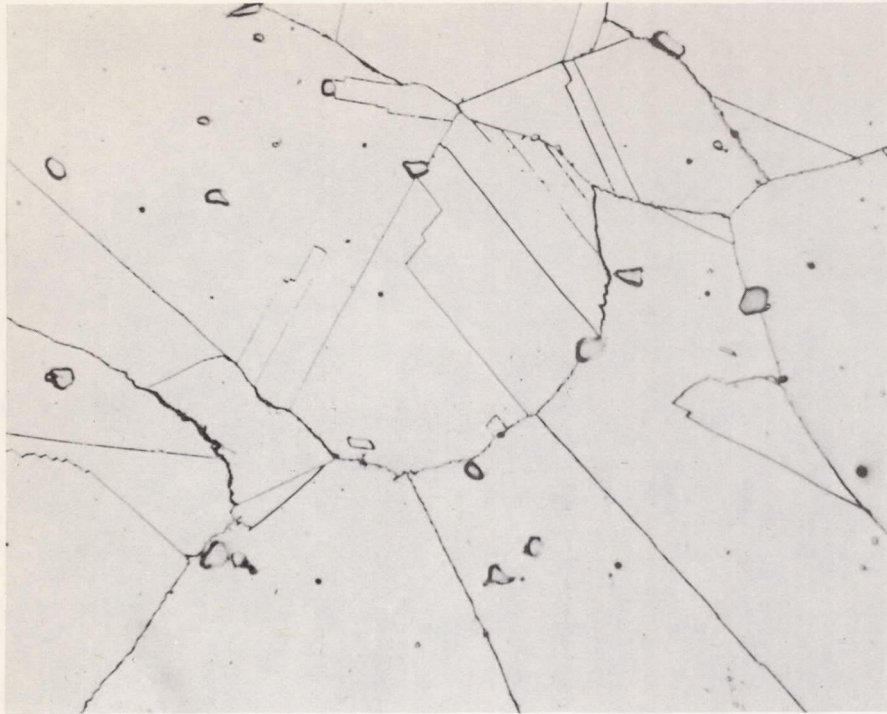
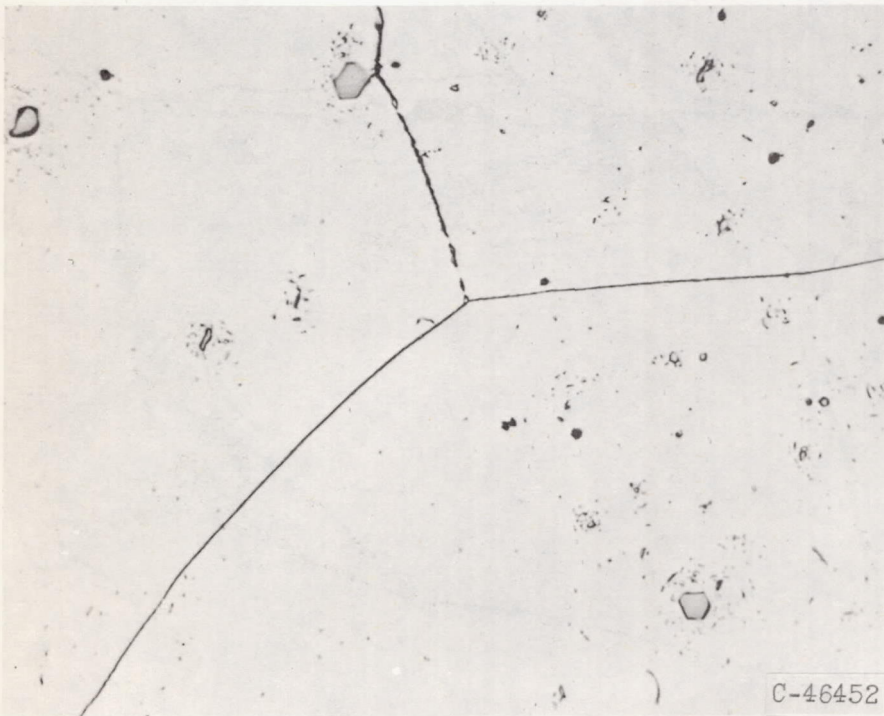
The typical microstructures of the six lots of buckets are shown in figure 10. The photomicrographs do not show the matrix precipitates that are often visible in an age-hardenable alloy. In all probability the precipitates are too fine (or coherent) to be resolved optically. (Long-time aging in a furnace or operating the buckets in an engine will cause the precipitates to grow and become readily visible, as will be shown later.) The larger minor-phase particles present in these microstructures have been identified as titanium carbonitride $Ti(C,N)$ (ref. 3).

Figure 10. - Typical as-heat-treated microstructures.
Original magnification, X750.
