RESEARCH MEMORANDUM

AN EXPERIMENTAL EVALUATION OF SEVERAL DESIGN
VARIATIONS OF HOLLOW TURBINE BLADES FOR
EXPENDABLE ENGINE APPLICATION

By W. C. Morgan and R. H. Kemp

NATIONAL ADVISORY COMMITTEE
FOR AERONAUTICS

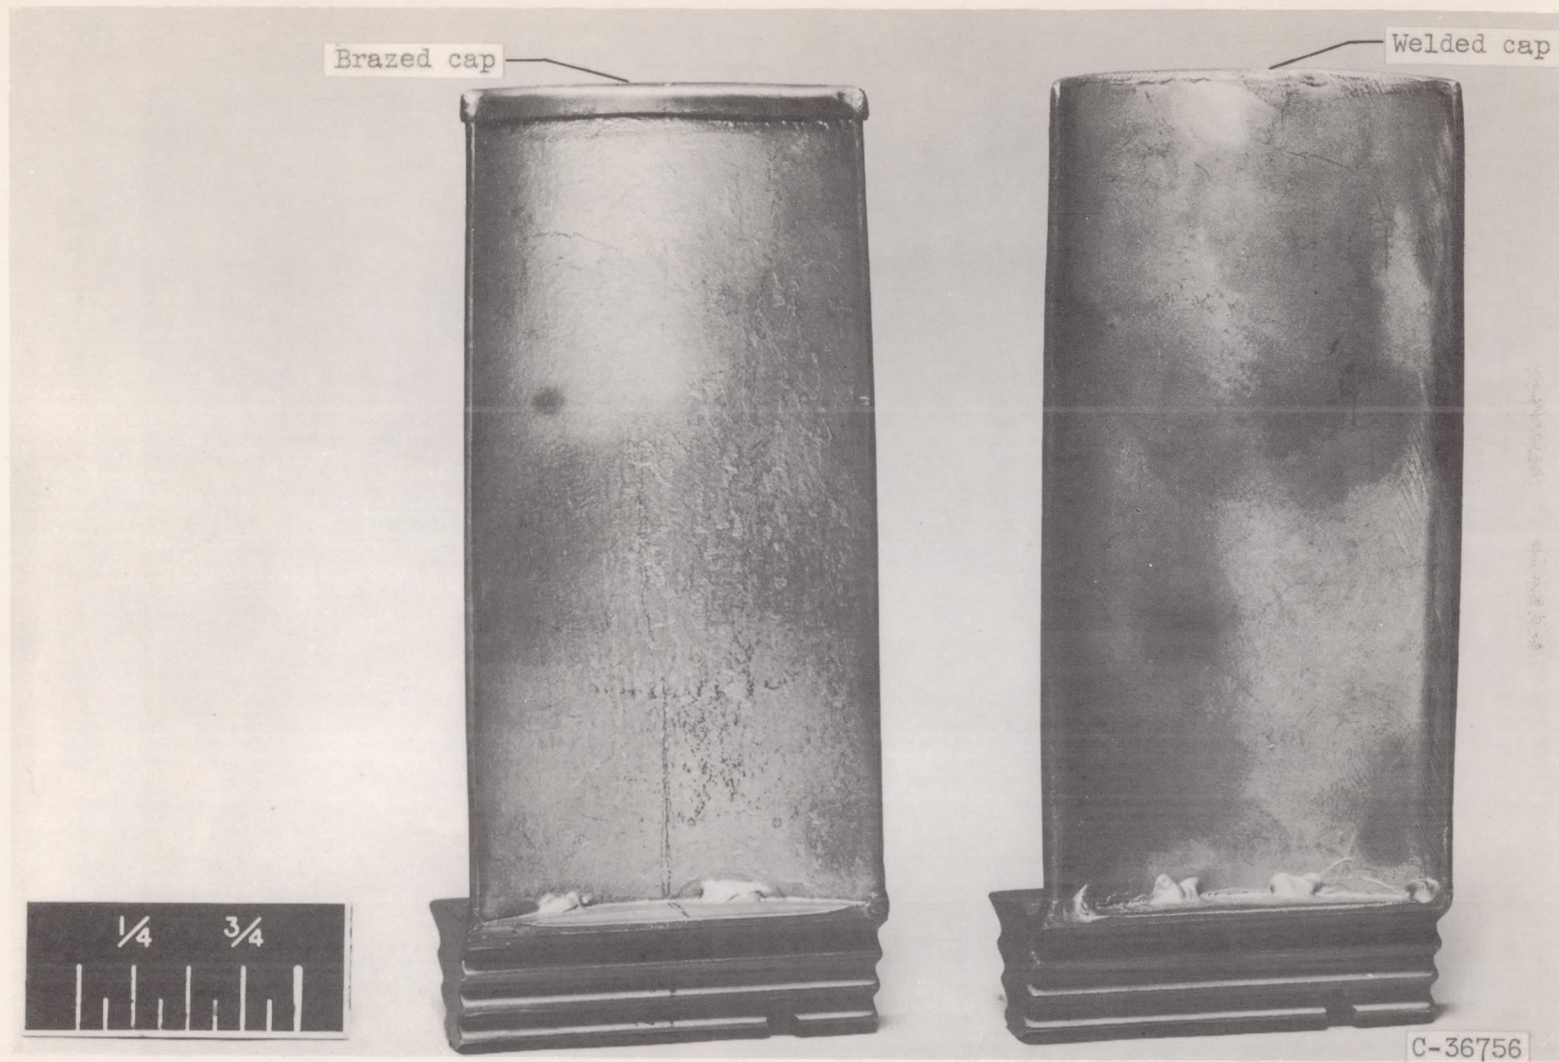
The hollow airfoils were attached to bases and the tips were closed by a welded or brazed cap. The purpose of the cap was to prevent a type of tip vibration characterized by independent wall movements. The two types of caps are shown in figure 2.

Figure 2. - Comparison between brazed and welded blade-tip caps.

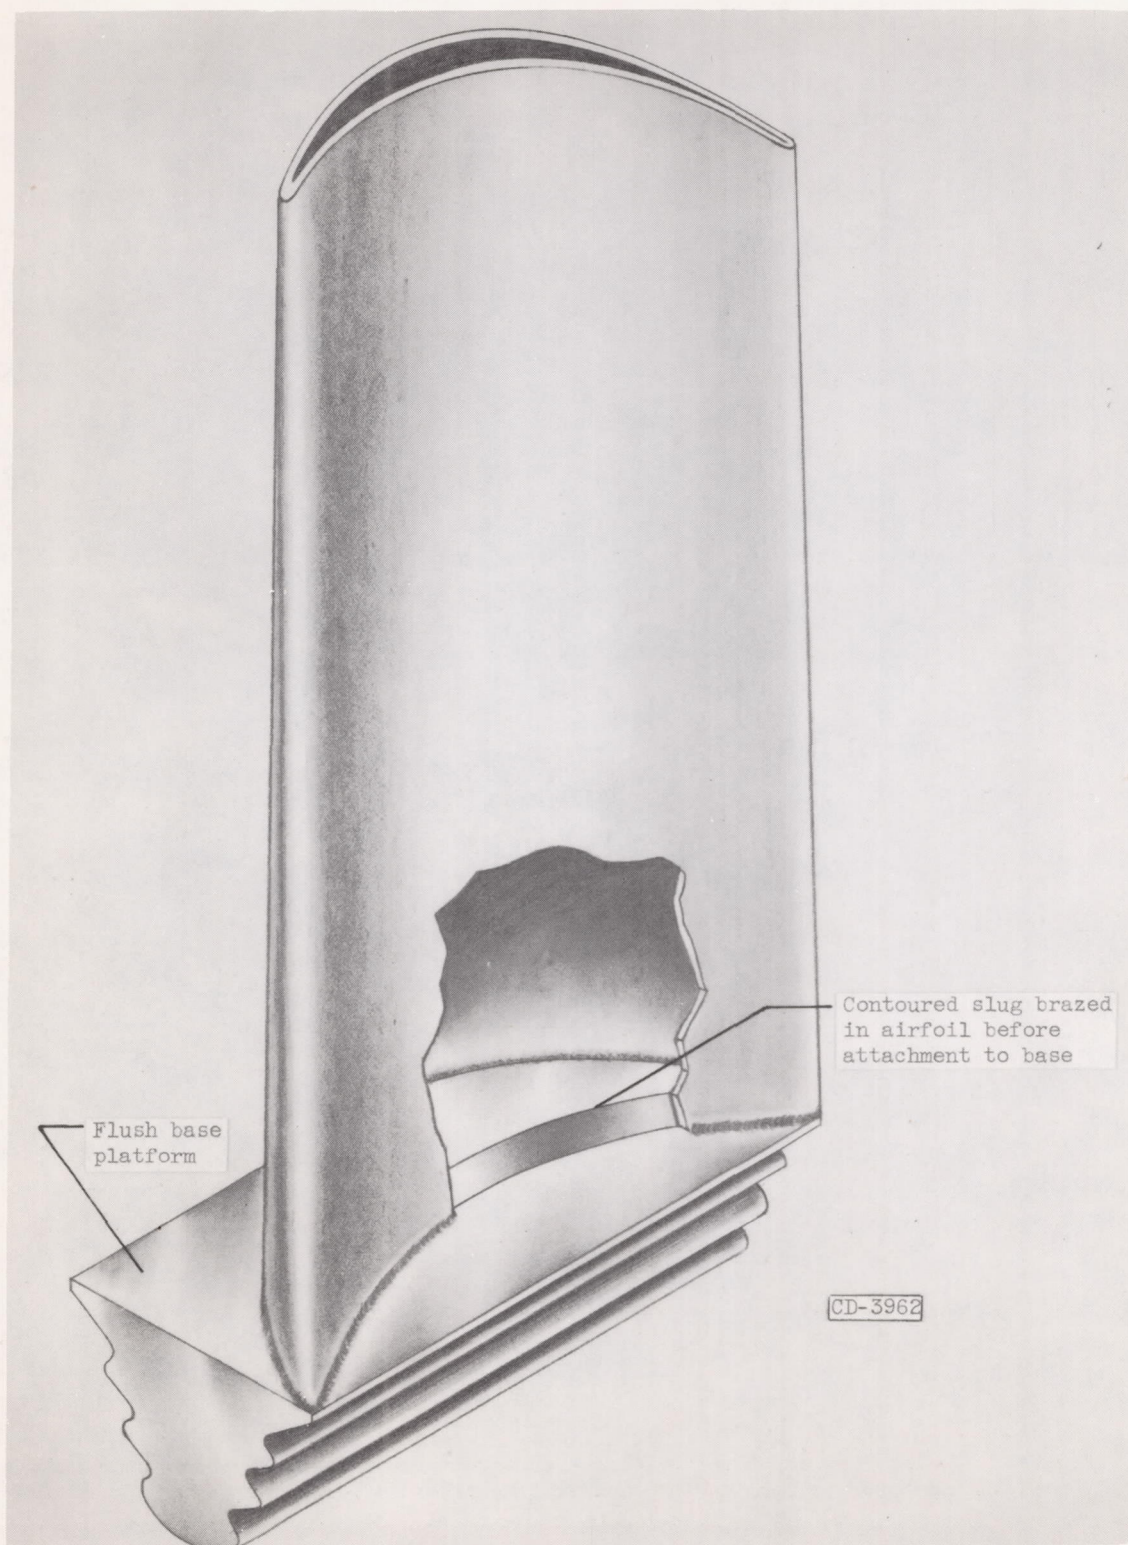
Group 7. - (L-605, 0.030-in. wall, welded airfoil brazed to flush platform as shown in fig. 4, fig. 3, base C.) The three specimen blades were intact at the end of 30 hours of operation. The results indicated that it would be practical to use a brazed joint in tension for the base attachment.

Figure 4. - Construction of sheet-metal airfoil brazed to flush base platform.

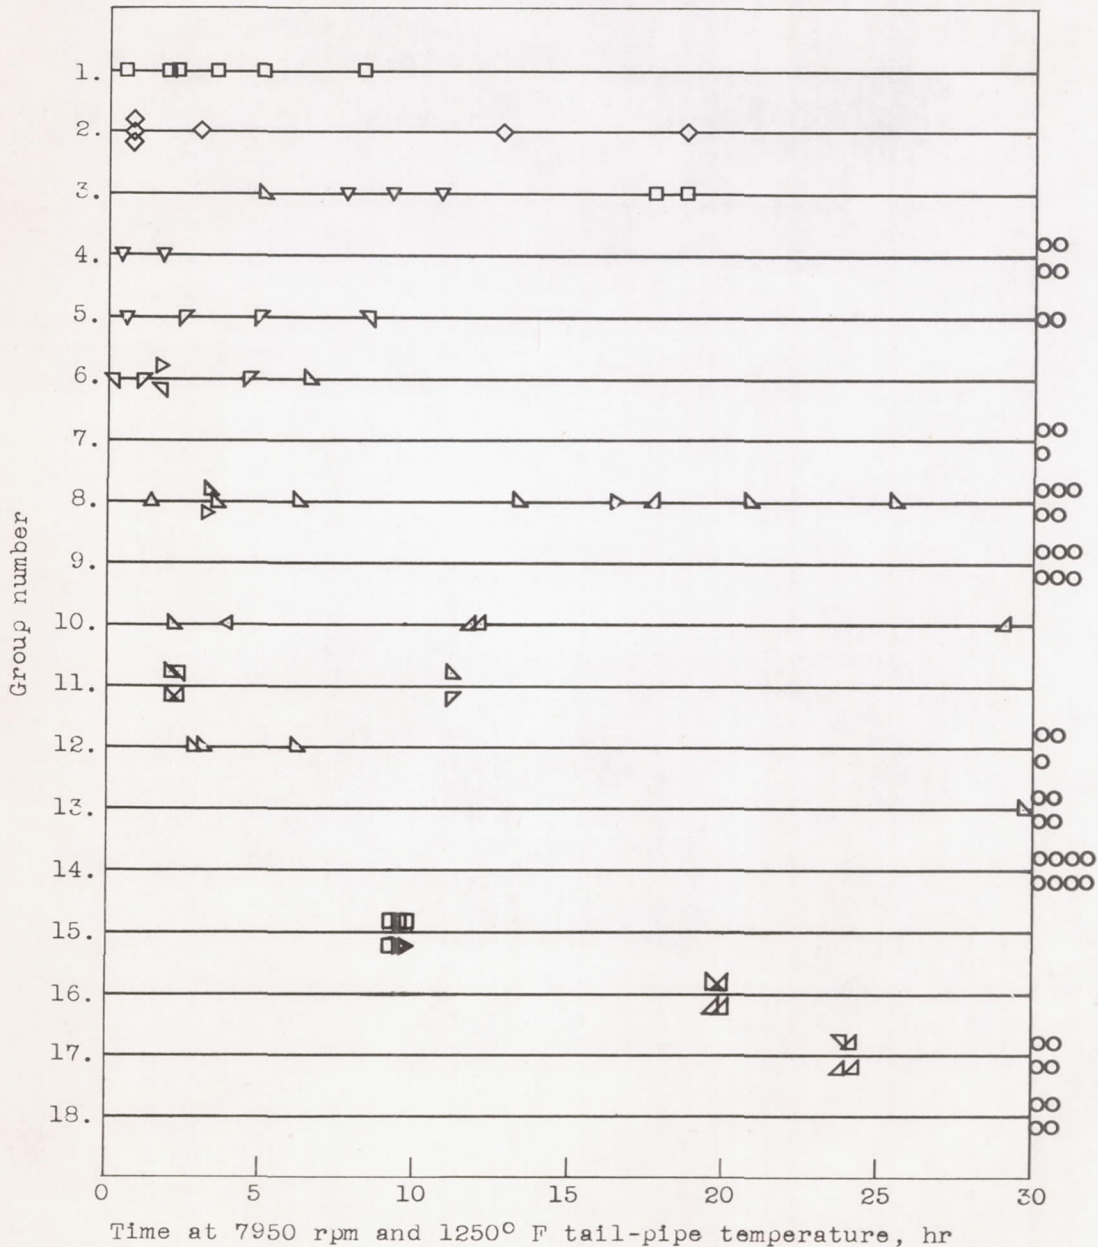
- Completed 30 hours
- Root serration failure
- ◇ Failure in welded attachment at base
- ◊ Failure in brazed attachment at base
- ▽ Failure in airfoil near base
- ▽ Failure in airfoil near midsection
- ▽ Failure in airfoil near tip
- ◊ Cracks in leading or trailing edge
- ◊ Cracks in tip
- ▽ Failure caused by improper fabrication
- △ Failure from impact damage

Figure 8. - Results of engine operation of 18 hollow-blade design variations.
