FULL-SCALE PERFORMANCE STUDY OF A PROTOTYPE CRASH-
FIRE PROTECTION SYSTEM FOR RECIPROCATING-
ENGINE-POWERED AIRPLANES

By Dugald O. Black and Jacob C. Moser

NATIONAL ADVISORY COMMITTEE
FOR AERONAUTICS

November 15, 1955

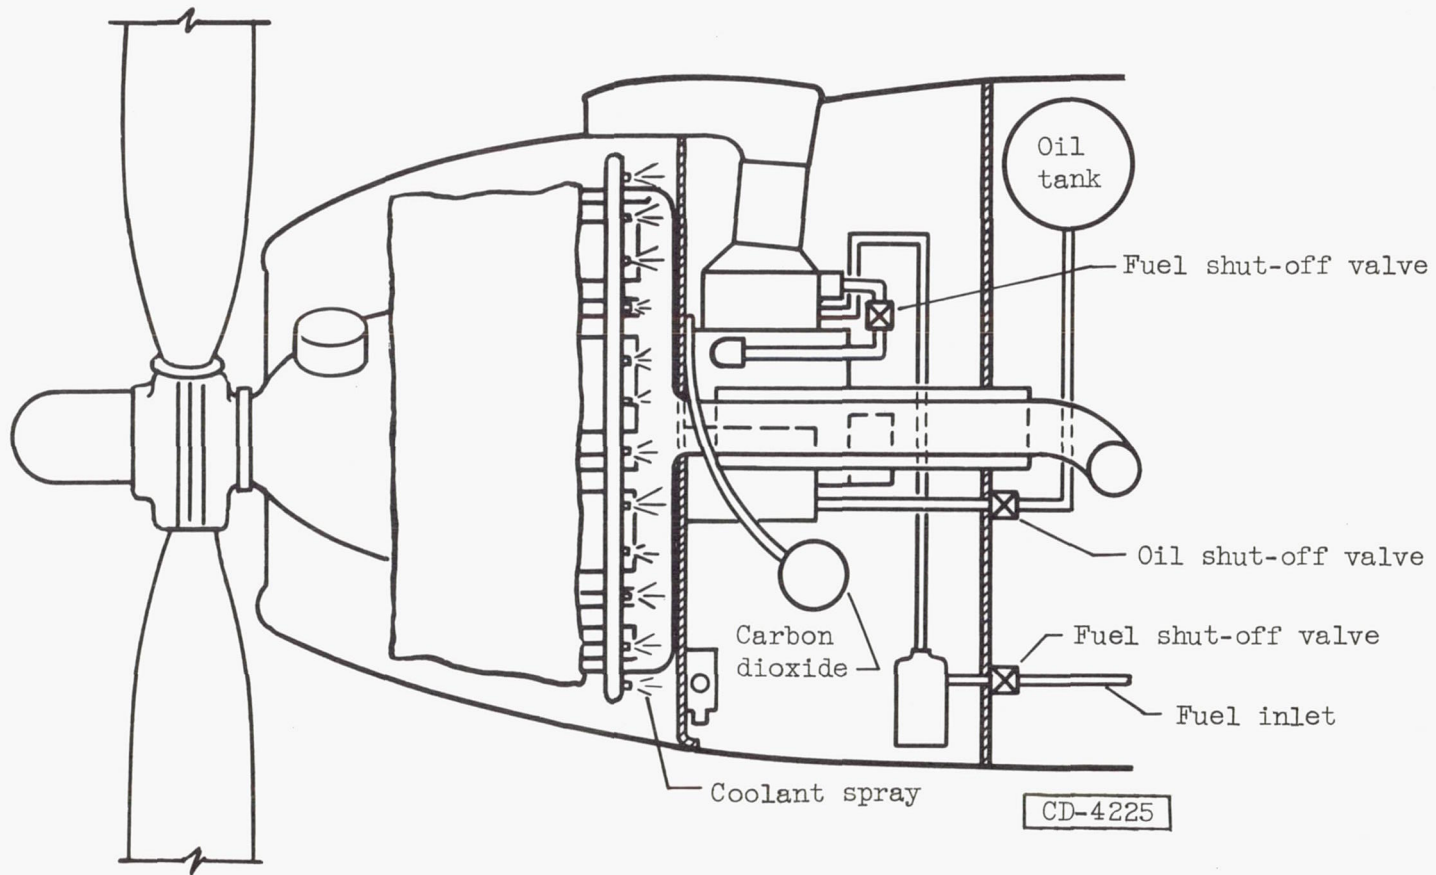
These components of the inerting system are installed in an engine nacelle at the locations shown by the schematic diagram in figure 1. This crash-fire ignition-source inerting system is completely automatic, since the inerting system is actuated at the time of impact with the crash barrier by the crash-actuated initiating system. All components of this crash-fire prevention system are described completely in reference 2.

Figure 1. - Schematic diagram of inerting-system components on engine.

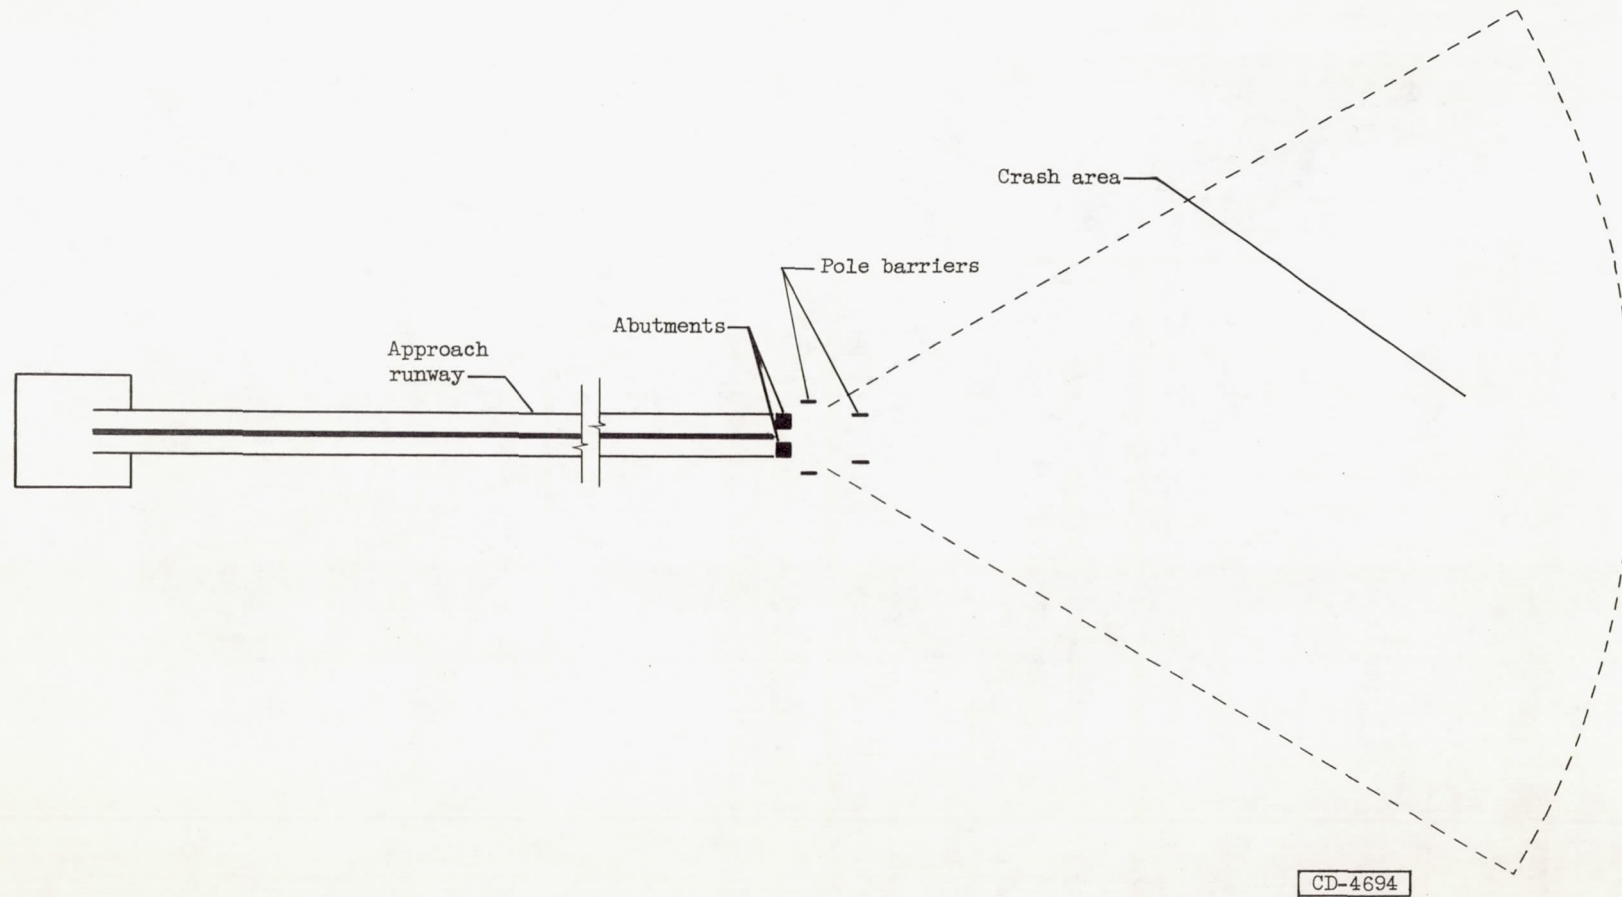
The procedure for such experimental crashes is fully described in reference 3. Briefly, however, the crash was conducted in the following manner. The unmanned airplane was guided by a rail along a 1700-foot paved runway at full power until it crashed into a series of obstacles at take-off speed (fig. 2). The first obstacles were two abutments, made of railroad ties and earth, placed in the path of the main landing wheels. These barriers removed the landing gear and damaged the propellers and engines. Four poles then ripped open the fuel tanks in the wings. After being damaged, the airplane slid across an open area on its belly. The sliding airplane was enveloped by a large volume of fuel mist formed by the fuel spilling from the wings while the airplane was in motion. Because the fuel in vapor, mist, and liquid form was extensively distributed, this crash was a severe test of the inerting system.

Figure 2. - Schematic drawing of crash site for conducting experimental crashes.

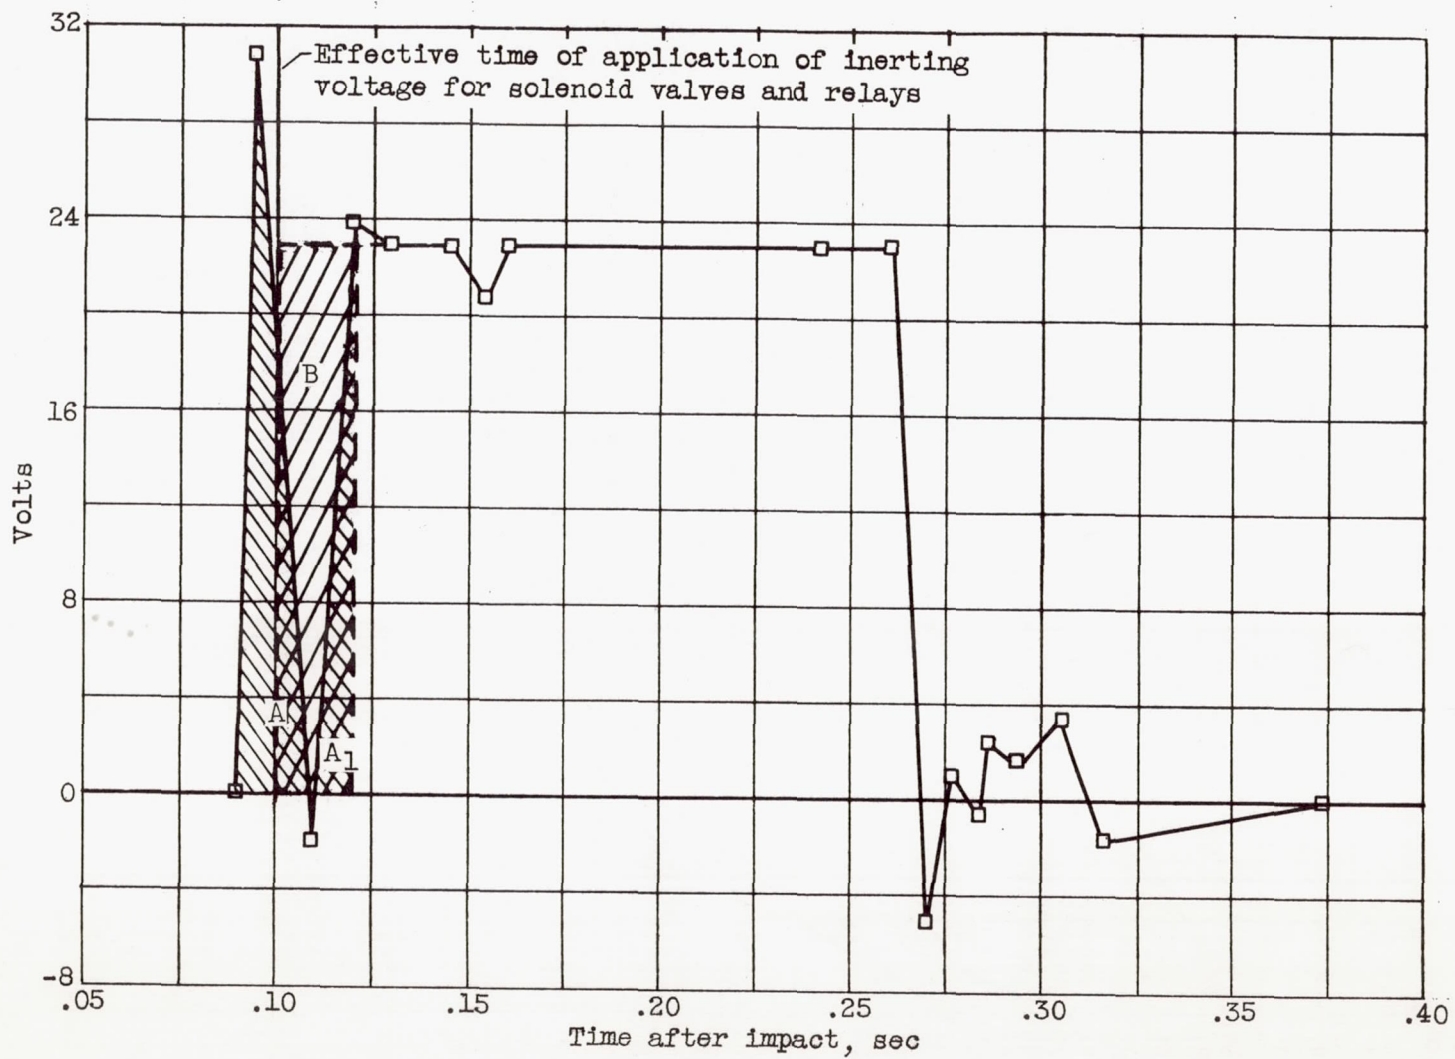
Figure 15. - Voltage applied to inerting system components.
