NACA RM E50C15

EFFECTS OF INLET ICING ON PERFORMANCE OF AXIAL-FLOW
TURBOJET ENGINE IN NATURAL ICING CONDITIONS

By Loren W. Acker and Kenneth S. Kleinknecht

Lewis Flight Propulsion Laboratory
Cleveland, Ohio

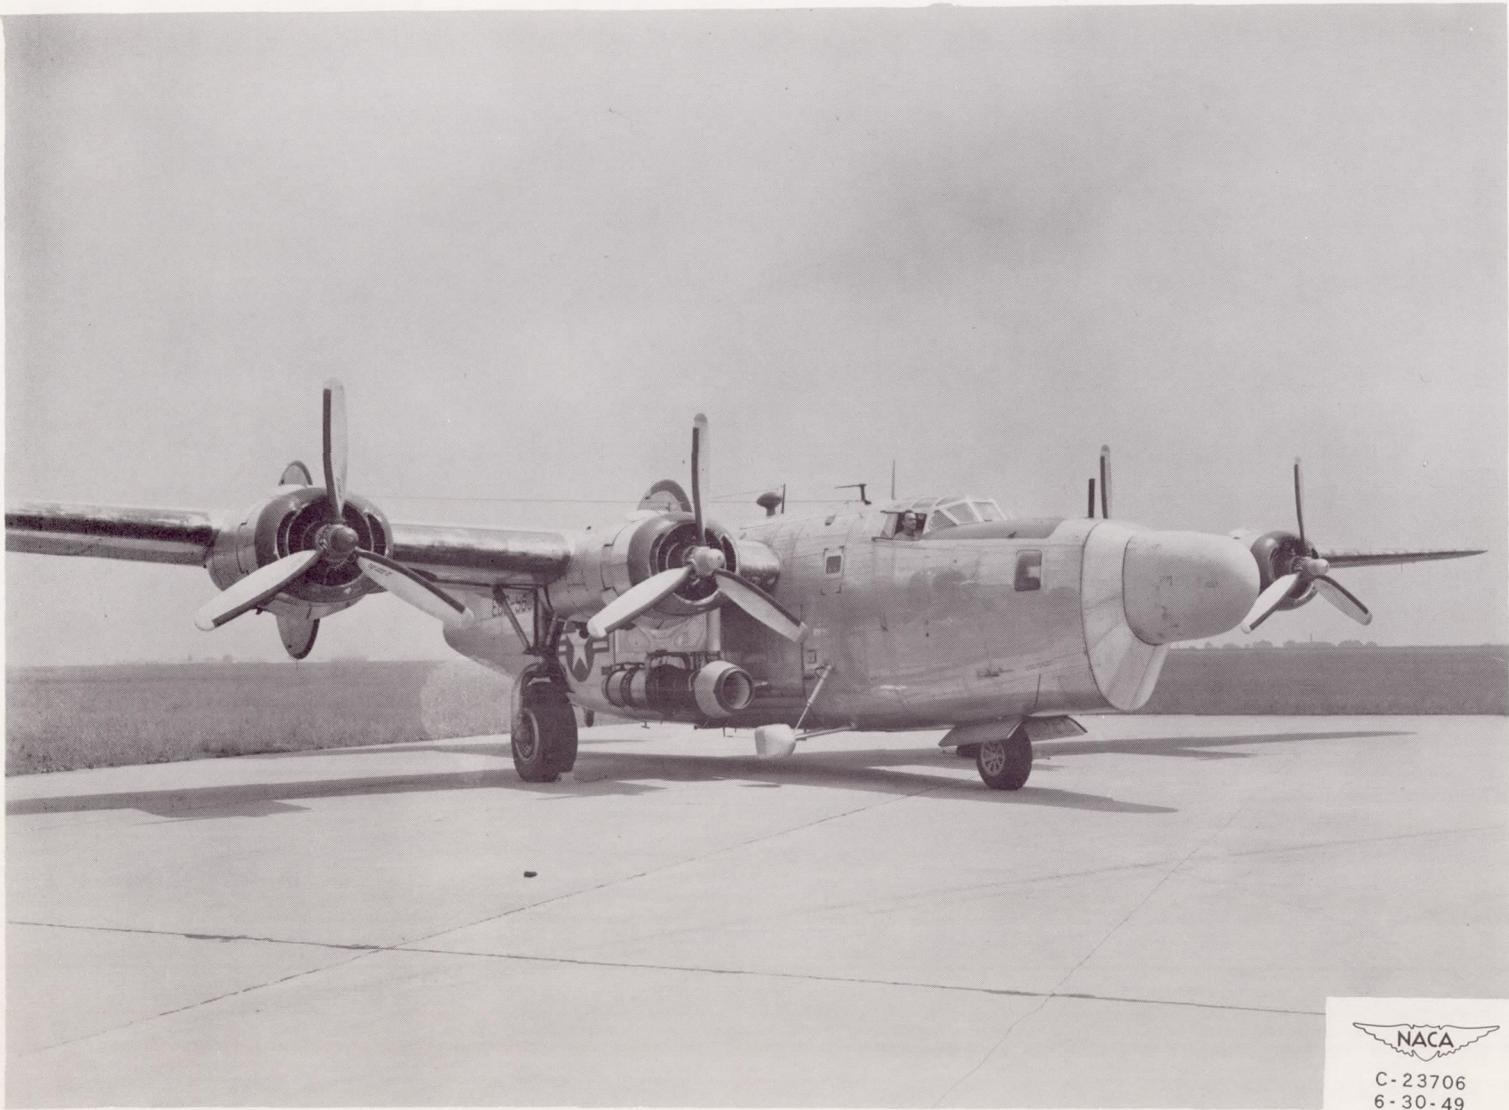
The engine was mounted on a strut under the wing and between the right inboard nacelle and the fuselage of a four-engine bomber-type airplane (fig. 1). The engine installation is shown in detail in figure 2.

Figure 1. - Flight installation for investigation of icing of axial-flow turbojet engine.

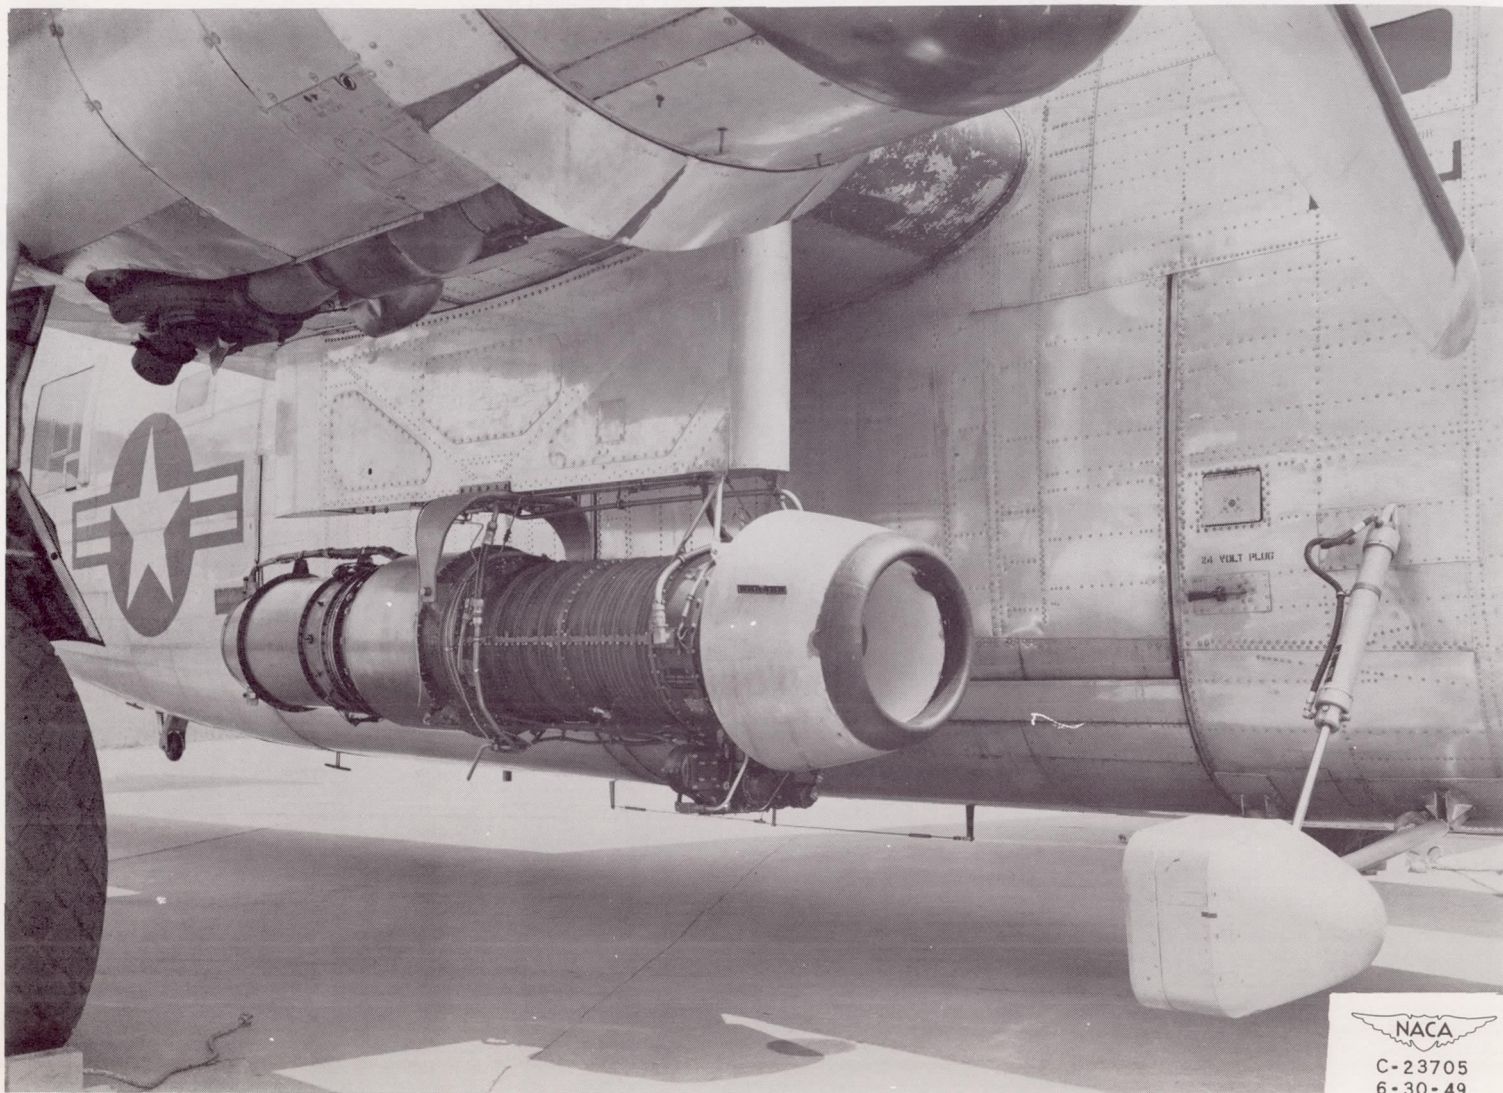
Figure 2. - Close-up view of turbojet engine and camera housing.

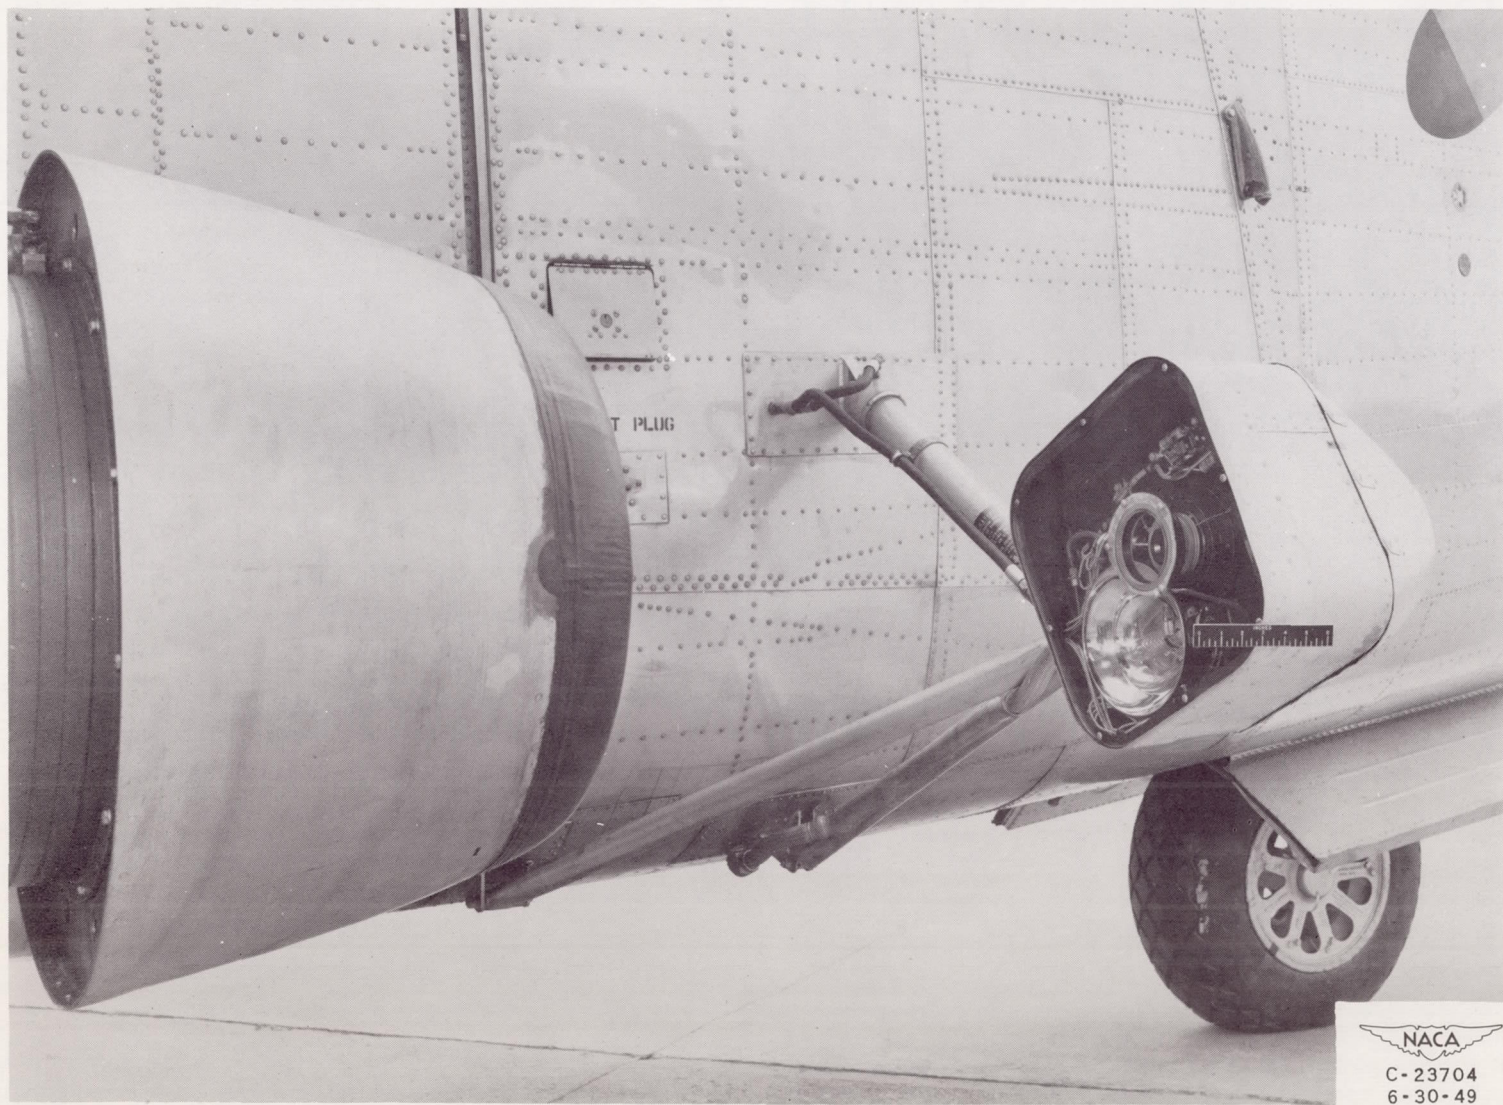
Photographs of the engine inlet were obtained in flight with an aerial camera body (fig. 3) fitted with a special lens and shutter assembly and an electronic flash unit. The camera was mounted on a movable tripod, which was anchored to the side of the airplane fuselage approximately 3 feet ahead of the turbojet-engine inlet. One leg of the tripod was a hydraulic cylinder and was used to lower the camera below the engine inlet after a photograph was obtained (fig. 3).

Figure 3. - Camera and mounting used for photographing turbojet-engine inlet in flight.

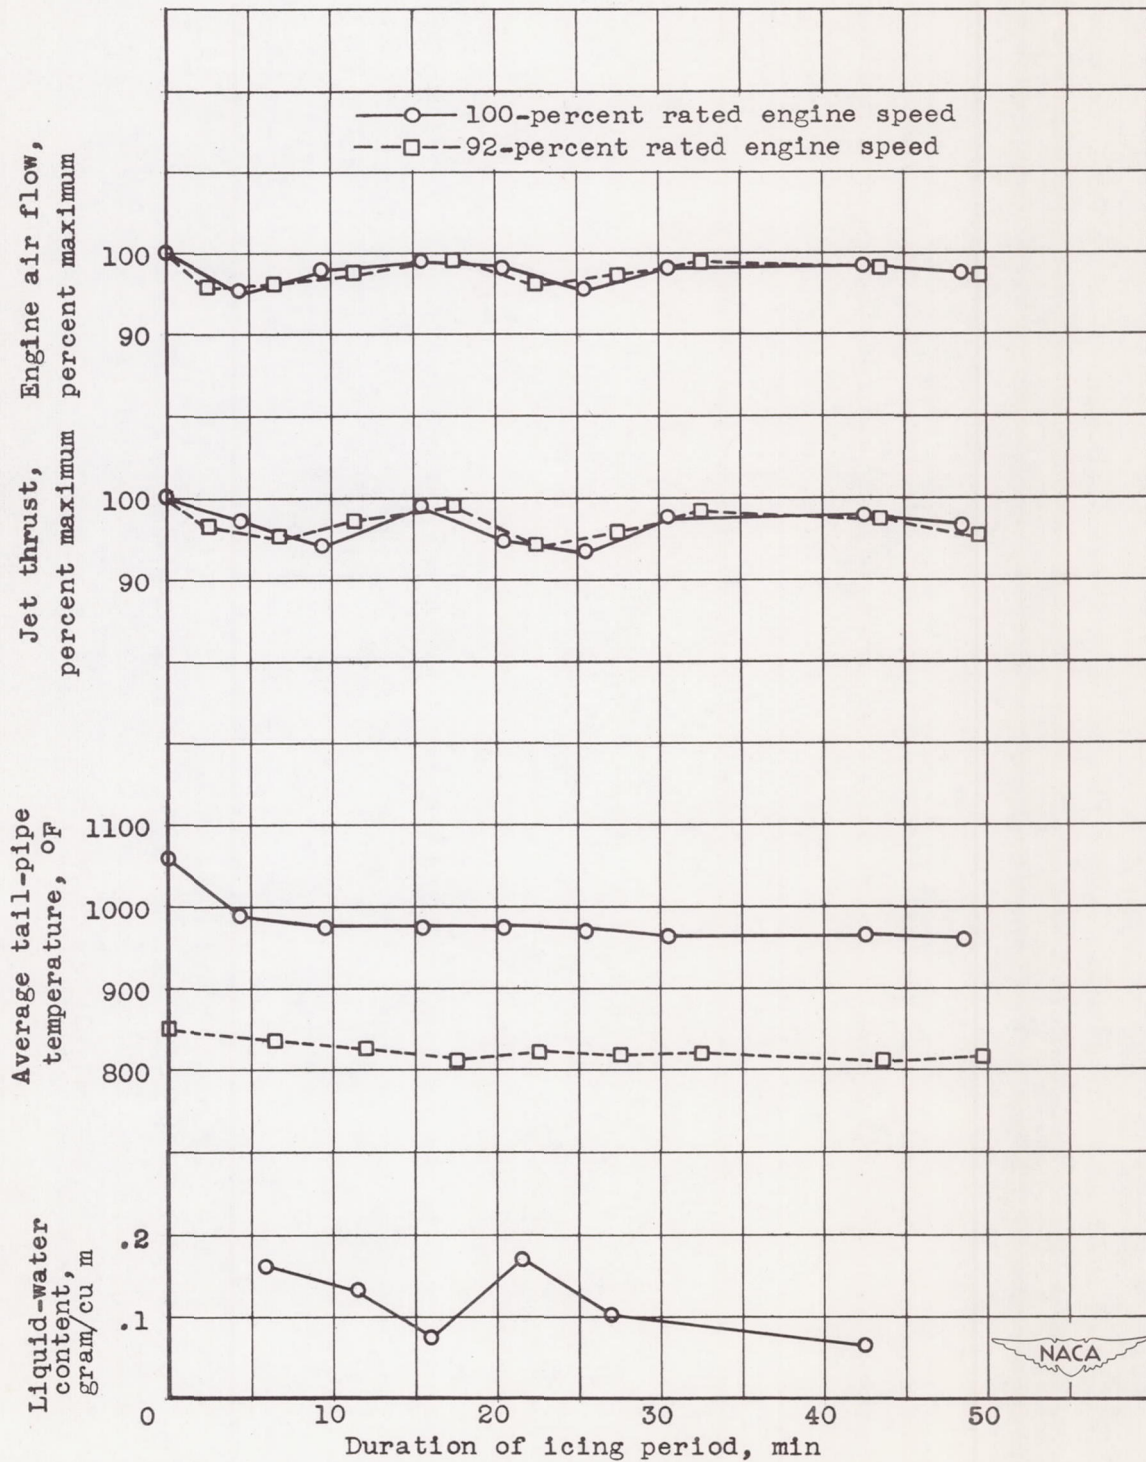
Flight 1 was made in a relatively light icing condition; the liquid-water content varied from approximately 0.1 to 0.2 gram per cubic meter at an ambient-air temperature of 13° to 16° F, with an average water-droplet size of 12 to 27 microns. The resulting ice accretions on the inlet guide vanes caused maximum reductions of approximately 7 and 6 percent in jet thrust and 5 and 4 percent in the engine air flow during a 50-minute operation at 100- and 92-percent rated engine speed, respectively, (fig. 4). The effect of inlet icing on tail-pipe temperature was negligible for both engine speeds.

Figure 4. - Time history of flight data obtained in icing condition during flight 1. Ambient-air temperature, 13° to 16° F; droplet size, 12 to 27 microns; indicated airspeed, 185 to 205 miles per hour; pressure altitude, 3400 to 9300 feet.

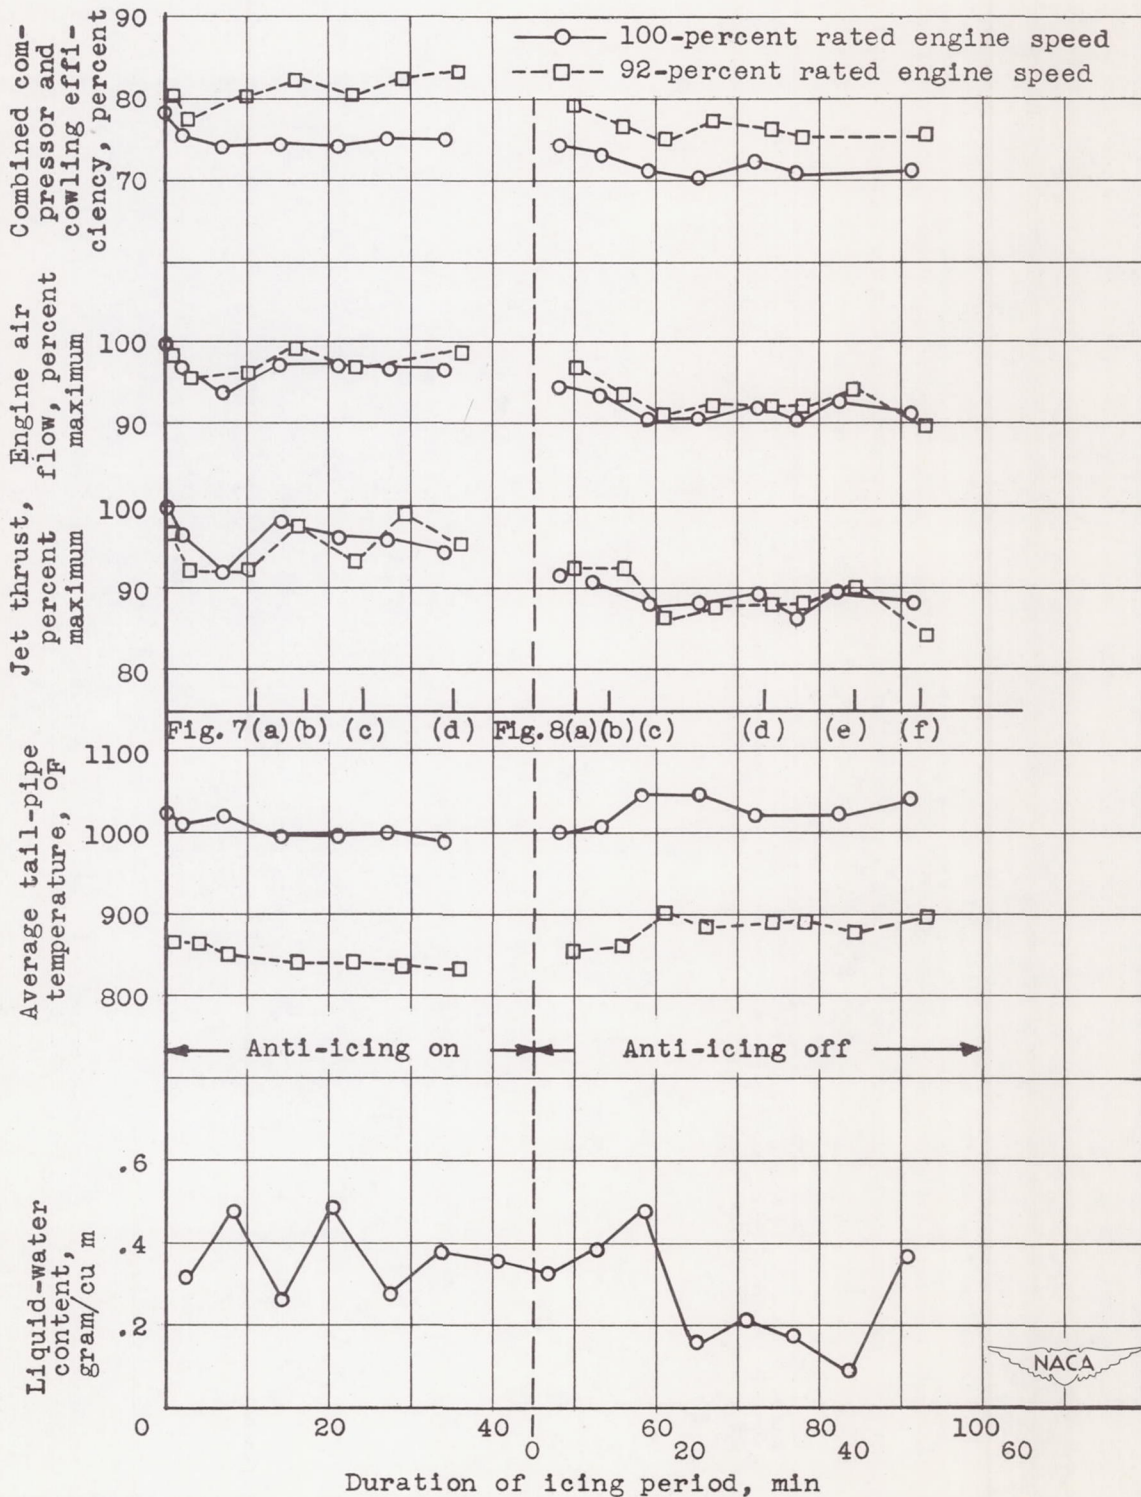
The data obtained from flight 2 are shown in figure 6. In the first part of the flight, during which icing protection was provided for all of the inlet components except the inlet guide vanes, maximum losses of 8 percent in jet thrust, 6 and 4 percent in air flow, and a 4- and 6-percent decrease in compressor efficiency occurred during 45 minutes of operation at 100- and 92-percent rated speed, respectively, because of the restriction imposed by ice on the guide vanes. Increase in engine tail-pipe temperature due to the ice formations was negligible during this period at both engine speeds.

Comparison of the results of the two phases of flight 2 (fig. 6) revealed that ice accretions on the compressor-inlet guide vanes accounted for about one-half the total reduction in engine performance caused by ice on the air inlet. The range of icing conditions remained sufficiently alike throughout the flight to validate this comparison.

Figure 6. - Time history of flight data obtained in icing condition during flight 2. Ambient-air temperature, 22° to 26° F; droplet size, 11 to 20 microns; indicated airspeed, 170 to 180 miles per hour; pressure altitude, 5000 to 6400 feet.

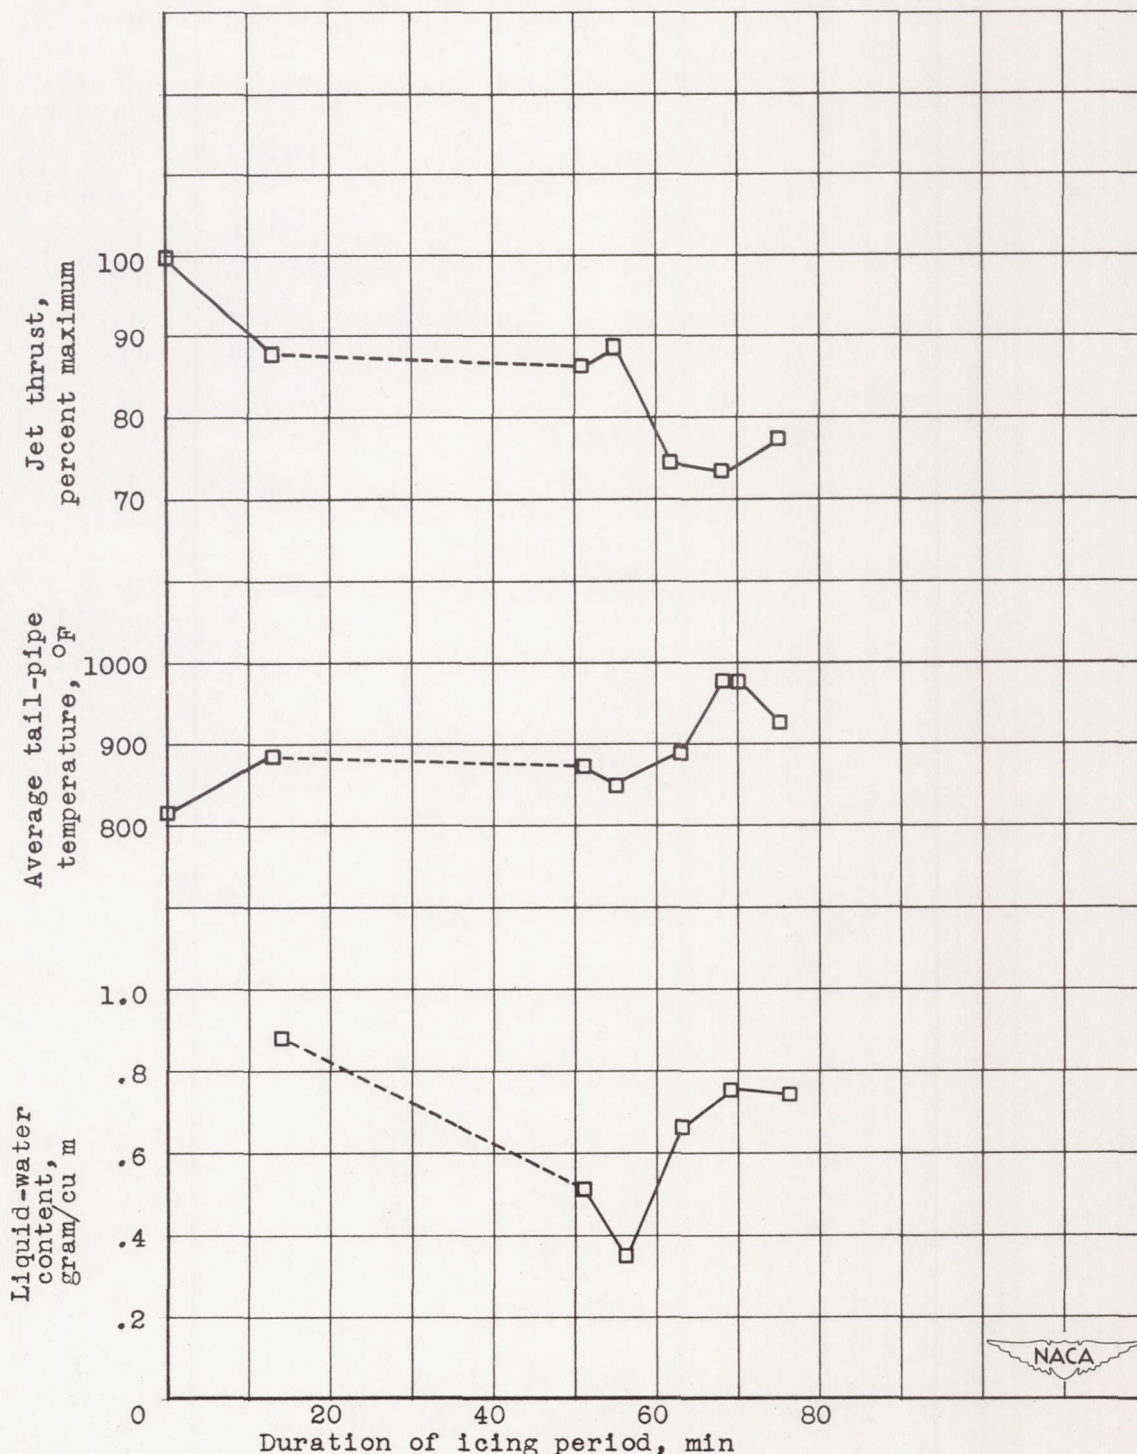
approximately 0.4 to 0.9 gram per cubic meter, which was the highest value of liquid-water content reached during the entire investigation. Water-droplet diameters ranged from 12 to 14 microns and the ambient-air temperature from 17° to 22° F. The resulting ice formations on the engine inlet caused a maximum reduction of 26 percent in thrust and a maximum increase of 160° F in tail-pipe temperature after 70 minutes of operation in the icing condition, as shown in figure 9. Photographs of these ice formations are shown in figure 10. During that part of the flight indicated by the dashed sections of the curves in figure 9, the icing was too intermittent and light to permit reliable measurements.

Figure 9. - Time history of flight data obtained in icing condition during flight 3 at 92-percent rated engine speed. Ambient-air temperature, 17° to 22° F; droplet size, 12 to 14 microns; indicated airspeed, 173 to 185 miles per hour; pressure altitude, 4600 to 5900 feet.

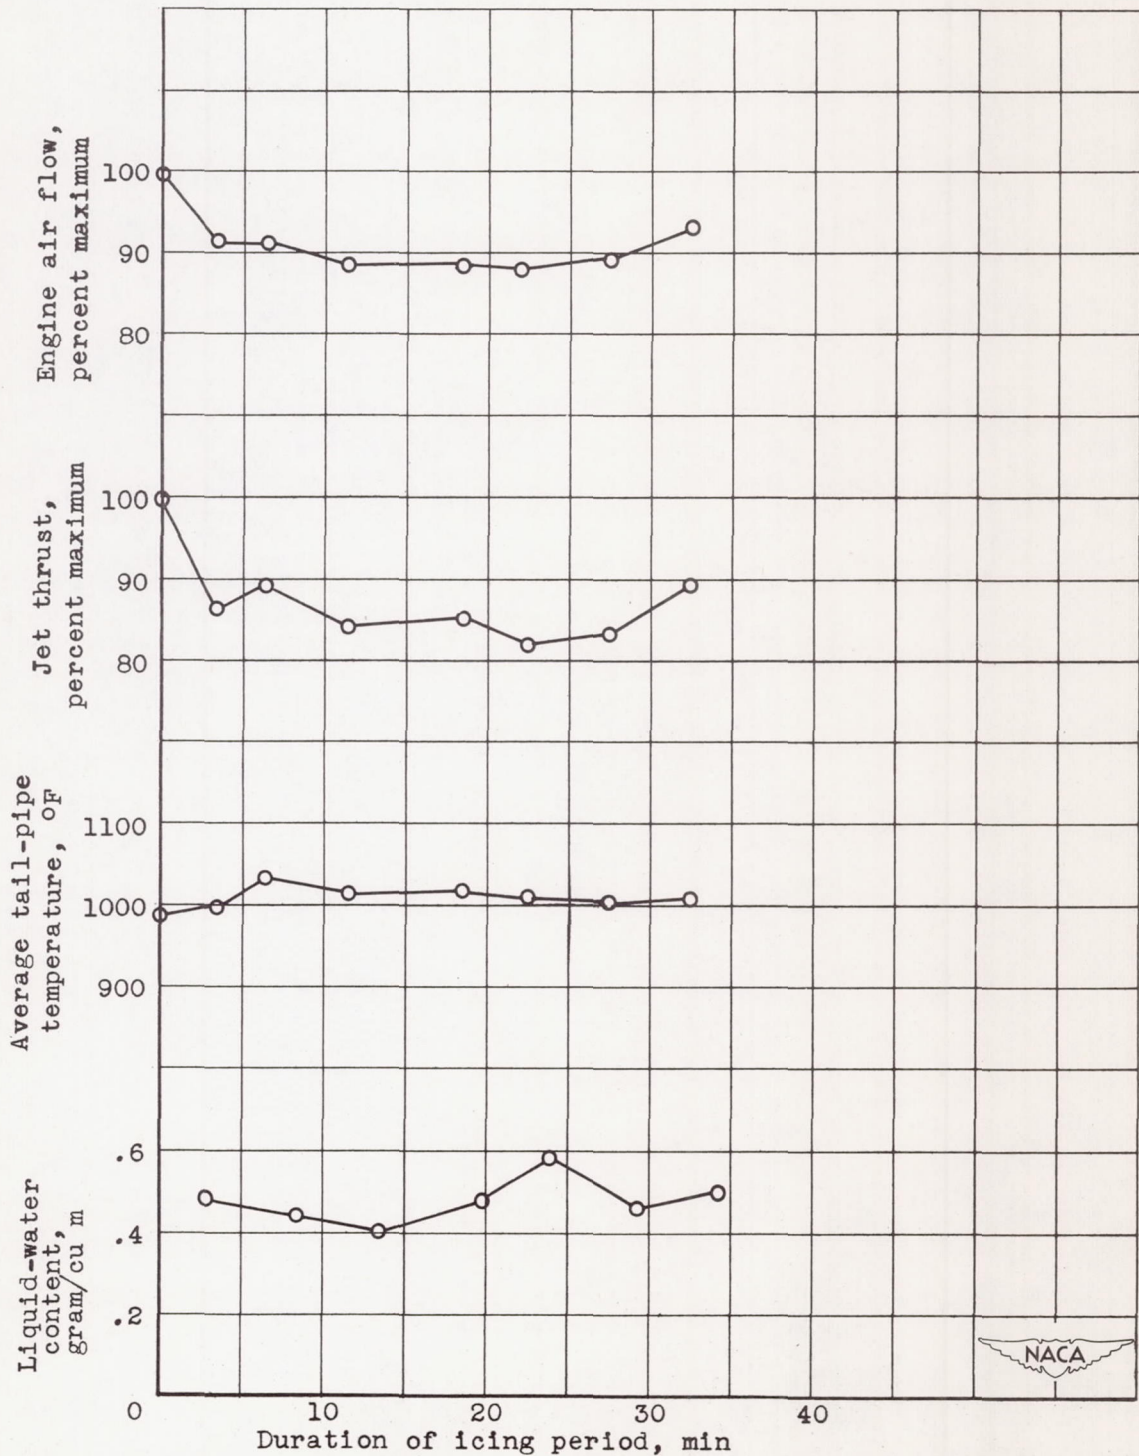
In flight 4, the turbojet engine was operated at rated speed for 35 minutes in an icing condition in which the liquid-water content varied from 0.4 to 0.6 gram per cubic meter, with water-droplet sizes of 11 to 16 microns and an ambient-air temperature of about 25° F. After 22 minutes of operation in this icing condition, the engine thrust was reduced approximately 18 percent, the air flow was decreased by 12 percent, and the tail-pipe temperature was increased 20° F (fig. 11). Within $3\frac{1}{2}$ minutes after entering the icing condition, the engine thrust was reduced 14 percent and the rate of air flow was reduced 9 percent. This rapid rate of reduction in engine performance during the first few minutes of exposure to the icing clouds was attributed to the fact that during this initial period no shedding occurred as in flight 2, which caused a steady growth of the ice formation. Following the initial $3\frac{1}{2}$ -minute period, the process of shedding and rebuilding began and effectively reduced the rate of growth of the ice. The rate of deterioration of engine performance was consequently reduced.

Figure 11. - Time history of flight data obtained in icing condition during flight 4 at rated engine speed. Ambient-air temperature, 25° F; droplet size, 12 to 16 microns; indicated airspeed, 165 to 180 miles per hour; pressure altitude, 2800 to 5000 feet.

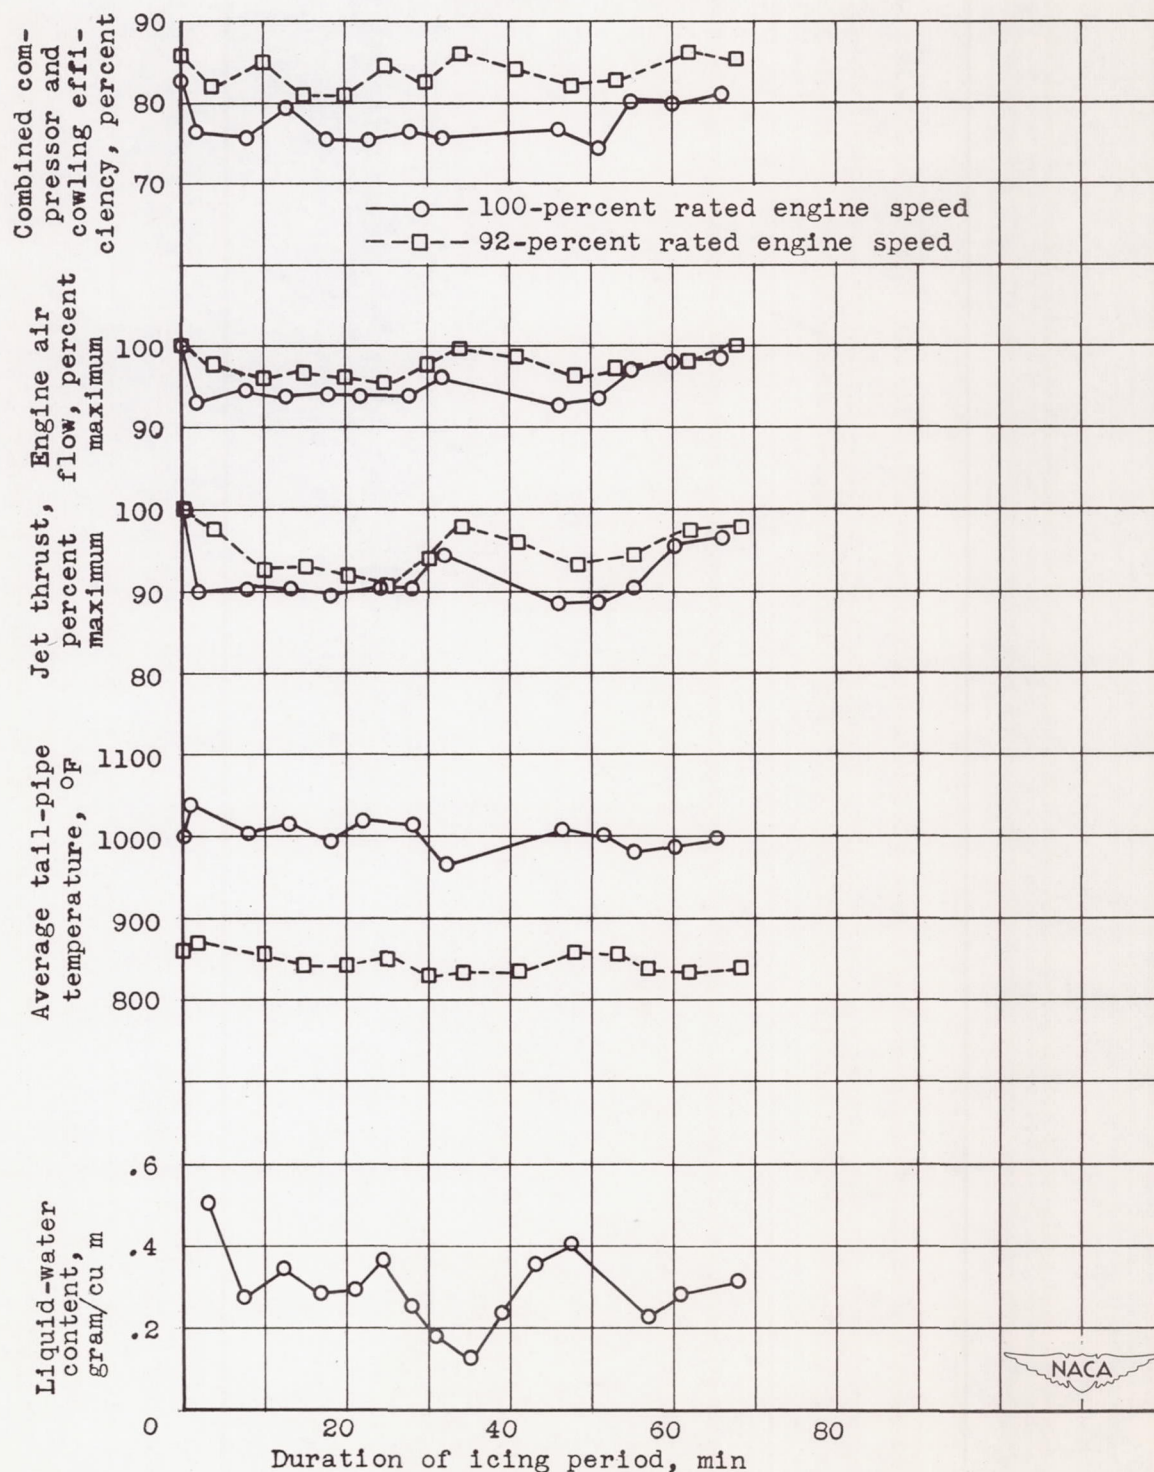
Figure 13. - Time history of flight data obtained in icing condition during flight 5. Ambient-air temperature, 20° to 24° F; droplet size, 10 to 18 microns; indicated airspeed, 175 to 180 miles per hour; pressure altitude, 4200 to 4500 feet.
