NACA RM E9G13

CYCLIC ENGINE OPERATION OF CAST VITALLIUM TURBINE BLADES
AT AN EXHAUST-CONE GAS TEMPERATURE OF $1440 \pm 20^{\circ}$ F

By Charles Yaker and Floyd B. Garrett

Lewis Flight Propulsion Laboratory
Cleveland, Ohio

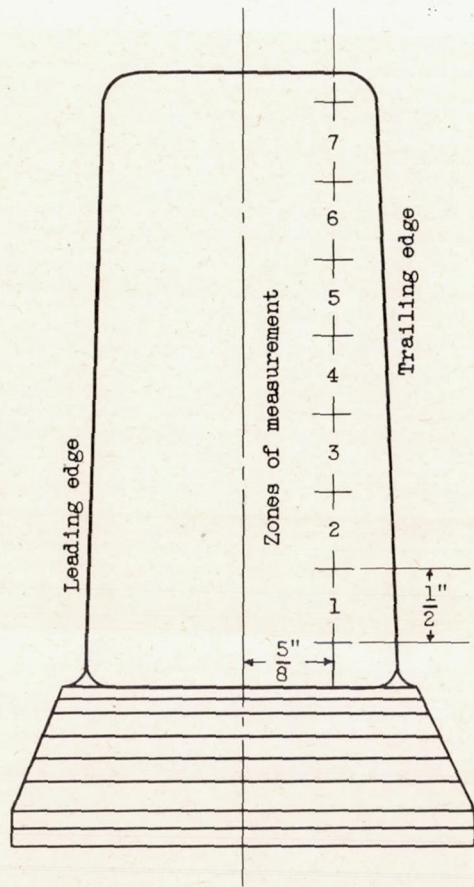
A determination of the amount of elongation in turbine blades is of importance in correlating performance in the engine with existing design data. In order to determine the amount of blade elongation, five blades were scribed, as shown in figure 1(a), and measurements made between these marks. This number of blades, which were spaced at random in the rotor, was selected to give a representative sample of the entire turbine rotor. The gage marks were scribed near the trailing edge of the blades to allow measurement without removing the turbine rotor from the engine. The measurements were made by means of an optical extensometer reading to ± 0.005 inch. In order to determine the amount of turbine-wheel elongation, scribe marks were placed at 1/2-inch intervals along two diameters at right angles to each other on the exhaust side of the rotor.

(a) Scribe marks on convex side of turbine blade for use in measuring elongation.

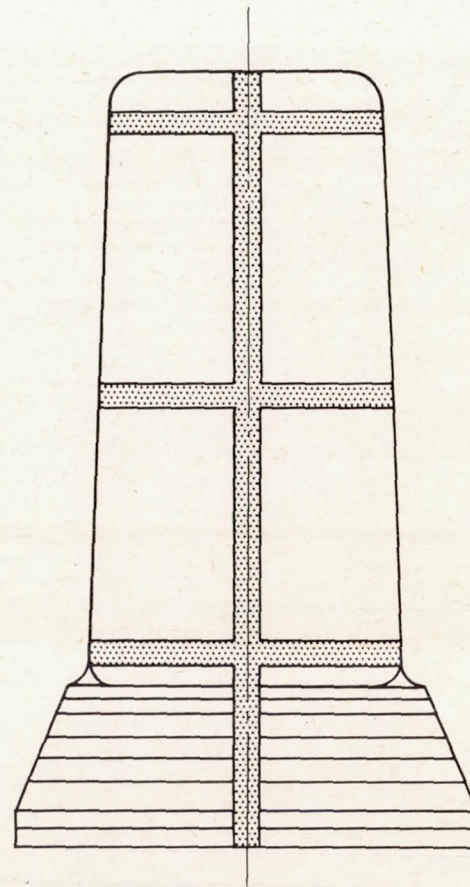
Hardness surveys. - Hardness measurements were made on a hardness tester of the indentation type, using a major and a minor load applied by a loaded lever system. The load of 150 kilograms was applied to a spheroconical indenter (Rockwell C). The hardnesses of all the broken blades and the five scribed blades were determined from base to tip along the center and from the leading to trailing edge at the base, the middle, and the tip of the airfoil section. The zones of the hardness surveys are shown in figure 1(b).

(b) Zones of blade (shaded areas) where Rockwell C hardness measurements were made.

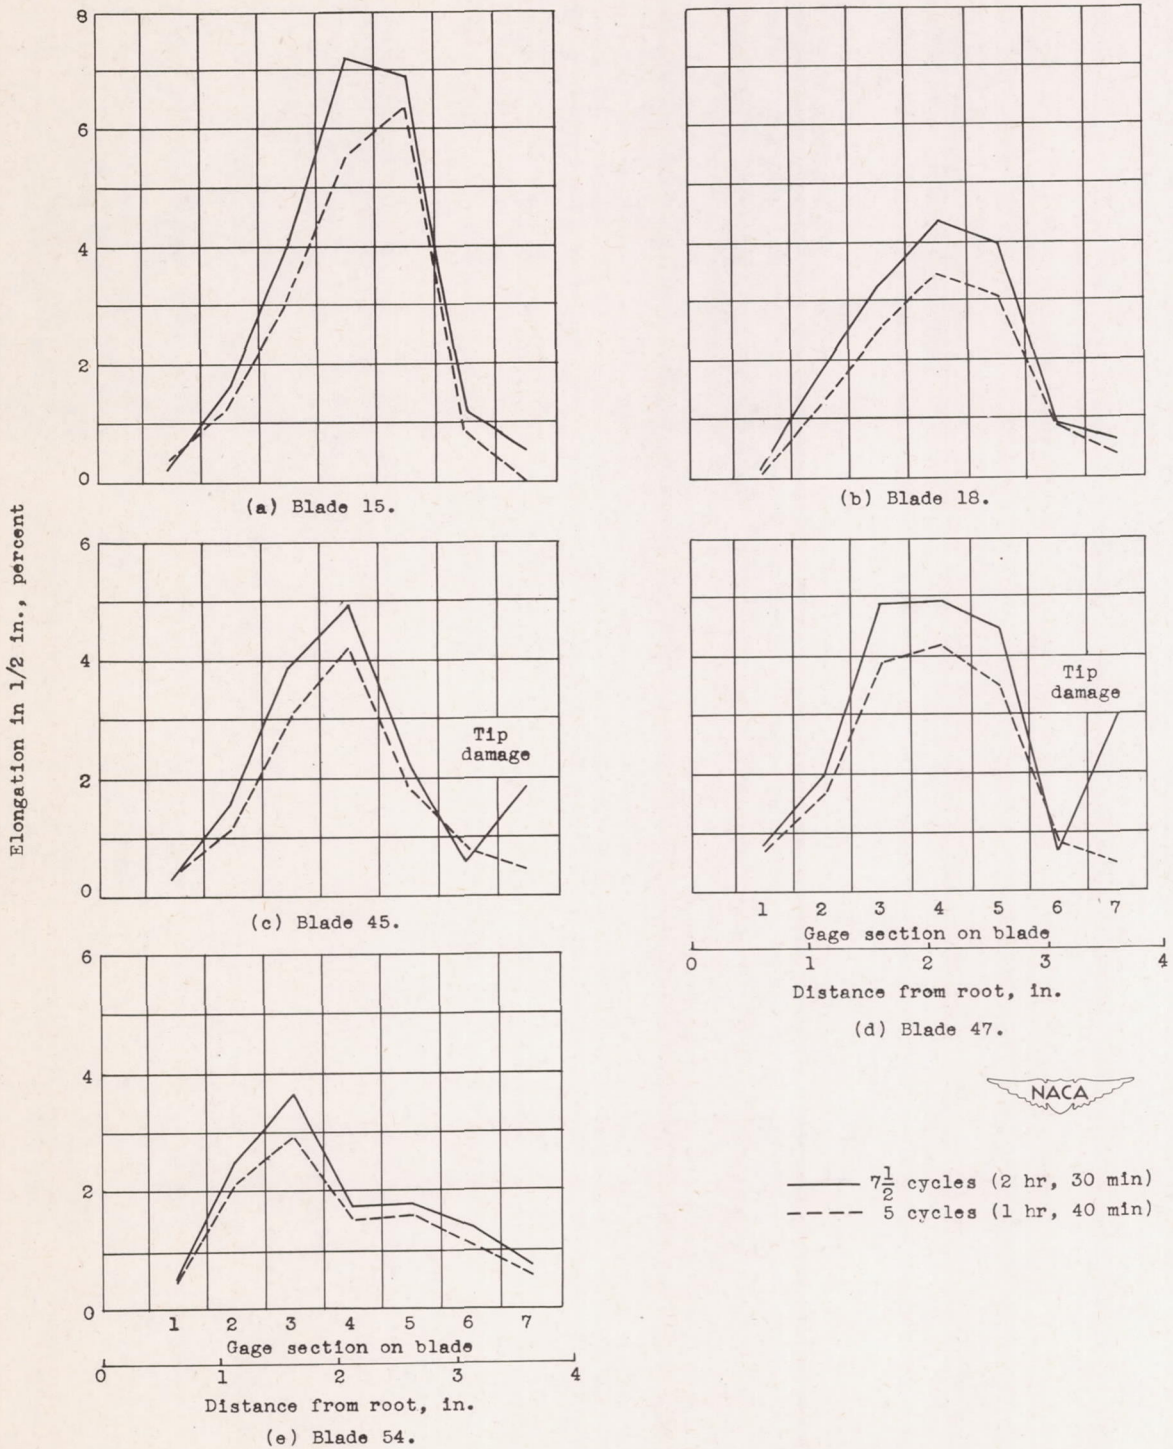
Final elongation measurements were made and plotted with the measurements made at the end of the first 5 cycles (1 hr, 40 min) as percentage elongation in each $1/2$ -inch-gage length, as shown in figure 5. Total blade elongations were determined and are presented in table II. The over-all blade elongations after $7\frac{1}{2}$ cycles range from 1.50 to 2.71 percent. From the elongation distributions, it can be seen that the largest portion of the blade elongation (2.37 to 6.04 percent) occurs in the section $1\frac{3}{8}$ to $2\frac{7}{8}$ inches from the top of the blade root. A comparison of the elongation in this section with the total elongation is also presented in table II. This comparison indicates that approximately 60 to 84 percent of the total blade elongation occurs in this zone.

Figure 5.- Variation in elongation along airfoil section of blade plotted at midpoint of gage section.

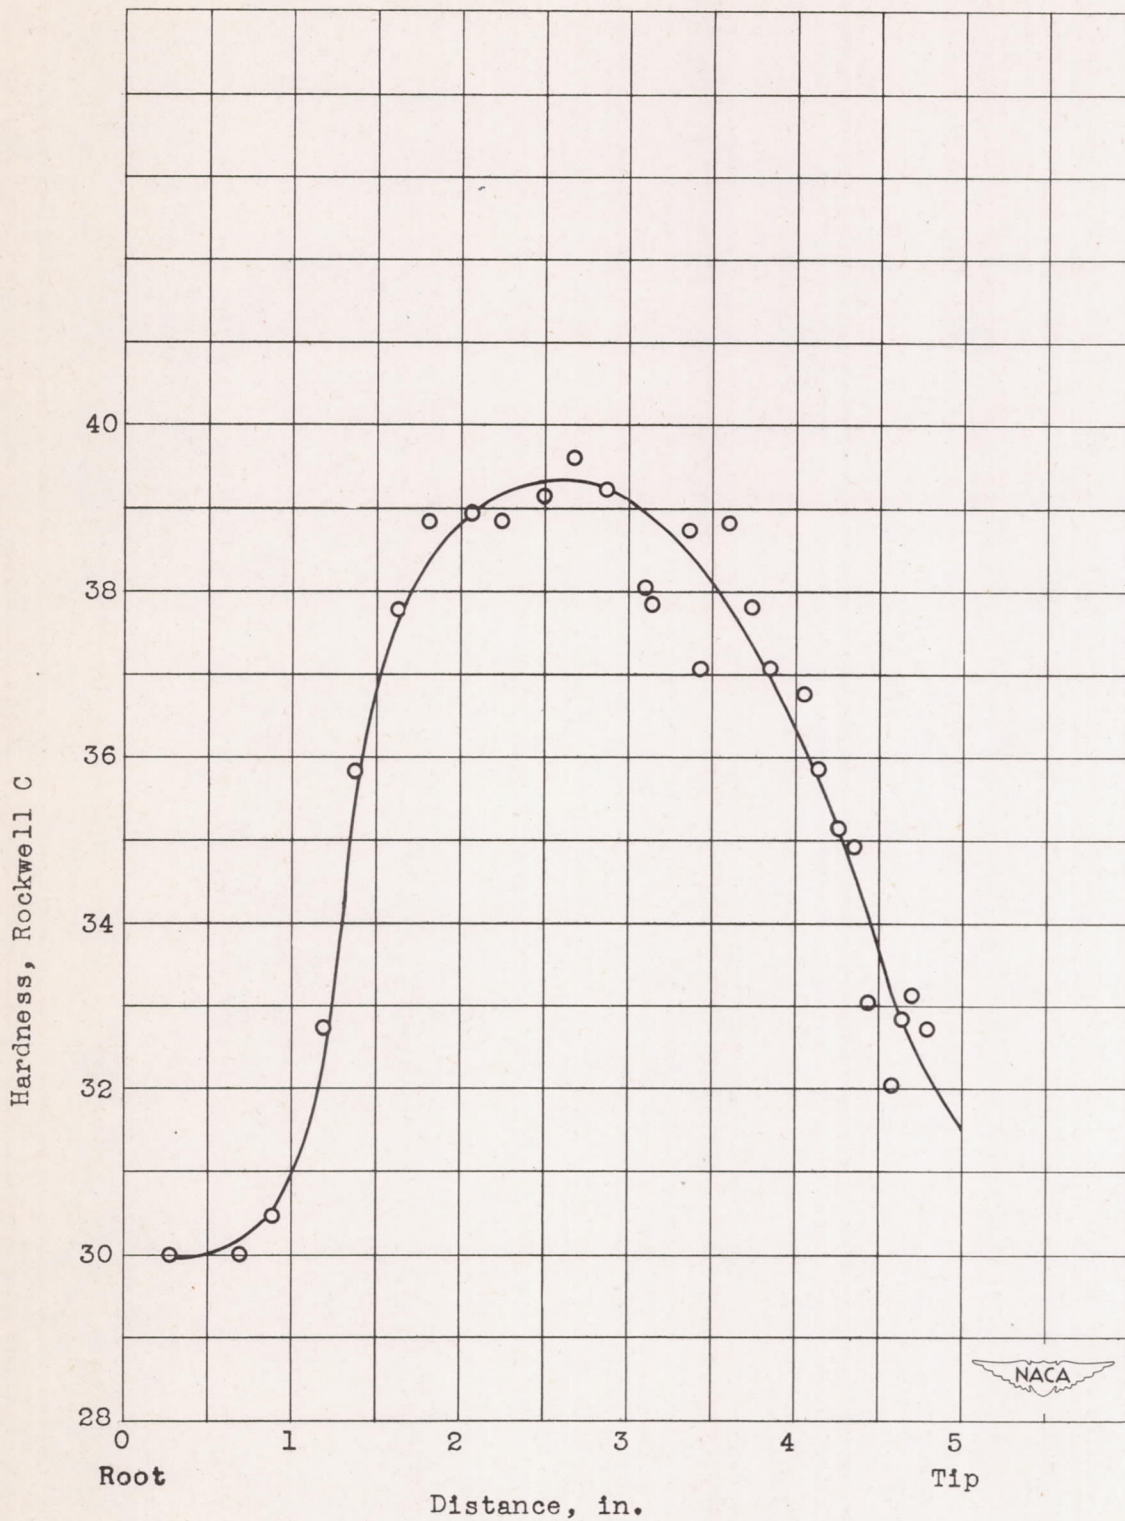
Hardness surveys. The hardness distributions throughout the broken, cracked, and the five unbroken and scribed blades are given in table IV. A typical spanwise hardness distribution along the center of a blade is shown in figure 7. All Rockwell C hardness values

The results of the hardness surveys yielded no correlation between blade failure or elongation and hardness. The hardness variation along the blades (fig. 7) is an indication of the combined effects of stress and temperature distribution in strain and age-hardening the blades during operation.

Figure 7. - Typical hardness distribution along center of blade. (Data points are average hardness values.)

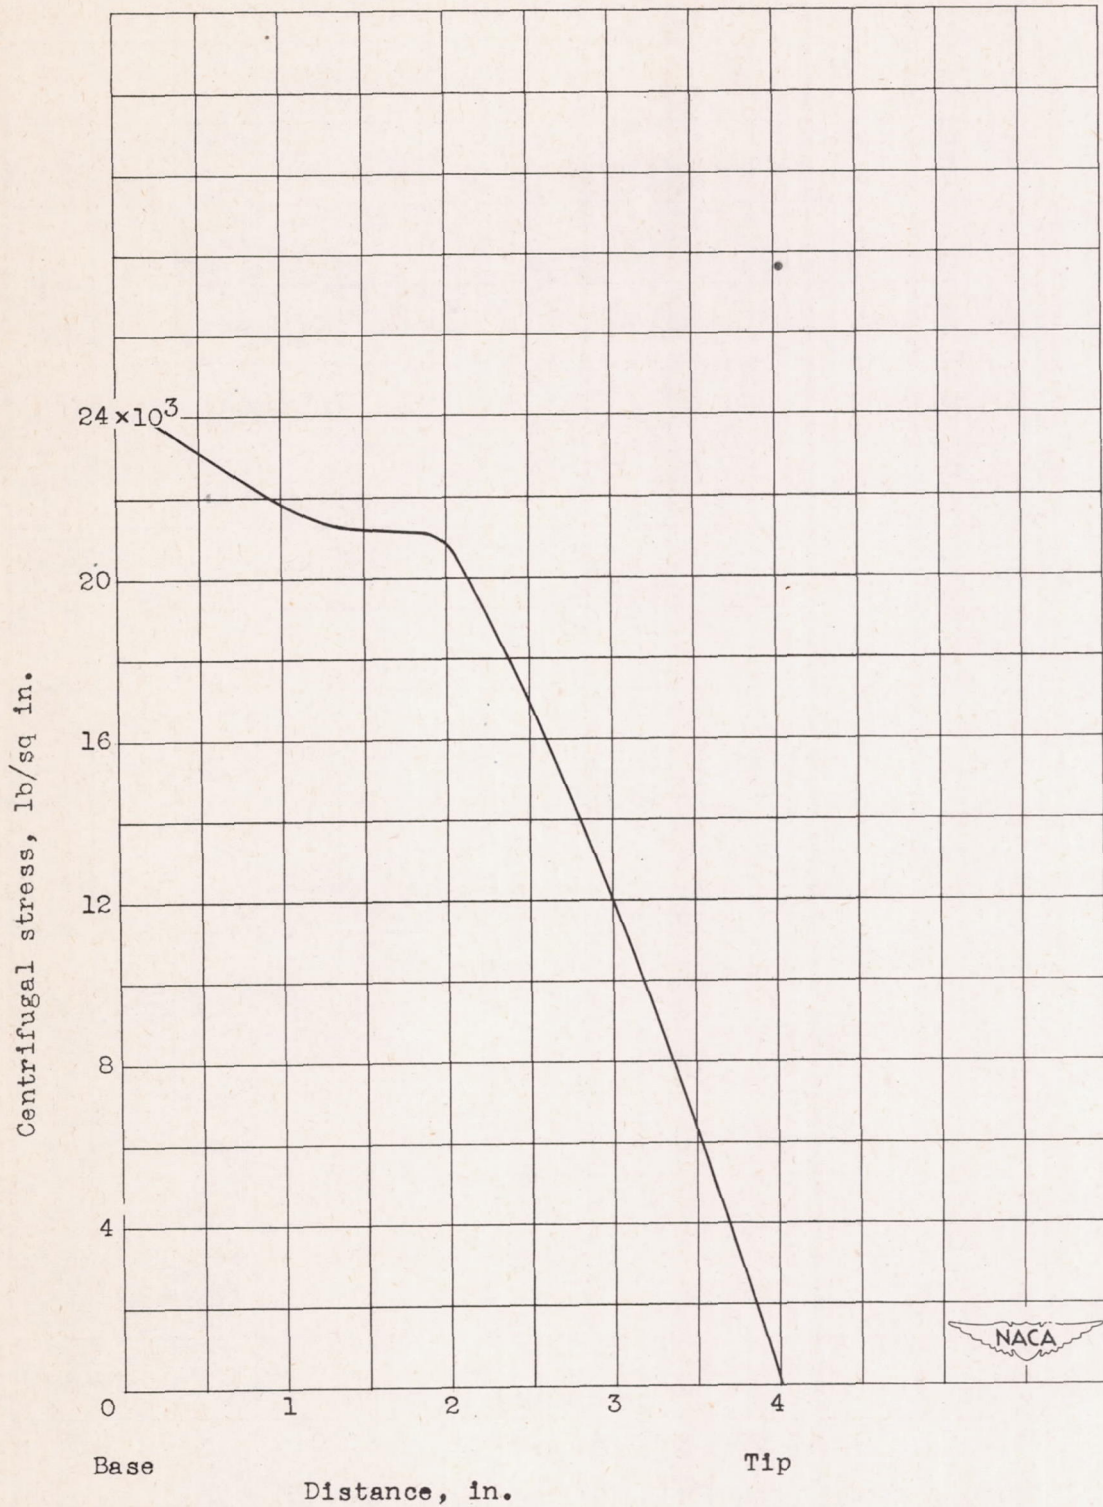
The centrifugal stress distribution in cast Vitallium blades at a turbine speed of 11,500 rpm is shown in figure 13. The maximum temperature of the blades of this investigation can be approximated on the basis of previous temperature surveys at low gas temperatures. By the extension of the curve of maximum blade temperature plotted against average gas temperature at the exhaust-cone outlet (fig. 14), the approximate maximum blade temperature was 1600° F during this evaluation at an average exhaust-cone-outlet temperature of 1440° F. The conditions of engine operation therefore resulted in a stress of about 21,000 pounds per square inch at the midsection of the airfoil section of the blade (fig. 13) and a maximum blade temperature of approximately 1600° F.

Figure 13. - Variation in centrifugal stress in cast Vitallium turbine blade. Turbine speed, 11,500 rpm; radius of turbine rotor, 8.99 inches. (Data obtained from fig. 6 of reference 2.)

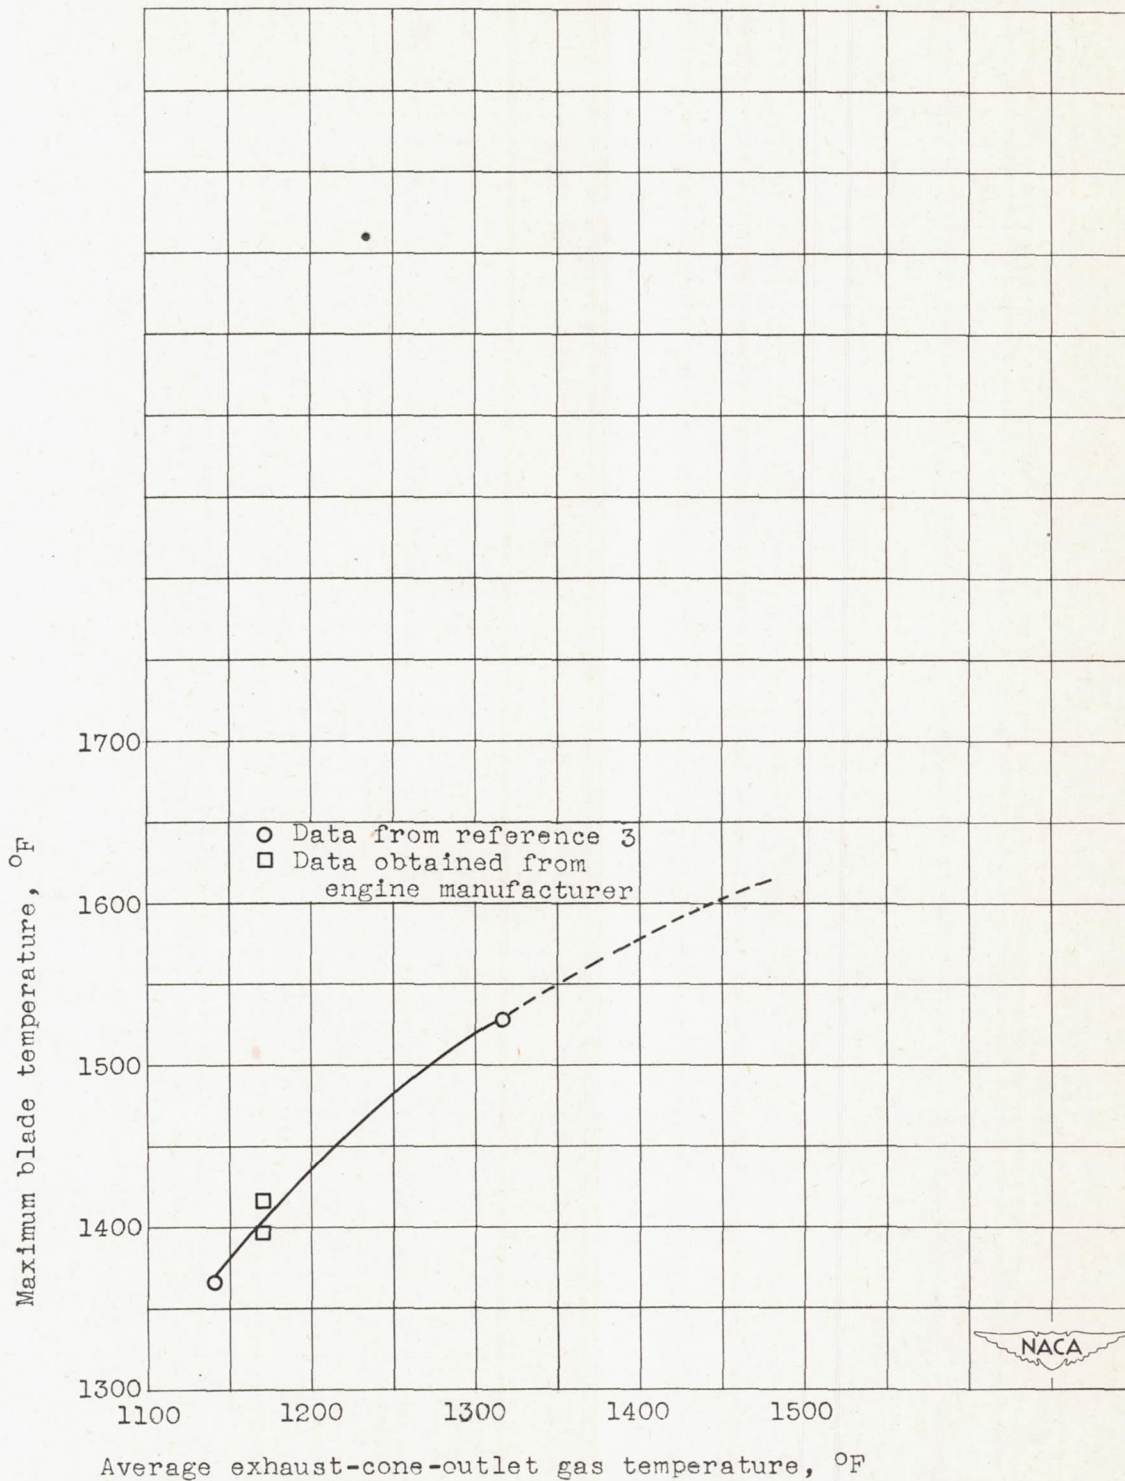
Figure 14. - Variation of maximum blade temperature with average exhaust-cone-outlet gas temperature.
