RESEARCH MEMORANDUM

OPERATING TEMPERATURES OF I-40-5 TURBOJET ENGINE
BURNER LINERS AND THE EFFECT OF TEMPERATURE
VARIATION ON BURNER-LINER SERVICE LIFE

By H. D. Wilsted, Robert T. Duffy
and Ralph E. Grey

Flight Propulsion Research Laboratory
Cleveland, Ohio

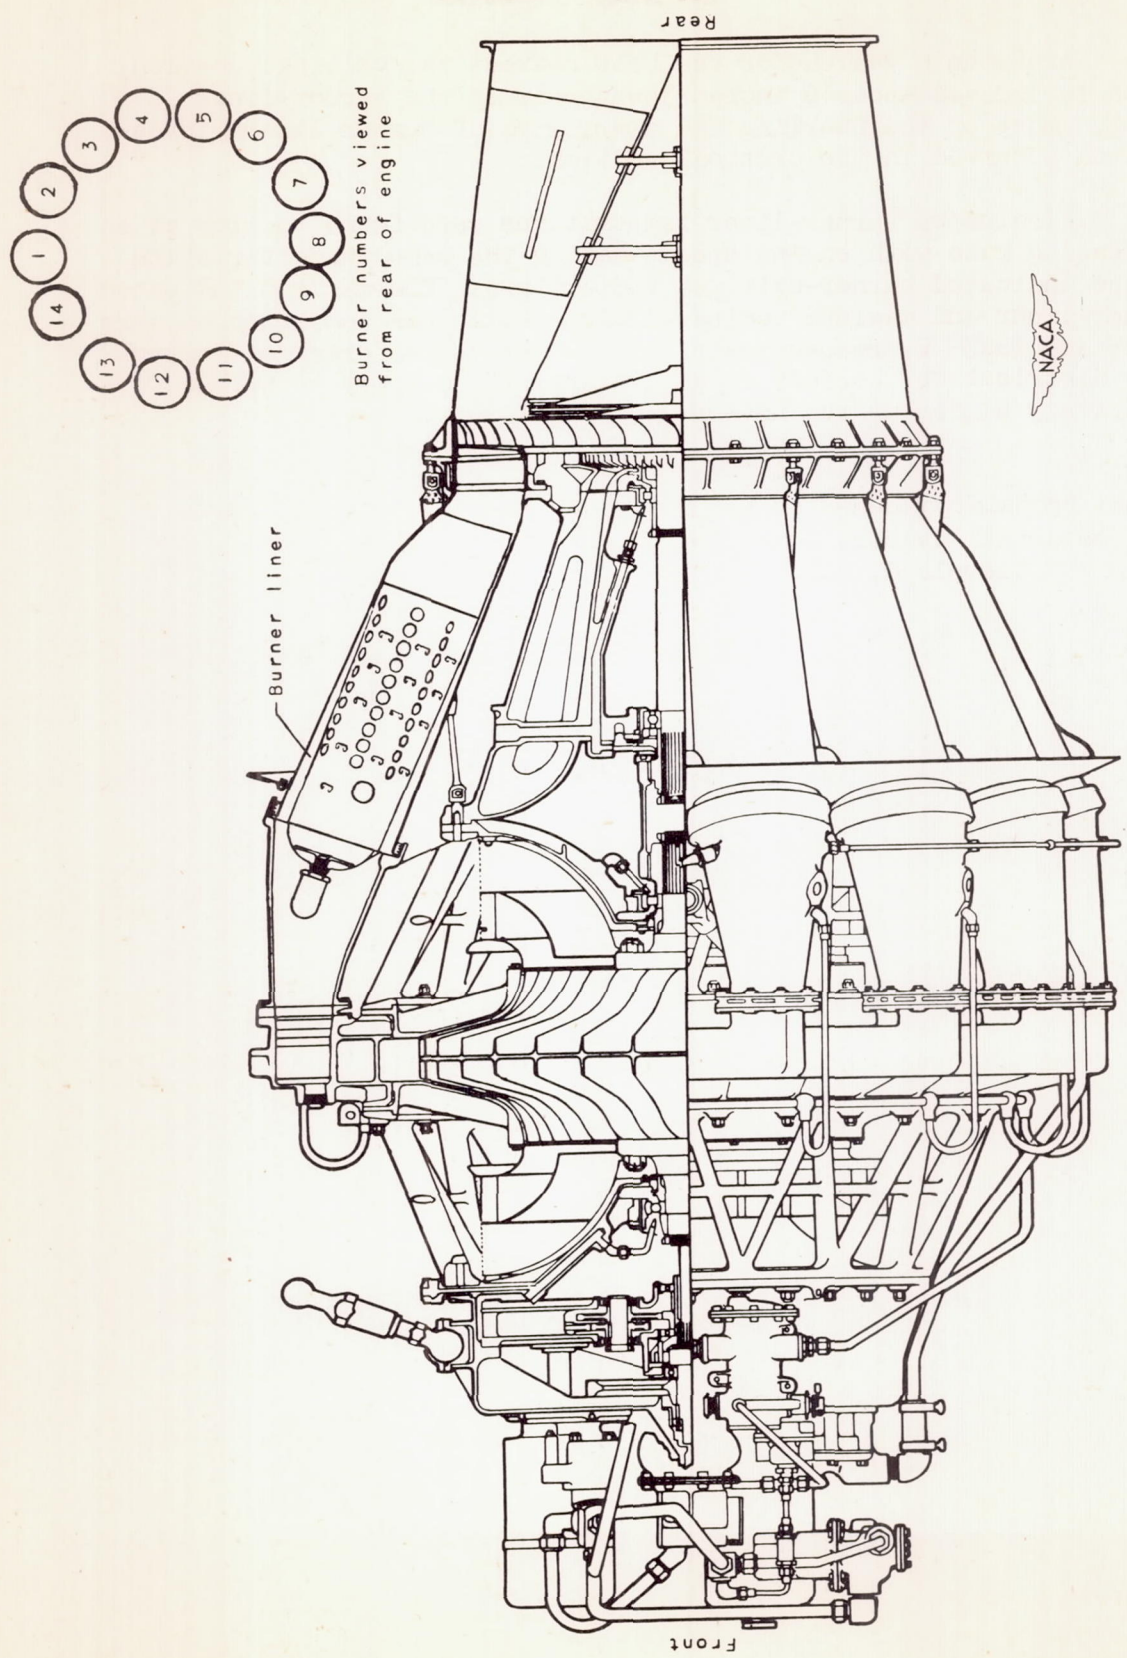
Figure 1. - The 1-40 turbojet engine showing typical burner-liner installation.

The I-40-5 turbojet engine used in this investigation was equipped with a 19-inch-diameter jet nozzle. A sketch of an I-40 engine showing a burner-liner installation is presented in figure 1 and a photograph of a burner liner before thermocouples were attached for testing is shown in figure 2. The liner material for the two liners investigated was 0.031-inch Inconel sheet. Each liner was investigated separately in burner 12. (See fig. 1.)

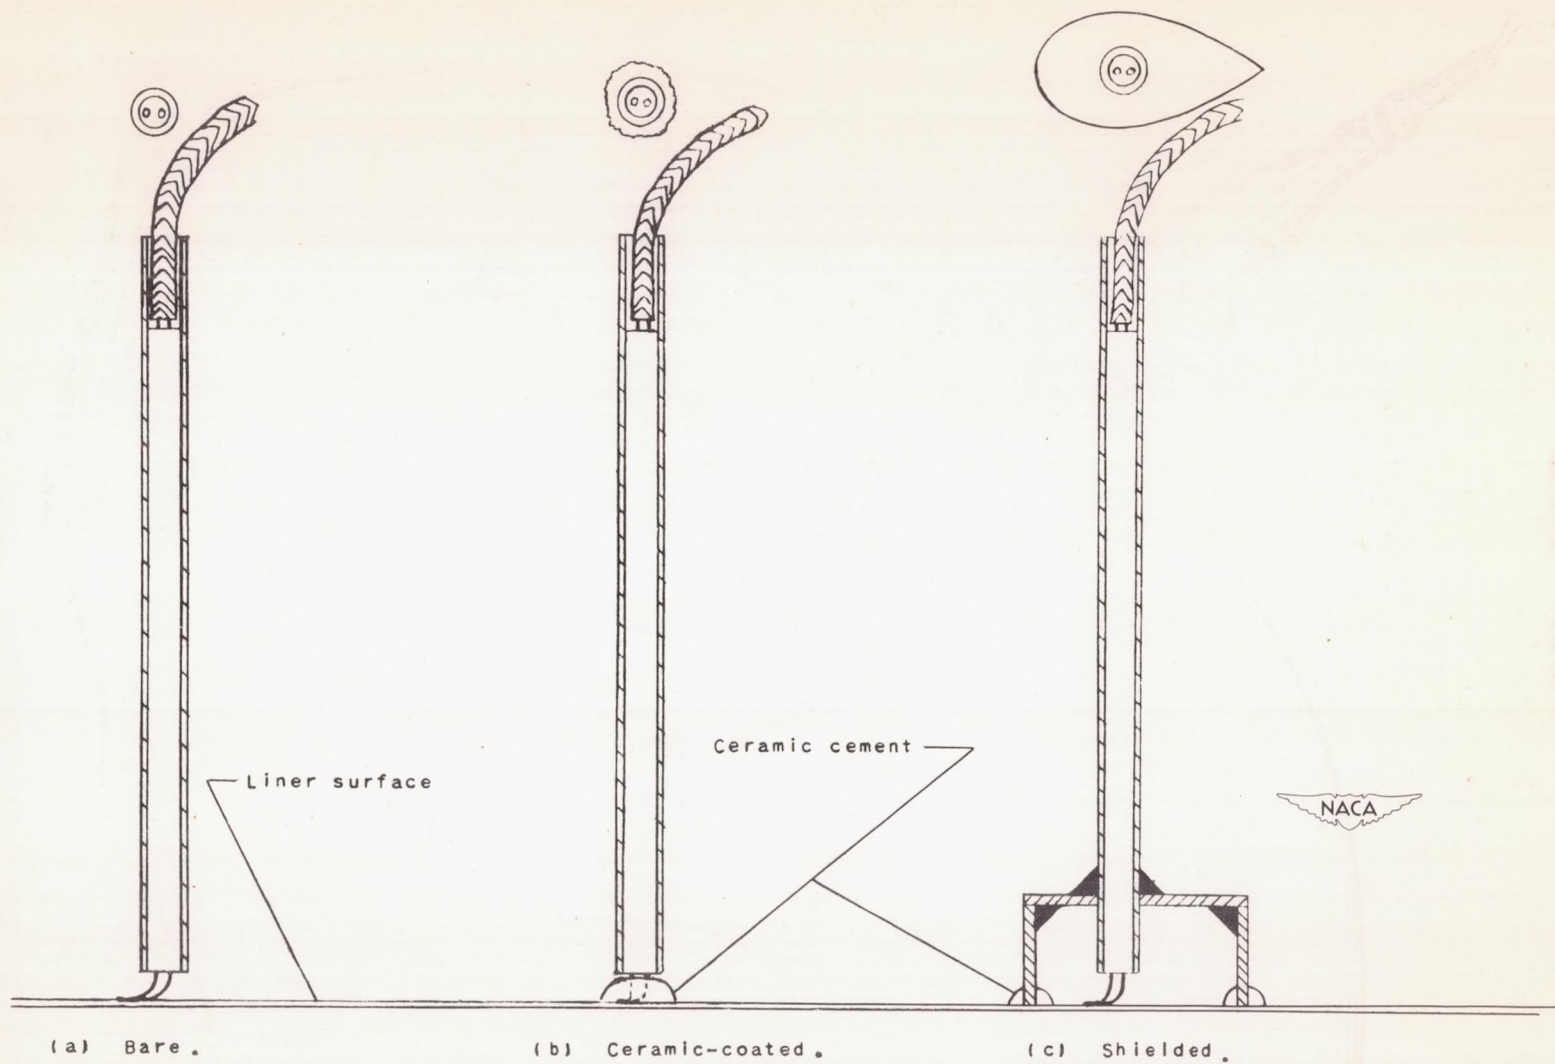
All burner-liner temperatures were measured by chromel-alumel thermocouples spot-welded to the burner liners and coated with ceramic cement, as shown in figure 3(b). The test runs were made using a different thermocouple arrangement on each of the two burner liners. The bayonet-type thermocouple used to indicate burner-exit gas temperatures is shown in figure 4. A chronometric tachometer was used to measure engine speed.

Tests were run with three different methods of mounting thermocouples on the burner liner to determine the effect of the comparatively cool combustion air passing over the thermocouple: bare, ceramic-coated, and shielded (fig. 3). The data presented in figure 5 show that the ceramic-coated thermocouple is least affected, the bare thermocouple only slightly more affected, and the shielded thermocouple most affected by the cool-air flow over the thermocouples. Apparently care must be taken to keep small the area of the liner covered by the ceramic in order that normal cooling of the burner liner adjacent to the thermocouple be maintained. At the time of application, the significance of the amount of ceramic

Figure 3. - Thermocouple installations used to determine most correct method of measuring burner-liner temperatures. Thermocouple wires spot-welded to liner.

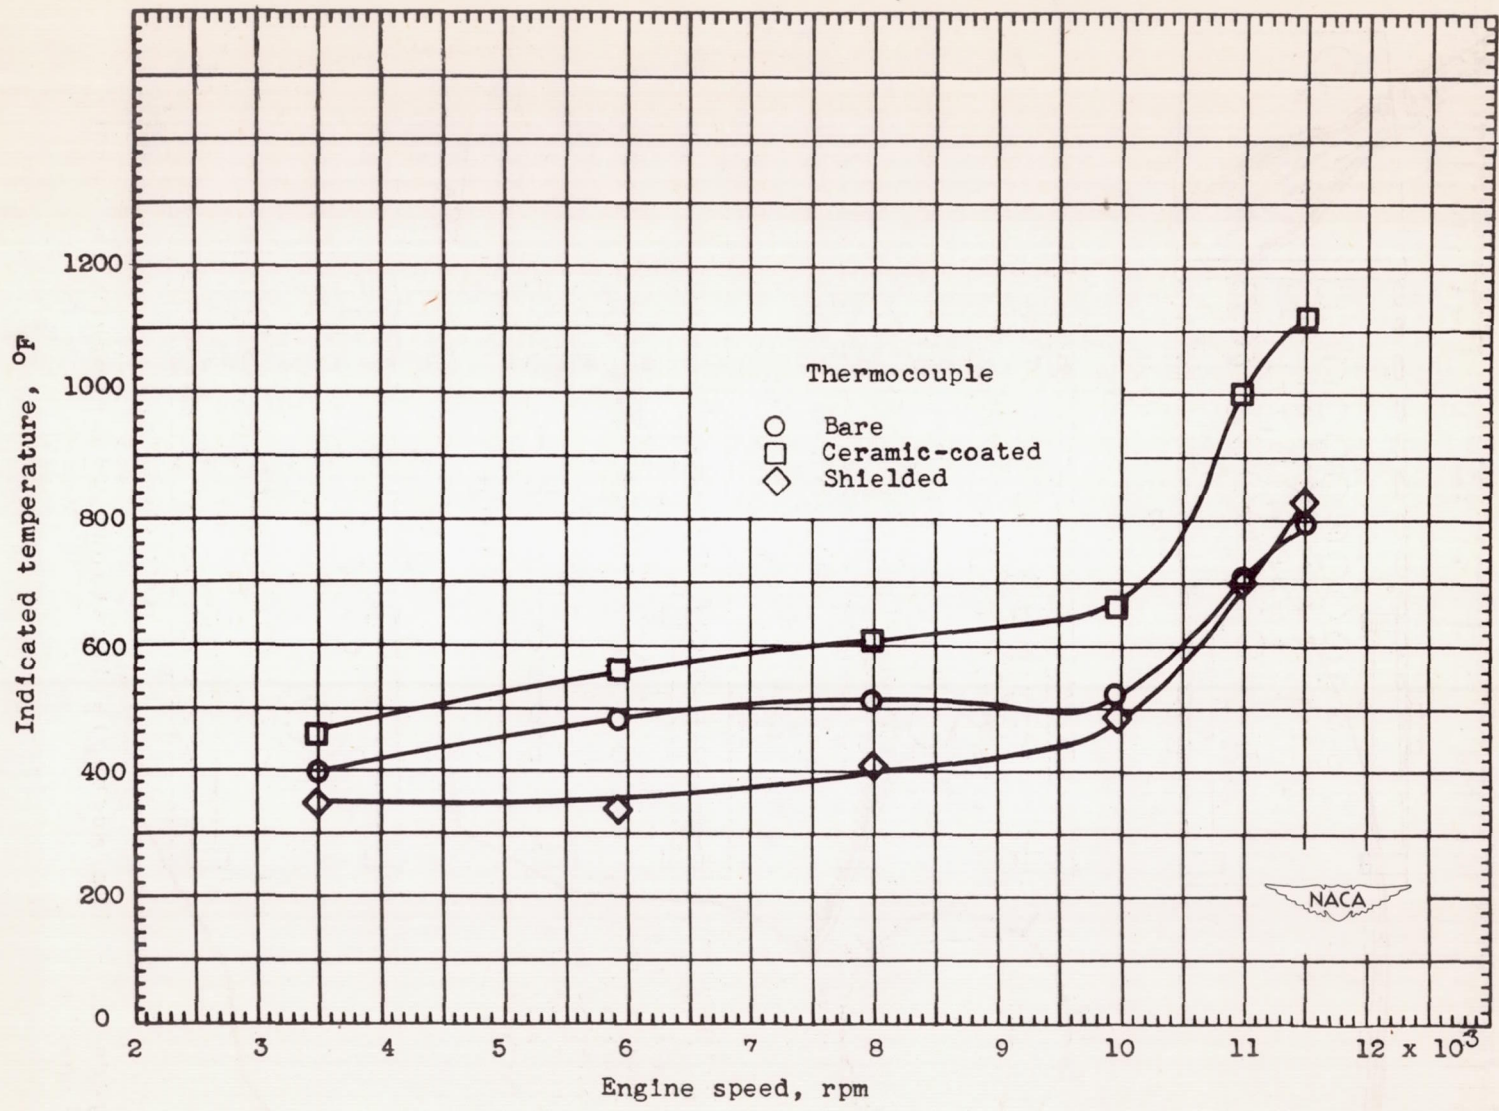
Figure 5 - Comparison of bare, ceramic-coated, and shielded thermocouple readings at various engine speeds.

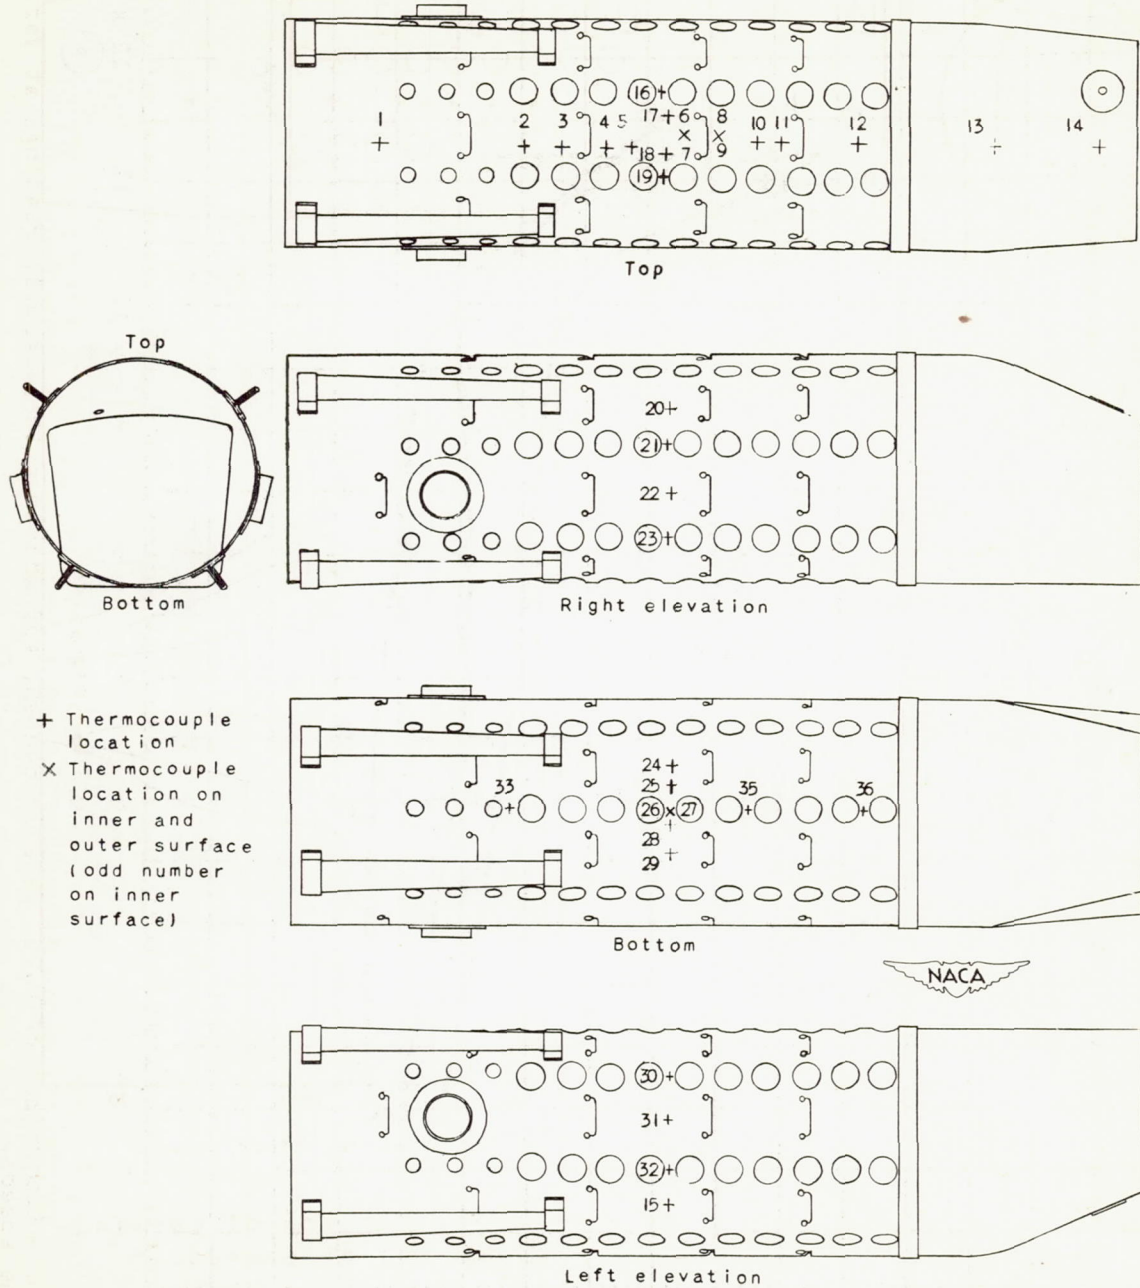
As a further check on the correctness of temperature measurement, ceramic-coated thermocouples were placed on the outer and inner surfaces of the burner liner at the same position, as indicated by thermocouples 6 and 7, 8 and 9, 26 and 27 (fig. 6). One thermocouple of each pair was then exposed to the hot combustion gases and the other to the cooler entering combustion air. The maximum variation was found to be 85° F between any pair of thermocouples. This variation is less than 7 percent or a probable error due to cooling of the outside ceramic-coated thermocouple leads of less than 3.5 percent.

The thermocouple locations on the first burner liner investigated (designated liner A) are shown in figure 6. The results of the investigations of liner A over a complete range of engine speed are shown in figures 7, 8, and 9. Figure 7 shows the temperature variation along the top row of cooling louvers. At maximum engine speed a variation of the order of 600° F in a length of 3 inches is shown. The maximum indicated temperature along the row of louvers is of the order of 1300° F.

Figure 6. - Thermocouple locations and numbers on burner liner A.

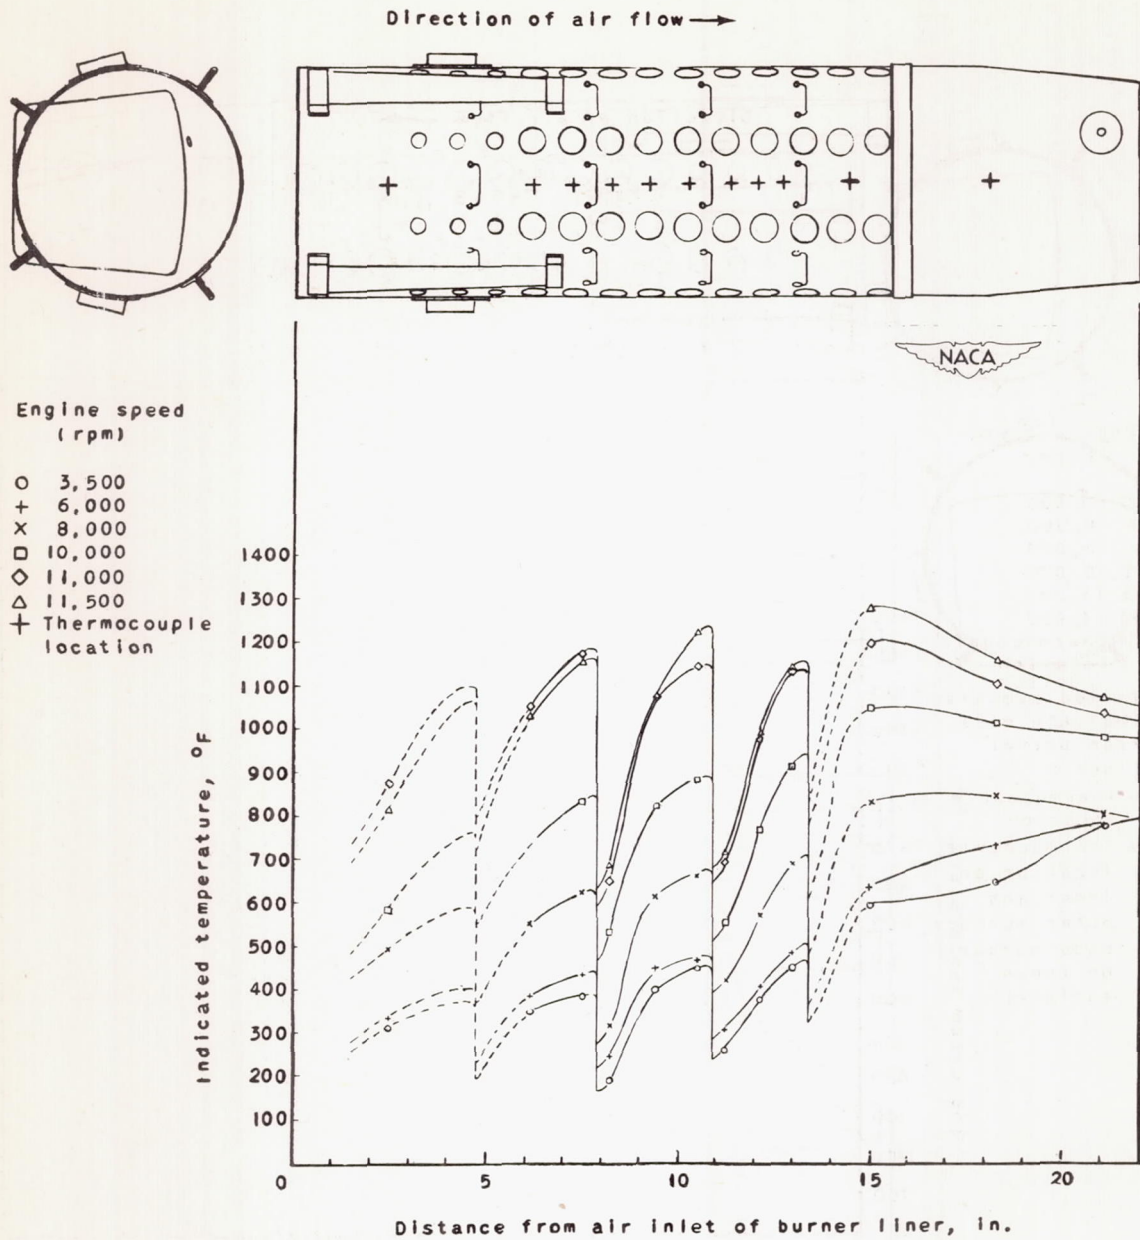
Figure 7. - Temperature variation along top row of cooling louvers on burner liner A at various engine speeds.

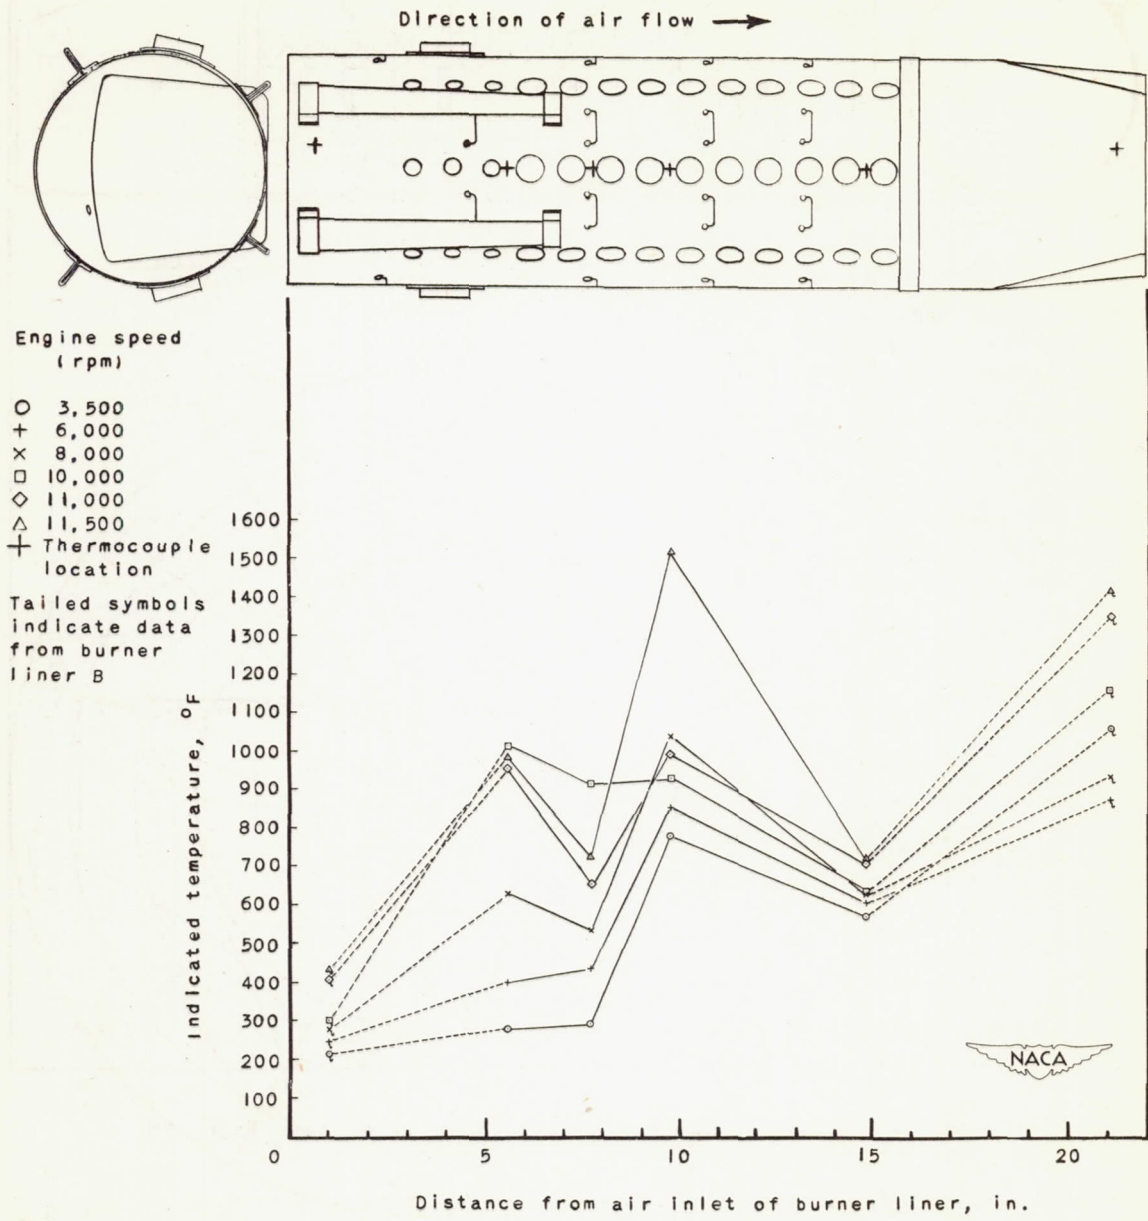
The temperature variation along the center line of a section containing air-intake holes is shown in figure 8. This section is on the bottom of the liner, as shown in figure 6. With one exception, the maximum indicated temperature was only of the order of 1000° F if the noncritical liner-exit section is not considered. As can be seen from figure 9, these values are probably peculiar to the particular sections and no general conclusions comparing the louver and air-intake sections can be drawn. The wide circumferential temperature variations shown in figure 9 indicate no definite trend. An irregularity exists, however, in the pattern with the highest temperature region located at the lowest portion of the burner liner as installed in burner 12.

Figure 8. - Temperature variation along bottom row of air intake holes on burner liner A at various engine speeds.

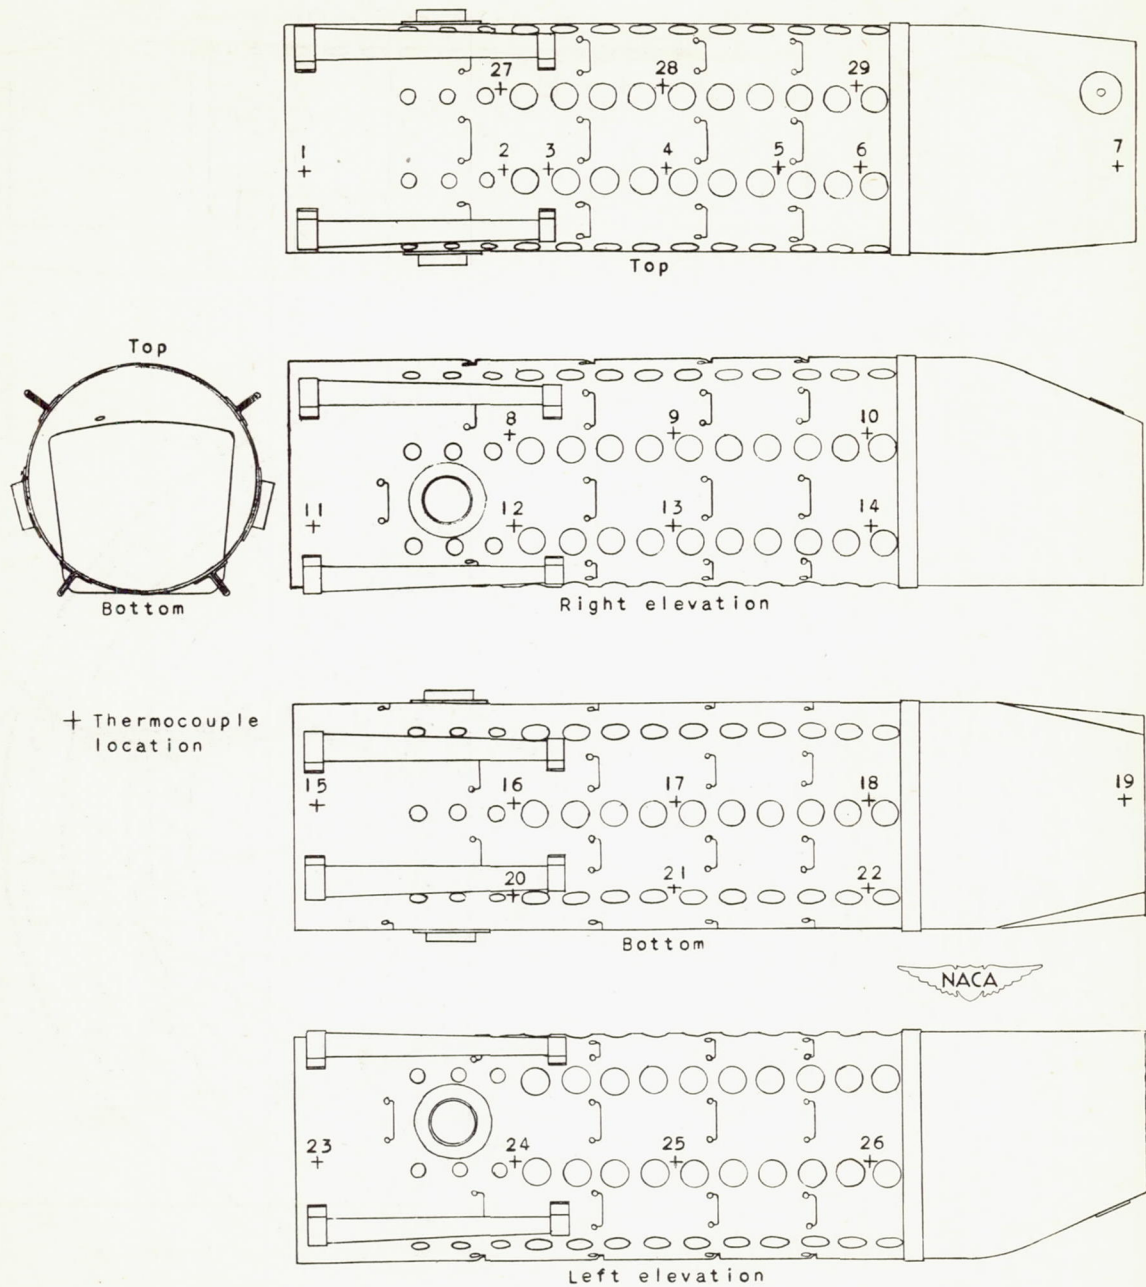
The thermocouple locations on burner liner B are shown in figure 10. In this case, it was felt that temperatures taken between the rows of holes and louvers would be more indicative of the effective liner temperature because less variation would result from cooling effects of the incoming air.

Figure 10. - Thermocouple locations and numbers on burner liner B.

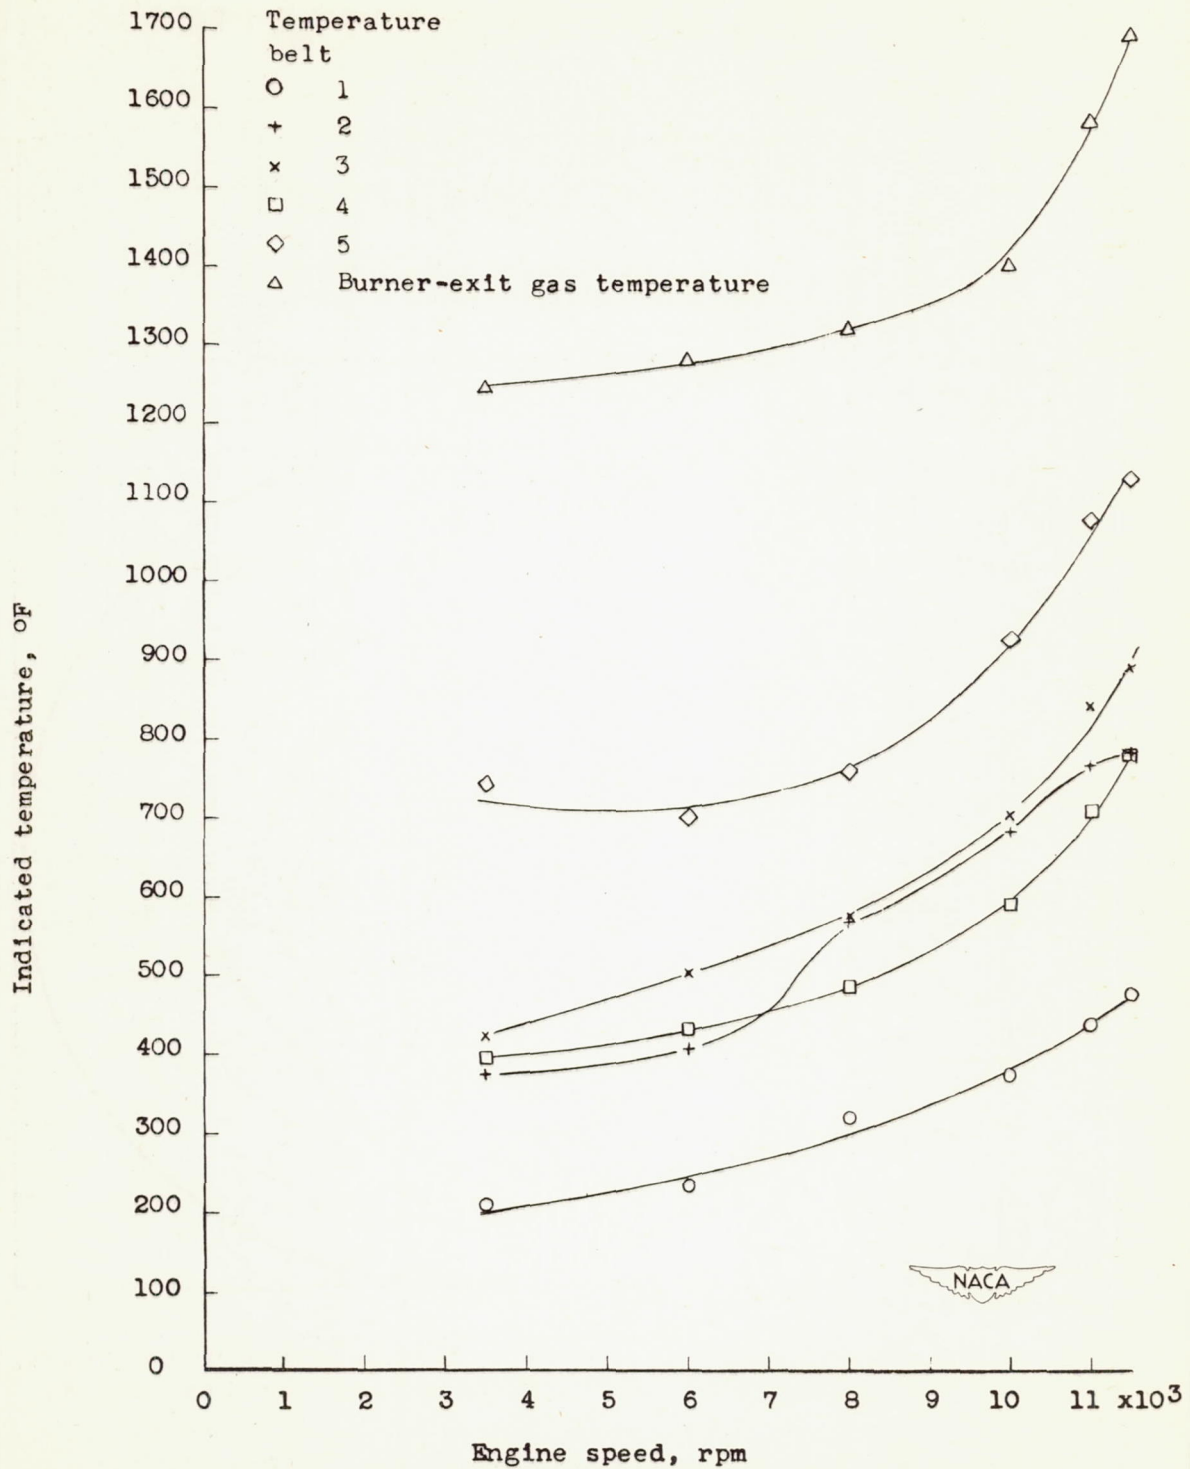
A replot of the data used in figure 11 is presented for each temperature belt in figure 12 to show the temperature variations with speed. The trend of rising burner-liner temperature with increasing speed or power in figure 12 is reasonably uniform. The irregularity of temperature belt 2 is attributed to the disturbance of the interconnector fittings on air flow. Also shown is the indicated burner-exit gas temperature, which reached a maximum of 1690° F at an engine speed of 11,500 rpm. In general, all the curves are reasonably smooth with temperatures rising at an increasing rate with engine speed.

Figure 12.- Temperature variation with engine speed of temperature belts on burner liner B. All points are average belt temperatures. (See fig. 11 for belt location.)
