NACA TN 4030

TECHNICAL NOTE 4030

EXPERIMENTAL INVESTIGATION OF CERMET TURBINE BLADES  
IN AN AXIAL-FLOW TURBOJET ENGINE

By William C. Morgan and George C. Deutsch

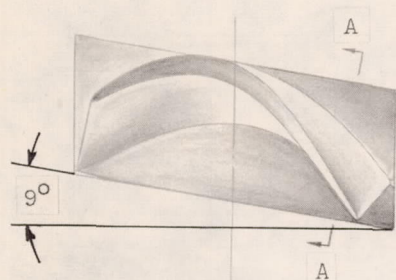
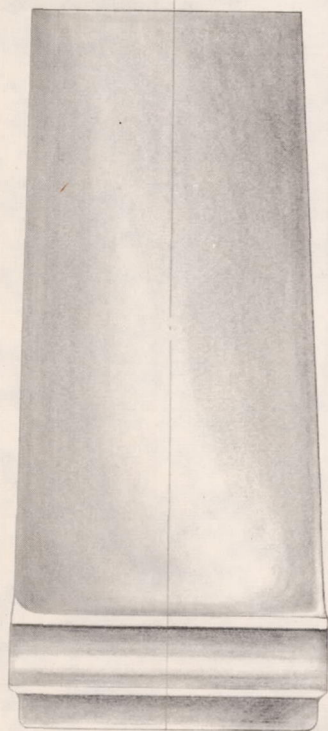
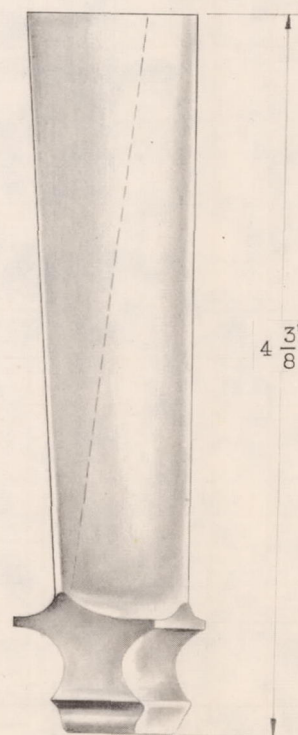
Figure 1. - Cermet turbine blade.

The root of the cermet blade (fig. 1) was skewed  $9^{\circ}$  relative to the turbine axis, as compared with  $2\frac{10}{2}$  used in the standard blades for this turbine. This change was made to reduce bending stresses in the root (ref. 5). The airfoil length was 0.030 inch shorter than standard for most of the tests (3 to 16, inclusive). This was done to eliminate possible rubbing between blade tips and turbine shroud, in the event of shroud deformation.

Modification used in some test  
operations ( $\frac{1}{4}$ " radii at blade tip)

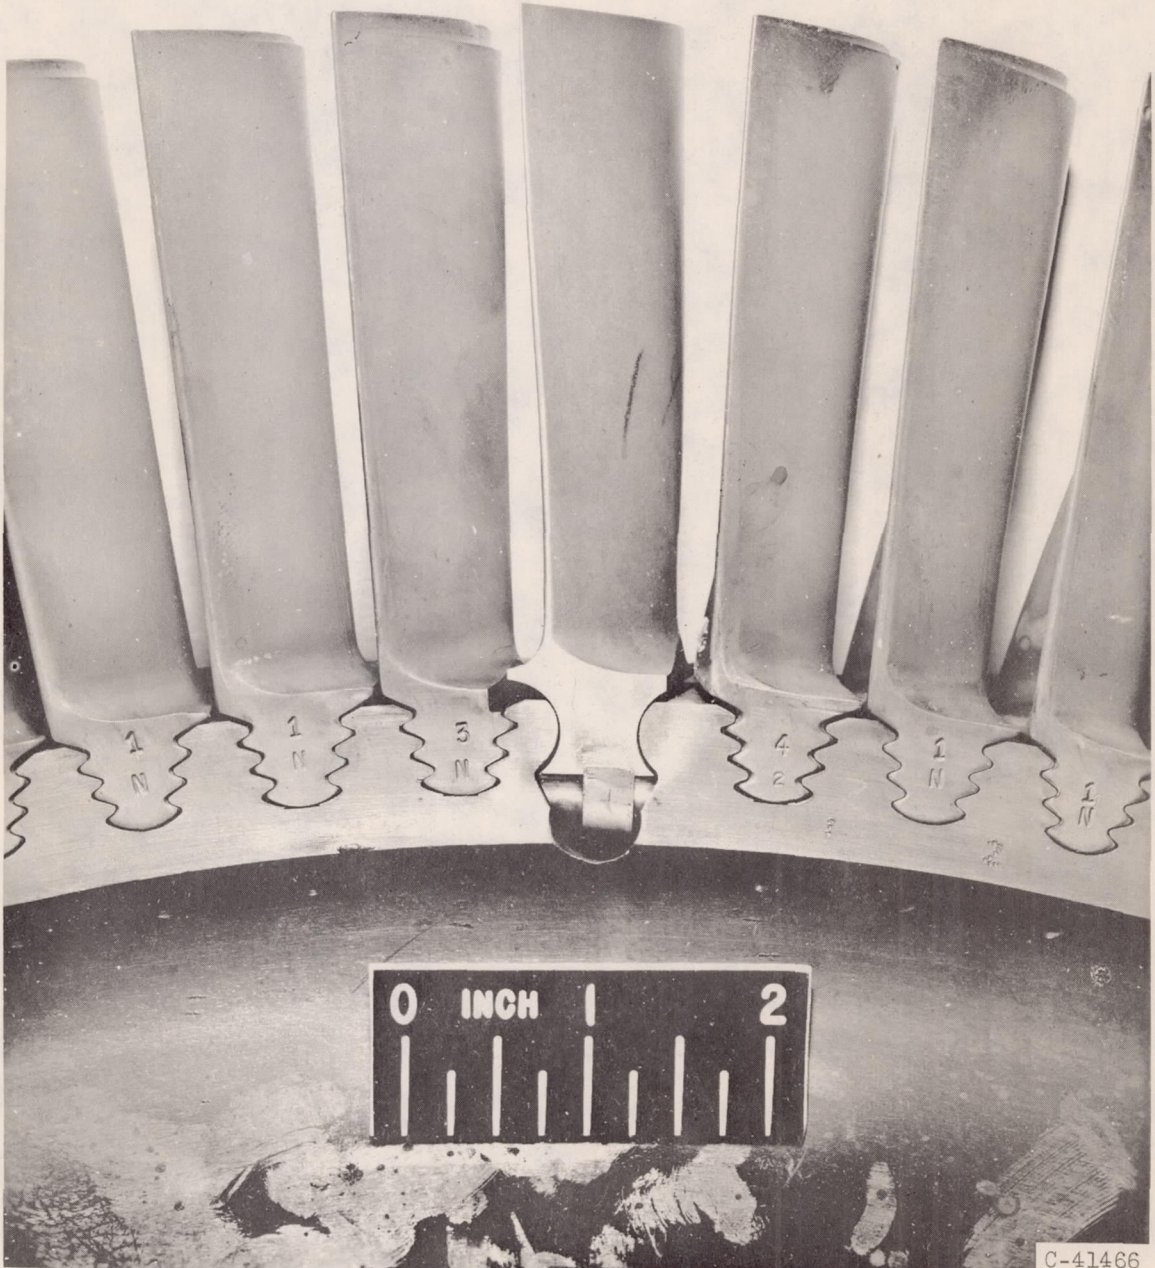
Figure 3. - Cermet turbine blade installed in standard spacing.

A third rotor used in this program was modified to provide for only two cermet test blades mounted diametrically opposite. The test blades were installed with the same spacing as the metal blades, as shown in figure 3. The purpose of this modification was to duplicate more closely the airflow conditions in a wheel with a full complement of cermet blades. An unfavorable rim-stress condition was introduced by the skewed root serration adjacent to the standard serration. However, additional cooling air was supplied to the rim, and the rim temperature was lowered to a safe level.

- (a) Elimination of excessive space between cermet and adjacent standard blade; installation in tests 15 and 16 of a single cermet blade in same relative position as standard metal blades, as shown in figure 3
- (b) Use of phased nozzle assembly to damp out excitation from the 64<sup>th</sup> order of turbine speed
- (c) Use of 57-vane nozzle assembly to bring excitation forces below the resonant frequency of a majority of blade complex vibration modes

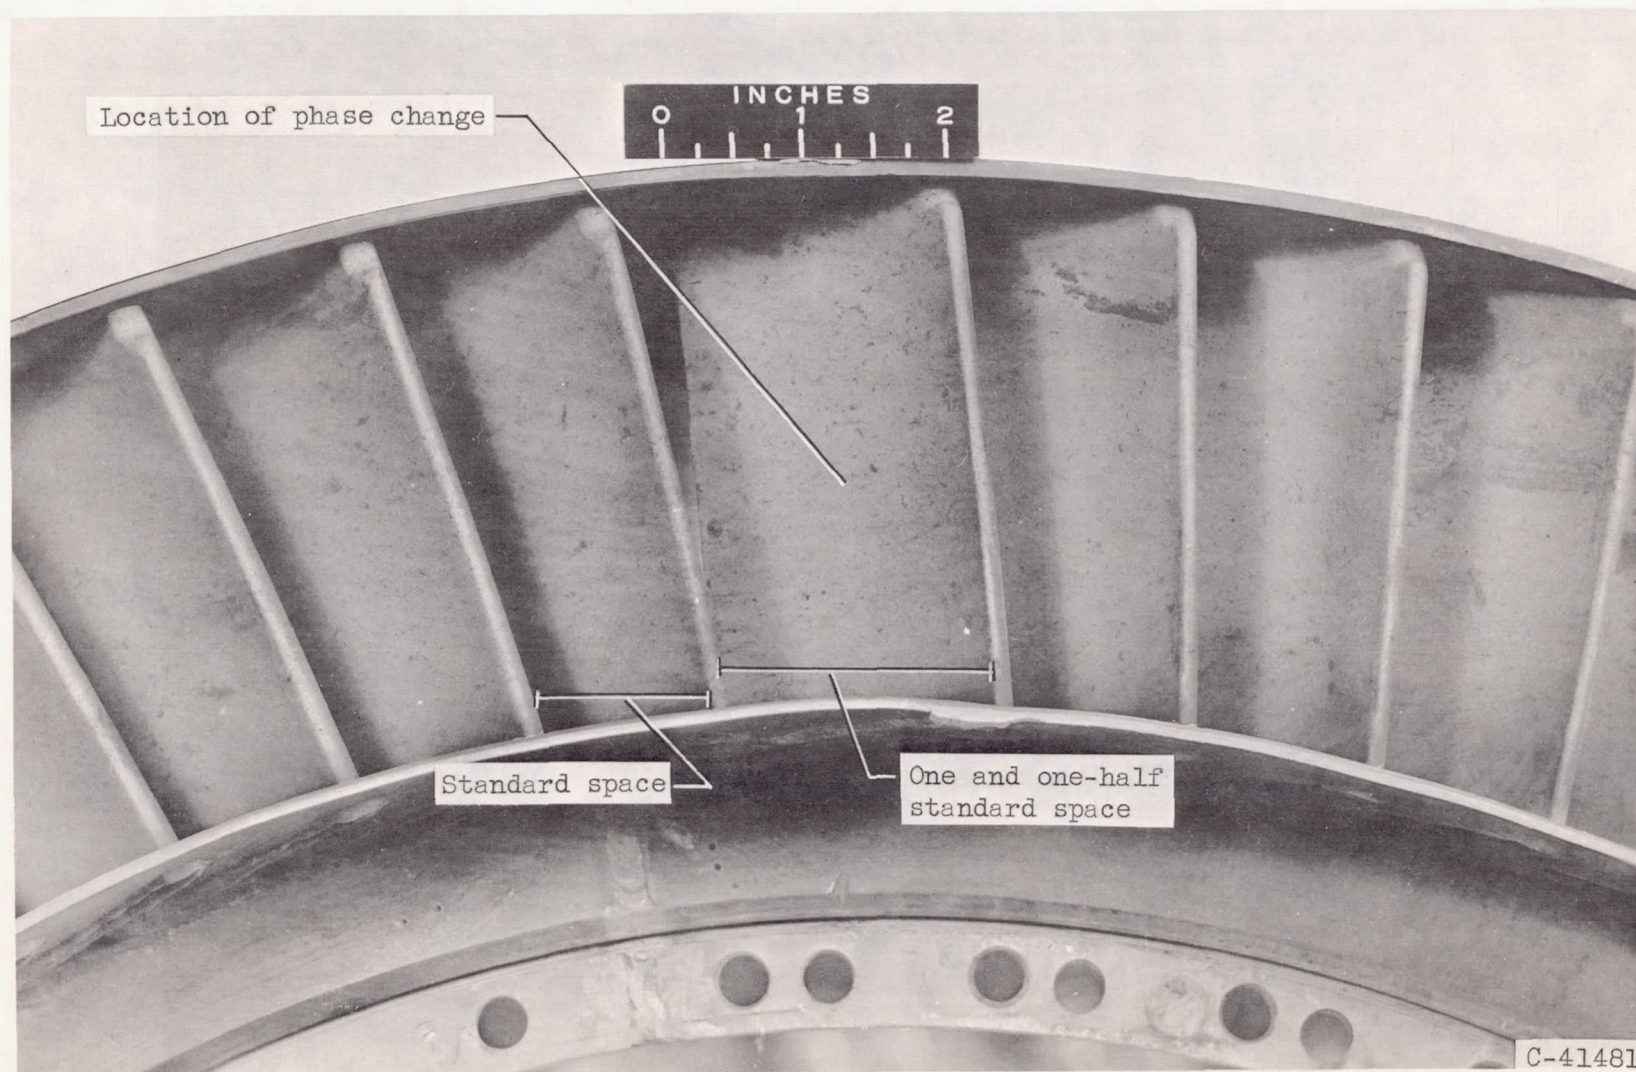
Figure 4. - Phased nozzle diaphragm, showing location of phase change; 61 standard spaces; 2 phase-change spaces.

One special assembly had 57 vanes equally spaced (tests 8, 8a, and 8b). In the fabrication of the second modified assembly ("phased" assembly for tests 10, 11, and 12) a standard unit was cut apart on a diameter. An arc segment containing one vane adjacent to a cut face was removed, and the remainder of that half of the assembly was revolved through an arc equal to one-half standard vane space. With the two parts fixed in this relation, material was added to the inner and outer rings where required to complete the reassembly. Figure 4 shows the resulting vane spacing at the location of phase change. There was a similar discontinuity nearly diametrically opposite.
