TECHNICAL NOTE 3190

FATIGUE INVESTIGATION OF FULL-SCALE
TRANSPORT-AIRPLANE WINGS

SUMMARY OF CONSTANT-AMPLITUDE TESTS THROUGH 1953

By M. J. McGuigan, Jr., D. F. Bryan, and R. E. Whaley

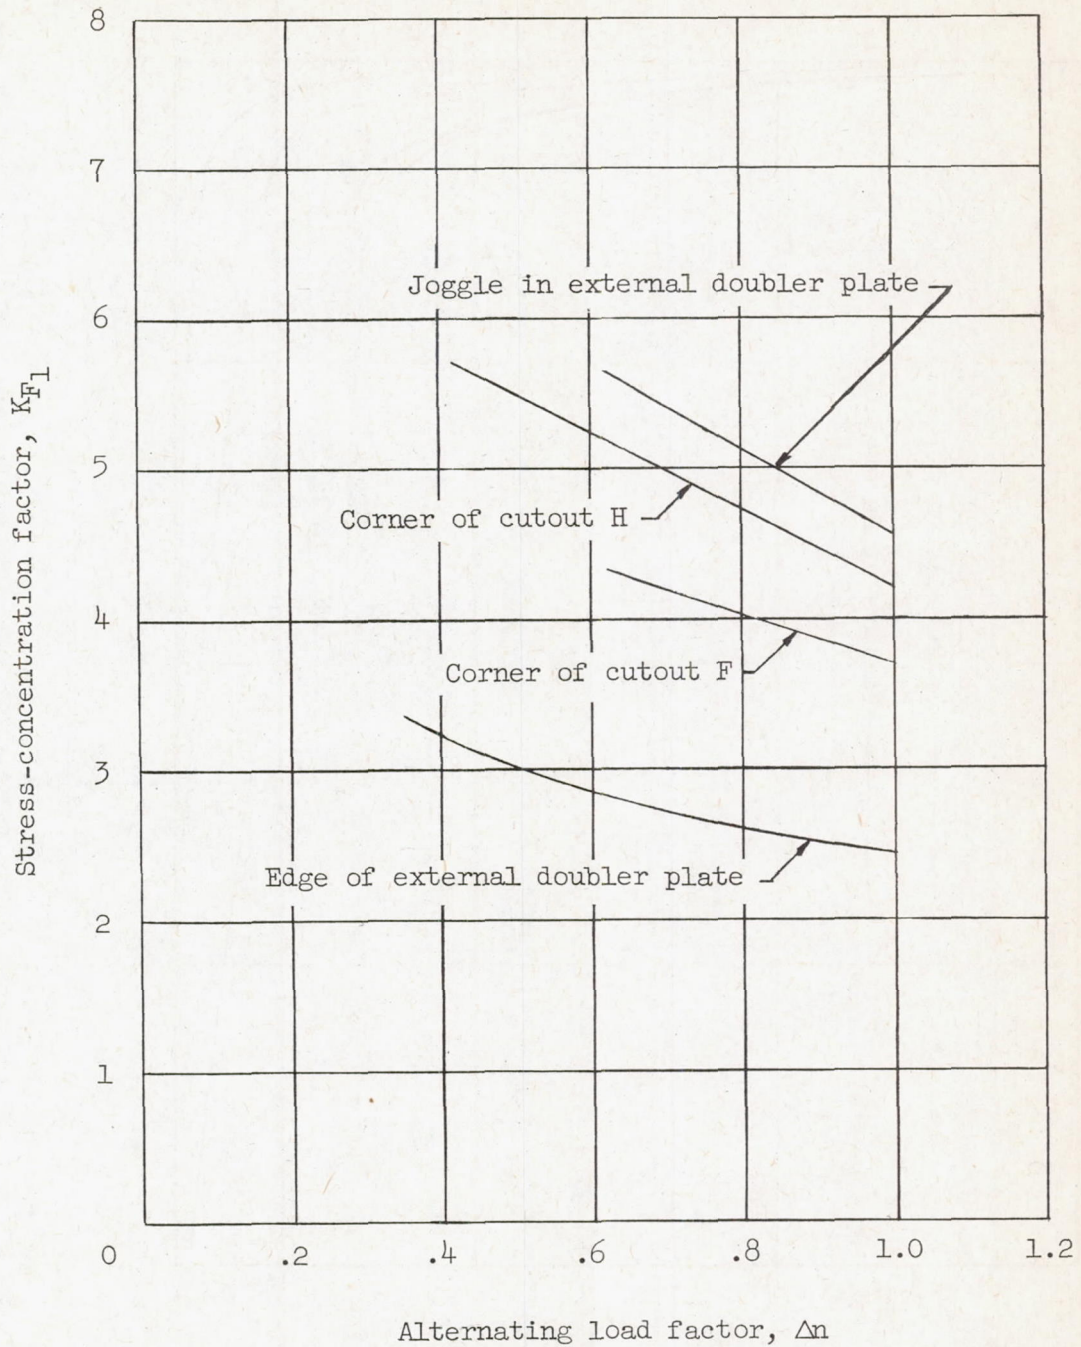
Figure 10.- Effect of load level on the stress-concentration factor.

The range of concentration factor K_{F1} occurring at each load level for the five types of failures is shown in table 2. It can be noted from this table that the concentration factor tends to decrease with increasing load level. This trend is shown graphically in figure 10 for several locations where failures occurred at more than one load level. The trend is assumed to be caused by the increasing effects of plasticity associated with higher stresses as the load level is increased. Both K_{F2} and K_{F3} show the same decreasing trend with increasing load level that K_{F1} does, but in the case of K_{F3} the trend is not very apparent because of the lower magnitudes involved.

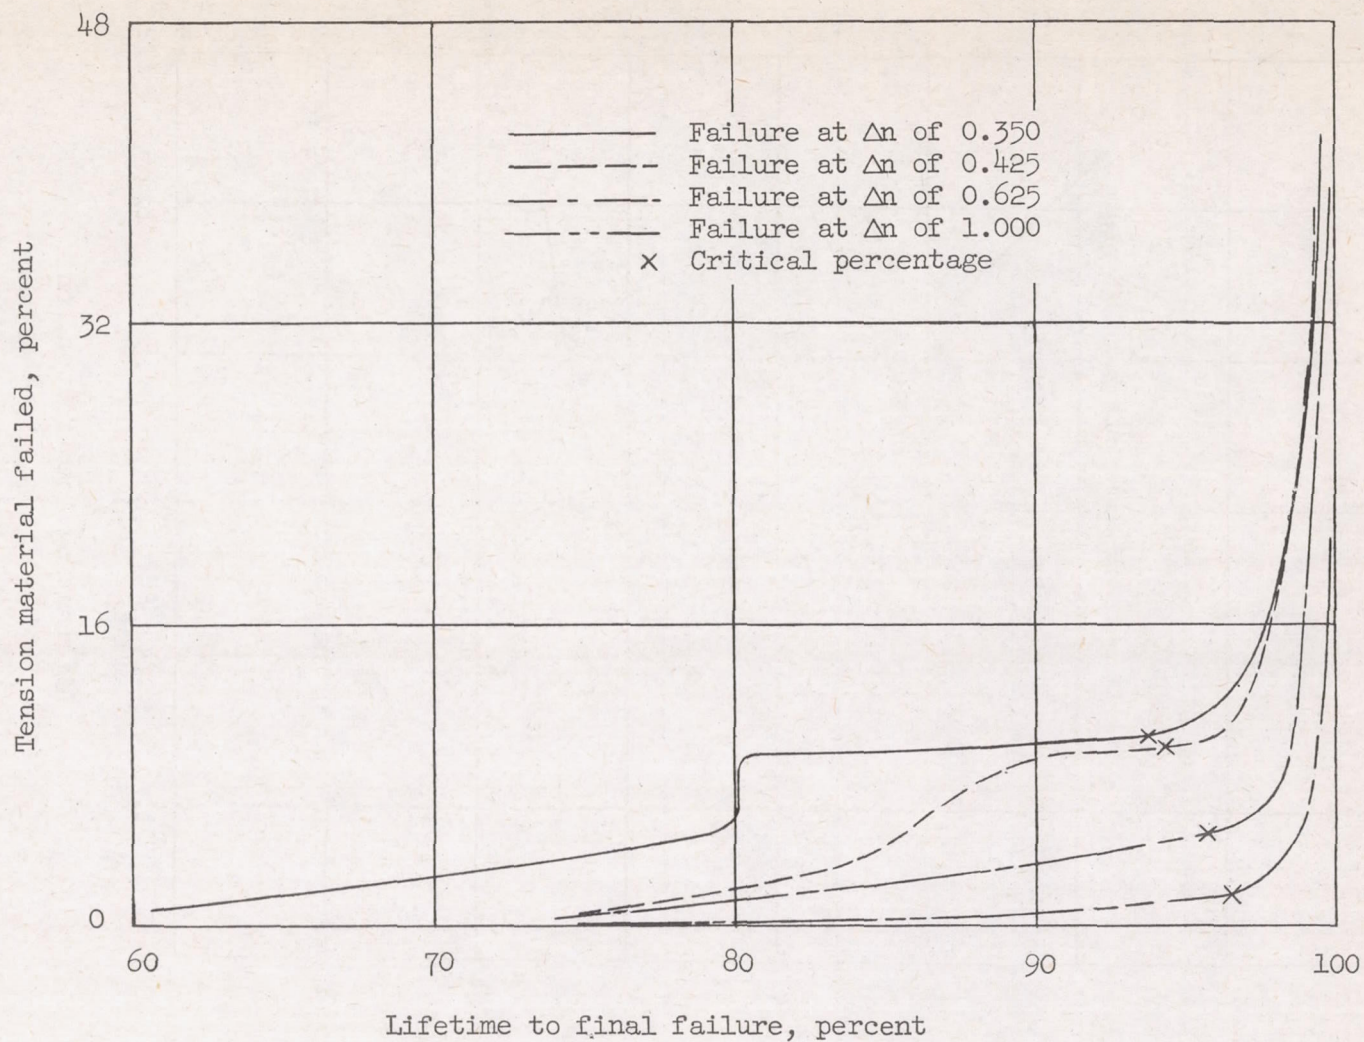
Figure 11.- Typical fatigue-crack propagation.

The growth of all fatigue cracks was observed during the course of the tests. In figure 11 the growth of typical failures is plotted for each of the test levels. In order to put all failures on the same comparative basis, the percentage of tension material failed in a cross section of the wing is plotted against the percentage of lifetime to final failure. In this figure it can be noted that all of the curves have the same general shape. In each case the failure grew slowly until a certain percentage of the tension material had failed. At this point, defined as the critical point, the growth of the cracks became very rapid. The percentage of tension material that had failed at the critical point decreased with increasing load level. For the 0.35g level the amount of tension material that had failed at the critical point was about 10 percent; for the 0.425g level, about 9 percent; for the 0.625g level, about 6 percent; and for the 1.0g level, about 2 percent. This critical point occurred at about 95 percent of the lifetime to final failure for all test levels. Tests of all specimens were continued until the critical point had been determined.

The number of cycles to initial failure is included in table 1. The fatigue life for this structure at the various test levels appeared in figure 9 in the form of a load-lifetime diagram. This figure showed the load-lifetime diagram for initial failure, as previously defined, for all failures that occurred during the tests. For no apparent reason some of these failures never grew to more than an inch in length, while others grew to a considerable size. In figure 12 is shown the load-lifetime diagram of initial and final failure for those failures that grew until their respective crack-propagation curves indicated that the critical percentage of tension material had failed. The number of cycles to final failure, estimated from the individual crack-propagation curves for each of the failures, is listed in table 1. It is evident from the rate of crack growth indicated by the curves of figure 11 that this estimate would not be much in error.

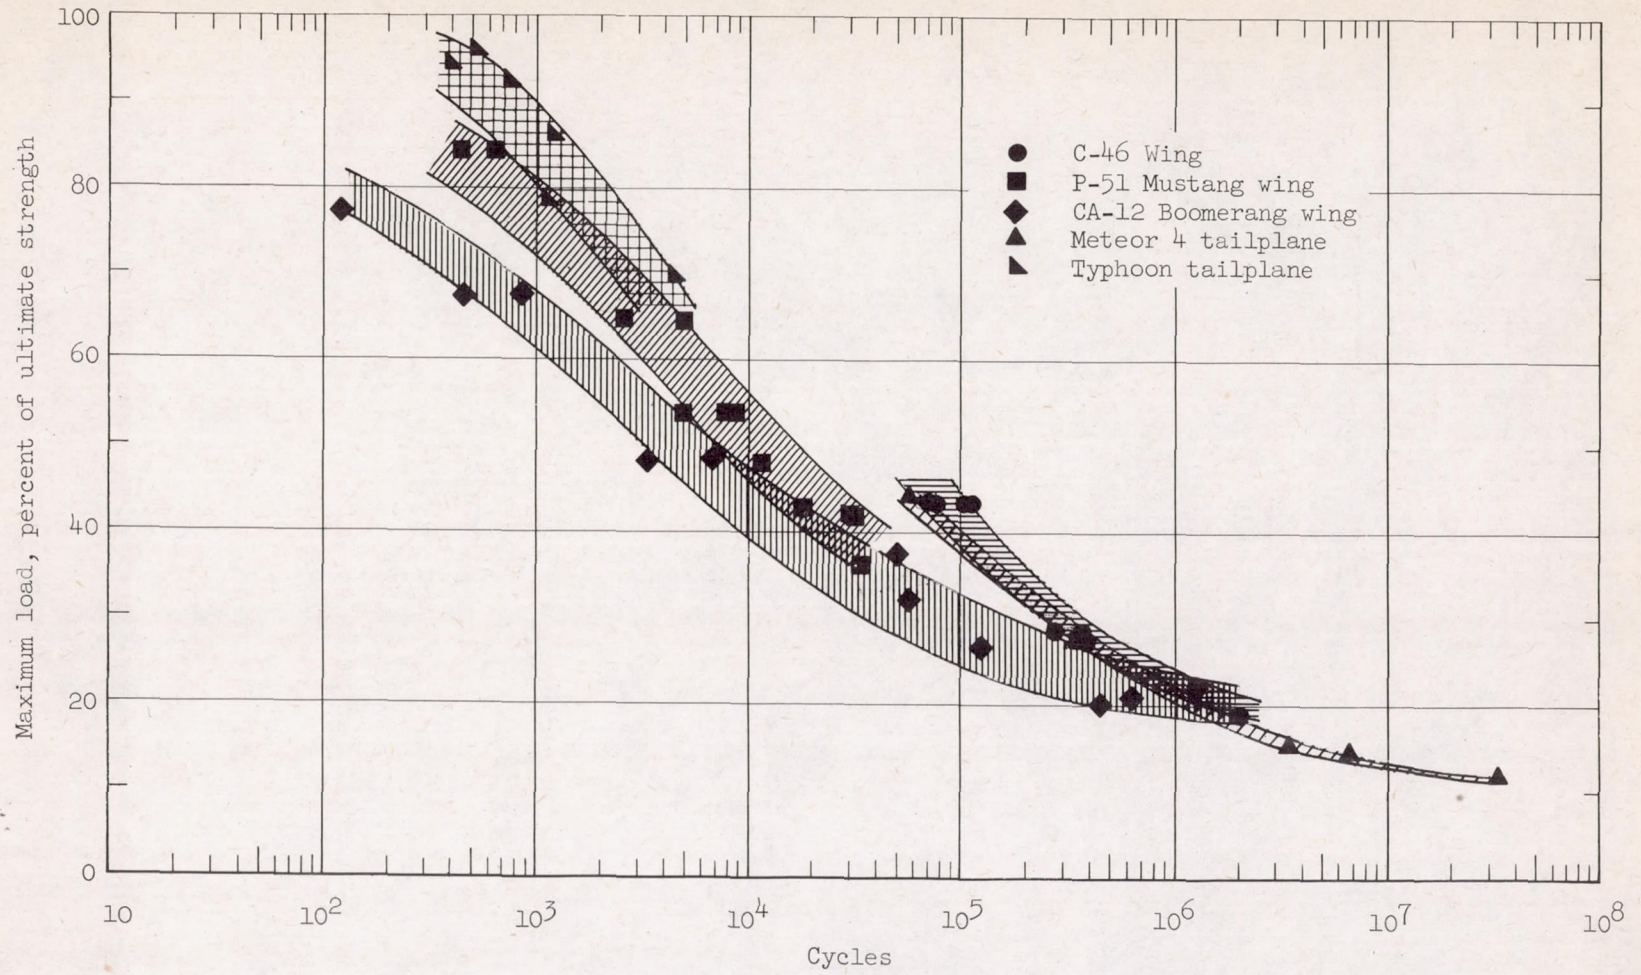
Figure 13.- Load-lifetime diagrams for several aircraft structures.

The load-lifetime diagram for final failure is presented in figure 13, along with results of fatigue tests on a number of other airplane structures taken from references 7 to 10. The load is given in percent of the ultimate static strength of the structure. It can be seen from this figure that all of the full-scale data presented lie within a comparatively narrow scatter band, considering the fact that the data include different types of airplanes and components with many types of stress raisers. Full-scale fatigue data from other airplanes have been found to fall within the scatter of the data that are presented.

Since the ordinate of figure 13 is based on the ultimate strength of the structures and since fatigue failures occurred principally on the tension surface, the load-lifetime comparison could best be made on the basis of the ultimate strength of that surface. In the static tests to determine the ultimate strength of the structures in references 7 to 10, the P-51 wing and Meteor 4 tailplane failed in compression while the remaining structures failed in tension. The C-46 curve in this figure is based on the design ultimate strength of the wing, because the actual ultimate strength is unknown. In static tests performed by the U. S. Air Force the wing failed in compression at 95 percent of the design ultimate load, and was subsequently reinforced but not retested.

If, in the case of those structures which failed in compression, the strength of the tension surface is assumed to be greater than the strength used in the comparison of figure 13, the load-lifetime curves would be shifted downward. This downward shift would very likely result in even less scatter in the data of this figure than is now present.
