TECHNICAL NOTE 2920

INTERIM REPORT ON A FATIGUE INVESTIGATION OF A
FULL-SCALE TRANSPORT AIRCRAFT WING STRUCTURE

By M. James McGuigan, Jr.

Langley Aeronautical Laboratory
Langley Field, Va.

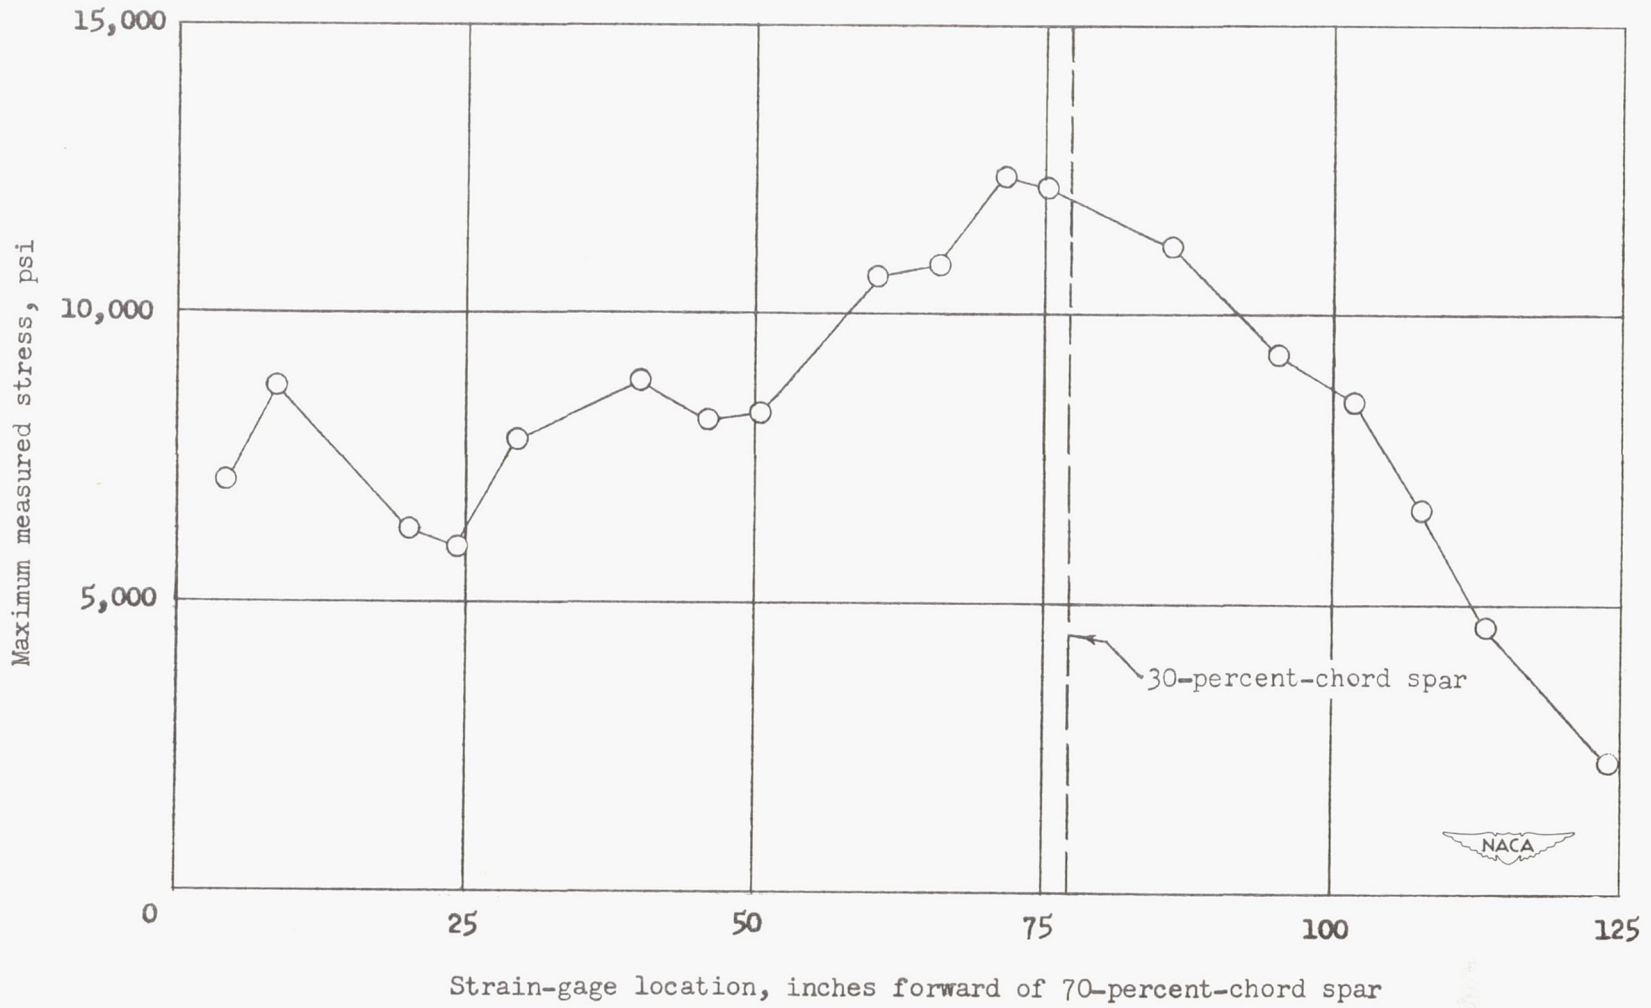
Figure 8.- Chordwise distribution of 1.625g measured stress at station 214.

The failures of type I, which occurred at the corners of inspection cutouts, all originated on the outer panels in the vicinity of span station 214. The chordwise distribution of stress through this section, as measured with strain gages, is shown in figure 8. Failure 3, which is a typical example of this type of failure, is shown in figure 9(a) a short time after starting and again in figure 9(b) after it had progressed to a length of about 17 inches. In figure 9(c) the same crack is shown after causing failure of the spar at the 30-percent-chord position. Another failure of this type is shown in figure 10. The crack originated at the cutout nearest the rear spar at span station 214 and was repeated more often than any other failure of this type. It appeared on all three left wings and on the third right wing. In no case, however, did this crack result in final failure of the wing. The failures originating in this identical location were failures 5, 17, and 33 on the left wing and 26 on the right wing. Failures occurring at the same locations on the left and right wings will be considered as identical for purposes of further discussion.

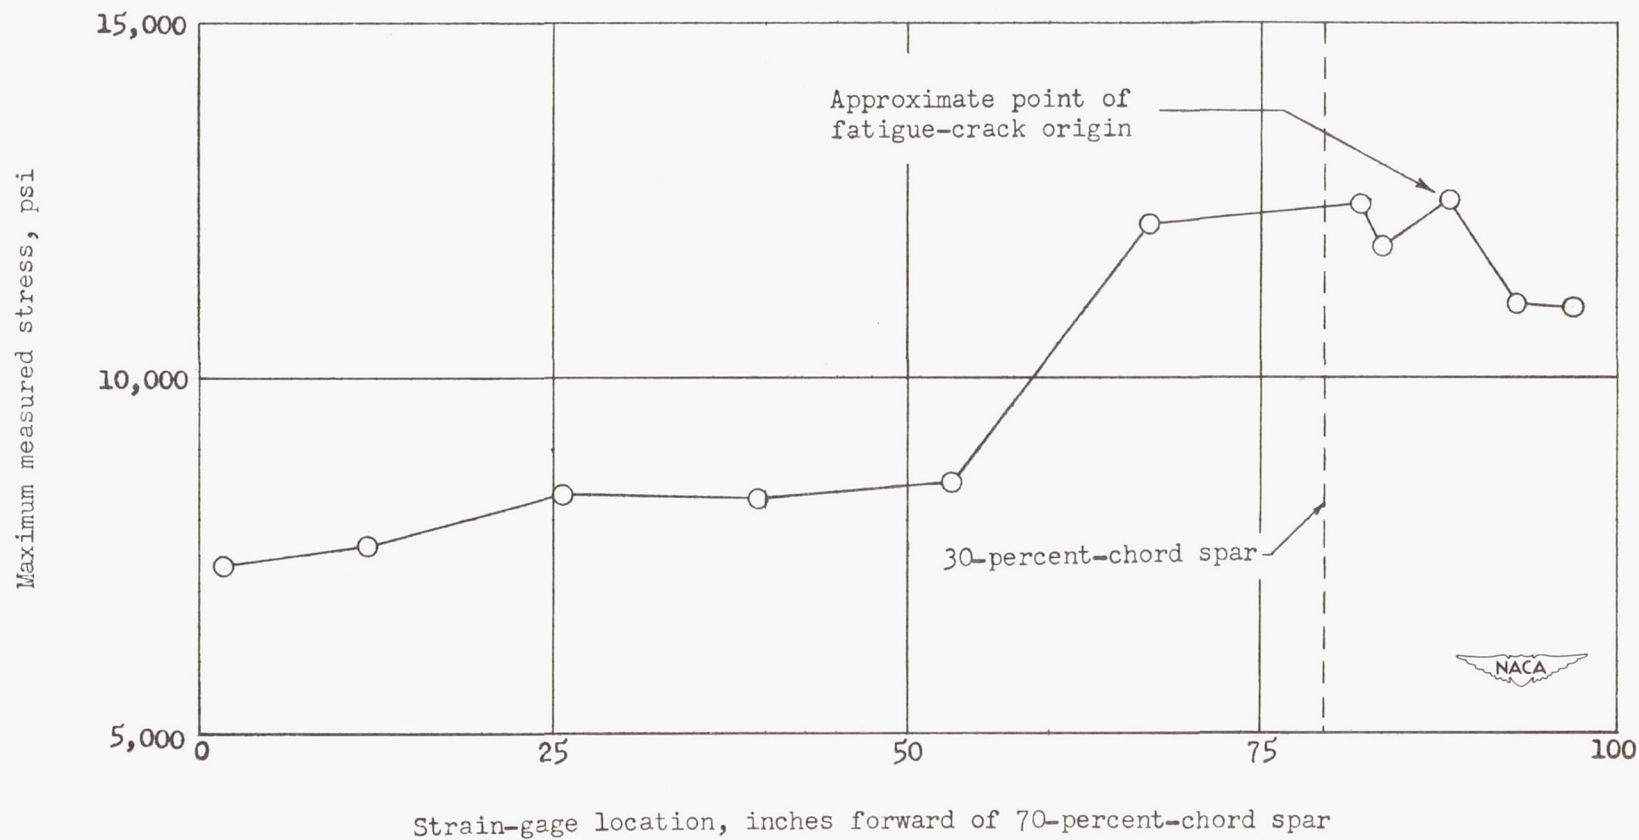
Figure 13.- Chordwise distribution of 1.625g measured stress at station 32.

The second type of failure occurred in a riveted tension joint 32 inches from the aircraft center line. The joint extended chordwise at this wing station from the front spar to the rear spar. Failures of this type appeared on the left and right wing of the first three wing center sections in the same chordwise location and are listed as failures 1, 2, 11, 14, 22, and 23. The details of this joint and the manner of failure are shown in figure 12. The measured chordwise stress distribution through this section is shown in figure 13, from which it may be seen that the highest stress occurs at the point where all the failures originated.

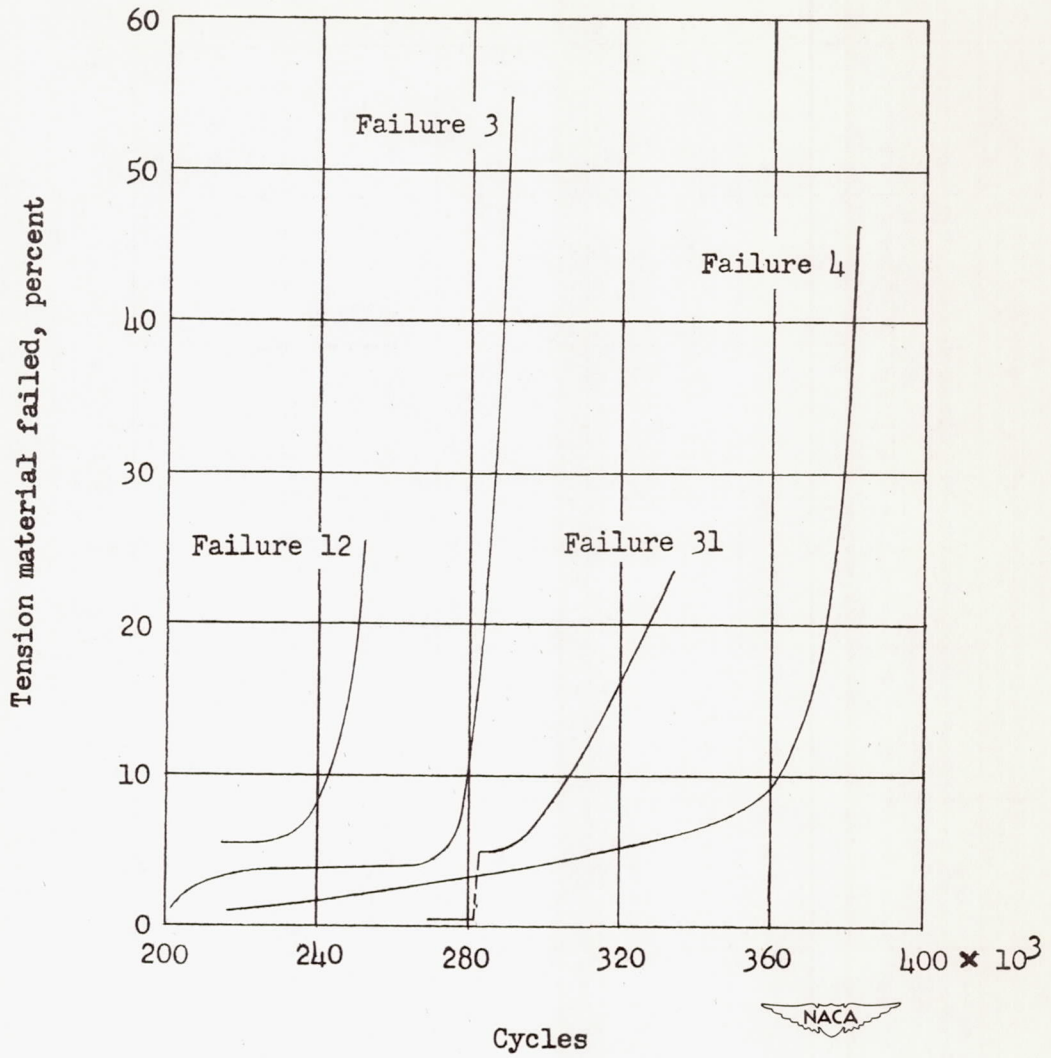
Figure 18.- Crack growth of several fatigue failures.

Several of the fatigue cracks in the wing outer panels were allowed to grow until a considerable amount of the tension surface had failed. The rate at which the cracks grew is shown in figure 18, in which the percent of cross-sectional material failed in the tension surface at the wing station where the failure occurred is plotted as a function of the number of cycles of load applied. The crack-growth curves of figure 18 indicate that the propagation of the cracks was relatively slow until about 5 to 9 percent of the tension material had failed. At this point the slopes of the curves abruptly become very steep and thereby indicate a rapid propagation of the crack thereafter. The abrupt discontinuity in

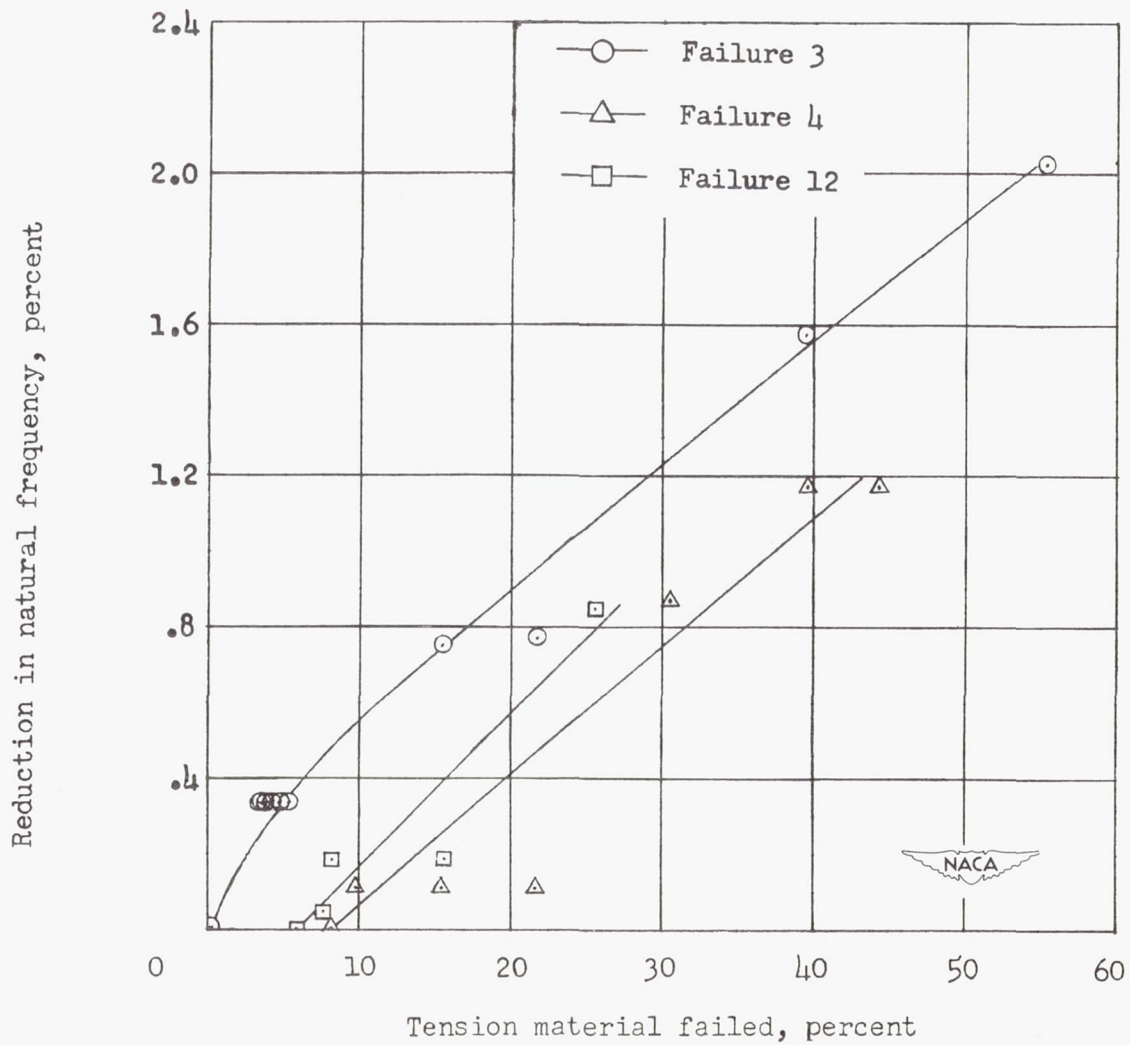
Figure 19.- Variation of natural frequency of test specimen with loss of tension material.

The tests indicated that the natural frequency of the test wings was not affected by fatigue damage until after a fatigue failure had originated. Even then, the change in natural frequency was very small and amounted to only about 2.0 percent with as much as 55 percent of the tension material failed in fatigue. In figure 19 the indicated change in natural frequency is plotted as a function of percent of tension material failed for several of the failures.
