NATIONAL ADVISORY COMMITTEE  
FOR AERONAUTICS

TECHNICAL NOTE 1938

MECHANISMS OF FAILURE OF HIGH NICKEL-ALLOY  
TURBOJET COMBUSTION LINERS

By John W. Weeton

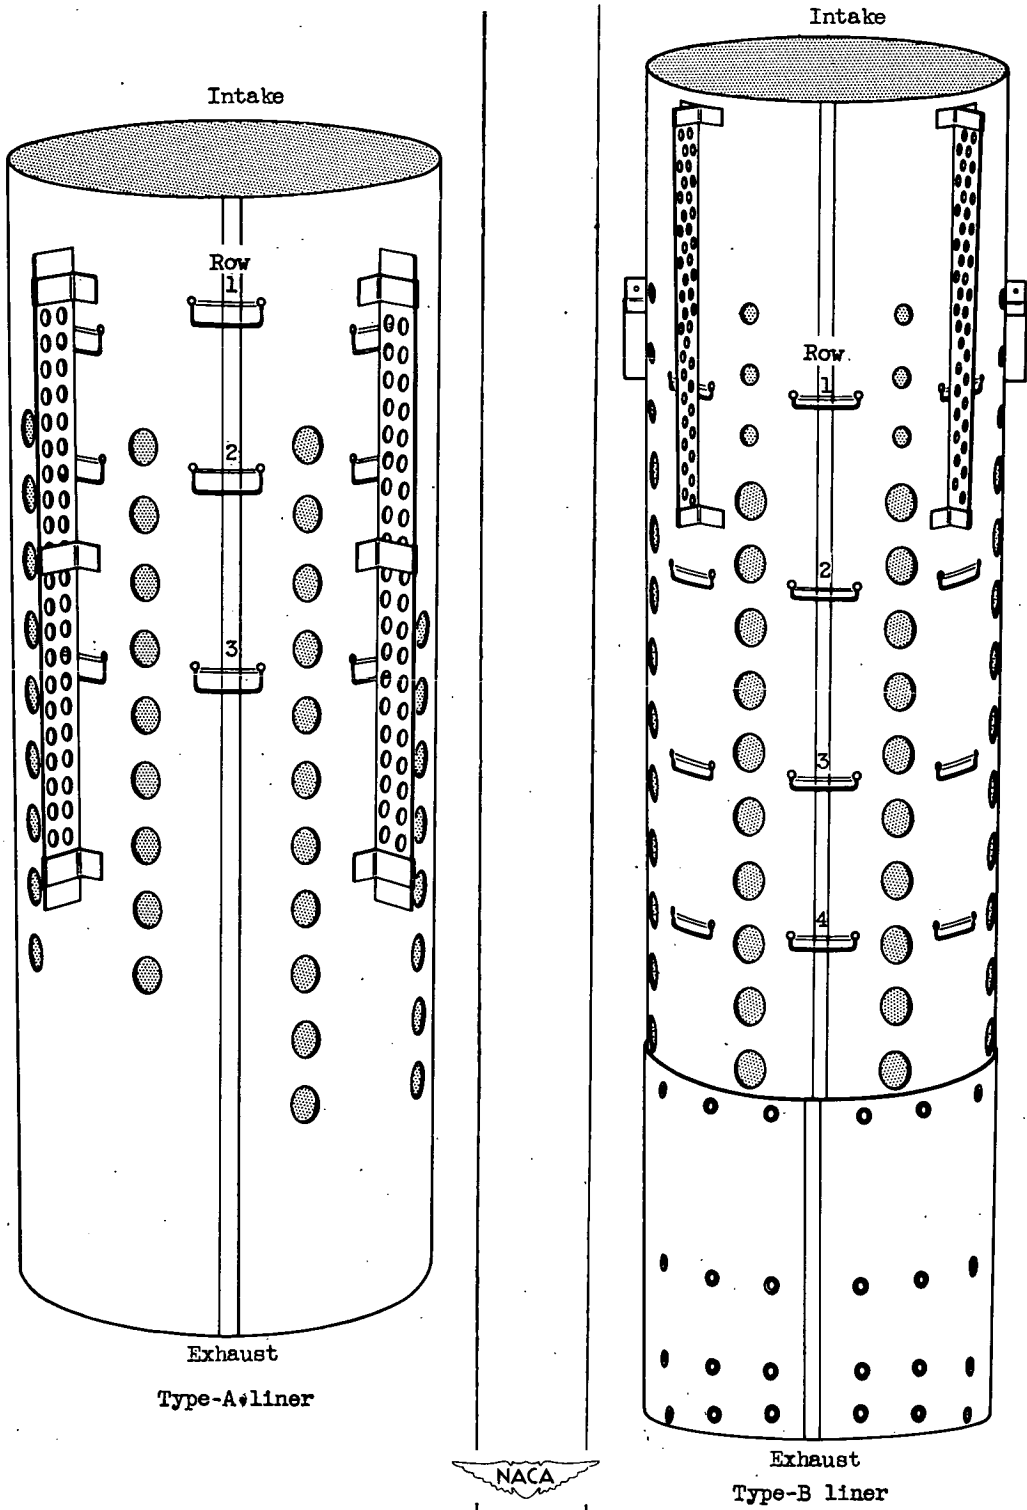
straight paths at this point and turn either away from the center line of the louver or parallel to the center line, as shown in figure 3(a), point 2. The cracks proceed in a slightly crooked path but continue in the same general direction, away from or parallel to the center line, (fig. 3(a), point 3). In extreme cases, cracks extended as far as the air-intake holes. Warping or buckling takes place at or near almost every crack. In many cases, the warpage forms either a ridge or a groove between the stress-relieving holes of the louvers and the nearest air-intake holes (fig. 3(c)). Buckling is most serious in the second row of louvers from the intake end (figs. 1 and 4). The louver flaps (fig. 3(a)) do not warp.

Some of the cracks were jagged and widely separated and looked like tears whereas others were minute. The smaller cracks were usually much more crooked than the larger ones. Most of the cracks were located in the second and the third row of louvers from the intake end (figs. 1 and 4).

Figure 1. - Combustion-chamber liner investigated.
