NATIONAL ADVISORY COMMITTEE FOR AERONAUTICS

TECHNICAL NOTE

No. 1637

EFFECT OF PREIGNITION ON CYLINDER TEMPERATURES
PRESSURES, POWER OUTPUT, AND PISTON FAILURES

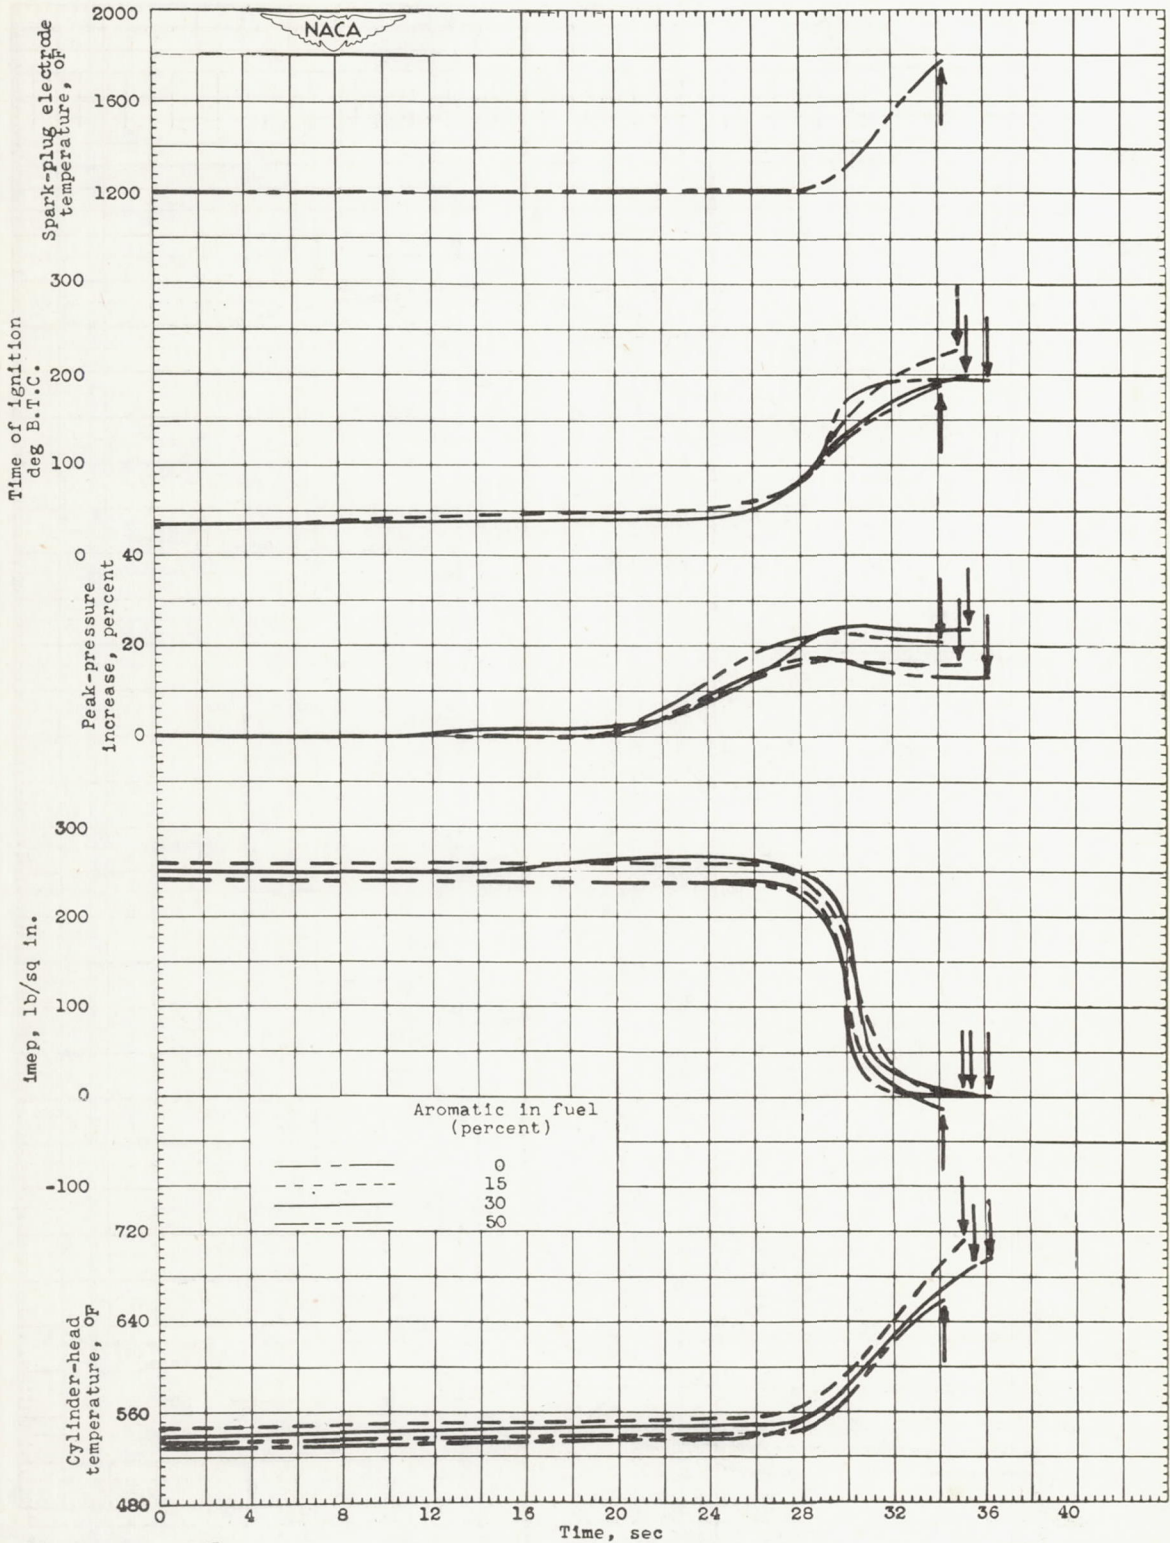
Effect of aromatic content of fuel. - The preignition rating of a fuel depends to a large extent on its aromatic content. At the conditions investigated, however, the percentage of aromatics in the fuel had only a small effect on the behavior of the engine after preignition was excited (fig. 7). The peak-pressure-increase curves show the greatest effect with a trend toward a direct relation between aromatic content and peak-pressure increase.

A curve is also included in figure 7 that shows the changes in the temperature of the center electrode of the intake spark plug during a preignition run. This spark plug was of a colder-operating type than that used in the exhaust side as the preignition source. The temperature of this intake plug increased approximately 550° F before backfiring was encountered. Because of difficulties involved in obtaining measurements of this temperature, the data shown are the only data available.

Figure 7. - Effect of aromatic content of fuels on behavior of engine after preignition is encountered. Engine speed, 3000 rpm; spark advance: inlet, 28° B.T.C.; exhaust, 34° B.T.C.; compression ratio, 6.65; outlet-coolant temperature, 250° F; mixture temperature, 175° F; inlet-oil temperature, 185° F; fuel-air ratio, 0.070; source of preignition, spark plug in exhaust side. (Arrows indicate time of backfire.)

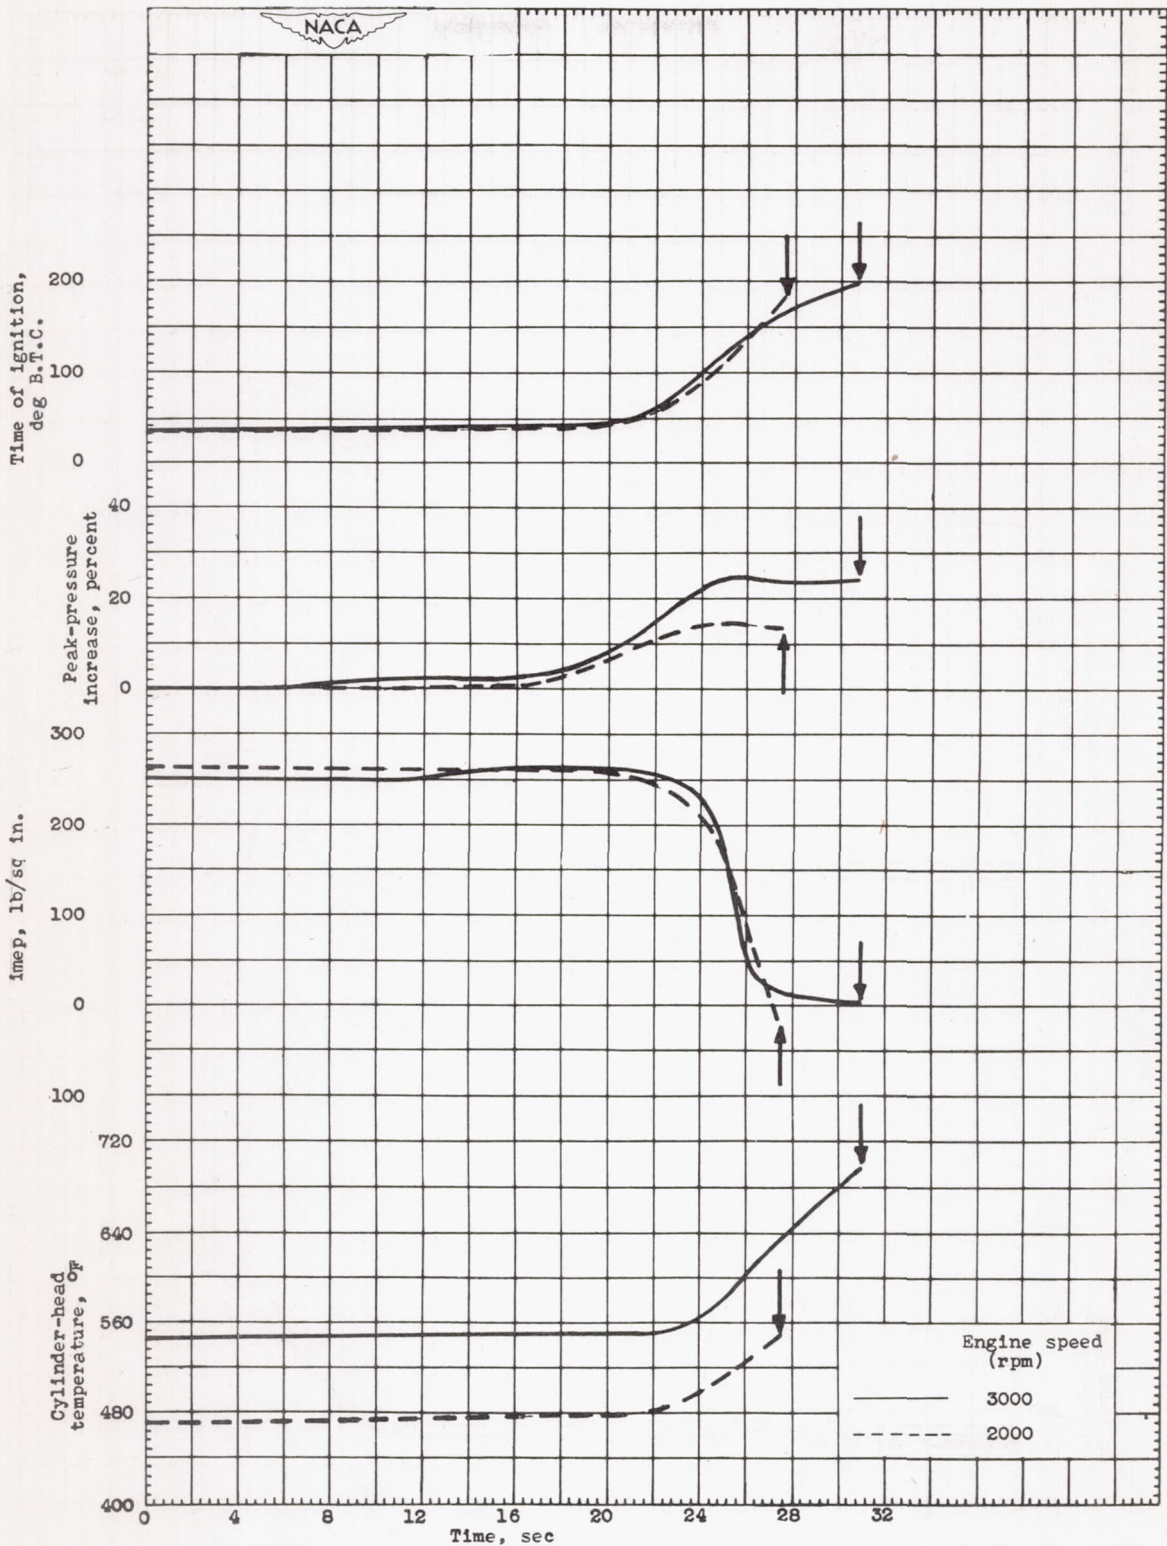
Effect of engine speed. - Data from runs at two engine speeds, 3000 and 2000 rpm, are shown in figure 8. Both runs were at approximately the same indicated mean effective pressure with spark plugs of the same type but of slightly different thermal ratings. The ignition advance required to cause backfiring was almost the same at both engine speeds.

Figure 8. - Effect of engine speed on behavior of engine when preignition is encountered. Spark advance: inlet, 28° B.T.C.; exhaust, 34° B.T.C.; compression ratio, 6.65; outlet-coolant temperature, 250° F; mixture temperature, 175° F; inlet-oil temperature, 185° F; fuel-air ratio, 0.070; fuel, 30-percent cumene blend; source of preignition, spark plug in exhaust side. (Arrows indicate time of backfire.)

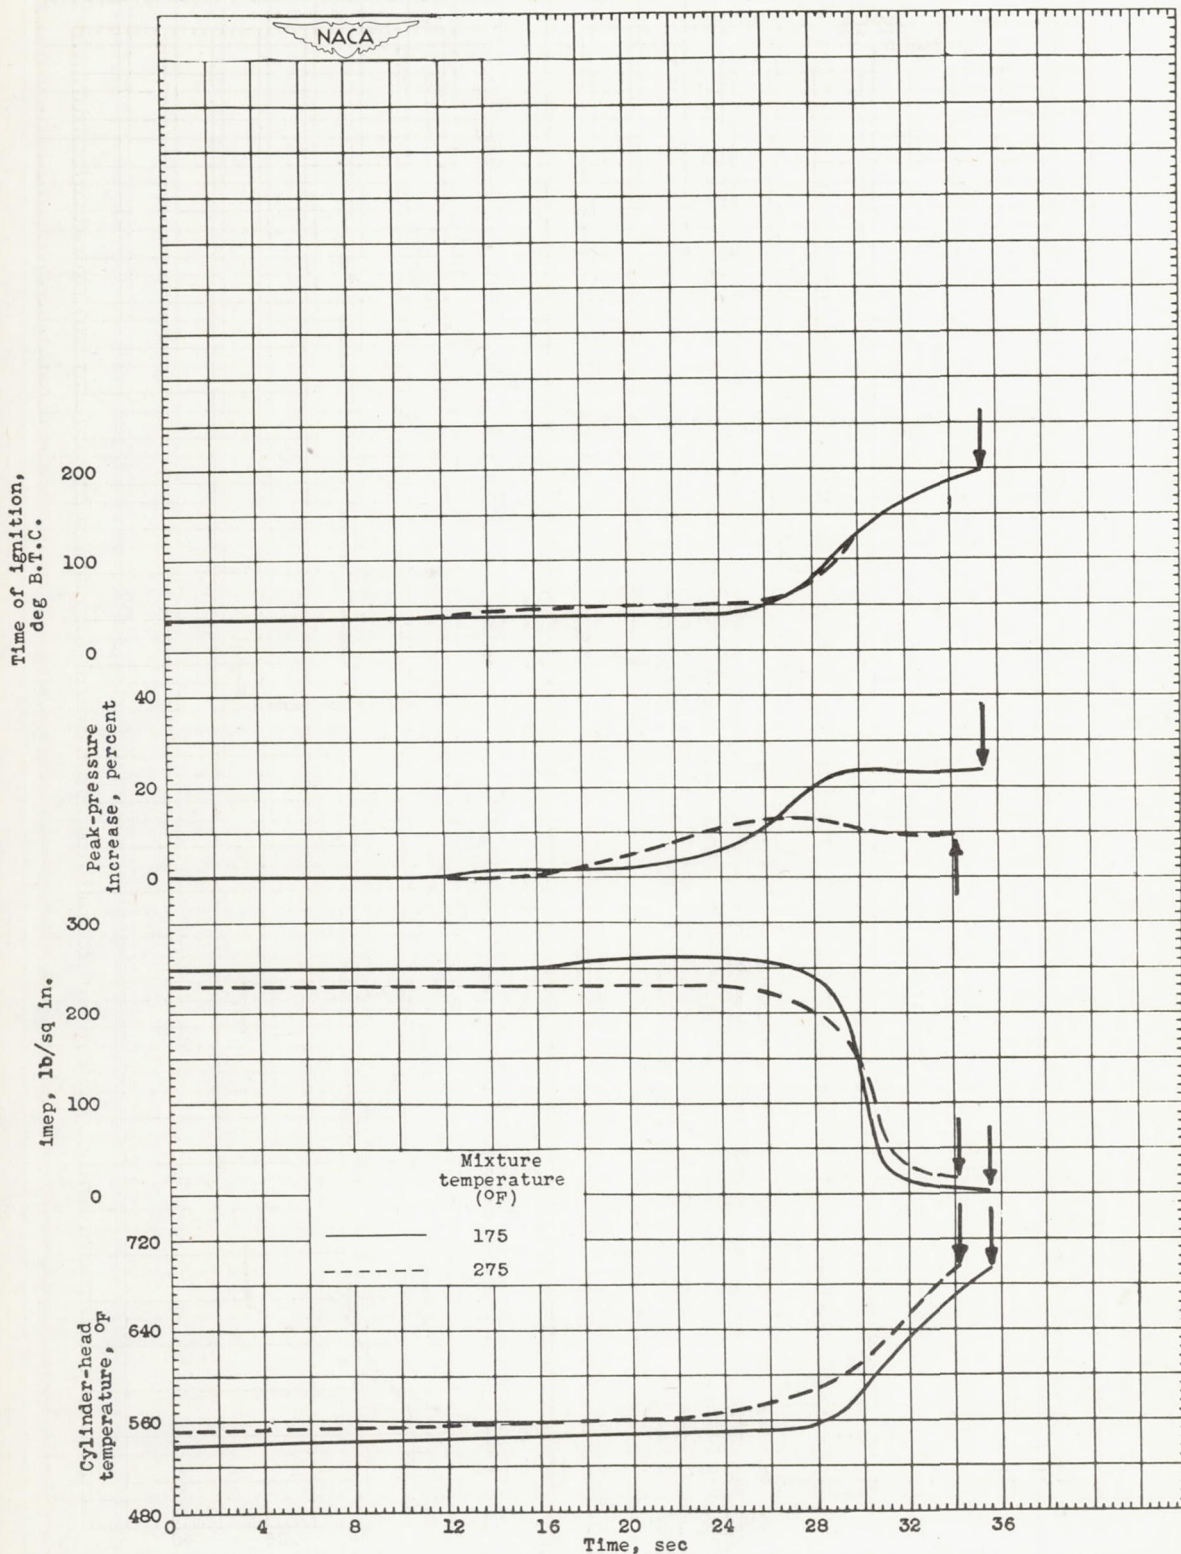
Effect of mixture temperature. - At approximately constant power output, mixture temperature had little effect on the behavior of the engine during preignition operation (fig. 9). At the higher mixture temperature of 275° F, the engine appeared to backfire a little more readily, probably because of better vaporization. The peak-pressure increase was greater at the lower mixture temperature of 175° F. Trouble was experienced with the ionization-gap trace (ignition indicator) during the runs at a mixture temperature of 275° F and therefore the time-of-ignition curve for these runs (fig. 9) is incomplete.

Figure 9. - Effect of mixture temperature on behavior of engine when preignition is encountered. Engine speed, 3000 rpm; spark advance: inlet, 28° B.T.C.; exhaust, 34° B.T.C.; compression ratio, 6.65; outlet-coolant temperature, 250° F; inlet-oil temperature, 185° F; fuel-air ratio, 0.070; fuel, 30-percent cumene blend; source of preignition, spark plug in exhaust side. (Arrows indicate time of backfire.)

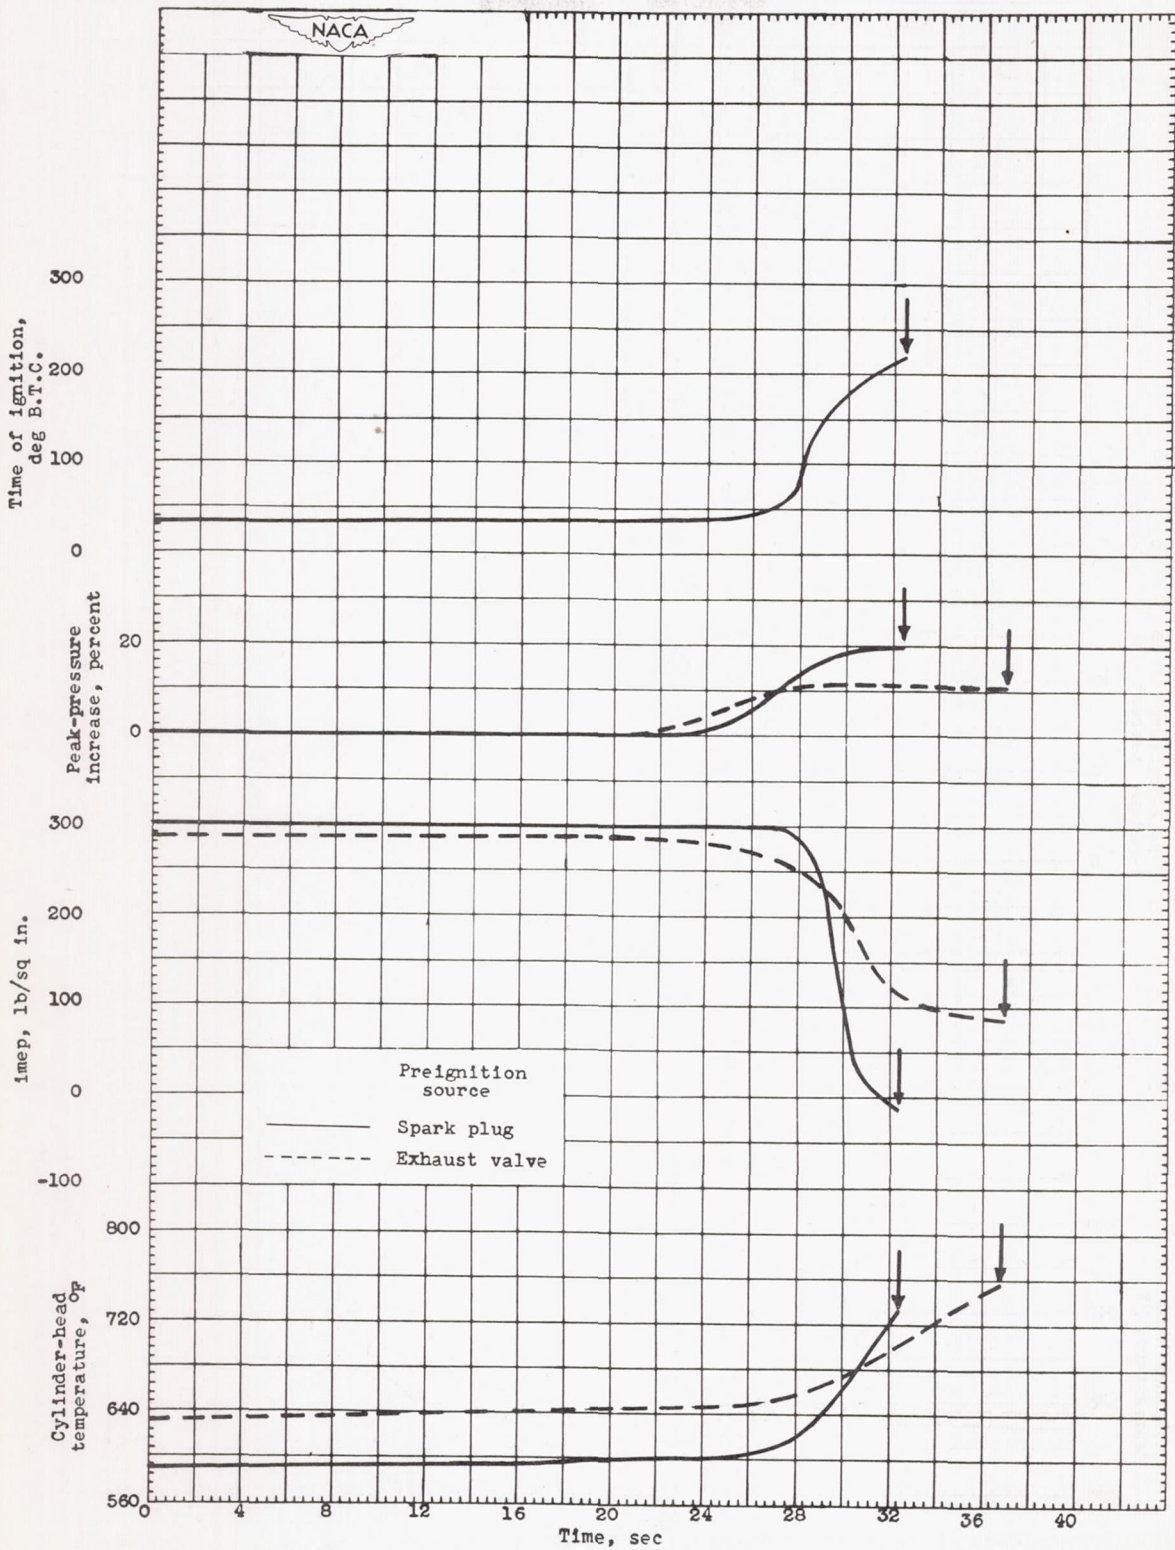
Effect of preignition source. - A comparison of preignition resulting from a hot spark plug and from a hot exhaust valve is shown in figure 10. When the hot exhaust valve was used, preignition advanced much more slowly than when the hot spark plug was used. Several minutes were required before preignition from the exhaust valve reached the point where it became rapidly accelerating. At the plotted zero point on the time scale, preignition was already in progress with the hot exhaust valve and had caused the cylinder-head temperature to rise approximately 50° F, whereas preignition had not yet begun with the hot spark plug. No satisfactory method of determining the time of ignition when the exhaust valve was the source was available, therefore the curve showing time of ignition is omitted from figure 10. From inspection of the power-output curves, however, it is apparent that backfiring took place with a less advanced time of ignition when the exhaust valve was the preignition source. This less-advanced time of ignition may explain the reason that the peak-pressure increase is lower for the exhaust-valve preignition than for the spark-plug preignition. These occurrences can be accounted for by the fact that the exhaust valves are much closer to the intake valves than is the exhaust spark plug.

Figure 10. - Effect of preignition source on behavior of engine when preignition is encountered. Engine speed, 3000 rpm; spark advance: inlet, 28° B.T.C.; exhaust, 34° B.T.C.; compression ratio, 6.65; outlet-coolant temperature, 250° F; mixture temperature, 175° F; inlet-oil temperature, 185° F; fuel-air ratio, 0.070; fuel, 30-percent cumene blend. (Arrows indicate time of backfire.)

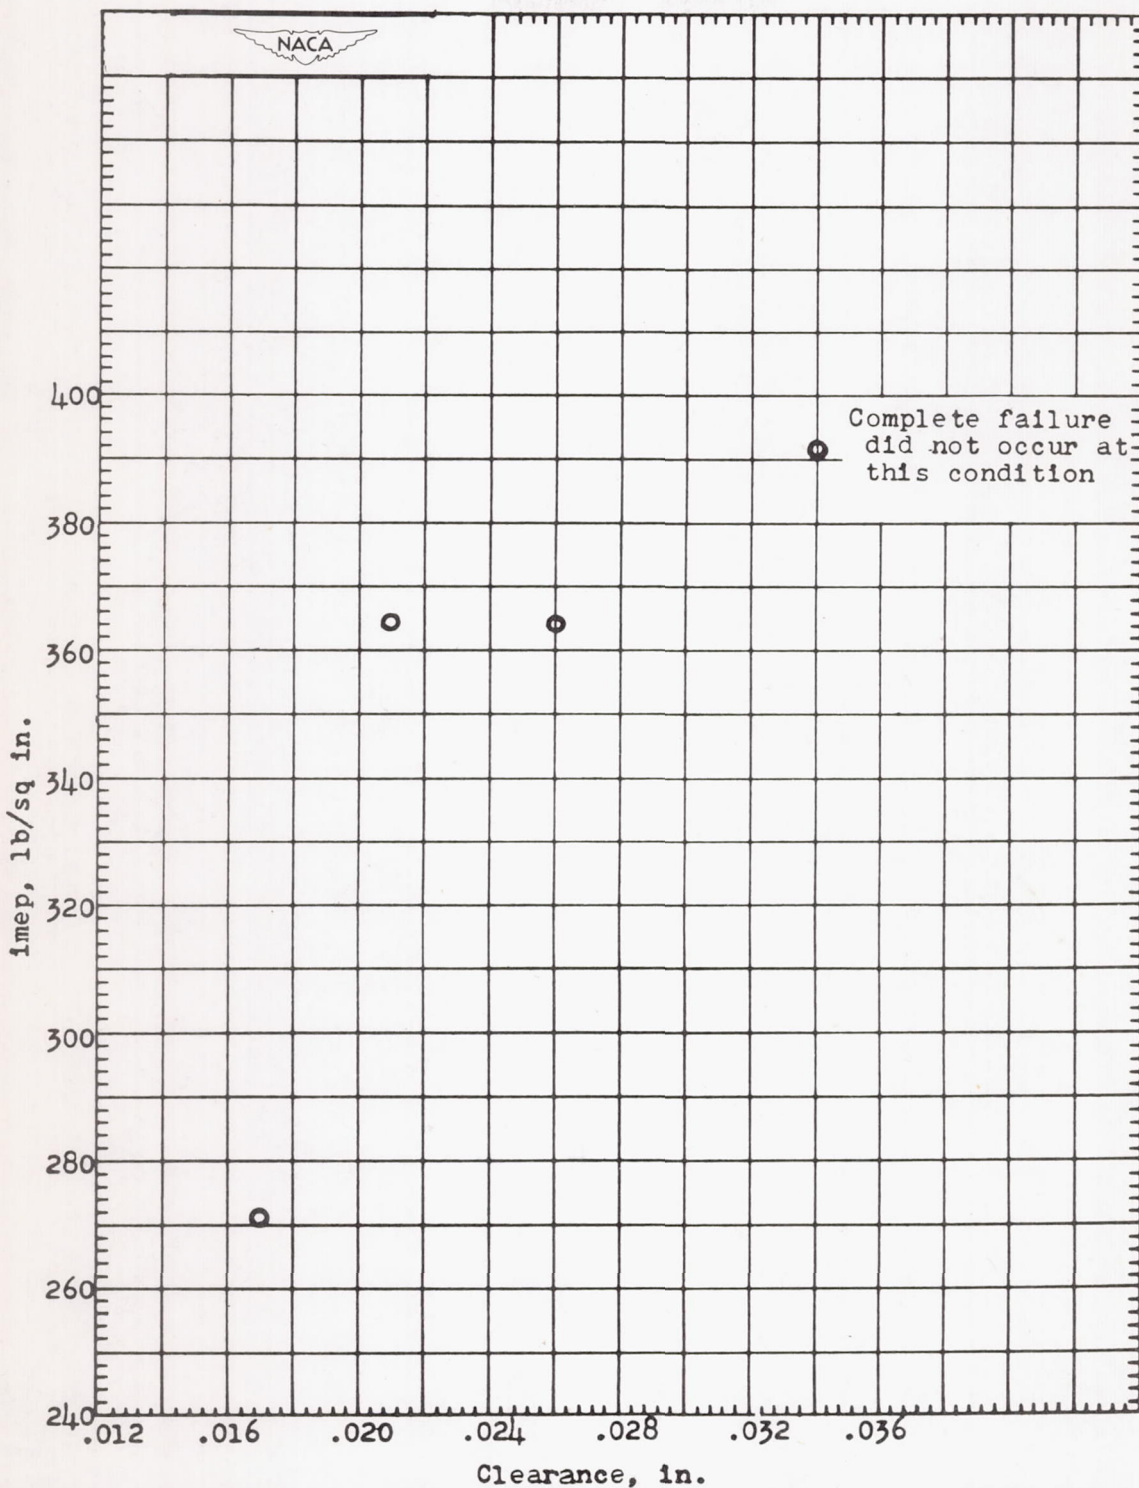
The indicated mean effective pressure required to cause piston destruction due to preignition as a function of clearance between the piston and the cylinder is shown in figure 13. Although the fuel-air ratios for the four runs were slightly different, the differences were small enough to be of no great importance. The points show that piston clearance is an important factor in preventing piston failures due to preignition. Determination of how near the piston cooling used for these destruction runs was to that used in the multicylinder engine is impossible; however, such a curve for other cooling conditions would undoubtedly show a similar trend.

Figure 13.- Effect of piston clearance (measured between top of piston skirt and cylinder barrel) on indicated mean effective pressure necessary to cause piston seizure when preignition is encountered.
