TIDEWATER AND WEATHER-EXPOSURE TESTS ON METALS

USED IN AIRCRAFT - II

By Willard Mutchler and W. G. Galvin
National Bureau of Standards

Washington
February 1942

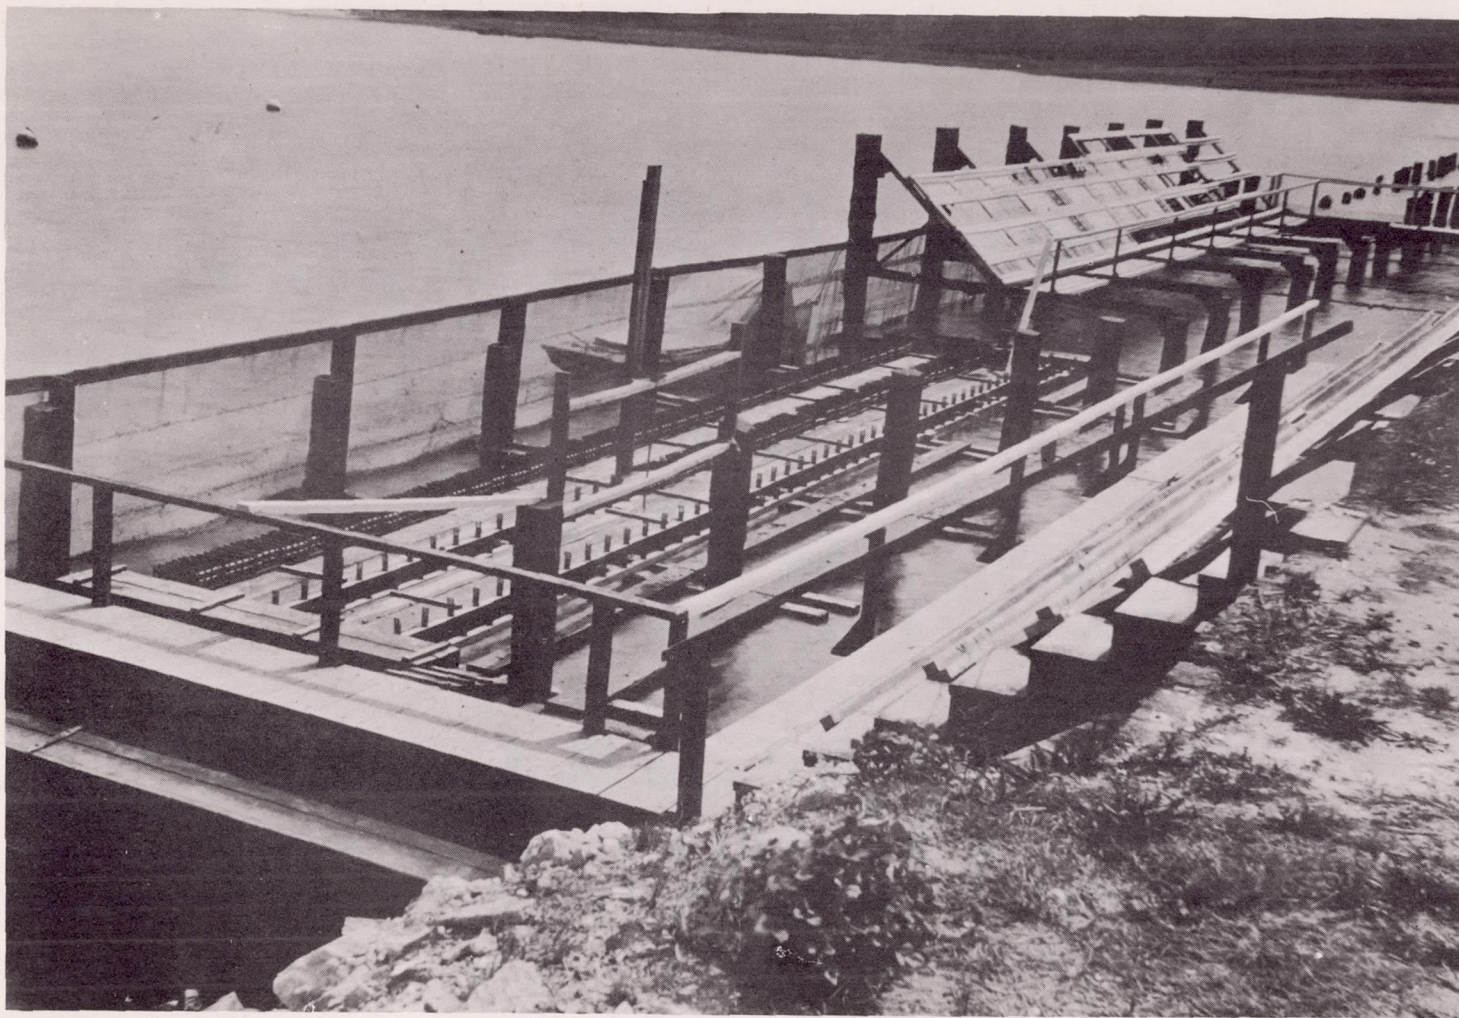
Figure 1.- The tidewater (left) and the weather-exposure (right) racks
at Boush Creek, Hampton Roads Naval Air Station (2).

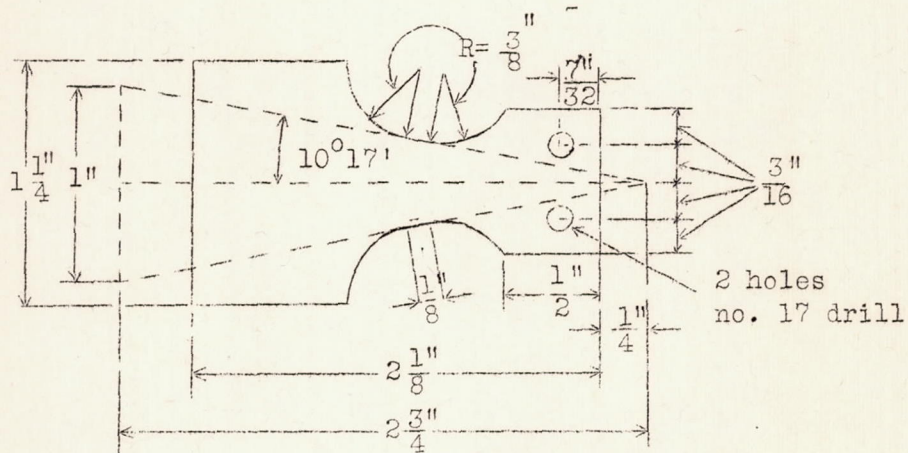
Krouse sheet fatigue specimen

Figure 30.- Sketch showing design and dimensions of specimens for tests in the Krouse flexural fatigue machines. x 1.

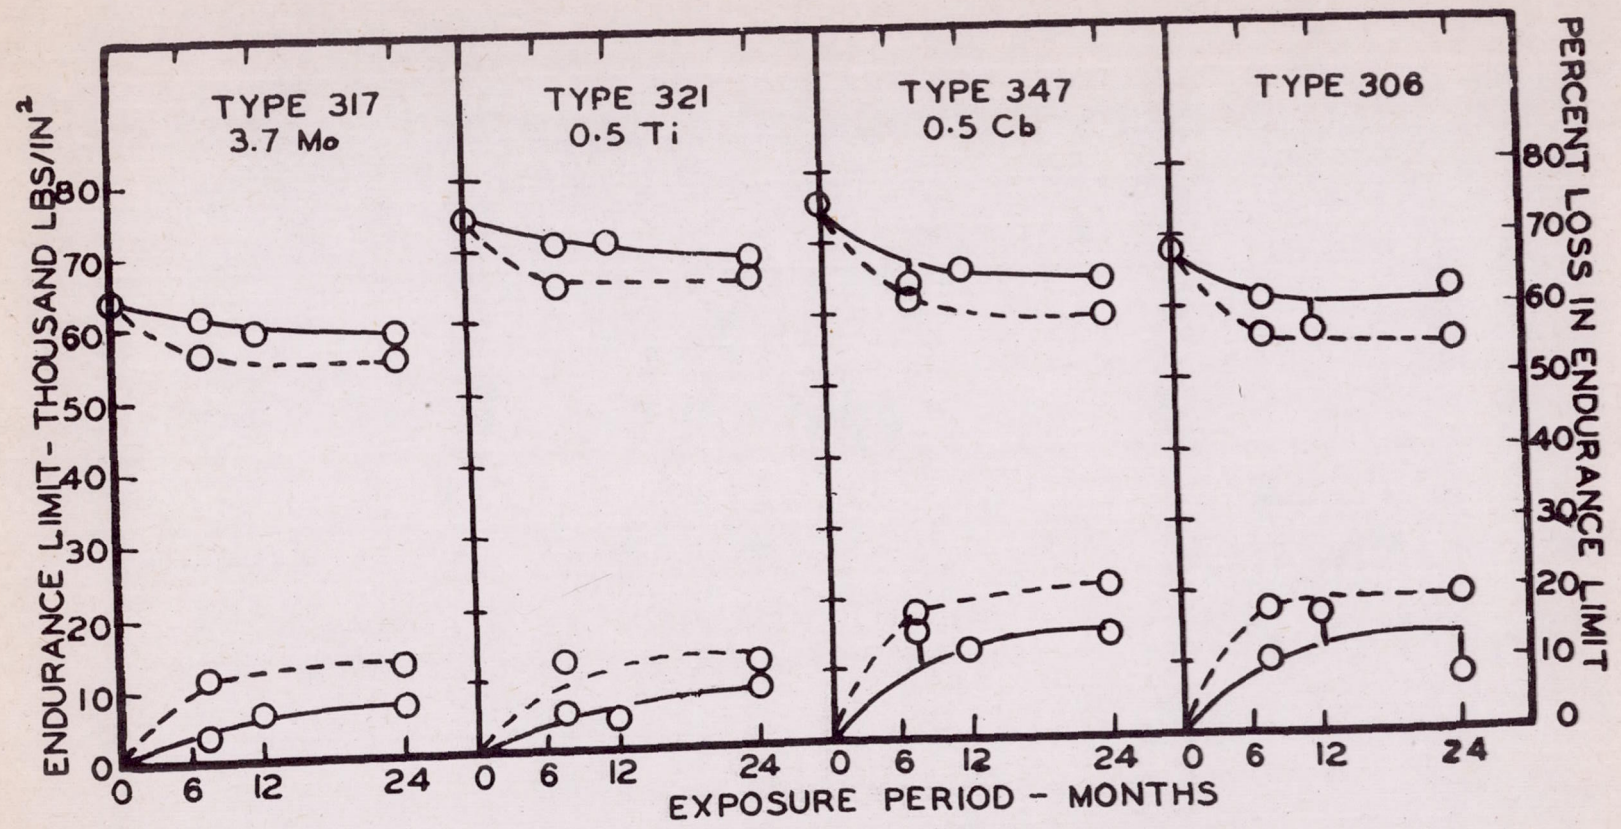
The endurance limits of some 300 specimens have been determined since reference 1 was released, both on panels as received (uncorroded) or on panels removed from the exposure racks during the first 2 years. The endurance limit values reported may be regarded as accurate only insofar as they serve to present a basis of comparison between the alloys tested. The values given (fig. 32 and table III) represent a stress, the half range of which was calculated to be within 800 pounds per square inch of the next highest stress, which resulted in fatigue failure, provided that at least two runs past 10^6 cycles had been made.

Figure 32.- Results of flexural fatigue tests on stainless steel. Solid line curves pertain to specimens exposed to tidewater; broken-line curves pertain to specimens exposed to the weather. The upper curves, in each instance, refer to values for endurance limits; the lower curves to percentage loss. Panels exposed to the weather consistently showed greater loss than those exposed to tide-water for equal periods. Steels containing molybdenum or titanium exhibited appreciably lower losses than those with columbium, or with no elements added to the typical 18 percent chromium, 8 percent nickel alloy (Type 306).
