AN OVERVIEW OF THE CRASH DYNAMICS FAILURE BEHAVIOR OF METAL AND COMPOSITE AIRCRAFT STRUCTURES

Huey D. Carden
NASA Langley Research Center
Hampton, VA

SUMMARY

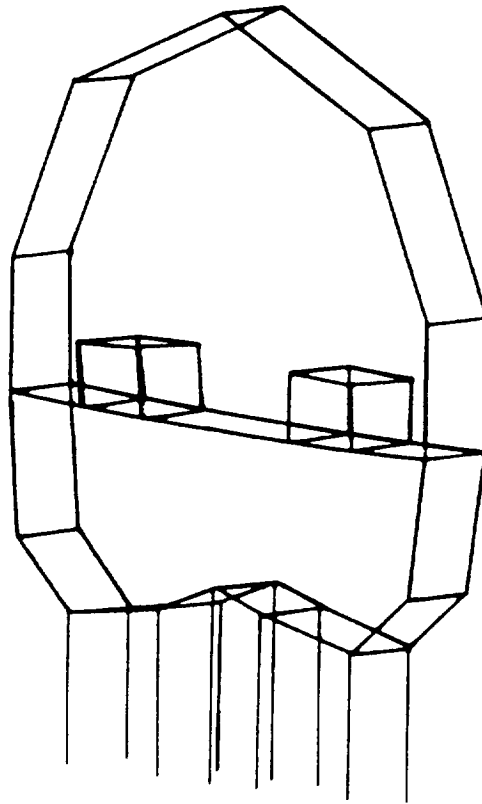
Figure 11.- Computer graphics showing analytical failure of metal transport section.

The predicted deformation pattern of the two frame model is shown in figure 11. As may be noted, the overall impression from the analytical model deformation pattern is quite similar to the visual behavior seen in the experiment shown in figure 9. The full section behavior was basically contained in the two frame model.

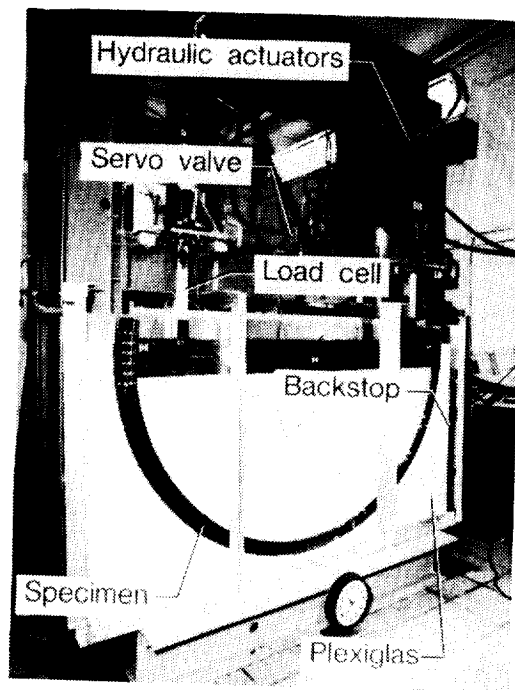
(a) Static test apparatus.

Static tests.- Figure 13 presents static results from tests of single composite Z-frames discussed in reference 26. A photograph of the static test apparatus in figure 13(a) shows that the splice plate was at the load point. The frame failed just outside the doubler splice plate area by a complete fracture across the Z-section. Load-deflection data and the location of failures of the frame are shown in figure 13(b). The load-deflection data show a saw-toothed behavior beginning with the essentially linear behavior of the frame up to initial failure with subsequent loading of the frame after failure being at a new, reduced stiffness for the damaged frame. Photographic data in figure 13(c) show that the initial failure was induced by a local buckling of the frame which occurred at about 18° from the bottom loading point outside the splice plate area. Second and third fractures occurred up the side at about 54° and 58° under continued loading as may be noted in the sketch at the right of figure 13(b). The sequence of events was local buckling near the splice plate induced out of plane deformations which led to a fracture of the section; the ends then remained in contact (jammed together under the compressive loads in the frame), the initial point of fracture moved vertically, essentially in a guided manner until two additional fractures occurred farther up the frame.

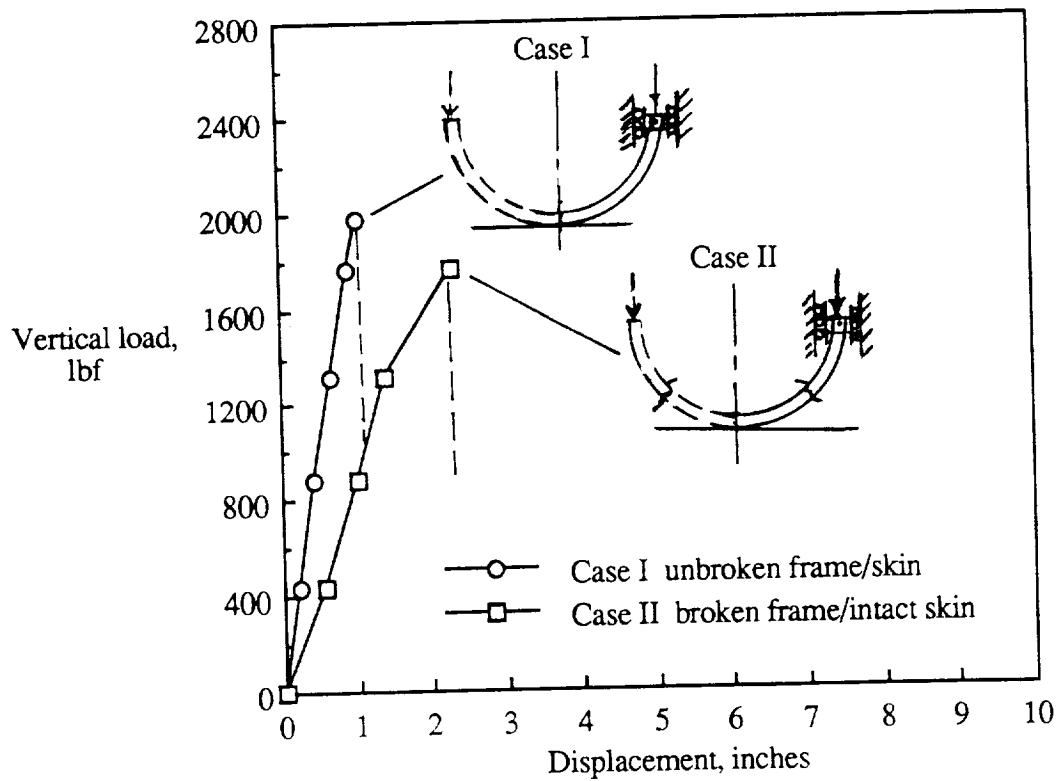
(a) Load-displacement.

Static analytical studies.- To demonstrate analytically the apparent behavior of the frames under load (exclusive of the local buckling which actually initiated the failure in the static case), a DYCAST finite element model was constructed. For ease of analysis, an I-section was modeled from the specimens described in the "Single Composite Frame" section. The frame was loaded at the top and a simulated ground plane (ground contact springs) resisted the vertical movement of the frame during load application. Boundary conditions were imposed at the bottom node of the model to account for the symmetrical situation thus only half the frame had to be modeled. The top node was constrained to allow only vertical displacement thus simulating the effect of a very stiff floor across the frame diameter. The static load was slowly increased until an input failure strain for the material (0.0086) was exceeded at the point of loading and failure was indicated. The curve labeled case I, *unbroken frame*, in figure 14(a) is the load-deflection plot for this case.

A comparison of the analytical cases (figure 14(a)) with the actual static load-deflection of the Z-section (figure 13(b)) indicates very similar load-deflection behavior patterns as discussed above. Although the Z-frame had no skin, if the ends jam together (as they did in several cases), the boundary is effectively between the skin stiffened case and a guided boundary. Thus, the predicted failure location in the simple beam-frame model at about 50° (See figure 14(b)) agrees well with the 54° and 58° failure locations in the experiment with the Z-section frame.

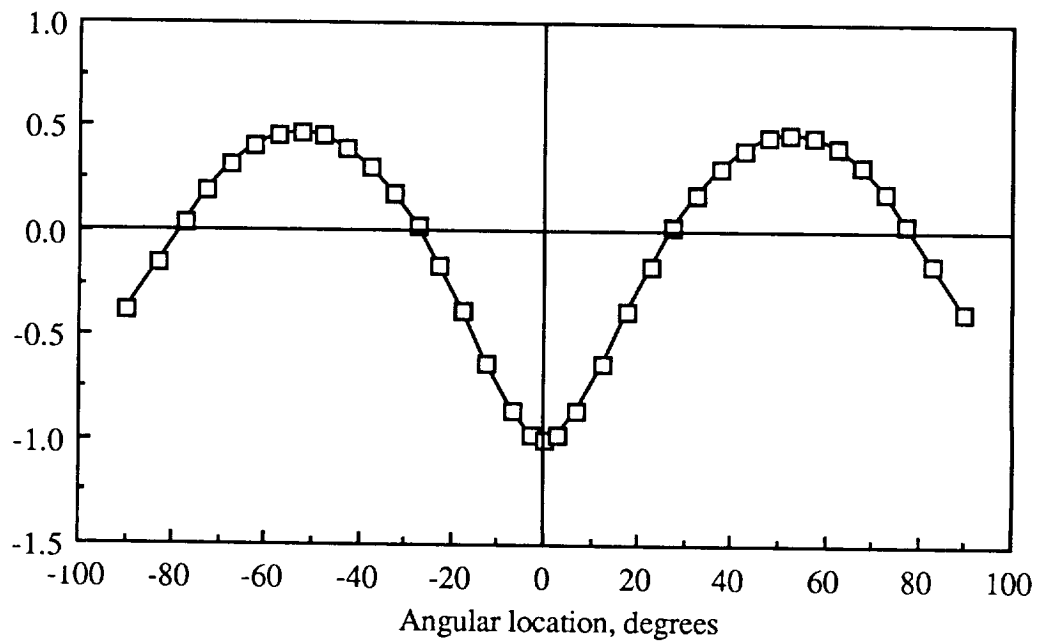
(b) Case I---Normalized moment (Prior to failure).

An examination of the normalized distribution of the bending moment on the frame shown in figure 14(b) provides insight and a better understanding of the failure/behavior. Maximum moments are indicated (just prior to failure) to be at the 0° location and between 50° - 60° from the bottom contact area. The locations correlate well with the failure locations in the experiment with the Z-frame.

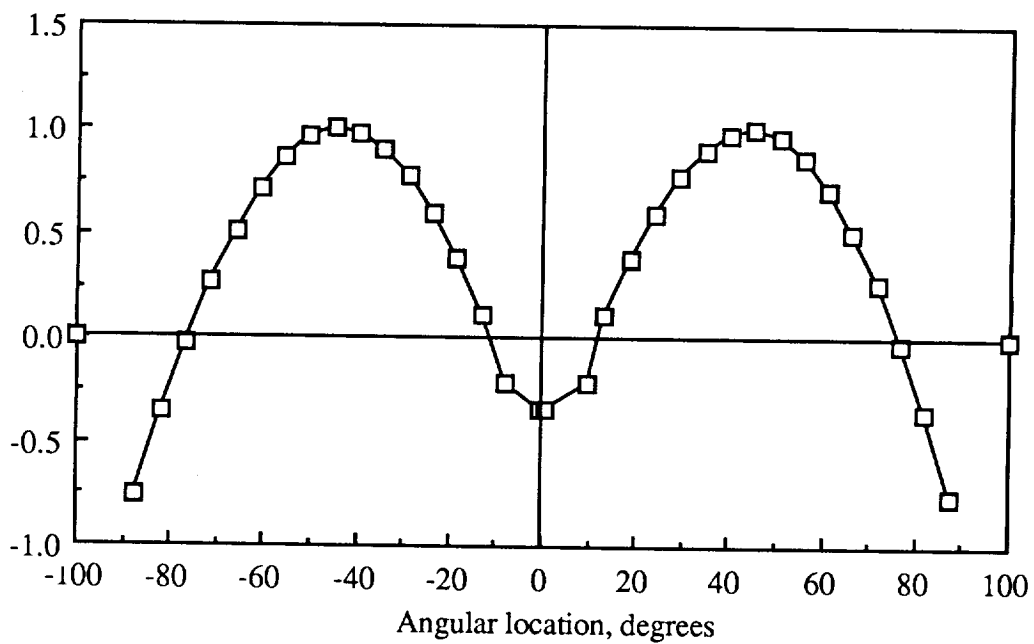
(c) Case II---Normalized moment (Broken frame-intact skin).

Figure 14(c) presents the normalized bending moment distribution on the broken frame. As may be noted, the distribution is quite similar to the initial model results in figure 14(b). The failure location is at the maximum bending moment location predicted to be about 45° which is somewhat lower than the same location shown in the initial model of the unbroken frame. The agreement between the two models, however, is still considered good. The effect of diameter on the moment distribution of the frame was assessed with a model having a 75 inch diameter (twice the initial diameter). The distribution was identical to the smaller diameter results; however, the loads producing the moments differed between the two models (as expected).

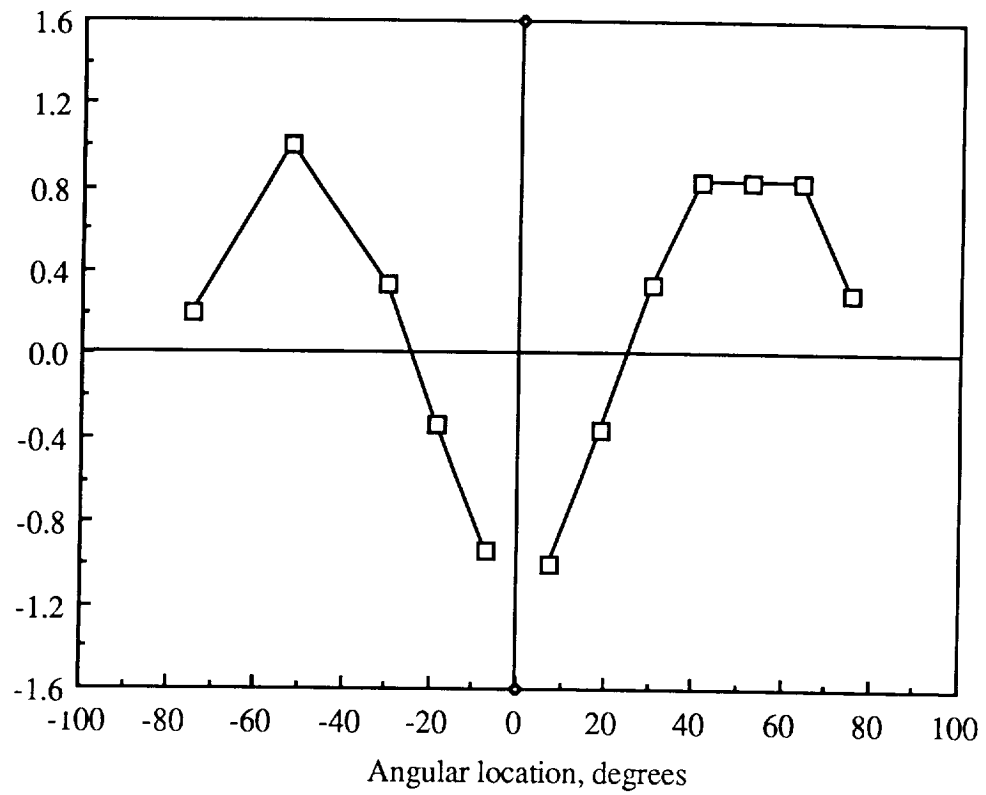
(c) Normalized strain distribution.

Dynamic tests.- Figure 17 shows the skeleton subfloor after an impact test onto a concrete surface at 20 feet per second. In the dynamic test of the skeleton subfloor, fractures were produced at notches in the frames (Figure 17(a)). The locations, shown in figure 17(b), were also near the point of impact (about 11° because of the splice plate) and at two other locations up the circumference of the frames ($\pm 45^\circ$ and $\pm 78^\circ$) and involve all three frames for a total of 15 fractures. The impact energy exceeded the energy absorbed by the local fractures and the floor bottomed out in the impact. Figure 17(c) is a normalized strain distribution measured on the first (end) frame during the dynamic test just before first failure. A comparison of the distribution to the moment distribution of Figure 14(b) and (c) shows essentially identical shape between the single frame and skeleton frame distributions. Maximums at 0° and at approximately $\pm 50^\circ$ to 55° agree well with the analytically predicted locations on the frame.

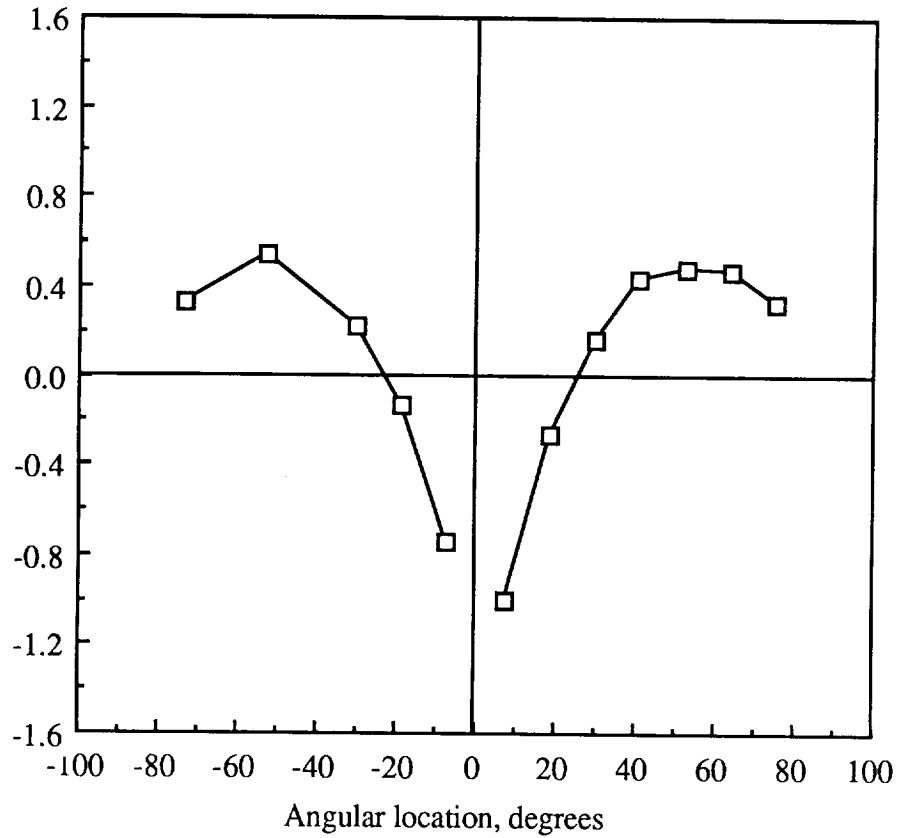
(c) Normalized strain distribution.

Figure 18 presents impact results for the subfloor with skin after an impact of 20 feet per second. Figure 18(a) is the subfloor specimen after the test. Points of failure of the frames in this specimen are indicated in figure 18(b). Again the points of failure are at/near the impact point (within 12°) and on the circumference at about $\pm 56^\circ$ up both sides of the frame on the middle and back frame and 11°, 22.5° and 45° on the front frame. It was observed that the subfloor impacted first on the front area which possibly explains the 11° and 22.5° fractures being different from the other locations. Again all three frames were involved in the failures. Some delamination of the frames from the skin was evident but the skin remained intact. Figure 18(c) is a normalized strain distribution (just prior to first failure) measured on the first (end) frame during the dynamic test. A comparison of the distribution to the moment distribution of Figure 14(b) and (c) and the strain distribution in Figure 18(c) shows essentially identical shape as the single frame and skeleton frame distributions. As was the case for the skeleton subfloor maximums at 0° and at approximately $\pm 50^\circ$ to 55° agree well with the analytically predicted locations on the frame.

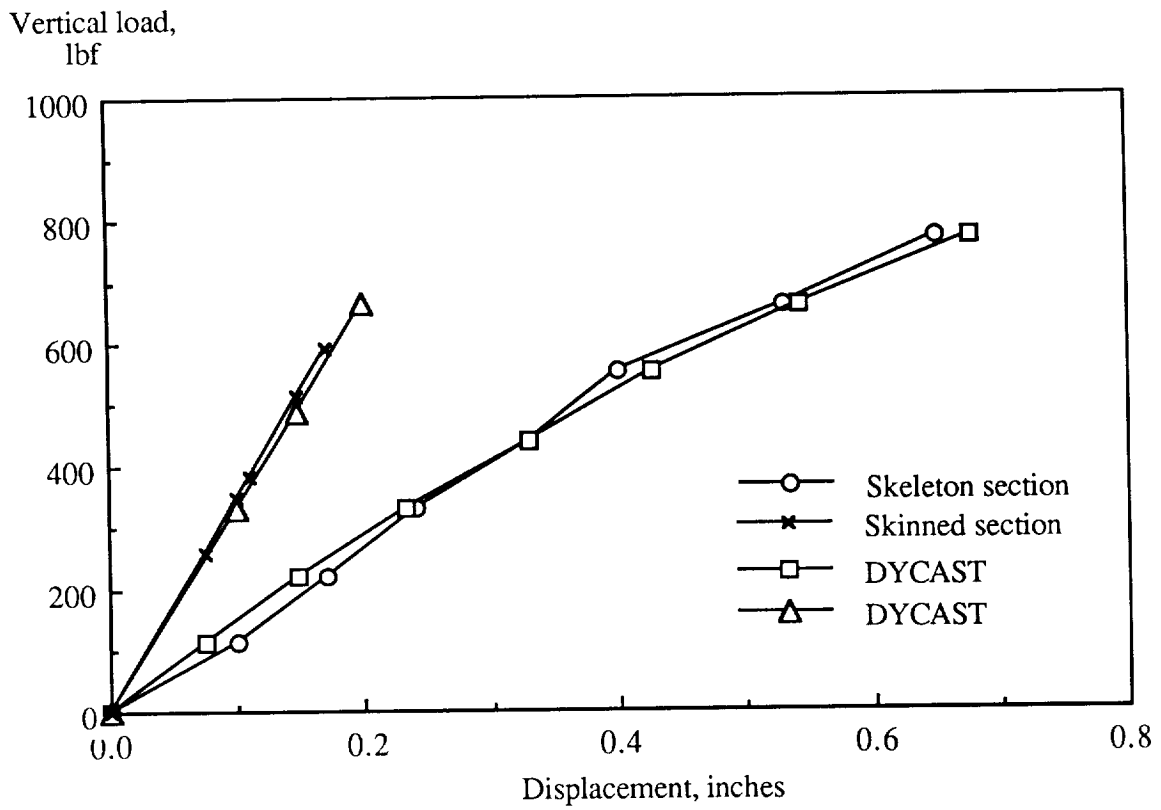
Analytical studies.-The contribution of the skin to the stiffness of the section with the antisymmetric frames is illustrated in figure 19. Static load-deflection data for the unskinned subfloor and the skinned subfloor along with the DYCAST predictions are shown in the figure. It can be noted that the subfloor stiffness (with skin) is approximately three times the stiffness of the skeleton subfloor, thus the skin's contribution to the structure is to maintain in-plane deflections of the non-symmetrical Z-section and prevent any substantial twisting of the frames. Out-of-plane bending and twist were allowed in the skeleton subfloor predictions. As a further note of interest, if for the skeleton subfloor, load in the load-deflection results (with three frames) is reduced by a factor of three, good correlation with single frame data is evident.

Figure 19.- Comparison of experimental and analytical stiffness of skeleton and skinned composite subfloors.
