SPACE ENVIRONMENTAL EFFECTS ON LDEF COMPOSITES: A LEADING
EDGE COATED GRAPHITE EPOXY PANELPete E. GeorgeBoeing Defense and Space Group
Seattle, Washington 98124-2499 M/S 73-09
Phone: 206/234-2679, Fax: 206/237--0052

SUMMARY

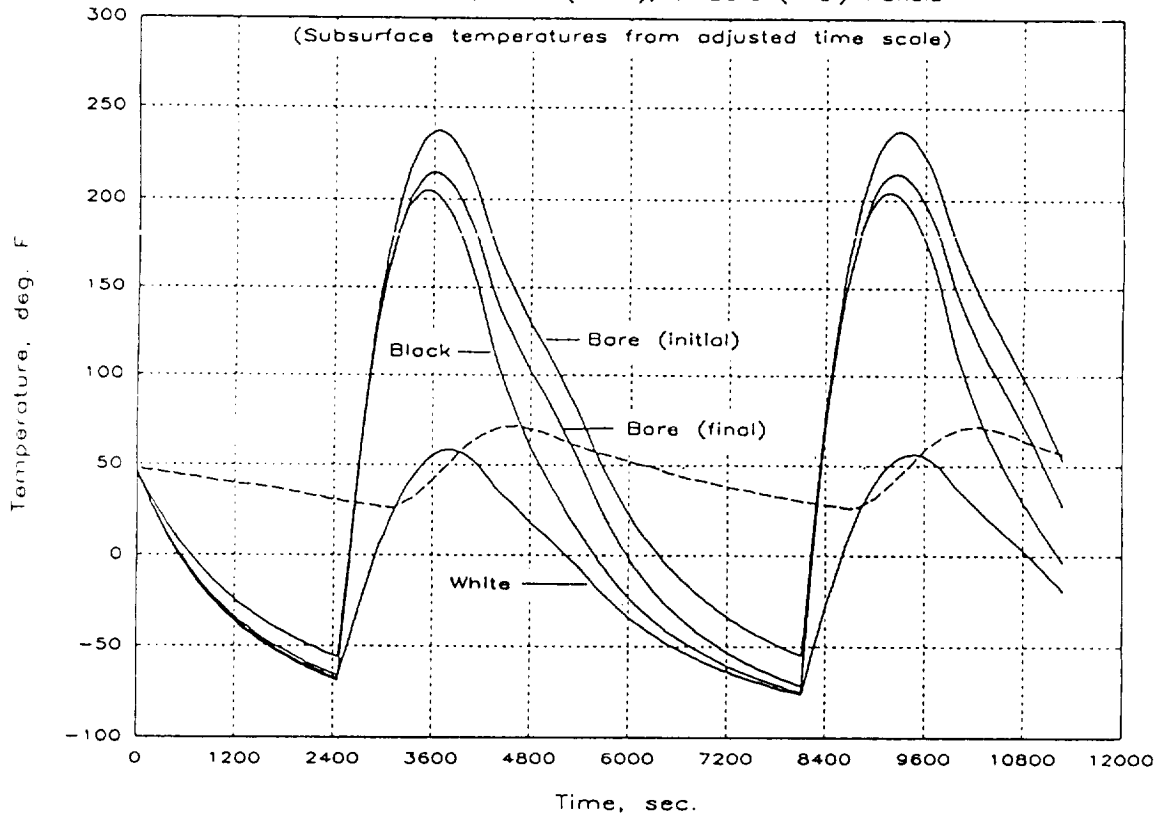
FIGURE XIV - RESULTS OF THERMAL CYCLE MODELING FOR LDEF
EXPOSURE OF T300 GRAPHITE 934 EPOXY PANEL

Undoubtedly other factors came into play during microcrack formation. The panel was restrained by the mounting points possibly interfering or aggravating the thermal expansion or contraction of the panel. AO erosion, which may have provided possible crack initiation sites in the black and bare coated quadrants, basically removed one ply from the bare quadrant creating an unbalanced layup. Finally, the heating and cooling from direct and reflected solar radiation occurred on one side of the panel possibly creating a significant thermal gradient through the thickness of the panel. Indeed there is more cracking in the exposed outer three plies than the shielded inner three plies for all the quadrants. The white coatings did adequately minimize thermal stresses in their quadrants to effectively prevent substrate microcracking. However, due to the complexity of the thermal stresses experienced by the panel, extracting quantitative design data from these results would be challenging.

The thermal cycling/microcracking results may offer the most useful information for space composite hardware designers. Adjustment of the thermal cycle calculations for the white coated regions will be necessary due to the temporary UV degradation of optical properties before AO bleaching occurred. CTE measurements of samples from the quadrants may reveal microcrack induced changes. Also, thermal cycling specimens from the white coated quadrants to the same extremes experienced by the black coated and bare quadrants followed by microcrack inspections will help verify the thermal modeling. Finally, incorporation of these results with additional ground based testing and existing work could lead to development of a comprehensive LEO exposure/microcracking model allowing refined prediction of mechanical properties.
