NASA Technical Memorandum TM 107556

Debris/Ice/TPS Assessment And Integrated Photographic Analysis For Shuttle Mission STS-53

DEBRIS/ICE/TPS ASSESSMENT
AND
PHOTOGRAPHIC ANALYSIS
OF
SHUTTLE MISSION STS-53

December 2, 1992

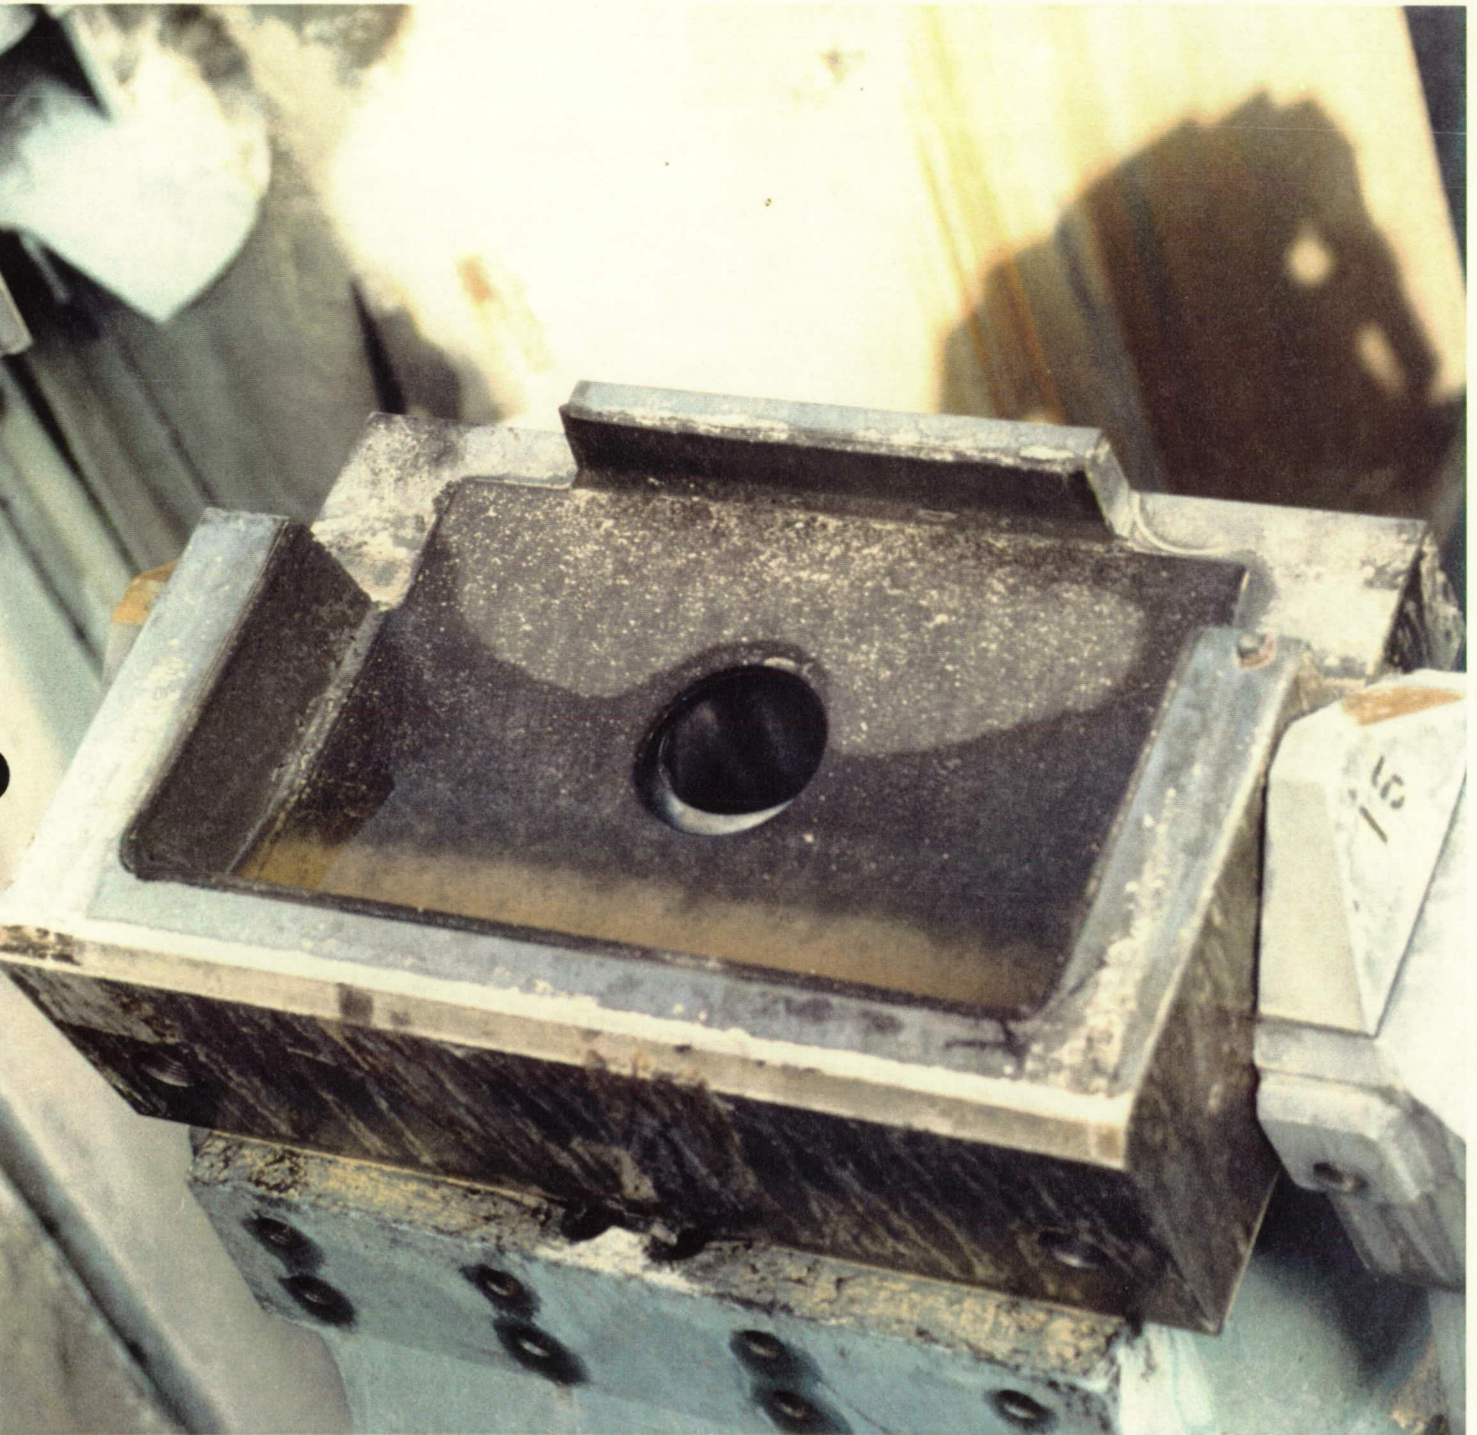
Plume erosion of the south SRB holddown posts was typical. EPON shim material was intact but slightly debonded from the sidewalls of the holddown post shoes.

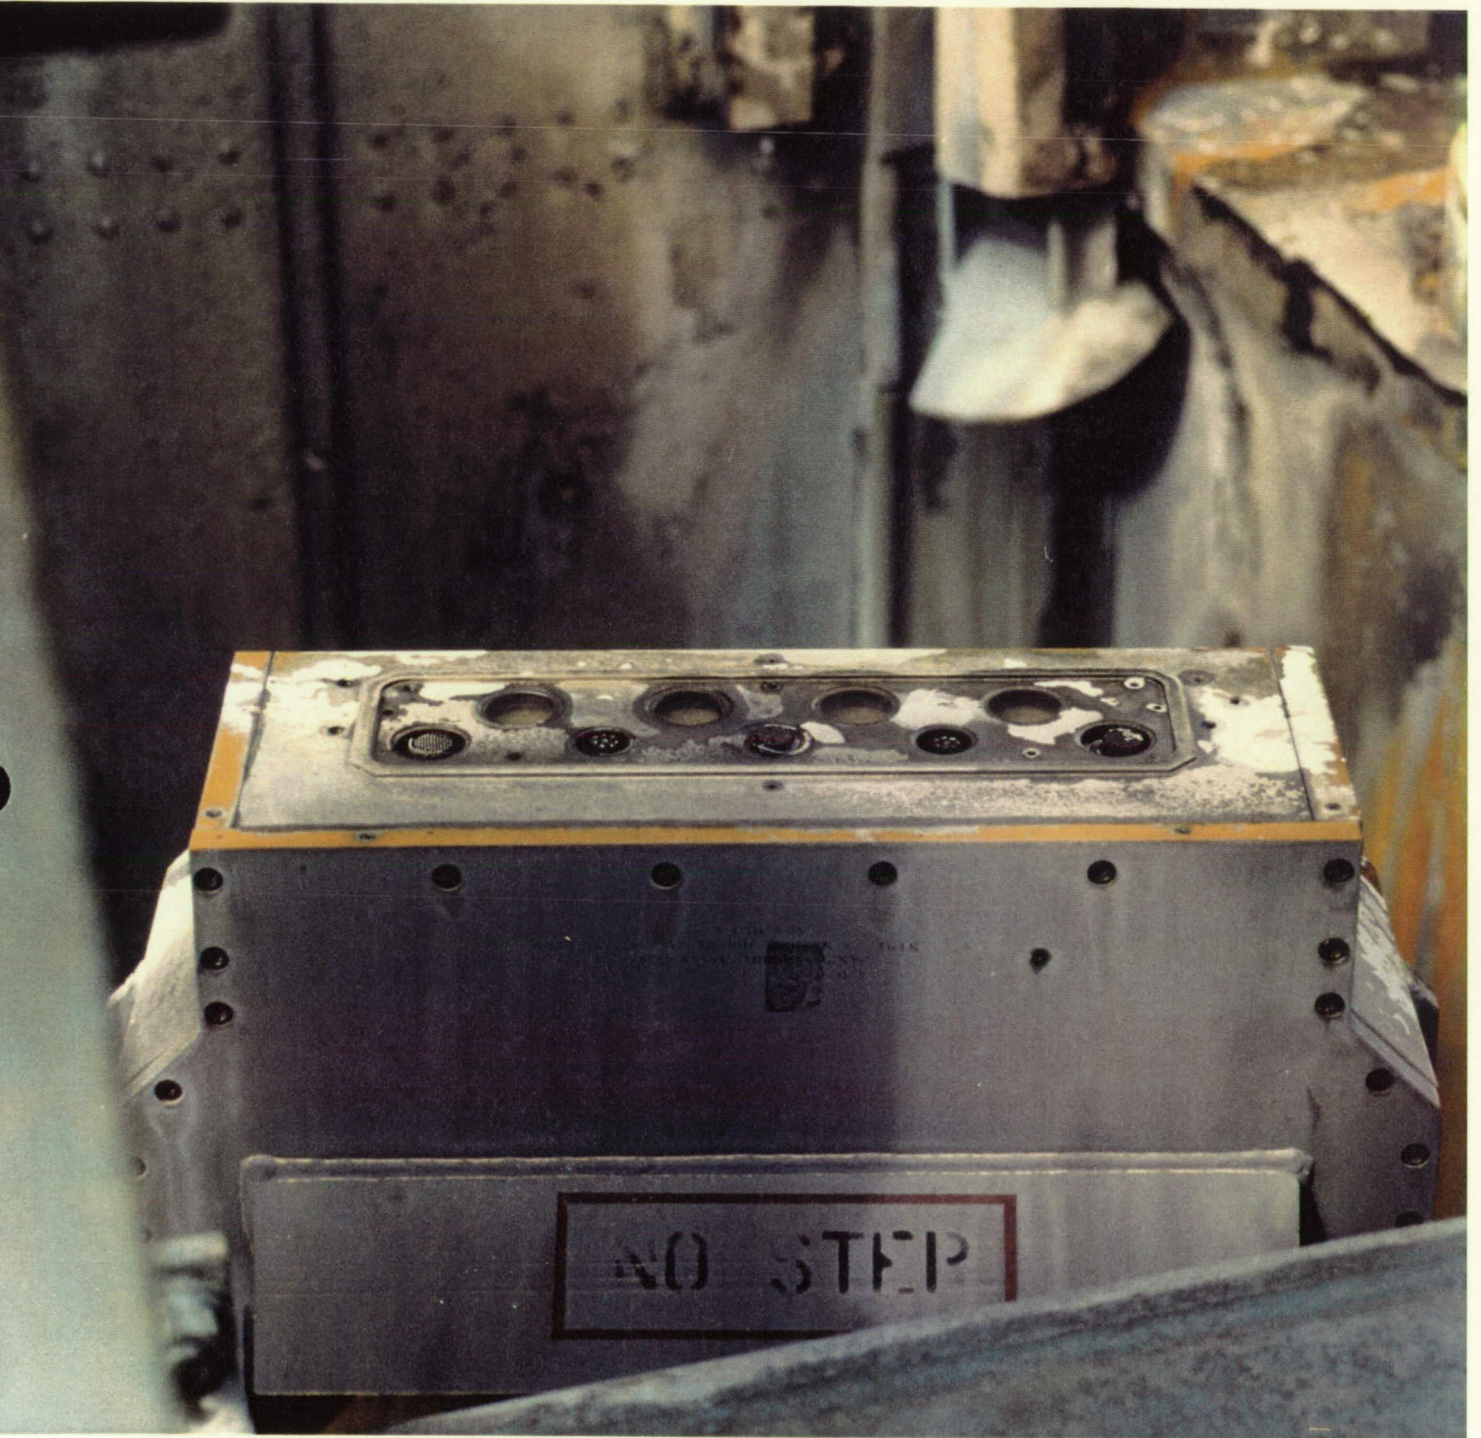
Deletion of aft skirt strain gauges resulted in less electrical connector sacrificial pieces on the SRB T-0 umbilical exposed to the SRB plume.

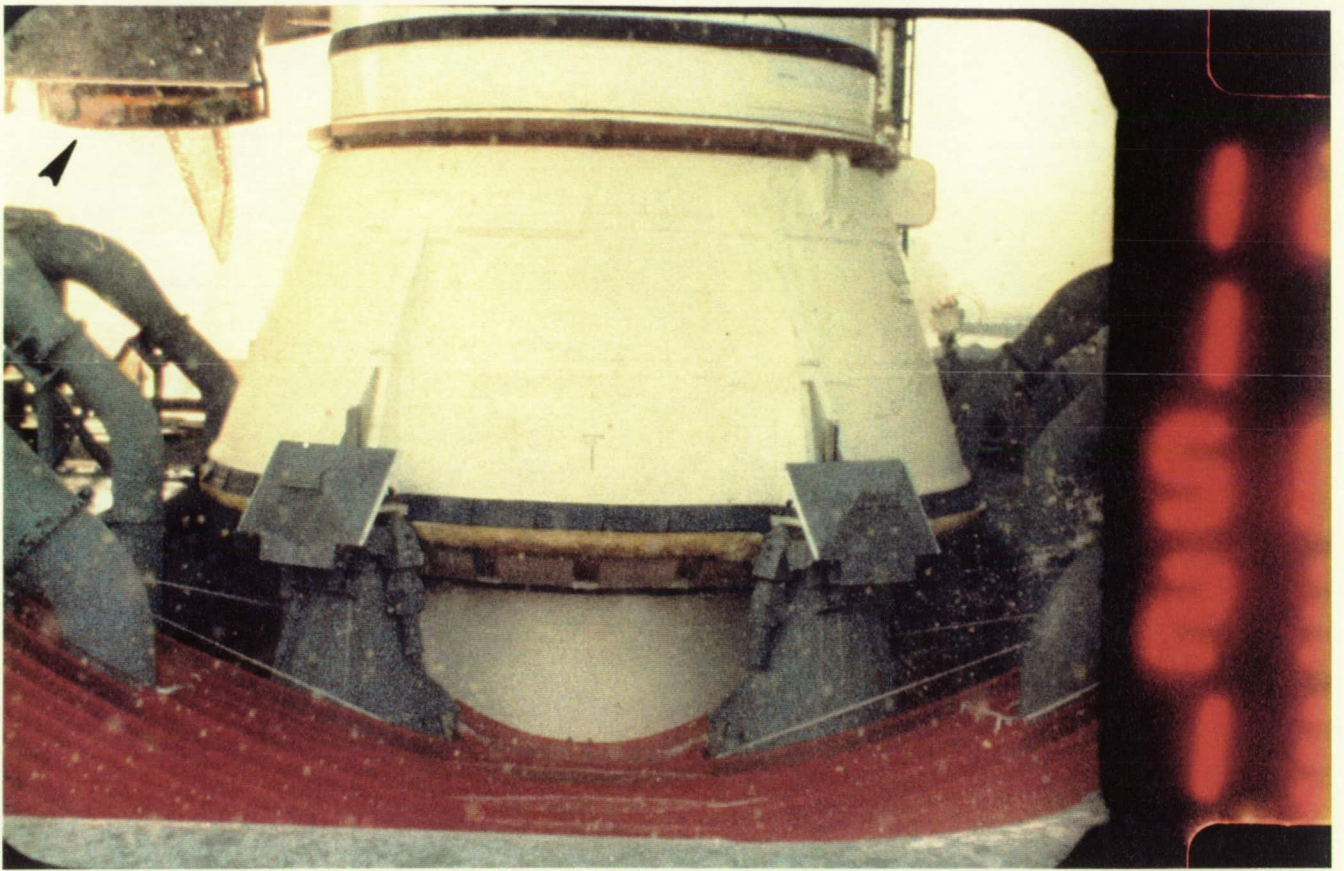
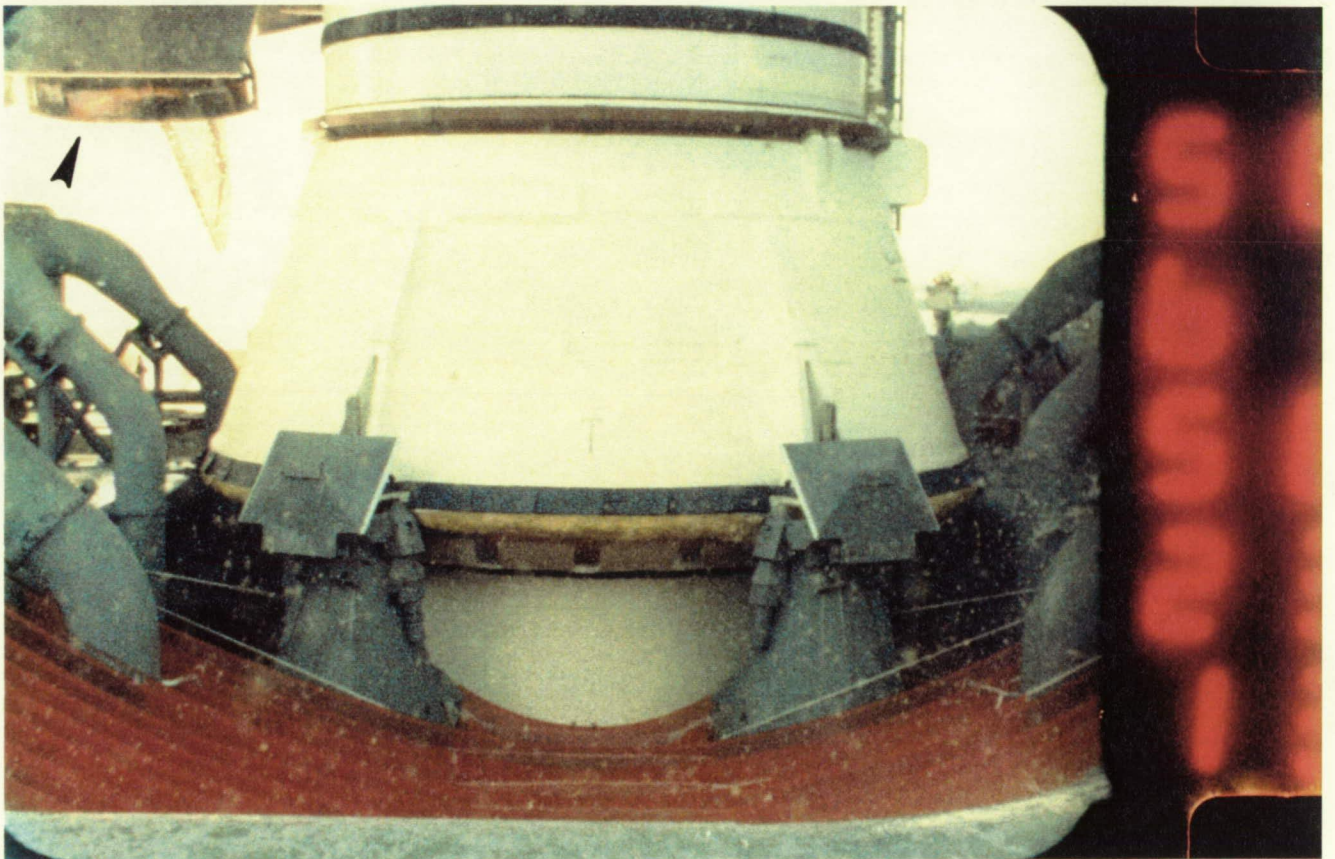
Orange vapor (burning hydrogen) was visible between the exit plane and the #9 hatband near the steer horn, or the coolant manifold, on the SSME #2 nozzle -Z side. This event may be indicative of a cold wall hydrogen leak.

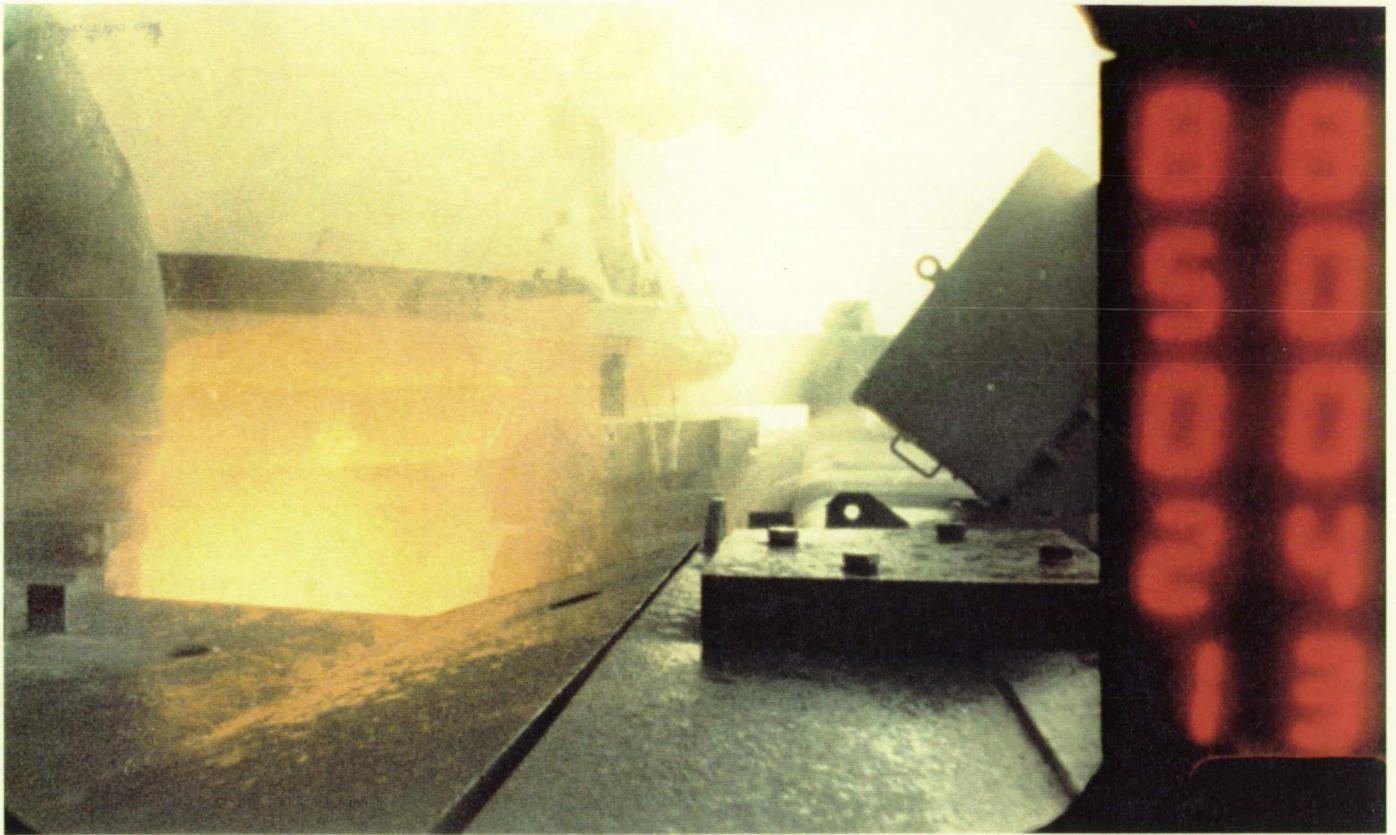
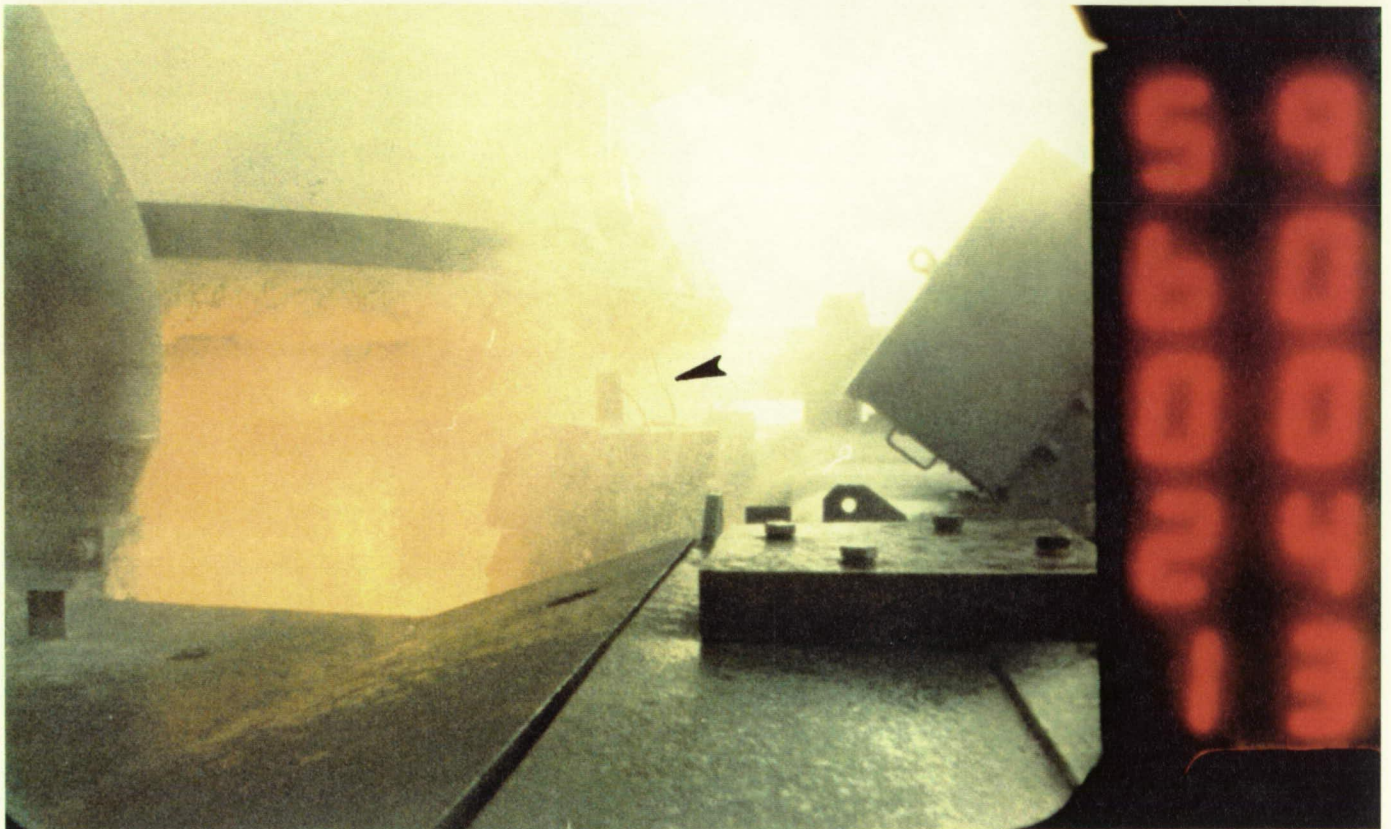
A stud hang-up occurred on HDP #1. One piece of ordnance debris fell from the DCS/stud hole into the HDP haunch area and may have been a frangible nut web.

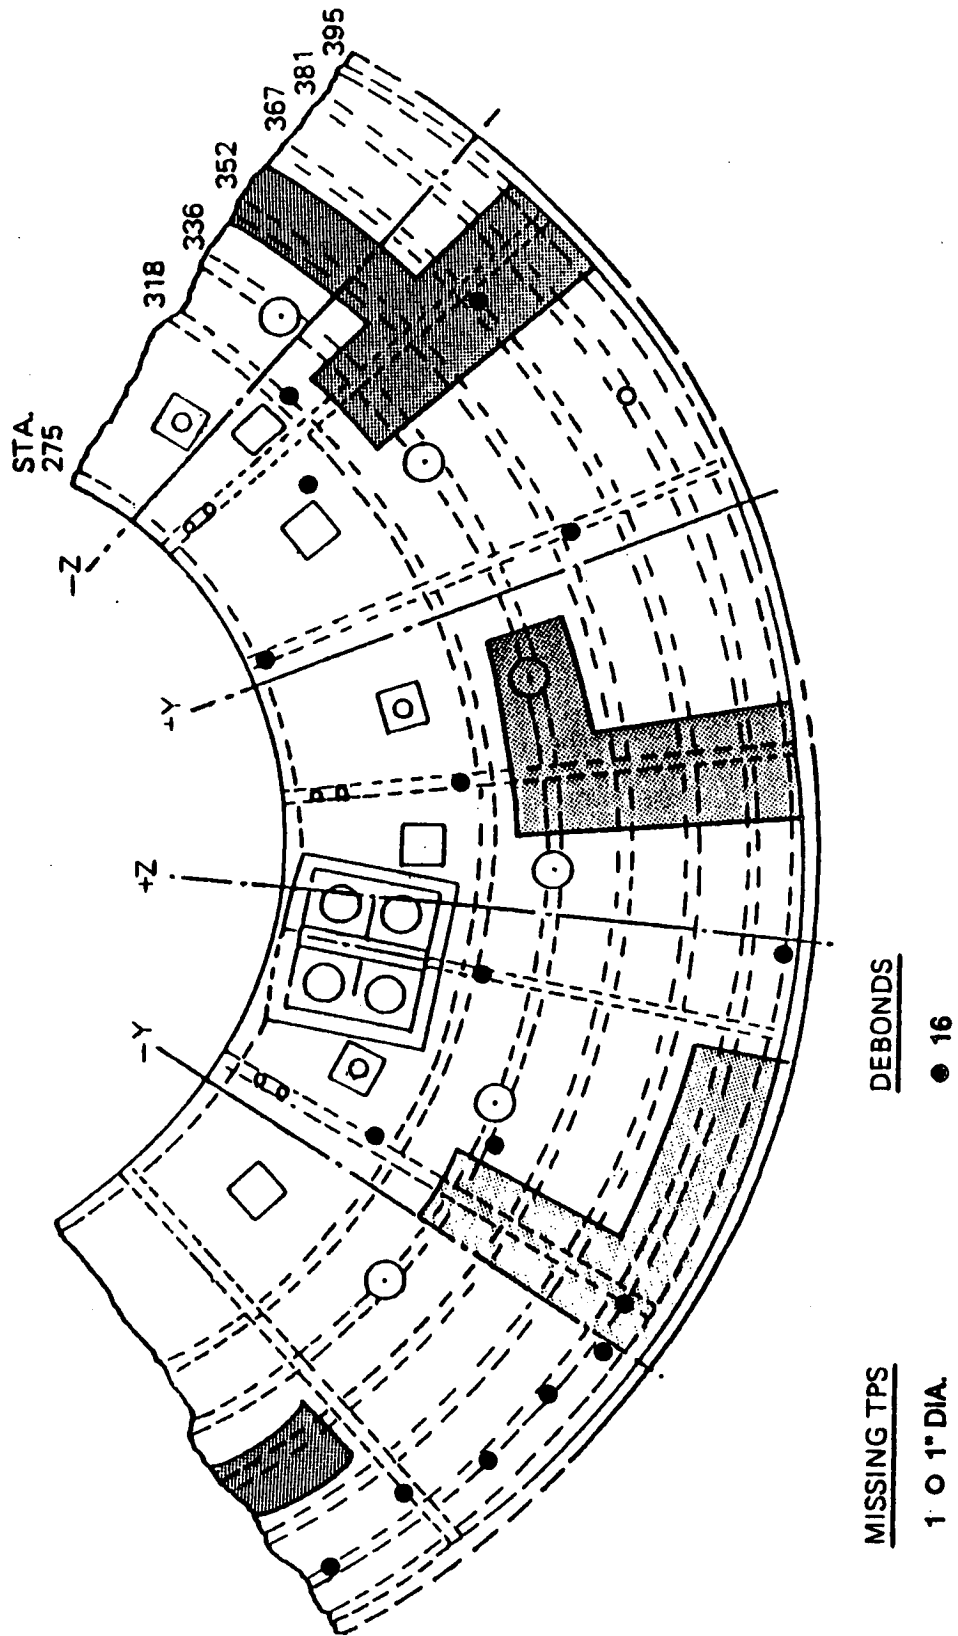
Figure 4. RIGHT SRB FRUSTUM

The RH frustum had 16 MSA-2 debonds and one 1-inch diameter area of missing TPS between the +Y and -Z axes at the 381 ring frame (Figure 4). Minor localized blistering of the Hypalon paint had occurred along the 395 ring. All BSM aero heatshield covers were locked in the fully opened position.

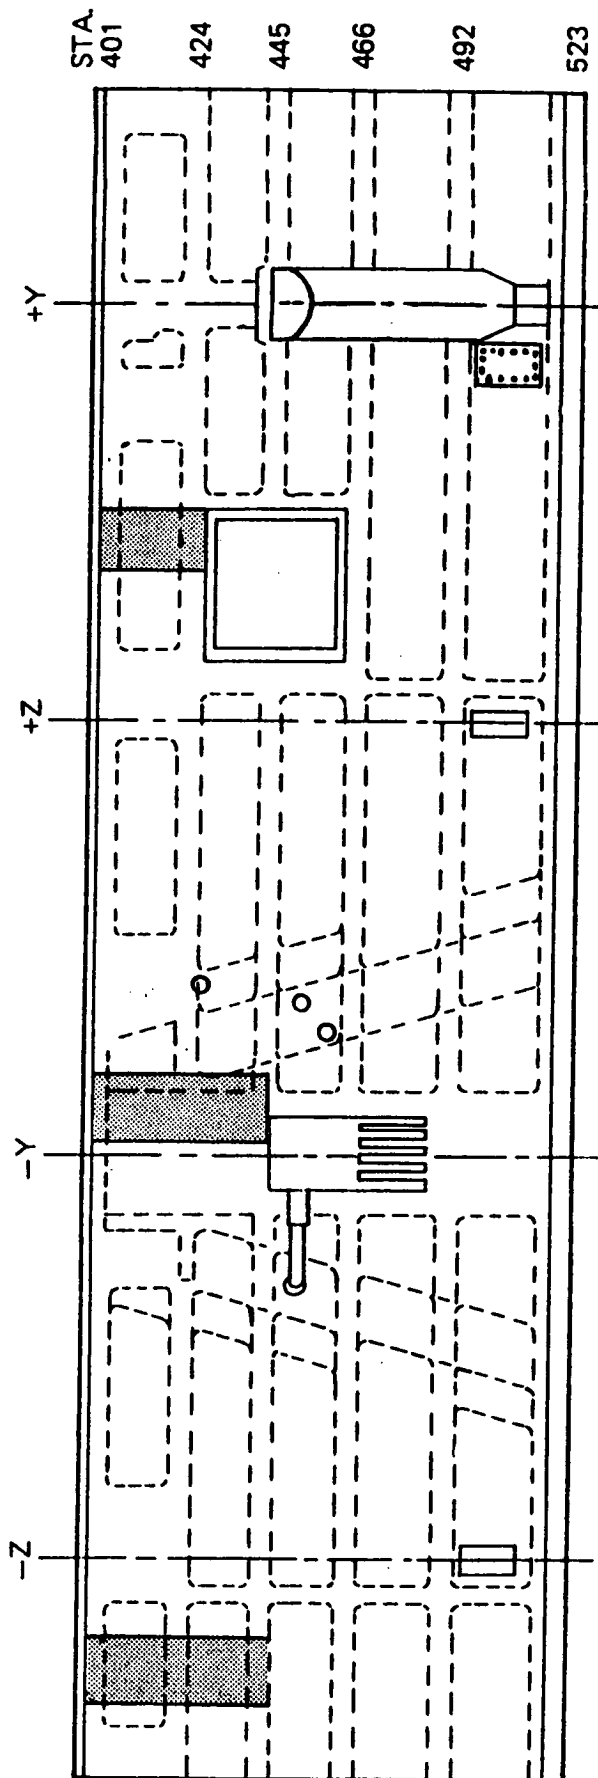
Figure 5. RIGHT SRB FWD SKIRT

The RH forward skirt exhibited no debonds or missing TPS. Both RSS antennae covers/phenolic base plates were intact. Minor blistering of the Hypalon paint occurred on the systems tunnel cover and around the ET/SRB attach point (Figure 5). No pins were missing from the frustum severance ring. The forward separation bolt and electrical cables appeared to have separated cleanly.

MINOR BLISTERING OF
HYPALON PAINT ON SYSTEMS
TUNNEL COVER AND AROUND
ET/SRB ATTACH POINT

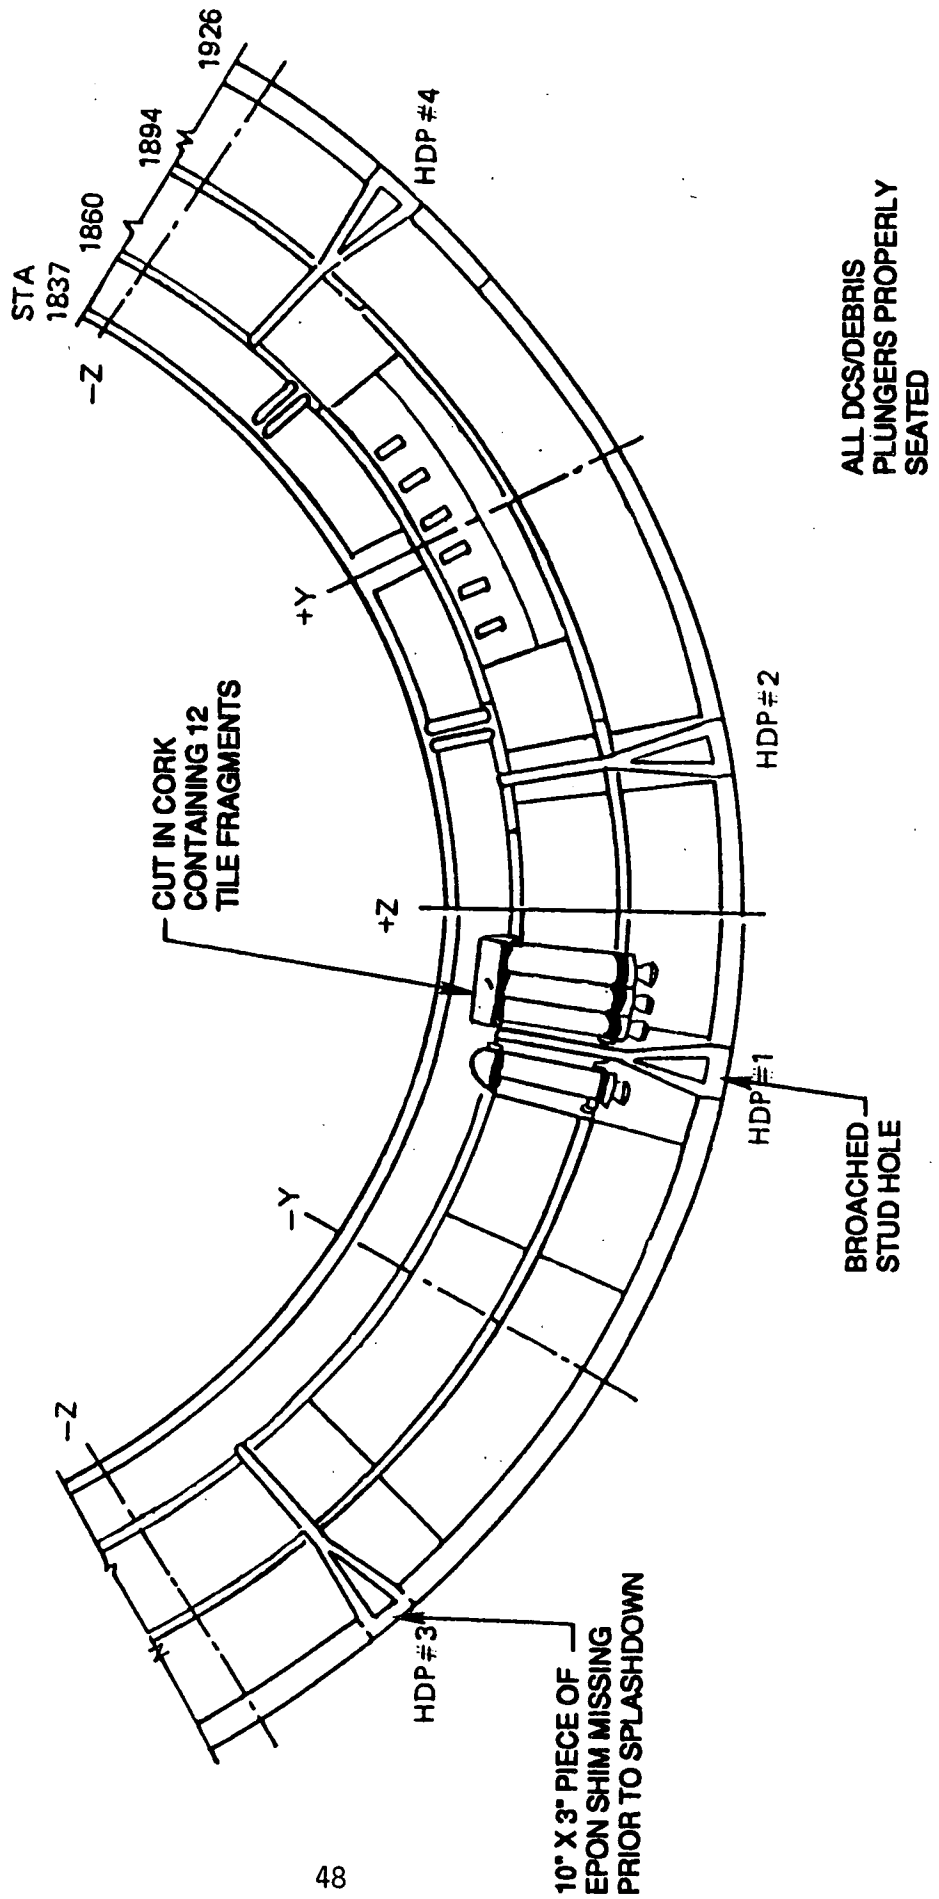
Figure 6. RIGHT SRB AFT SKIRT EXTERIOR TPS

The HDP #1 stud hole was broached due to a stud hang-up. A 10"x3" area of EPON shim was missing from HDP #3 (Figure 6). The material was lost prior to water impact (sooted/charred substrate). All Debris Containment System (DCS) plungers were seated properly.

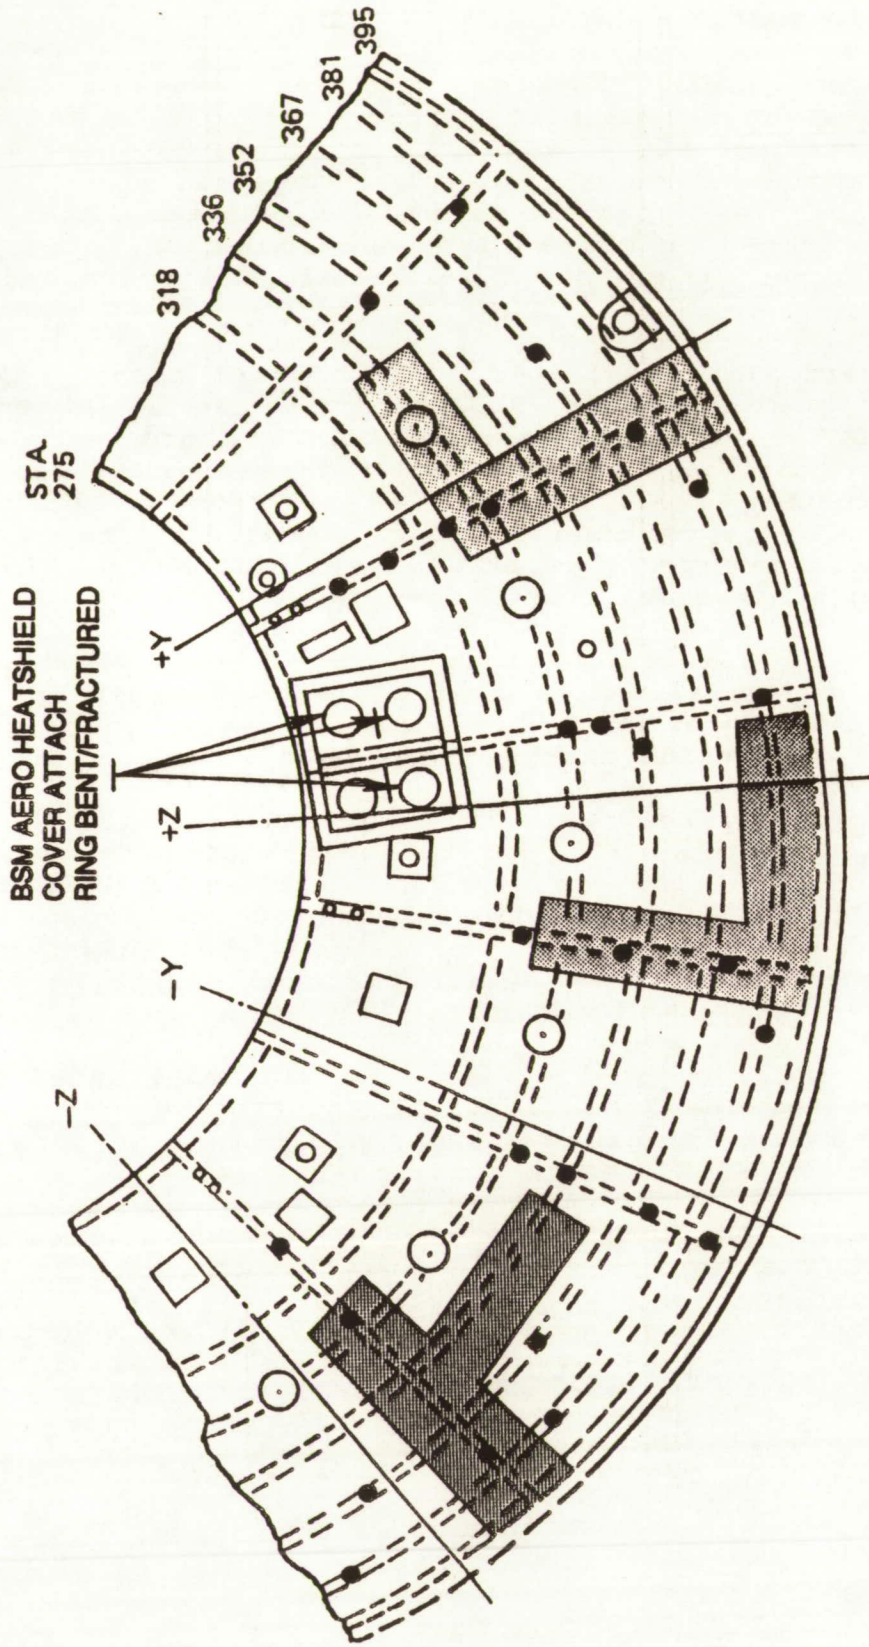
Figure 7. LEFT SRB FRUSTUM

The LH frustum had 28 MSA-2 debonds over fasteners. Torn and missing MSA-2 (1-inch diameter) from one location between the +Y and +Z axes just aft of the 336 ring frame may have been the result of handling damage (Figure 7). There was minor localized blistering of the Hypalon paint. The BSM aero heat shield covers were locked in the fully opened position, though three of the four cover attach rings had been bent by parachute riser entanglement.

MISSING TPS
1 0 ~ 1 SQ. IN

DEBONDS
28 ●

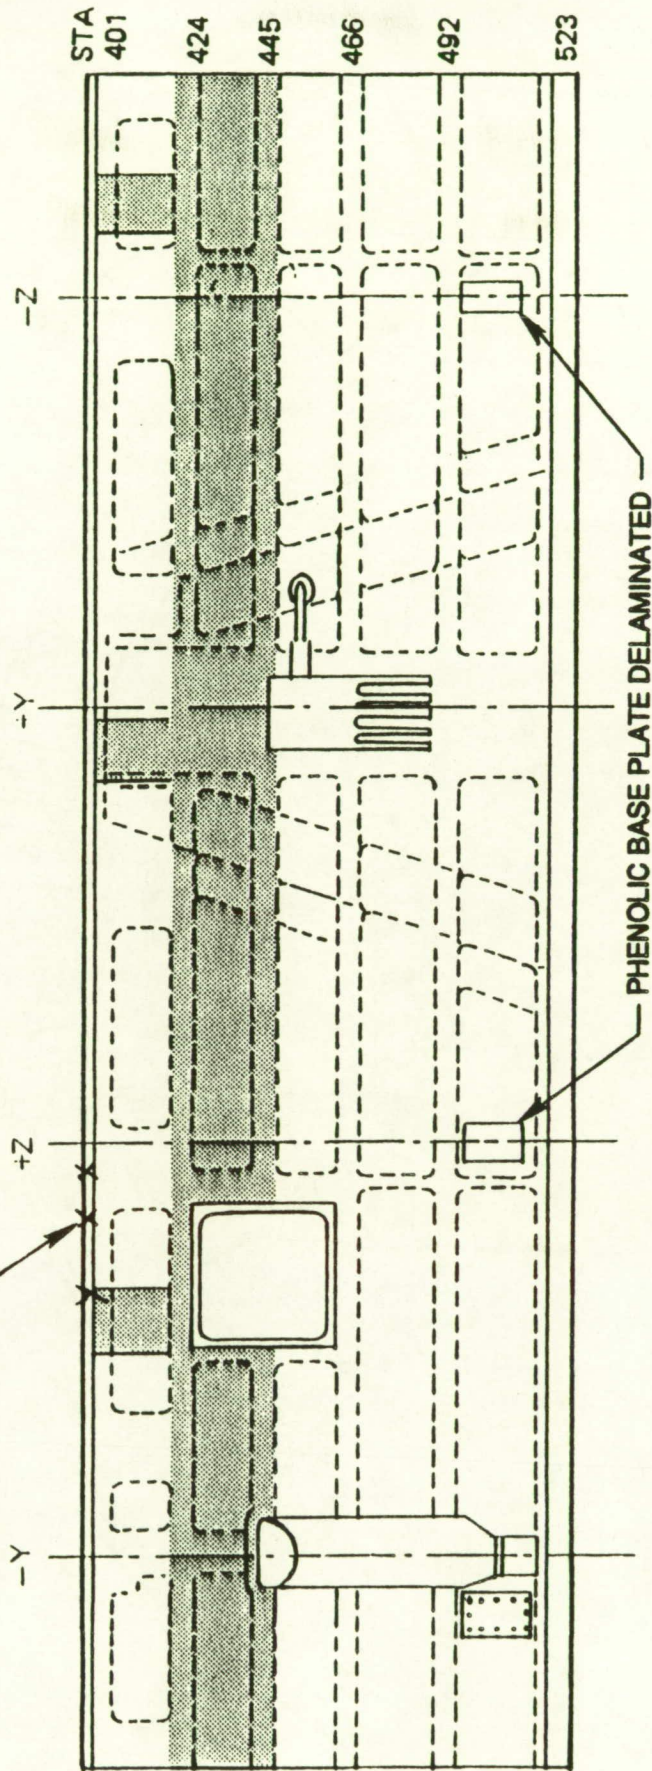
LEFT SRB FWD SKIRT

3 FRUSTUM SEVERANCE
RING PINS MISSING

MINOR BLISTERING OF
HYPALON PAINT ON SYSTEMS
TUNNEL COVER AND AROUND
ET/SRB FITTING

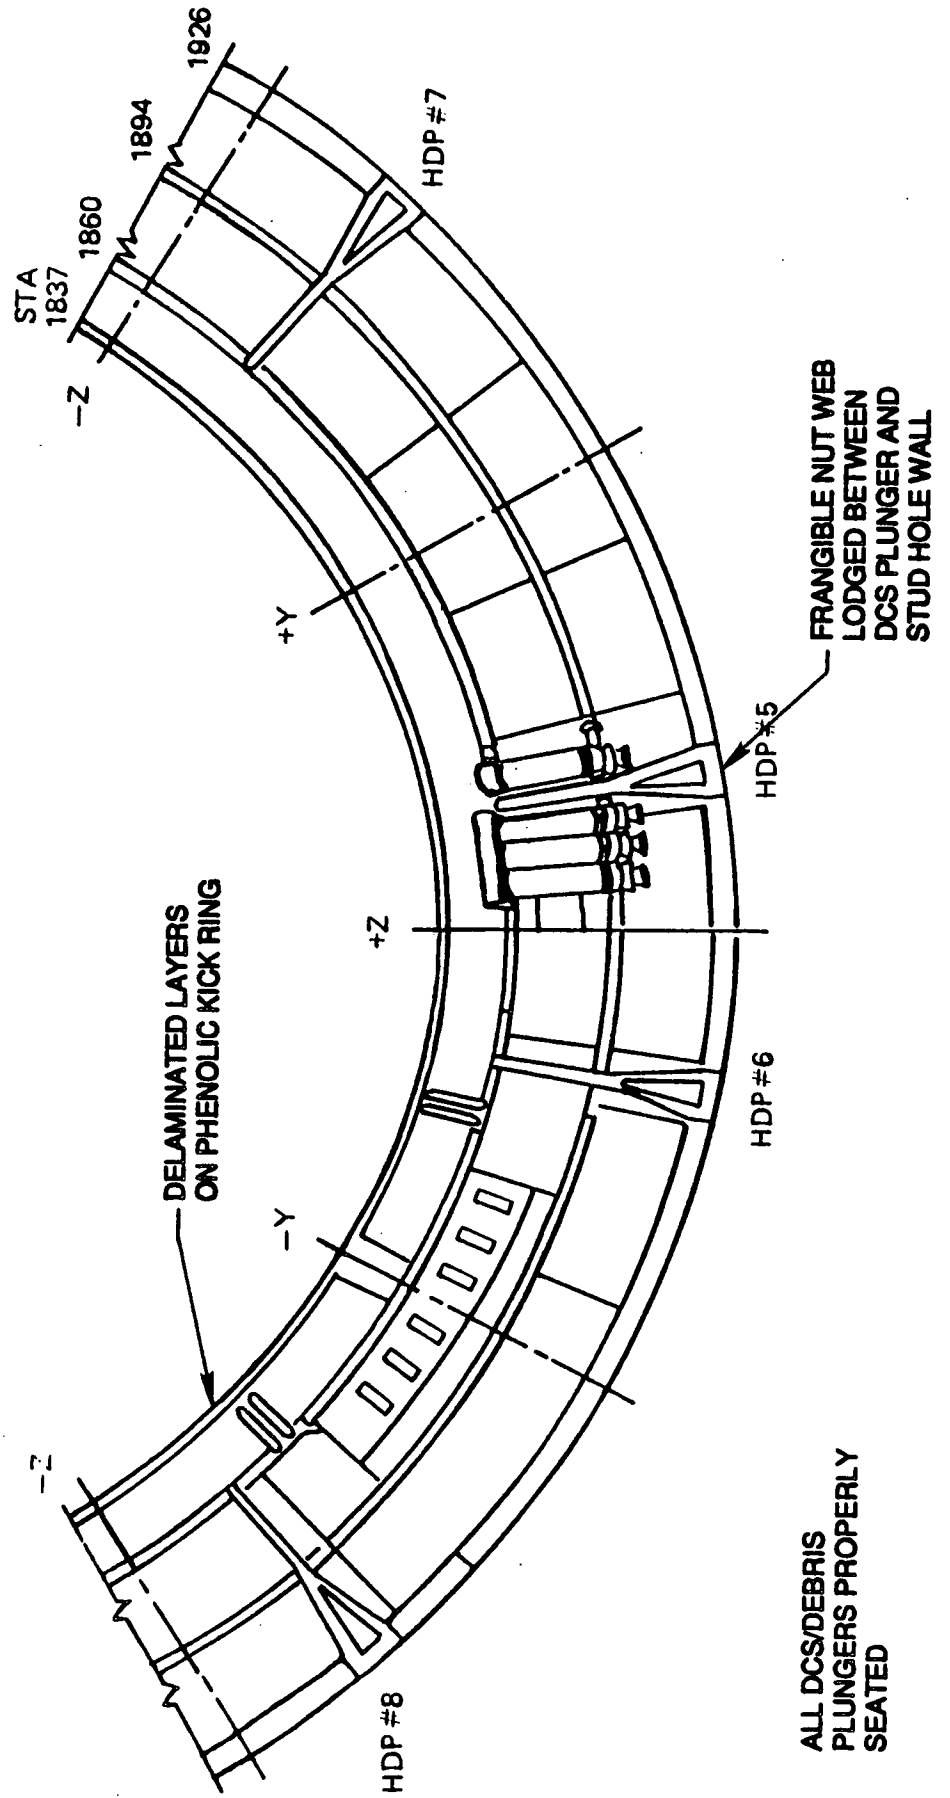
Figure 9. LEFT SRB AFT SKIRT EXTERIOR TPS

All four Debris Containment System (DCS) plungers were properly seated, though a frangible nut web was caught between the DCS debris plunger and the stud hole wall. The small K5NA repair on the inside of the HDP #5 foot, which was applied 24 hours prior to launch, was intact. None of the EPON shim material was lost prior to water impact (Figure 9).

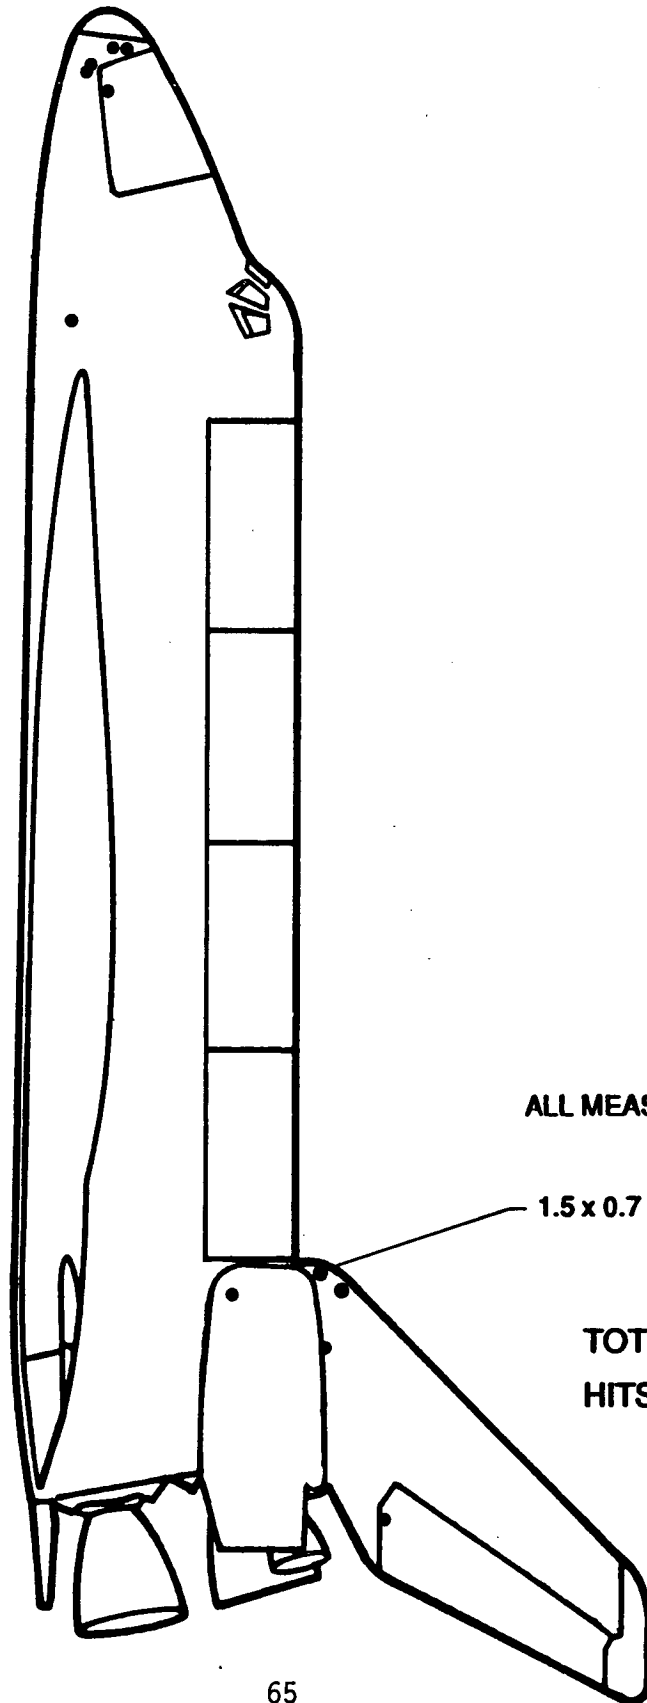
Figure 11. **DEBRIS DAMAGE LOCATIONS**

The tiles on the left OMS pod leading edge sustained more damage than usual. Access to this area was not available at Dryden, therefore the number of impact sites and dimensions shown in Figure 11 are approximate. The cause of this damage is still undetermined.

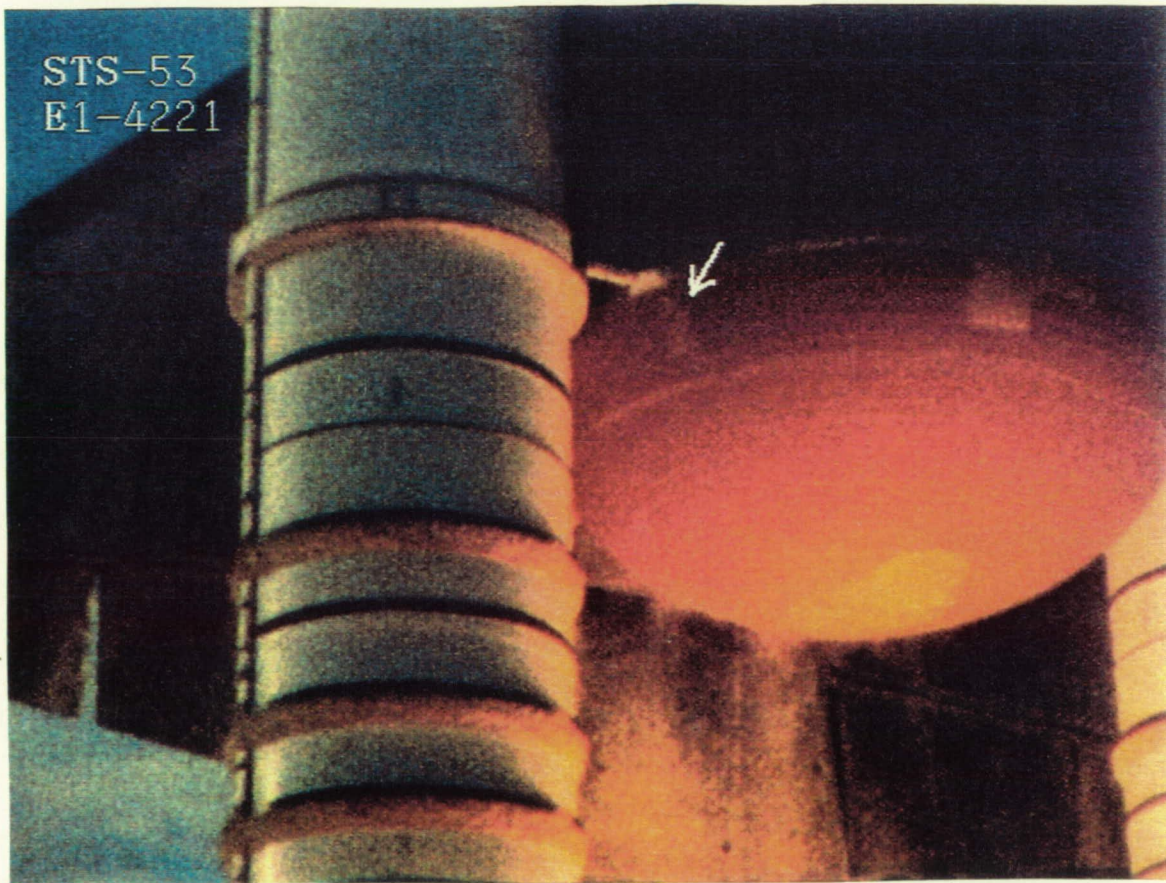
White debris, probably ice, originated from the north side of the ET/RSRB and the ET/LSRB aft attach struts and fell aft prior to and during liftoff. No further photographic analysis has been requested.

Figure 2.1.1.3 White Debris from the North Side of the ET SRB Aft Attach Struts

Figure 2.1.1.3 shows the white debris falling from the north side of the RSRB/ET aft attach strut. The debris falls aft and south between the SRBs but did not appear to strike the SLV.

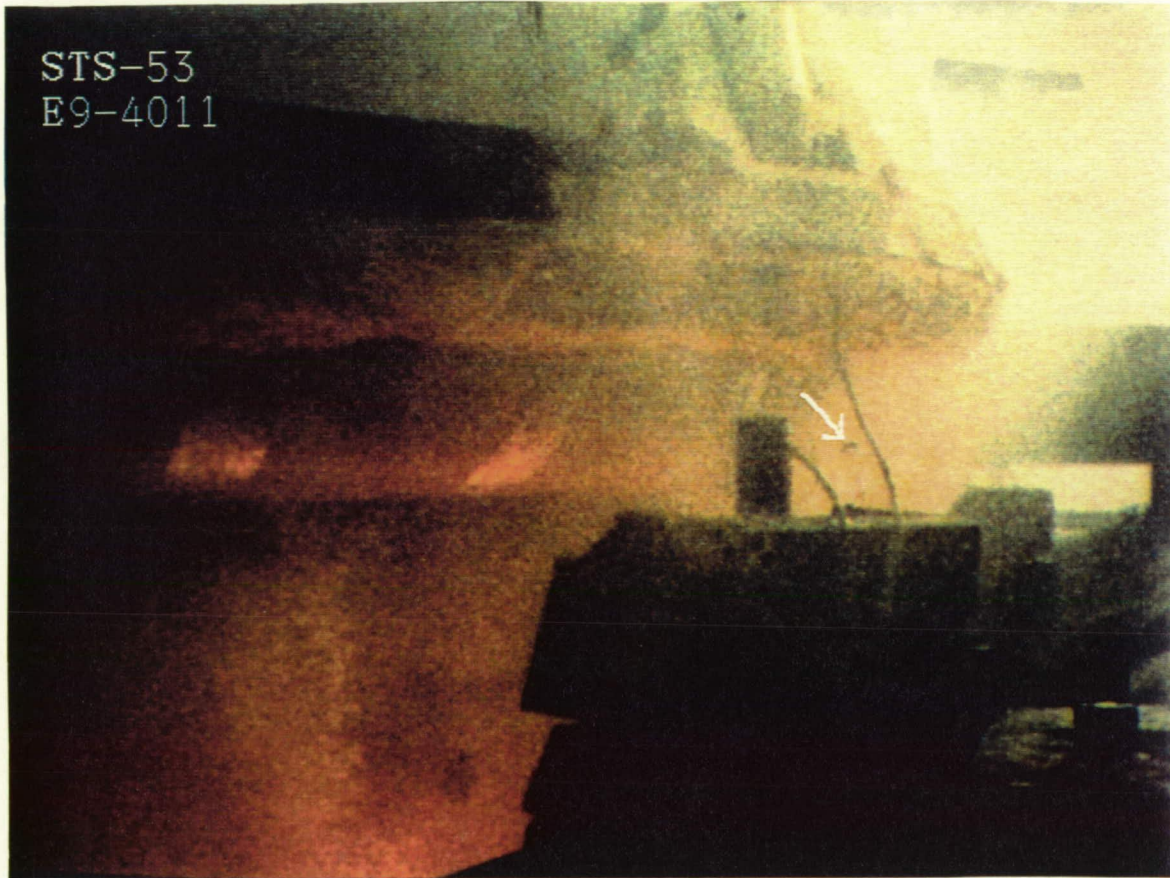
A single dark, curved piece of debris was seen at the time of the bolt release at HDP #M-1 (camera E-9). This piece of debris fell on to the holddown post shoe and then into the RSRB flame duct. No further photographic analysis has been requested.

Figure 2.1.2.1 Debris First Seen Near the Holddown Post Area

Figure 2.1.2.1 shows a piece of debris falling from the HDP #M-1 area. This debris seen between the pyrotechnic initiation controller (PIC) wires was first seen as the bolt released from the DCS hole.

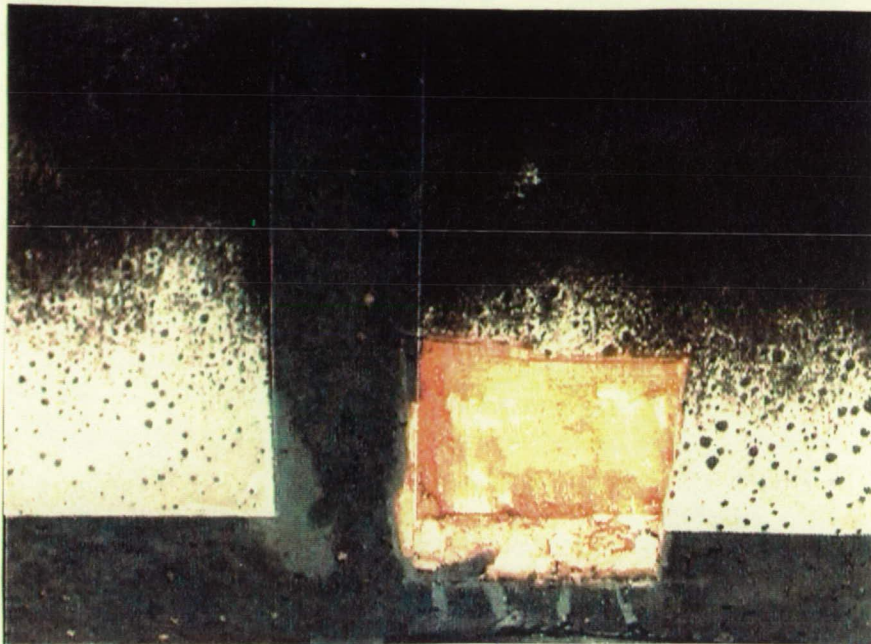
Figure 2.1.4b RSRB Aft BSM Triple Motor Housing without Protective Insulation

Figure 2.1.4b is aligned in the same manner as Figure 2.1.4a with the aft end of the RSRB toward the bottom of the frame. The protective insulation had been removed and sent to two independent laboratories. The elliptical scar is not visible in this view.

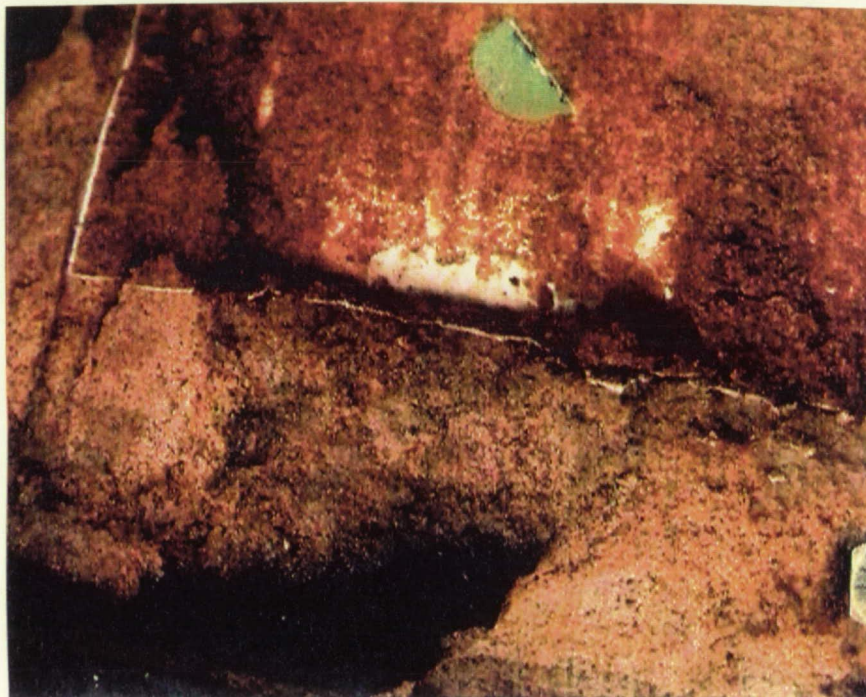
Figure 2.1.4c Close Up View of RSRB Aft Triple Motor Housing

Figure 2.1.4c shows a close up view of the area of interest. The alignment of the (linear feature) is the same as Figure 2.1.4a. The dark metallic scar at the bottom of the frame is the same as the dark metallic scar seen in Figure 2.1.4b (arrow). The green area below the linear feature is
