NASA Technical Memorandum TM 107556

Debris/Ice/TPS Assessment And Integrated Photographic Analysis For Shuttle Mission STS-53

DEBRIS/ICE/TPS ASSESSMENT
AND
PHOTOGRAPHIC ANALYSIS
OF
SHUTTLE MISSION STS-53

December 2, 1992

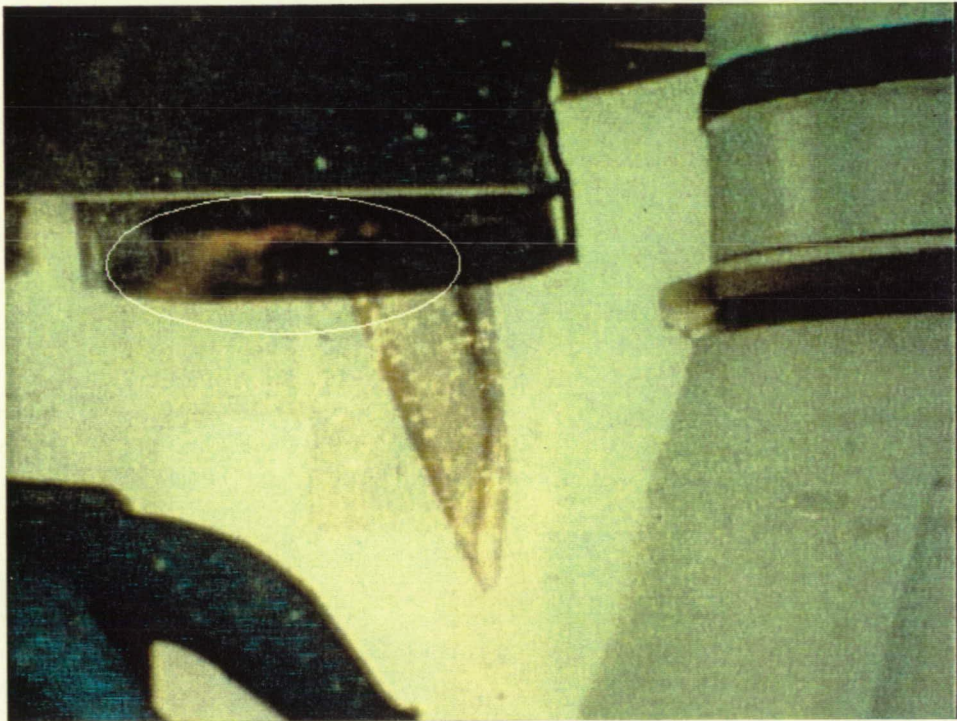
Figure 2
Holddown Post M-1 Stud Hang Up

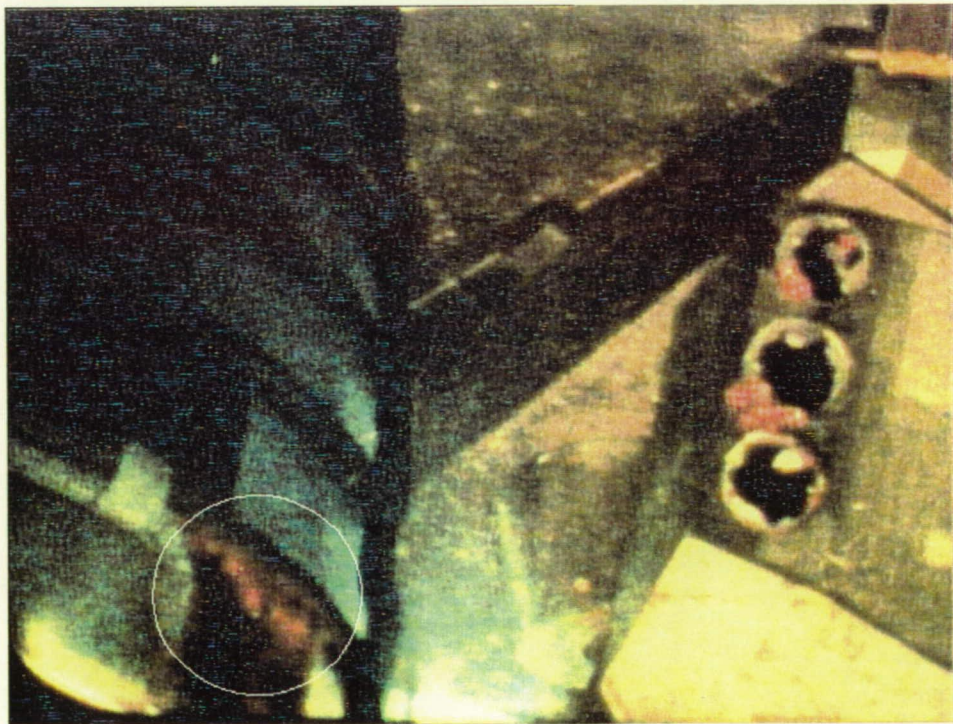
Figure 3

Flame Noted on SSME #2, Camera E-16
