NASA Technical Memorandum TM 107558

Debris/Ice/TPS Assessment and Integrated Photographic Analysis for Shuttle Mission STS-54

March 1993

John F. Kennedy Space Center

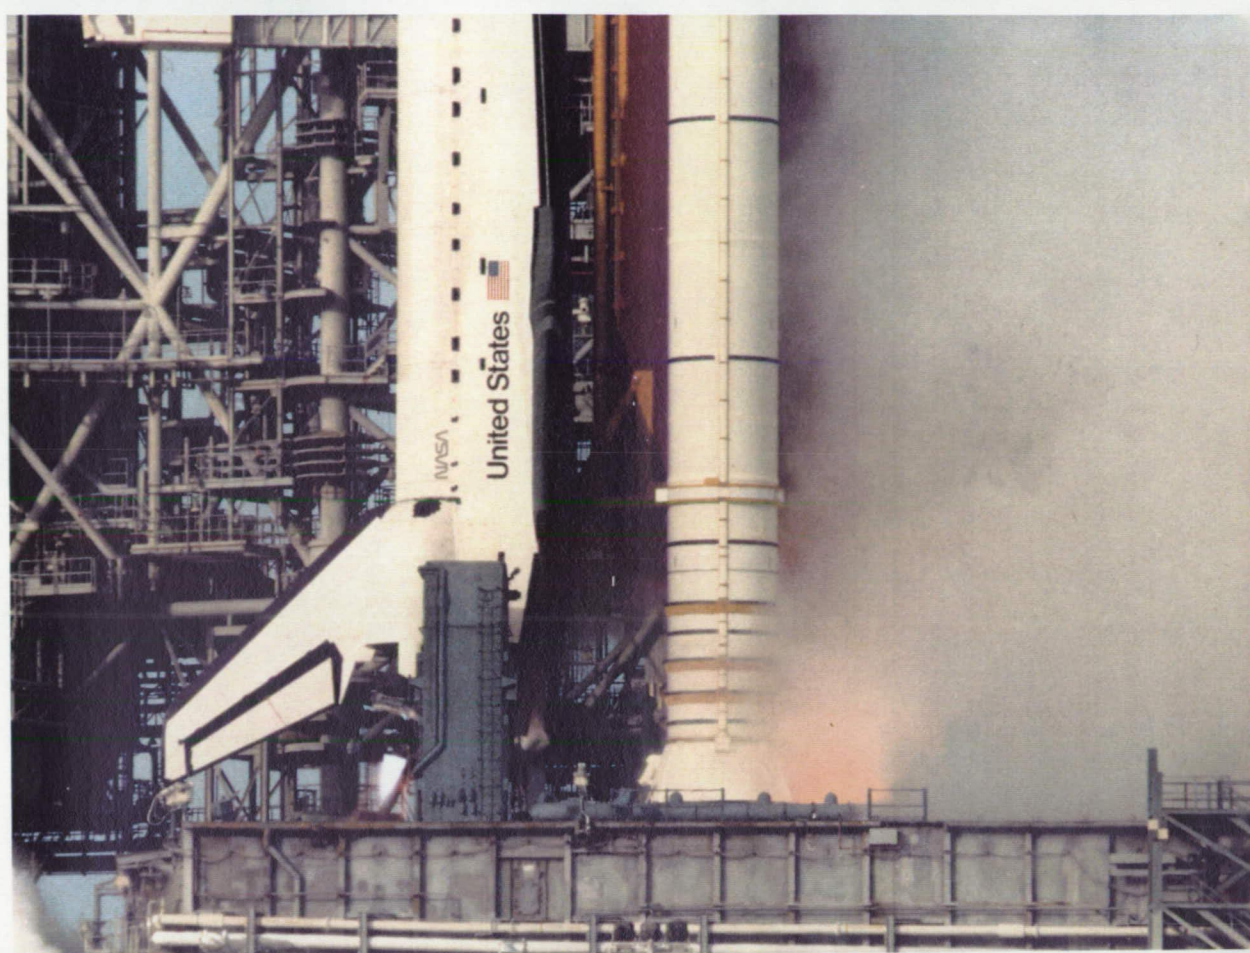
A brown-colored object, 6 inches long by 1 inch wide, appeared in the body flap hinge area and fell aft during SSME ignition. The object is believed to be a brown GSE tile shim, or spacer.

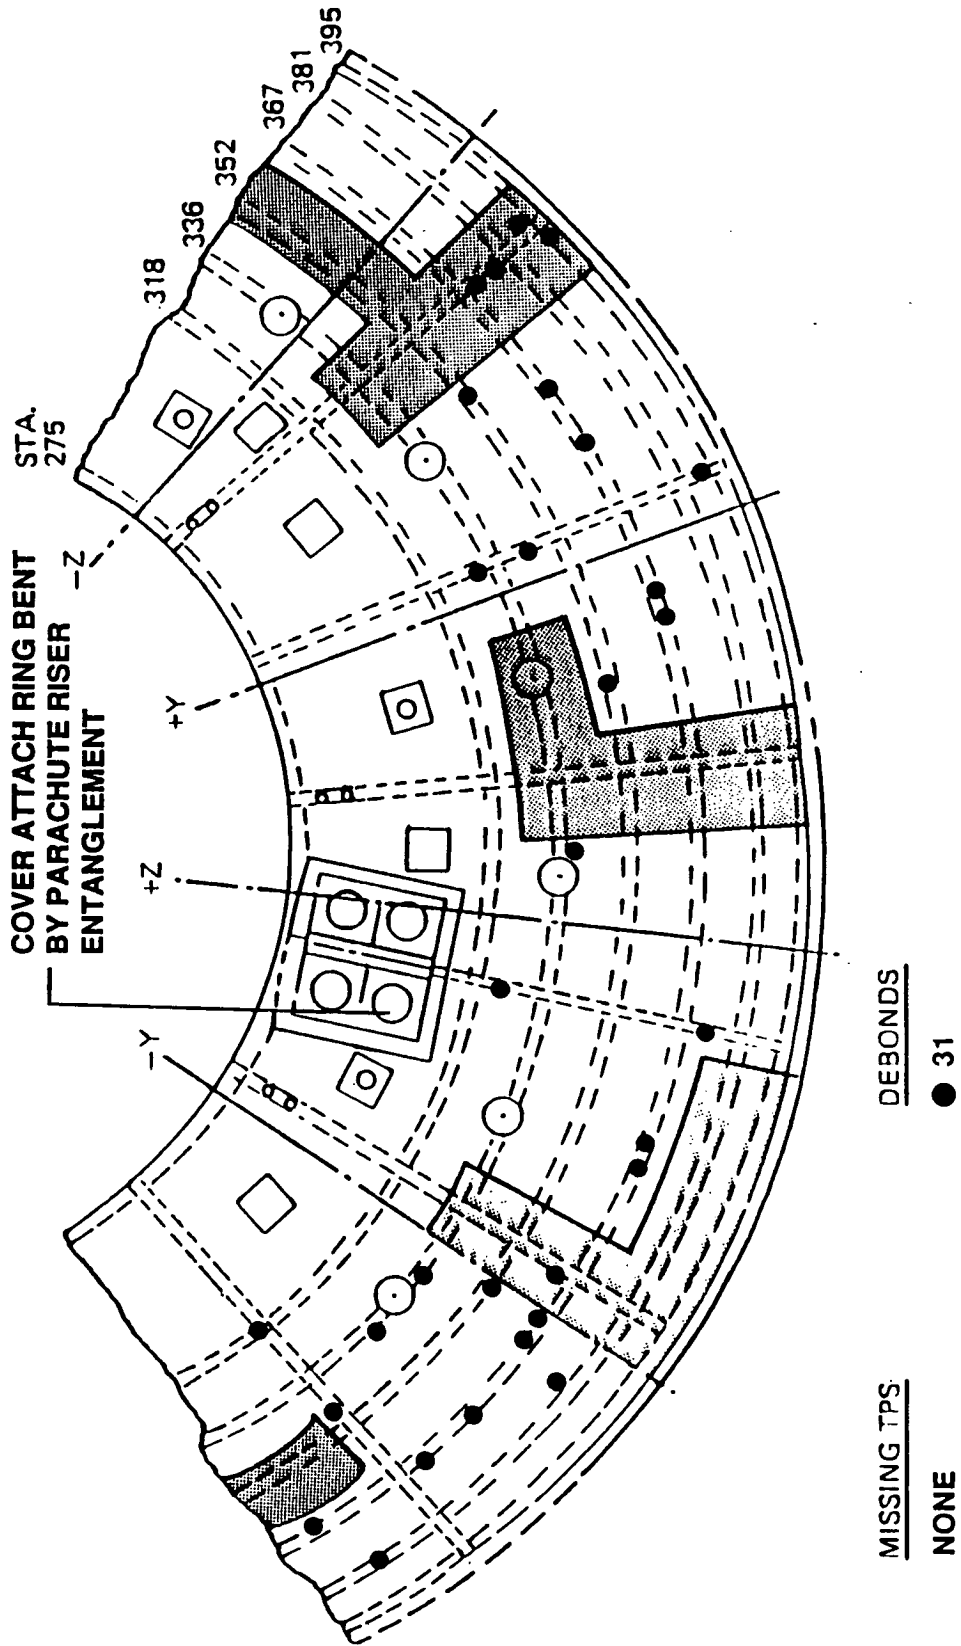
Figure 4. **RIGHT SRB FRUSTRUM**

The RH frustum was missing no TPS, but had 31 MSA-2 debonds over fasteners. Minor localized blistering of the Hypalon paint had occurred along the 395 ring (Figure 4). All BSM aero heat shield covers were locked in the fully opened position though the lower left cover attach ring had been bent by parachute riser entanglement.

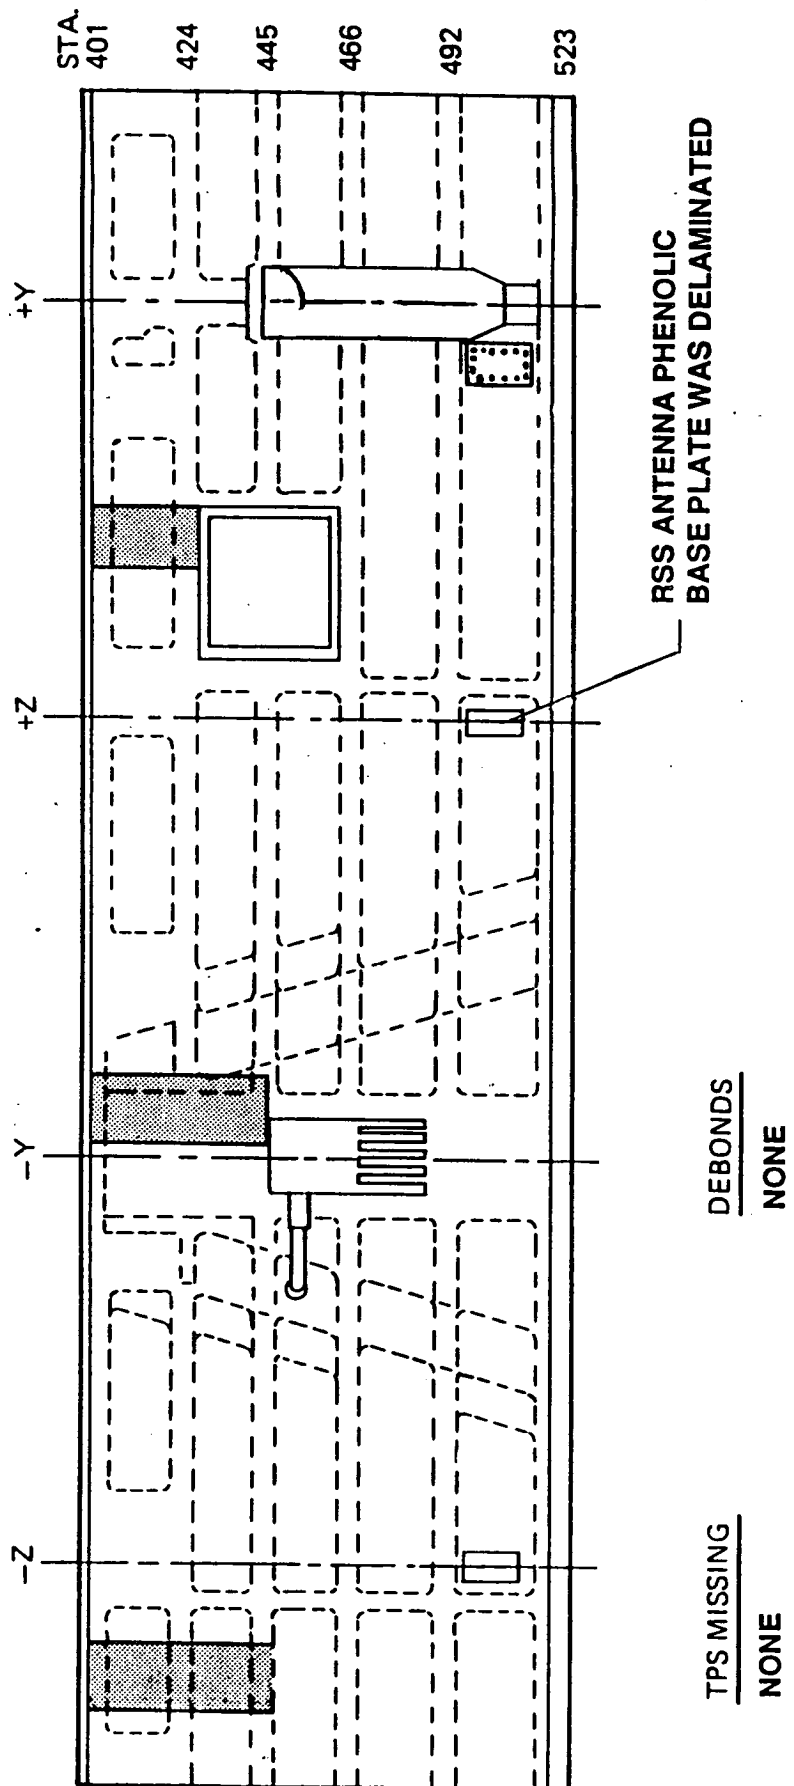
Figure 5. RIGHT SRB FWD SKIRT

The RH forward skirt exhibited no debonds or missing TPS. Both RSS antennae covers/phenolic base plates were intact, but the plate on the +Z antenna was delaminated. Minor blistering of the Hypalon paint occurred on the systems tunnel cover and around the ET/SRB attach point (Figure 5). No pins were missing from the frustum severance ring. The forward separation bolt and electrical cables appeared to have separated cleanly.

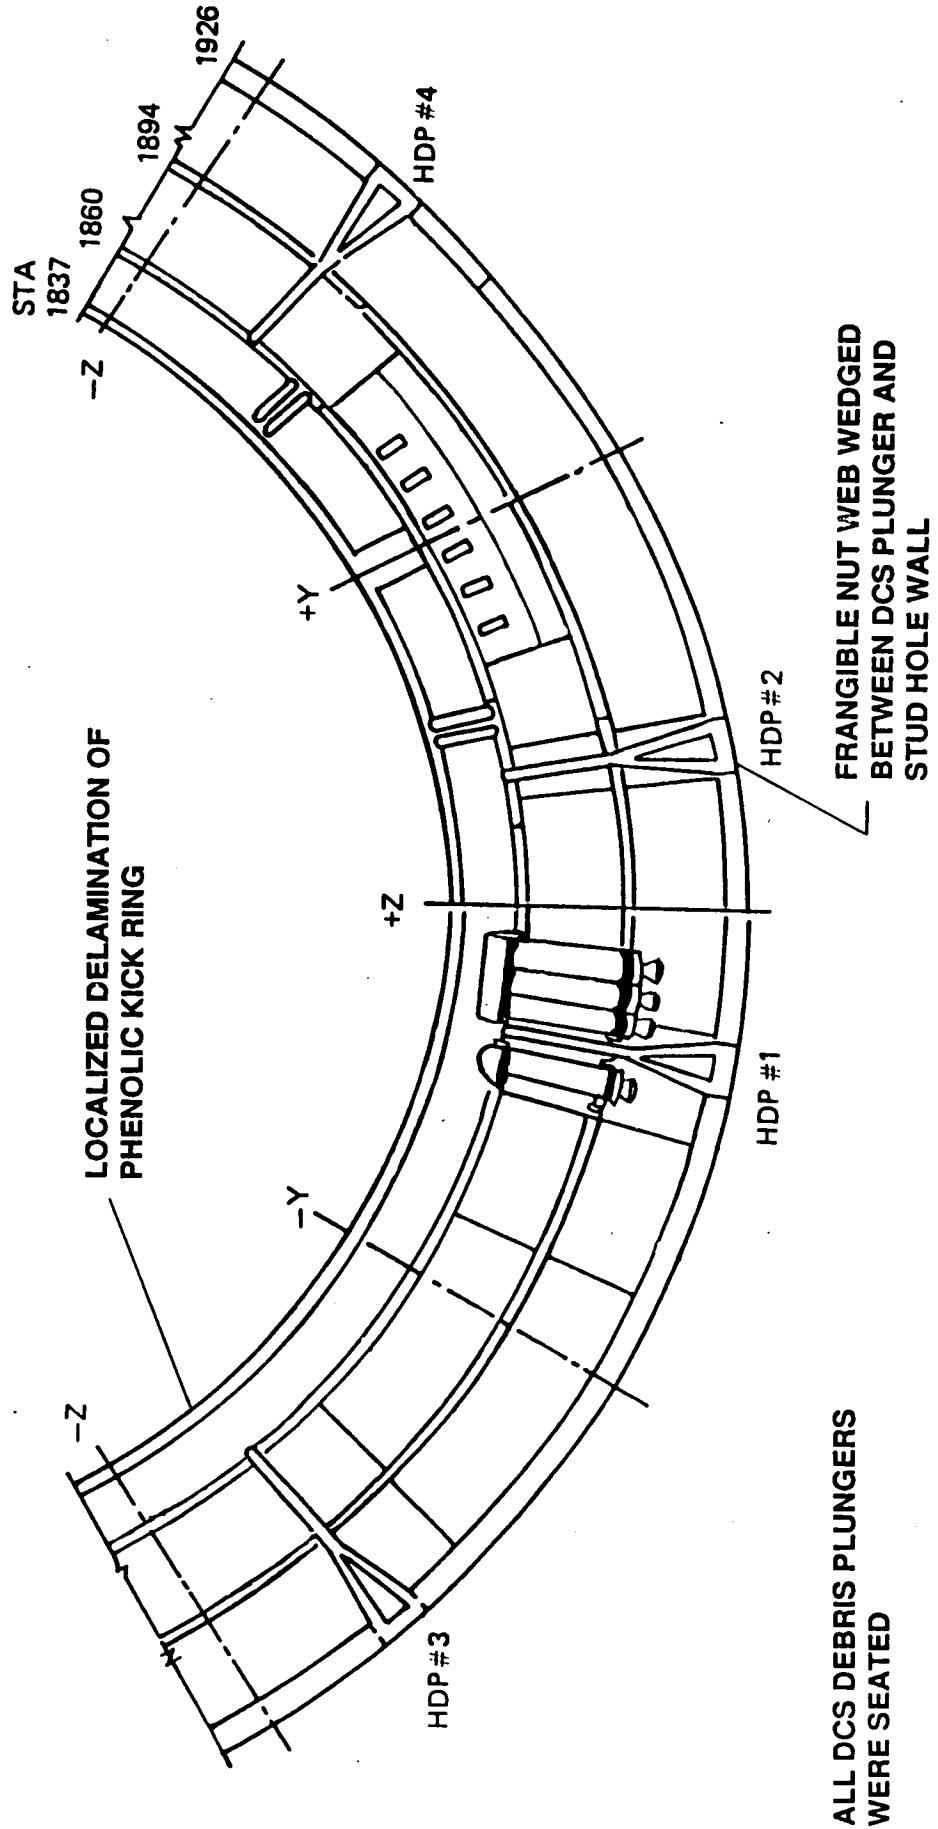
Figure 6. RIGHT SRB AFT SKIRT EXTERIOR TPS

The phenolic material on the kick ring was delaminated. The K5NA closeouts (protective domes) on the kick ring forward and aft fasteners had been eliminated. RTV-133 replaced the K5NA over the forward fasteners (Figure 6).

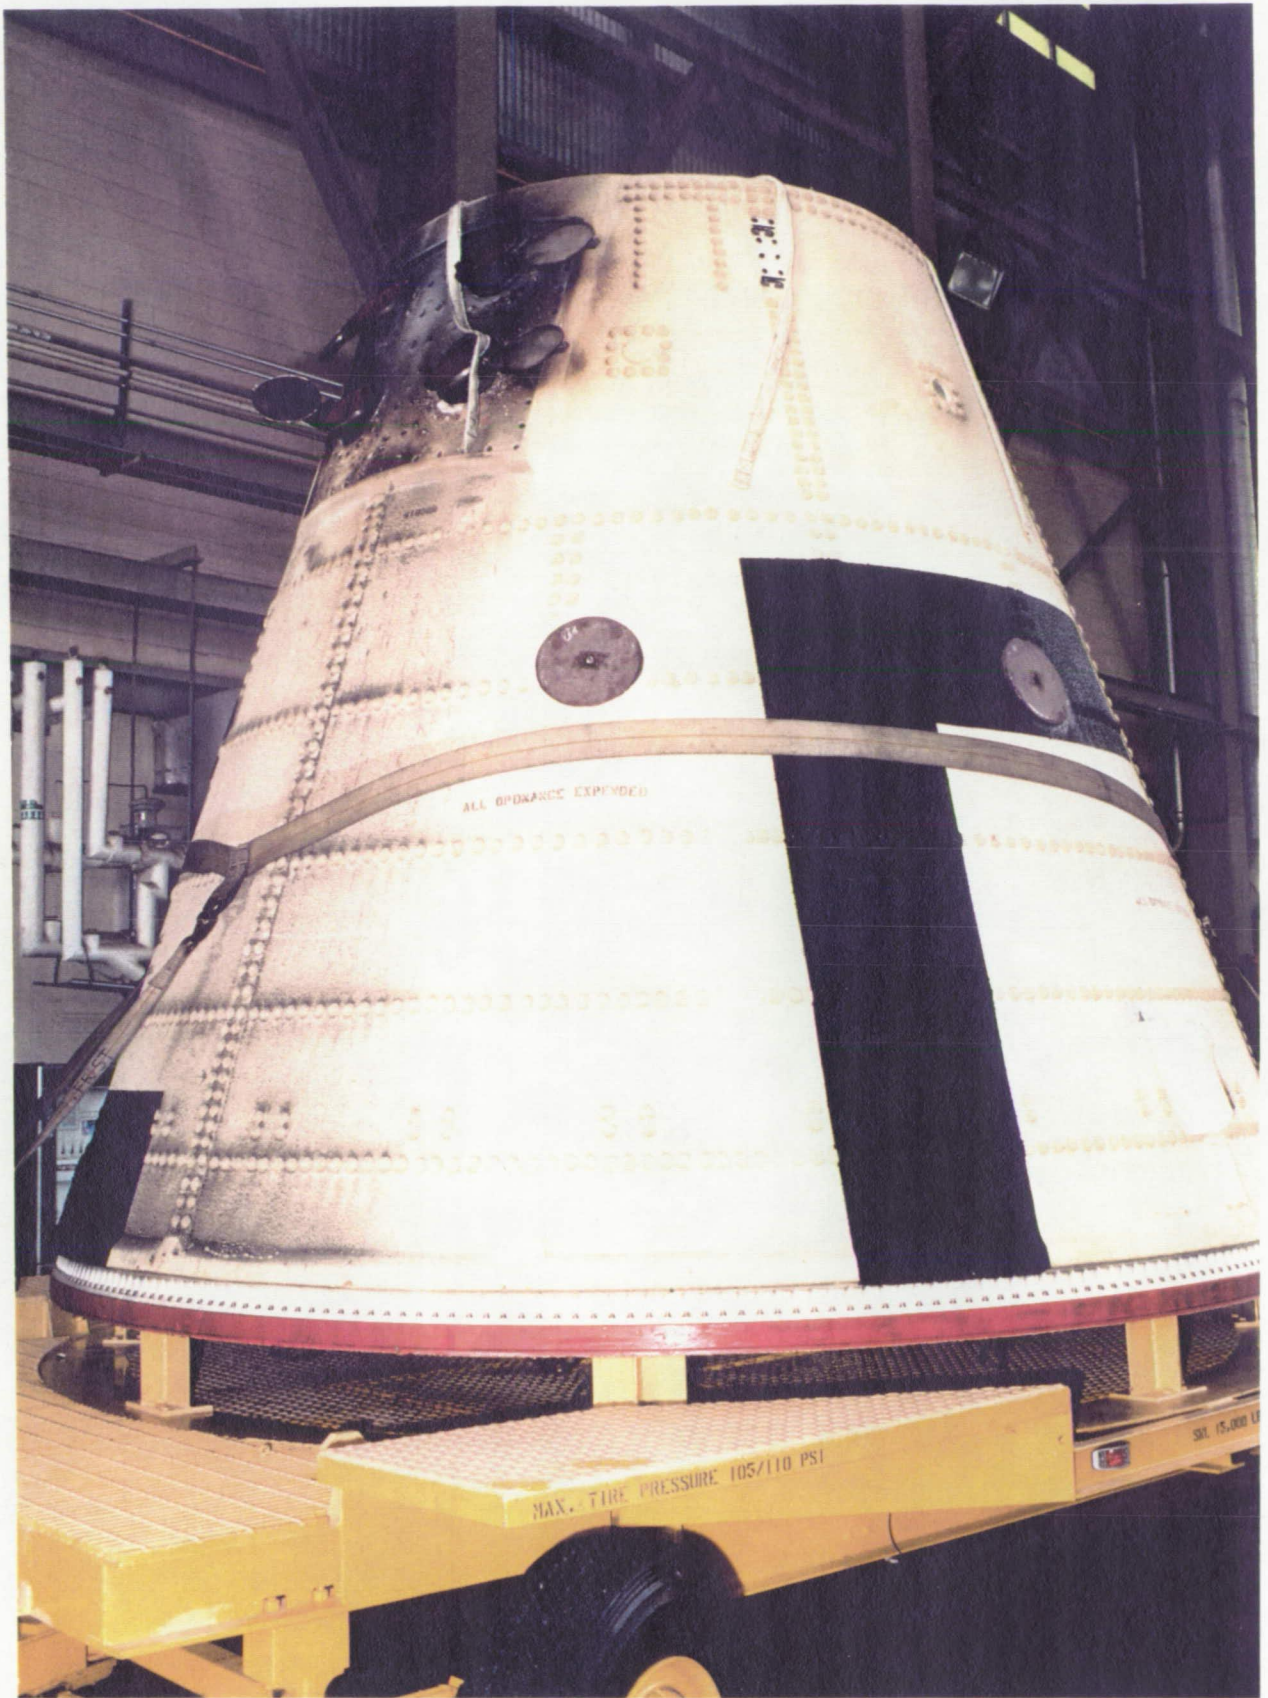
The RH frustum was missing no TPS, but had 31 MSA-2 debonds over fasteners. All BSM aero heat shield covers were locked in the fully opened position though the lower left cover attach ring had been bent by parachute riser entanglement.

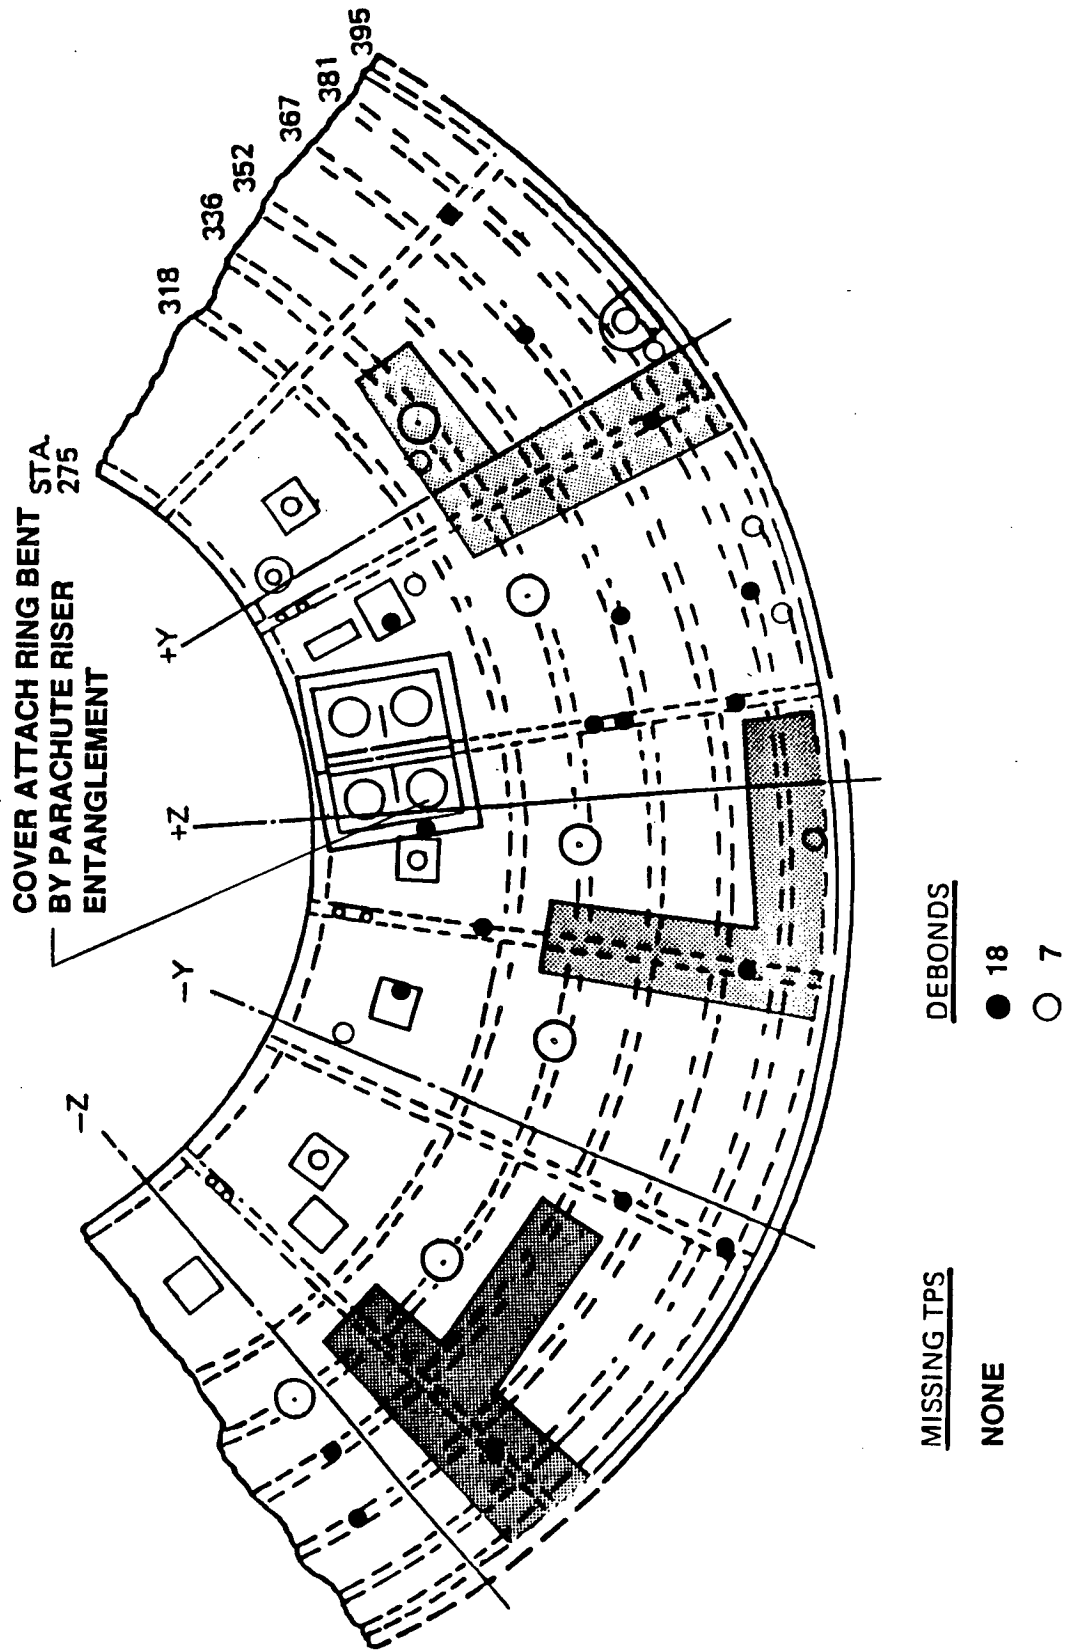
Figure 7. **LEFT SRB FRUSTUM**

The LH frustum was missing no TPS, but had 18 MSA-2 debonds over fasteners and seven acreage debonds (Figure 7). Minor localized blistering of the Hypalon paint had occurred along the 395 ring. The BSM aero heat shield covers were locked in the fully opened position, though the lower left cover attach ring had been bent by parachute riser entanglement.

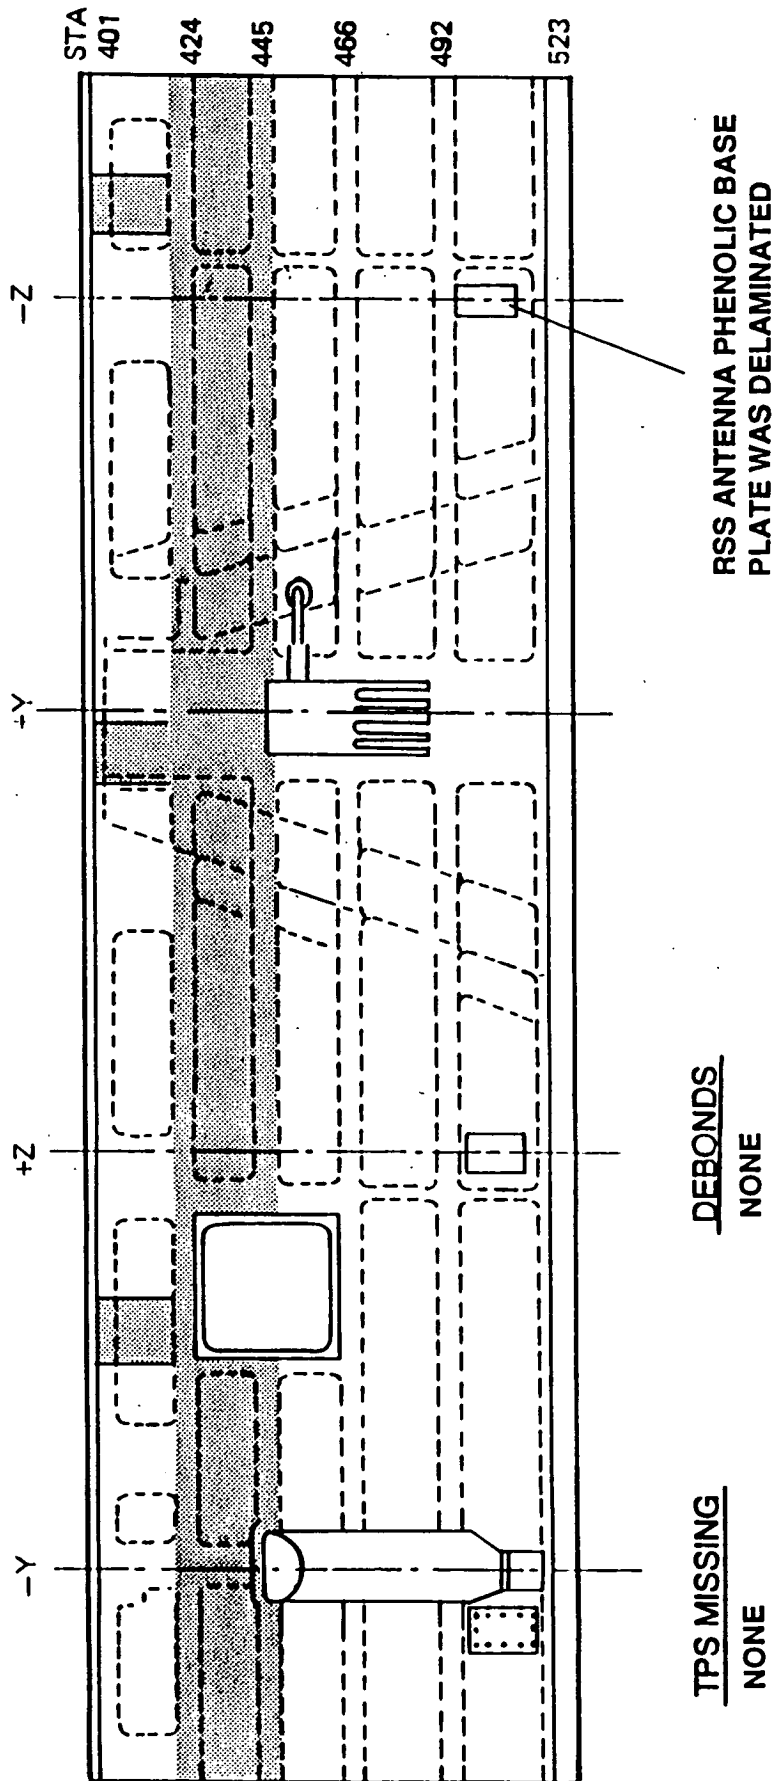
Figure 8. **LEFT SRB FWD SKIRT**

The LH forward skirt exhibited no debonds or missing TPS. The phenolic plates on both RSS antennae were intact, but the -Z plate was delaminated. Minor blistering of the Hypalon paint occurred near the ET/SRB attach point and on the systems tunnel cover (Figure 8). No pins were missing from the frustum severance ring. The forward separation bolt and electrical cables appeared to have separated cleanly.

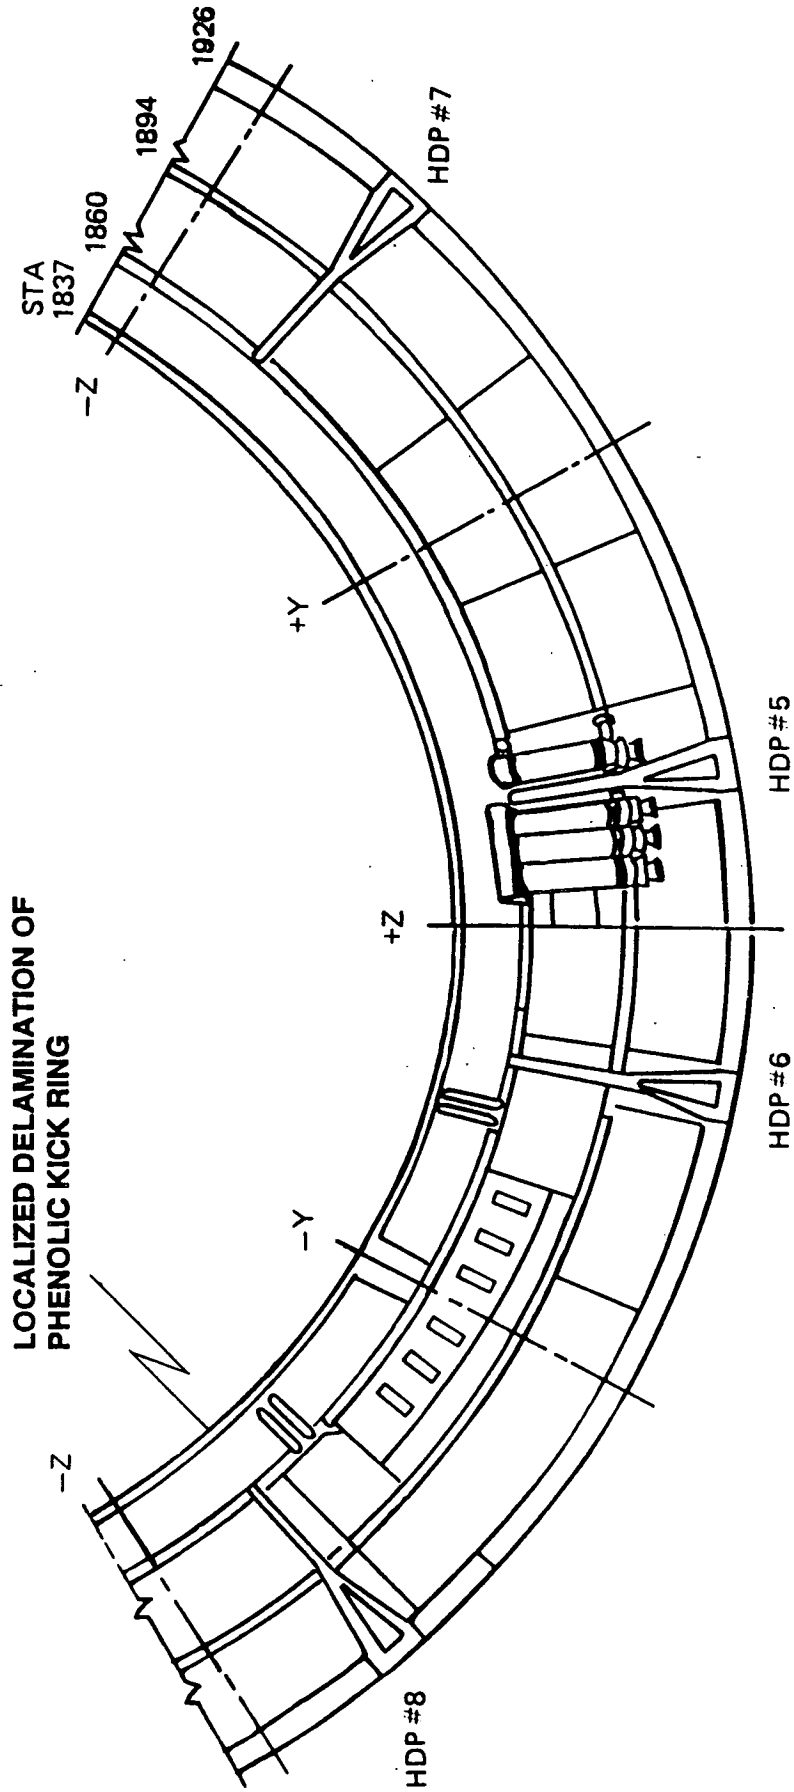
Figure 9. LEFT SRB AFT SKIRT EXTERIOR TPS

The phenolic material on the kick ring was delaminated in only localized areas. The K5NA closeouts (protective domes) on the kick ring forward and aft fasteners had been eliminated. RTV-133 replaced the K5NA over the forward fasteners (Figure 9)

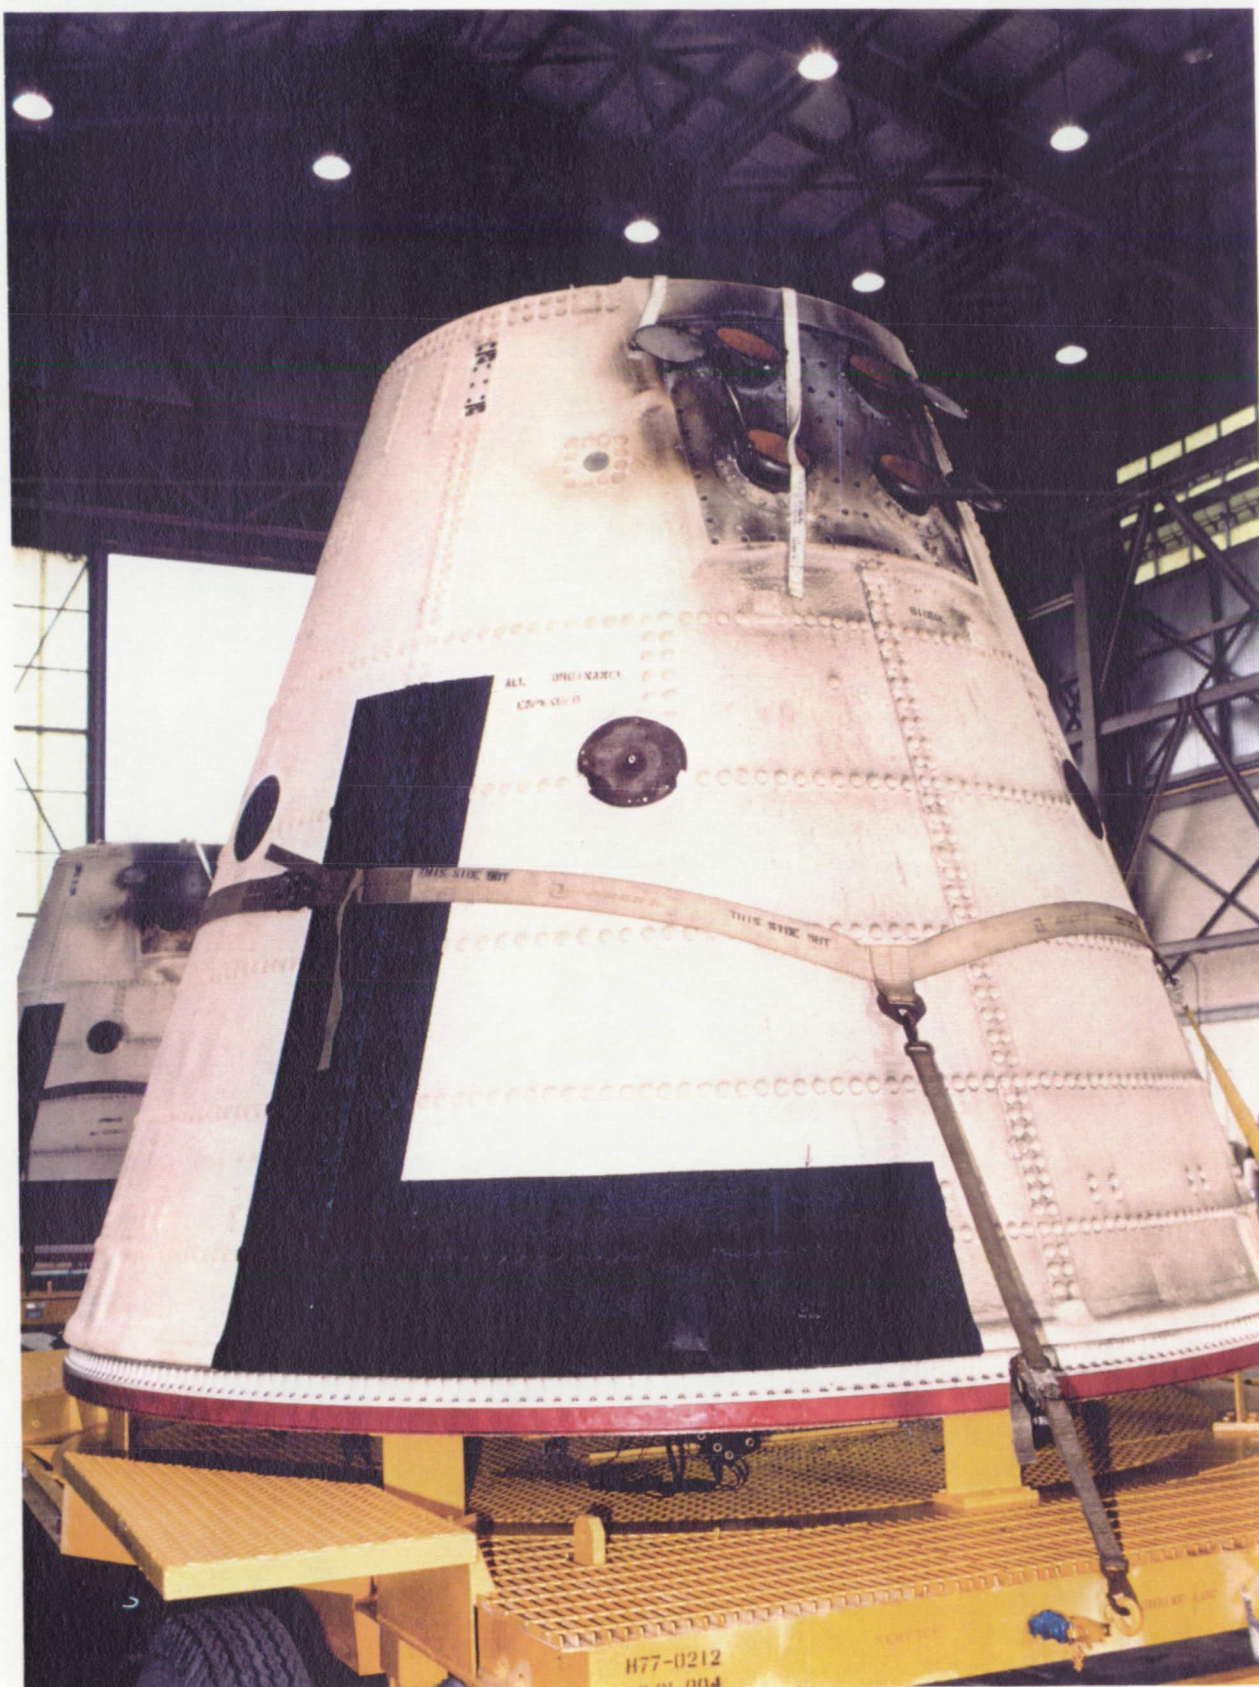
ALL DCS DEBRIS PLUNGERS
WERE PROPERLY SEATED

The LH frustum was missing no TPS, but had 18 MSA-2 debonds over fasteners. The BSM aero heat shield covers were locked in the fully opened position, though the lower left cover attach ring had been bent by parachute riser entanglement.

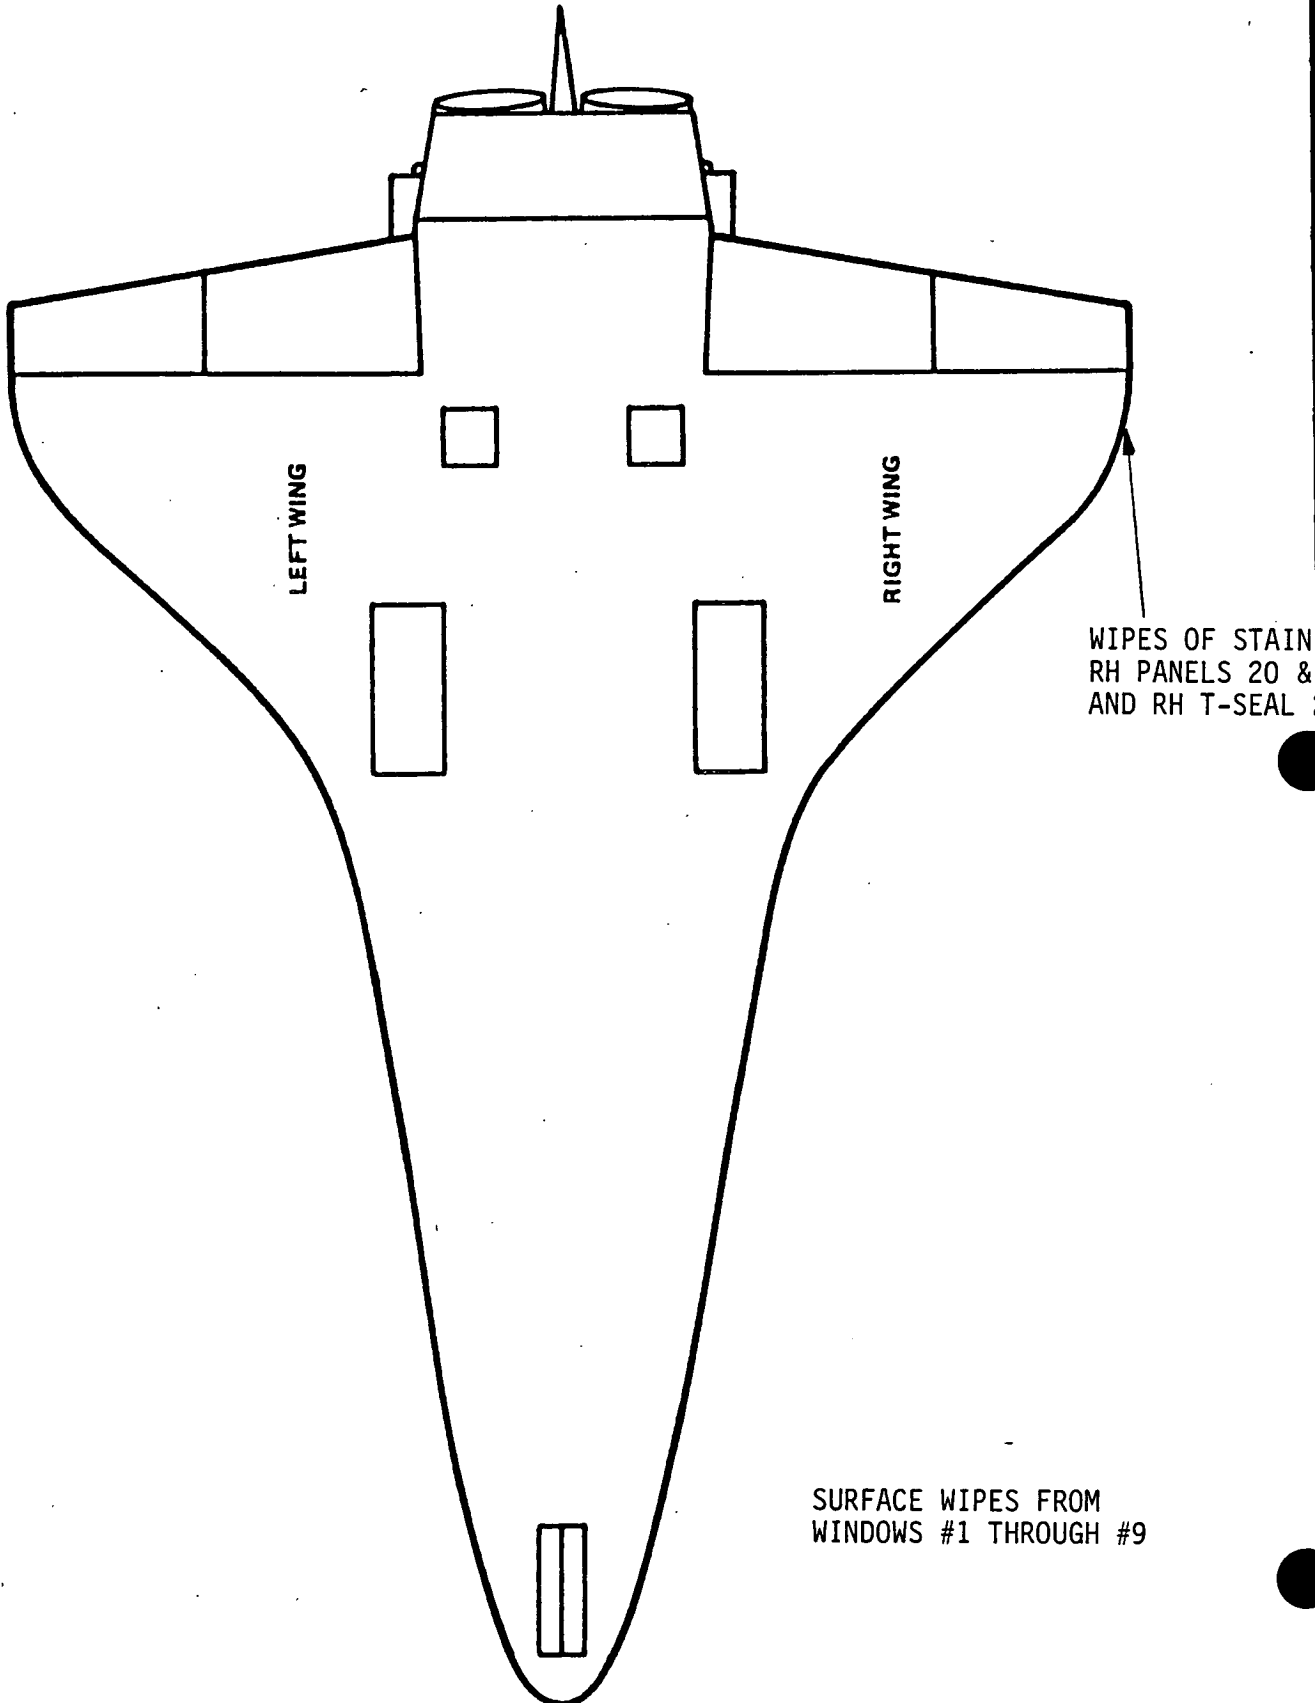
Figure 14. **CHEMICAL SAMPLE LOCATIONS**

Orbiter windows #3 and #4 exhibited moderate hazing and several streaks. Only a very light haze was present on the other forward facing windows. Surface wipes were taken from Windows #1 through #9 for laboratory analysis (reference Figure 14).

Wipes of stains on the right hand RCC panel #20, panel #21, and T-seal #21 were also taken for laboratory analysis (reference Figure 14).

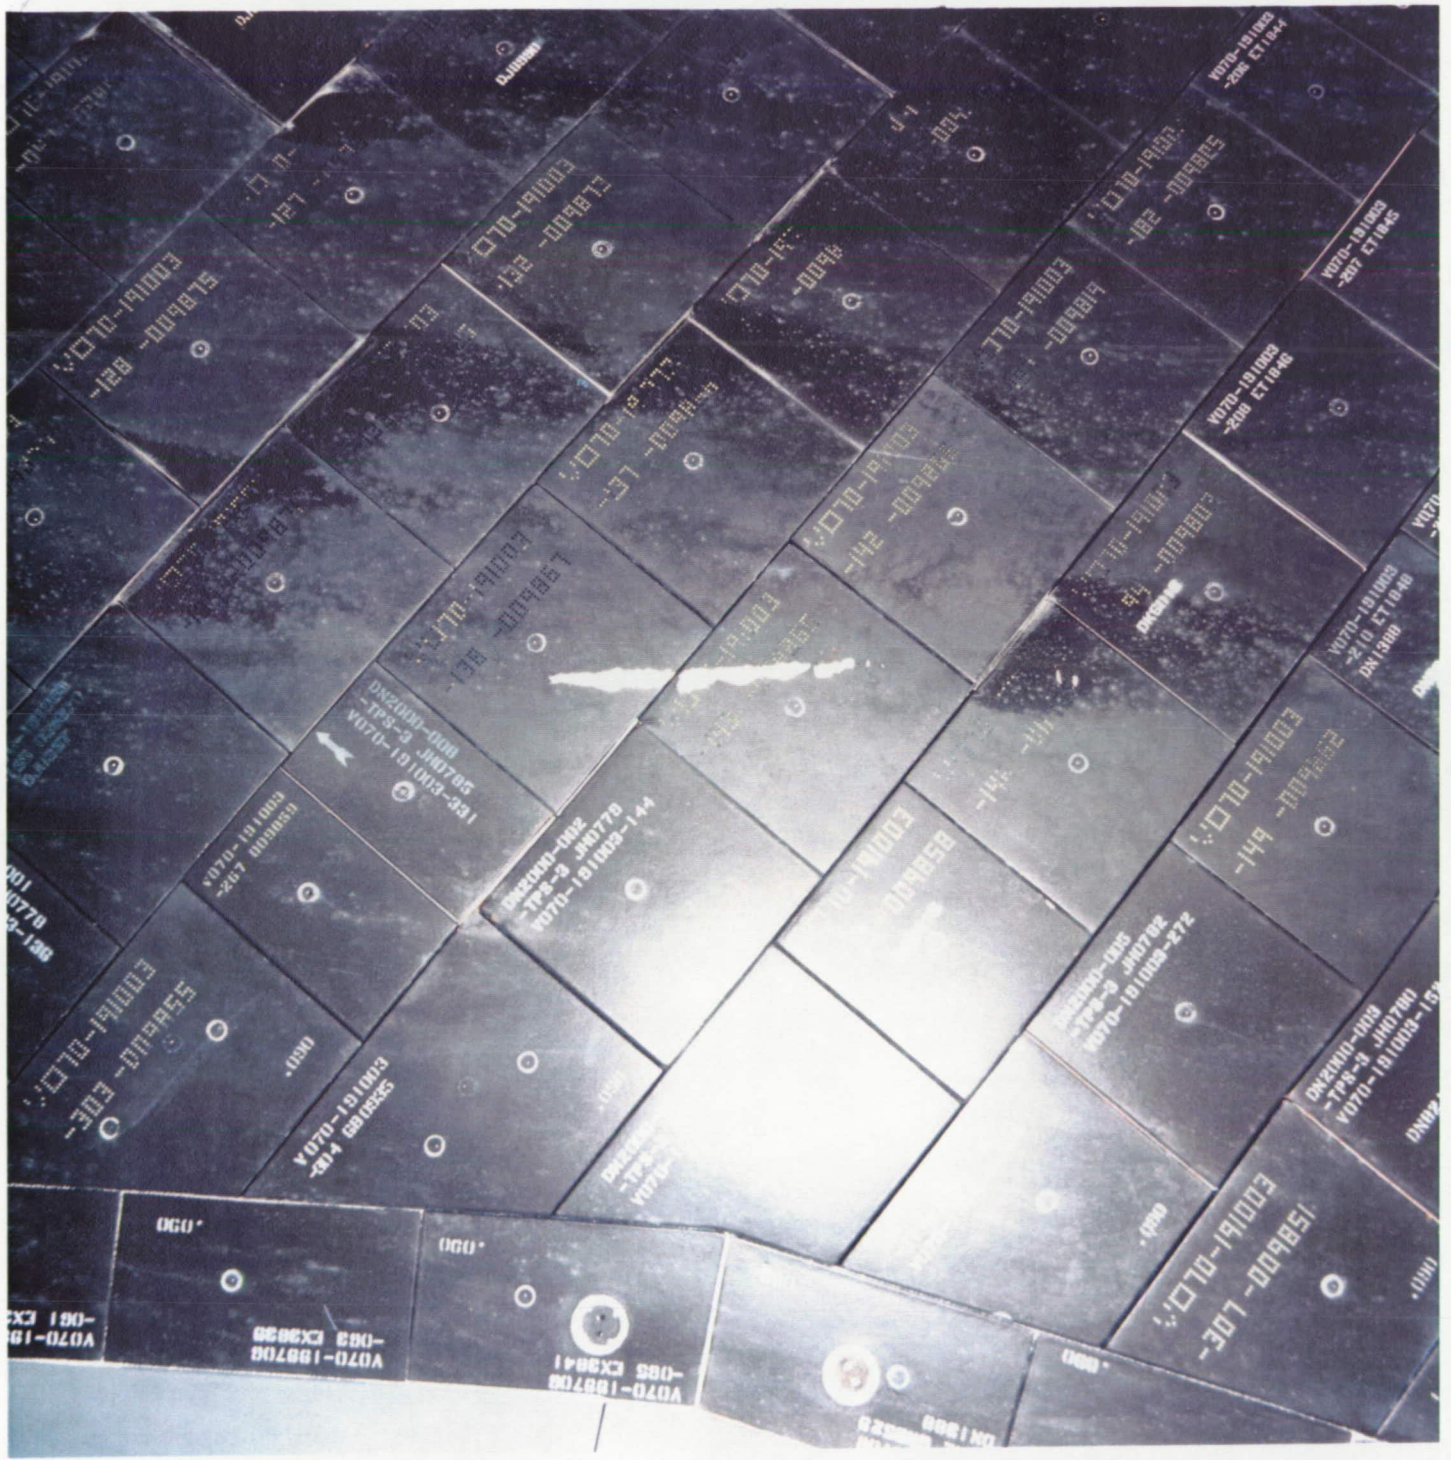
The Orbiter lower surface tiles sustained a total of 80 hits (less than average), of which 14 had a major dimension of 1-inch or greater (average).

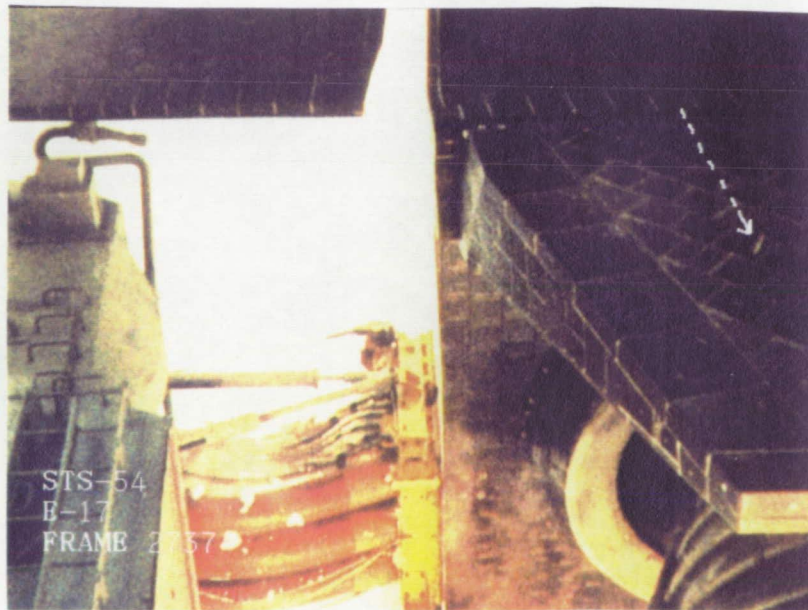
Figure 2.1.1.2 Debris from Body Flap Hinge Gap

A small, thin piece of debris which was light on one side and dark on the other was first seen emerging from the Orbiter body flap hinge gap. This piece of debris traveled aft along the body flap out of the field of view (FOV). Using the thickness of the body flap (5.78 inches) as a reference, an approximate size of this object was estimated to be 3 inches by 1 inch. This debris was later identified by KSC as possibly a brown tile shim or spacer. No damage to the Orbiter was noted.

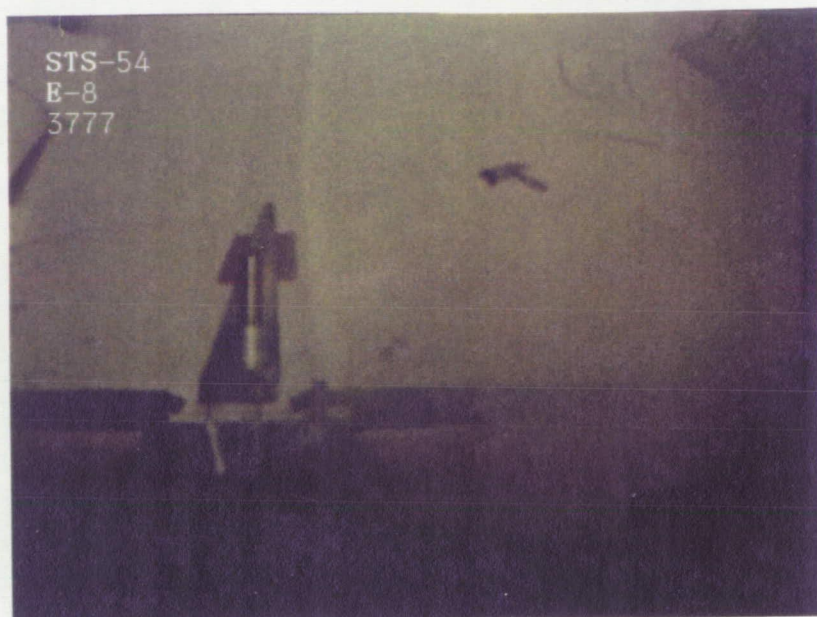
Figure 2.1.2.1 Flexible Debris from SRB Flame Duct

The size and velocity of two pieces of debris that apparently came from the SRB flame ducts were measured. The first piece of debris was a large piece of tape-like debris (possibly thermal curtain tape) seen coming from the right SRB flame duct at liftoff. The position of the debris was digitized for 31 frames from camera E-8. The scale marker on the shoe of the SRB holddown post was used for scale and the object was assumed to be moving in the same plane (i.e. the same distance from the camera) as the M-2 holddown post. Velocity was determined by fitting a linear regression line to the distance of the debris from its initial position versus time. The slope of the regression line was then used as the velocity of the debris. The two dimensional (2D) velocity of the debris was found to be 119 ft/sec and the length of the debris was approximately 10.8 inches. This debris did not appear to strike the vehicle. For more details and a plot of the debris distance versus time see Appendix D, Task #7.

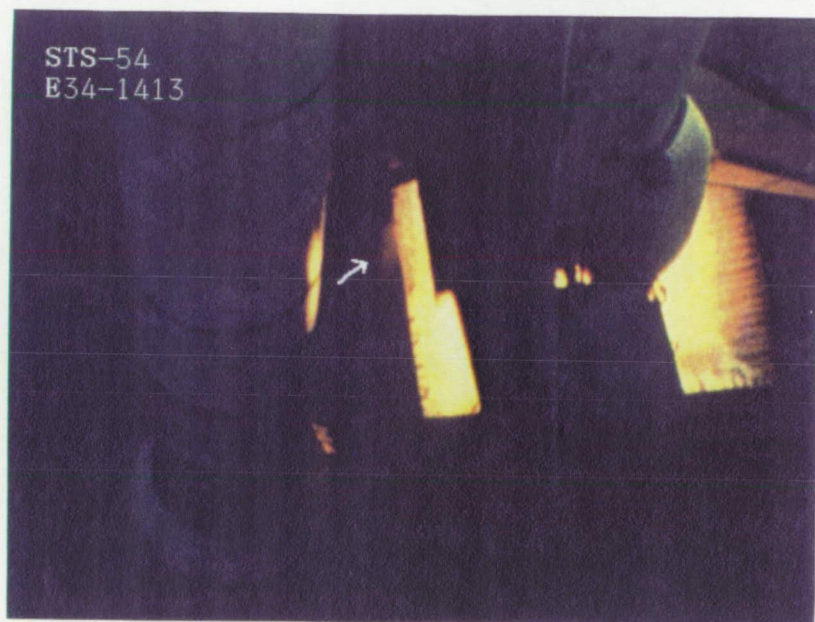
Figure 2.2.2 **Orange Vapor Curling under Body Flap**

On E-17, E-18, E-30, E-36, E-41 and OTV-163, an orange vapor (possibly free burning hydrogen) was seen curling under the body flap at T-5.37 seconds MET. An orange vapor was noted below the SSME bells on E-2 and E-3 prior to SSME ignition.

This orange vapor has been observed on previous missions prior to SSME ignition and no follow up analysis has been requested.

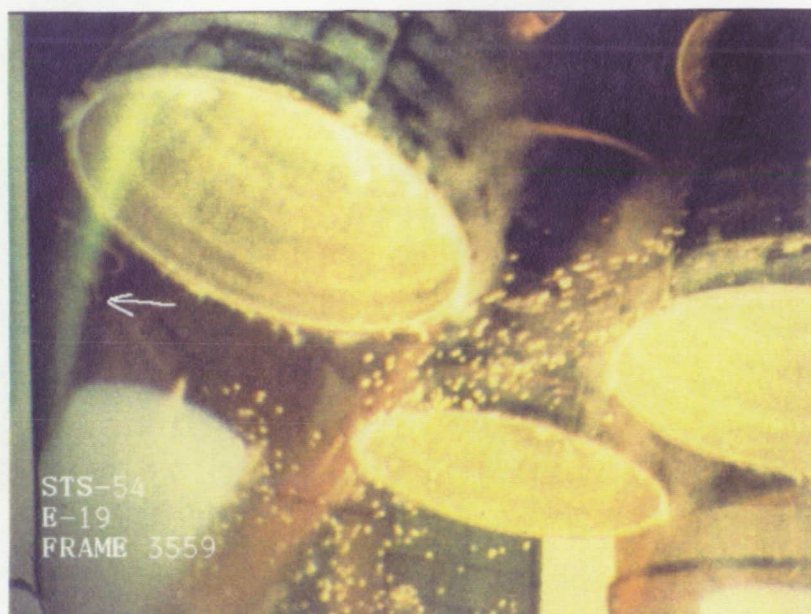
Figure 2.2.3 Green Streak in SSME #1 Plume

A minimum of six green streaks were seen as depicted in the above photo in SSME #1 plume prior to liftoff. These streaks occurred at 13:59:26.913, 13:59:27.592, 13:59:27.941, 13:59:27.970, 13:59:29.181 and 13:59:29.840 UTC. These green streaks were reported to the Mission Evaluation Room Manager. No follow-up analysis has been requested.

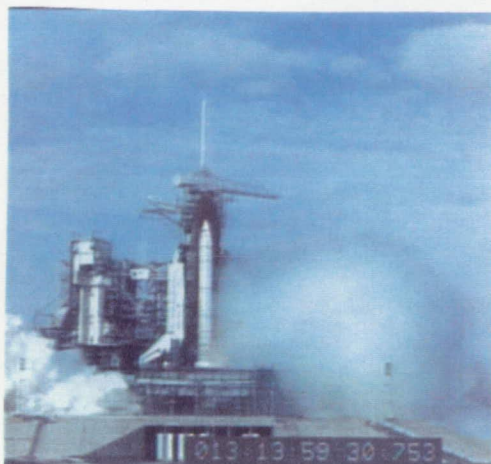
Figure 2.2.7 Composite Photo of Pressure Wave on STS-28, STS-32 and STS-54

Missions since reflight with over 80% humidity at the time of launch were investigated to determine if a large pressure wave was noted at SRB ignition. Of these previous missions, five flights were found to have this phenomenon. They were STS-28, STS-32, STS-37, STS-39 and STS-40. A composite photo was made of the missions (STS-28 and STS-32) with the largest and most visible waves along with STS-54 for comparison. The pressure waves for STS-37 and STS-40 were not as pronounced. Camera KTV-7 was used as the view of choice.

The pressure waves noted on the five missions previously mentioned are characteristically the same as seen on STS-54 in shape and color. The wave seen on STS-54; however, was much larger than those seen on other missions.
