NASA Technical Memorandum TM 107558

Debris/Ice/TPS Assessment and Integrated Photographic Analysis for Shuttle Mission STS-54

March 1993

John F. Kennedy Space Center

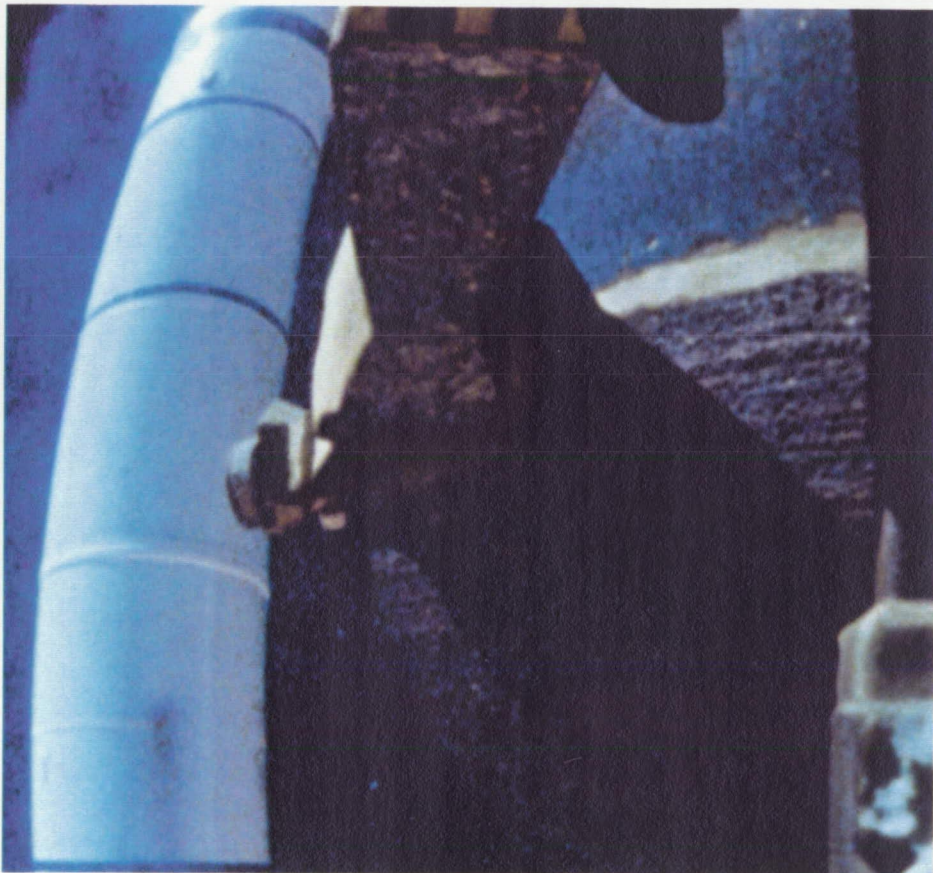
Separation of the left SRB from the external tank appeared normal on this 16mm umbilical well camera. No anomalies were observed on the left SRB. Multiple divots were visible on the base of the external tank electrical cable tray. Multiple small pieces of debris [possibly chips or flakes from the thermal protection system (TPS)] were in view throughout the entire SRB separation sequence. Small pieces of the TPS were seen to ablate from the ET electrical cable tray. The aft ET/Orbiter attach brace and the ET aft dome showed charring similar to that seen on previous mission's umbilical films.

Figure 2.4.2.1 16mm View (5mm Lens) of Left SRB Separation
(Frame STS-54-57-1464)

Numerous pieces of small debris were seen in the 16mm umbilical camera views of the left SRB before, during and after SRB separation. The debris appeared to be small pieces of TPS that had ablated off the external tank.

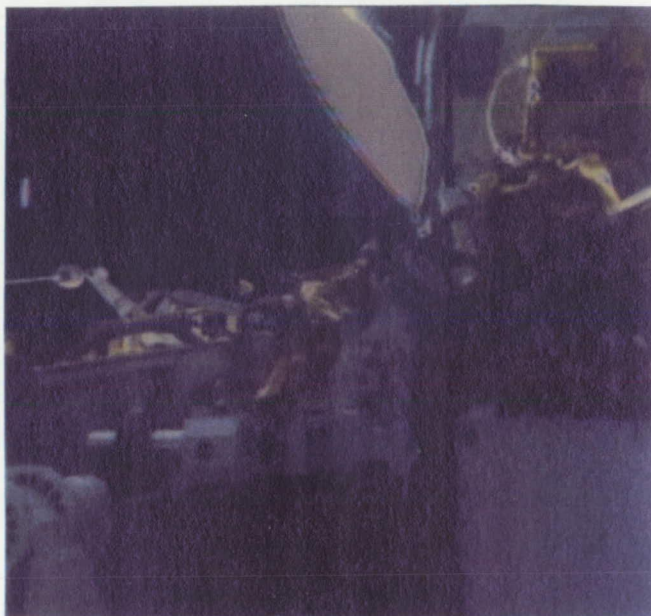
Numerous pieces of debris were observed on orbit from the Payload Bay Camera A between 13:22:01:44 UTC and 13:22:21:31 UTC after the Tracking and Data Relay Satellite (TDRS) deploy. Payload Bay Camera A was pointed toward the aft end of the Orbiter and none of the debris appeared to originate from within the payload bay. Most of the debris were small, but three large pieces were chosen for more detailed study as well as one small slow moving piece of debris that moved in an arced trajectory. The exact origin or composition of this debris is unknown (The most likely explanation is that the debris was ice from a water dump.) since the debris does not pass in front of a known object, the exact distance from the camera to the debris cannot be determined. Without knowing the debris' origin or its distance from the camera, the true size and velocity of the debris cannot be determined. The larger pieces of debris are, however, seen to pass behind the aft edge of the payload bay and this does allow for a minimum distance to be determined; therefore, a minimum size and velocity can also be found.

Figure 2.4.3 Debris Observed near Payload Bay

The second large piece of debris, seen at 13:22:12:06 UTC, was very large, rectangular in shape and was tumbling. Like the first large piece of debris, it was also observed toward the aft end of the payload bay on the +y side. The debris moved both in the +z and +y direction until it disappeared from the FOV. The minimum size of the object was approximately 3.2 inches x 3.4 inches x 1.2 inches and the approximate minimum velocity was 3 inches per second. The tumble rate of the debris was approximately 514 degrees per second.

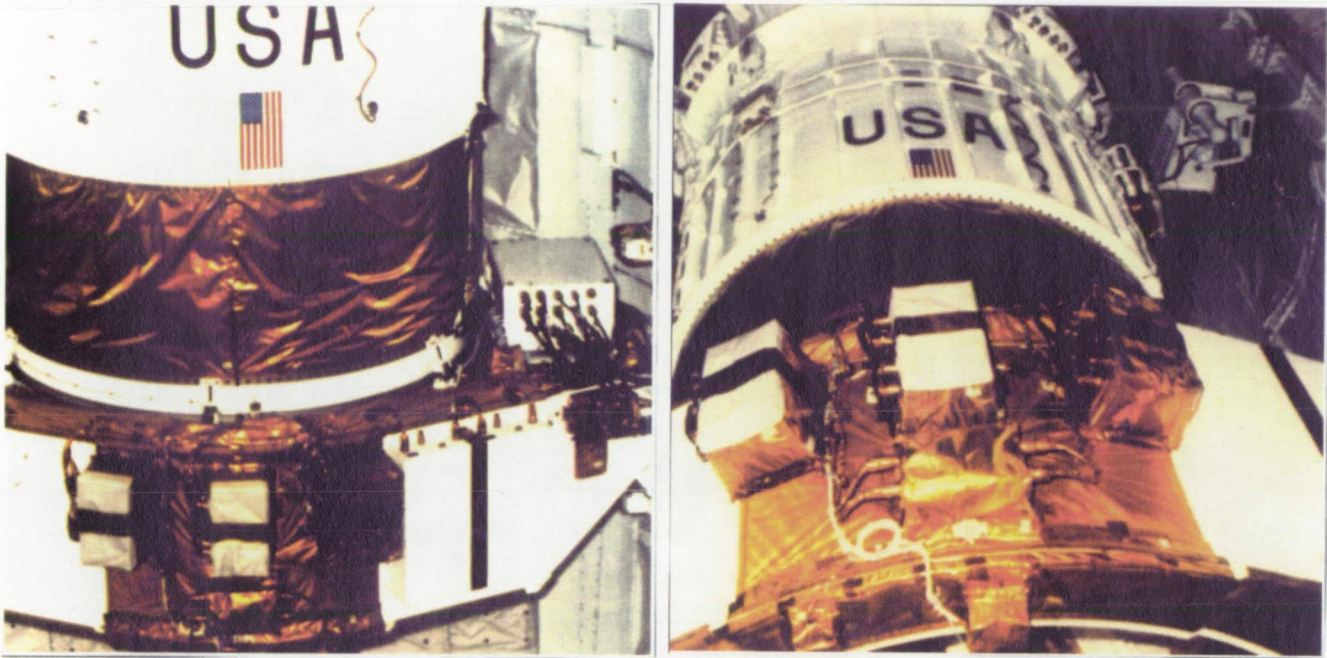
Figures 2.4.4 (A) and (B) Prelaunch Closeout Views of the Batteries

A visual comparison was made between the closeout views and the onboard video views. No obvious signs of damage to any of the six batteries or associated structures could be detected. The edges of the battery boxes appeared straight and the covers to the battery box appeared intact (similar to the closeout views). The multi-layer insulation wrapping on the batteries was not seen to be torn, discolored or misshapen at the level of detail present in the INCO's videos. The multi-layer insulation covering over the individual batteries did have a "wrinkled" appearance which was consistent with the prelaunch closeout pictures. No liquid or vapor was detected in any of the onboard video views. The following is a summary by individual camera:

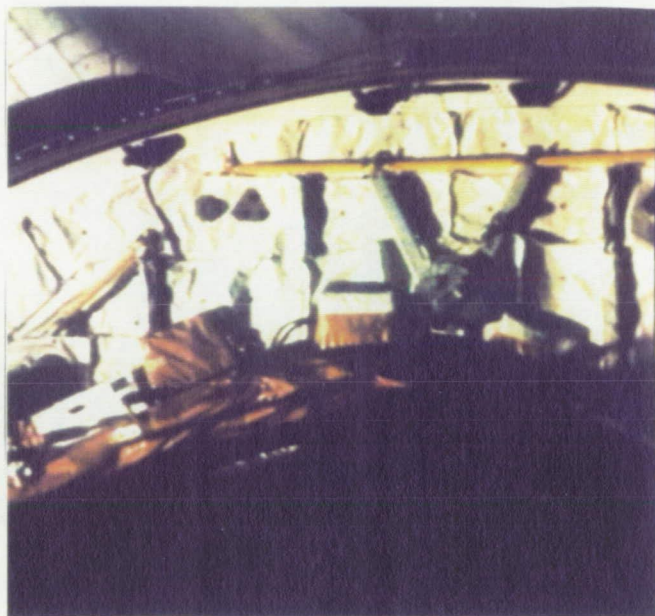
Figure 2.4.4.1 View of Batteries from Payload Bay Camera A

A discoloration was present on the white cover of the port forward battery; however, this was determined to be due to shadowing when viewed over a period of time. The cabling going to the middle group of batteries appeared to be positioned normally. The wrinkling of the multi-layer insulation on the starboard forward battery did not appear excessive when compared to the prelaunch closeout pictures.

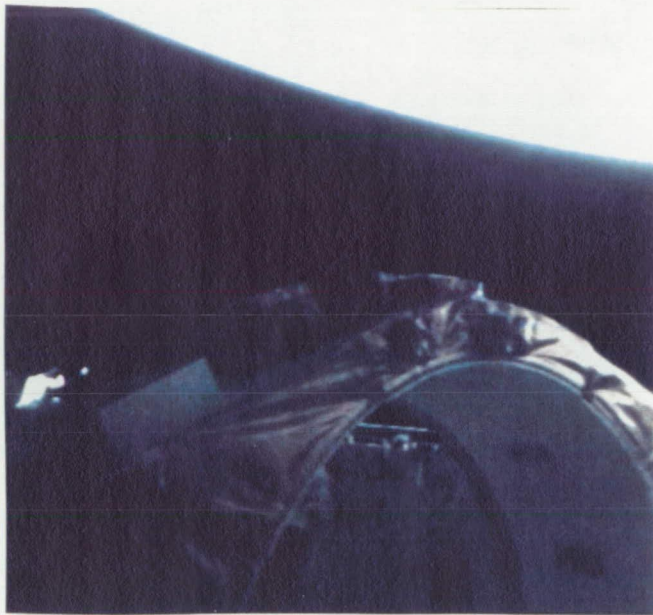
Figure 2.4.4.2 View of Batteries from Payload Bay Camera B

Wrinkling of the multi-layer insulation covering on the port rear and center rear batteries was visible. The covering over the top of these two batteries appeared intact.

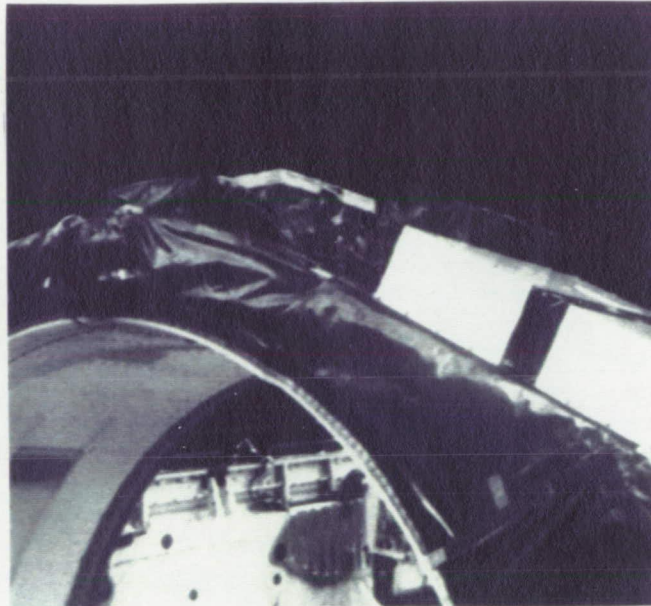
Figure 2.4.4.3

View of Batteries from Payload Bay Camera C

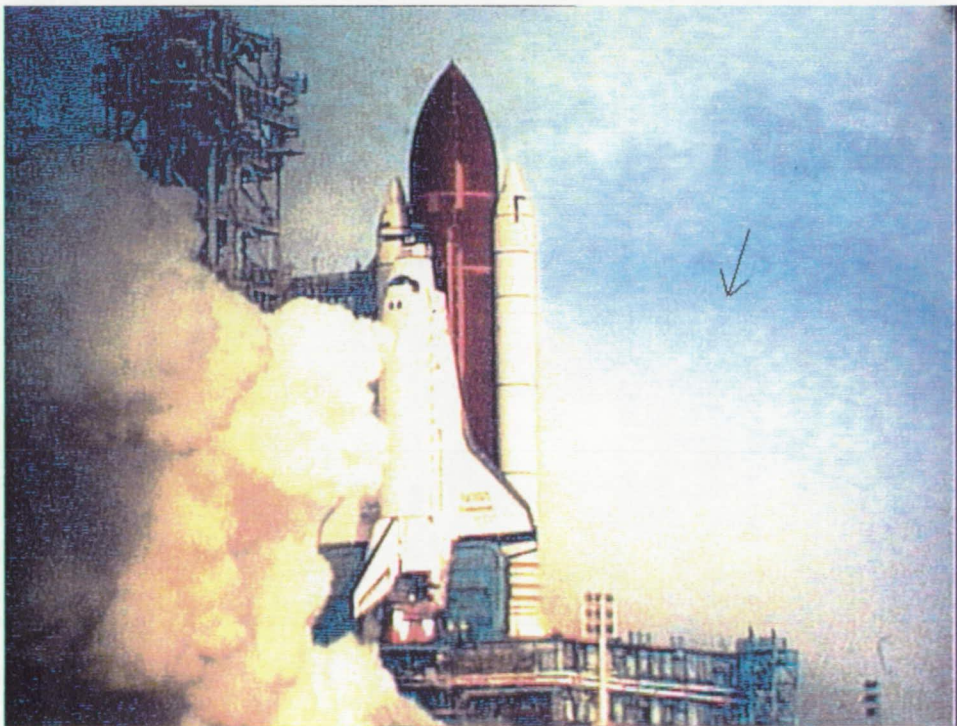
Figure 2

Large Condensation Cloud

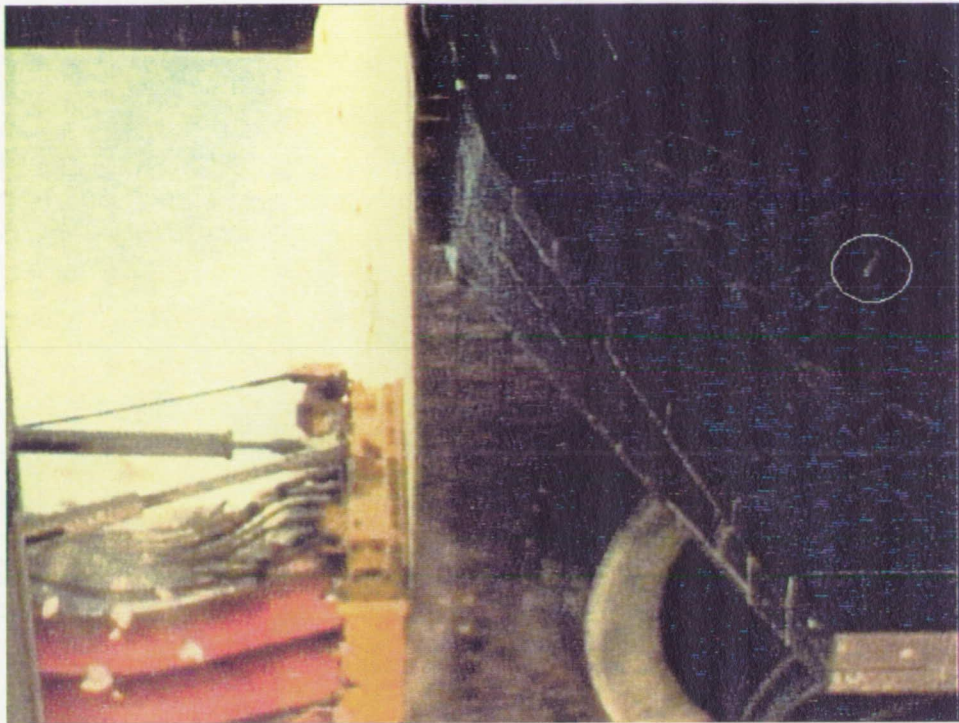
Figure 3
Debris From Body Flap Area

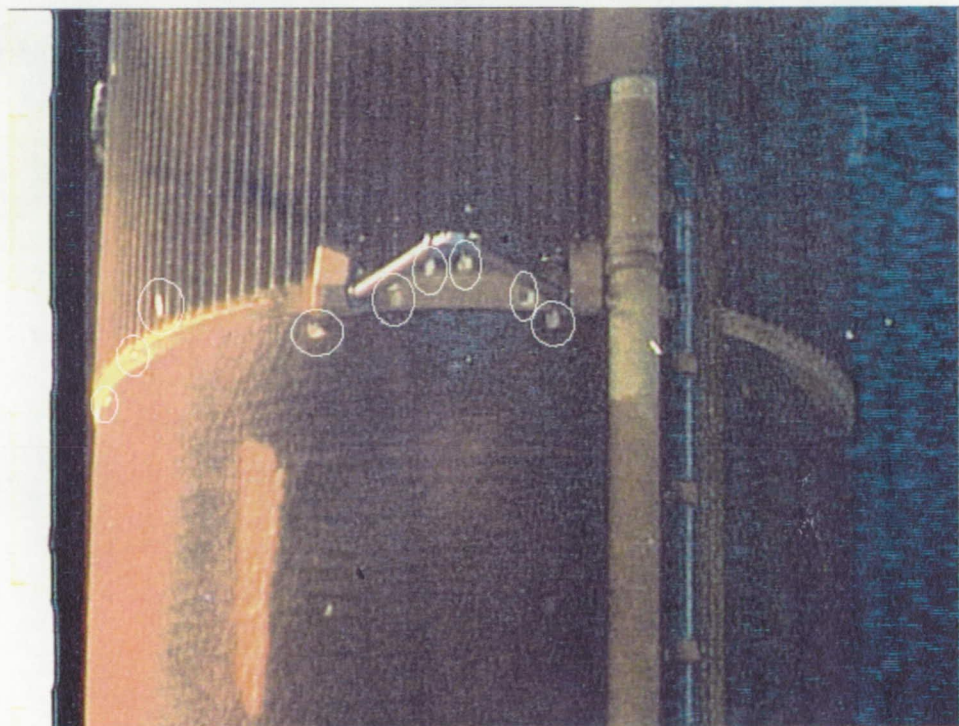
Figure 4
TPS Divots
132
