NASA-CR-192522

Final Report on the SRB Frustrum "Smiley" Cracking Phenomenon Study

February 6, 1993

Thomas A. Cruse, Ph.D.
401 Bowling Ave. #6
Nashville, TN 37205
(615) 343-8727; (615) 343-8730 (fax)

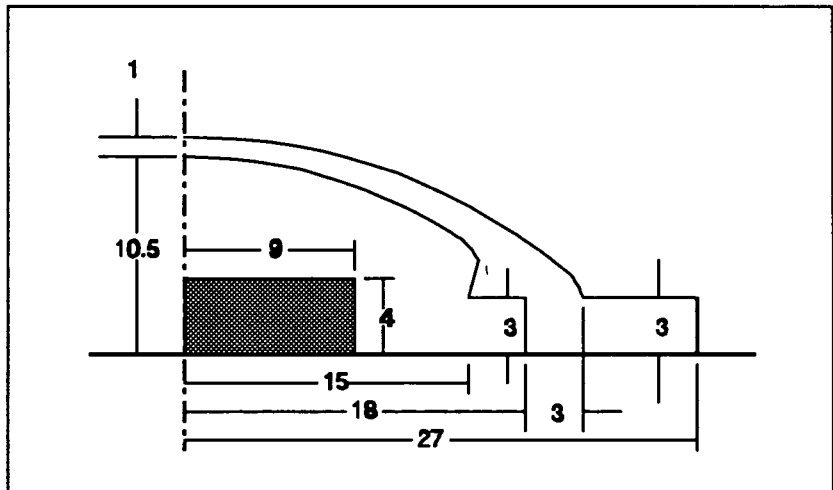
Figure 3: Nominal Dimensions of FEM Model (mm.)

The nominal geometry defined for analysis is shown in Figure 3, where the dimensions are given in millimeters. The configuration is taken to be axisymmetric, and only the right-hand side of the geometry is shown. The nominal geometry has been taken to have a large amount of excess PR-1422 material, taken to be 3 mm thick and extending to the edge of the low profile cap, which has been removed. The right hand edge of the indicated geometry is taken to be a surface with no normal motion of the MSA-2 material, thereby approximating the restraint of the surrounding MSA-2 material. The slight undercut of the low profile cap has been simplified by using an angle to the interface. The volume occupied by the fastener is indicated by the shaded region. The MSA-2 material is shown with a 1 mm thickness at the centerline, and a 3 mm thickness away from the fastener.

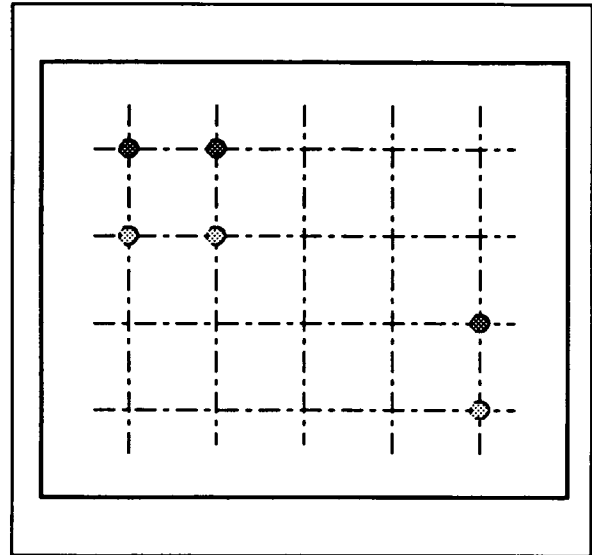
Figure 5: Proposed Test Panel

The test panels should be prepared in a fashion similar to that shown schematically in Figure 5. Each test panel of 0.125" thick aluminum contains four rows of five simulated fastener locations. The figure indicates typical locations for each of the 20 simulated fasteners, which are arranged in alternate rows of five with overfill, five without, etc. The simulated fastener locations were located on centers approximately 10x the size of the raised region which includes the PR-1422 material, and the raised MSA-2 material covering the sealant. The distance is to provide space sufficient to isolate each test location from all others, and for cutting each test specimen such that the 2"x 2" test specimen is large enough to minimize the influence of edge failures during tensile testing.

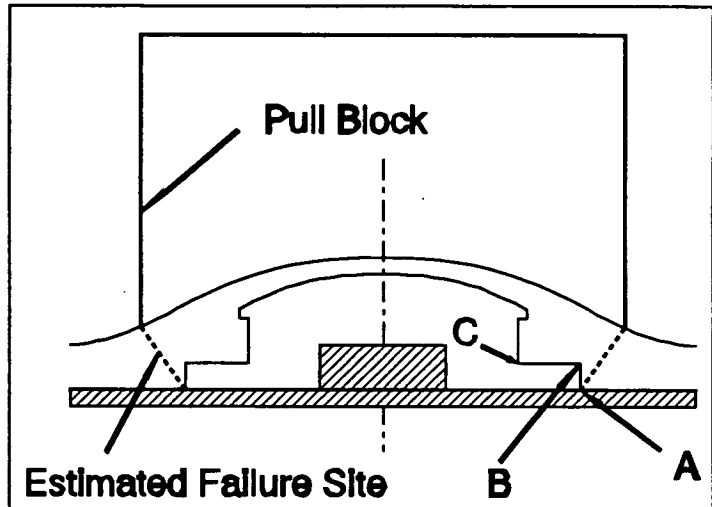
Figure 6: Schematic of Local Failure Region and Test Block

It was anticipated that failure of the locations with overfill will initiate at location B. Disbond will extend from B to locations A and C and beyond C toward the centerline, along the material interface. It was not known how suddenly the disbond along this path will be. At this time, I assume that the bond will remain intact up to some critical load level at which the disbond occurs. Following disbond, the load deflection curve is likely to be more compliant, indicating that there is softer support for resisting the pull bar. The break point is indicated in Figure 6 as point B. Final failure will likely occur as a separation along the path indicated as the estimated failure site.

The testing was largely successful. The test pieces were successfully fabricated and failure surface appearance seemed consistent with the PFA in that interface fracture took place on all test pieces. In many cases the painted aluminum surface is seen near Location A in Figure 6. The interface at the PR-1422 curved surface above the nut location failed on all tests, as expected; good bonding of this surface was observed.

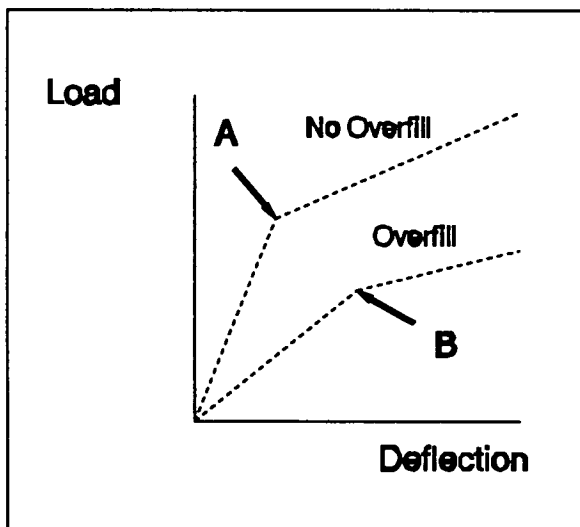
Figure 7: Schematic of the Load-Deflection History for the Pull Test

The pull test for no overfill of the PR-1422 material will show less compliance than for the test with overfill. The reason is that there is more MSA-2 material between the pull bar and the aluminum panel, to resist the applied loading. At a critical load level, the MSA-2/aluminum bond will fail (indicated in Figure 3 as point A). The loading will shift more toward the MSA-2/PR-1422 interface centered over the simulated fastener location. This load path is much more flexible than the original load path prior to bond failure and the load deflection curve will likely show a significant increase in compliance. Failure at the indicated failure site in Figure 6 will likely occur at point A in the load history.
