**NASA
Technical
Paper
3222**

Hot Fire Test Results of Subscale Tubular Combustion Chambers

John M. Kazaroff,
Robert S. Jankovsky,
and Albert J. Pavli

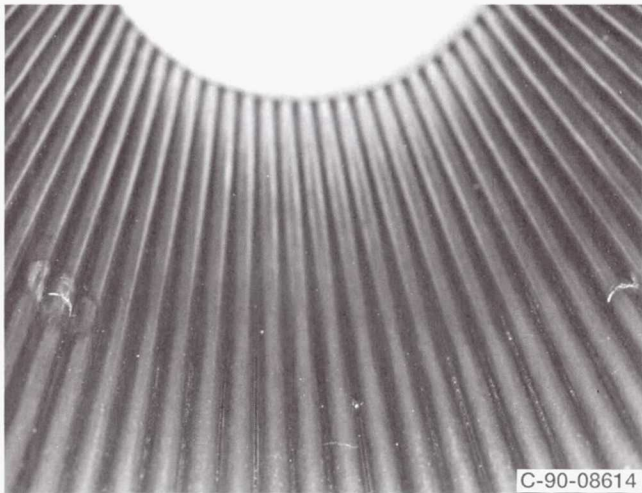
Figure 4.—Inside view of tubular chamber showing two installed crown thermocouples.

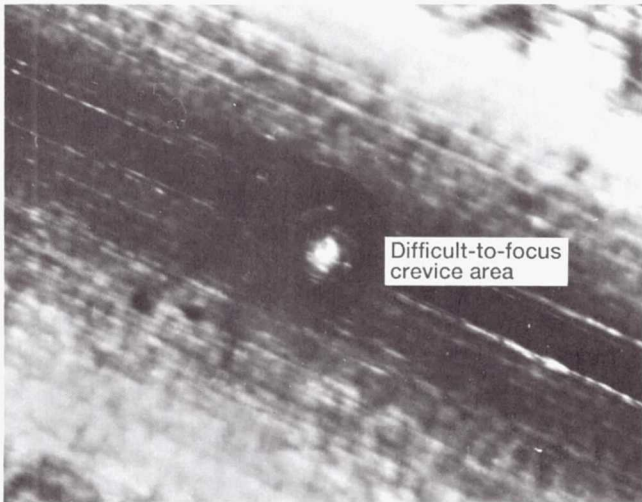
Figure 5.—Thermocouple junction in the crevice area.

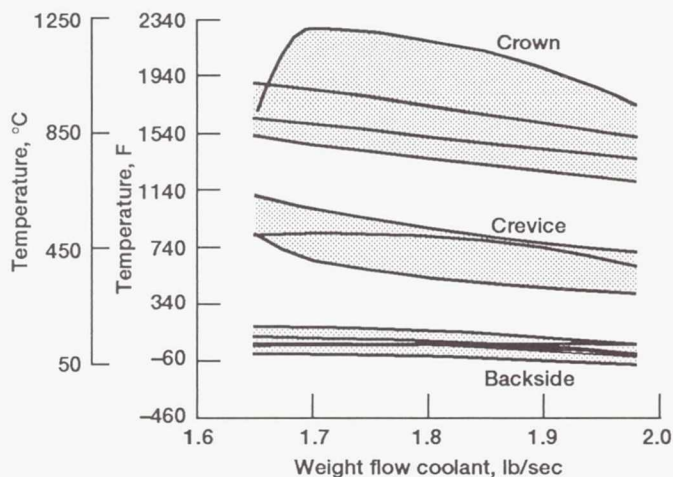
Figure 6.—Instrumented tube chamber data.

The first hot-fire tests were performed to determine flow set points and to measure the hot-gas-side wall temperatures. The results of these tests are shown in figure 6, which is a plot of the various temperature measurements as a function of coolant flow rate. The melting-point temperature of the OFHC copper tubes is 1083 °C (1981 °F). Clearly, some of the crown thermocouples were not correct. The measurement of crown temperatures by milling away almost one-half of the wall thickness, to provide a groove for the thermocouple and then replacing the copper of that groove with stainless steel, ceramic, and chromel/alumel wires, may have unduly affected the true crown temperatures. The crevice temperature thermocouples, however, are located in a more forgiving environment and are more likely to provide some insight into the severity of the thermal environment.

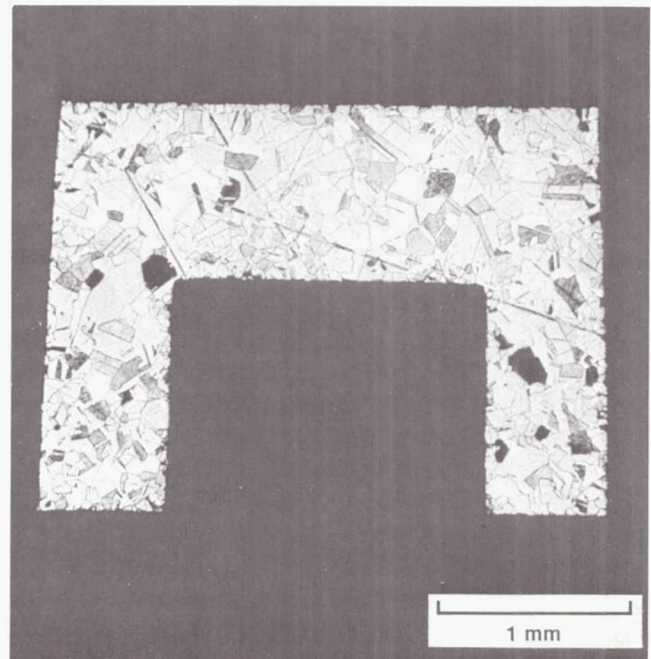
Grain growth phenomena of OFHC copper were also examined in reference 8. In this work coupons of OFHC copper were subjected to a variety of temperatures. The coupons were ground, polished, etched, and then photographed to compare them with the tubular thrust chamber specimens. This was done to obtain better definition of the thermal environment to which the specimens had been exposed. Figure 18 was taken from the work reported in reference 8. This figure shows the grain size obtained after heating an OFHC copper channel 10 min at 760 °C (1400 °F). The photograph was taken at a magnification of 25×. For comparison, a sample of

Figure 18.—Grain size specimen from annealing study, 10 min at 770 °C (1400 °F).

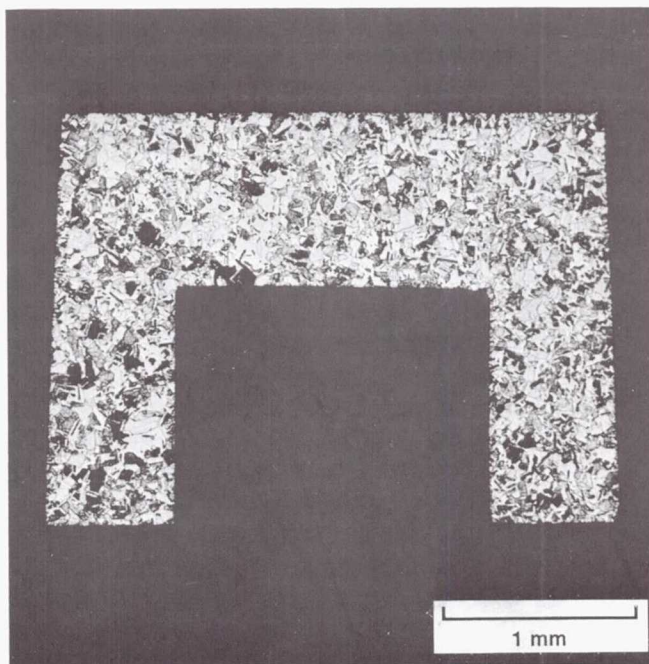
Figure 20.—Grain size specimen from annealing study, 10 min at 538 °C (1000 °F).

Figure 20 shows the grain size resulting from exposure to 538.1 °C (1000 °F). Grains of this size are also seen in figure 19, which shows an area just below the crevice region. This indicates that the temperature in the crevice region was slightly higher than 538.1 °C (1000 °F). This accounts for a crown to crevice difference of just under 204.4 °C (400 °F), which agrees reasonably well with the analytical prediction of 171.4 °C (340 °F) for this difference.
