NASA Technical Memorandum 105807

Nondestructive Evaluation of Ceramic and Metal Matrix Composites for NASA's HITEMP and Enabling Propulsion Materials Programs

Edward R. Generazio
Lewis Research Center
Cleveland, Ohio

August 1992

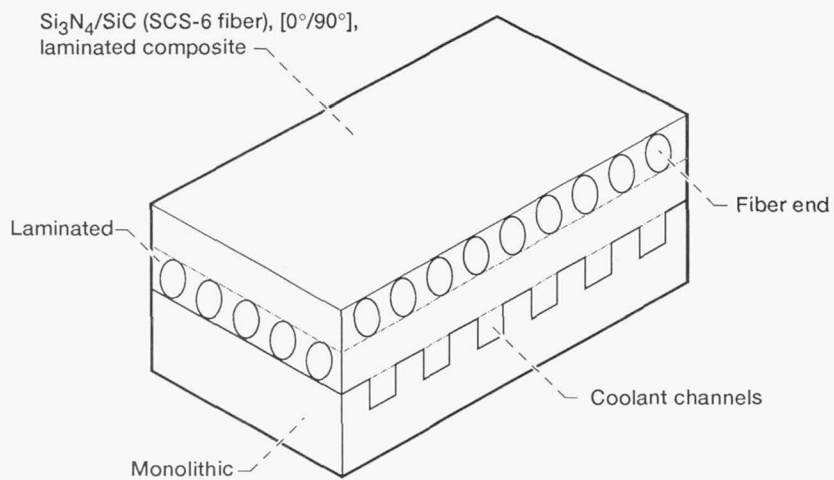
We begin our study with the development of a Si_3N_4 /SCS-6 (ref. 15) panel that contains coolant channels (fig. 1). The actively cooled panel is made up of a monolithic, 10.0 by 10.0 cm, Si_3N_4 slab that is laminated to a cross-ply composite panel Si_3N_4 /SCS-6 [0-90]. The laminated panel is 0.335 cm thick. The monolithic panel has 0.05 cm wide and 0.05 cm high coolant channels. The channel walls are 0.05 cm thick. During the development of this panel the interlaminar bonding procedure is evaluated by bonding two similar but monolithic plates. The bond between planar layers may be evaluated with radiographic and through transmission, focused 10 MHz, ultrasonic c-scan analysis; the results are shown in figures 2 and 3, respectively. A low x-ray intensity, i.e., high x-ray attenuation, corresponds to dark region in the x-ray film positive. The dark vertical bands in the radiograph correspond to the walls of the coolant channels. The channels are uniform in shape and there are no chips, cracks or occlusions present. There are two lighter vertical bands at areas where poor reaction of the bonding material produced low densities. (A subsequent modification of the manufacturing process eliminated these poorly reacted areas.)

Figure 1.—Schematic diagram showing structure of composite, actively cooled panel.

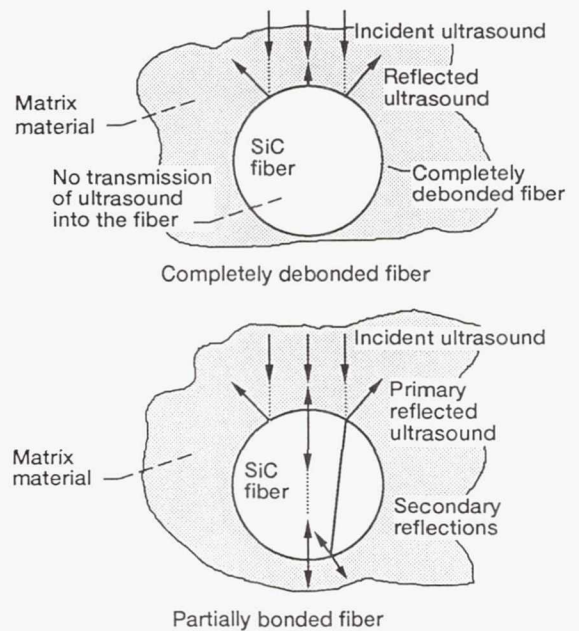
Figure 21.—Schematic diagrams indicating possible source of secondary image blurring scattering.

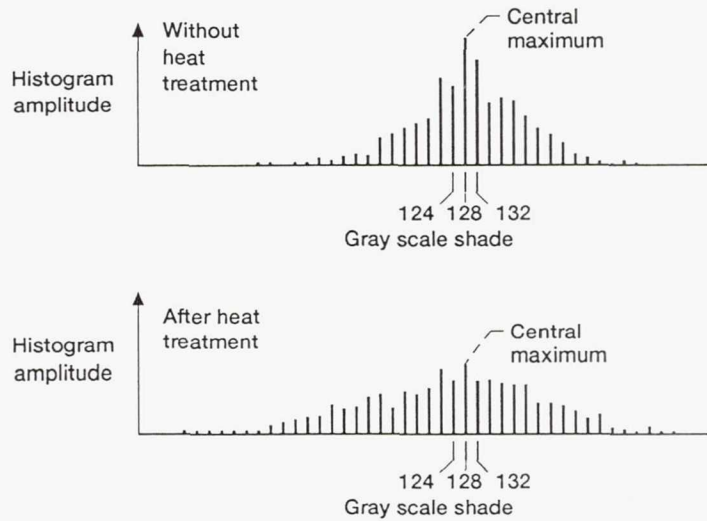
Two identically produced specimens of $\text{Si}_3\text{N}_4/\text{SiC}$ (SCS-6) [0] were ultrasonically evaluated using the DERICI technique. The DERICI images are spatially filtered with a two-dimensional high pass filter before further evaluation. This filter extracts the important spatial high frequency components (i.e., reflections from the fiber-to-matrix interface) from the reflections from porosity which are generally observed as mottling in ceramics (refs. 16 to 22 and figs. 5 and 7). The DERICI results reveal similar features in both samples before heat treatment (fig. 26). The vertical features in these images are due to reflections at the subsurface fiber-to-matrix interfaces. One sample was heat treated at 600 °C for 100 hr in flowing oxygen to degrade the fiber-to-matrix interface (via oxidation) (ref. 24). This heat treatment decreased the interfacial shear strength from 18 ± 4 MPa to 0.8 ± 0.4 MPa (ref. 24). After heat treatment there is a marked change in the DERICI image. After heat treatment the reflections from the interface are more intense so that the fibers become more visible. This change in the DERICI results before and after heat treatment can be quantified. The histogram maximum of the gray scale of each of the images may be used to quantify the DERICI results (fig. 27). A low value for the histogram maximum indicates that there is considerable amount of scattering at the fiber-to-matrix interfaces per unit area. A high maximum value indicates that the fibers are difficult to observe and that the image is rather bland or smooth. Ideally, if the fibers were perfectly bonded, and therefore essentially unobservable (except for the small variation in the acoustic impedance between the fiber and matrix) then the DERICI images would contain predominantly one shade, 128, in the gray scale. The gray scale maximums for the untreated and heat treated specimens are 1.9 and 3.3 (arbitrary units), respectively. This corresponds to about a 75 percent change in histogram amplitudes. These values can be correlated with the respective interfacial

shear strengths. If the interfacial shear strength is strongly dependent on the contact area between the fiber and matrix, then the DERICI results, which are also sensitive to changes in this contact area, are images of variations in interfacial shear strength. Since the fiber and matrix acoustic impedances are not identical, then the interrelationship between the DERICI results and the interfacial shear strength, which to first approximation is assumed to be a linear relationship, will contain a calibration or scale factor. The radiographs before and after the heat treatment (fig. 28) show essentially similar results.

Figure 27.—Histograms of DERCI images of $\text{Si}_3\text{N}_4/\text{SiC}$ SCS-6 [0] RBSN samples before and after heat treatment.

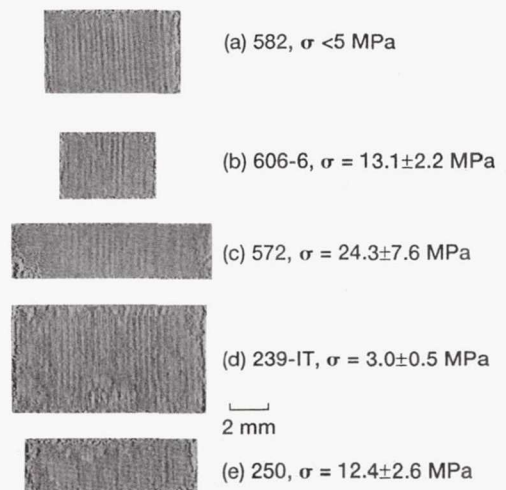
These ultrasonic results are similar (ref. 7) to those found for a series of CMC samples (fig. 29) produced to have a wide range of interfacial bond strengths (fig. 30).

Figure 29.—DERCI images of $\text{Si}_3\text{N}_4/\text{SiC}$ SCS-6 [0] RBSN samples having a range of interfacial shear strengths.

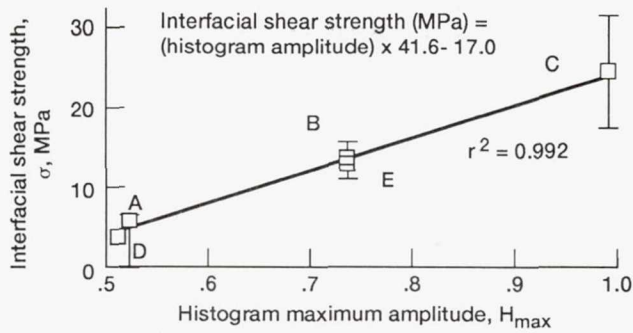
Figure 30.—Histogram maximum amplitude versus interfacial shear strength for the $\text{Si}_3\text{N}_4/\text{SiC}$ SCS-6 [0] RBSN samples.

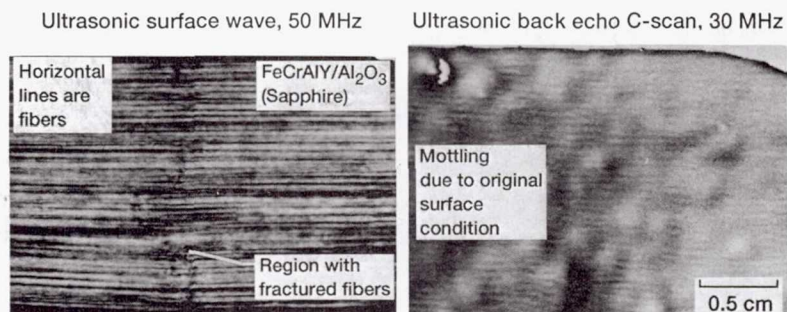
Figure 32.—Ultrasonic surface wave and back echo images of FeCrAlY/Al₂O₃ (sapphire fiber) composite.

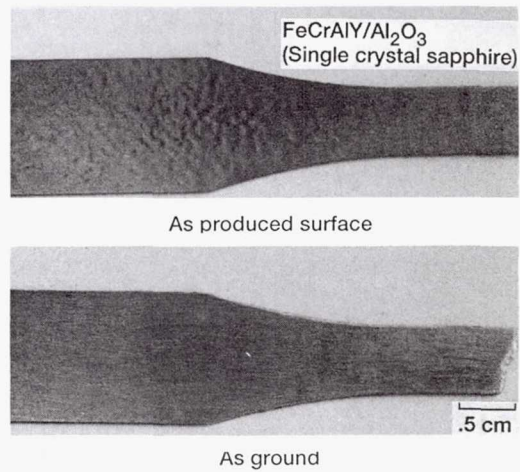
Figure 33.—Optical images of "as produced" and "as ground" FeCrAlY/Al₂O₃ (sapphire fiber) composite.
