## ADDITIONAL RESULTS ON SPACE ENVIRONMENTAL EFFECTS ON POLYMER MATRIX COMPOSITES — EXPERIMENT AO180

R. C. Tennyson  
University of Toronto Institute for Aerospace Studies  
Toronto, Ontario, Canada  
M3H 5T6

### ABSTRACT

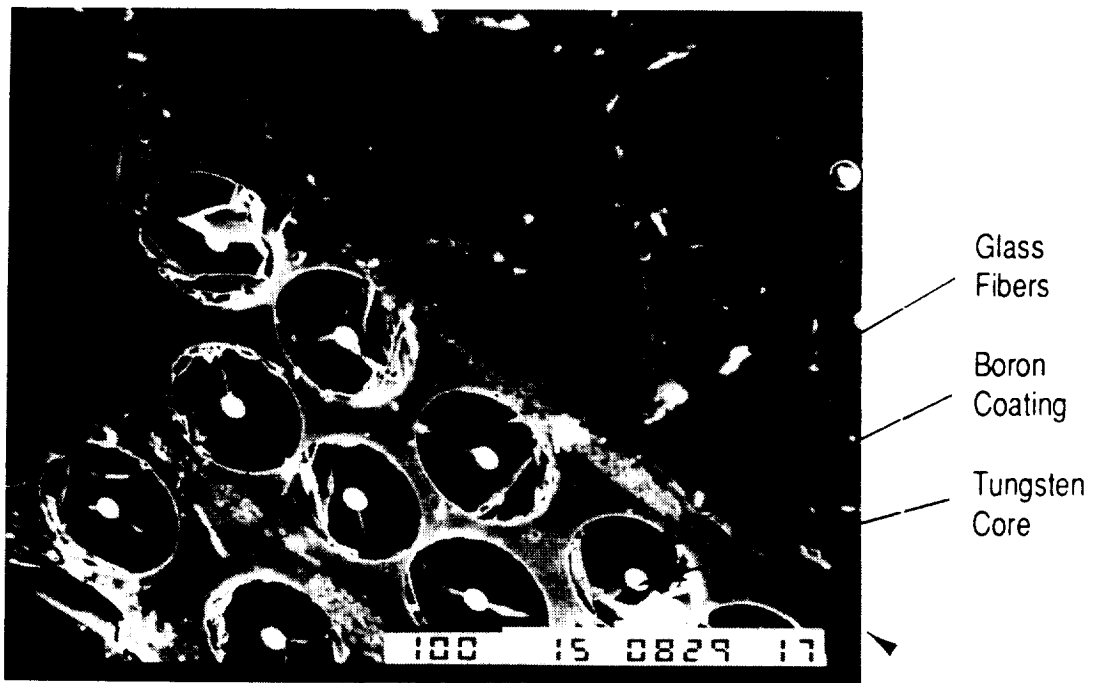
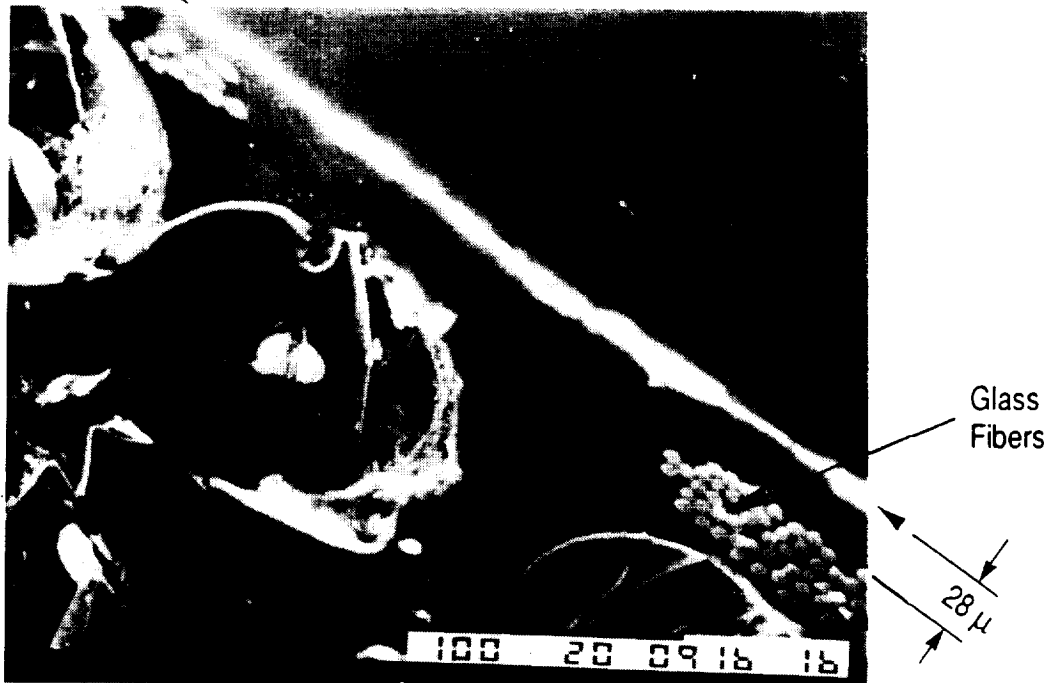
Fig. 2 SEM Photographs of Cross-Section of Unexposed Boron/Epoxy Tube [SP-290,  $(\pm 45^\circ)_4S$ ]. (Arrows delineate boundary between outer epoxy layer and potting compound)

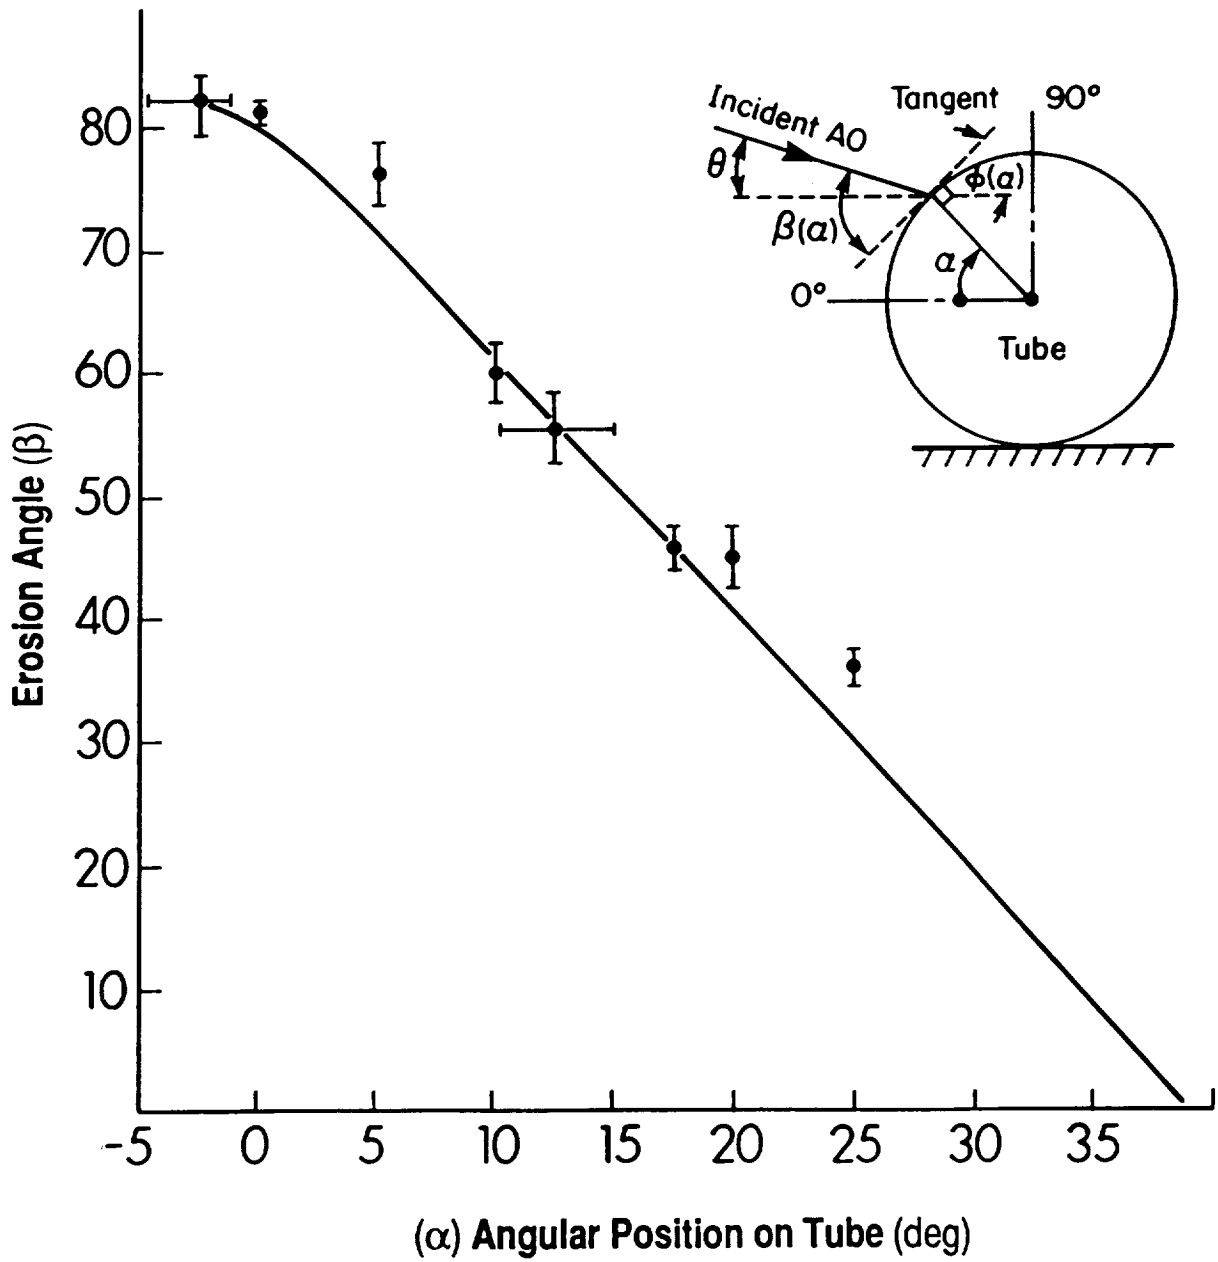
Fig. 4 Variation in Erosion Angle ( $\beta$ ) with Angular Position ( $\alpha$ ) around Boron/Epoxy Tube [SP-290, ( $\pm 45^\circ$ )<sub>4S</sub>]
