NASA Contractor Report 181780

Manufacturing Development of Pultruded Composite Panels

LOCKHEED AERONAUTICAL SYSTEMS COMPANY
BURBANK, CALIFORNIA 91520

PREPARED FOR
LANGLEY RESEARCH CENTER
UNDER CONTRACT NAS1-15069
APRIL 1989

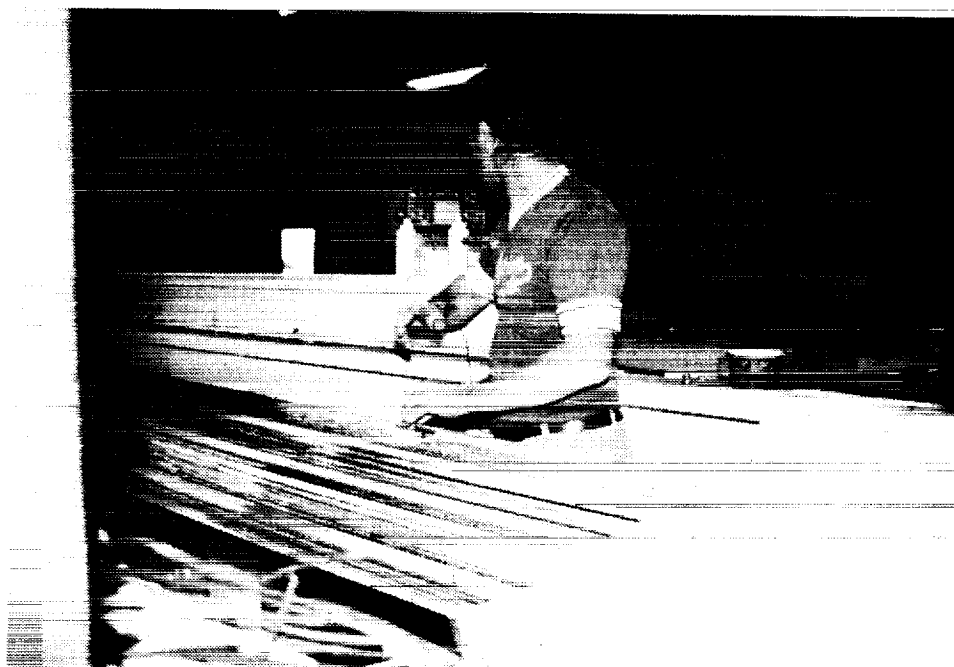
Figure 18. Ultrasonic A-scan of pultruded plank

The pultrusion run produced 10-1/2 feet of pultruded J-stiffened panel (shown in Figure 20). Ultrasonic inspection revealed numerous indications of porosity. These indications were confirmed by photomicrographs.

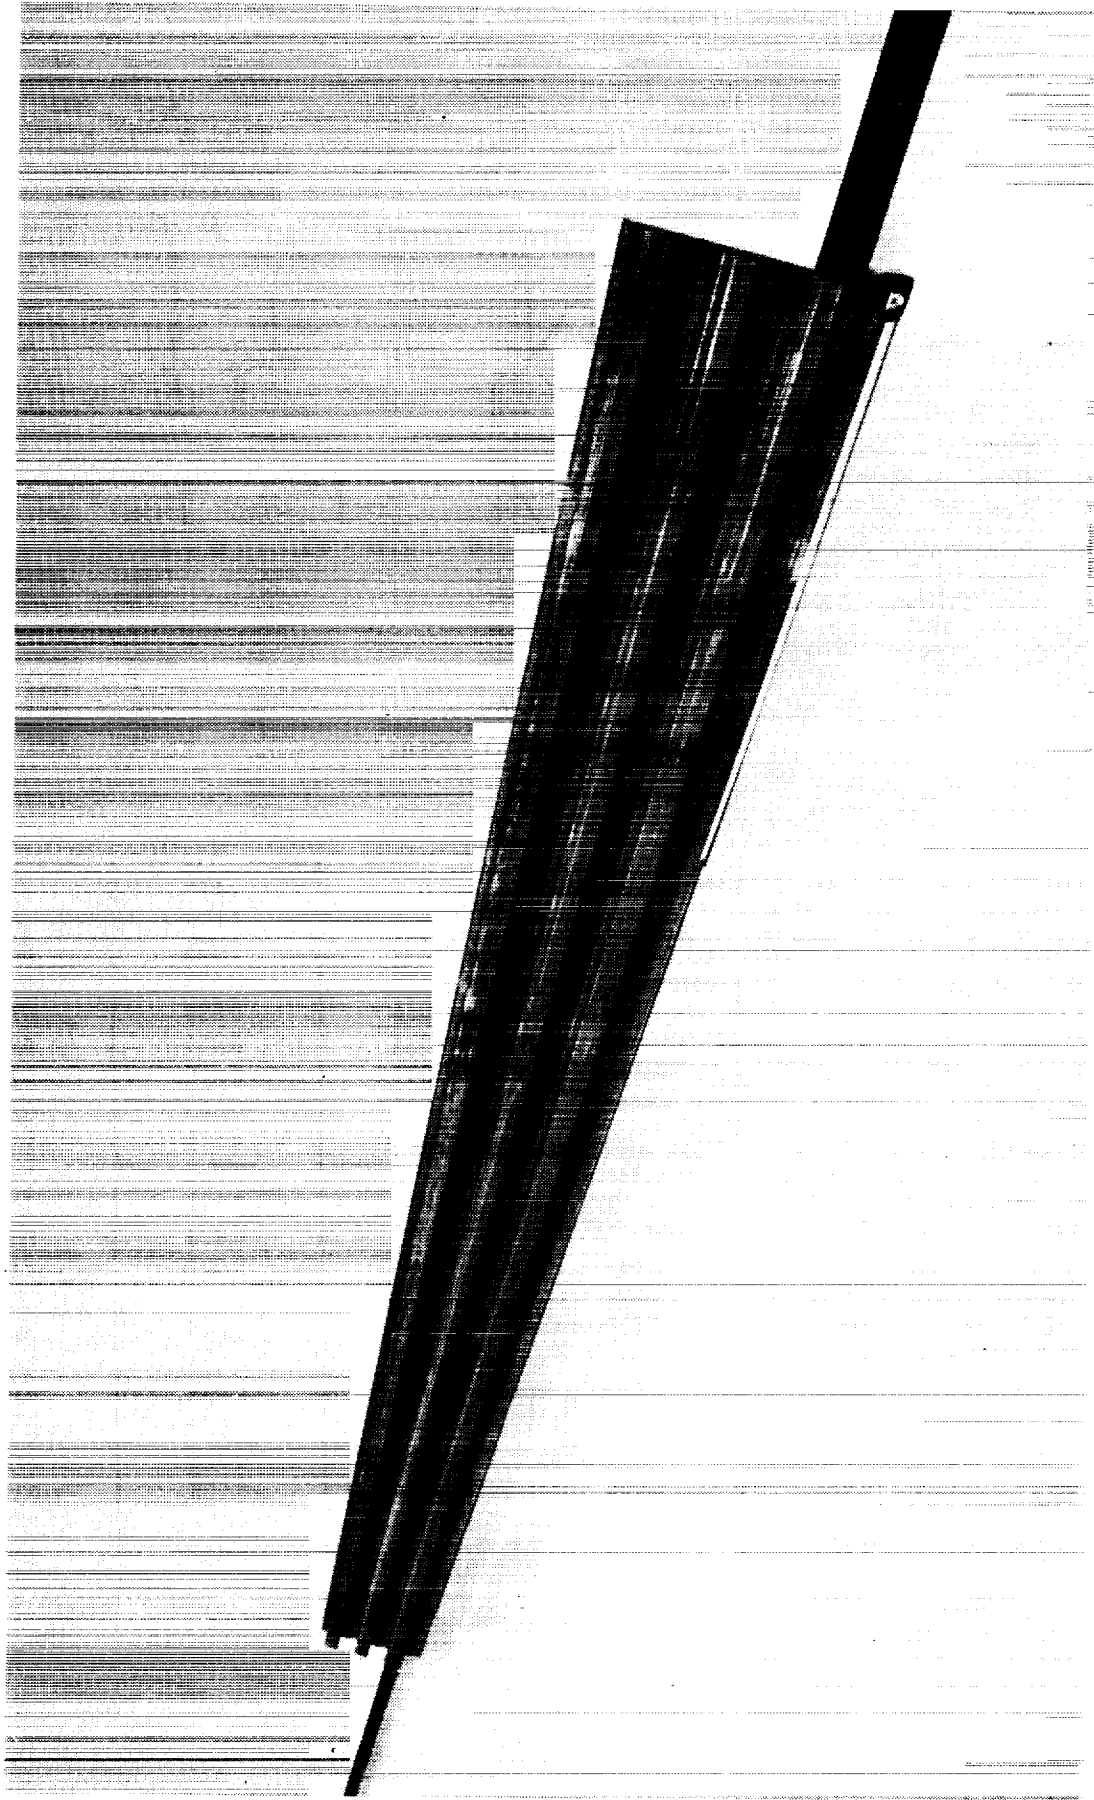
Figure 23. - Twenty-three foot long pultruded panel

The 23 foot pultruded panel, shown in Figure 23, was received by LASC and was postcured for two hours at 350°F. Following the postcure, the panel was inspected on a large gantry robot to determine the flatness of the panel. Results are shown in Figures 24, 25, and 26. The panel exhibited the same warping observed in previous panels whether autoclave cured or pultruded. Three pieces were cut from the panel for ultrasonic inspection and tag end

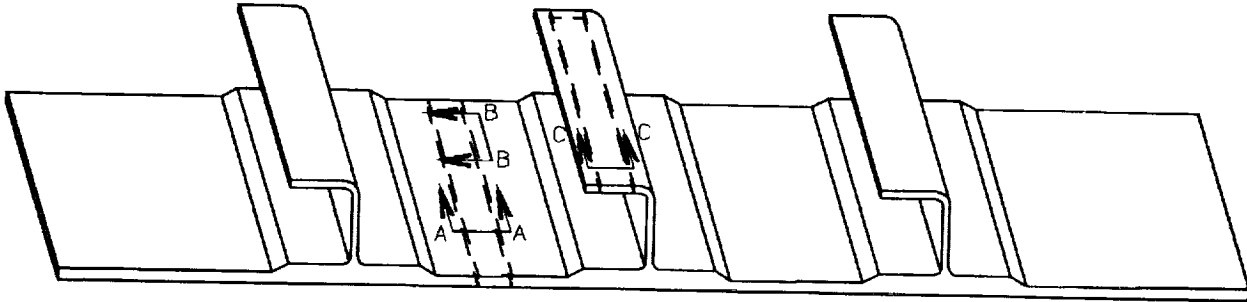
Figure 27. Key to photomicrograph locations

testing. Ultrasonic inspection revealed numerous porous areas. This result was confirmed by photomicrograph. Figures 27 through 27E show typical areas of the panel. Unwetted fiber could be seen as well as voids within the resin itself. Tag end tests on the panel were made. Upon completion of the inspection, a 10 foot section was shipped to NASA for structural testing. Results of the NASA testing are presented later in this report.

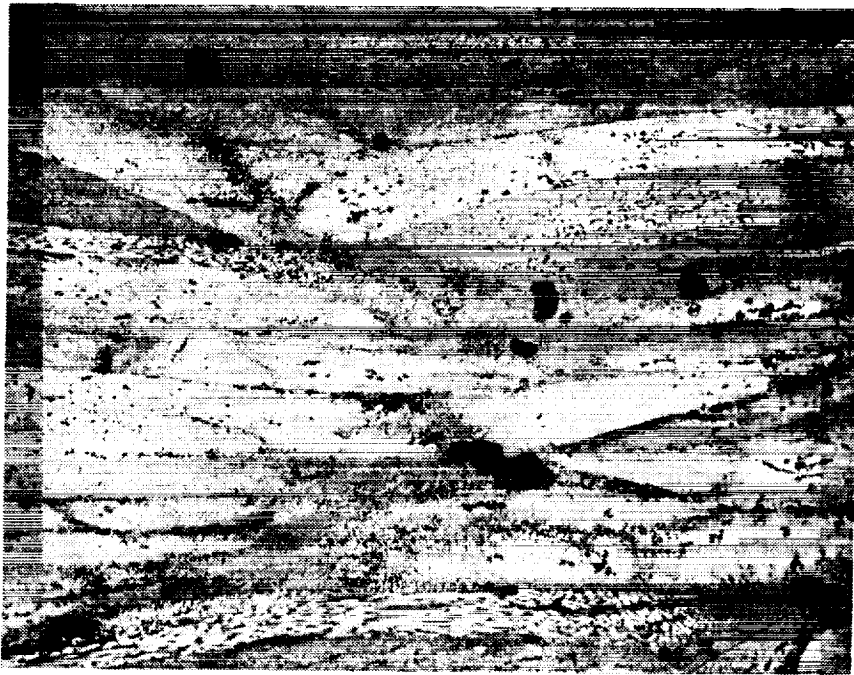
Figure 27A. Photomicrograph A-A (25X)

Preliminary measurements showed the first 1986 panel to have 1.5 percent voids in the skin section compared to 0.75 percent voids in the 1987 panel. Measurements at the base of the stringer indicated 2.0 percent in the 1986 panel and 1.9 percent in the 1987 panel. However, the resolution of the camera may exclude a significant void area. A higher resolution system was sought to better measure the void content.

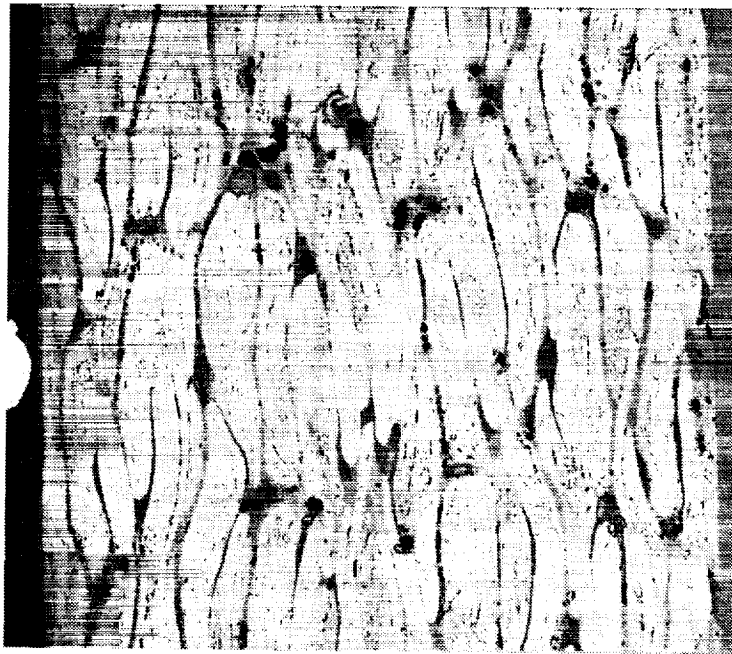
Figure 39. 9310 pultruded laminate 10x magnification

The investigation included several discussions with and visits by Shell technical personnel. Also performed were three processing studies using a wet layup of 9310 in a press. The purpose of the processing studies was to establish a baseline for the 9310 resin. It was not evident whether poor consolidation and subsequent poor mechanical performance was a function of the pultrusion process creating the porosity or the resin system itself volatilizing to form the porosity.

The second wet layup was made using a "puddle" method with a press and vacuum bag. To obtain the correct resin content, resin was poured (or puddled) onto each ply. The layup was then placed under vacuum and into a 300°F press at 200 psi for 30 minutes to simulate the pultrusion process. The resin content of this laminate was in the desirable range, however, photomicrographs indicated porosity levels similar to that of the pultruded panels. Figures 38 and 39 show photomicrographs of the puddle method and pultruded plank, respectively.

The residual porosity entrapped in the resin in the second pultrusion session could either be caused by items 3) or 4). To eliminate air being carried into the pultrusion bath by the fibers, the bath could be pressurized slightly to push the air out as the fibers enter the bath.

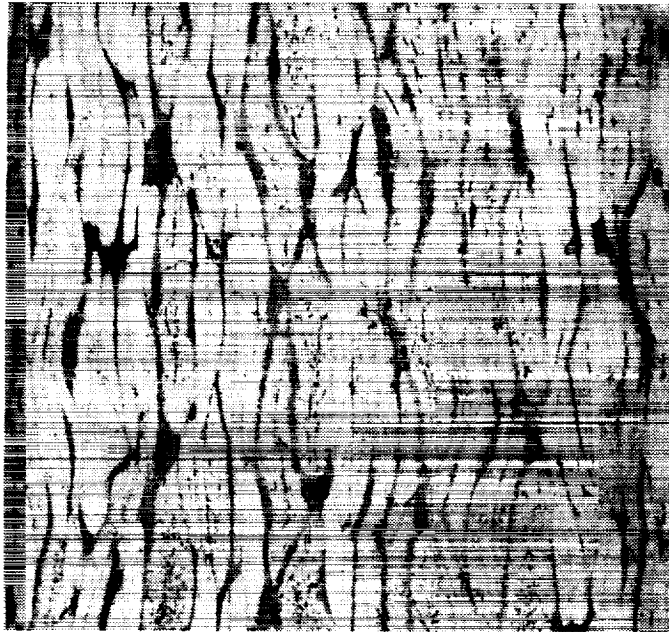
Figure 40. Third "wet layup" trial panel 10x magnification

Based on the results of degassing studies, the resin was degassed for another wet layup trial. The "dip" method was used to impregnate the fibers for this trial and so about a half gallon of resin was degassed. The resin was degassed for two hours and there was still a 1-inch head of foam on the resin. Since it was not desired to detrimentally stage the resin, the layup was started after the two hour degassing step. The panel was cured in a press under vacuum, at 170 psi and 300°F for 30 minutes. Photomicrographs of this panel are shown in Figure 40.

cups foamed to almost double its original volume. This result indicated an agent in the resin which is highly reactive or volatile. According to the Material Safety Data Sheet (MSDS) sheet for 9310, the resin is loaded to 10.34 percent by weight with styrene. Figure 41 is the vapor pressure diagram for styrene for pressures up to 1 atmosphere. (Data is from the Chemical Engineer's Handbook.) Two significant points were noted from this chart. First, boiling temperature is logarithmic with respect to pressure, that means the boiling point of 293°F at 1 atm does not increase significantly even at 10 atmospheres. The second point noted was that the processing temperatures of 300-325°F are above or extremely close to the boiling temperature of styrene. Dialogue was continued with the vendor to determine how to combat this problem prior to the last pultrusion.
