TWR-17548 Volume II

FLIGHT SET 360L009 (STS-36)  
 CASE AND SEALS COMPONENT FINAL REPORT

NOVEMBER 1990

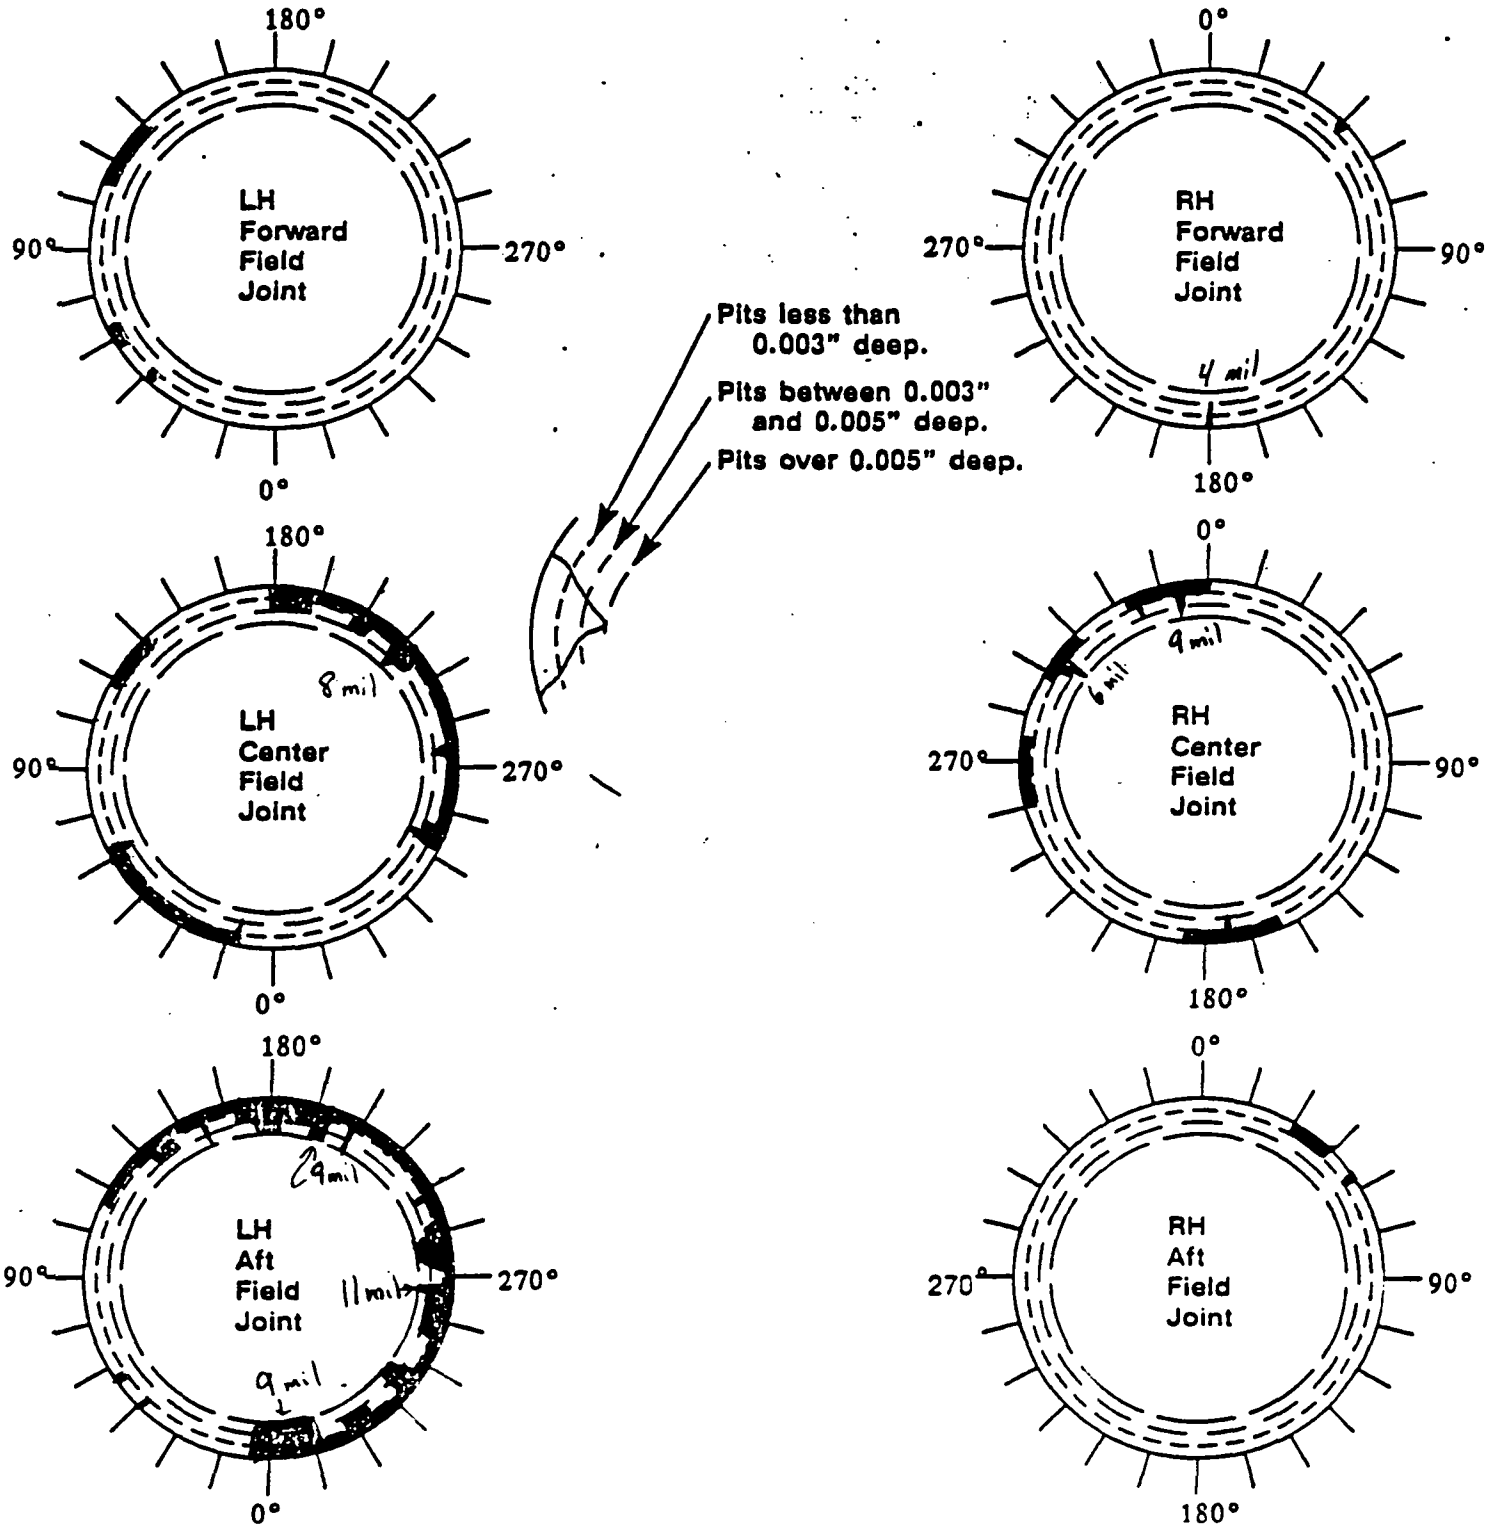
The post fire assessment of both motors showed the case segments to be in good condition. Field joint fretting on this flight set ranged from light (<0.003 inch deep) on most of the joints to locally heavy (>0.005 inch deep) on three of the joints, figure 5 visually summarizes the fretting on all the joints. The LH aft field joint is the most heavily fretted joint to date, this joint had previously fretted areas from STS-27. No new fretting was found in old fretting locations; however new frets were found at the edges of repaired areas on both the LH center and aft field joints. All fretting was mapped from the inner clevis leg. The capture feature fretting was not mapped due the difficulty of measuring the fretting in the capture feature region, but it is assumed that the capture feature had similar damage as the inner clevis leg. Listed below is a summary of fretting for each field joint:

- LH/CTR Intermittent light fretting around most of the joint with concentrations of moderate (0.003 to 0.005 inch deep) and heavy (>0.005 inch deep) fretting between 180 and 300 degrees. A 0.008 inch deep fret was found at 225 degrees.
- LH/AFT Intermittent light fretting around most of the joint with concentrations of moderate (0.003 to 0.005 inch deep) and heavy (>0.005 inch deep) fretting from 135 through 0 to 9 degrees. Two 0.009 inch deep frets were found at 195, and 350 degrees and a 0.011 inch deep fret at 278 degrees.
- RH/FWD Light frets at 44 and 45 degrees and a 0.004 inch deep fret at 180 degrees.
- RH/CTR Light fretting from 156 to 187, 256 to 280, 298 to 315, and 338 through 0 to 1 degrees. Moderate (0.003 to 0.005 inch deep) fretting at 118, 305, and 340 degrees. A 0.009 inch deep fret was found at 350 degrees.
- RH/AFT Light fretting at 30, 35, 42, and 55 degrees.
